**Site at Hillhead of Lethenty, Inverurie,  
Aberdeenshire, AB51 0HT**

**Report on Level 1 Standing Building Survey**

**Alison Cameron  
Cameron Archaeology  
15 September 2014**

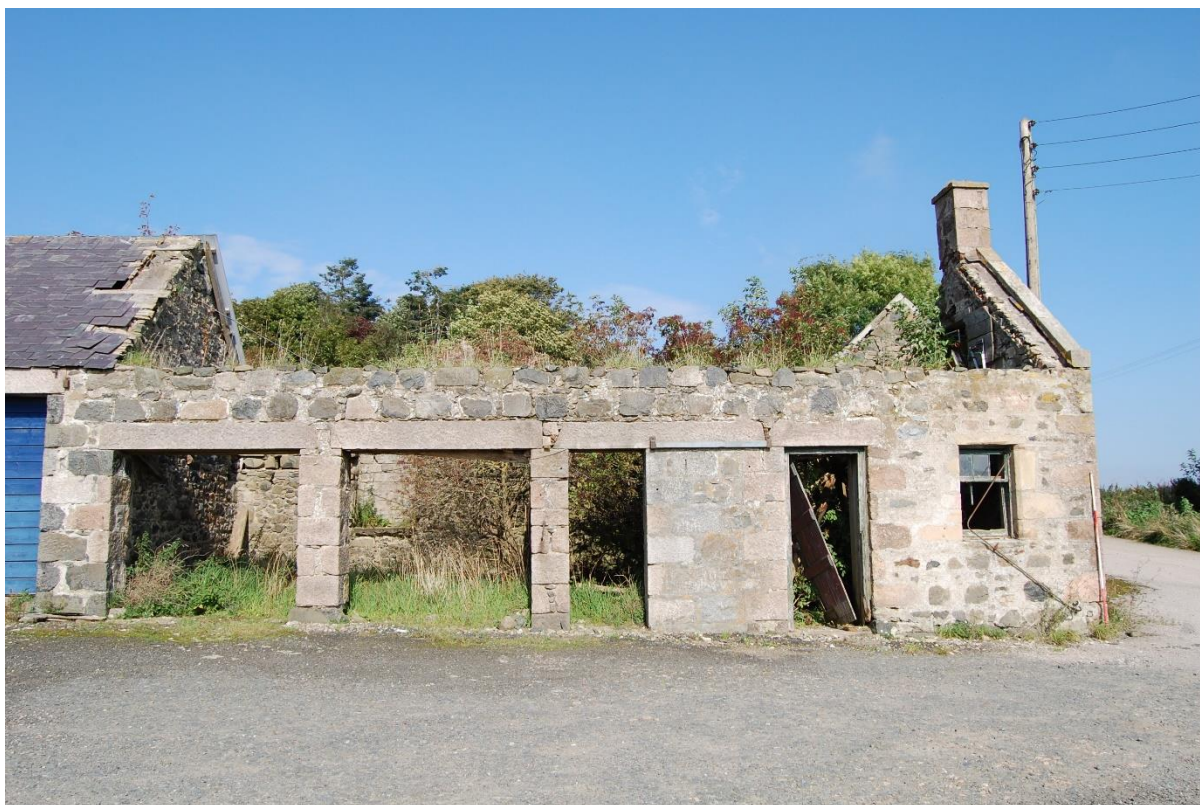
Rooms 1 and 2 are in poor condition with limited access to the interior. They are 13.6m long and 5.7m wide. They formed a separate building on the First Edition OS map (Illus 14).

They have two large cart doors 2.3m wide and 2.2m high (Doors D3 and D4). Room 1 was probably a bothy for the 19<sup>th</sup>-century farm and Room 2 the cartshed.

Illus 4 Room 1 (right) and Room 2 (left) with cart doors; facing NW

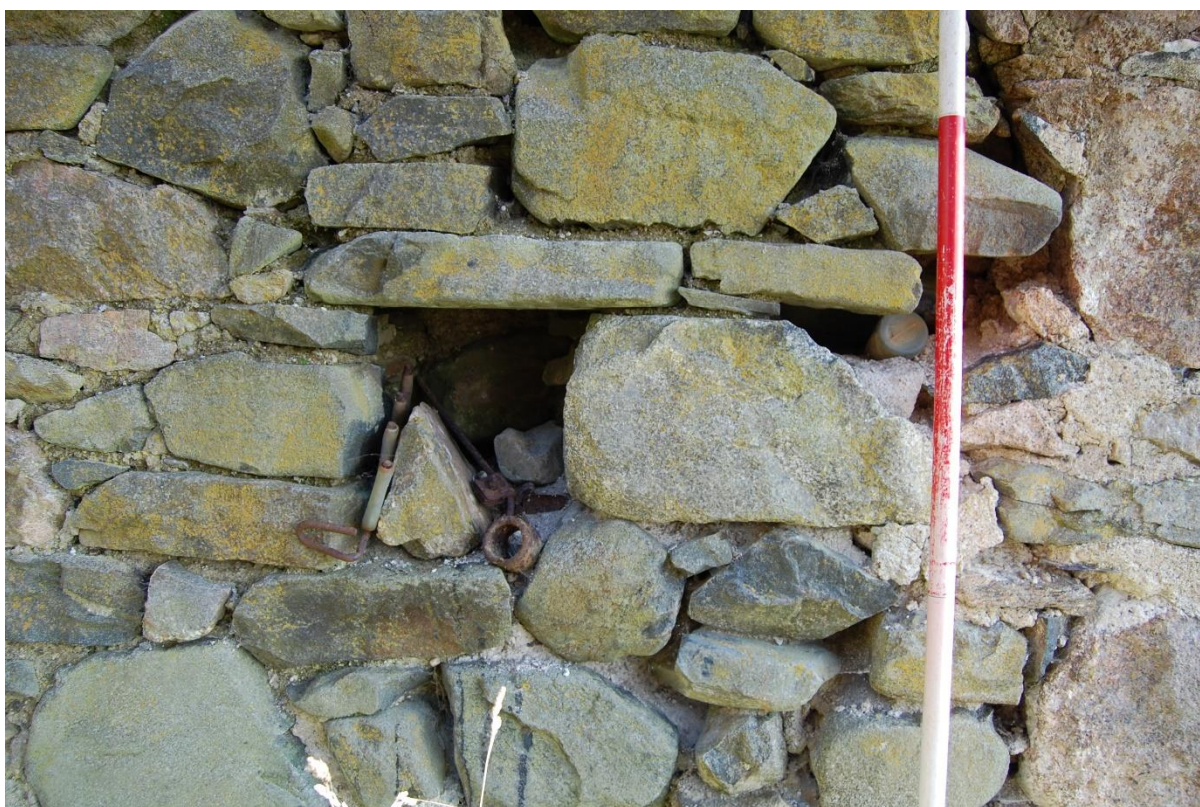
Illus 5 Stone alcove in NE wall Room 2

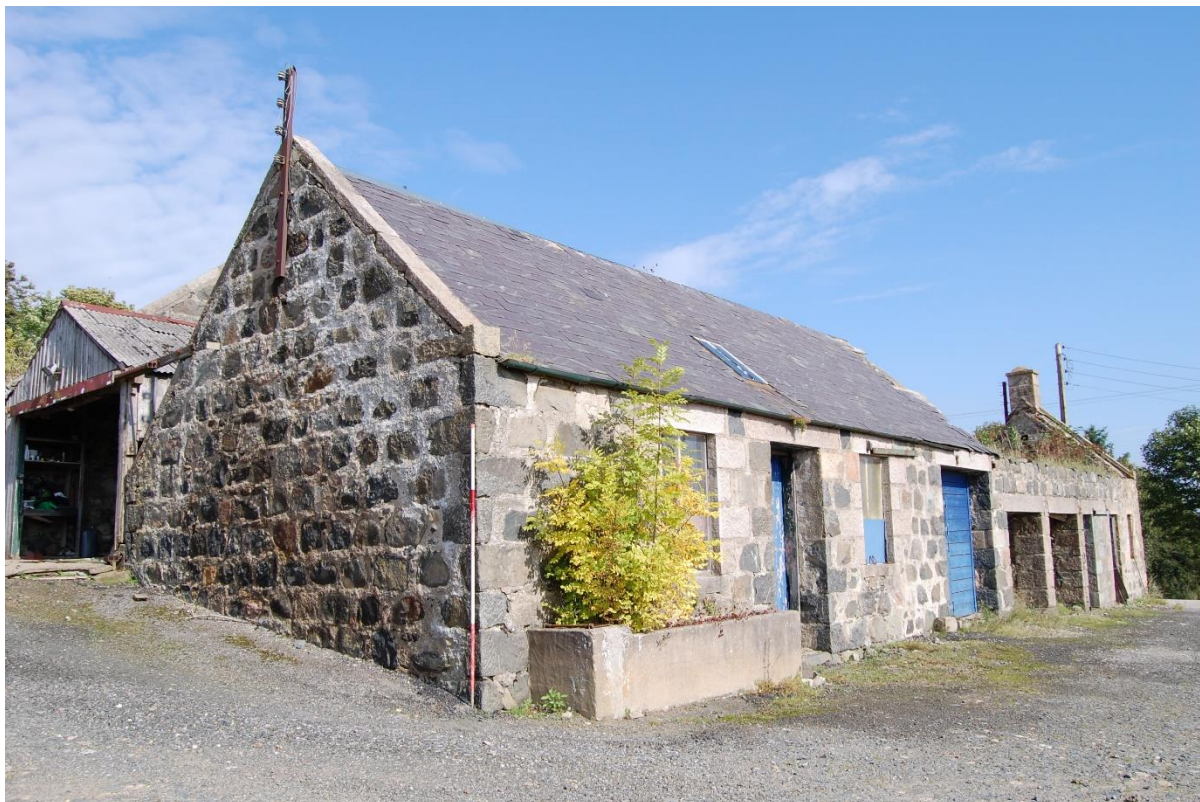
The cottage (Room 3) is 12m long and 6.4m wide and constructed of large granite blocks with cherry cocking. It has been rebuilt since the Second Ordnance Survey maps when a small building was located at the SW corner of the farm, not attached to the adjacent cartshed.

Illus 6 The cottage (Room 3); facing NE

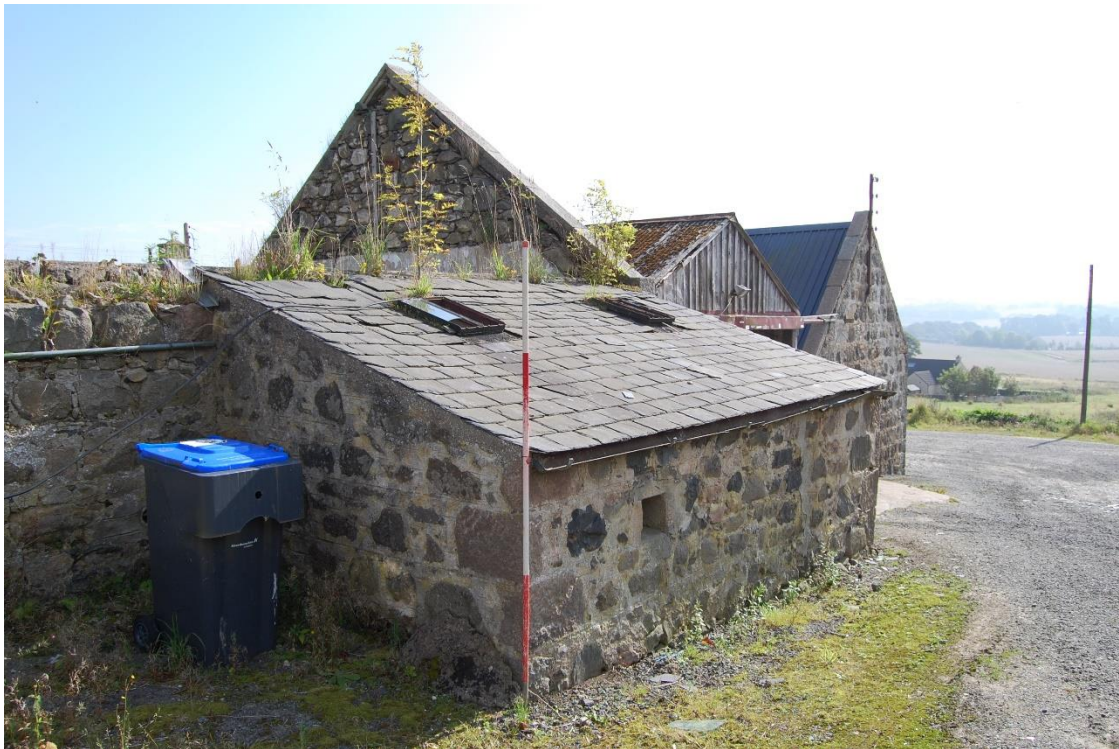
Room 6 is a stone lean-to shed 5m long and 2.6m wide on the SW side of R8. It was built on the site of a larger building which itself had been built on the location of the horse mill.

Illus 7 Lean-to shed Room 6; facing SE

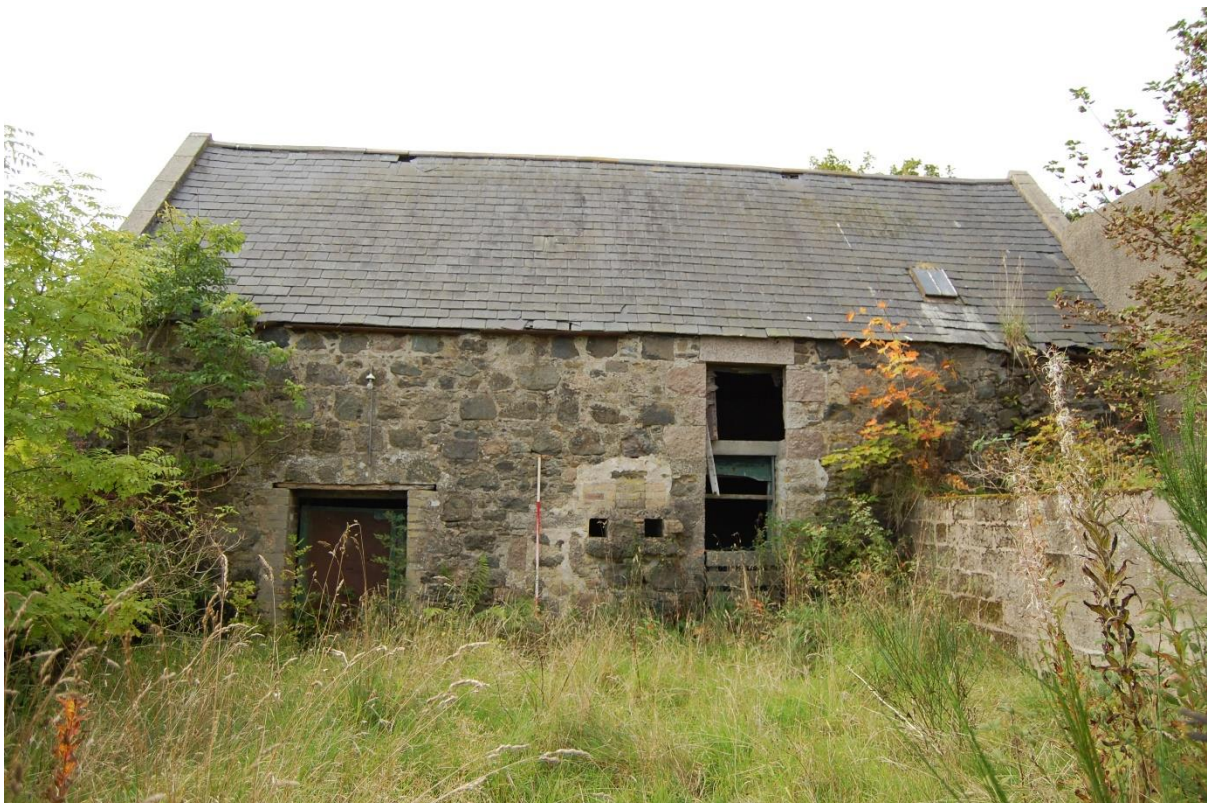
Room 9 (ground floor) and Room 10 (upper floor) formed the mill of the farmer farm complex on the 2<sup>nd</sup> Edition OS map when a horse mill was sited on the NE side of the building. The upper floor is inaccessible due to the poor condition of the wooden floor. The ground floor room has a metal grain chute (F3) and a wooden chute (F4). The NE wall has a concrete and wood grain chute (F2), 0.18 x 0.18m in size and a fitting (F1) which consists of a section of concreted stone wall with two square concrete apertures 0.2 x 0.2m in size.

Illus 8 Mill building rooms 9 and 10; NE wall facing SW

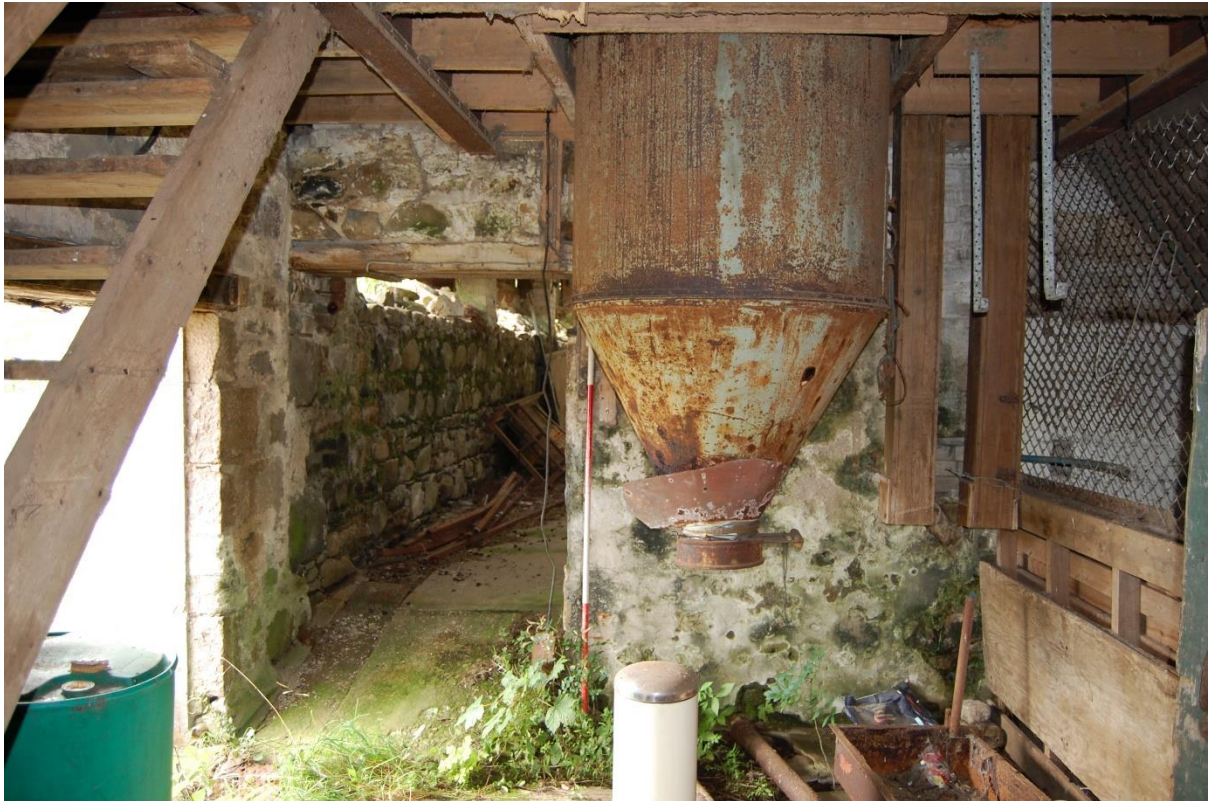
Illus 9 Metal grain chute F3; facing SW

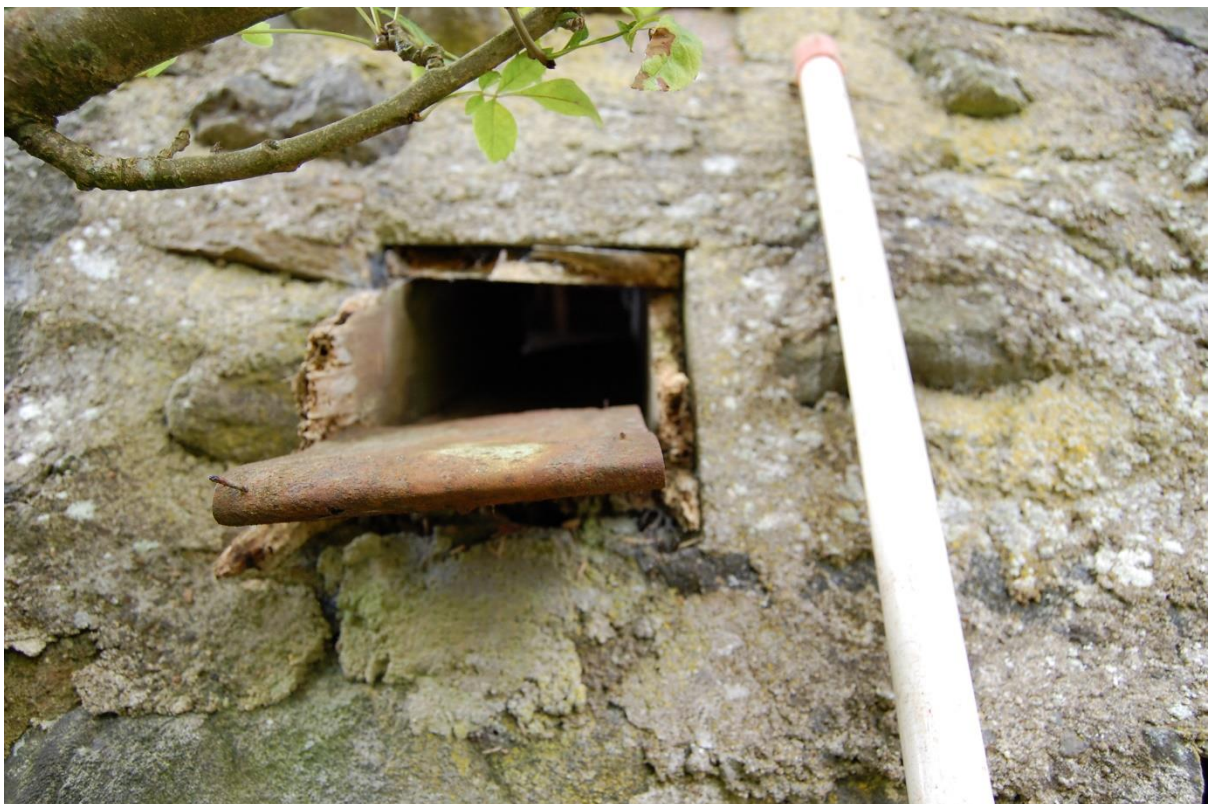
Illus 10 Grain chute F2; facing SW

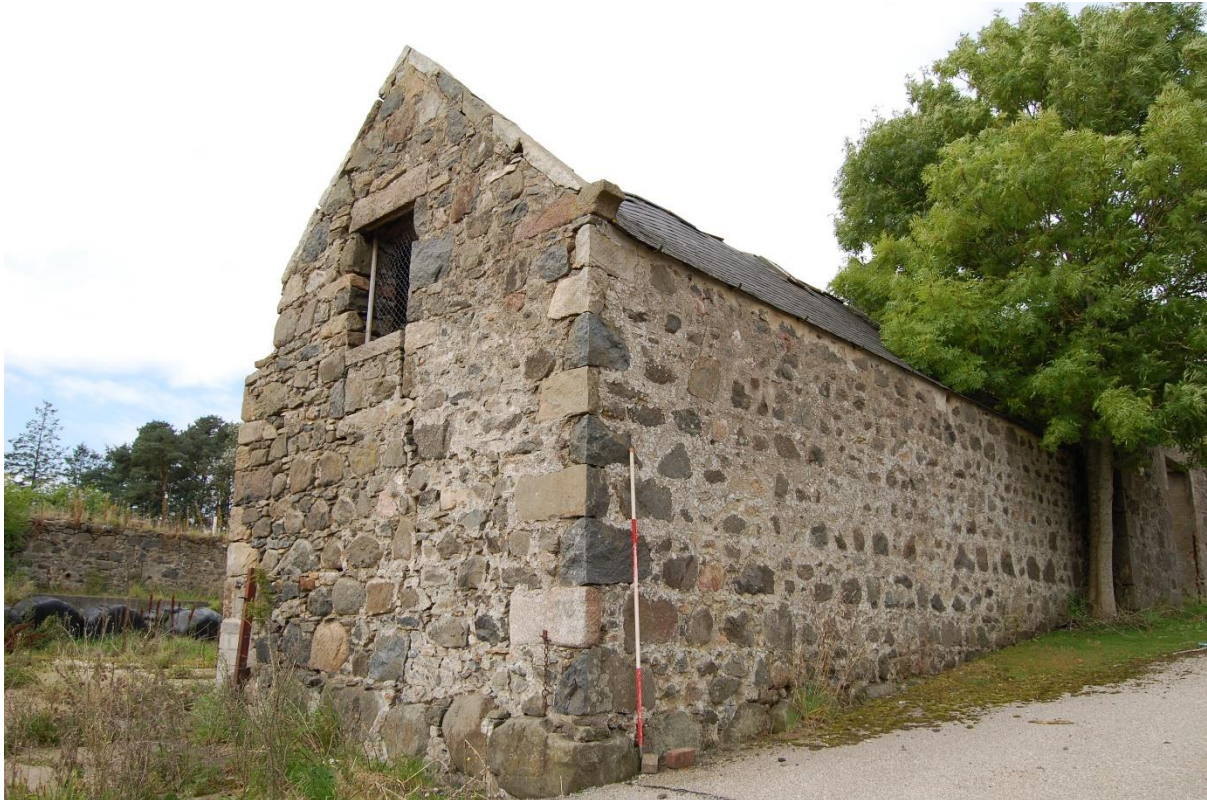
Room 12 is in poor condition and forms the NE arm of the C-shaped steading dating to before the First edition OS map and forms the NE side of the open courtyard. It is 10.8m long and 5.3m wide and constructed of large granite fieldstones the granite lintels and quoins. Window 11 in the SE gable has been converted from an upper door using a granite lintel and as a result there is a large crack down this wall. There are large stone foundation stones exposed at the SE corner of this building (Illus 11).

Illus 11 Room 12; facing NW

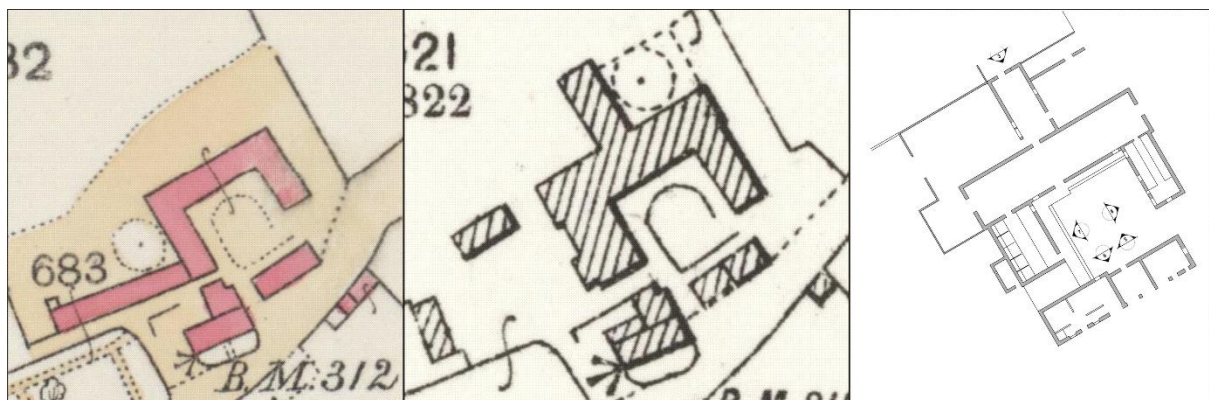
A Level 1 standing building survey was carried out on 11 September 2014. Several phases of buildings have been identified. In Phase 1 there is a C-shaped steading with a horse mill on the SW side; several buildings seen on the First Edition OS map including the horse mill have been demolished. In the second phase mill building (Rooms 9 and 10) were built on the north of the C-shaped steading and a horse mill constructed on the NE side of this building. It is recommended that no further archaeological work is required during this planning application.

Illus 14 Phase plan showing First and Second Edition OS maps (copyright National Library of Scotland) and 2014 plan (copyright Ian Duncan Architects)
