**Ley Farm, Crathes, Banchory, AB31 5QD
Report on Level 1 Standing Building Survey**

**Alison Cameron
Cameron Archaeology
14 November 2014**

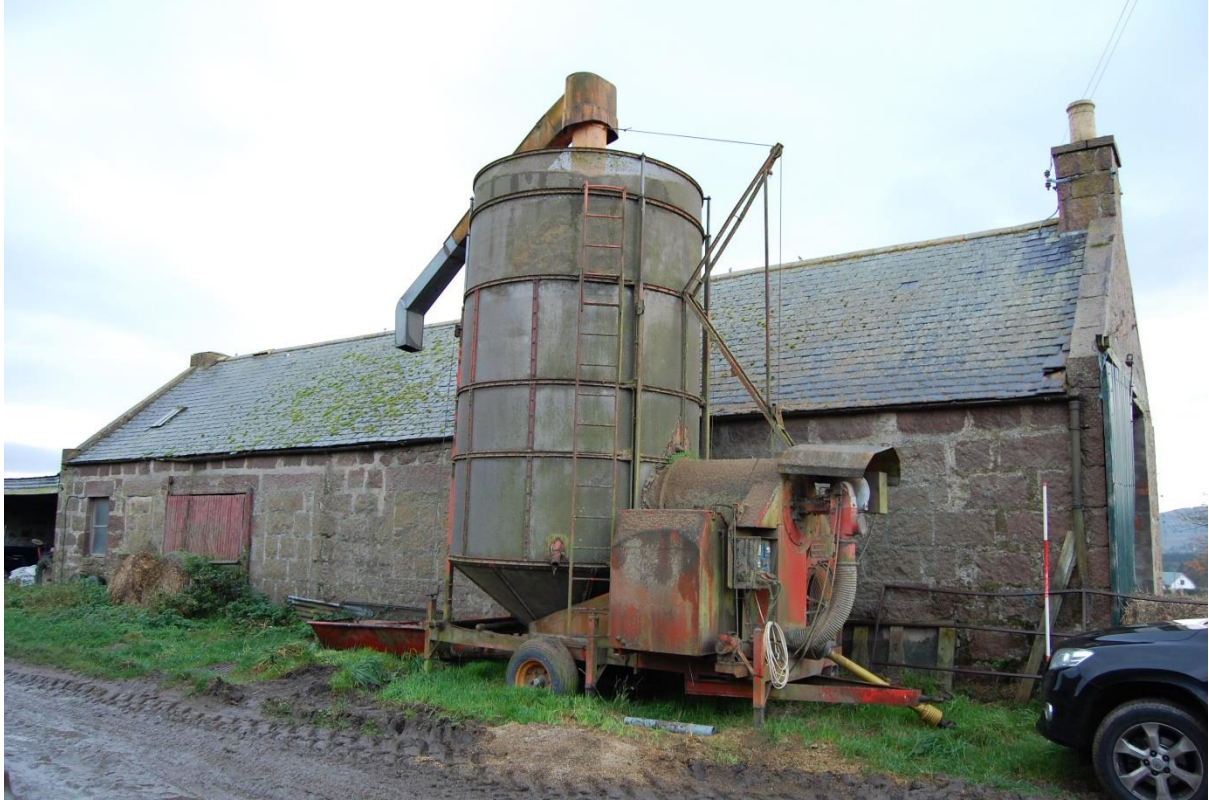
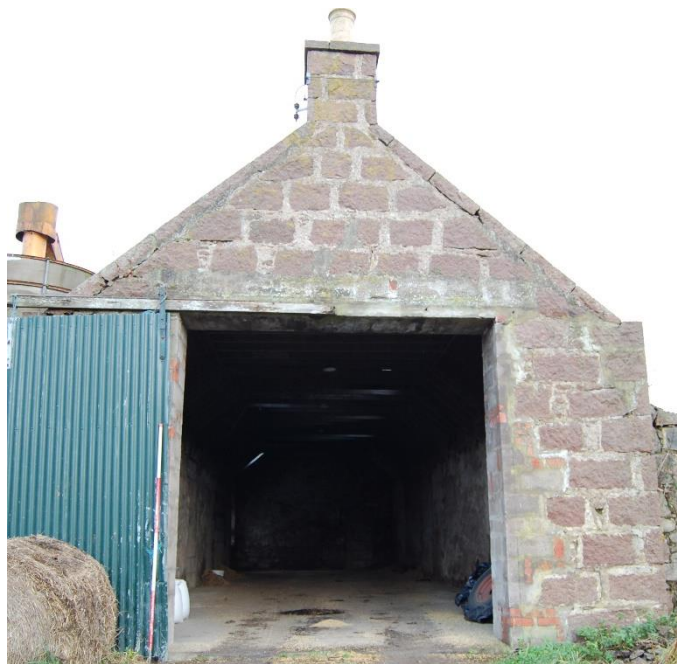
Cover: top Building 1 NE wall with multiple blocked aperture; bottom Building 1 NW gable

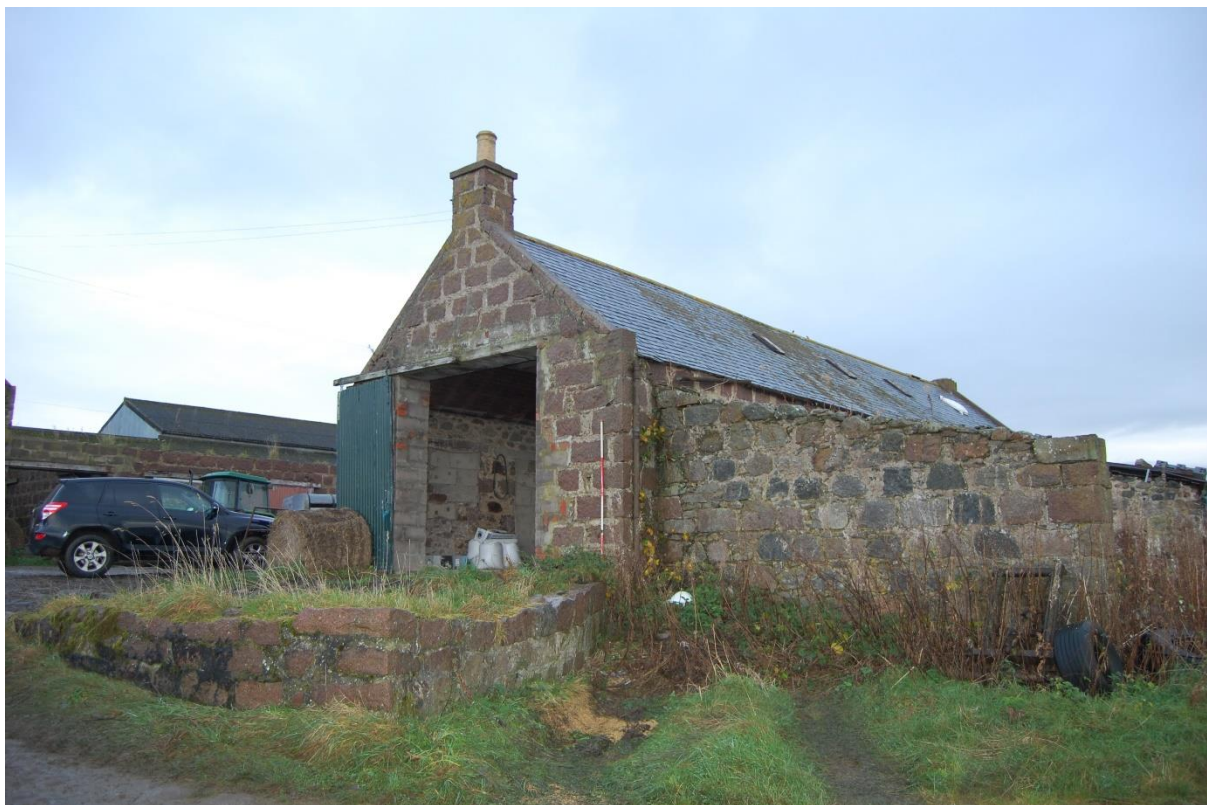
Illus 5 Building 1 (left) with W11 and 1B (right); facing SE

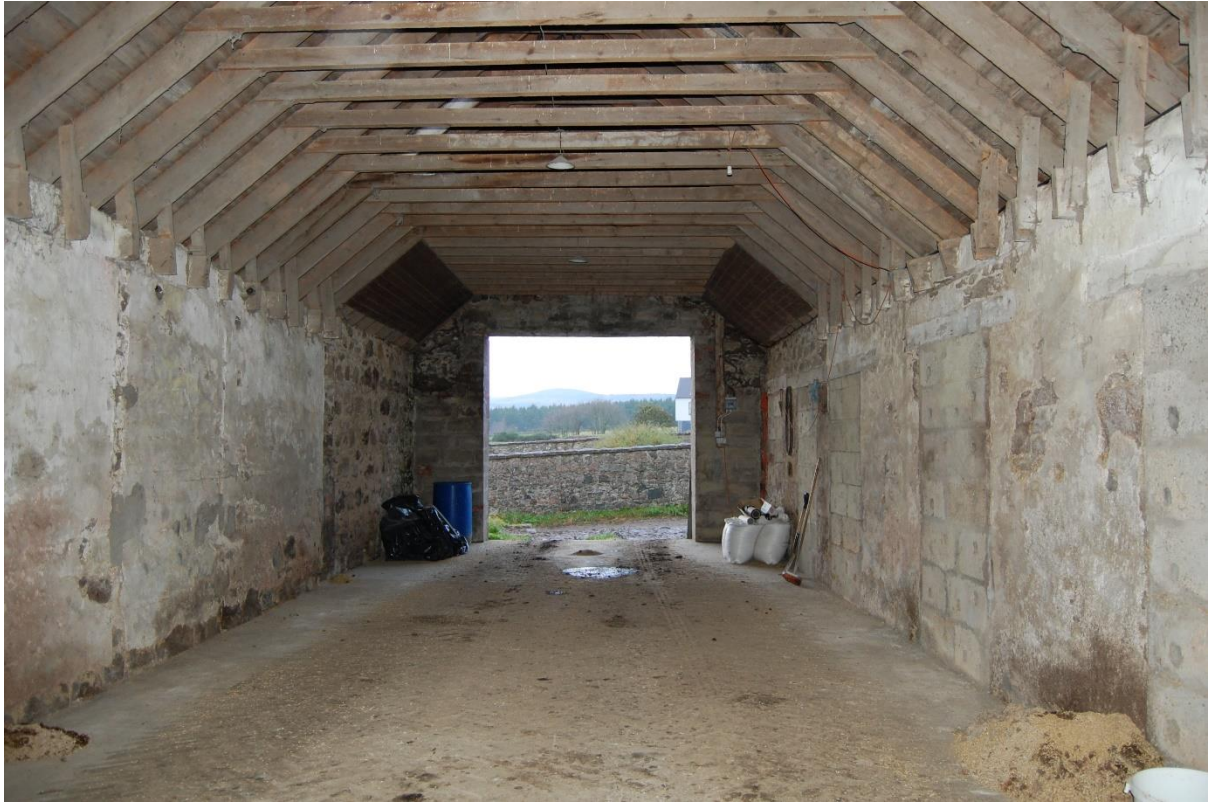
Illus 6 Interior Building 1 with blocked doorways (right); facing NW

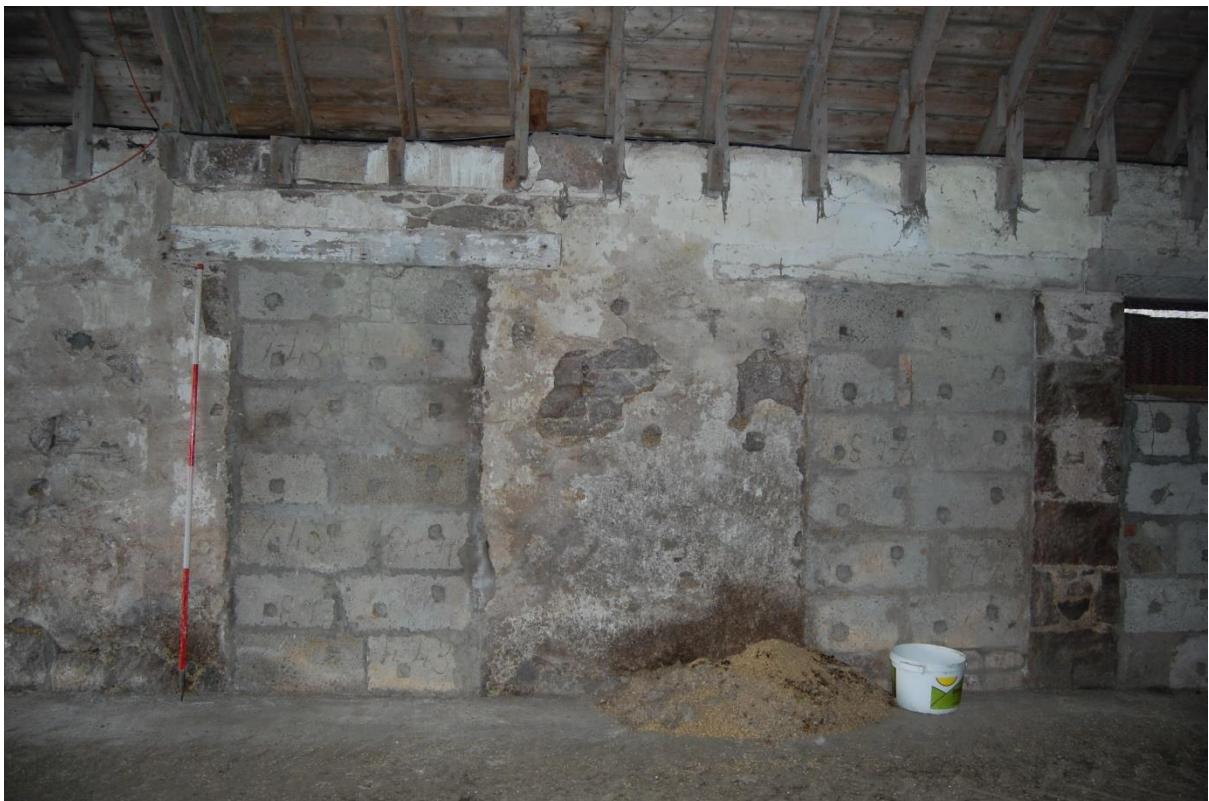
Building 1 is 27.6m long and 9.85m wide and is constructed of large blocks of quarried granite with concrete floor. Room 1 is the main steading building and has two windows and six doors on the NE wall (Illus 3, 4) and one blocked on the SE wall (D21). All but W2 have been blocked with concrete brick or breezeblock. W1 and Doors 1-5 and 21 are all blocked with concrete blocks inscribed with 7-43 (Illus 7, 8) possibly representing the date of infill.

Illus 7 D1 (left) D2 (centre) D3 (right); facing NE

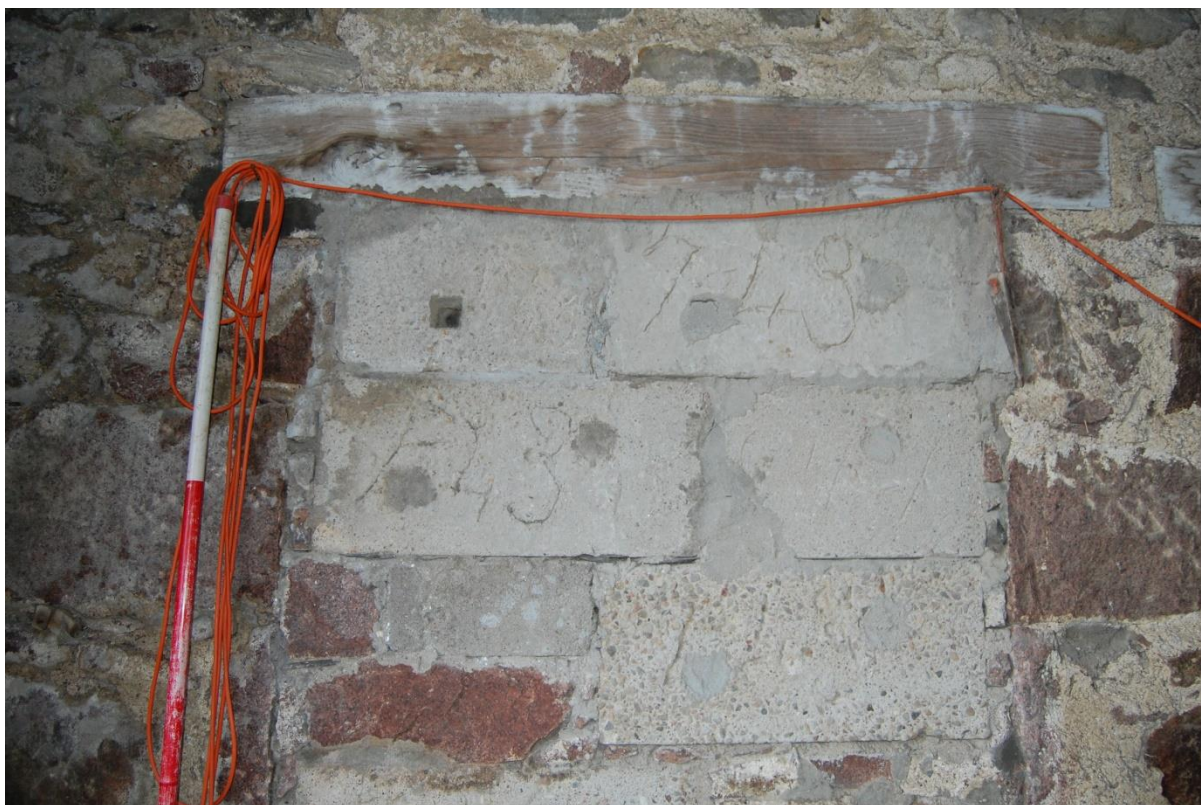
Illus 8 Detail W1 with incised numbers '7 43' on concrete blocks; facing NE

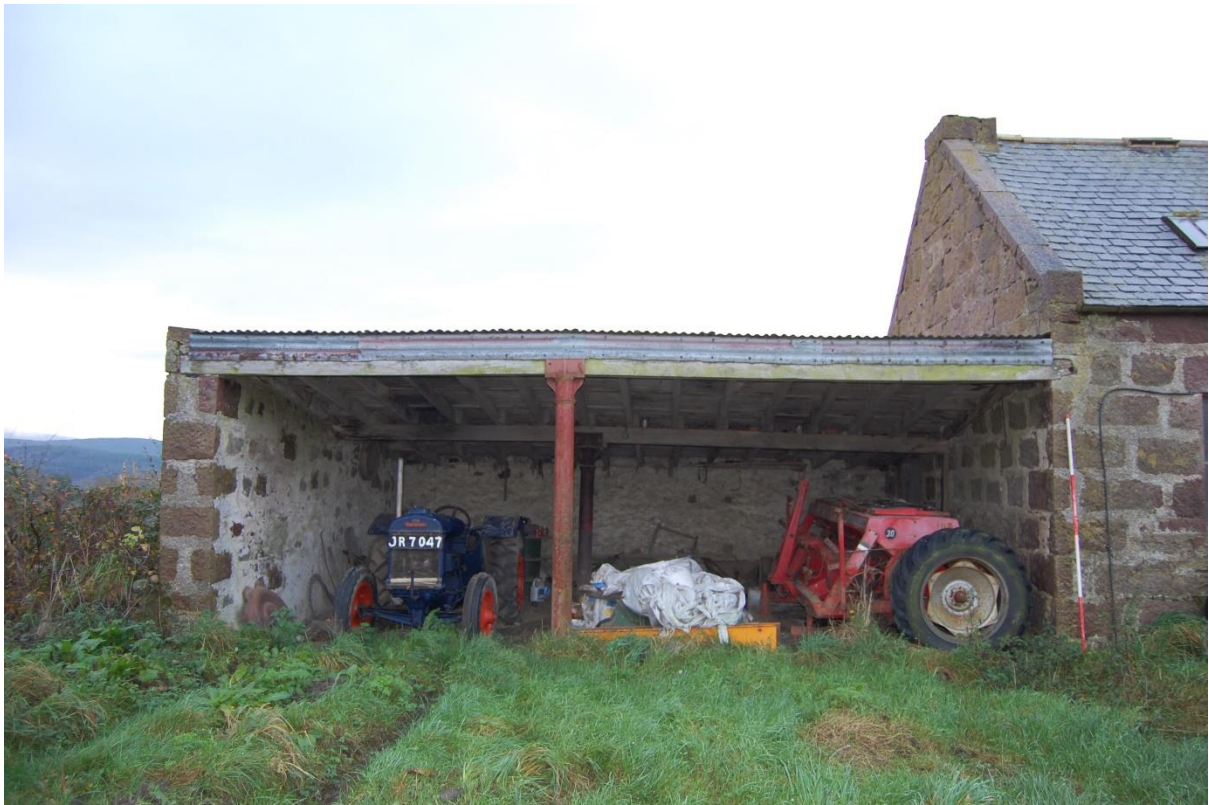
Illus 10 Building 1A with cast iron pillars; facing SW

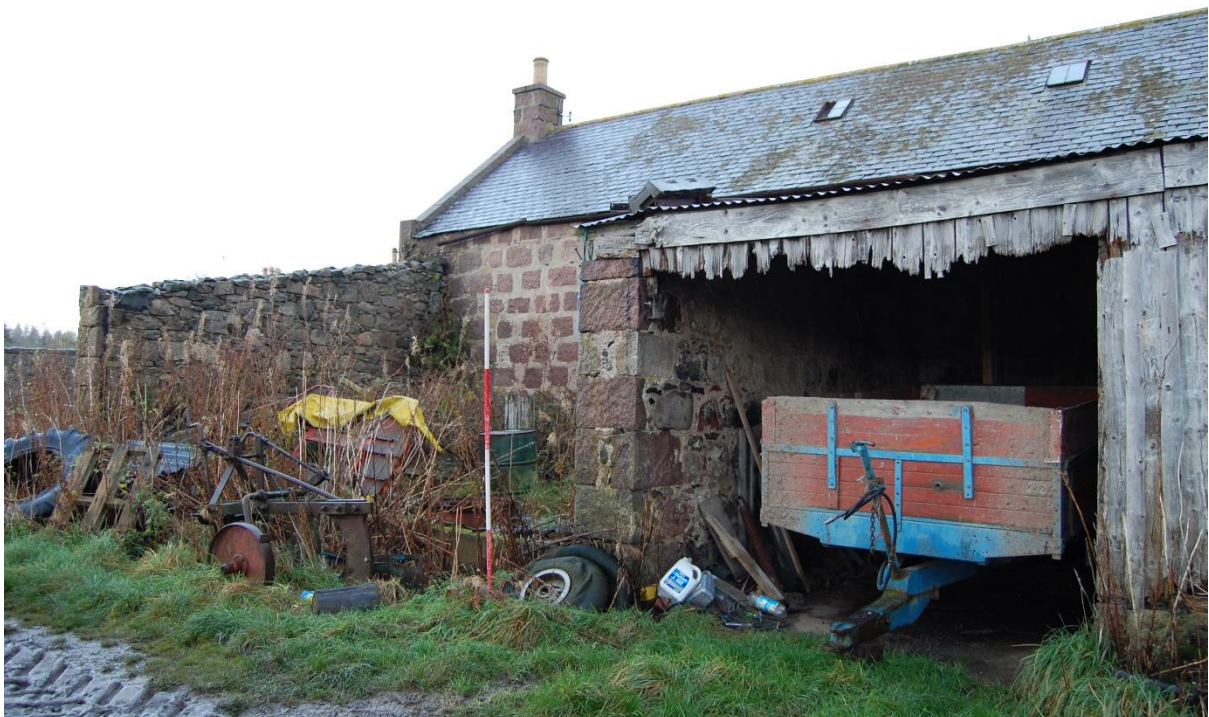
Illus 11 Building 1B; facing N

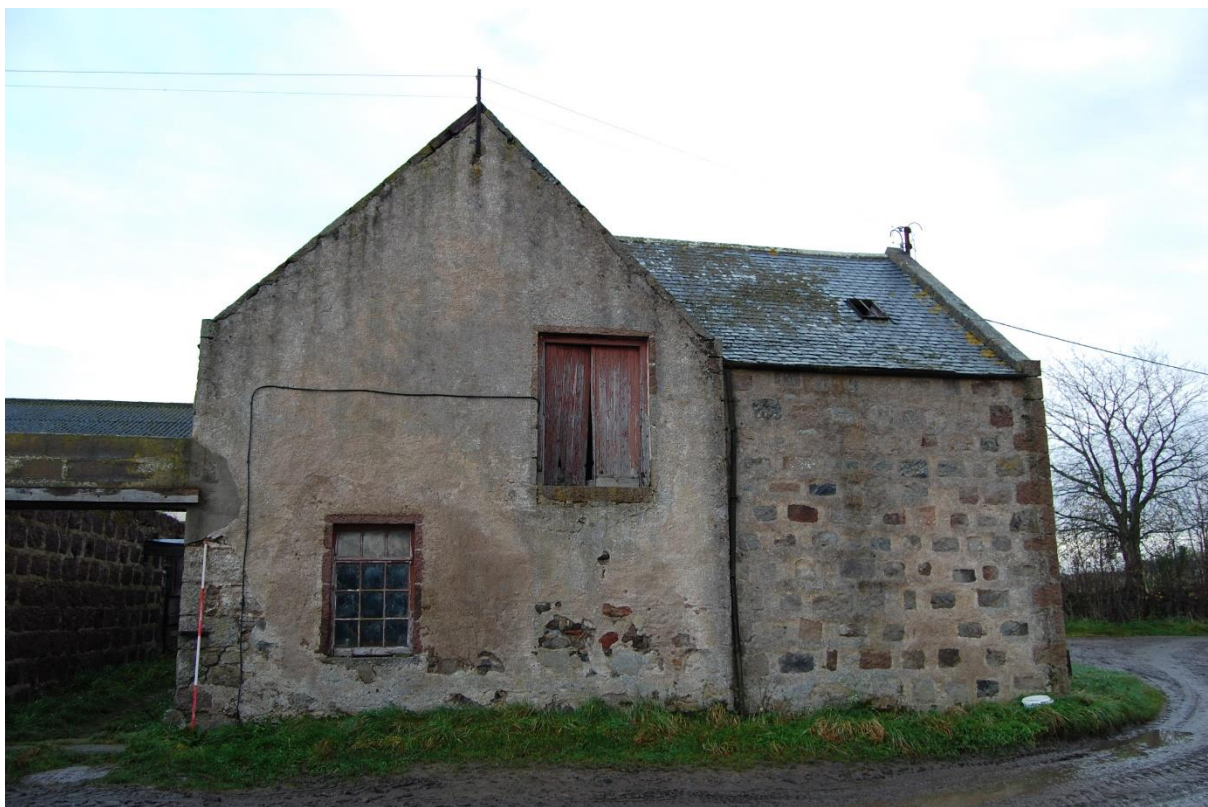
Illus 14 Building 2A (left) and 2B (right) SW facade; facing NE

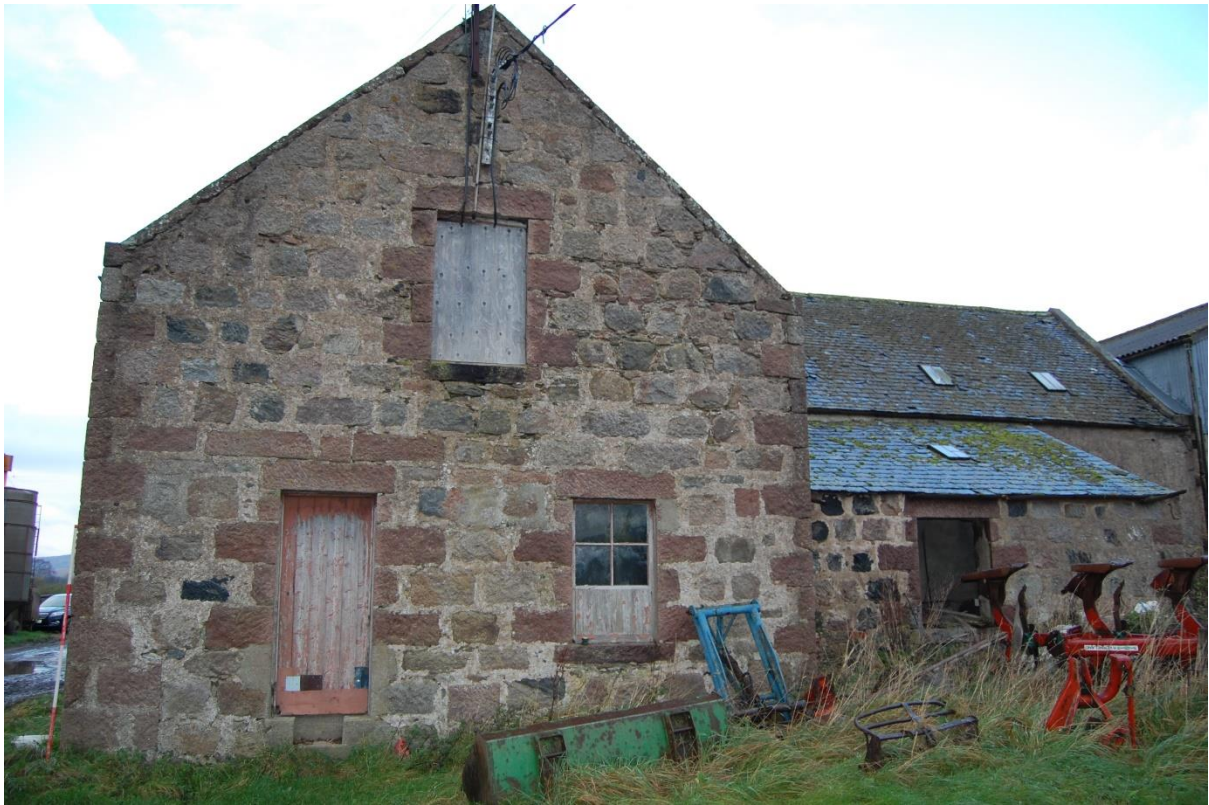
Illus 15 Building 2B (left) and 2C (right), SE façade; facing NW

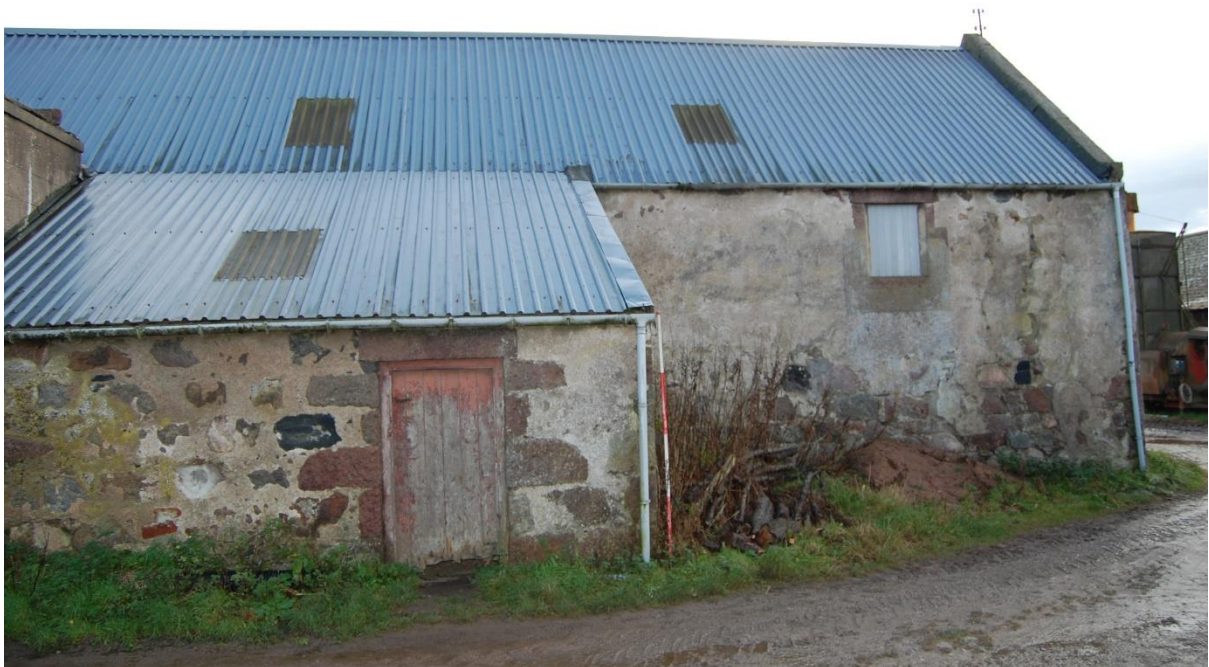
Illus 16 Building 2E (left) with D22 and 2D (right) with W9 NW façade; facing SE

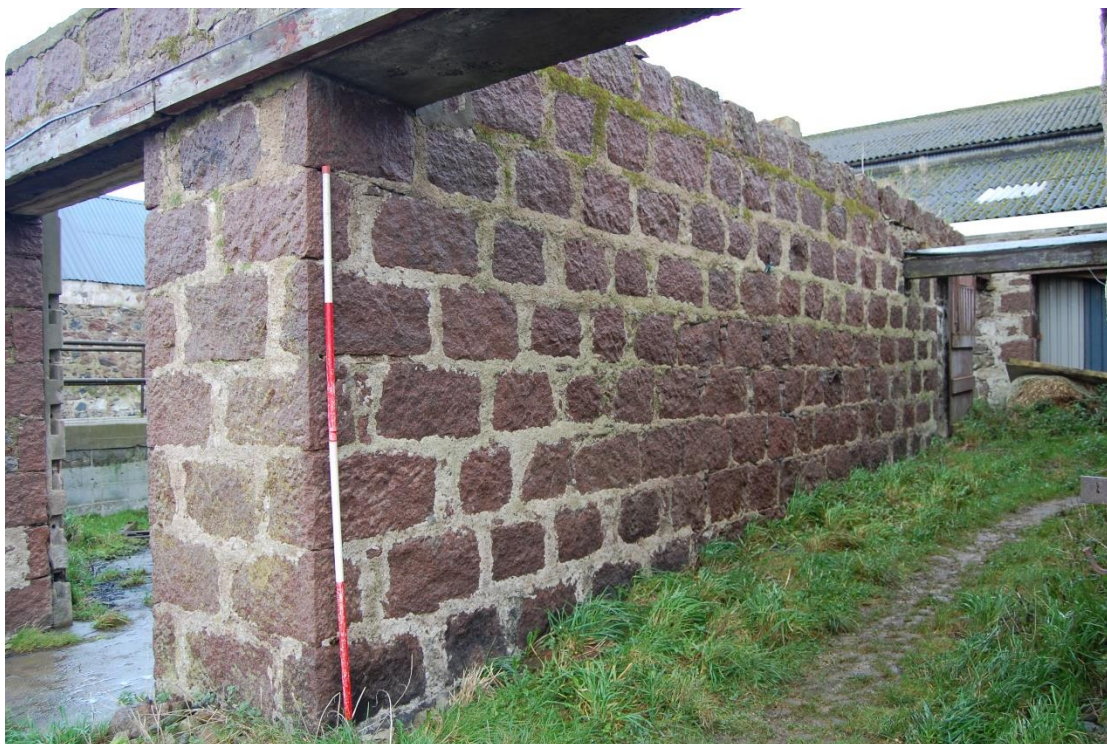
Illus 17 SE wall of courtyard; facing NE
