**Balmaleddie Steading, Marykirk, AB30 1XL
Report on Level 1 Standing Building Survey**

**Alison Cameron
Cameron Archaeology
7 January 2015**

A Level 1 standing building survey was carried out on 15 December 2014; the weather was clear and bright. All exterior walls were recorded photographically and architects plans were annotated and measurements taken. The roofs were in poor condition and so there was no access to the interior of the steading buildings. The building had been built for agricultural use and it is therefore recommended that no further archaeological work is required during this redevelopment (Aberdeenshire planning application 2014/3073). Further archaeological work may be required if the Spear Mill building itself is to be redeveloped.

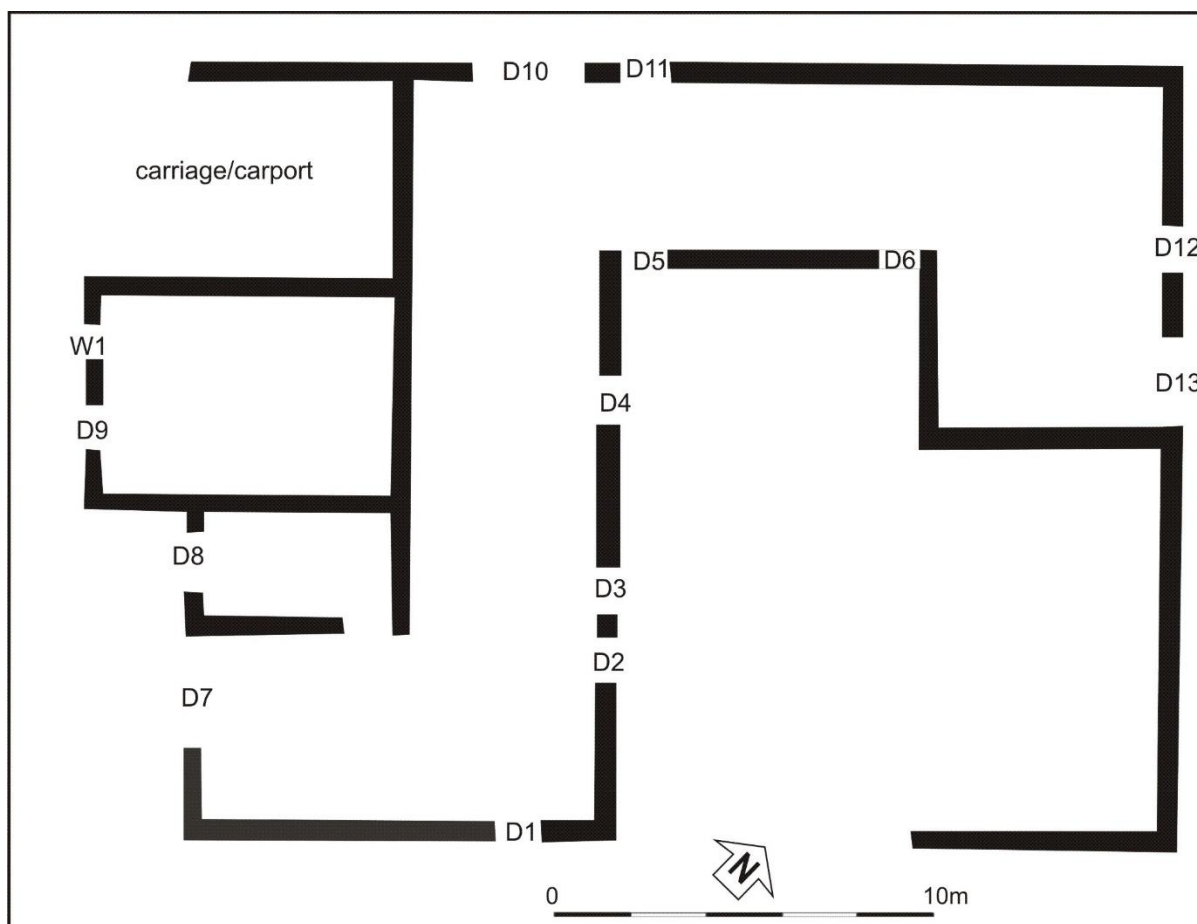
Illus 3 Plan of Building 1 with features recorded (*from copyright AB Roger & Young*)

The steading is 21m NW-SE and 29m NE-SW (Illus 3). The steading has developed over from a group of separate buildings on the First Edition OS map (Illus 8) and there is use of ashlar sandstone tooled blocks (SW wall), granite fieldstone and brick.

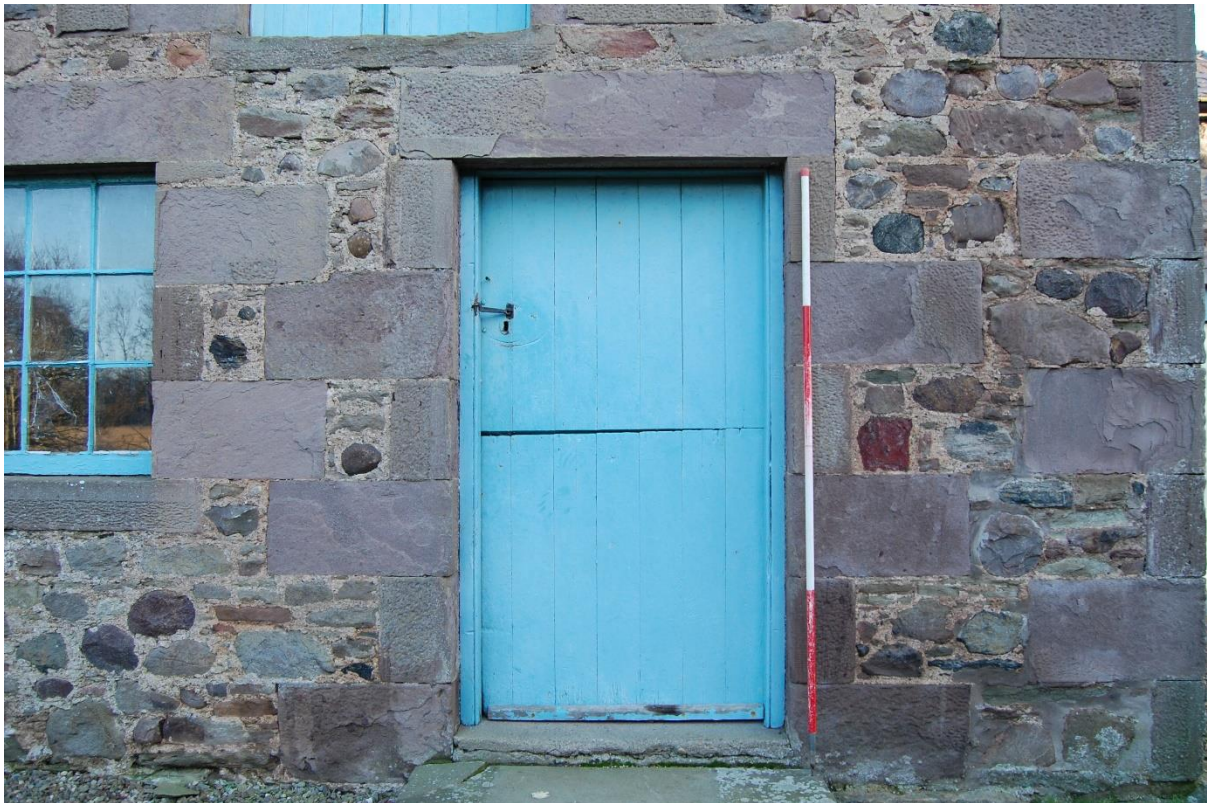
The earliest section of the building may date to the 18th-century (Phase 1 Illus 4-7). The Phase 1 farmhouse on the SW side of the current steading was once a separate building (see First Edition map Illus 7). It has tooled ashlar sandstone blocks for quoins, jambs and lintels (Illus 4). Walls of granite fieldstones were added to the NW and SE walls to incorporate this building into the steading and a new farmhouse built after the 3rd Edition OS (c1923).

Illus 4 Phase 1 farmhouse façade with Door 9 on SW façade showing tooled sandstone blocks for jambs, lintel and quoins; facing NE

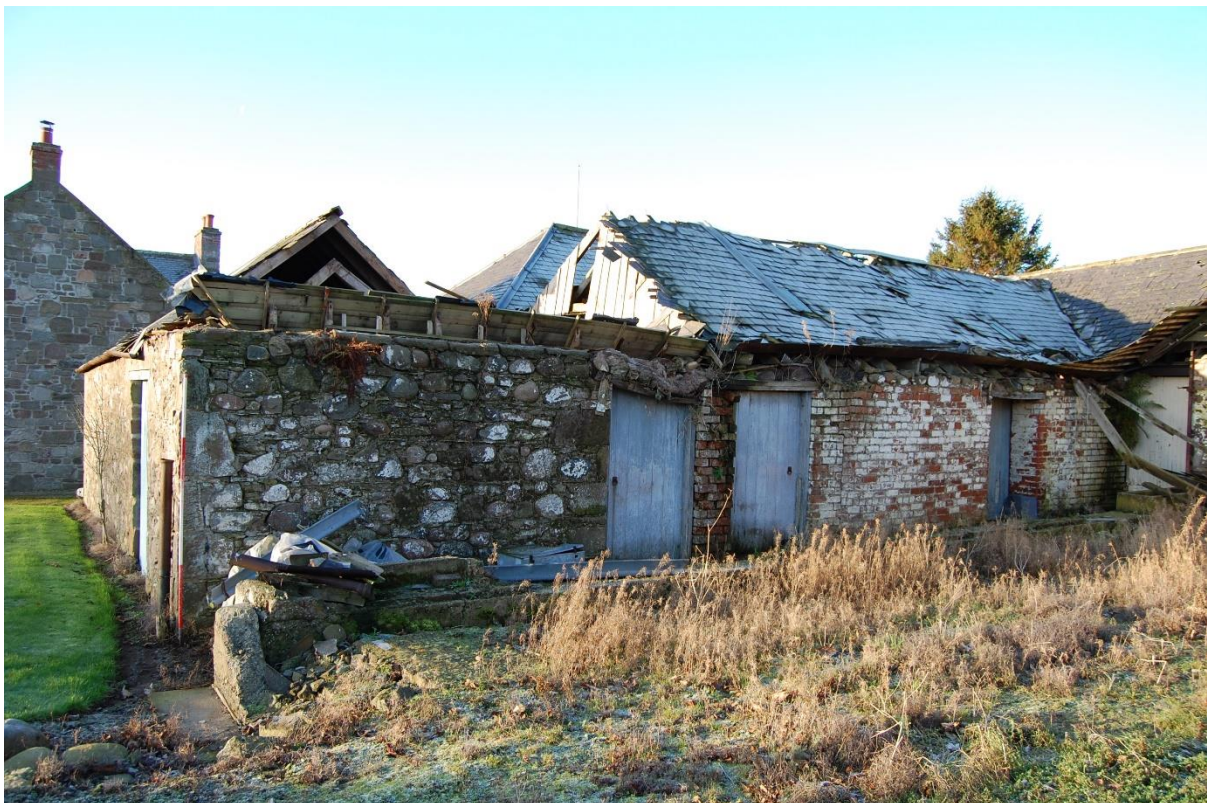
The steading constructed by the late 19th century was formed around a central courtyard with an opening on the SE side. The courtyard walls are partly formed in granite fieldstones and brick (Illus 5).

Illus 5 SW wall of courtyard with (l-r) Doors D2, D3, D4, D5 showing stone and brick sections of construction

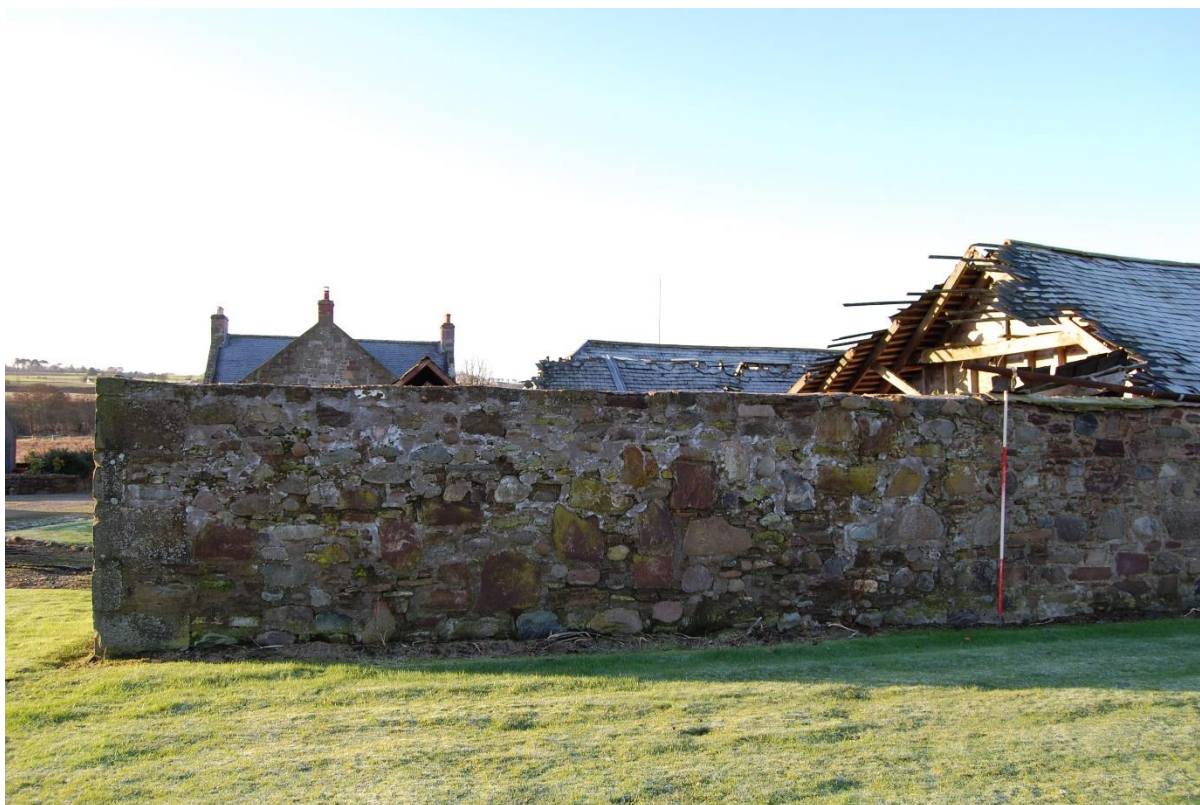
Illus 6 NE wall showing Phase 1 section of wall (left); facing SW

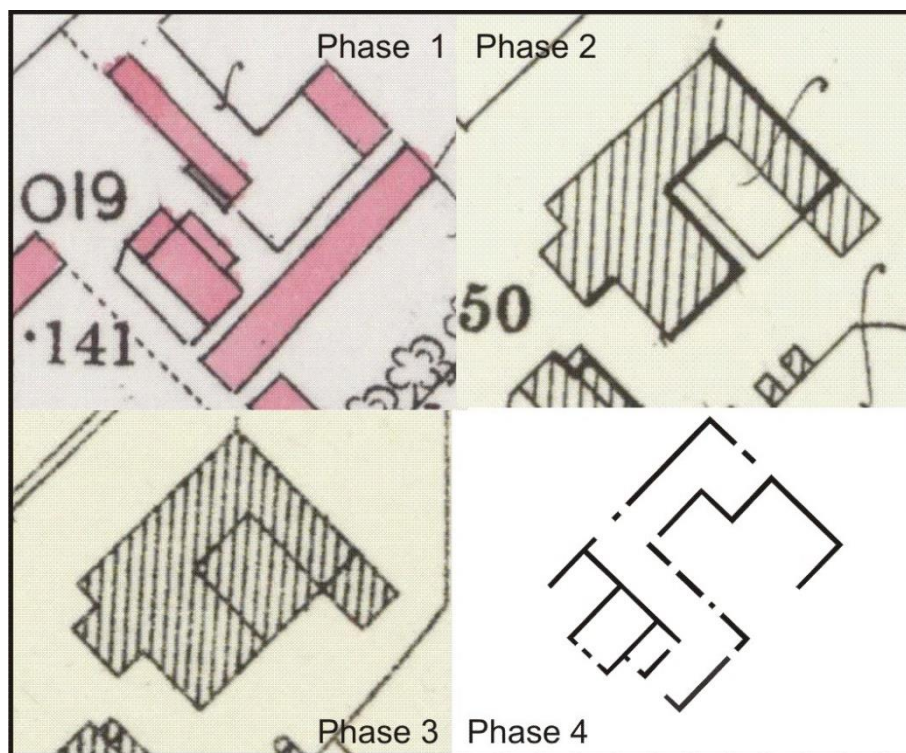
Illus 8 Phase plan showing development of Building 1 on the Ordnance Survey and the modern plan. Top left First Edition OS Forfar Sheet XXVIII.1, 1865 (top right) Forfarshire, Sheet 028.01, 1904 (bottom left) Forfarshire, Sheet 028.01, 1924 (*all copyright National Library of Scotland*); (bottom right modern plan (*from copyright AB Roger & Young*))
