**Porsche Centre (former Newlands Farm), Wellington Road,
Aberdeen, AB12 3HT
Report on Level 1 standing building survey and watching
brief**

**Alison Cameron and Robert Lenfert
Cameron Archaeology
23 March 2015**

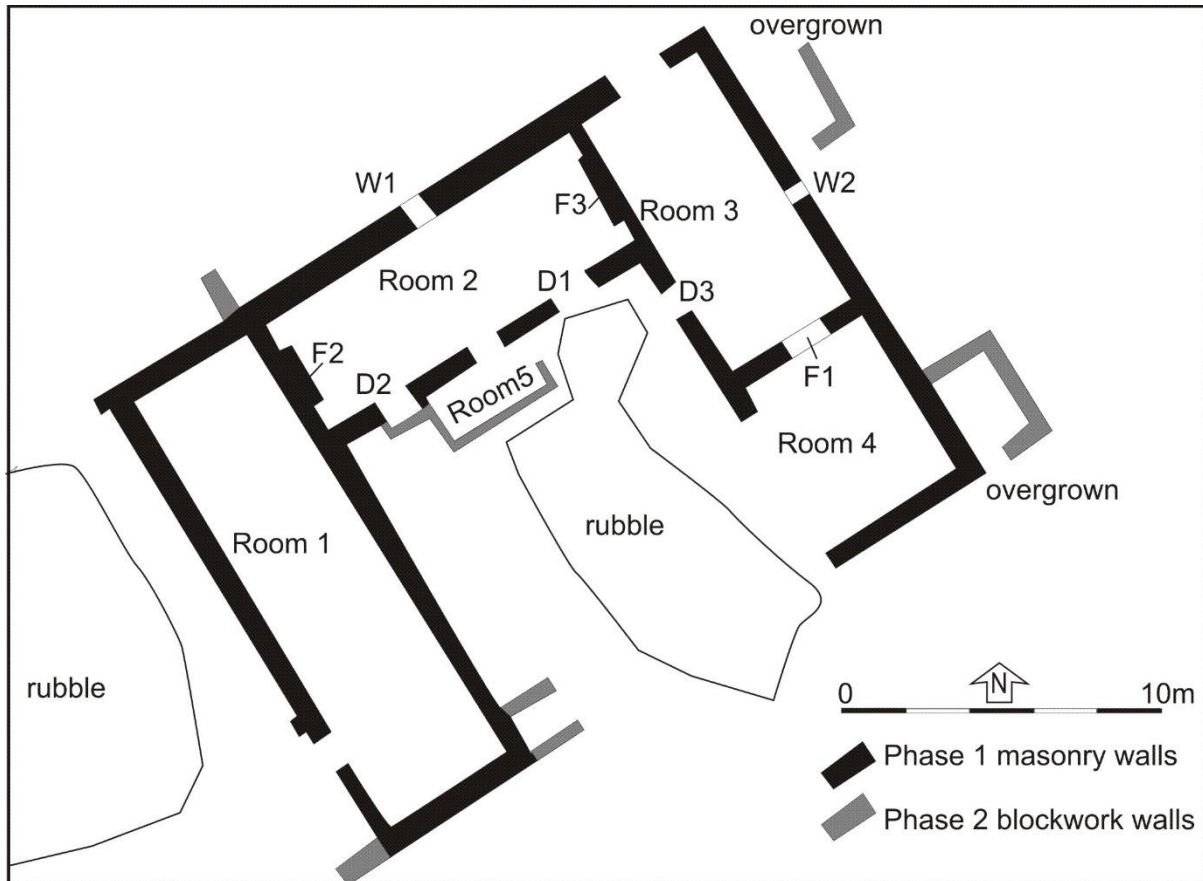
Illus 3 Plan showing features recorded (based on Taylor Design Architects Ltd).

The buildings are 17.6m north-south and 23.5m east-west. The main buildings are constructed of large granite rubble and the west room has been concreted on the interior and exterior for animal use. The buildings consist of a C-shaped steading with central courtyard (Illus 3). Room 1 is constructed of large granite rubble with concrete on interior and exterior. The interior is virtually inaccessible but was converted for animal use with modern stalls and ventilation.

Room 2 was a 2-room cottage with chimney breasts and fireplaces at both ends (F2 and F3) and there is a small central window in the north wall. Rooms 3 and 4 form the east wing of the building and have a possible blocked fireplace between the rooms (F1).

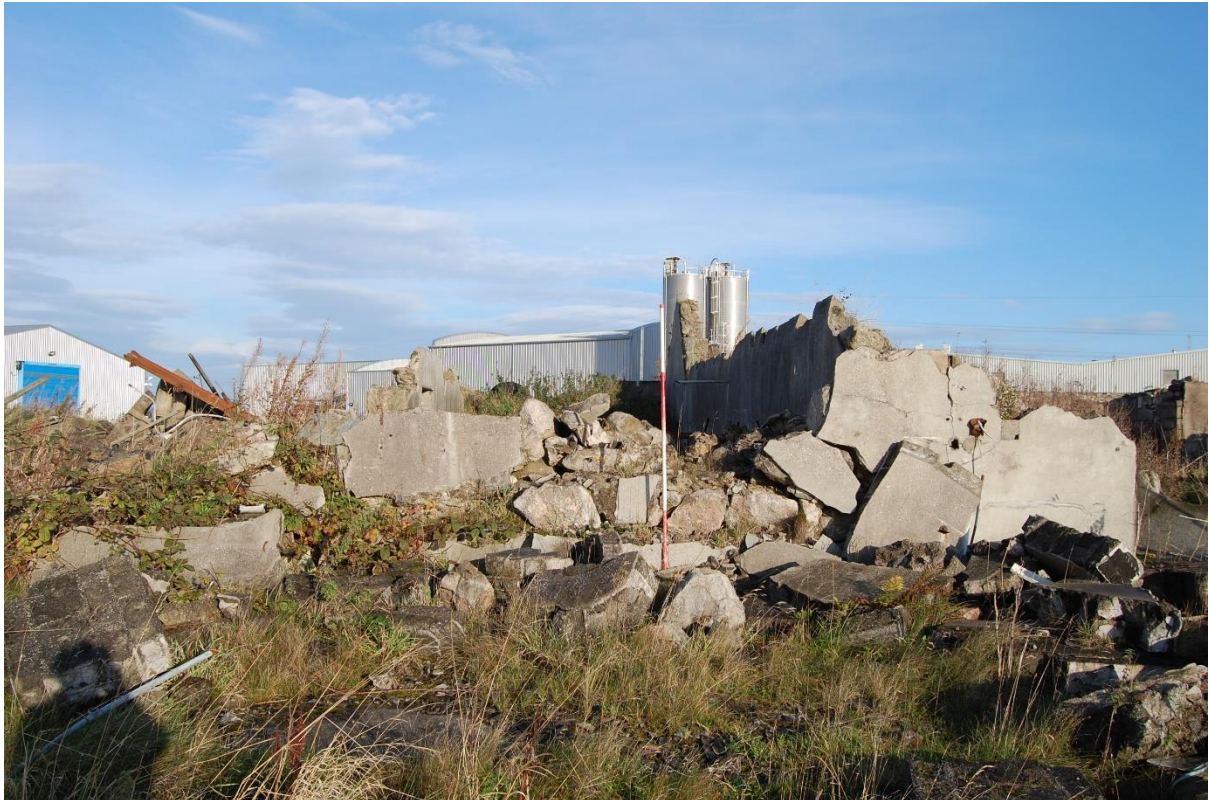
Illus 4 South wall Room 1 showing ruinous nature of buildings and concrete in exterior and interior; facing NW

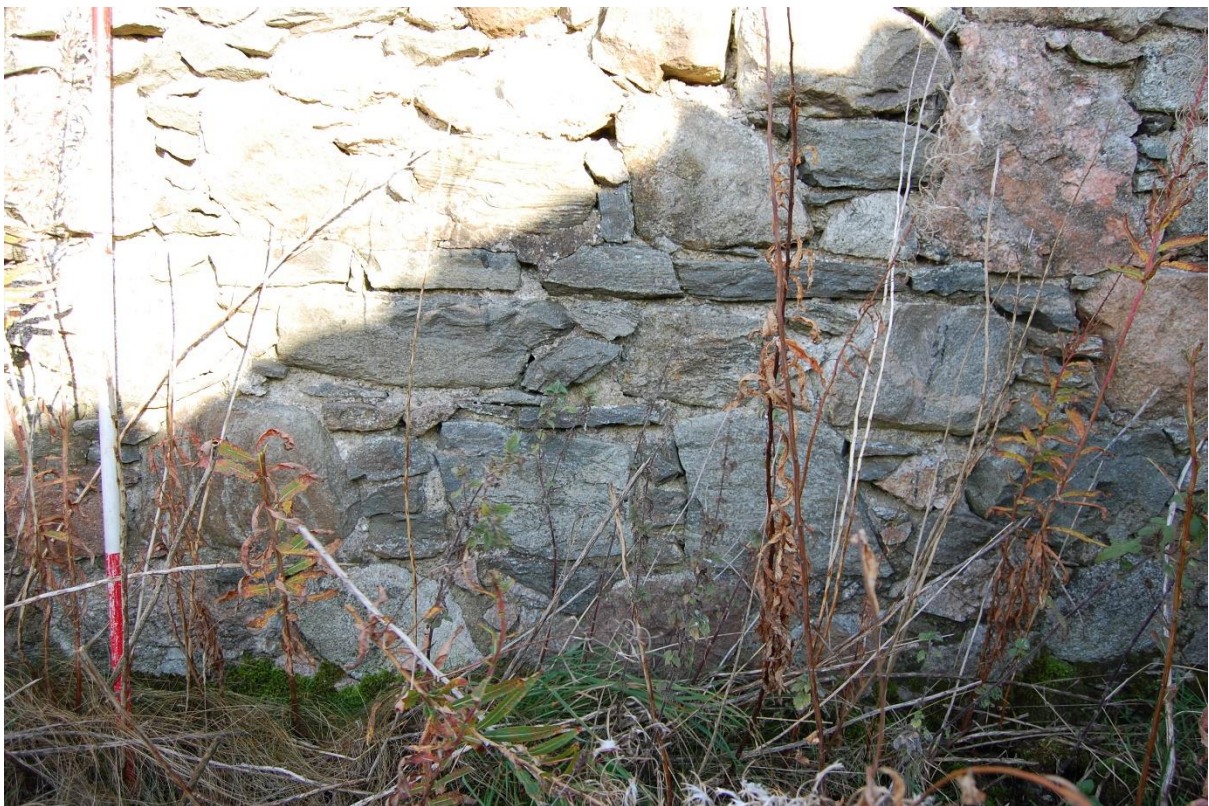
Illus 5 Blocked aperture F1 in north wall Room 4; facing NW

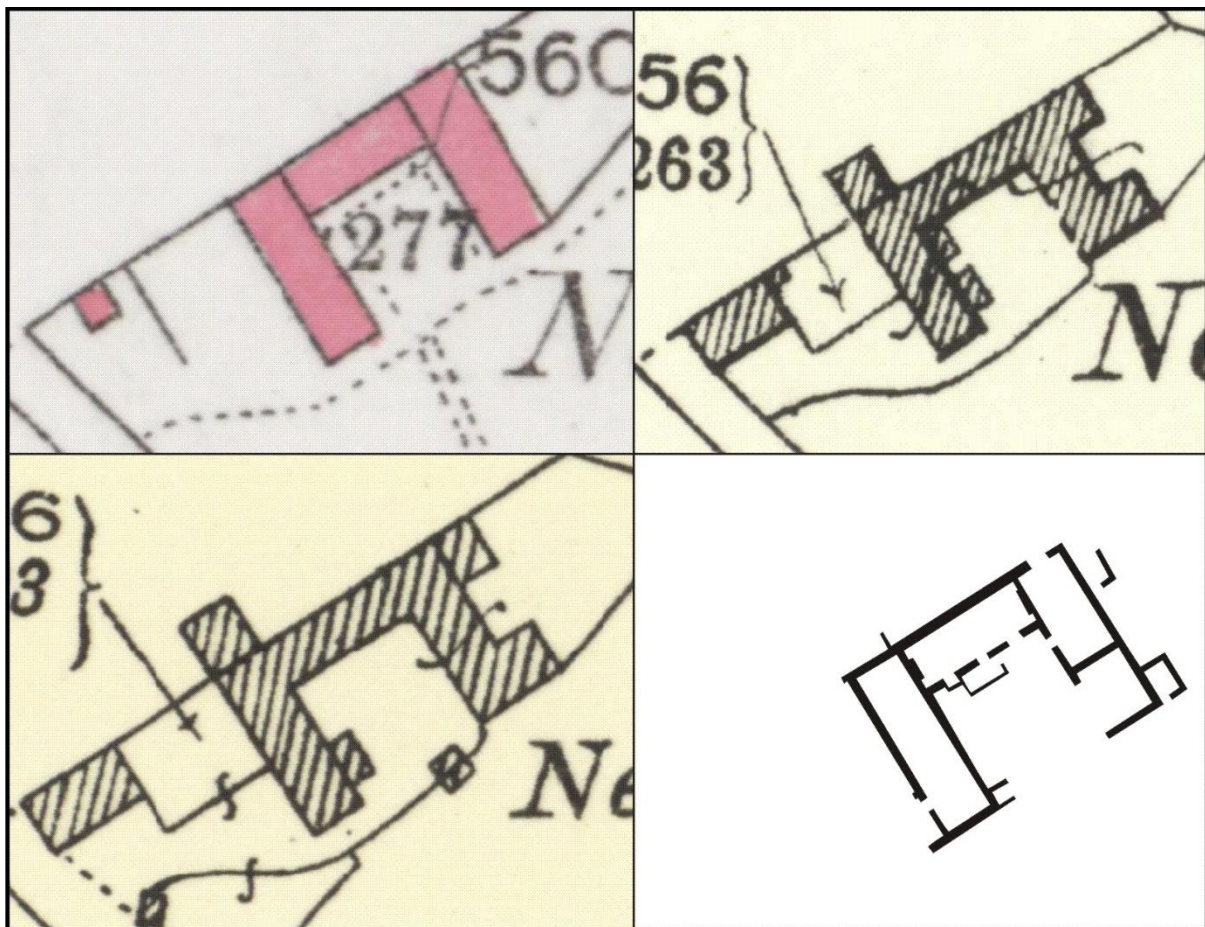
5.1 Newlands Farm was surveyed on 5 October 2014. It is very ruinous and overgrown and some sections were not accessible. The main walls pre-date the First Edition OS map (1865) and the form continued until the end of its use as a farm, with minor alterations and additions (Illus 6).

Illus 6 Phase plan showing First Edition OS (top left), Second Edition (top right), 3rd edition (bottom left) and current plan (bottom right)
