**Meikle Endovie, Alford, AB33 8EE**  
**Report on Level 1 Standing Building Survey**

**Alison Cameron**  
**Cameron Archaeology**  
**31 May 2015**

A Level 1 standing building survey was carried out on 25 May 2015; the weather was clear and bright. All exterior walls were recorded photographically and architects plans were annotated and measurements taken and main elevations drawn. Some of the roofs were in poor condition and so there was limited access to the interior of the steading buildings. It is recommended that no further archaeological work is required during this current development.

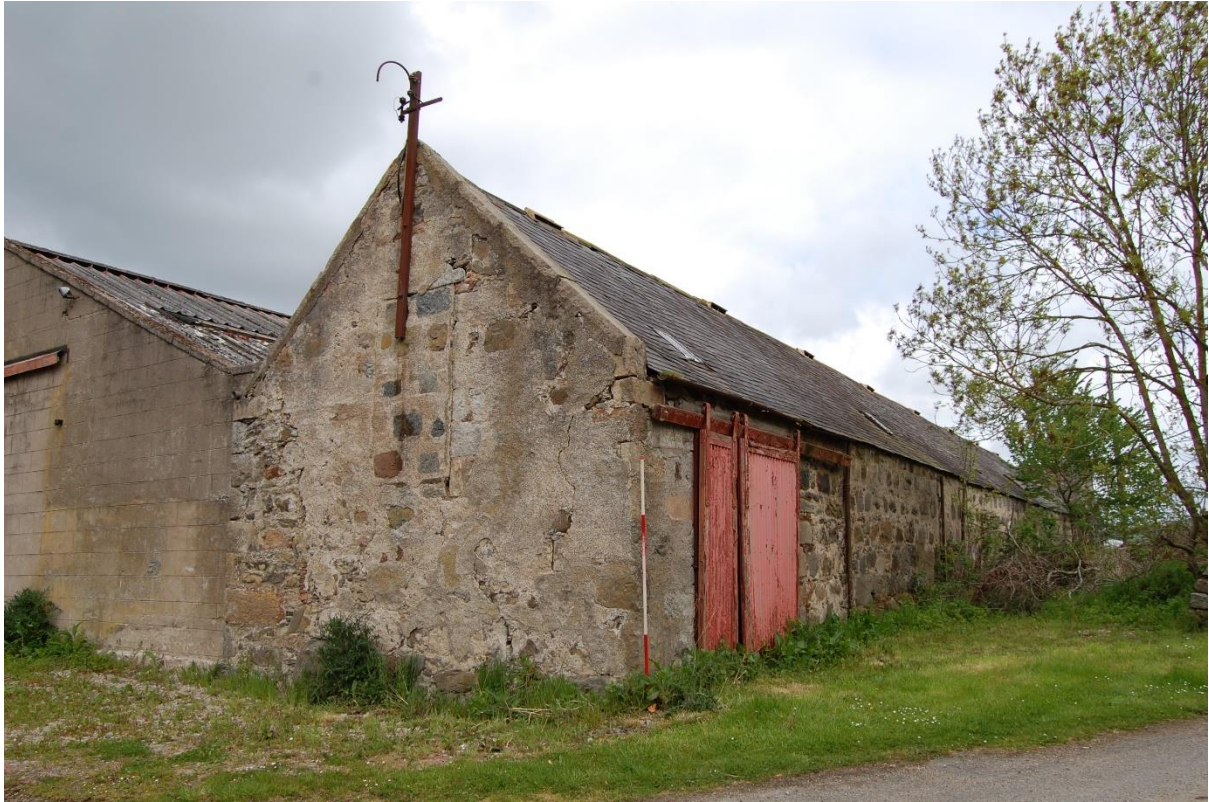
Illus 4 Room 1 from SE; facing NW

Room 1 forms the east wall of the C-shaped steading (Illus 4); it is 5.7m wide and has a first floor window in the south gable and door on the south end of the east wall.

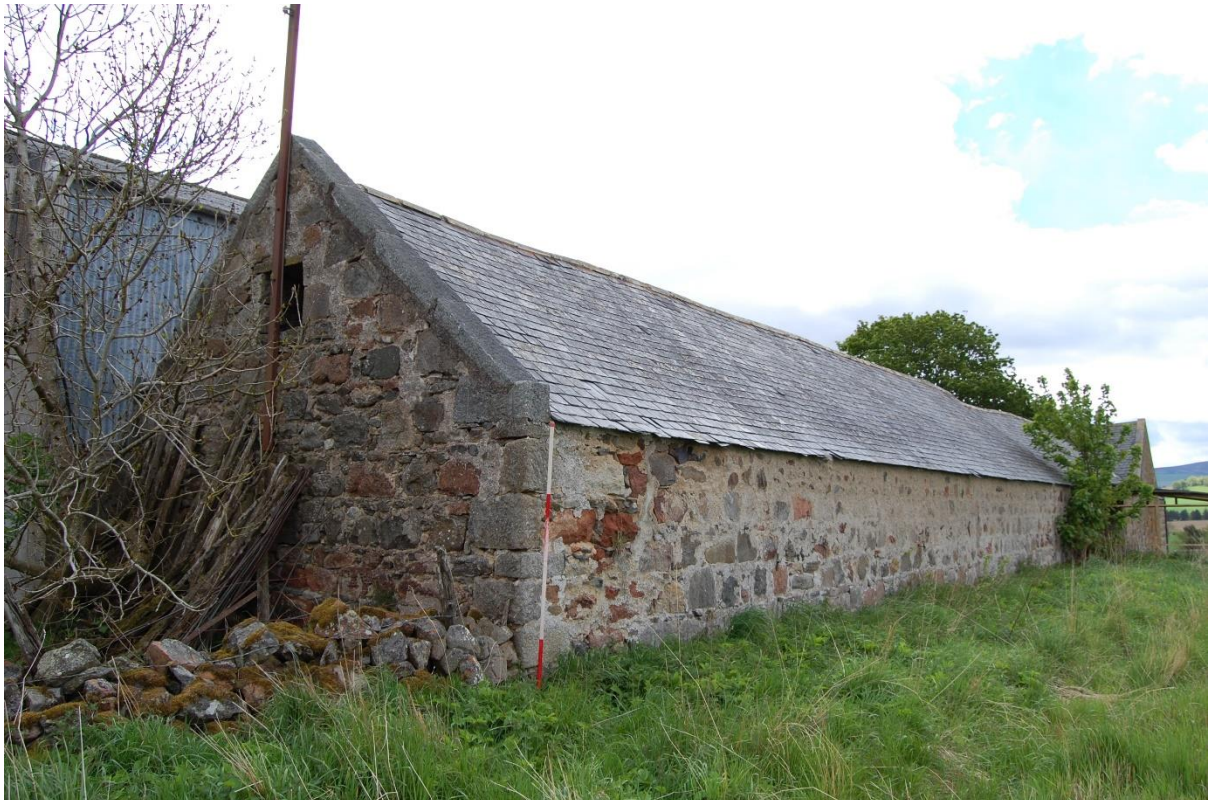
Illus 5 Room 3 from NW; facing SE

Room 3 on the west of the complex is 6m wide and is constructed of granite rubble with granite quoins. There are small first floor gable windows (Illus 5).

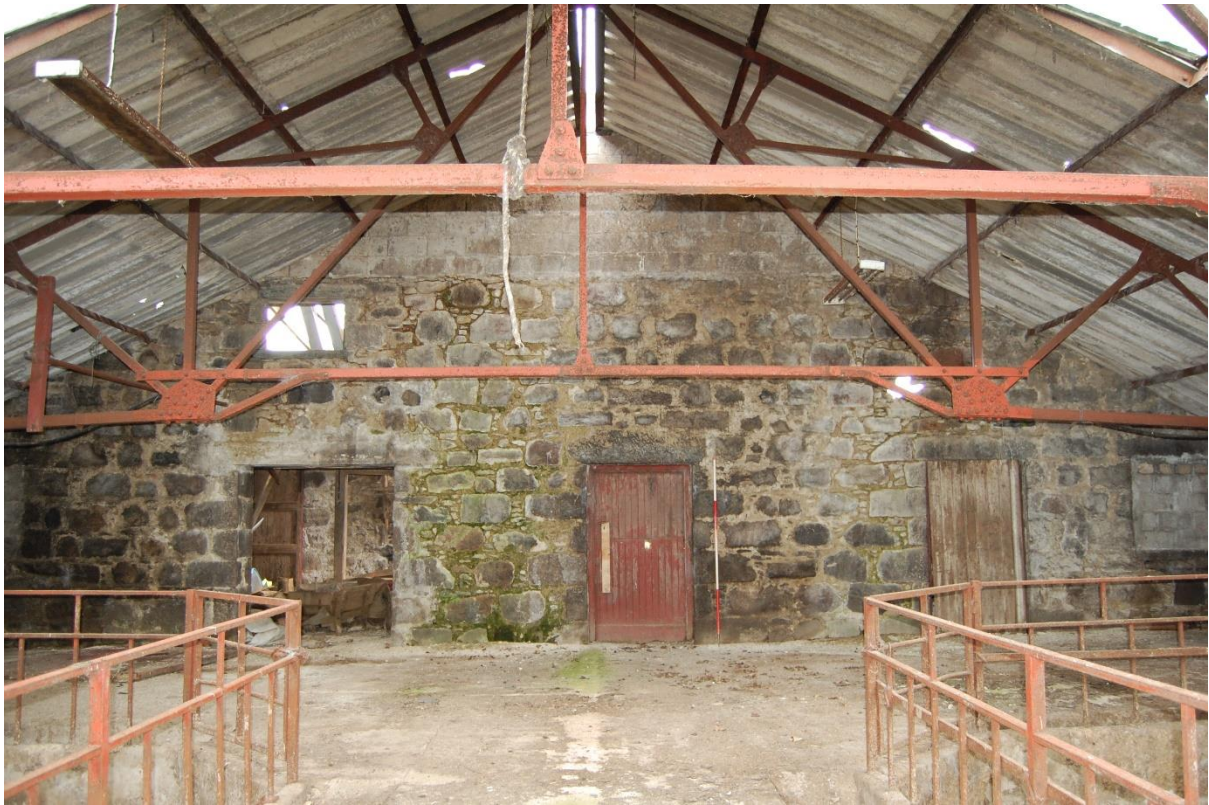
Illus 6 S wall of Room 6 forming N wall of cattle court Room 4; facing N

Room 6 is the north wing of the C-shaped steading. It is constructed of granite rubble and has a cart door in the centre of the north wall (D1). It is 6.65m wide (Illus 6,7, 8).

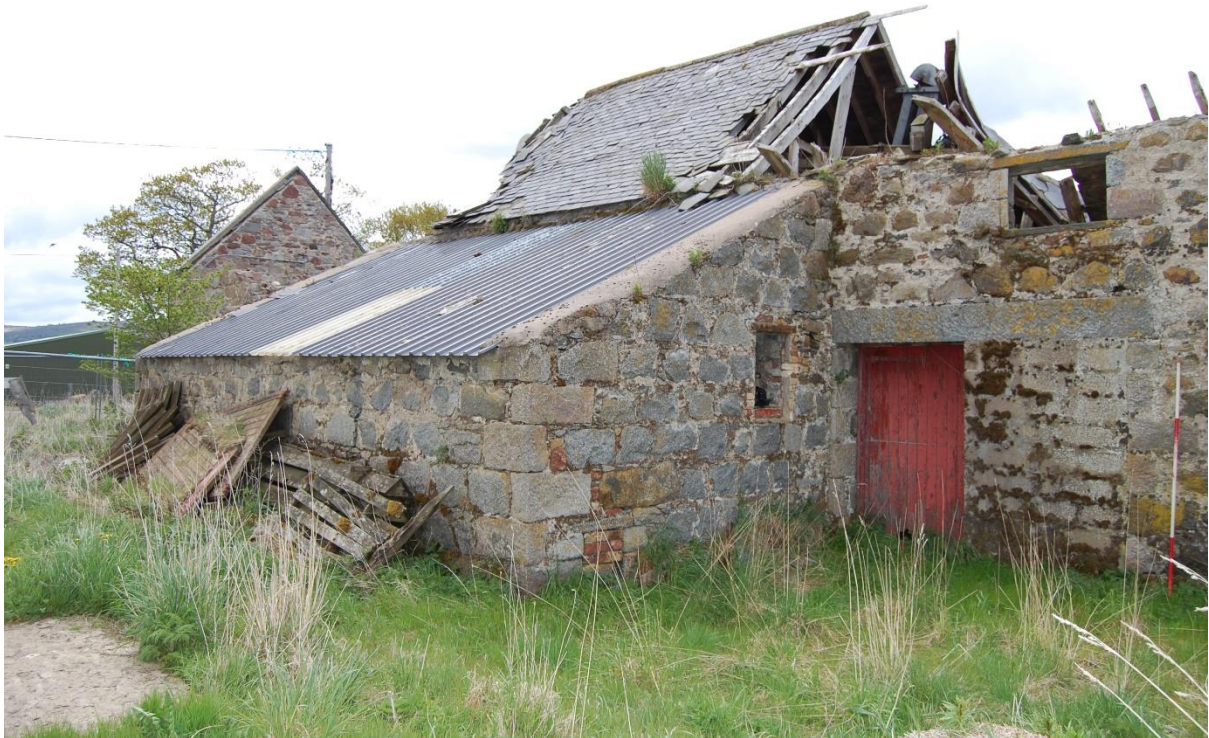
Illus 7 Room 6 N wall with lean-to Room 7; facing SE

Room 7 is a granite rubble lean-to (Illus 7) on the north wall of Room 6 replacing the horse mill between the dates of the 1<sup>st</sup> and 2<sup>nd</sup> OS maps.
