**East Town Farm, Drumlithie
Aberdeenshire, AB39 3YR
Report on Level 1 Standing Building Survey**

**Alison Cameron
Cameron Archaeology
16 June 2015**

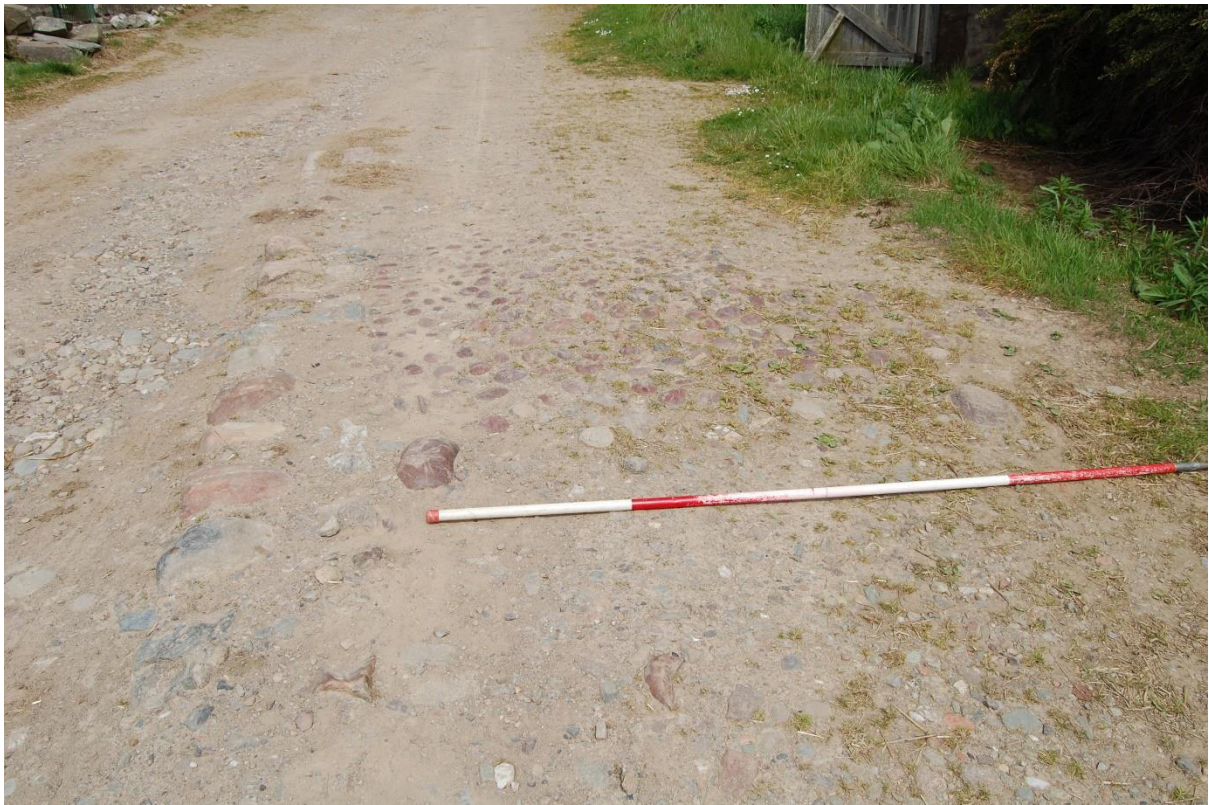
A foundation (F8) and cobbled surface (F7; Illus 4) which were parts of a SW range were demolished prior to the memory of the current farmer (Illus 2).

Illus 4 Phase 1 wall foundation F8 and cobbled surface F7; facing NW

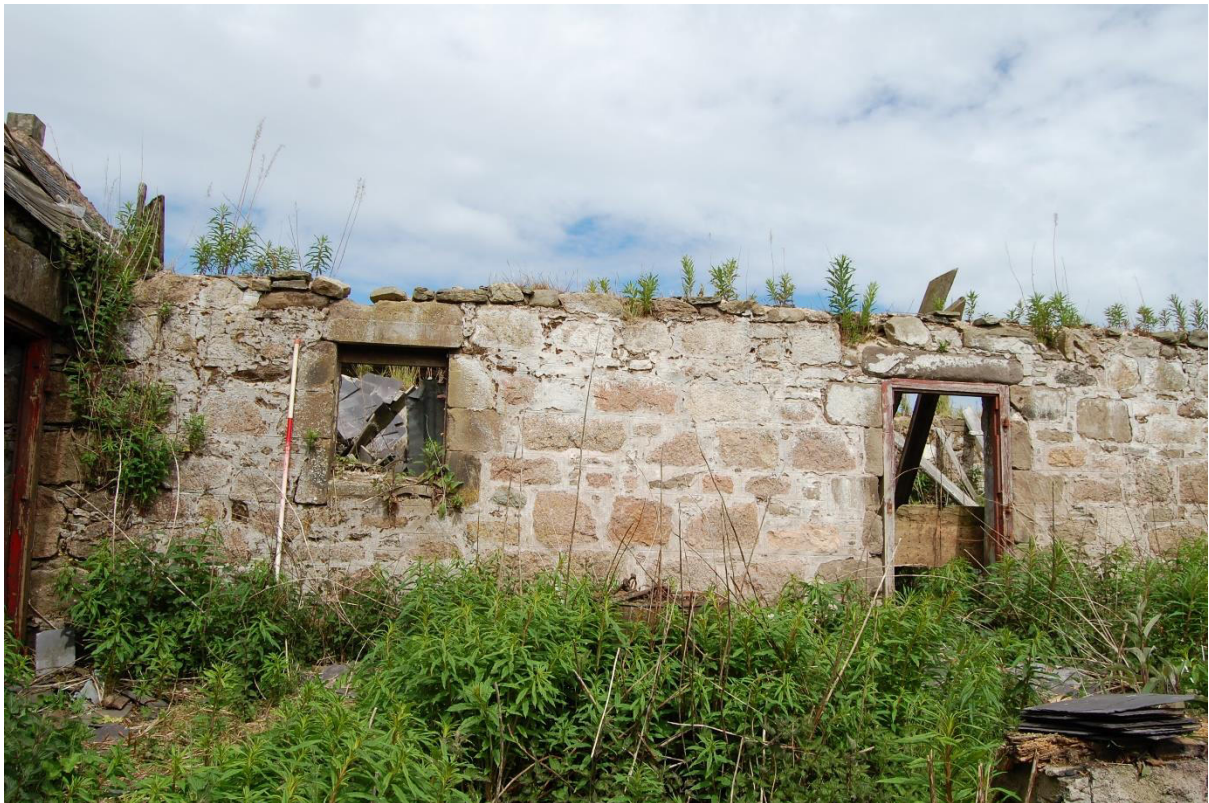
The earliest structures are the NE range (Rooms 4, 9-11) which are rubble built with large granite block quoins and lintels. The doors and windows on the SW wall of Rooms 9 and 10 have red sandstone facings (W11, D18-20, W17-19; Illus 7, 8). The NE wing is in fair condition but the NW wing was damaged in a fire in the 1940s and the roofs were replaced but collapsed in recent times due to the weight of deep snow (James Eddie pers comm; Illus 5, 6).

Illus 5 Phase 1 NW range SE wall with W13 and D25; facing NW

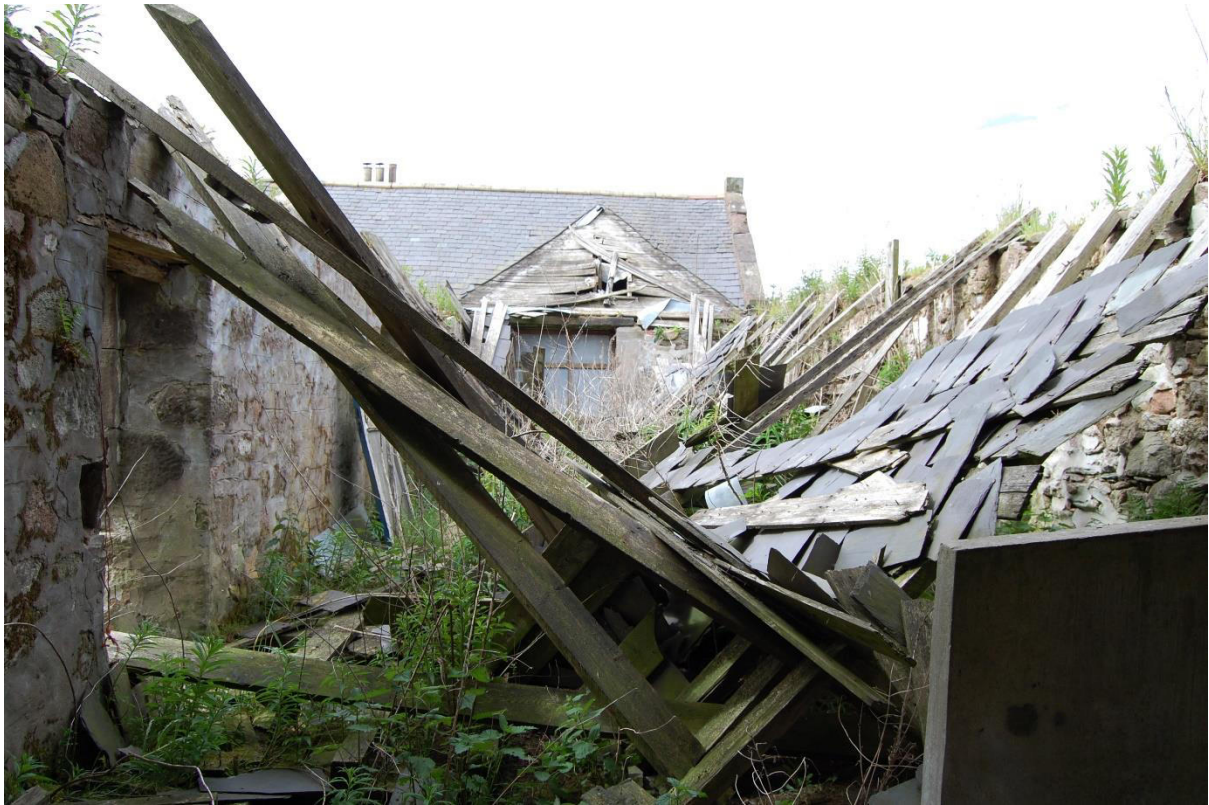
Illus 6 Phase 1 Room 4 SW end showing collapsed roofing and Phase 2 Room 3 (top centre); facing SW

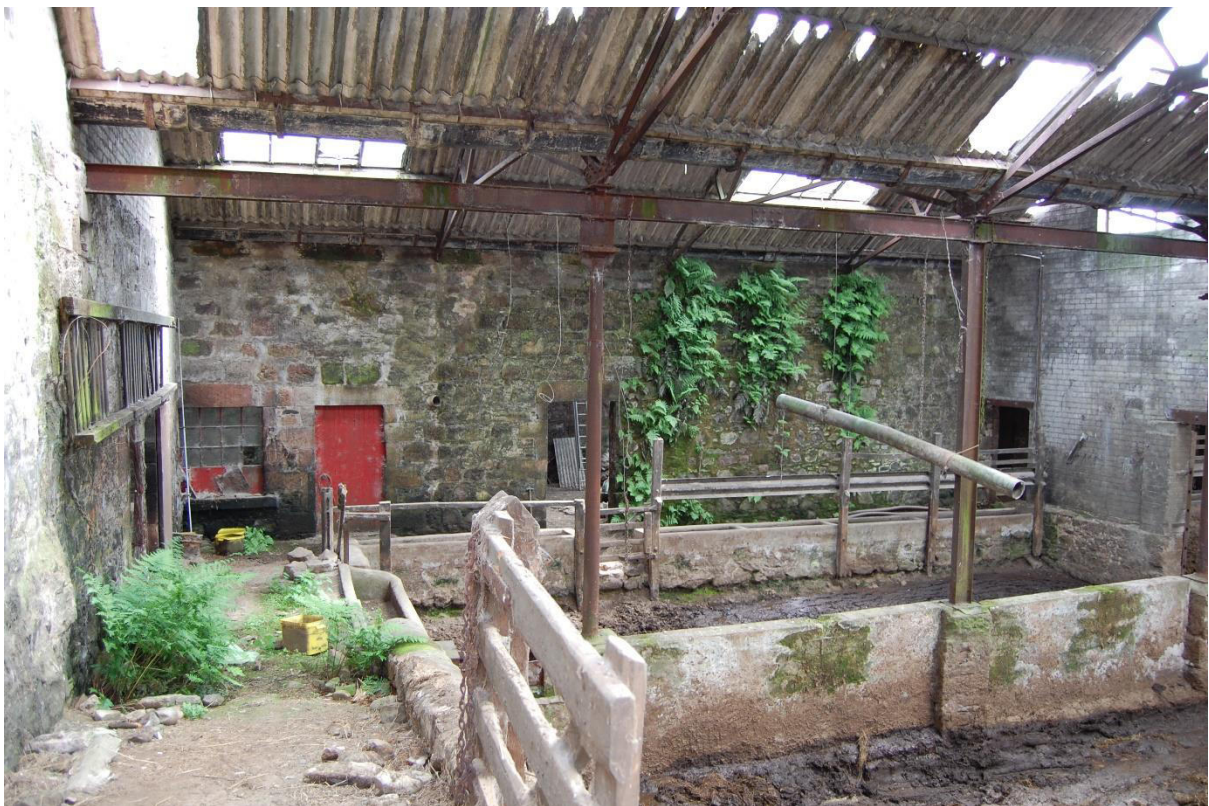
Illus 7 Phase 1 Room 9 SW wall built into later cattle court (Rooms 7 and 8); facing ENE

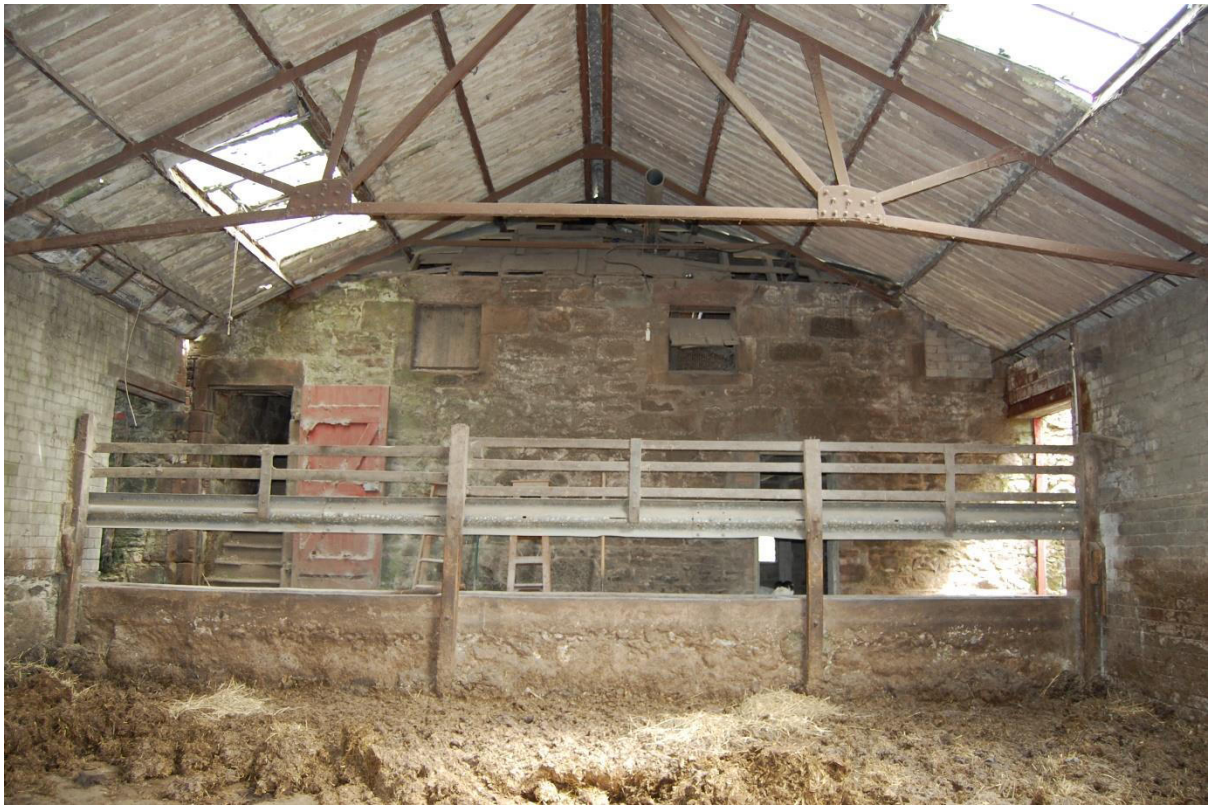
Illus 8 Phase 1 Room 10 D18 and D17 (below) Room 13 windows W17, 18, 19 (above) SW wall later built into cattle court Rooms 7/8; facing NE

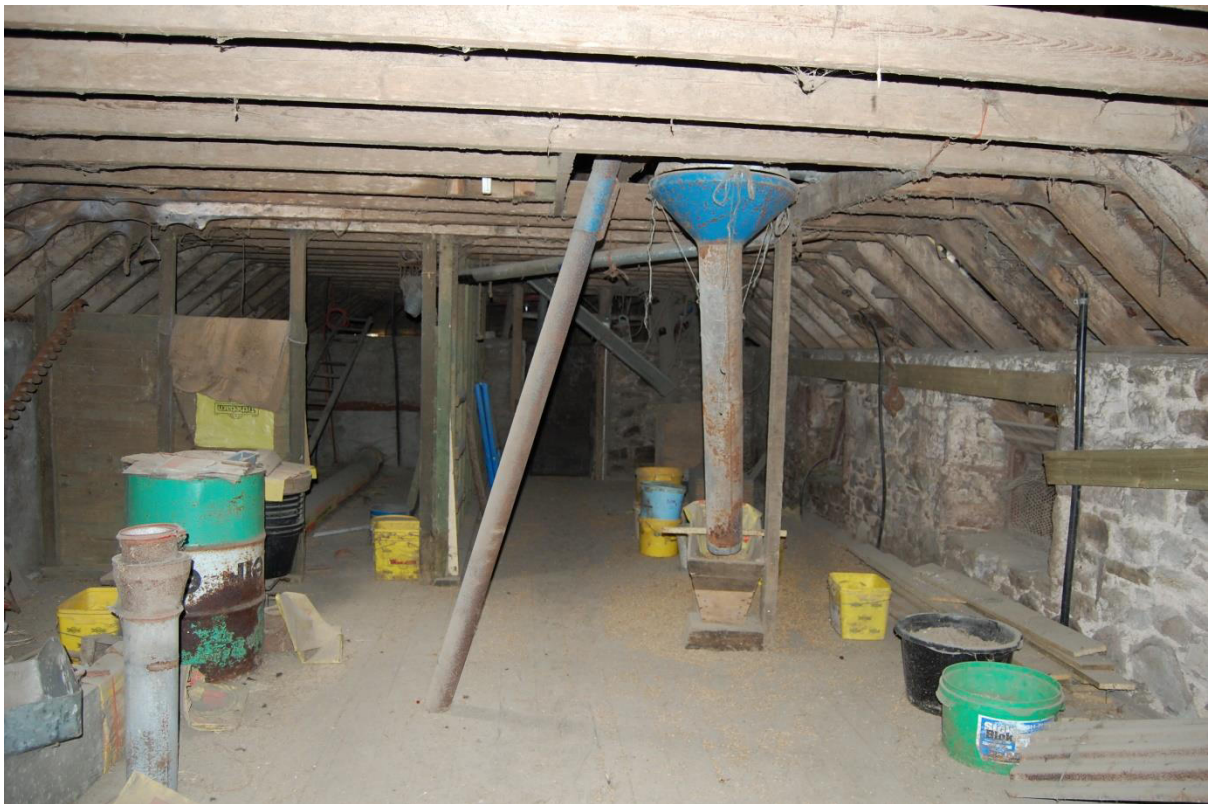
Rooms 9, 10, 11 and 13 are still in use for grain storage (Room 11) and grain preparation and current and former milling equipment was recorded as part of this survey as well as grain chutes (Illus 9). Room 11 was probably the Phase 1 farmhouse; the windows have been blocked and the room is now a grain store (Illus 10).

Illus 9 Phase 1 Room 13 (first floor above Room 10); facing SE

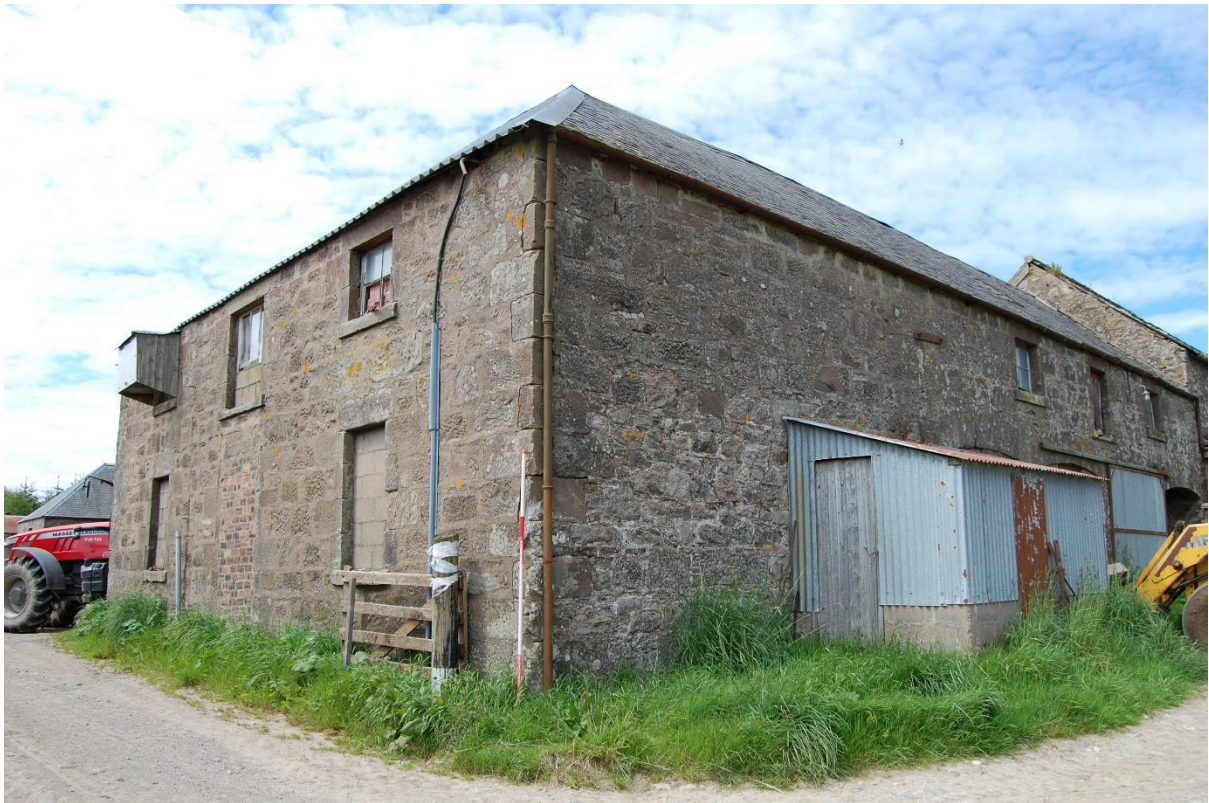
Illus 10 Phase 1 farmhouse Room 11 with blocked windows now used as a grain store; facing W

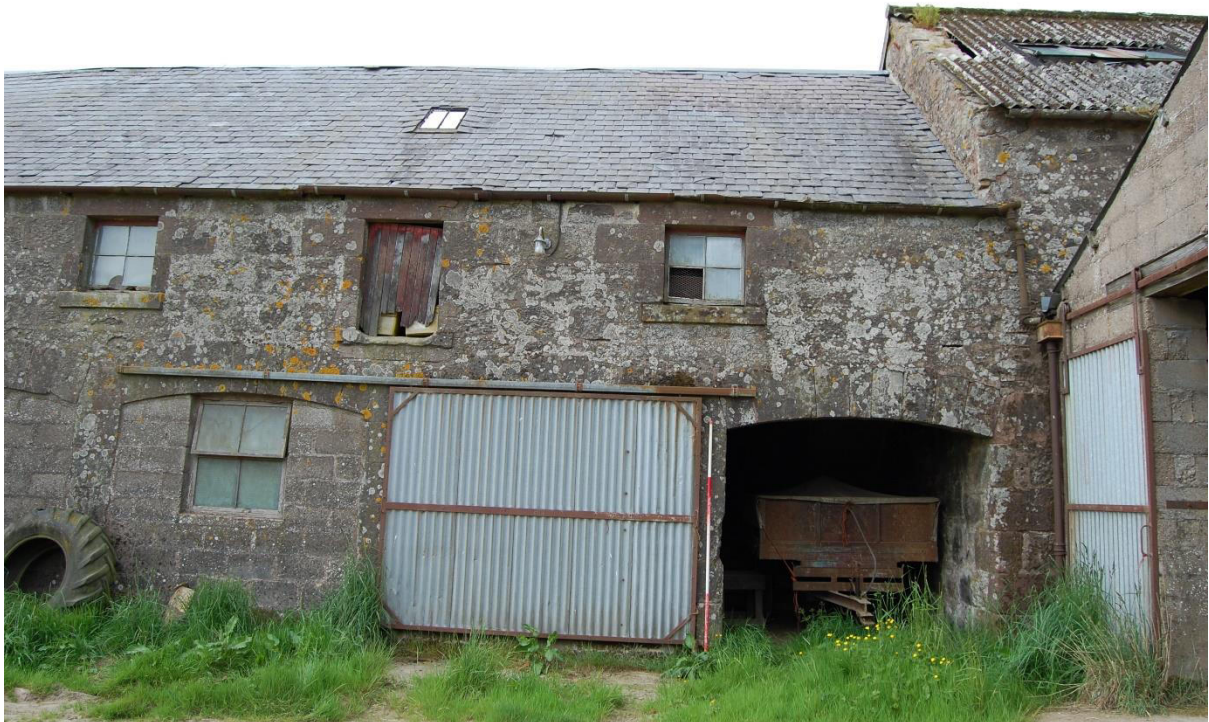
The NE façade has four granite cart doors (Illus 11, 17) and some of these have been blocked with breeze blocks in a later period.

Illus 11 Phase 1 cartshed Room 10 with Door D6 (right, D5, D4 (left); facing SW

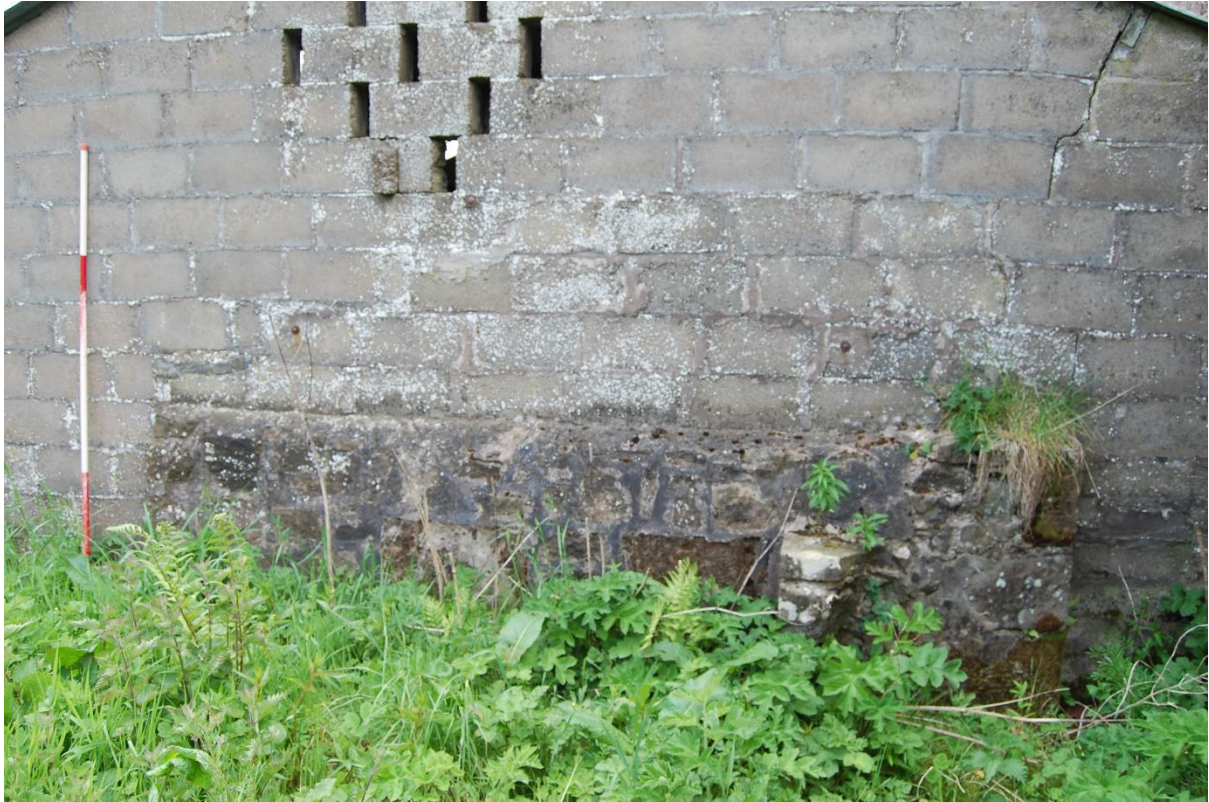
Illus 12 Wall F4 built into later NW wall Room 12; facing SE

By the date of the 2nd Edition OS map (Illus 25) the detached SW wing has been demolished (F7, F8) and a SW wing attached to the SW end of Room 4 (Illus 21). This includes further steadings and a bothy at the south corner (Room 1; Illus 22). The waterwheel may have been added in Phase 1 or Phase 2. A fragment of wall (F3 and F4; Illus 12, 17) was built into a Phase 5 room (Room 12); it is the remains of a small building adjacent to the waterwheel on the 2nd Edition OS map.

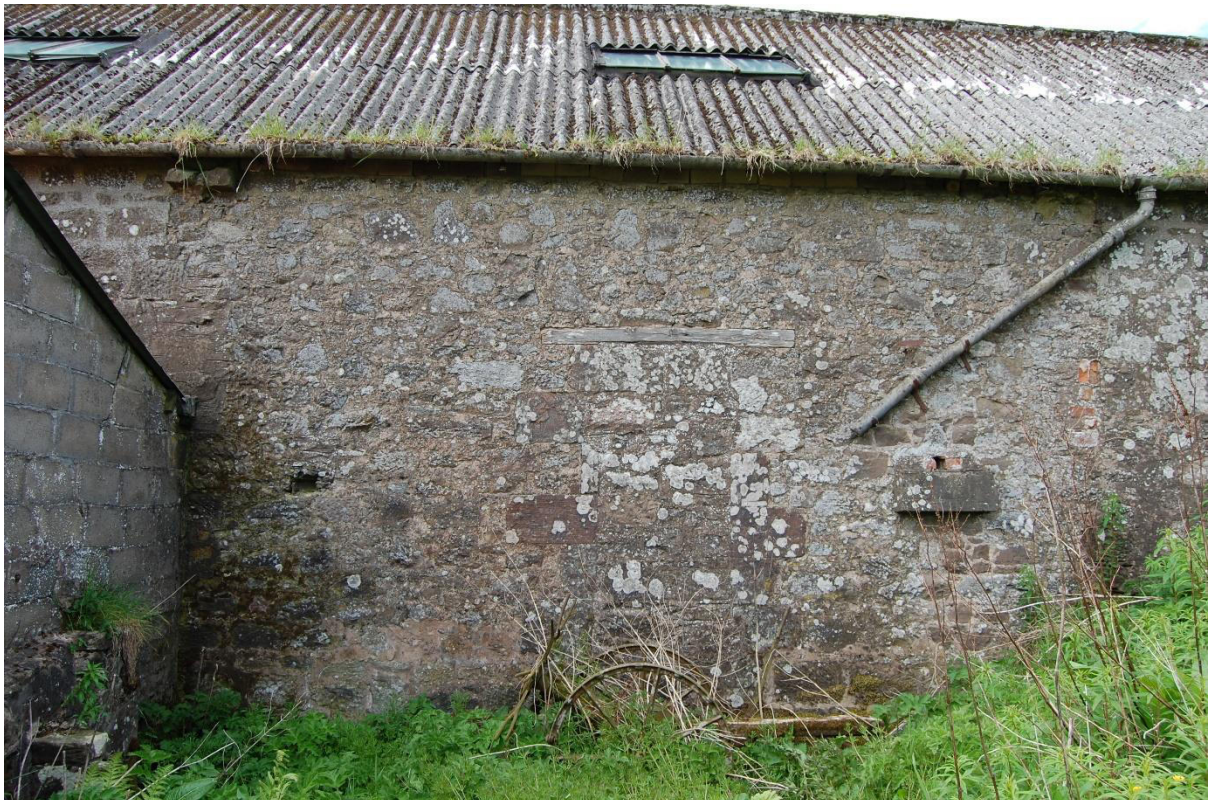
The NE wall of Room 9 had been the site of an overshot water wheel (James Eddie pers comm) and fittings for this wheel survive in this wall (F5, F6) and part of the lade survives (F1 and F2) (Illus 12-15). There is a sluice on the First edition OS map (Illus 24) but the lade is not mapped. The current owner indicated the line of the lade (see Illus 2 for approximate line of lade).

Illus 13 NE wall Room 9 with blocked door D7 (centre) and waterwheel fittings F5 and small aperture F6 (above); facing SW

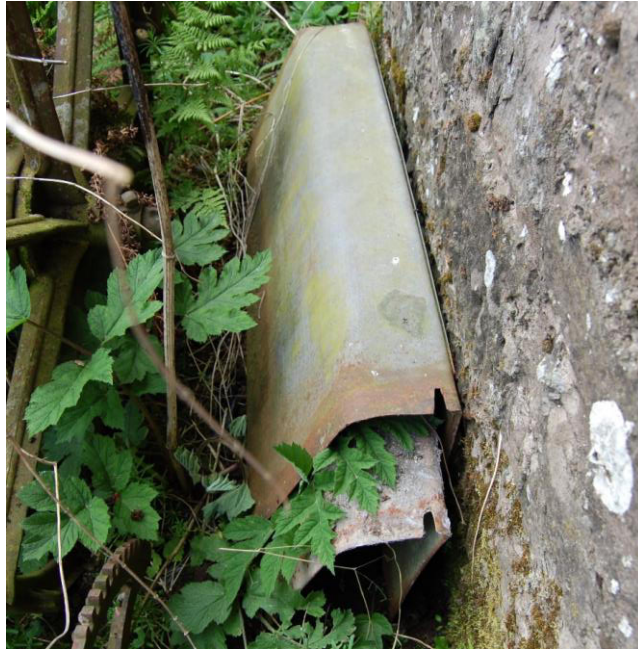
Illus 14 Metal waterwheel paddle

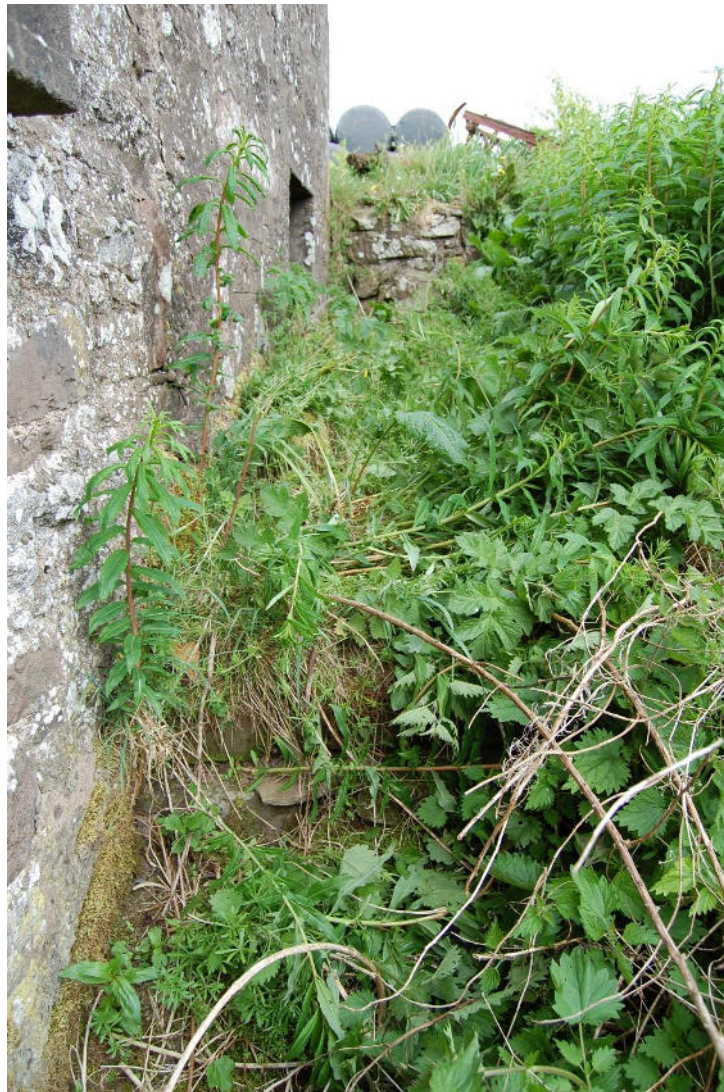
Illus 15 NE wall Room 9 (left) with remains of mill lade walls F1 (top) F2 (bottom)

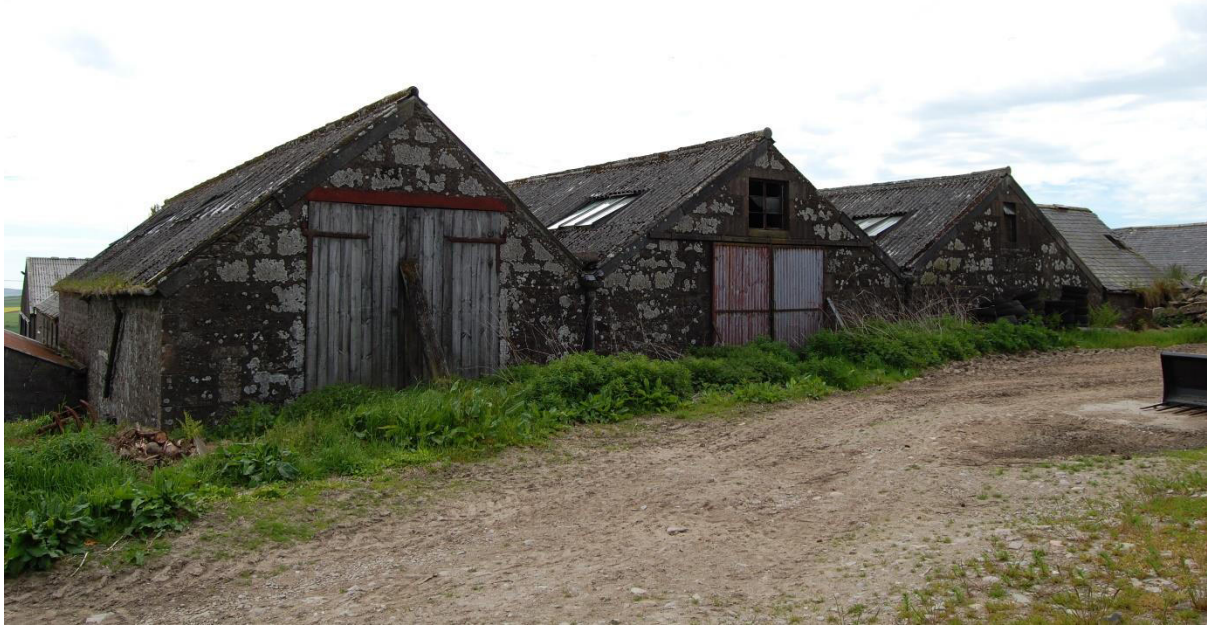
Illus 16 NW aspect of steadings showing Phase 1 gables Room 9 (left) and Room 4 (right)

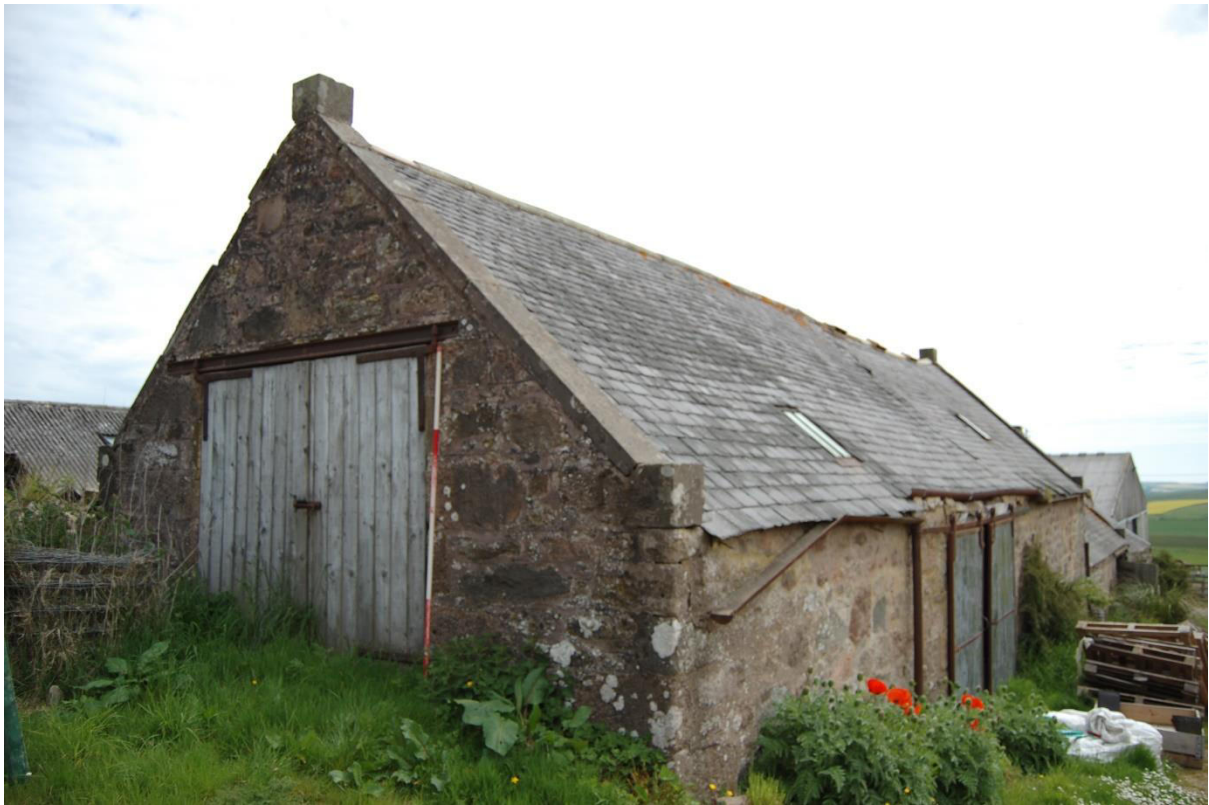
Illus 21 Phase 2 Room 3; facing E

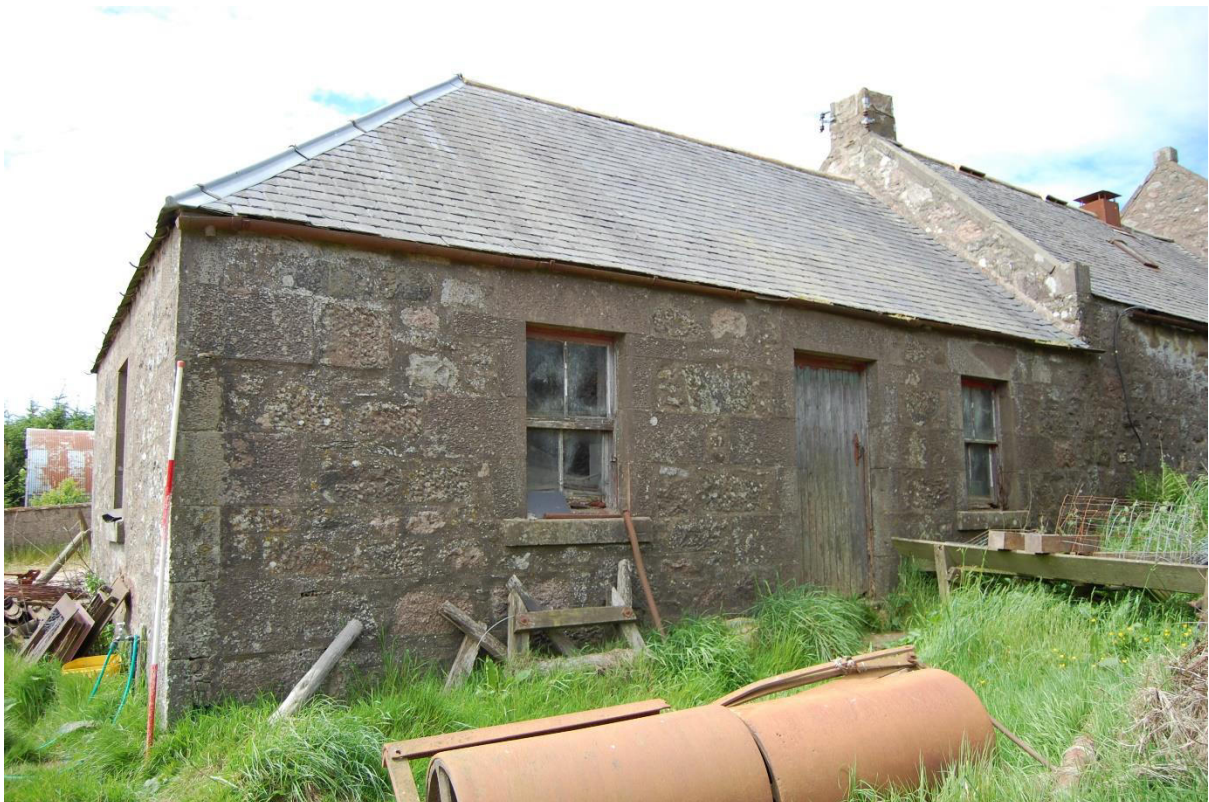
Illus 22 Phase 2 bothy Room 1; facing WSW
