**Thainstone House Home Farm, Thainstone,
Inverurie, AB51 5NT**

Report on Level 1 Standing Building Survey

**Alison Cameron
Cameron Archaeology
26 June 2015**

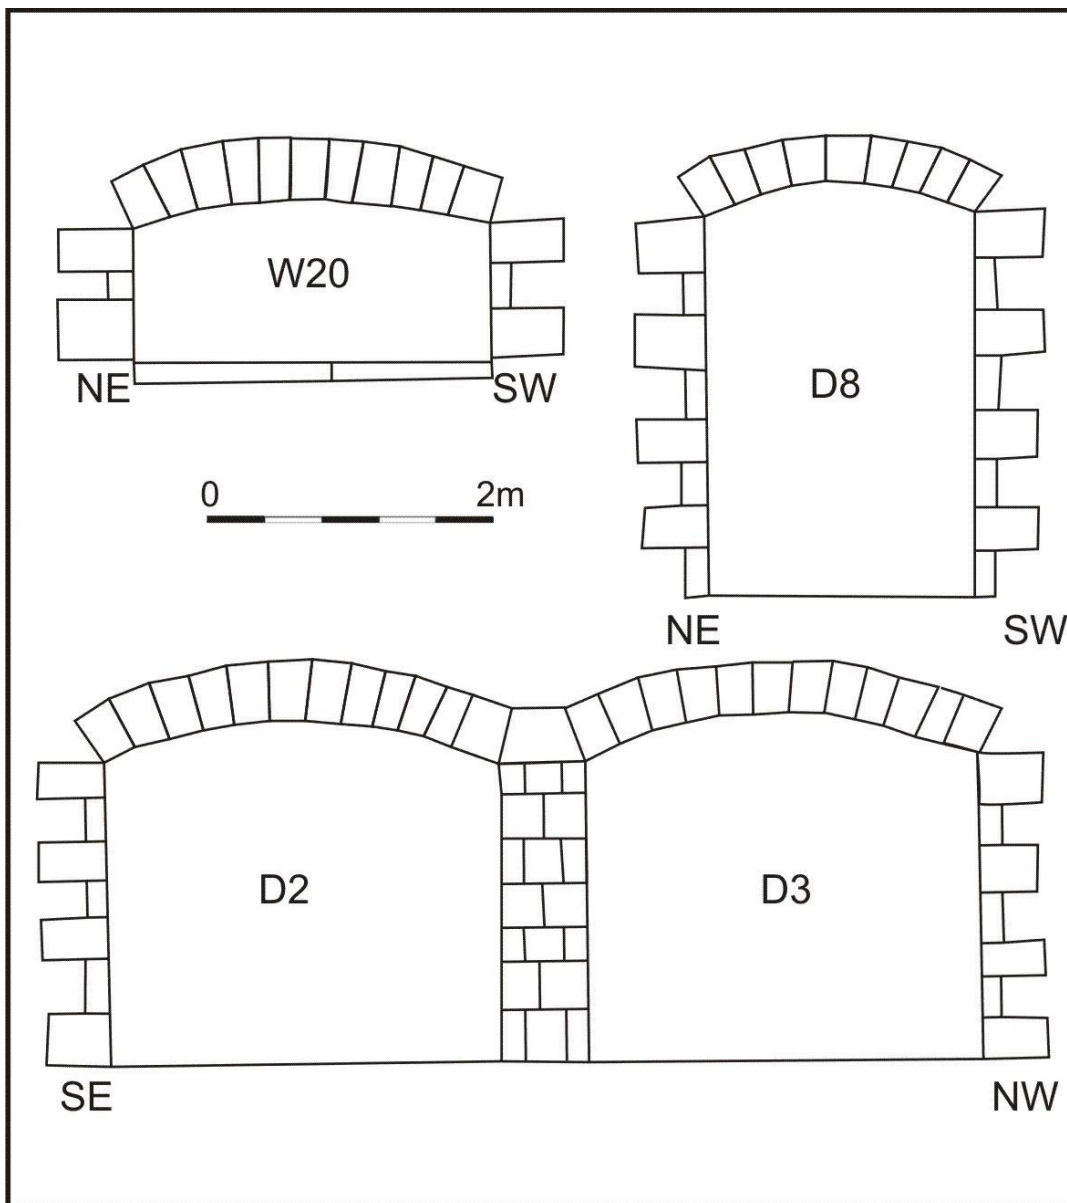
Illus 6 Elevation drawings of W20, D8 and D2 and D3

The buildings are constructed of large fieldstone with cherry cocking. The SE end of the SW range has been a cart shed and has two cart doors (D2, D3; Illus 6, 7). The NW end of this range was a mill and a waterwheel had been sited on the SW wall (Illus 8). A blocked aperture (F1; Illus 11) was probably the former location of the driveshaft for the waterwheel, and remains of the lade (F3; Illus 3, 12) was very overgrown. The interior of this wall is not accessible due to previous internal refit. The mill lade and sluices can be seen on the 1st, 2nd and 3rd Edition OS maps (Illus 18-20). All the Phase 1 apertures have arched stone lintels (Illus 6) and there are thin slit windows for ventilation in the SW wall of the SW range (W18, W19; Illus 5). Fragment of wall F2 is the remains of a small building (Illus 18-20) which appears to have housed the waterwheel. Windows W13, 14 and 16 probably belong to a later phase.

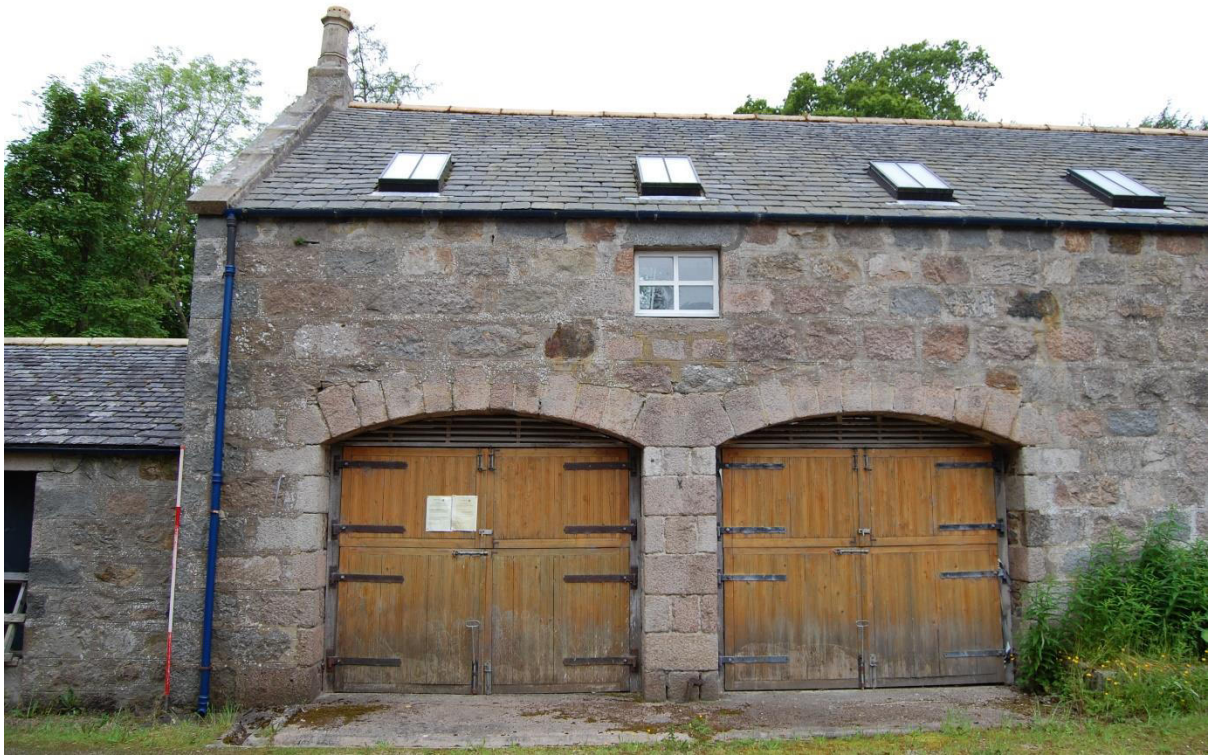
Illus 7 Cart doors D2, D3; facing SW

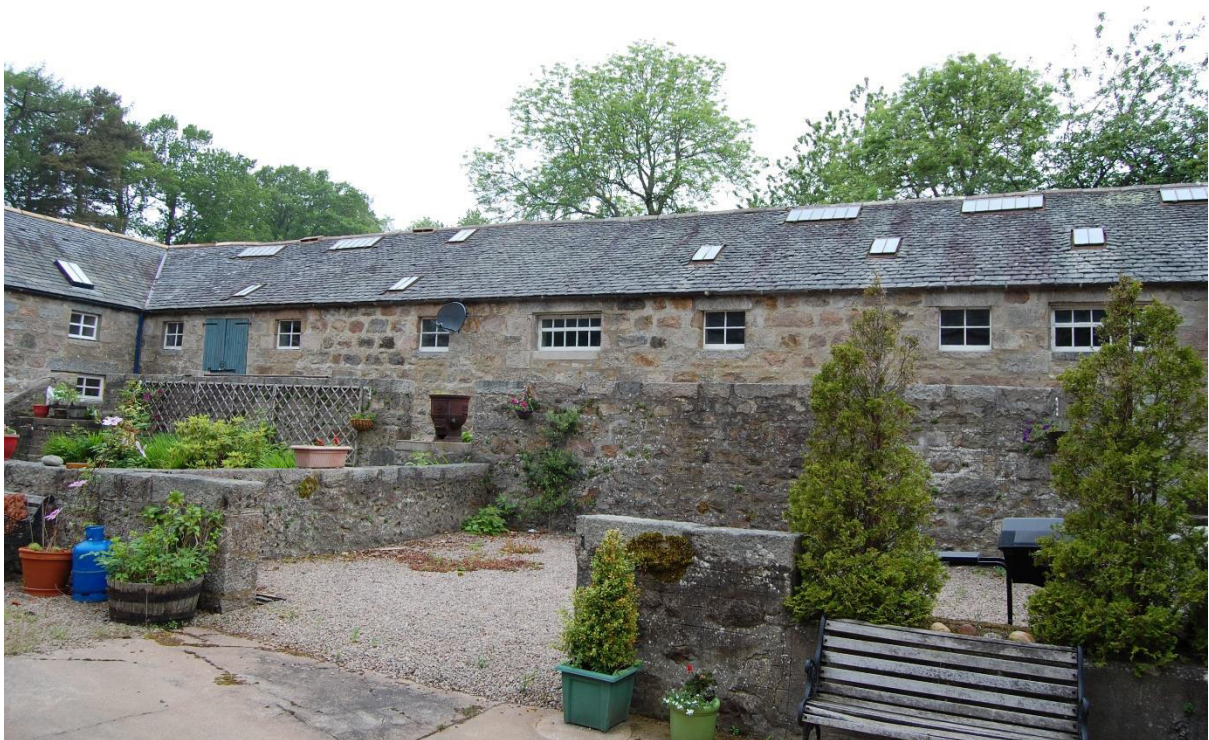
Illus 8 NW range SE wall within courtyard; facing WNW

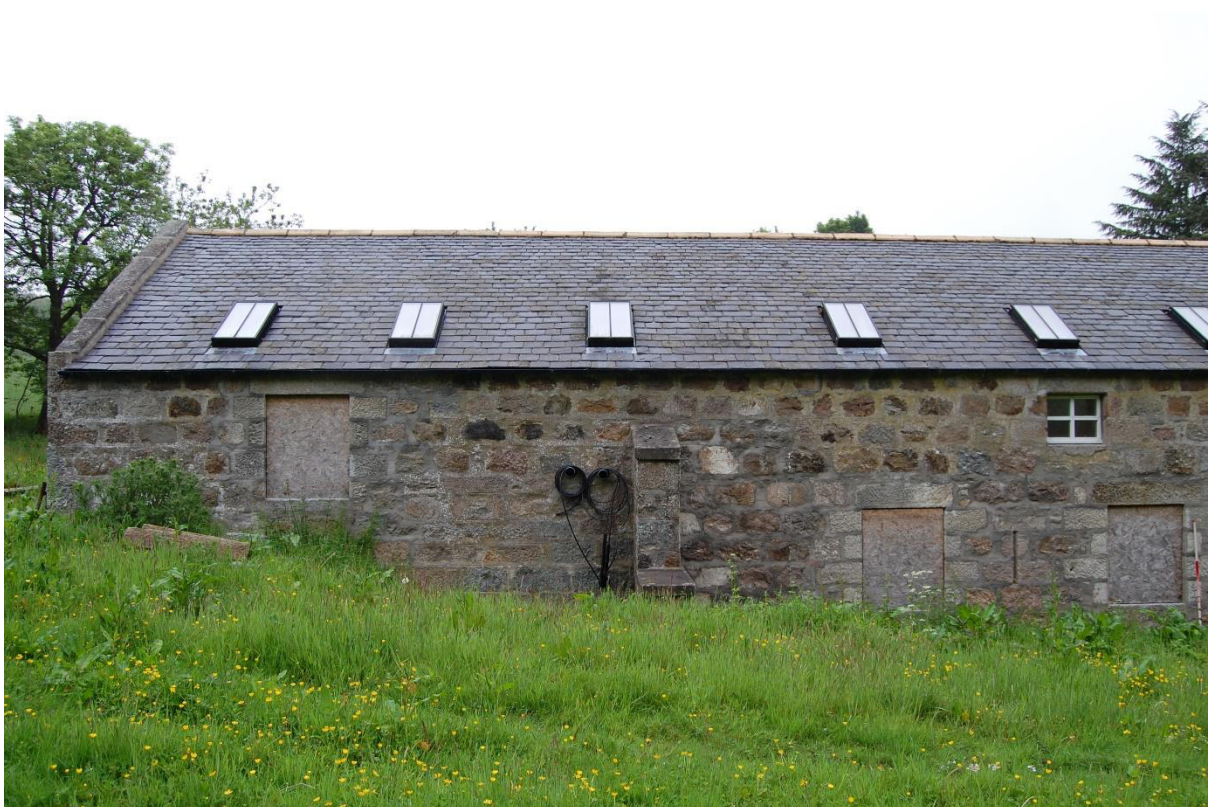
Illus 10 SW elevation with W13, F1, F2, W14, W15; facing NE

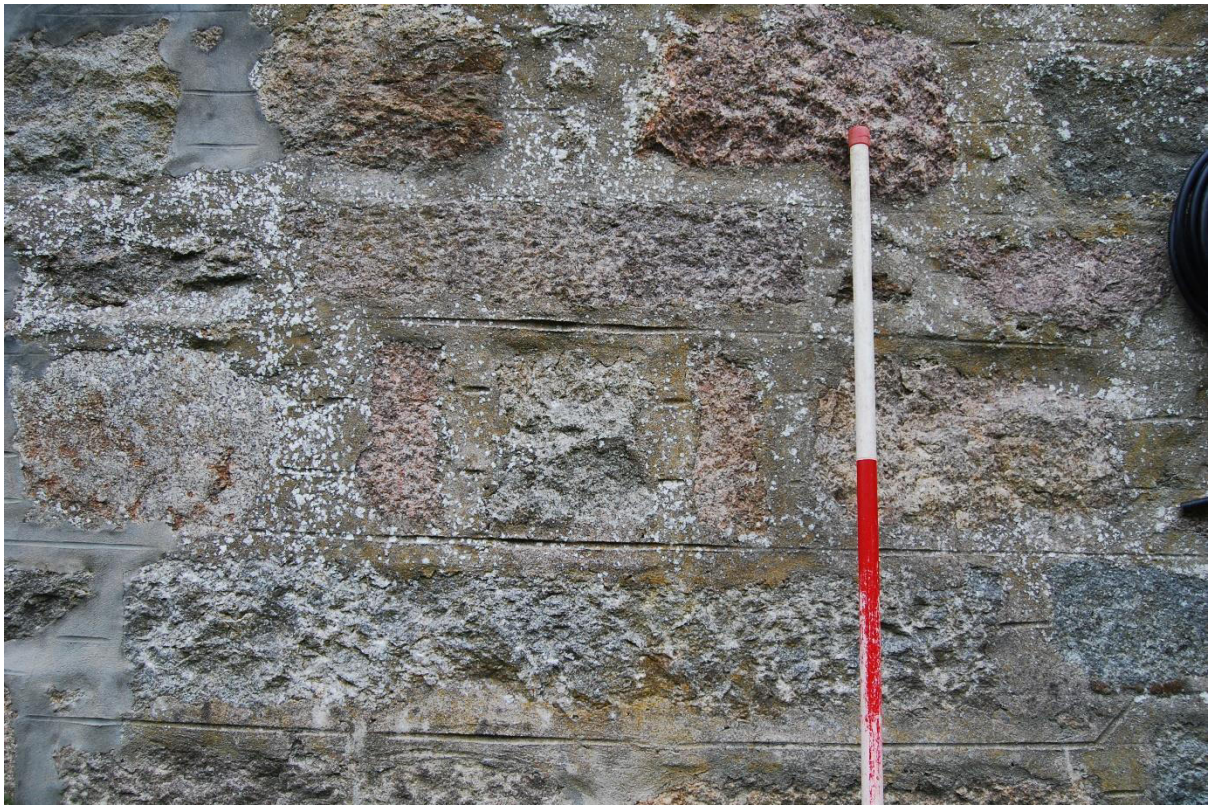
Illus 11 F1; facing NE

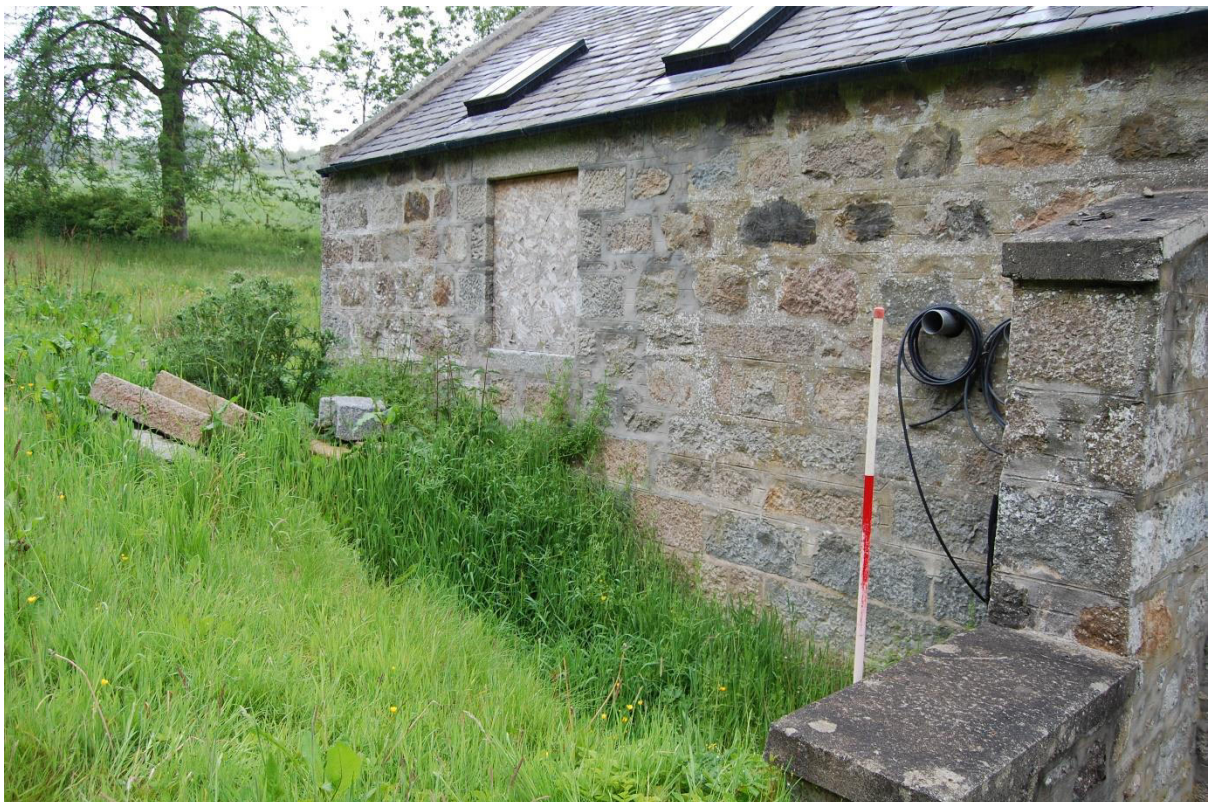
Illus 12 Remains of mill lade F3 (adjacent to building overgrown with vegetation), F1 and F2 (right); facing NNW
