**Plot G, Walled Garden House, Wardhouse Estate,  
Kennethmont, Huntly, AB52 6YL  
Report on Level 1 Standing Building Survey**

**Alison Cameron  
Cameron Archaeology  
30 June 2015**

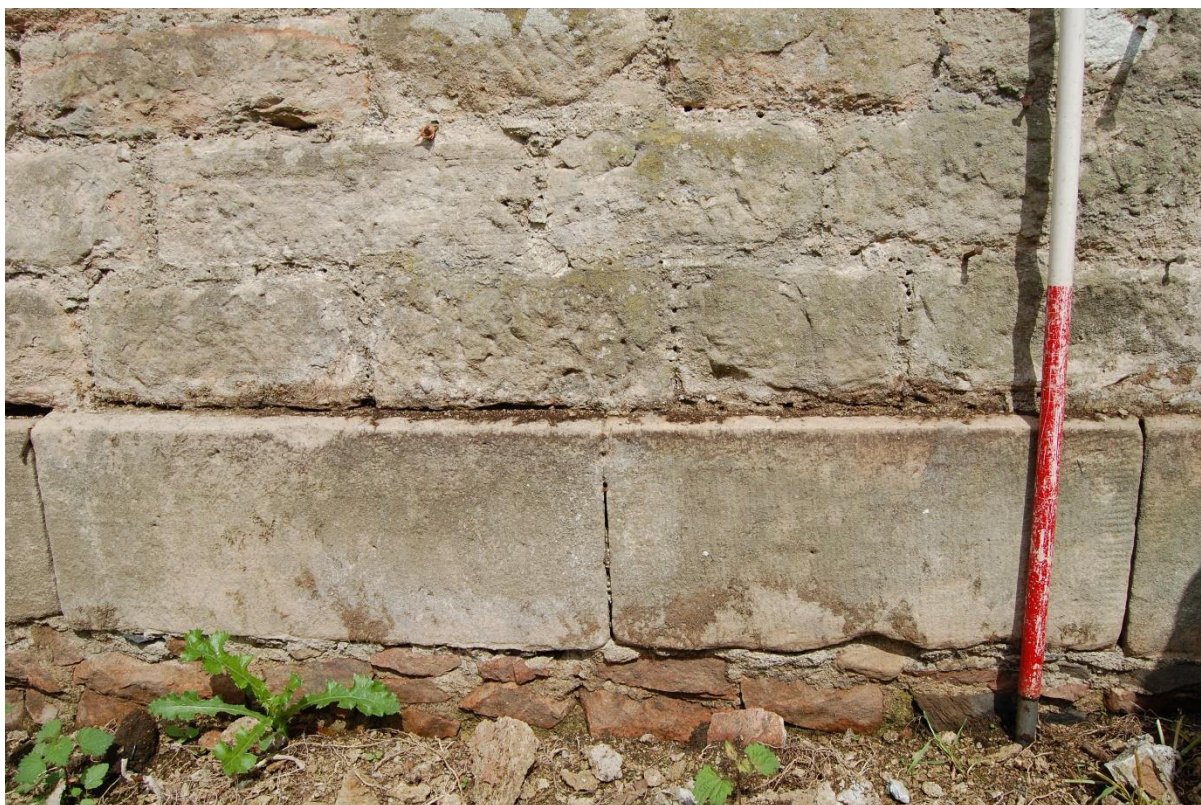
The NNW wall of the former walled garden of Wardhouse survives and has been carefully and sensitively cleared of undergrowth by the current owners revealing a well-preserved wall (F7; Illus 3). The wall is constructed of sandstone blocks with an ashlar base course and red sandstone foundation (Illus 4) and stands to a maximum of 3m high. The wall has curved corners at the WSW and ENE ends and is the inner garden wall; there was an outer wall as well as the rest of this walled garden and no trace of these walls now survives (see OS maps Illus 21-23). There is a socket stone towards the WSW and a stone with a drilled hole (F5). The outer skin of stone wall around F5 has collapsed (Illus 5) and it is possible that this is the former location of a niche or other feature but there are no internal features such as niches or bee boles. At the terminal of each end of the wall are the bases for gateposts or pillars (F3, F6 Illus 3, 6) and the ashlar sandstone pillar stones were found by the current owners in the undergrowth (Illus 7). There are sparse iron sittings on the N face of the wall but numerous on the S face (Illus 8) for espalier of fruit trees. The undergrowth cleared by the current owners included a number of fruit trees and bushes.

Illus 4 Foundation for the wall F7; facing NNW

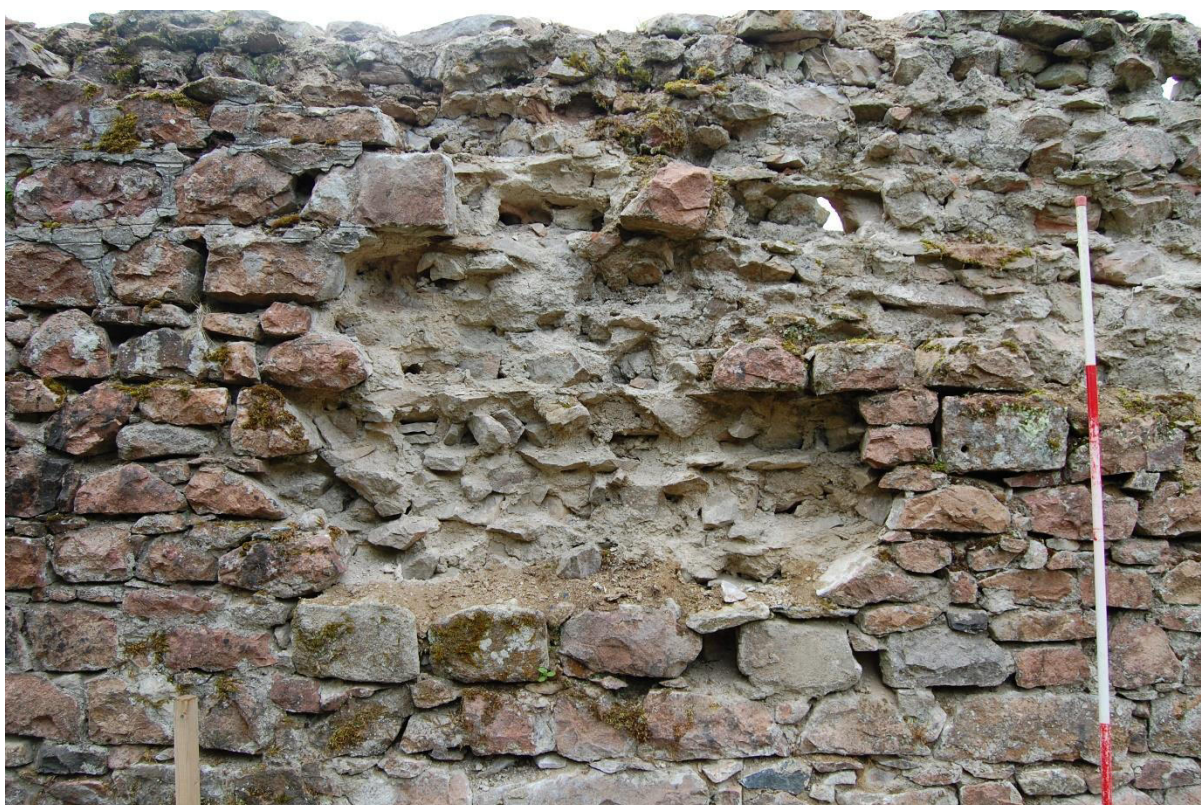
Illus 5 N face of wall F7 showing area of damage (left) and socket stone F5 (right)

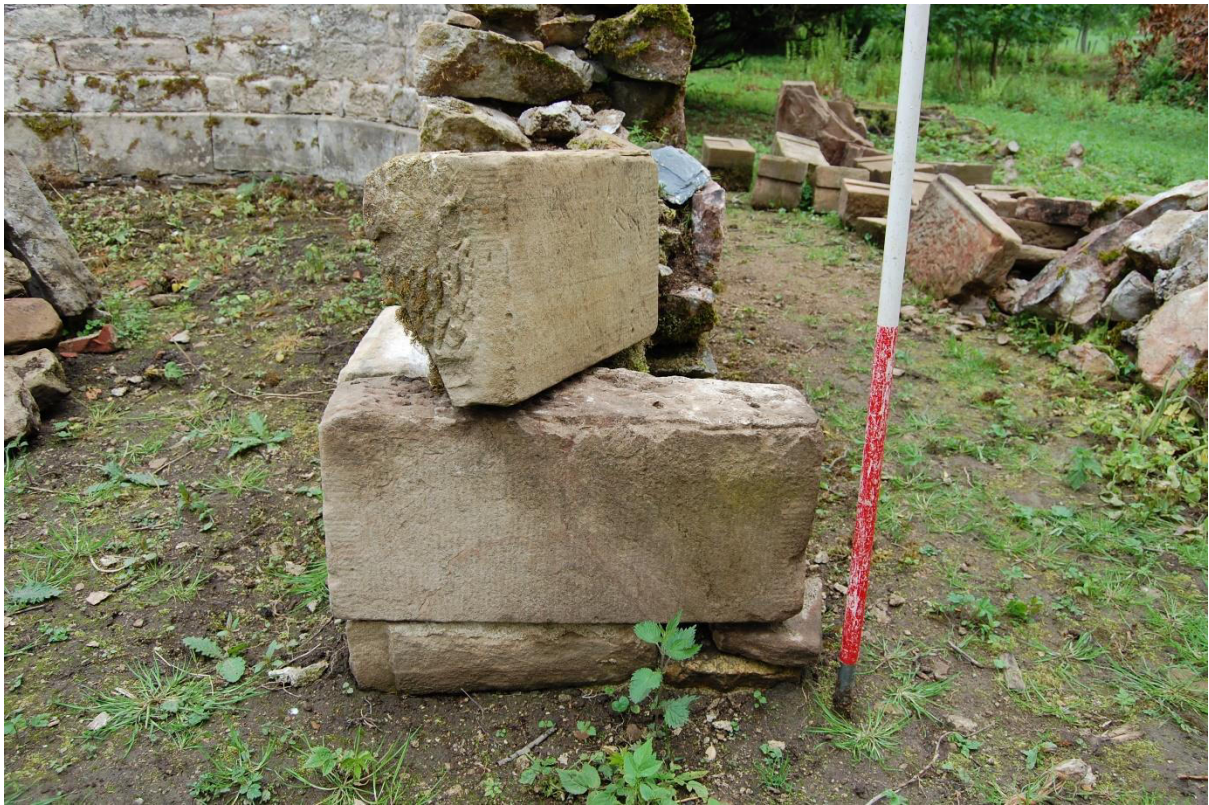
Illus 6 Ashlar sandstone gate post F6 with basal stone in situ; the remainder of the stones were recovered from undergrowth by the present owners

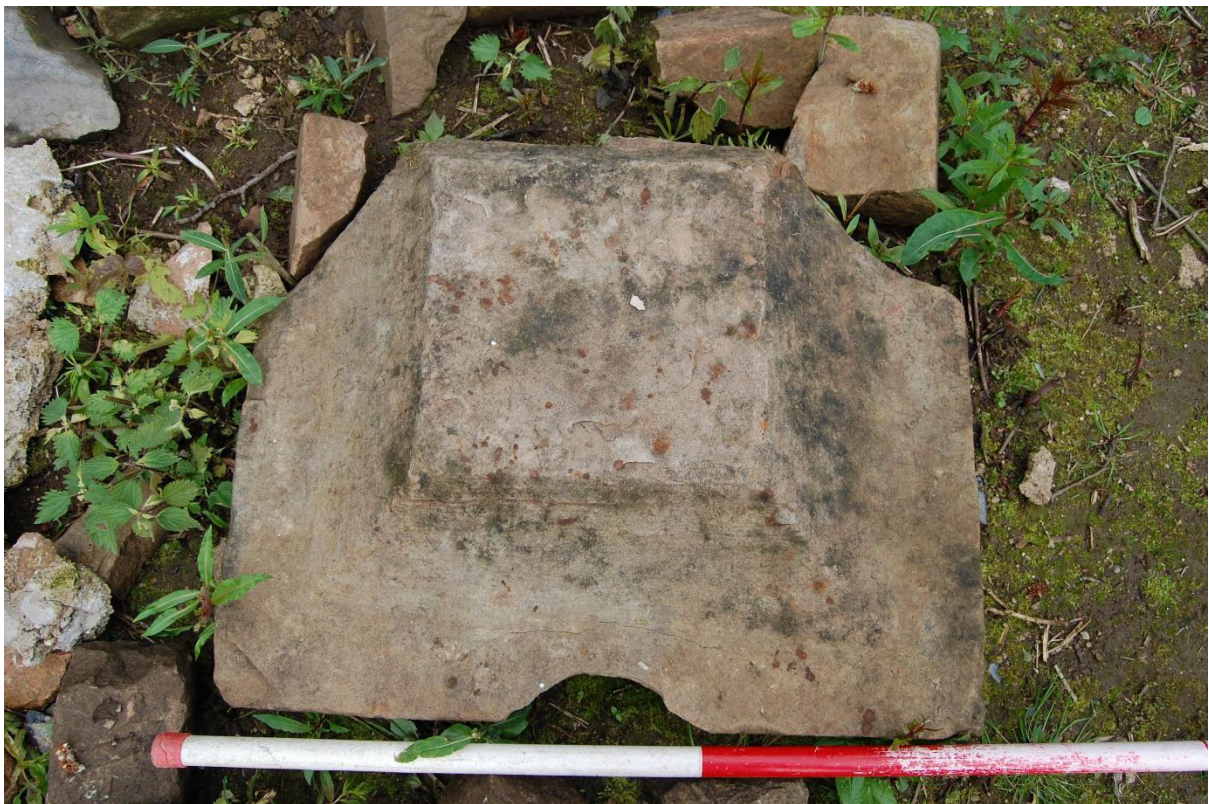
Illus 7 Sandstone capstone from gatepost F3 (recovered from undergrowth by present owner)

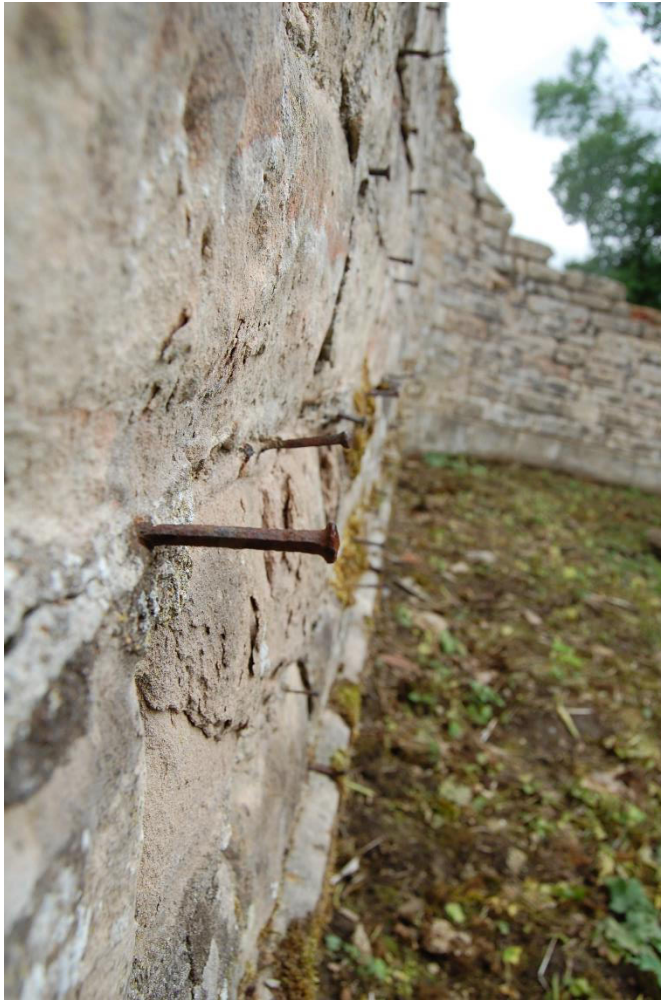
Illus 8 Iron nails concentrated on the S facing inner face of the wall for espalier; many overgrown fruit trees were cleared from this area by the present owners; facing ENE

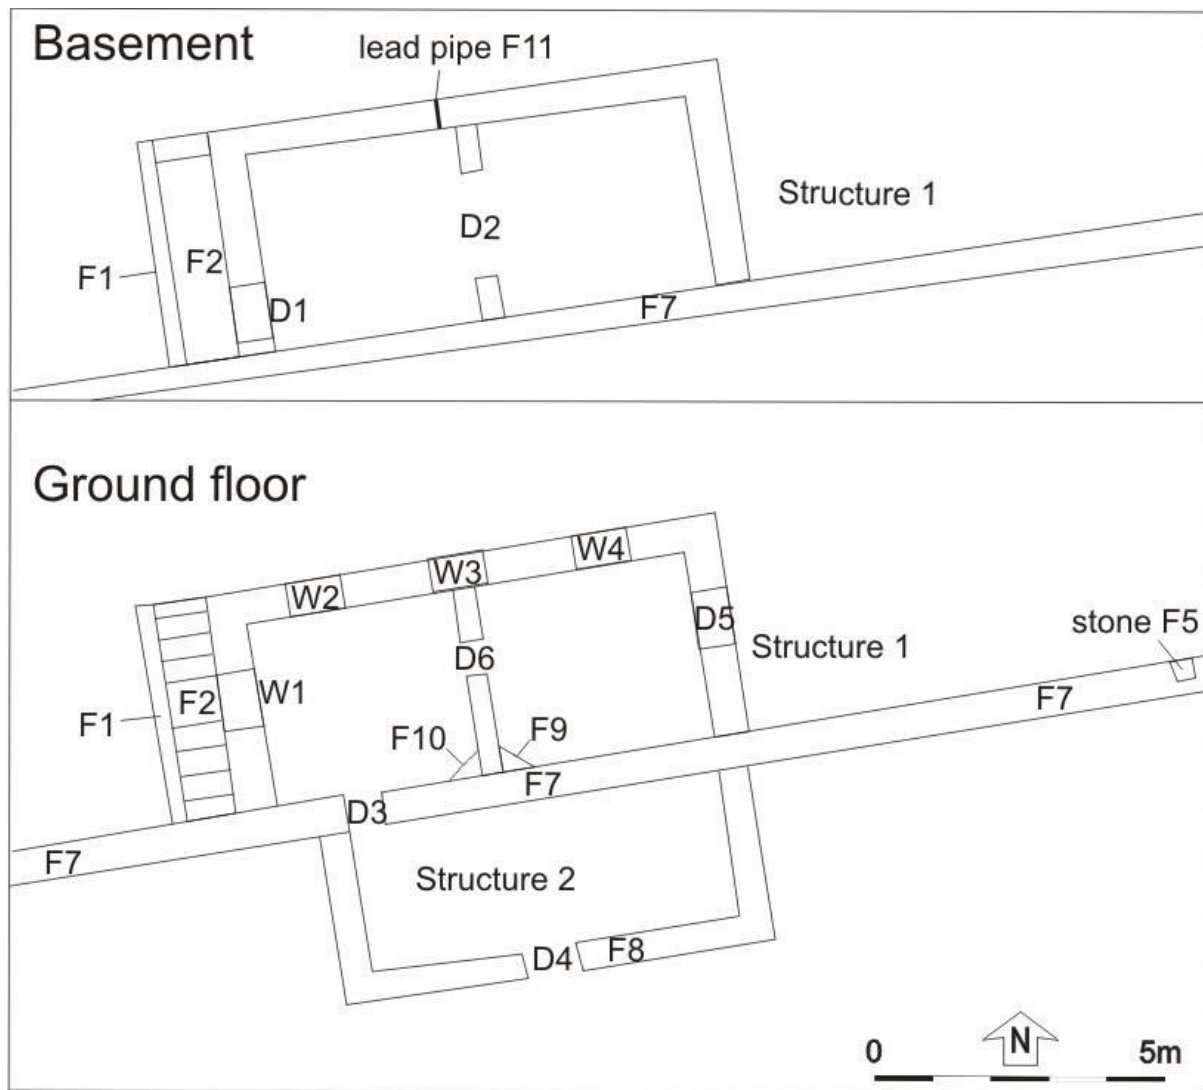
Illus 9 Plan of Structures 1 and 2

Structure 1 was been butted on to the N side of the walled garden wall (Illus 9, 10) in Phase 1. It is 8.9m long and 3.8m wide and 2.75m high above ground level. There is also a basement accessed by a set of steps (F2) on the WSW side of the building. The building is constructed of a light fine sandstone with ashlar base course (identical to the base course of garden wall F7), exterior lintels, jambs and sills (Illus 10, 12). The interior lintels of all the Phase 1 apertures are arched stone lintels (Illus 120). The exterior walls have been plastered. In Phase 1 the ground floor consisted of one room with three windows (W2, W3, W4) in the N wall D5 in the E wall and W1 in the W wall.

The basement consists of two rooms divided by a 2m wide door (D2) with an arched stone lintel; it is probable that this is a Phase 1 door and that the basement was constructed in Phase 1 with 2 rooms. There is a lead pipe through the N wall (F11; Illus 9) which is the remains of a water supply and this room may have been the location of a boiler for heating the N wall of the walled garden to increase plant growth. The floor of the basement consists of substantial slate paving with slabs in the W room c 0.42 x 0.61m in size, 0.62 x 0.67 in the E room and adjacent to the E wall the slabs are 1.15 x 1.04m in size. There is no floor surviving, just the joist holes.

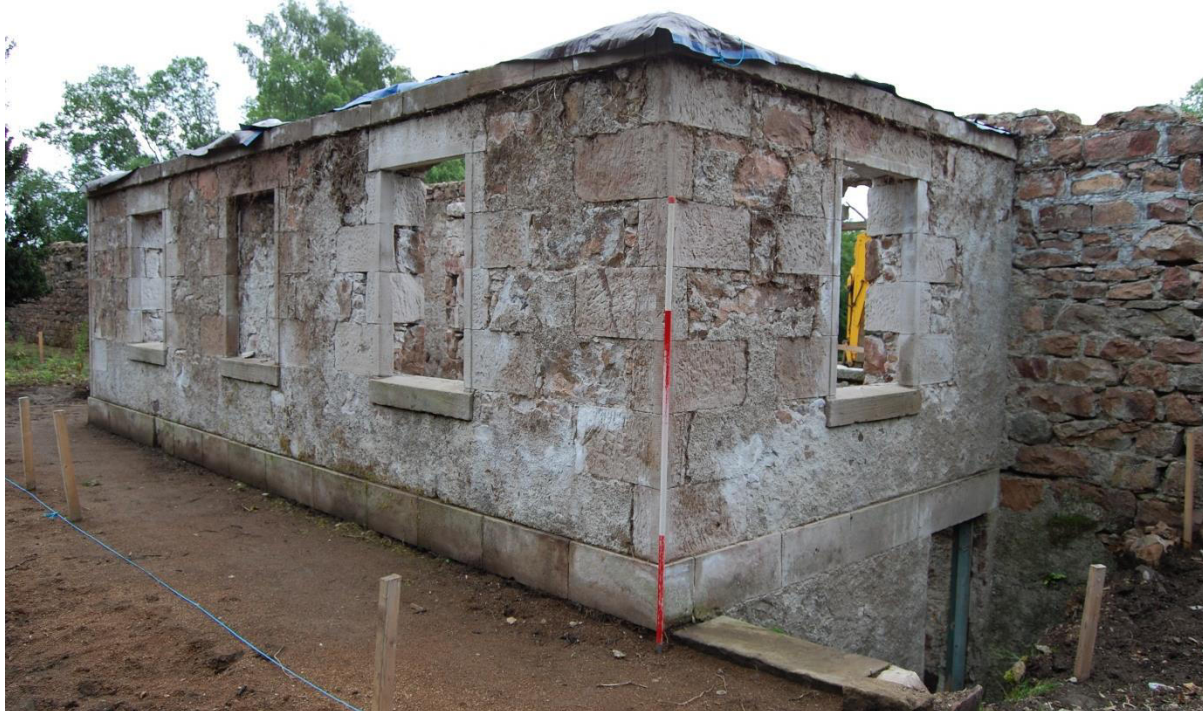
Illus 10 Structure 1 facing ESE

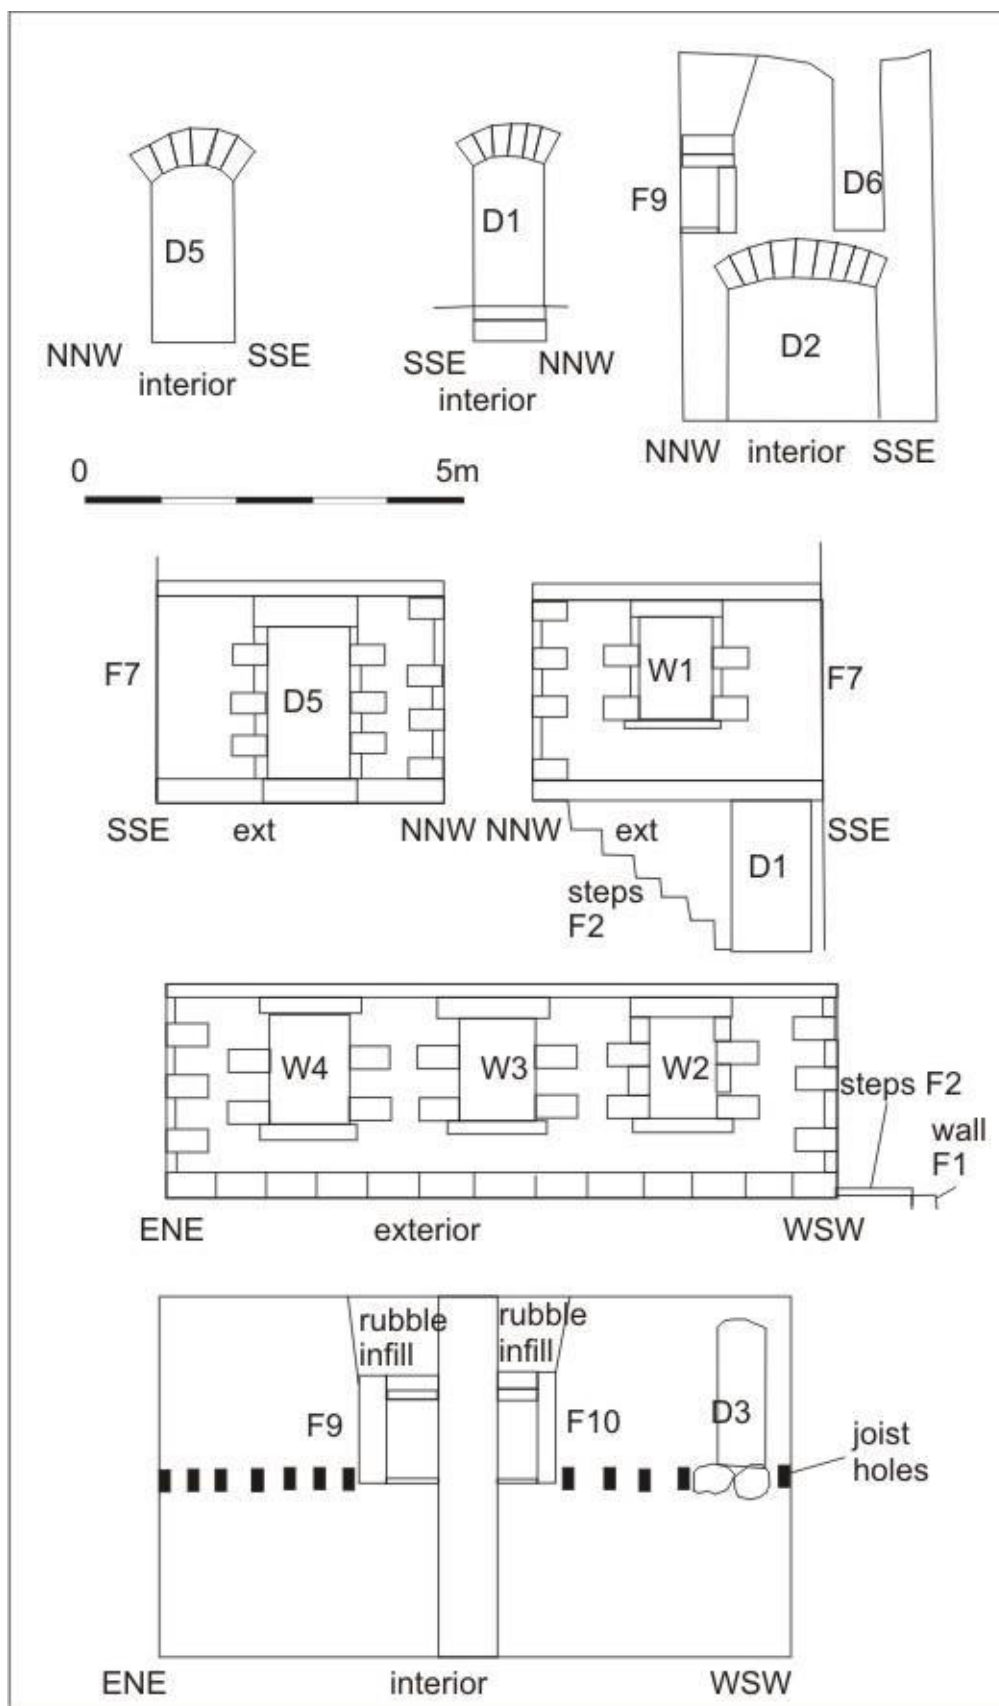
Illus 11 Elevations D5 interior, D1 interior, central basement wall, E wall exterior, W wall exterior, N wall exterior, S wall interior

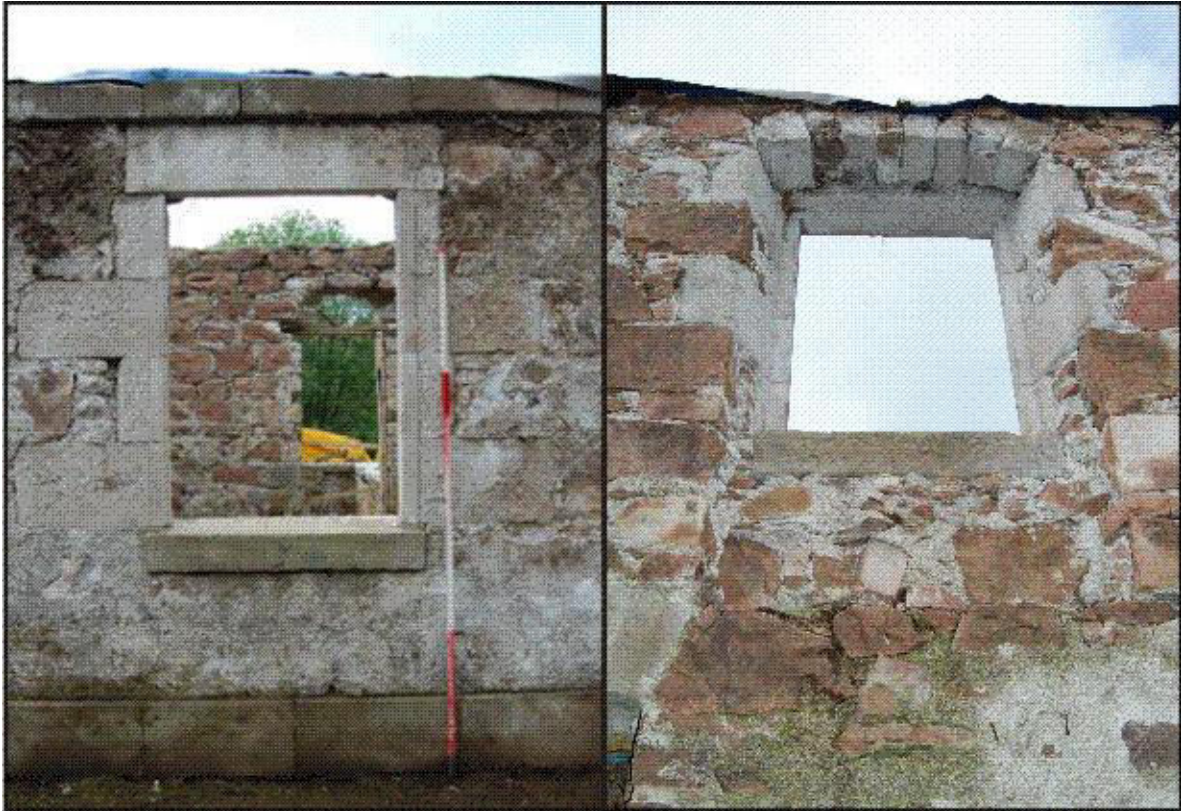
Illus 12 Window W2 (left) exterior with ashlar jambs, lintel and sill; facing SSE (right) interior with arched stone lintel facing NNW

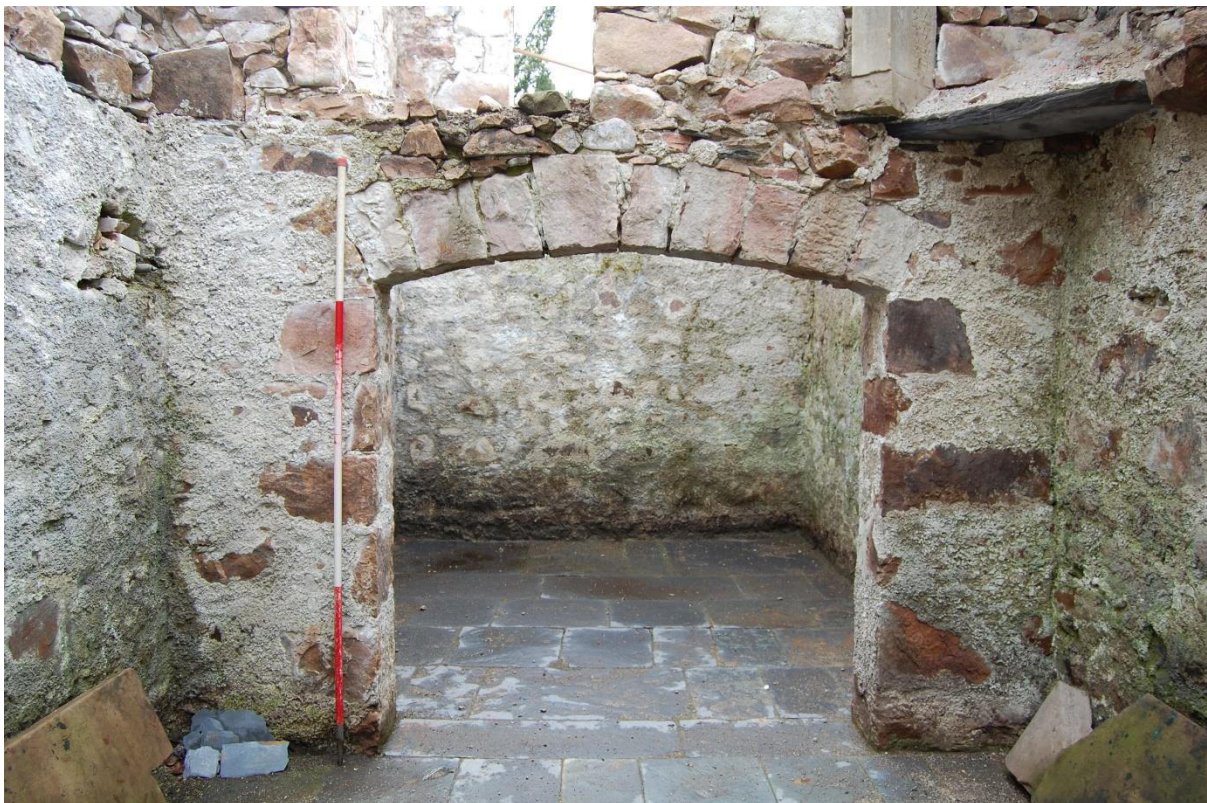
Illus 13 Structure 1 basement door D2; facing ENE

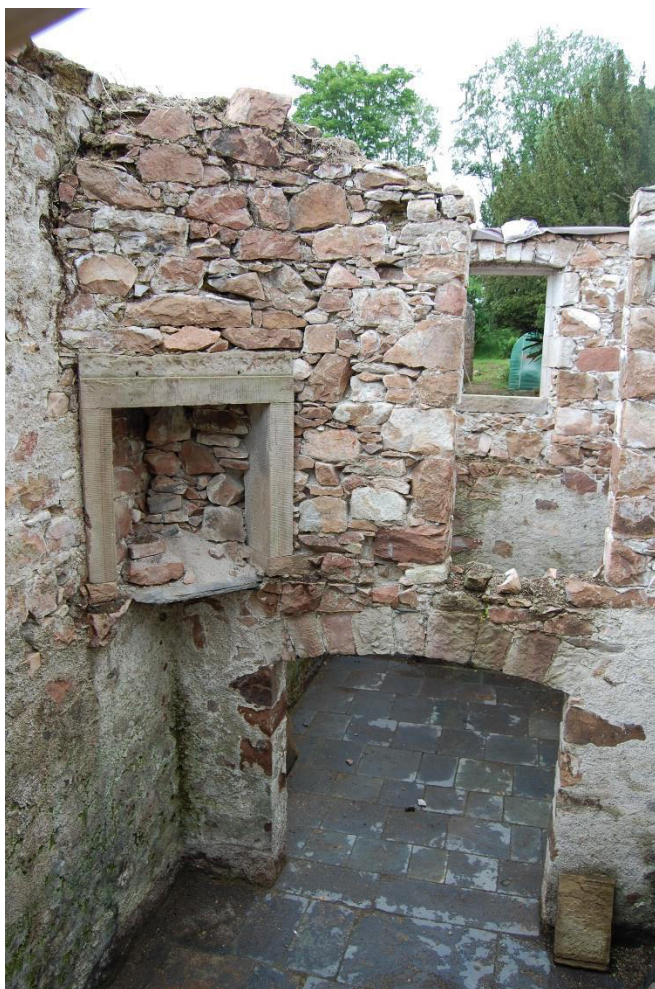
Illus 14 Structure 1 showing Phase 1 inserted wall with corner fireplace F9 showing stone rubble above, door D2 (below) and door D6 (above) with W1 in background; facing WSW

Structure 1 was altered in this phase (see Illus 16). Window W3 in the centre of the N wall was blocked and a central wall added (Illus 16). The ground floor of Phase 2 consisted of two rooms accessed through a door on the ENE wall (D5; Illus 12) with an internal door between rooms (D6). There are small fireplaces in the corner of each room (F9, F10; Illus 9, 11, 14) which were added in this phase. They are 0.9 x 0.9m internally with ashlar sandstone lintel and jamb and a slate base and the wall above each fireplace has been built up with granite rubble (Illus 14).

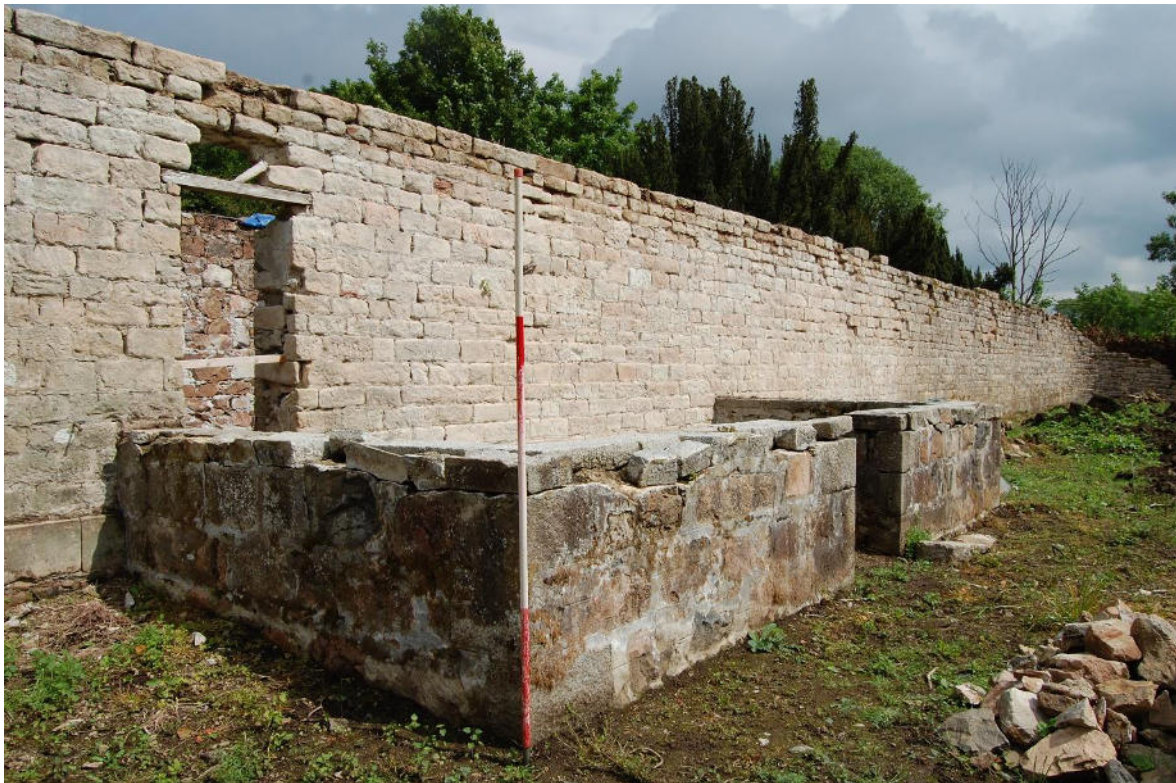
In Phase 2 Structure 2, a small enclosure 7.35 x 3m in size was butted on to the S face of wall F7 (Illus 9, 15). The wall is constructed of granite rubble 0.46m thick and up to 1.12m high (F8) with coping stones on the top. There is a door (D4) in the S wall. In Phase 2 a door was been opened in F7 between Structure 2 and Structure 1 (D3). It has been roughly constructed with a wooden lintel (Illus 9, 15) to allow access to the ground floor of Structure 1. The stones forming the base of this door has removed joist holes in the S wall of Structure 1 (Illus 11, bottom). Fragments of window glass around Structure 2 may suggest this had a glass superstructure or there had been greenhouses sited in this area.

Illus 15 Structure 2 butted on to the south face of wall F7 in Phase 2 showing door D3 which was formed in the wall in Phase 2

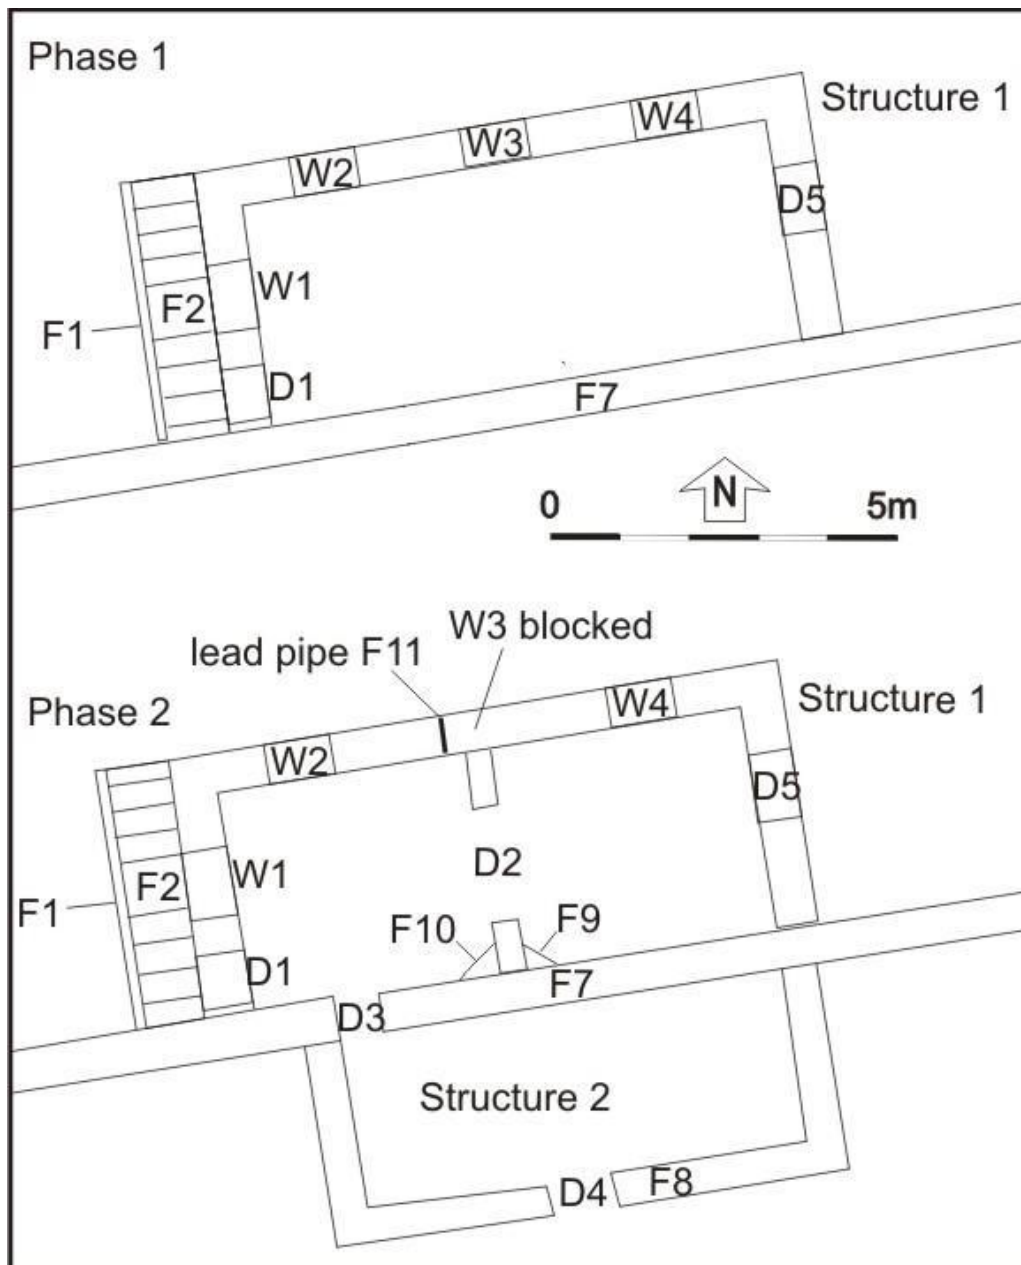
Illus 16 Phase plan showing development of Structures 1 and 2

A Level 1 standing building survey was carried out on 26 June 2015 and at least two phases of building were identified. The garden house on the north side of the walled garden wall (Structure 1) was a one room feature in Phase 1, probably with a boiler in the basement. In Phase 2 the ground floor was split into two rooms and a door added between this building and Structure 2. Structure 2 is probably the base for a greenhouse, and window glass found in this area suggests that it had a glass superstructure. It is likely that Structure 1 took on a more utilitarian use in Phase 2, possibly as a greenhouse or potting shed due to its roughly constructed joining door (D3).
