**Corgarff Parish Church, Corgarff, Strathdon,
Aberdeenshire, AB36 8YL**

Report on Level 1 Standing Building Survey

**Alison Cameron
Cameron Archaeology
5 August 2015**

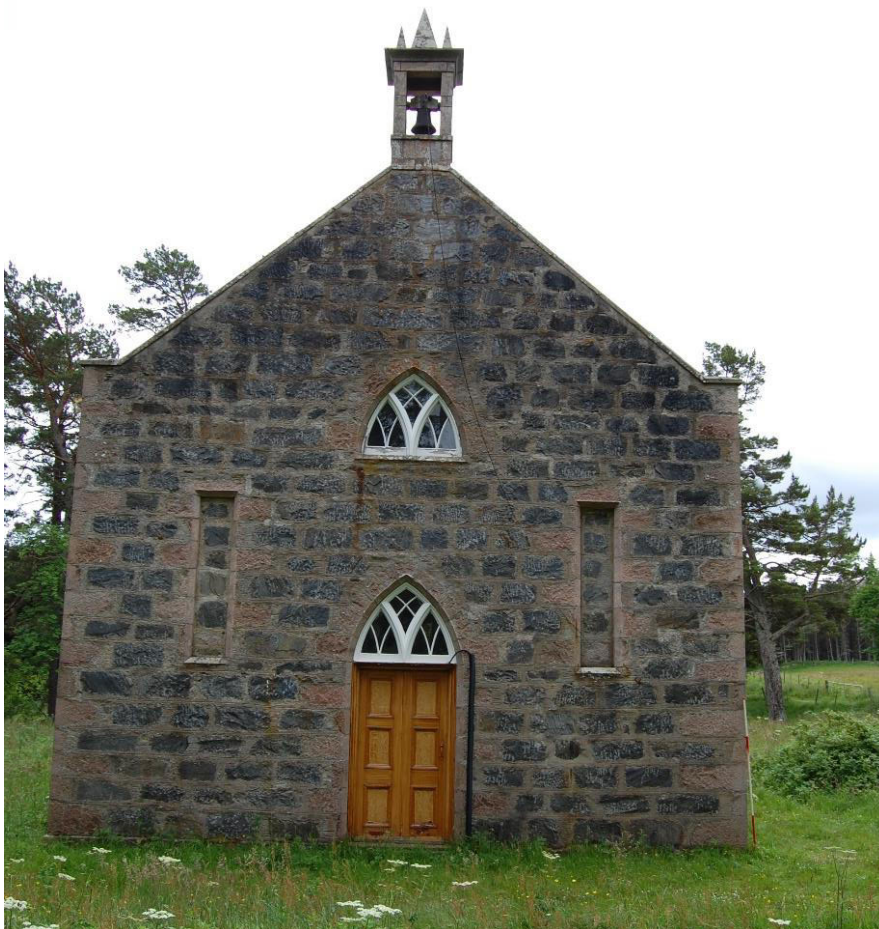
Illus 8 NNW gable with central door (1) first floor window (W2) and long narrow blocked windows (W1 and W3) with bell-cote above.

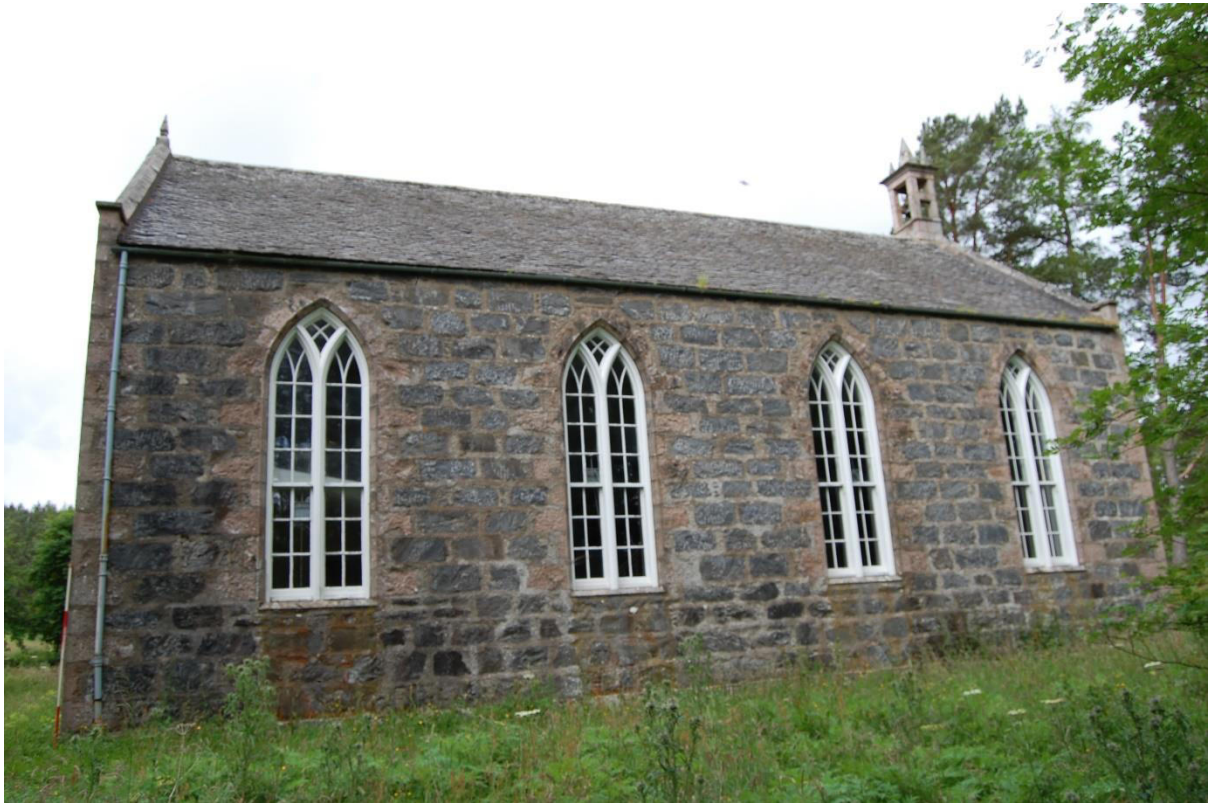
Illus 9 ENE wall with windows W4 (right), W5, W6 and W7

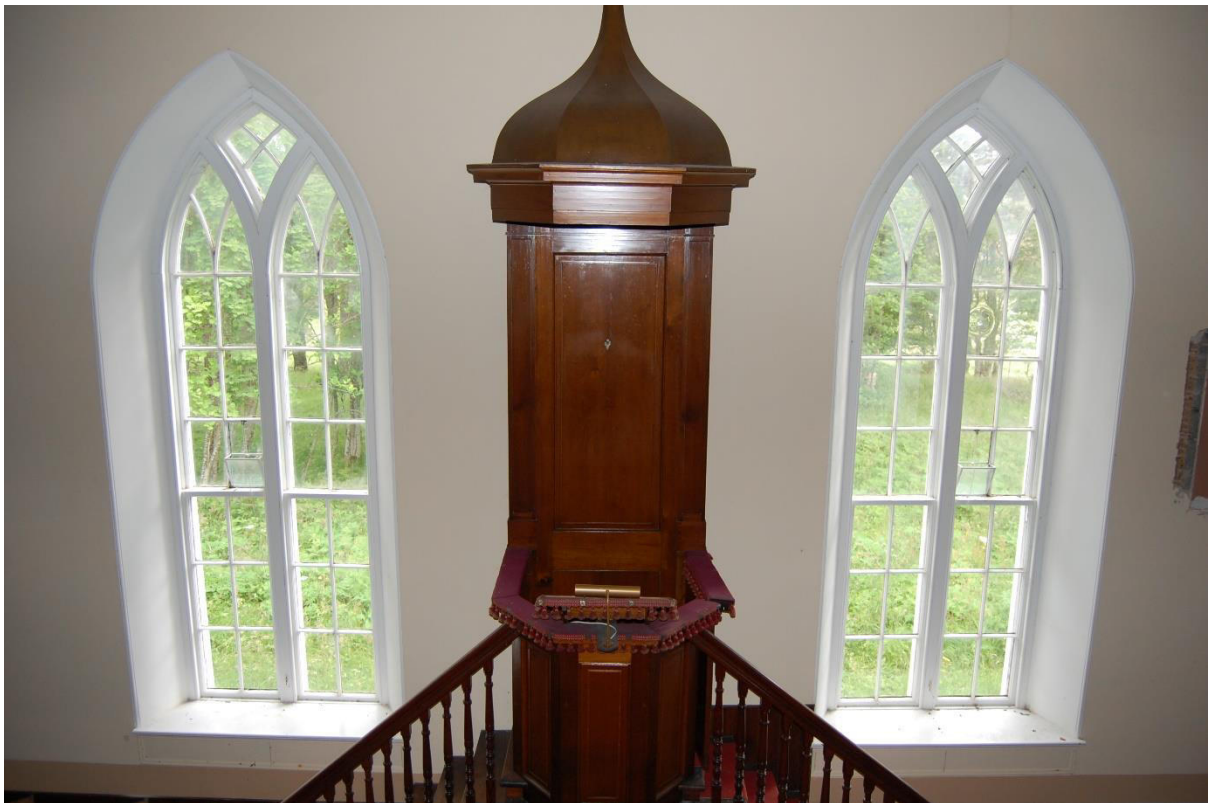
Illus 10 Pulpit (centre) with W5 (left) and W6 (right); facing ENE

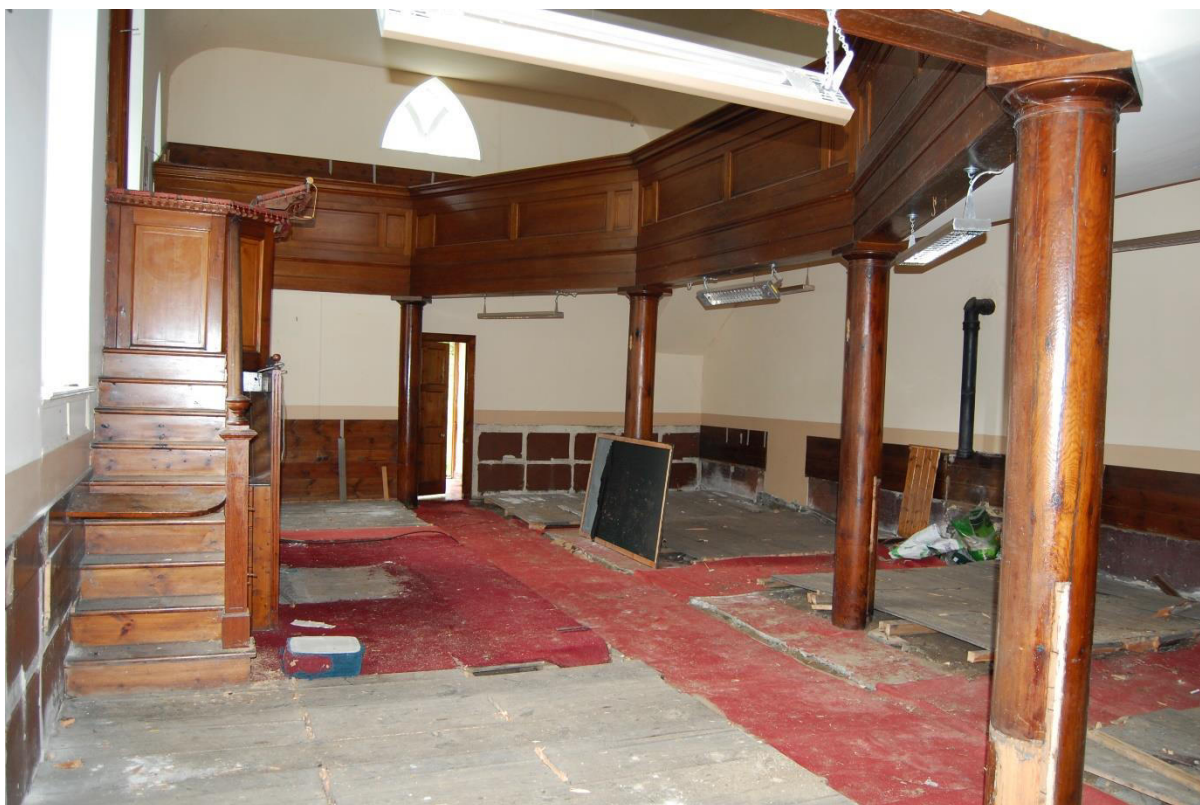
Illus 11 Pulpit (left) and column supports for gallery; facing SSE

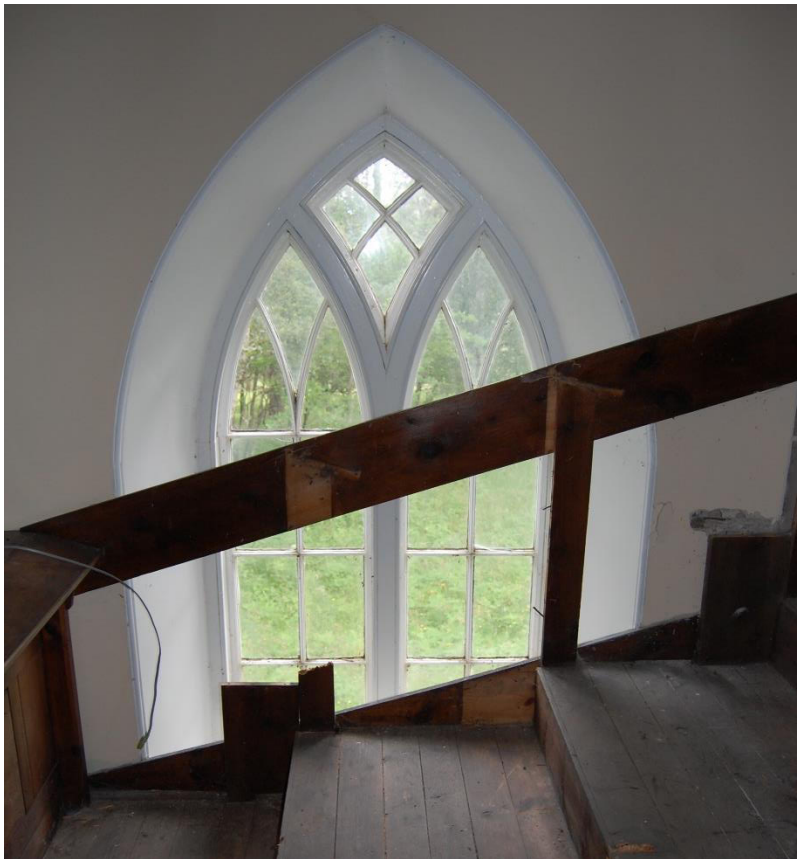
In Phase 2 the horseshoe shaped gallery was added in its current location bisecting window W7 (Illus 12, 13). Presumably long, narrow windows in the gables (W1, 3, 8, 10) were blocked at this time as these are now covered by the gallery. Room 2 was probably created at this time and stairs (Stairs 1 and 2) added to access the gallery.

Illus 12 Gallery bisecting window W7; facing ENE

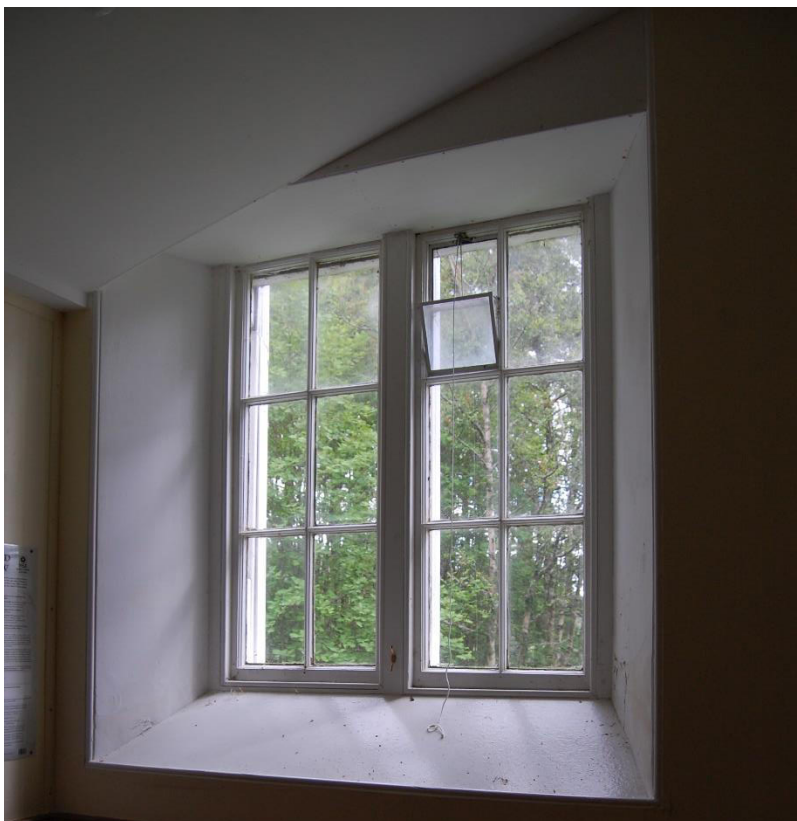
Illus 13 Window W7 lower section below gallery which bisected this originally larger window; facing ENE

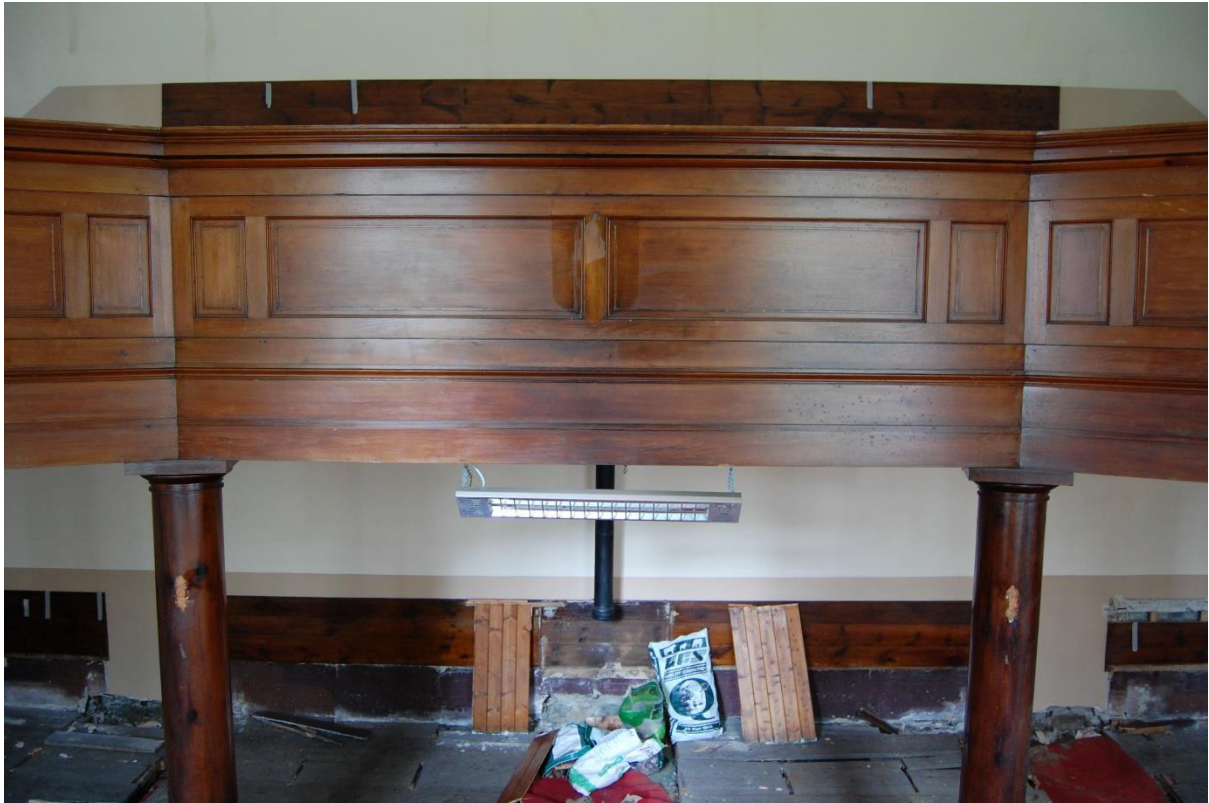
Illus 14 Gallery from the pulpit; facing WSW

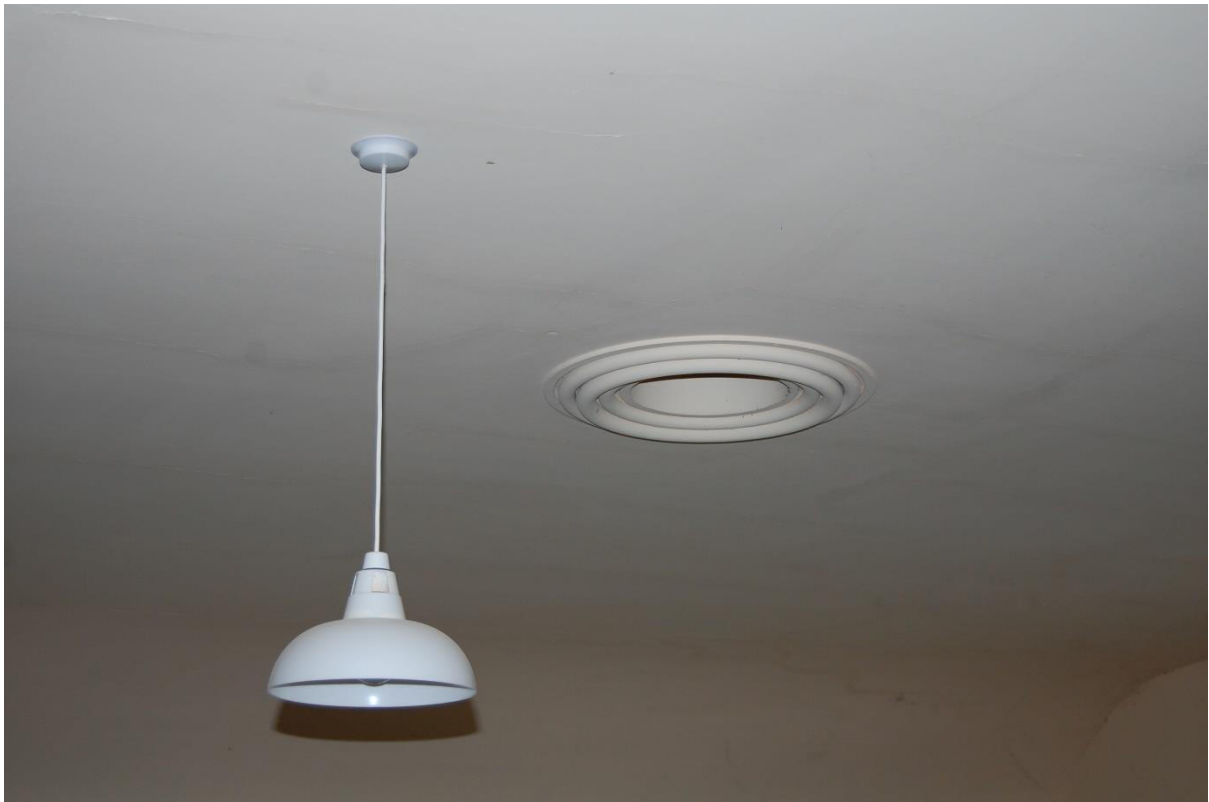
Modern lighting was installed in the 20th century and older (?gas) light fittings (Illus 15) were removed and modern lighting added to light the gallery.

Illus 15 Detail of older light fittings (?gas; right) and modern light fittings

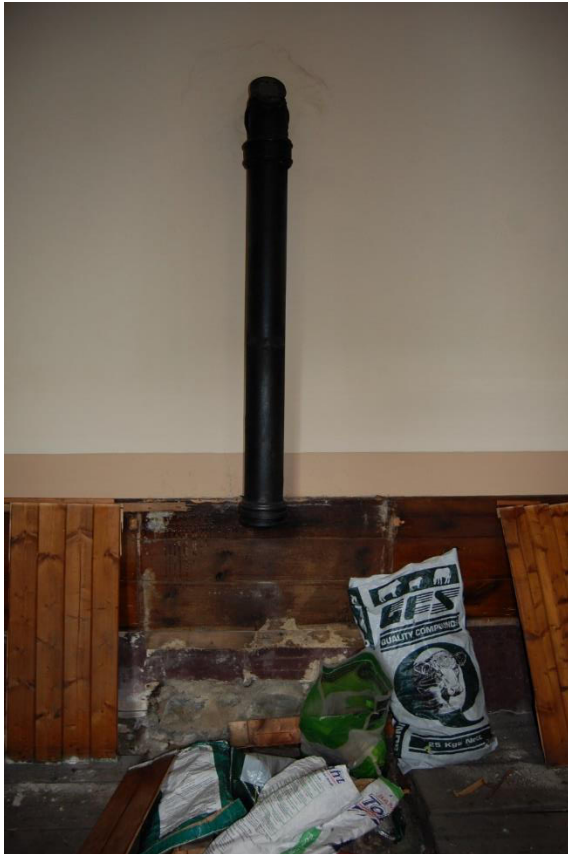
Illus 16 Former location of stove
