Former Mill At Glencally, Glen Prosen, DD8 4RQ

Report on Level 1 Standing Building Survey

**Alison Cameron
Cameron Archaeology
4 August 2015**

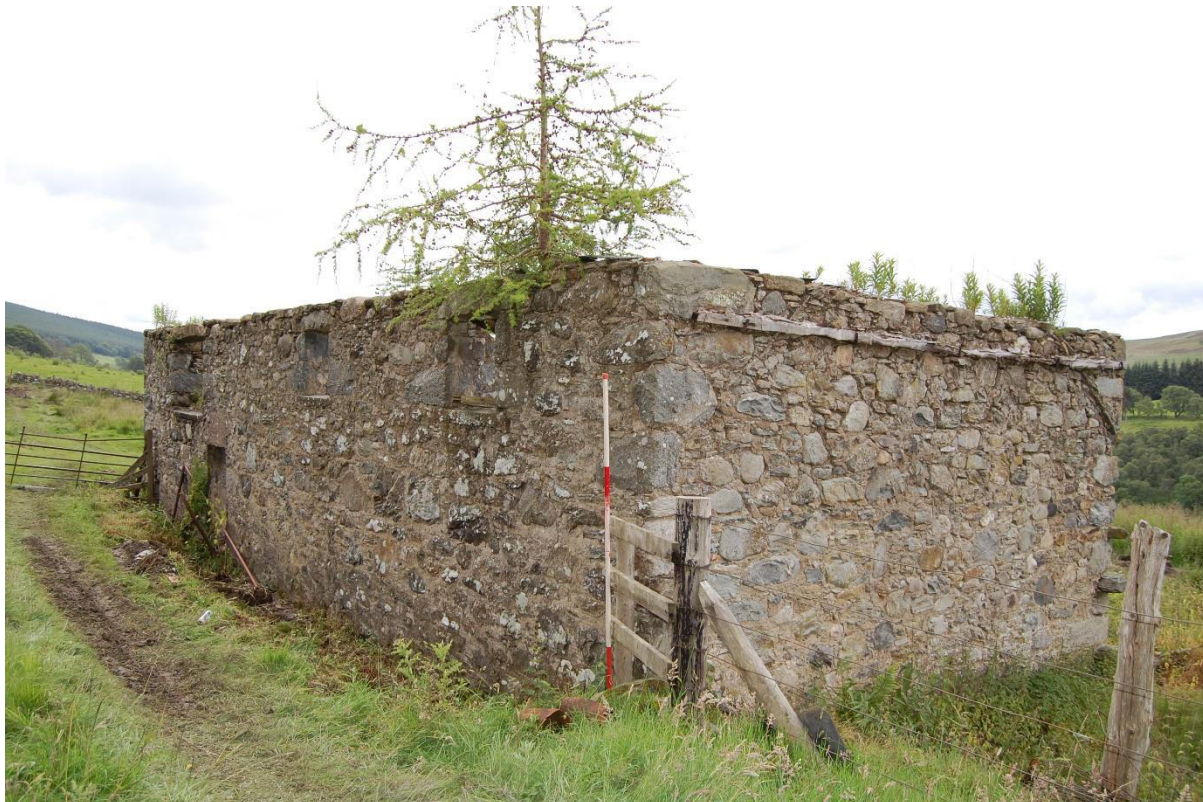
Illus 4 Mill from the north; facing S

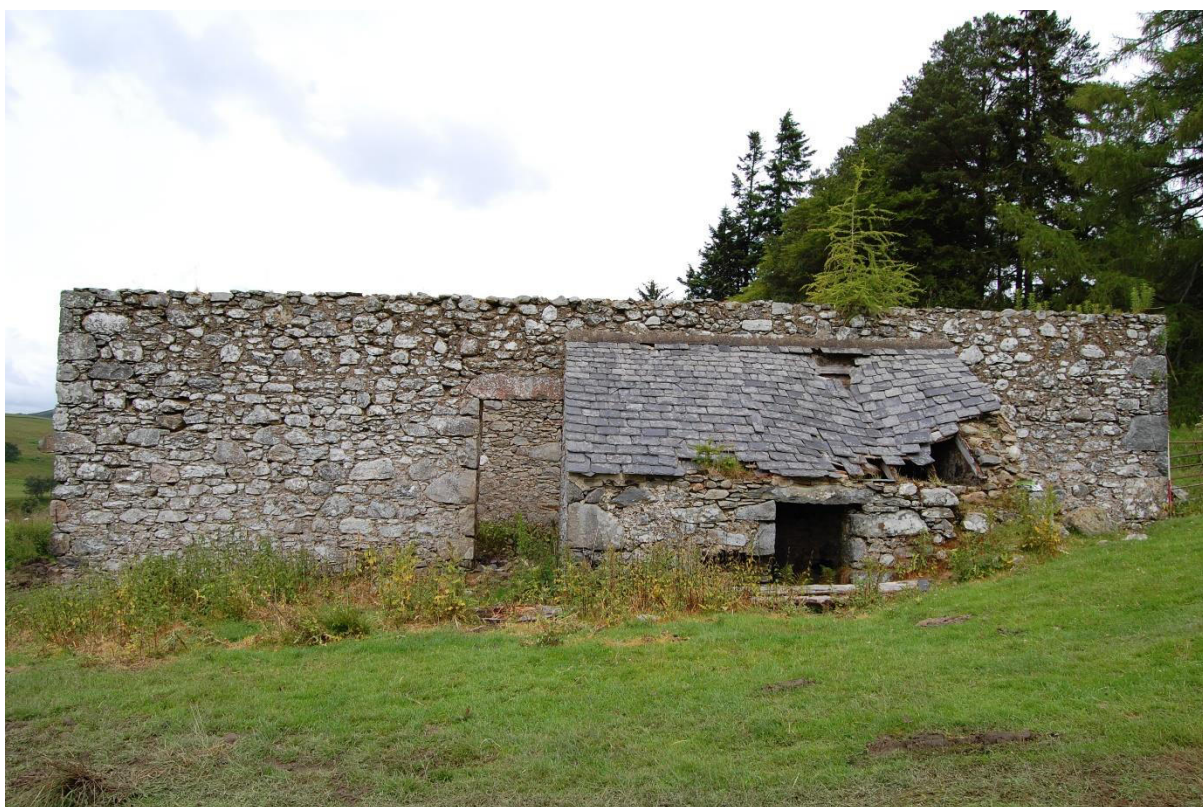
survives in the SE wall (F2; Illus 7). The walls of the main building are 0.6m thick and Room 3 the wheelhouse has walls 0.55m thick. Roofs survive only on the wheelhouse which is in a poor condition.

Illus 5 Mill from SE showing wheelhouse Room 3 (right); facing NW

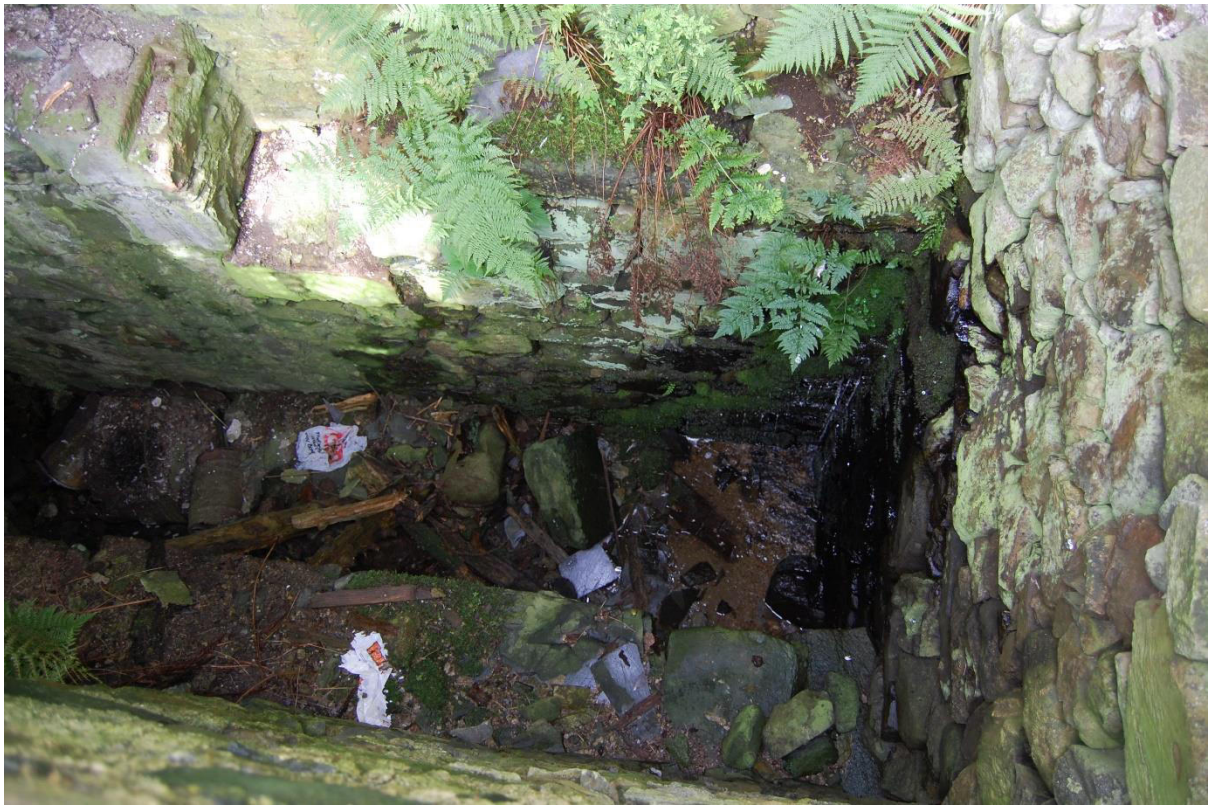
Illus 6 Wheel pit F1 (not accessible) photographed through roof of Room 3; facing NW

The wheel pit (F1) is a maximum of 4.9m deep (from the wall-head) and is contained in a slate roofed building added on to the SE wall of Room 2. An aperture through the wall (F2) is 0.5 x 0.5m in size houses the cast iron driveshaft for the mill wheel (Illus 7); the wheel has been removed.

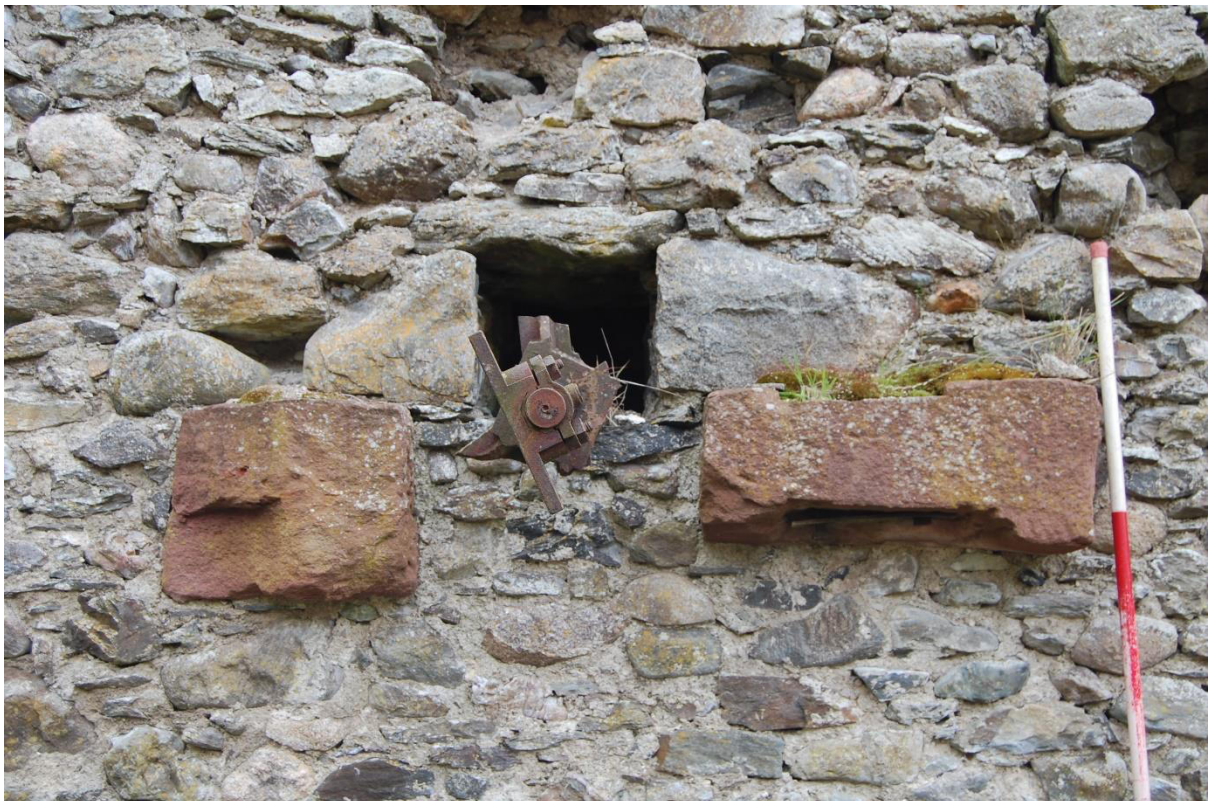
Illus 7 Wheel driveshaft F2; facing SE

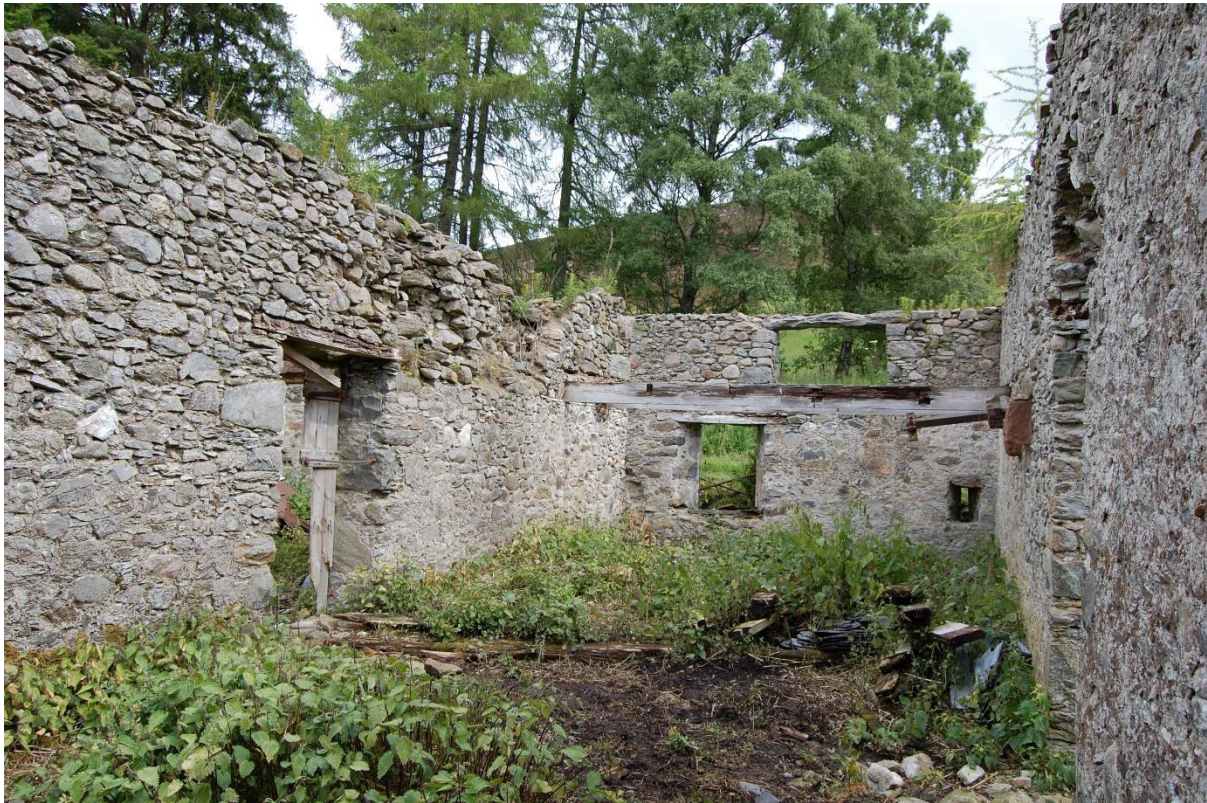
Illus 8 Interior Room 2; facing NE

Beam slots on the NW and SE walls of Room 2 and upper windows throughout indicate that the mill had a first floor throughout.

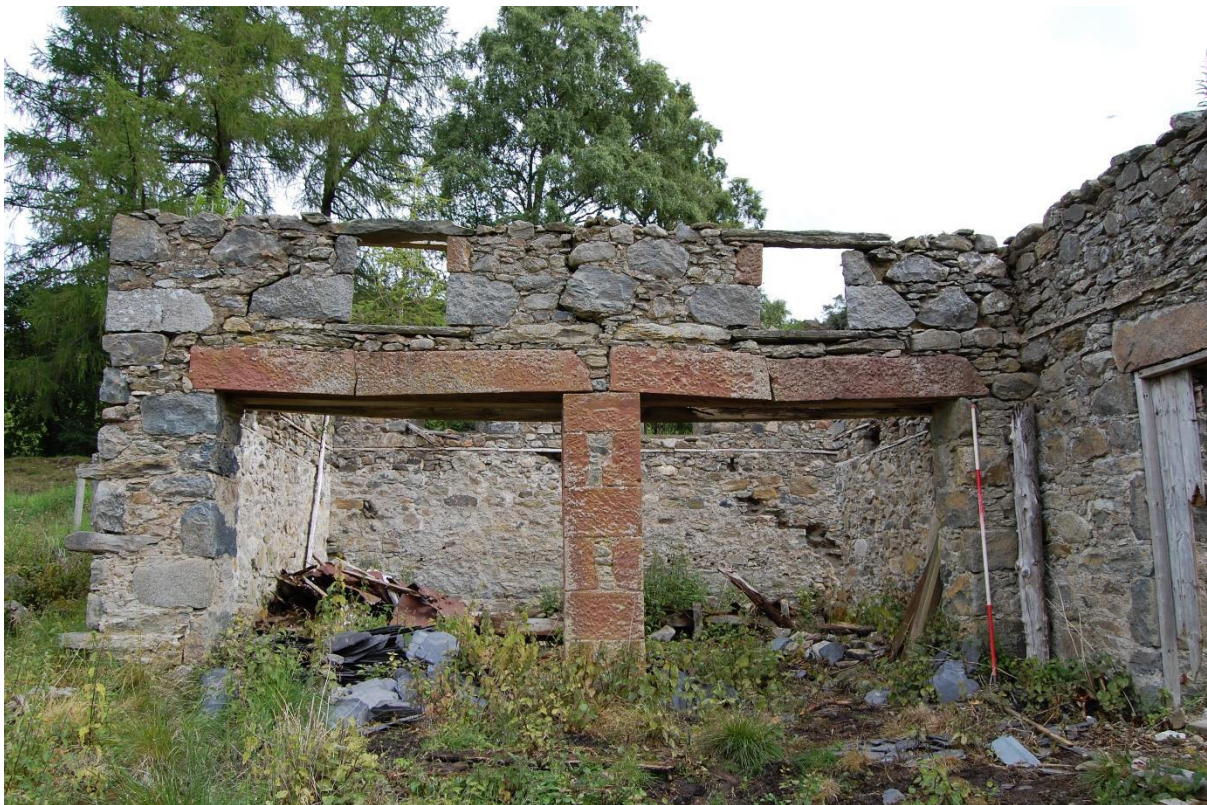
The Phase 1 mill is 13m NW-SE and 13.9m NE-SW and consisted of three rooms. The buildings are constructed of granite and sandstone rubble with granite lintels, quoins and jambs except Room 1 cart doors D3 and D4 which has red sandstone lintels (both cracked; Illus 9) on the SW façade. Room 2 is the main mill and Room 3 the wheelhouse (Illus 4, 5). Room 2 has doors in the NW and SE walls and the driveshaft mechanism for the wheel

Illus 9 Cartshed Room 1 SW facade with Doors D3 (left) and D4 (right); facing NE

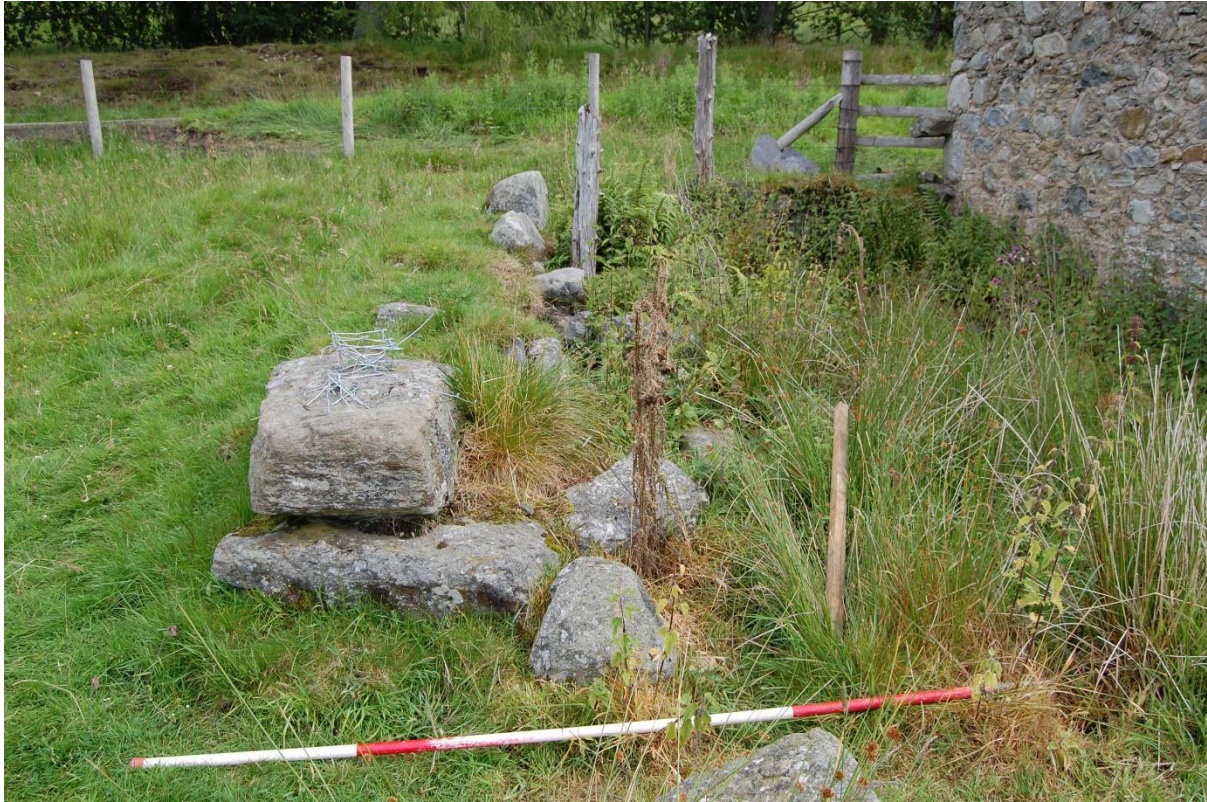
Illus 10 Room 4 wall F3; facing NW
