Forvie Church, Newburgh

Report on Level 1 Standing Building Survey for Scheduled Monument Consent

Alison Cameron Cameron Archaeology 7 August 2015

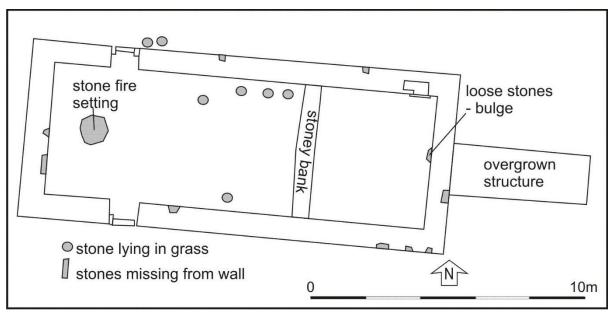
The structure is in a very exposed position in the landscape and shows signs of wear and tear due to both weather and visitors. The lime mortar pointing has been worn from between the stones on the interior and exterior and the stones are standing proud. This has resulted in stones becoming loosened and falling from the walls. Some of these stones are lying near where they have fallen (Illus 9) and some have been covered with grass growing on the interior and exterior of the church (see Illus 2 for a location of these stones). Grass has also taken root in some of these gaps and is causing further erosion of the mortar (eg on the W wall; Illus 3). Some of the loose stones have been gathered on the interior near the W wall and used as a setting for a small fire (Illus 4).

Illus 2 Plan showing main features and areas of repair required

There are several areas where stones require to be replaced and the whole structure requires repointing. This survey was carried out to support and application by SNH for Scheduled Monument Consent to carry out these repairs.

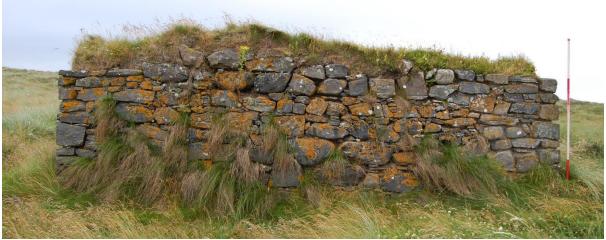
Illus 3 Exterior west elevation; facing E

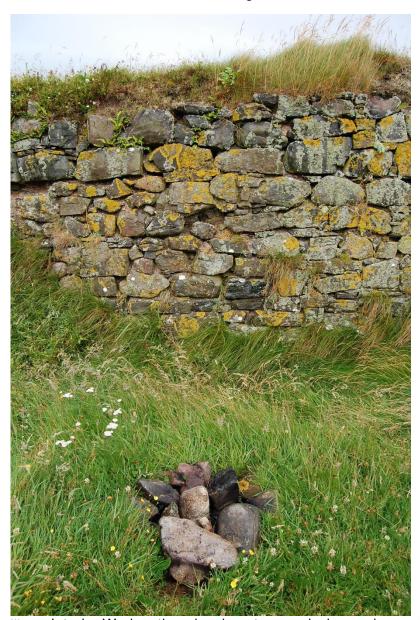
Illus 4 Interior W elevation showing stones missing and recent fire setting (foreground)

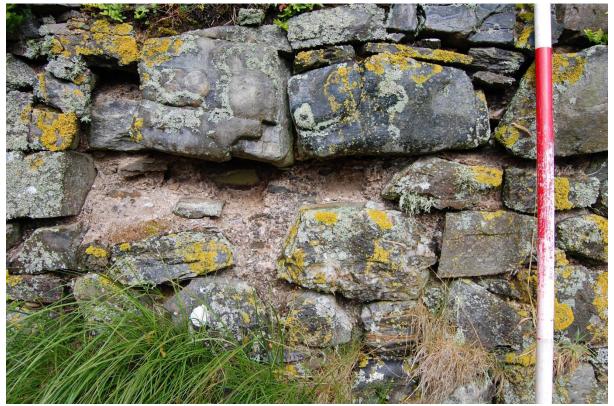
Illus 5 Interior E elevation with detail of missing stonework

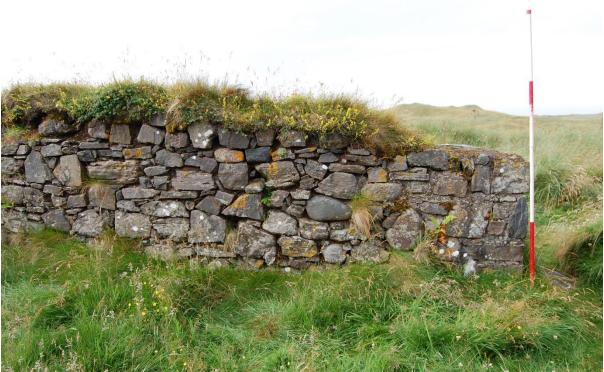
Illus 6 Interior S wall with South Door (right) showing mortared E jamb, vegetation on wall-heads and stones and pointing missing from wall

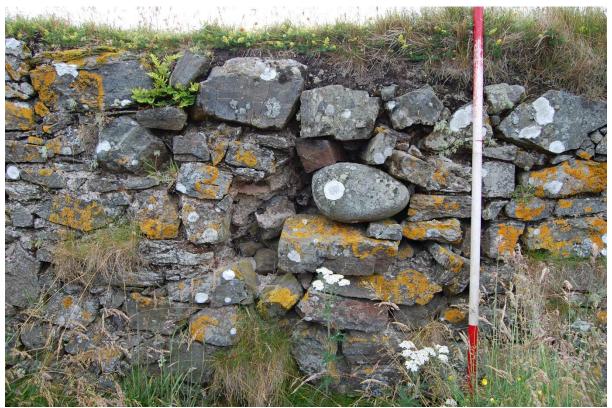
Illus 7 Interior E wall showing detail of bulge in wall where stones require to be removed, replaced and re-mortared

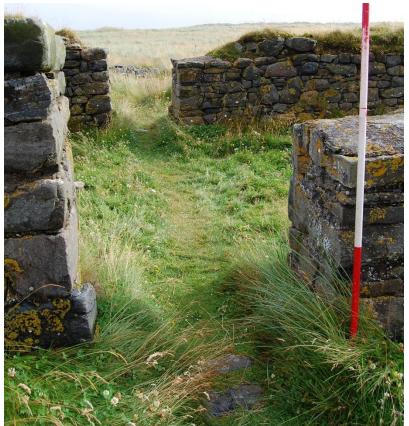
The areas around the N and S doors have been heavily pointed at one time and the wall-heads in this area covered with mortar (Illus 8). This has meant that these well-travelled accesses to the building are in better condition than other areas of the walls. The remaining wall-heads are all covered with sand and grass which seems stable with little loss of stone at this level. There is a bulge in the centre of the interior of the E wall where stones are falling from the wall (Illus 7) and these will need to be removed, replaced and repointed. There is an overgrown structure (Illus 2, cover, top) against the exterior of the E wall and this may be affecting the integrity of this wall. This may have been a factor in the creation of this area of loose stone.

Illus 8 S door (foreground) and N door showing little repair needed, mortar along jambs and well-used access route

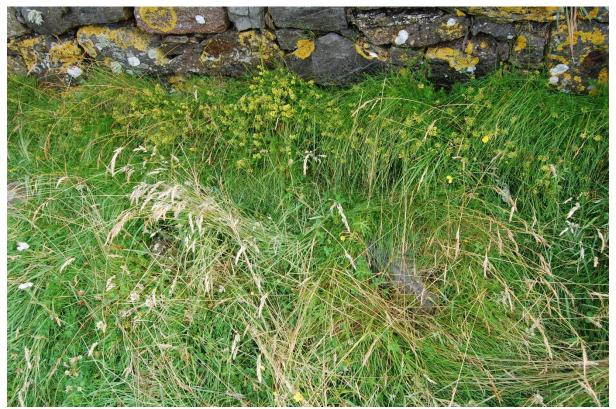
Illus 9 Detail of stones lying in long grass adjacent to interior N wall

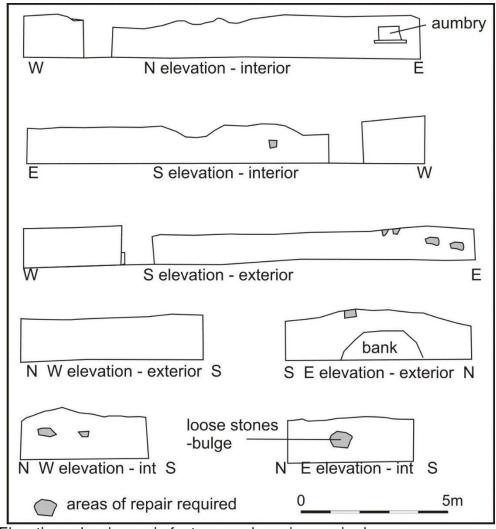
Illus 10 Elevations showing main features and repairs required
