**Steading at Caldhome Farmhouse, Luthermuir,
Laurencekirk, AB30 1PS
Report on Level 1 Standing Building Survey**

**Alison Cameron
Cameron Archaeology
19 August 2015**

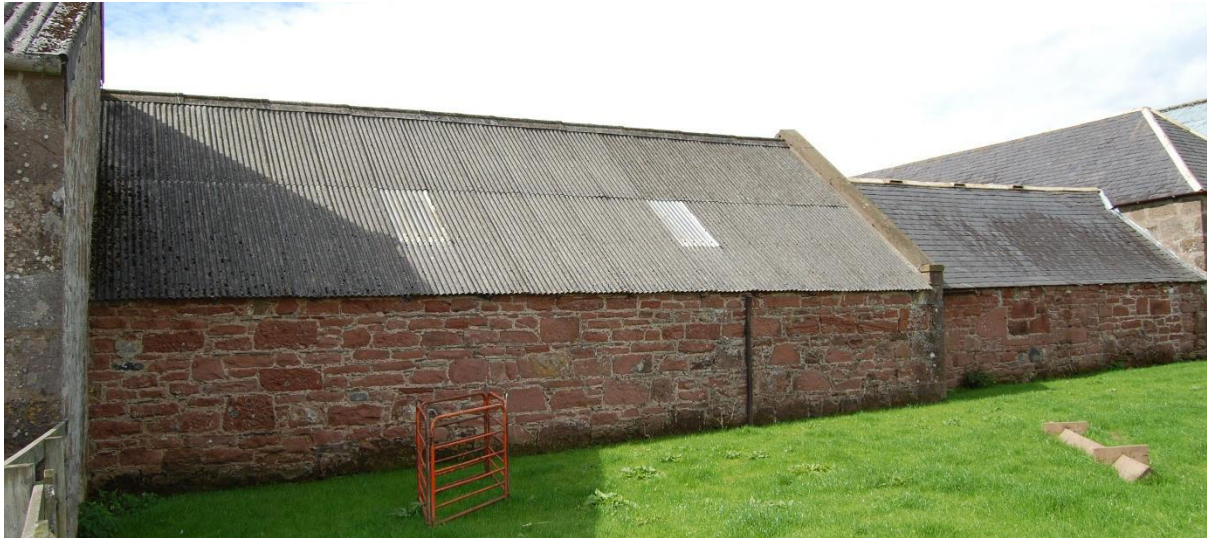
Phase 1 is constructed of red sandstone blocks and is 9.3m long and 5.5m wide; the NW wall of this room is built into later Room 3 (F9; Illus 7). Room 4 has two blocked windows on NE wall with lintel and lower jamb made from one large carved block of red sandstone (W12, W13; Illus 4). There is a door and two windows with red sandstone mouldings on the SW wall facing onto the central courtyard; this façade is heavily whitewashed.

Illus 3 NE exterior walls Phase 1 Room 5 (left) Room 4 (right) showing red sandstone construction; facing WNW

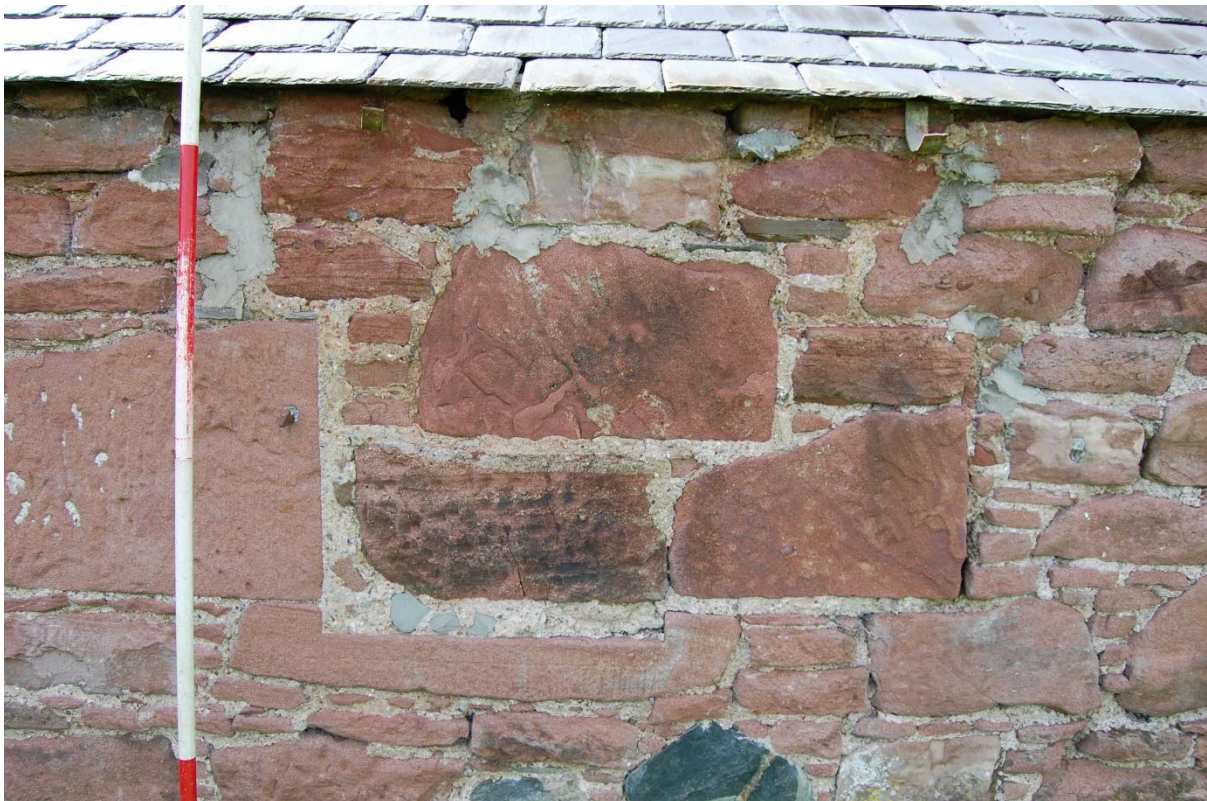
Illus 4 Red sandstone sill and jamb Phase 1 window W12; facing SW

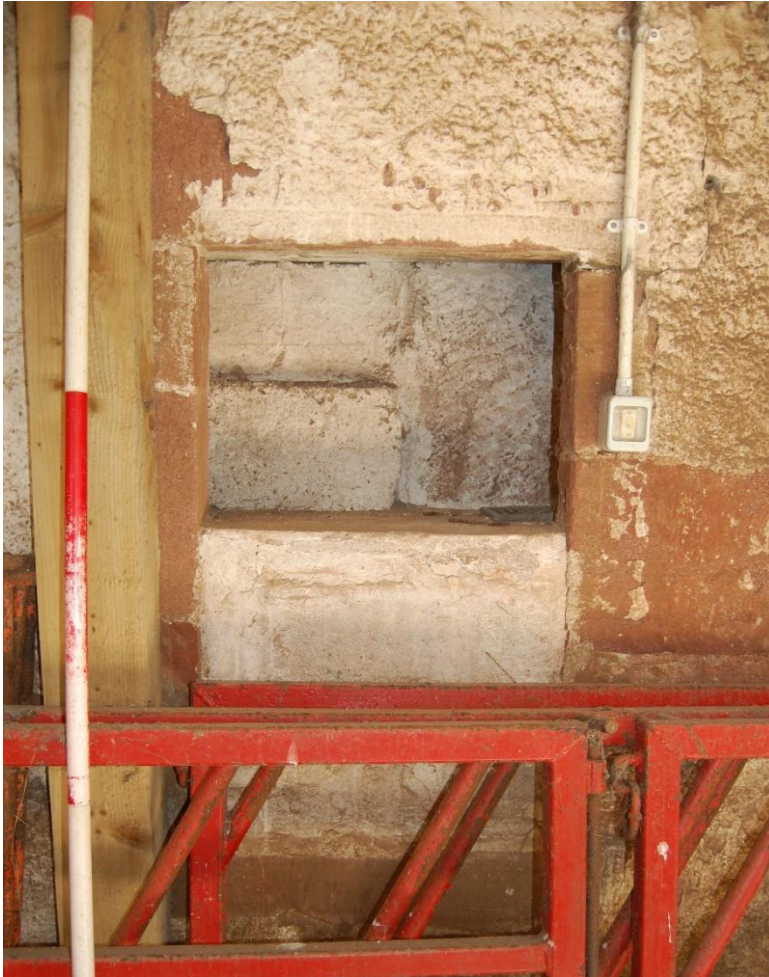
Room 5 is attached onto the SE wall of Room 4 and is 11.3m long and 6.6m wide. It is also constructed of red sandstone blocks; it was built into Room 6 in a later phase (Illus 7). There are no apertures on the NE wall but a door and two windows have red sandstone mouldings (Illus 5, 6) in the SW wall facing the central courtyard.

Illus 5 Room 5 SW wall; window W7 with Phase 1 red sandstone showing difficulties of access to some features and heavy whitewash on some walls (top right); facing NW

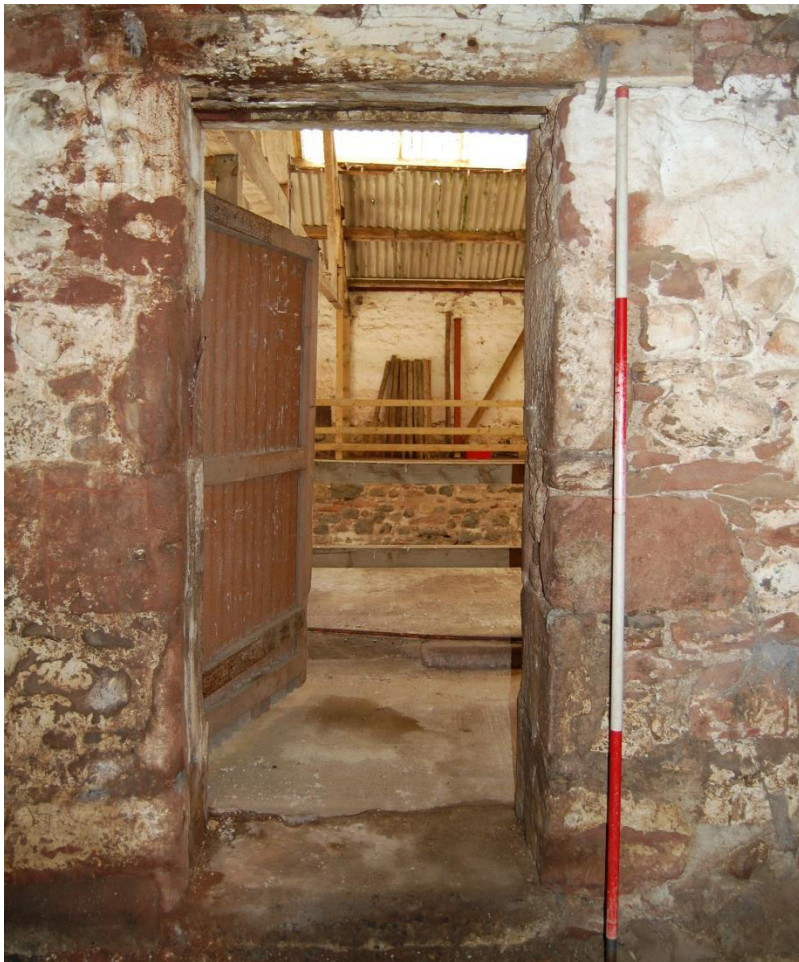
Illus 6 Room 5 door D15 NE façade showing old red sandstone jambs; facing SW

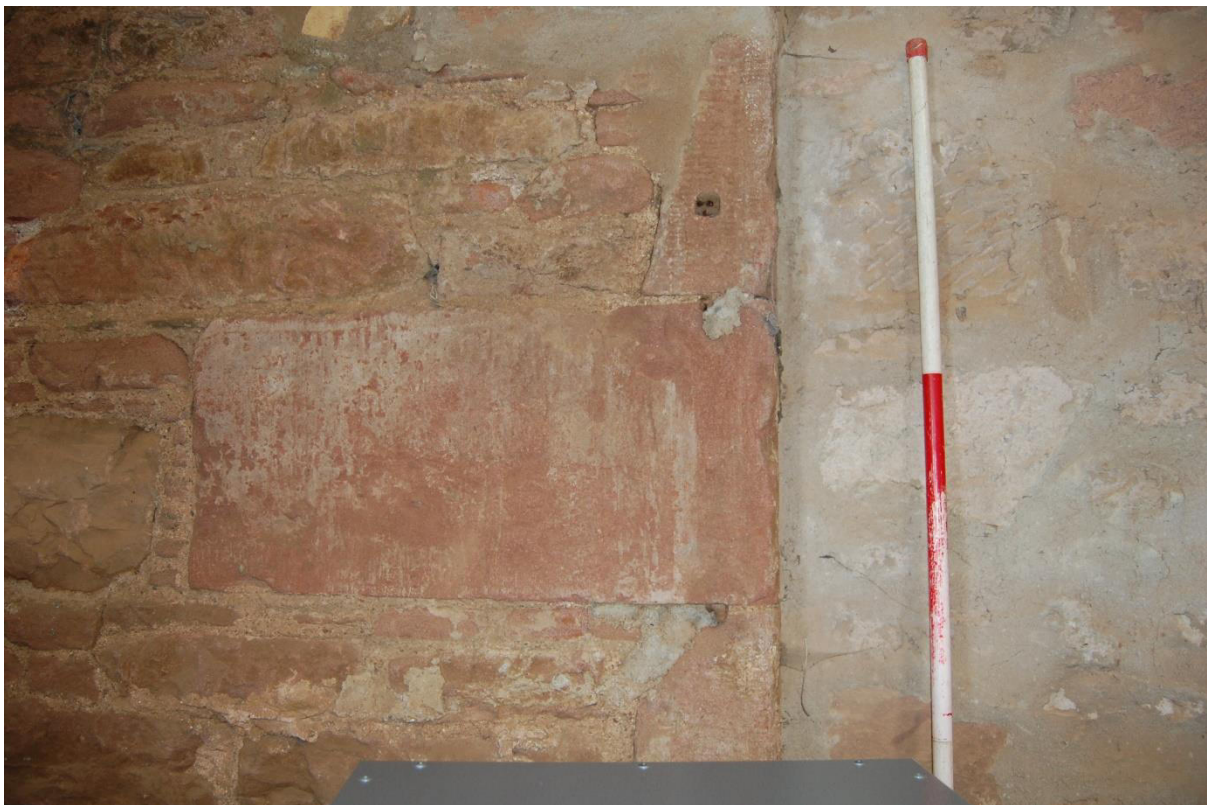
Illus 7 Room 5 exterior SE wall showing Phase 1 red sandstone blocks (left) and Phase 2 grey sandstone extension (right); facing NW

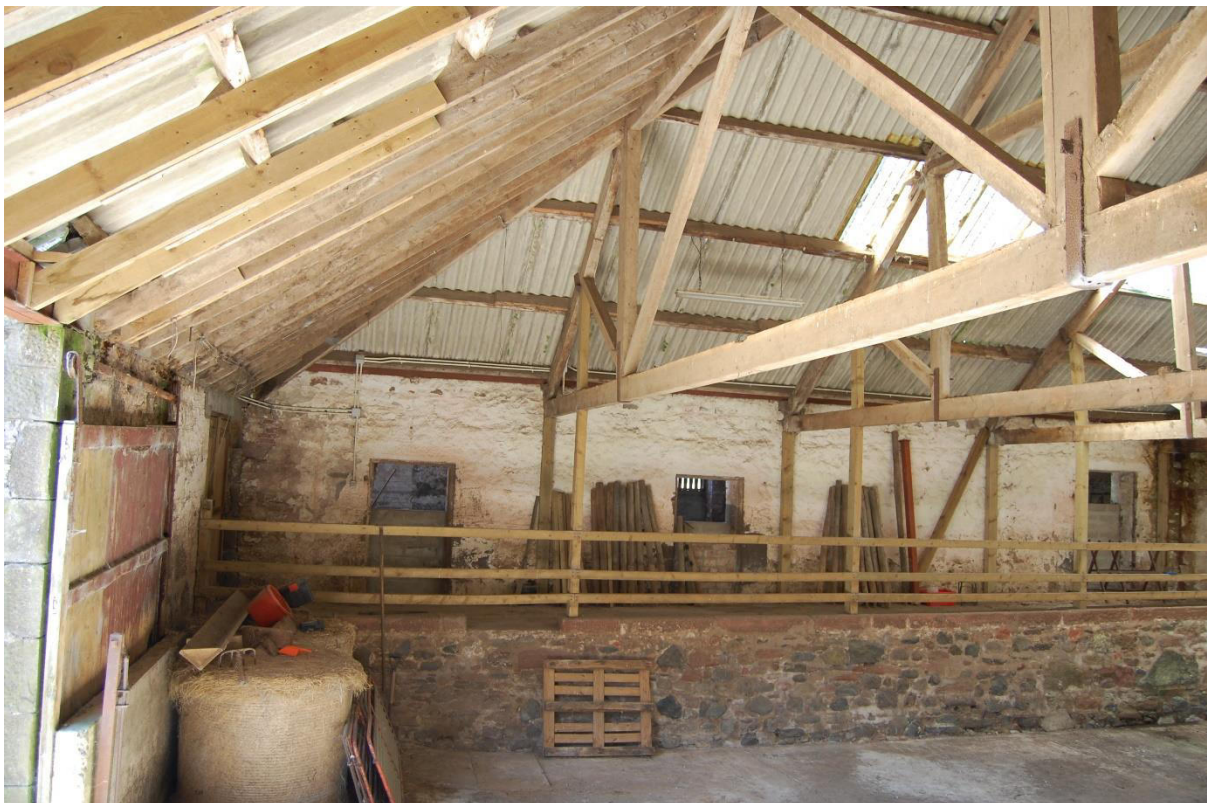
This room is 40.1m long and 6m wide. The SW wall is bowed slightly and this may be due to the number of apertures which are either open or have been blocked in this wall. The exterior of this wall is heavily pebble-dashed. The SE end of the room had been a separate room 3m long (Room 1a); this may have been a bothy with two small windows (W1 and W2) on the SW wall and a small window W4 on the NE wall. SE gable wall and door replaced by current owner (since c 1995). The floor at the NW end of the room has been raised with concrete to form a sloping floor down towards the door at the SE end.

Illus 8 Room 1 NE wall exterior showing doors D12 (left) D11, D10 which were incorporated into the covered courtyard Room 7; facing W

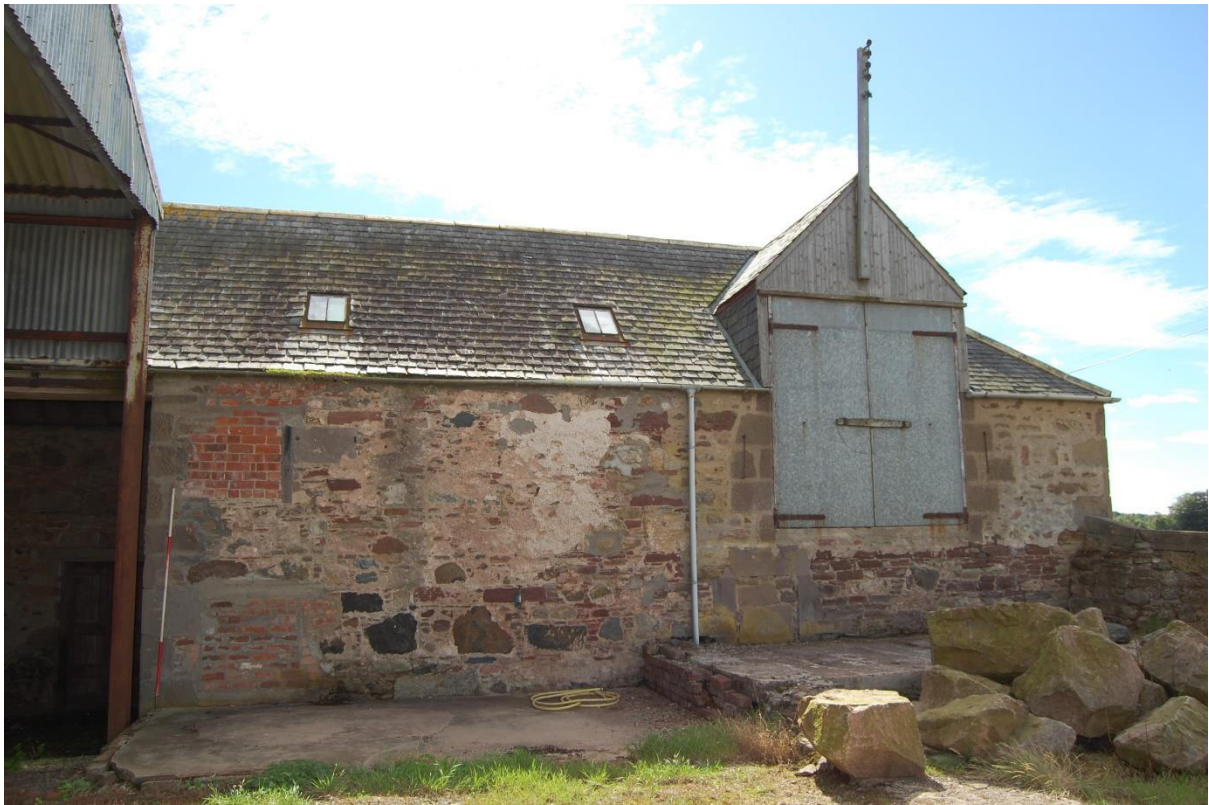
Room 3 is 25m long and 5.9m wide. It is accessed through two doors in the SE wall into the courtyard (D19, D20). The SW end originally had two upper doors on N wall and two floor and beam slots survive on the N and S wall (F10 and F11). The SE wall at the NE end has an area of pink sandstone (F9) which is the N wall of Room 4 which has been incorporated into the later NE end of this room. The NW wall has several blocked apertures including F3, a small window with grey sandstone mouldings (Illus 9, 26) which was probably the location of the former mill wheel. The ground level on the exterior of this wall has been raised and a building floor and foundation (F13, Illus 2, 9) constructed over this façade and probably over remains of the lade. The lade is now infilled under a small field but appears on the OS maps of the farm (Illus 10). On the interior of this wall is a large granite block (F2; Illus 25) which is associated with the former mill wheel. The large door (D17) has been increased in size and a concrete lintel added recently.

Illus 9 NW façade Room 3 showing probable former location of mill wheel with D16 (right) F3 (centre) and brick-blocked windows W17 and W11 (right of ranging rod) with Door D17 (left)

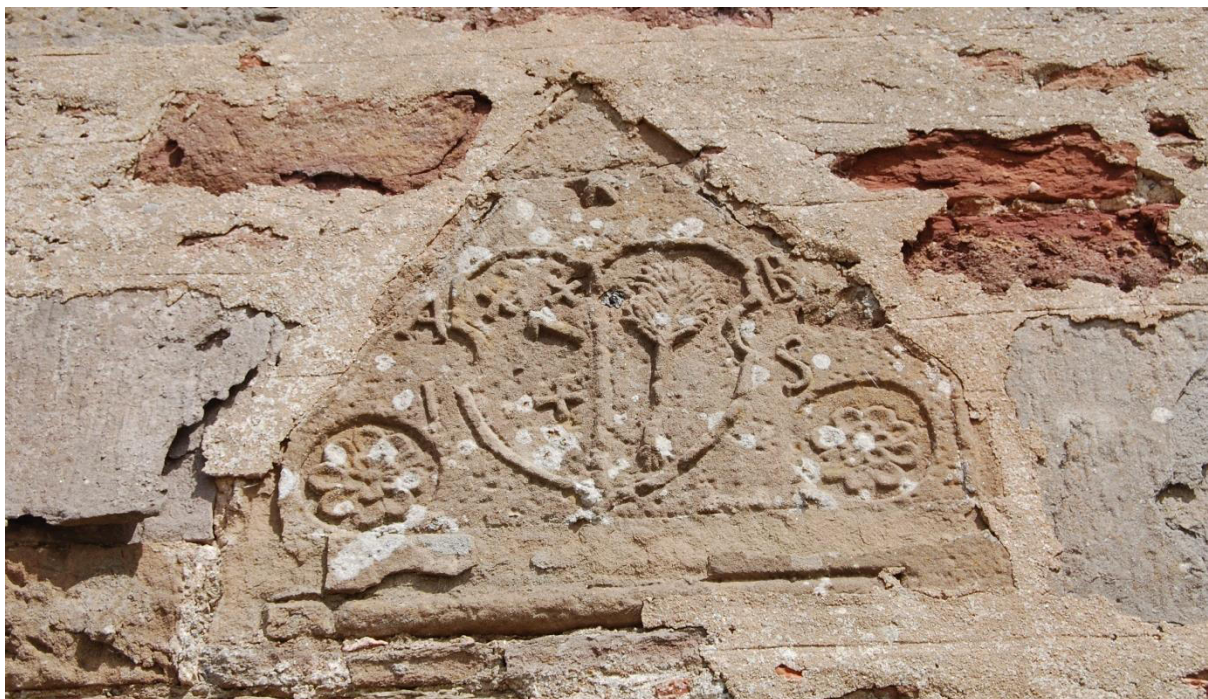
The SW gable of Room 3 has a central door with blocked window above and one ground floor window, also blocked. Three grey sandstone armorial panels have been inserted into the first floor of this exterior gable. The left hand (NW) stone (F6) bears a coat-of-arms and the initials AS and IB diametrically opposed. The centre stone (F7), built into the blocked window, bears the Barclay arms; the initials IB; at the bottom right hand corner the figures 7 1 and is pointed at the bottom left hand corner covering the numbers 1 6 (Jervise 1875-9, 138). The right hand (SE) stone (F8) is badly weathered but there is 'E O' visible. All the stones are delaminated to varying degrees.

Illus 12 Armorial panel F6 with a coat-of-arms and the initials AS and IB diametrically opposed; facing NE

The panels are being retained *in situ* (David Carnegie pers comm); if this changes their rehousing should be discussed with Aberdeenshire Council Archaeology Service (Claire Herbert).

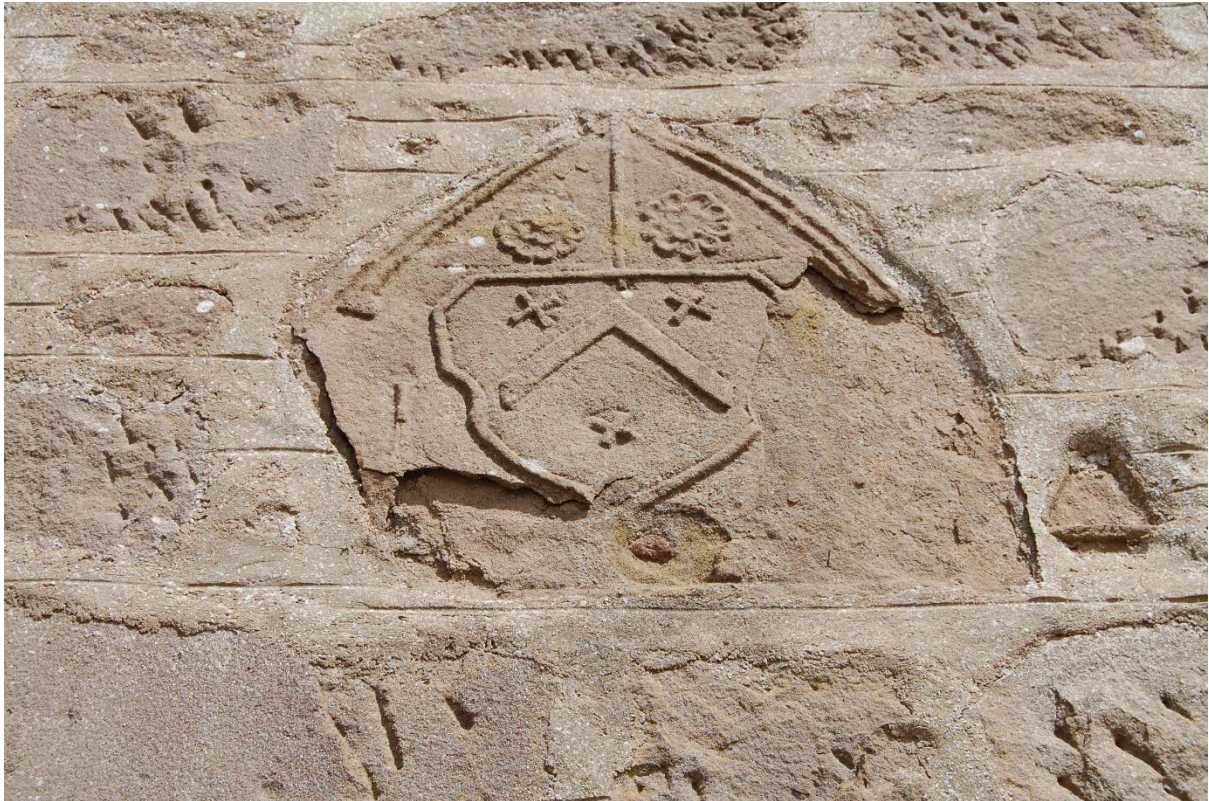
Illus 13 Armorial panel F7 the Barclay arms; the initial I (part of IB which together with the figures '7 1' at bottom right and a '1 6' at the bottom left, have been lost due to delamination of the stone); facing NE

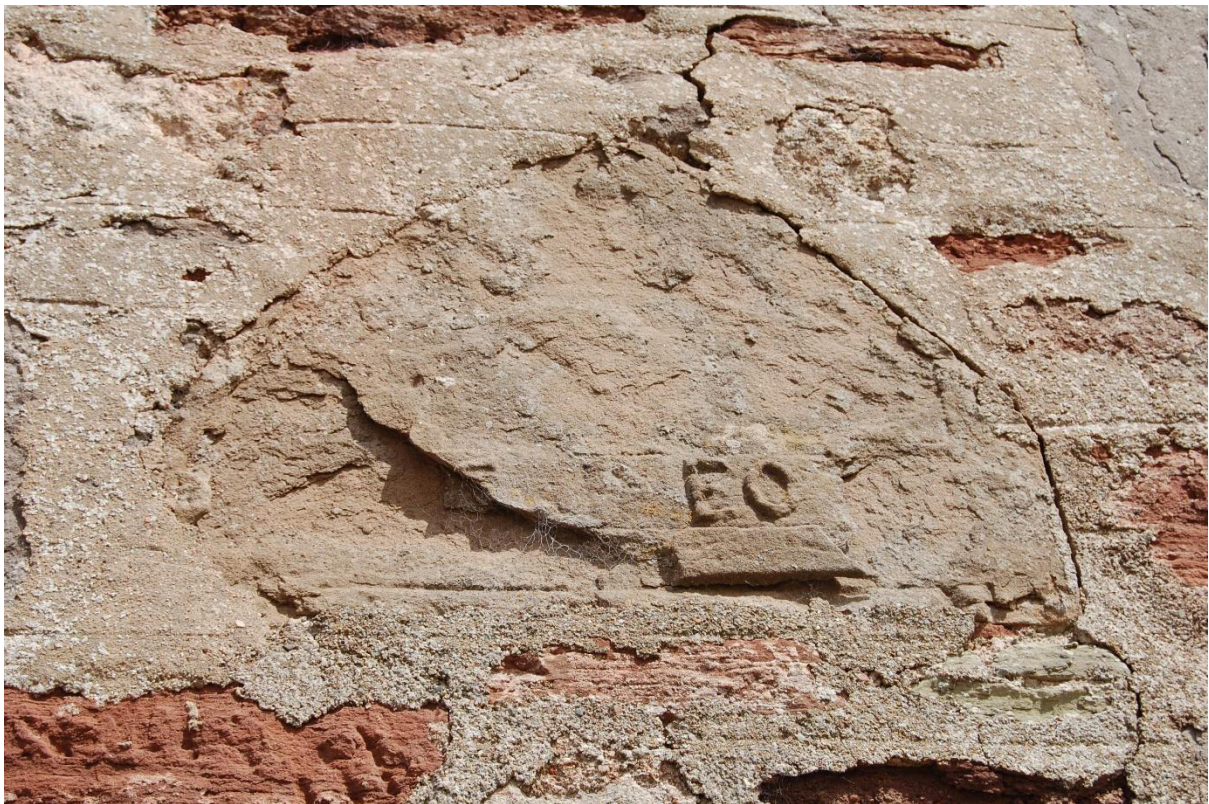
Illus 14 Armorial panel F8 is very delaminated but has lettering 'E O?'; facing NE

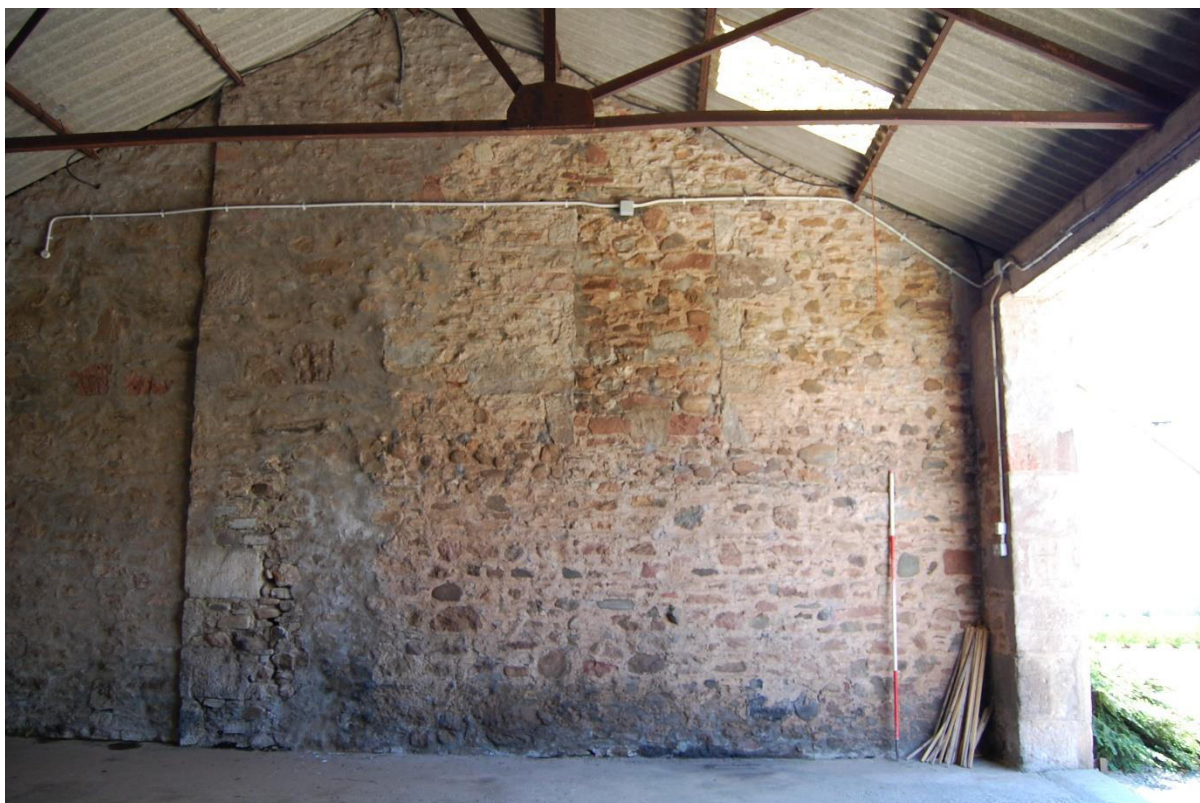
Room 6 was originally 3.2 x 6.6m in size and constructed of granite and sandstone rubble; it has an upper door (D23) which has been blocked with sandstone and granite rubble. It was extended to the NE (Room 6a). The earlier corner of the building can be seen built into the new larger gable walls (F15 and F17, Illus 15, 26) and the original roofline can be seen on the gable elevations F16 and F18. There are large blocks of red sandstone built into the SE gable of Room 6a and these may have been stone from an earlier building reused in this structure. There is an upper door (D17).

Illus 15 SE internal wall Room 6 with stonework F15 (left) and upper door D23 (centre); and the extension in Phase 3 to form larger Room 6a (left); facing SE

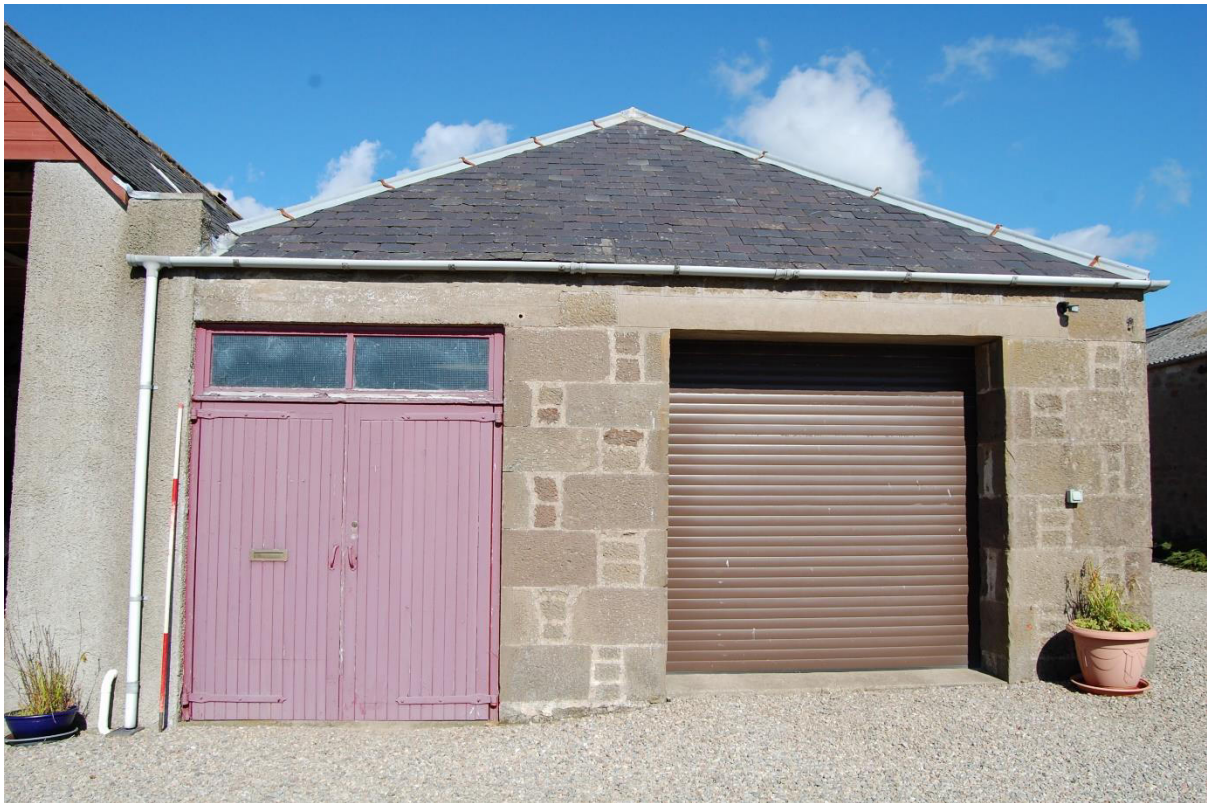
Room 2 is 13.1m long and 6.7m wide and now used as a garage. There was little access to the interior of this room. The SE wall (Illus 16) is constructed of large granite blocks with cherry cocking and there are two large cart doors (D1 and D2). Door D1 was reduced in width when the SE gable of Room 1 was rebuilt in the recent past. There was an L-shaped building on the 1st and 2nd Edition OS maps (Illus 19) but this appears to have been demolished and a larger rectangular room constructed in the early 20th century.

Illus 16 Room 2 SE façade showing large cart doors D1 (left) D2 (right) showing early 20th century stonework; facing NW

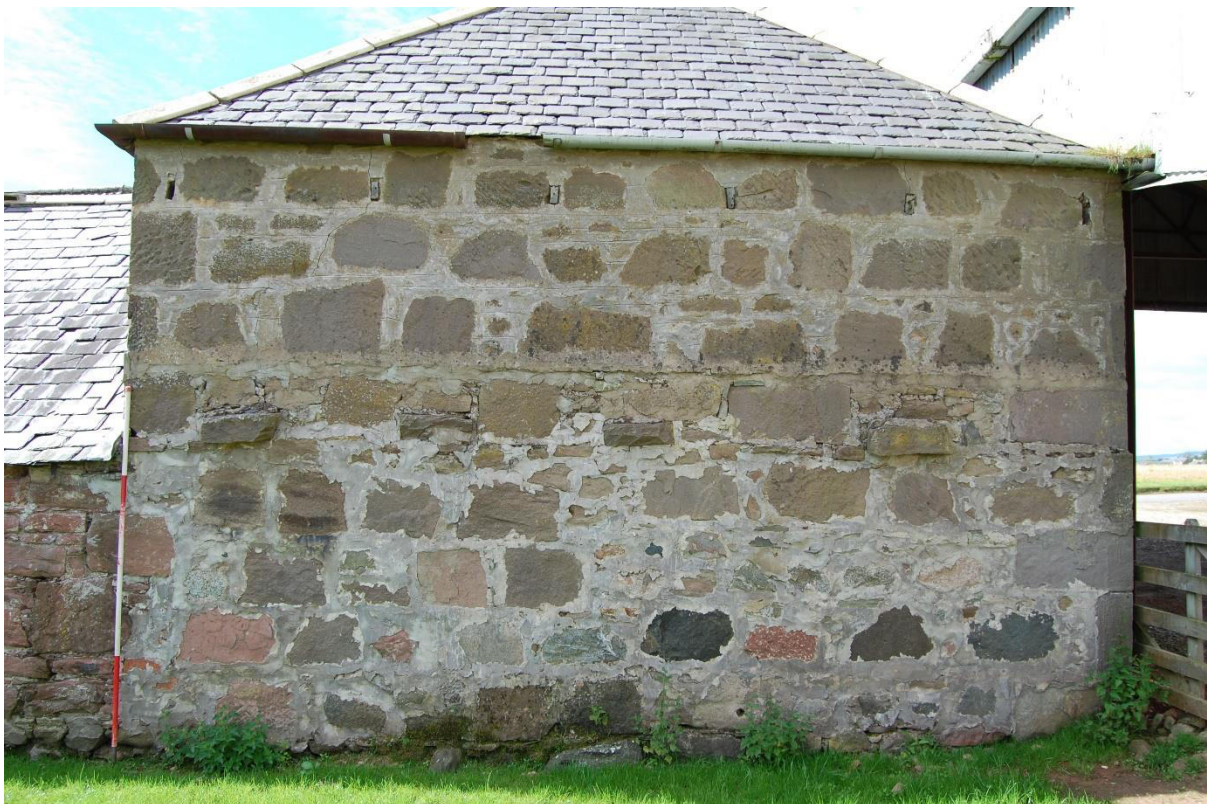
A building was constructed on the NE end of Room 3 in this phase and the joist holes (F20; Illus 17, 26) and tying in stones (F21; Illus 17, 26) can be seen on the exterior of the NE gable of Room 3 (Illus 17) but the building has since been demolished.

Illus 17 Room 3 NE wall showing joist holes (F20, top) and tying in stones (F21, centre) for building recorded on 3rd Edition OS and demolished in the late 20th century; facing SW
