**Mergie House, Rickarton, Stonehaven, Aberdeenshire,  
AB39 3TH  
Report on Level 1 Standing Building Survey and watching  
brief**

**Alison Cameron  
Cameron Archaeology  
27 August 2015**

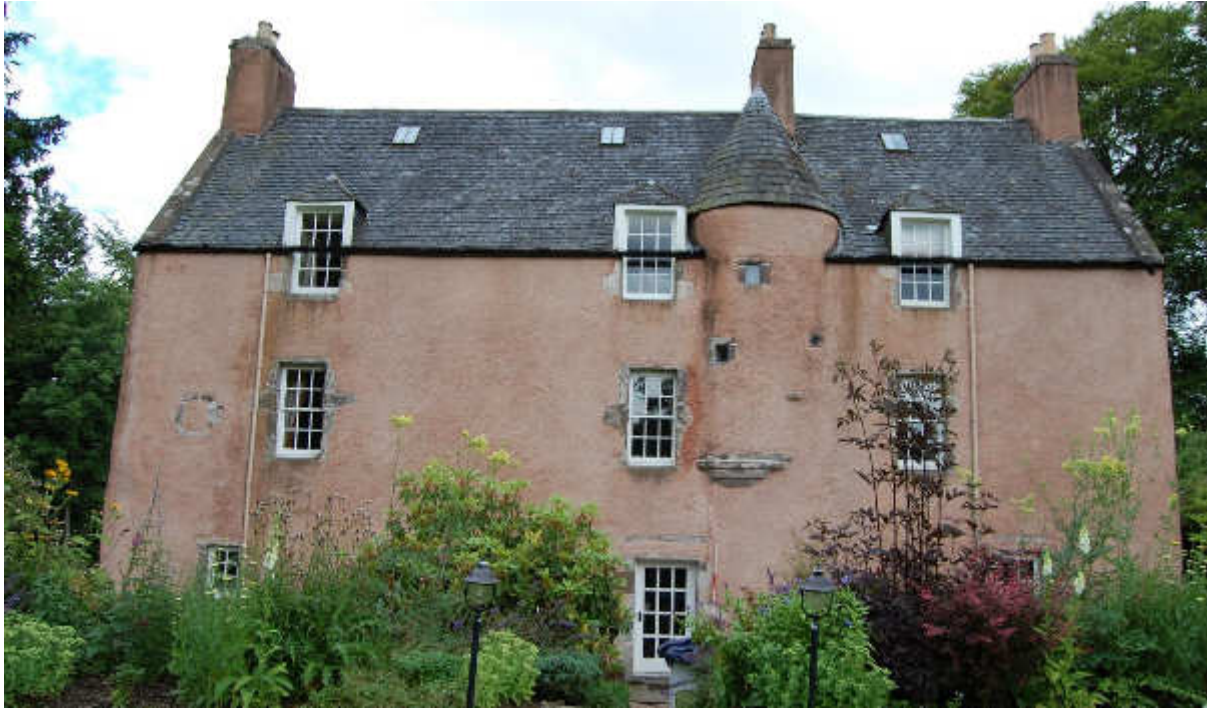
There is also a corbelled turret stair on the WSW façade (Room 10; Illus 4, 5) and a similar one on the ENE wall (F8; Illus 7-8) although if F8 is original to the 16<sup>th</sup>/17<sup>th</sup>-century house it has been heavily rebuilt with new stairs and the exterior completely harled.

Illus 5 WSW façade with turret stair Room 10 with three small windows or shot holes (W28, 29, 30); facing ENE

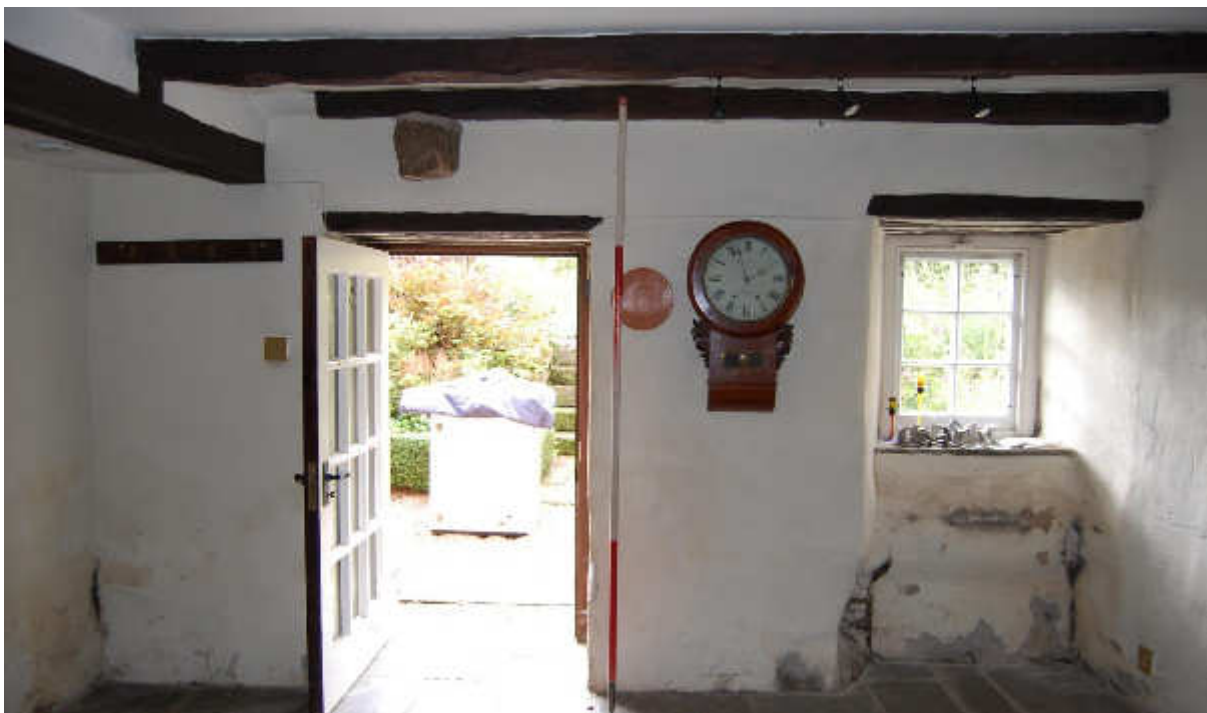
The ground floor rooms have low ceilings with wooden beams; there are stone corbels in Rooms 1 and 2 (F1, F2; Illus 6) from an earlier ceiling.

Illus 6 Room 2 Stair turret blocking F7 (left), Door D2 (left centre) and window W3 (right); facing WSW

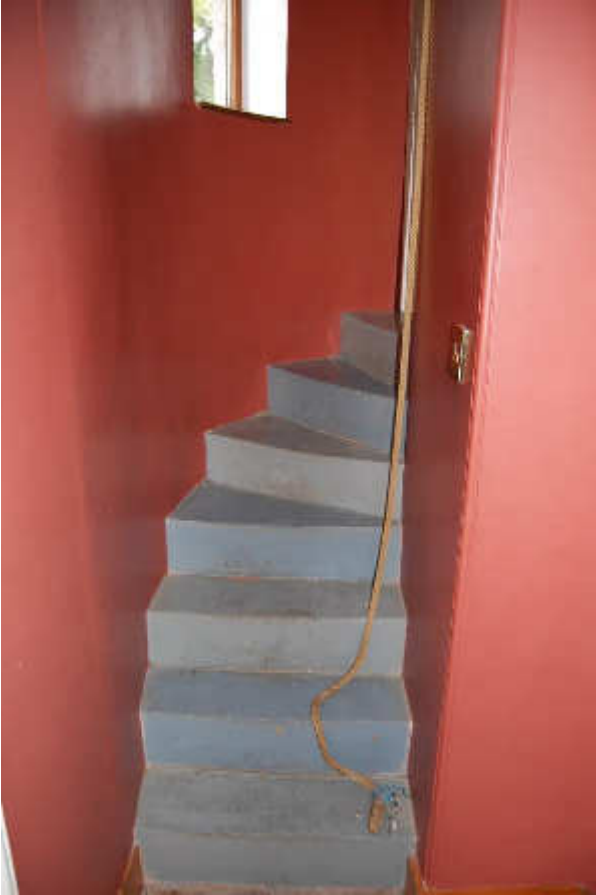
Illus 7 Stair turret F8; is this an original feature or a 19<sup>th</sup>-century addition?; facing SSE

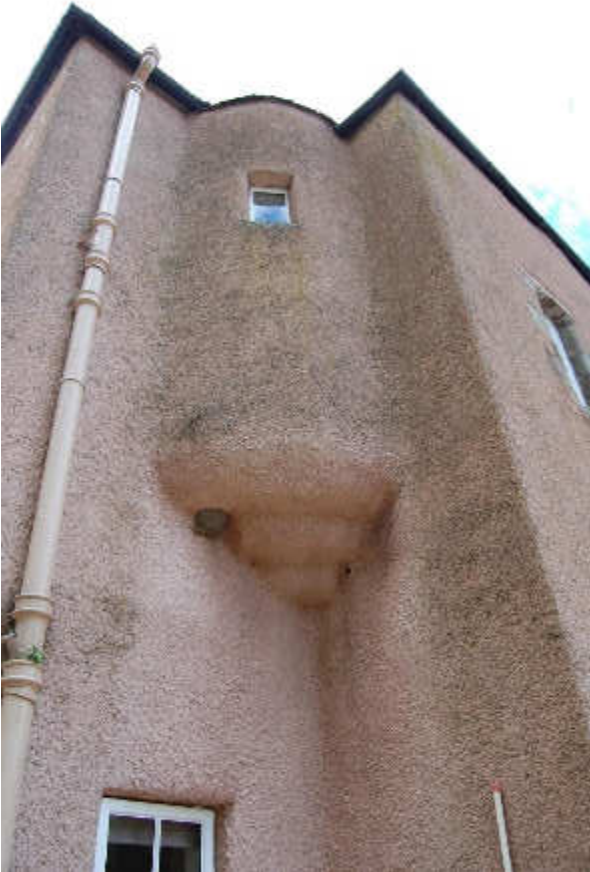
Illus 8 Exterior of corbelled turret stair F8 with W22 (top); facing NW

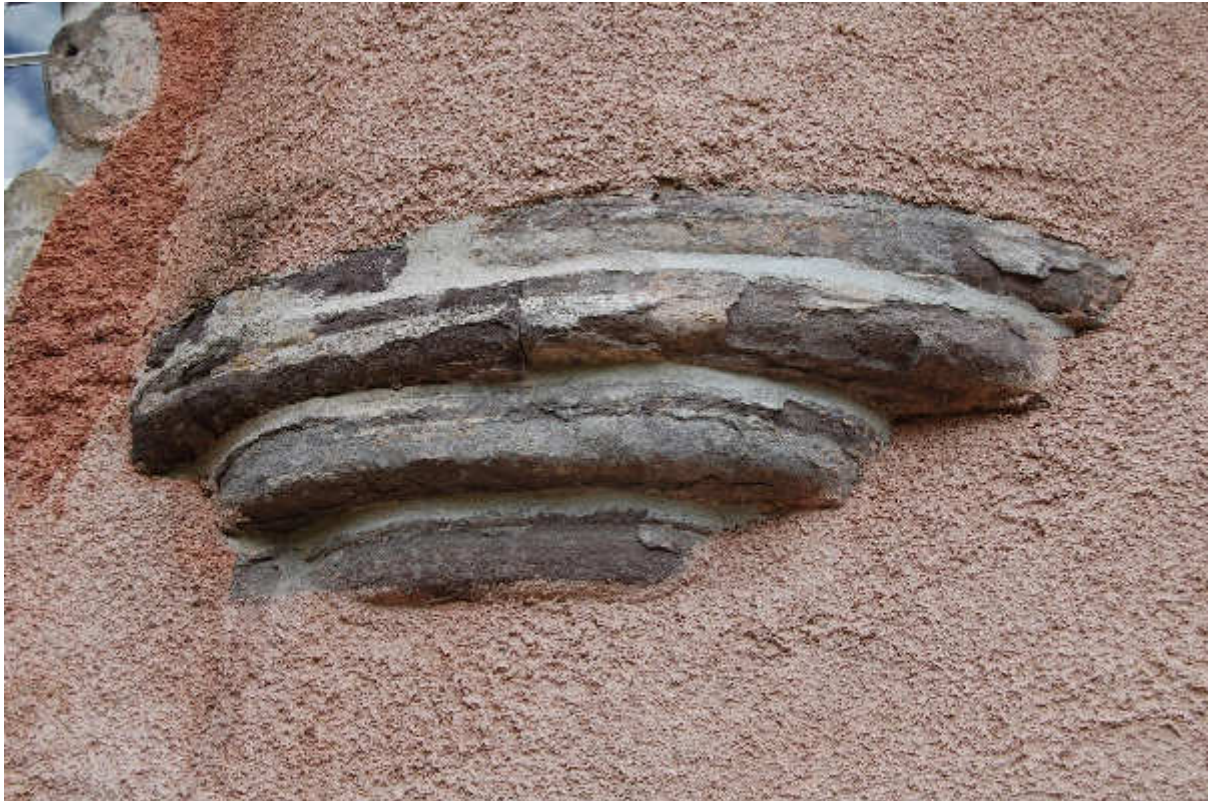
Illus 9 Grey sandstone corbelling Room 10; facing SE

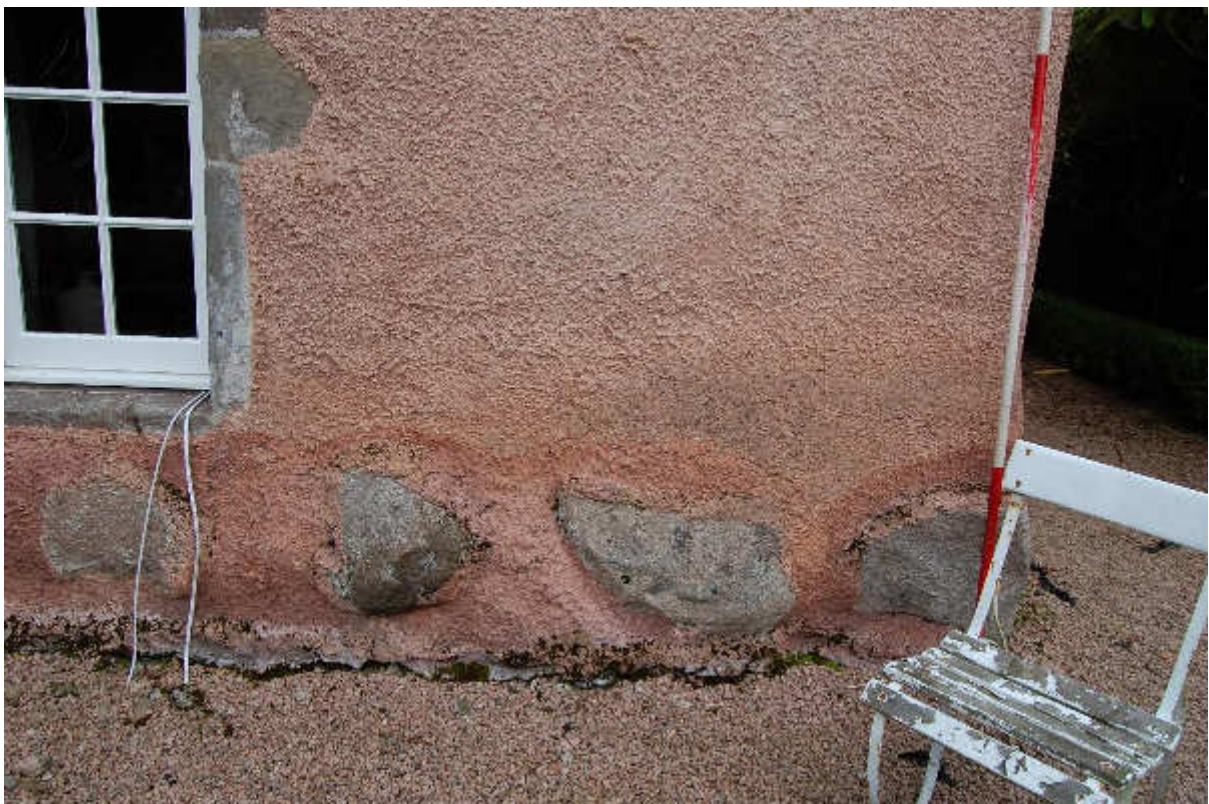
The large foundation stones (F4) can be seen on all elevations (Illus 10) and during the watching brief the foundation of the walls was observed but not fully investigated. The wall foundations of Building 1 had been built into trenches in the natural clayey sand subsoil. The original exterior walls are 0.85m thick (Illus 13).

Illus 10 Large grey sandstone foundation (F4) at SW corner Phase 1 house; facing ENE

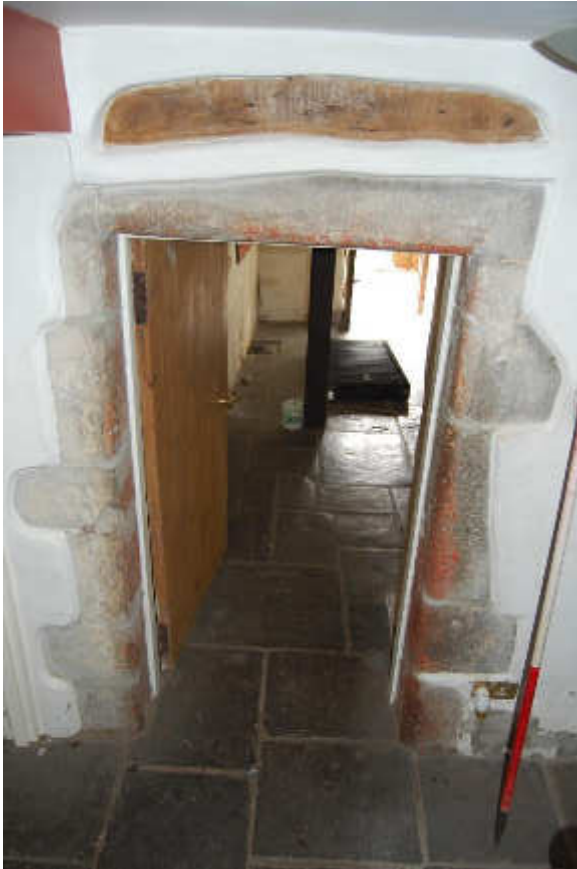
Illus 11 Door D6 ENE face leading from WSW door to gardens with grey sandstone mouldings; facing WSW

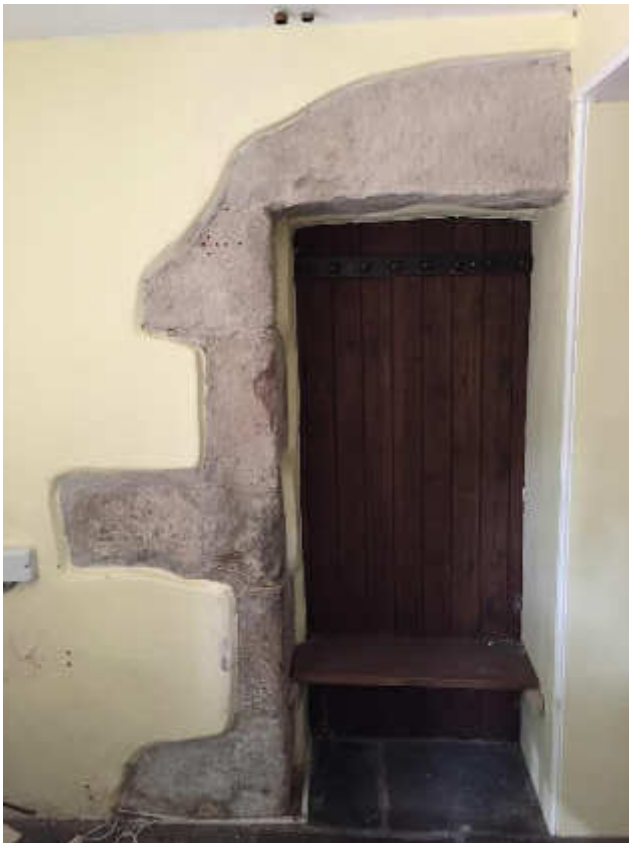
Illus 12 Door D5 the original exterior door on ENE façade with grey sandstone mouldings; facing WSW

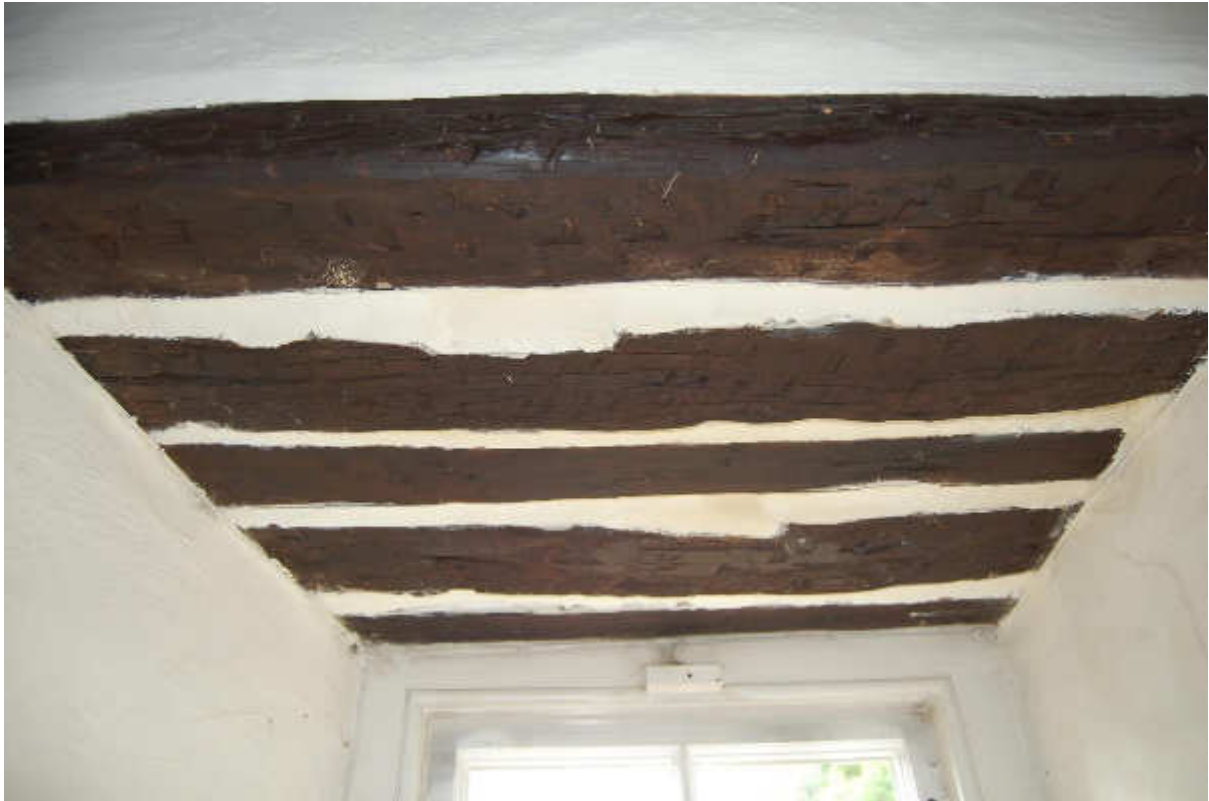
Illus 13 Detail of wooden beam lintel above window W3 showing thickness of wall; facing WSW

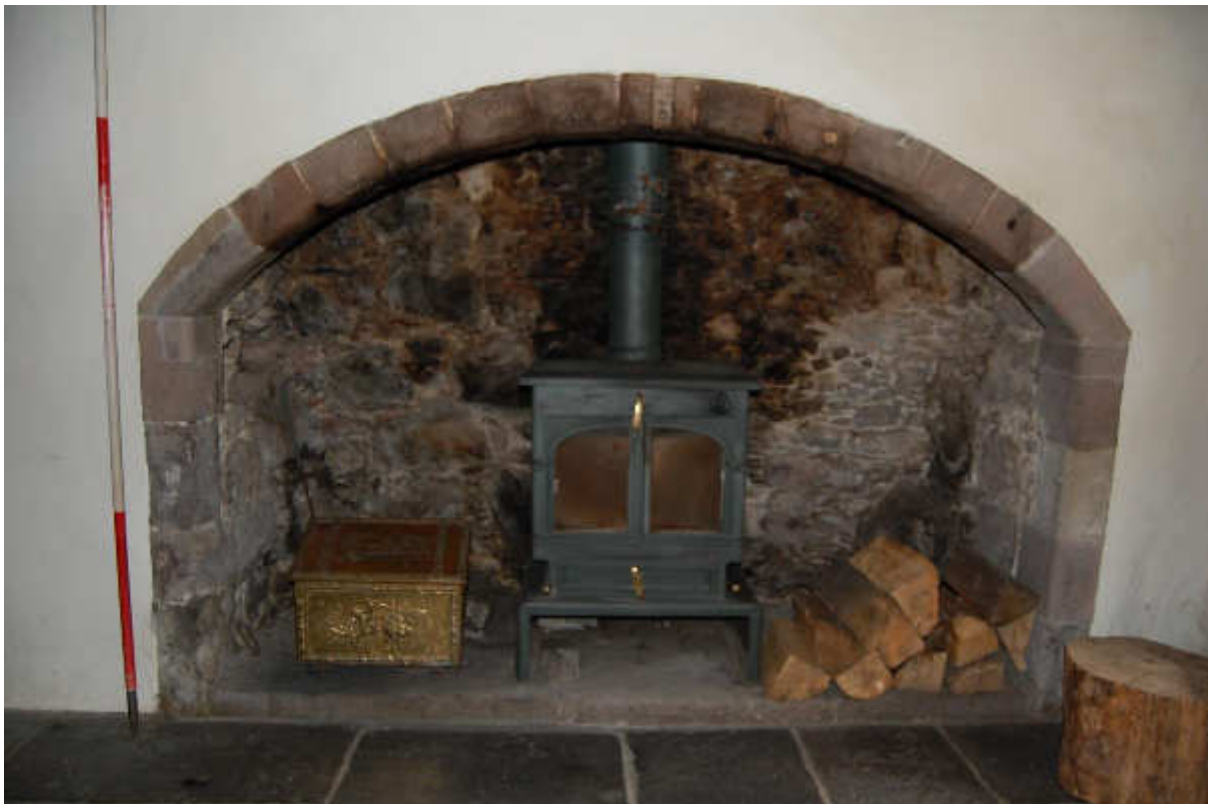
A large fireplace on the SSE wall of Room 2 has sandstone lintel with holes for fittings (Illus 14, 15). It has been heavily altered and infilled.

Illus 14 Inglenook fireplace F3; facing SSE

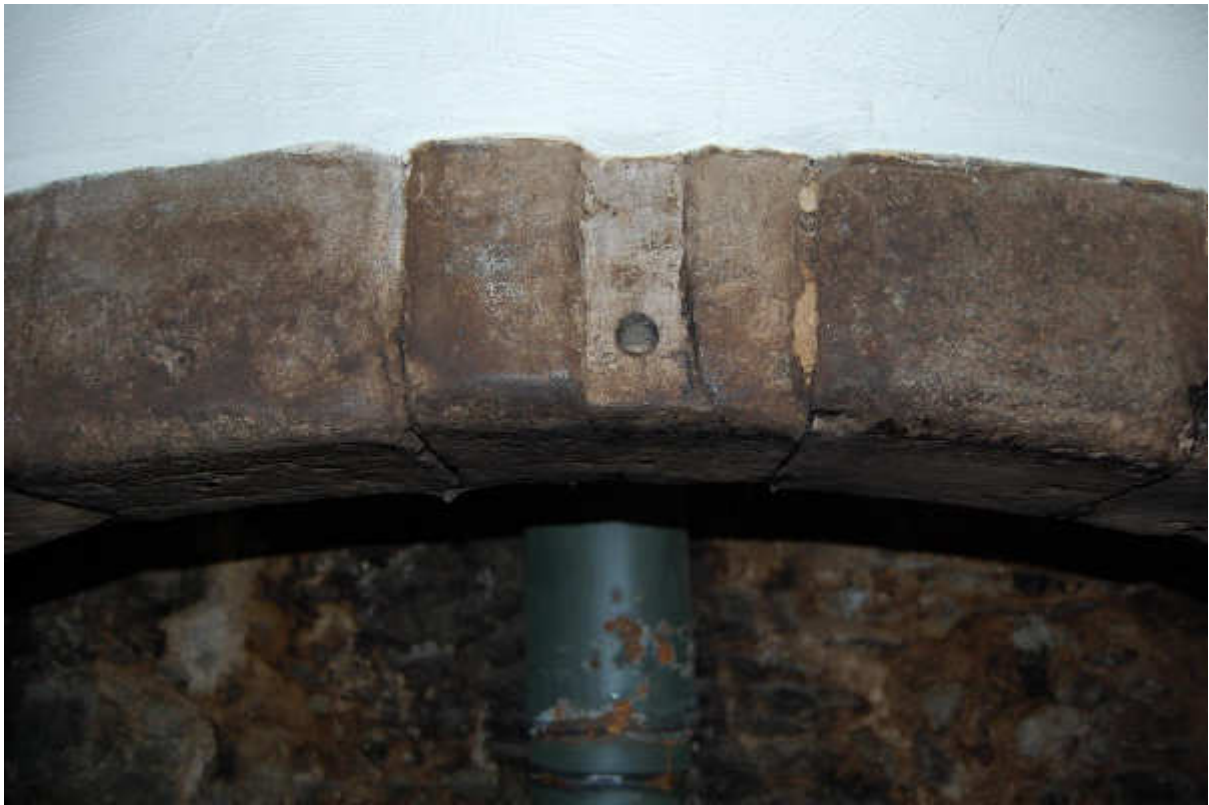
Illus 15 Inglenook fireplace F3 detail of central lintel of grey sandstone and recess for fittings; facing SSE

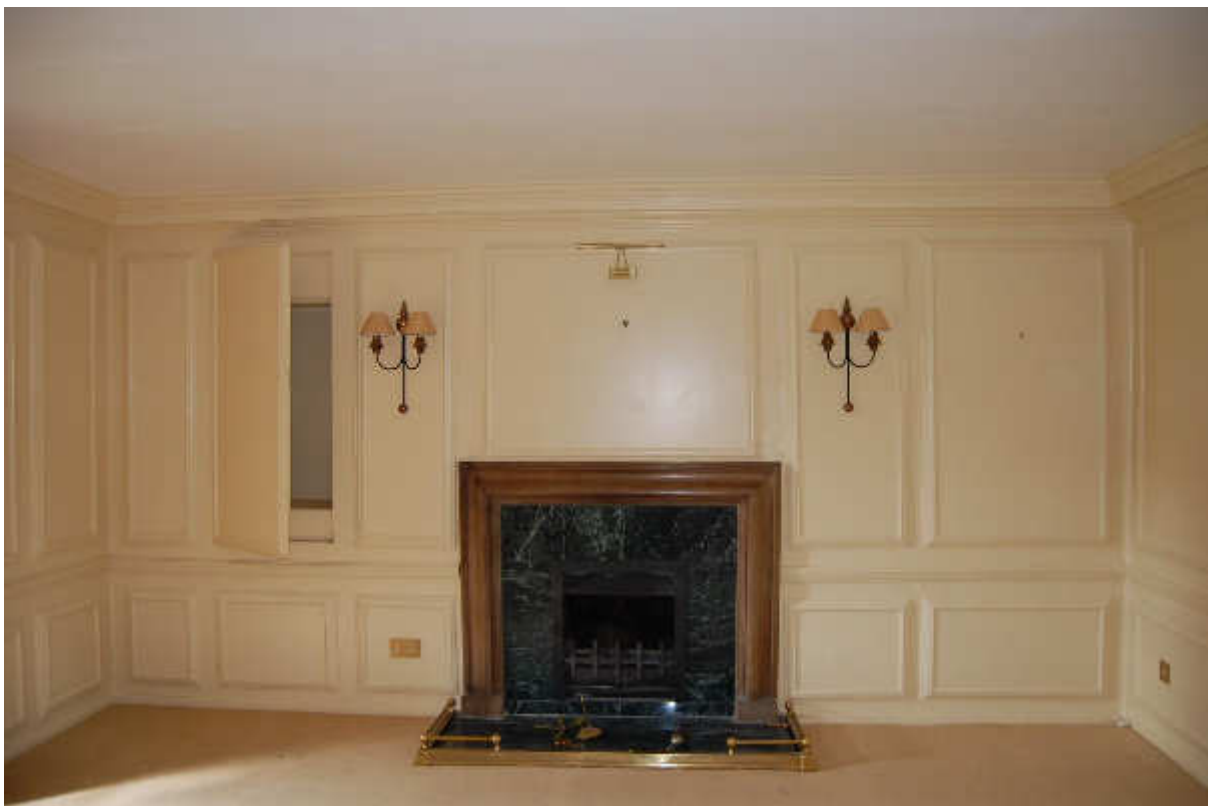
In Phase 2 the first floor was panelled in wood (Illus 16). It is presumably at this time that windows W27 on the WSW façade and WE15 and W26 on the ENE façade were blocked. These are infilled and harled on the exterior and covered with wood panelling on the interior. The corbelled turret stair Room 10 (Illus 5) originally leading from Room 8 on the first floor to Room 12 on the second floor was covered with the wood panelling. The small access door on the second floor survives in the NW corner of Room 12. The rectangular platform supported by a beam (F7) in the SW corner of Room 2 is presumably where the stair turret originally accessed the ground floor but this stair has been removed when the later stair was added into the tower (Room 5/6/11) probably in Phase 2.

Illus 16 Painted wood panelling throughout the first floor bedrooms

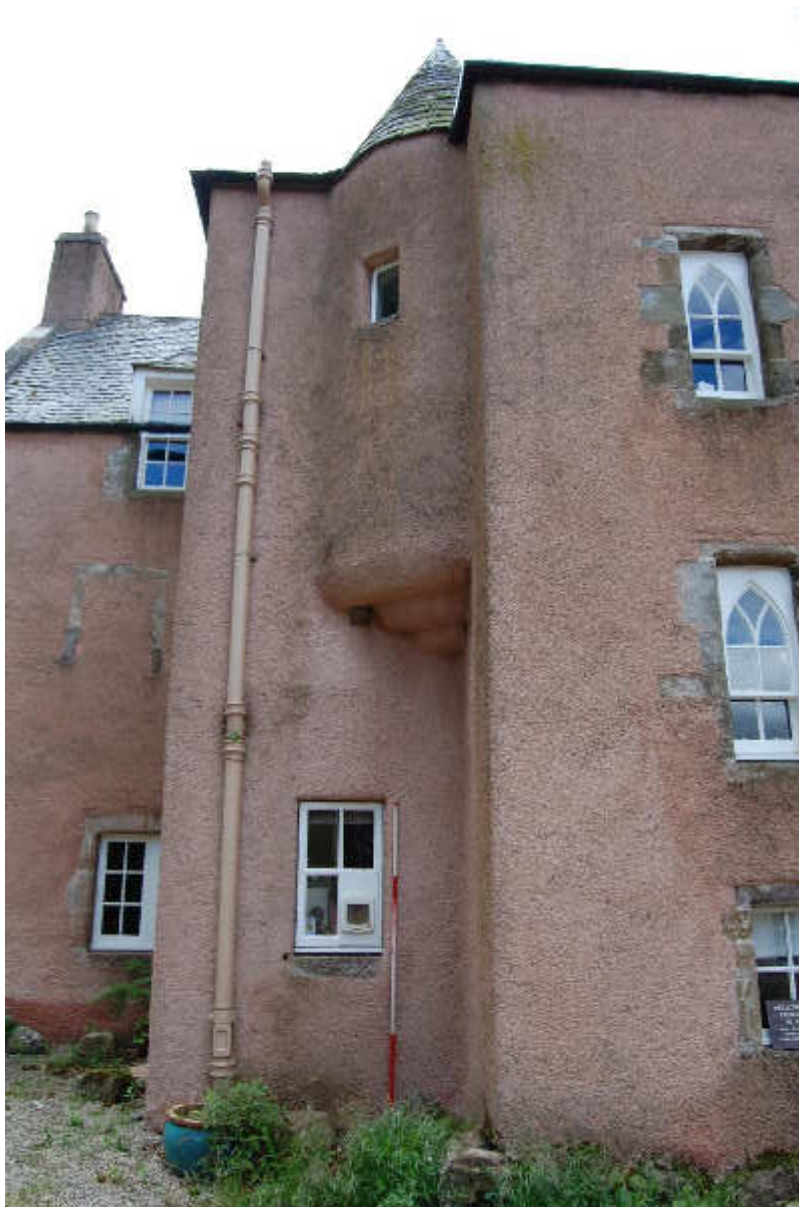
Illus 17 ENE façade showing original house (left), 19<sup>th</sup>-century extension with windows with narrow granite sills (centre) and entrance stair probably added 19<sup>th</sup> century (right)

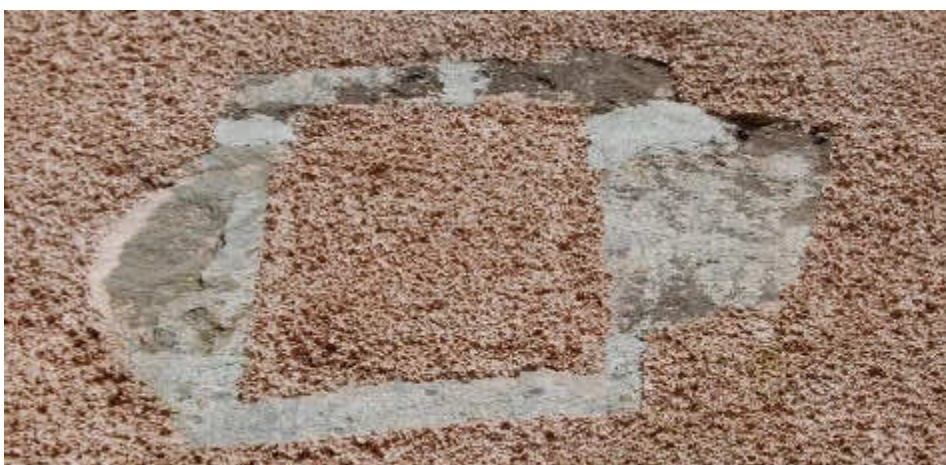
Illus 18 Blocked window W27 on first floor WSW façade; facing ENE

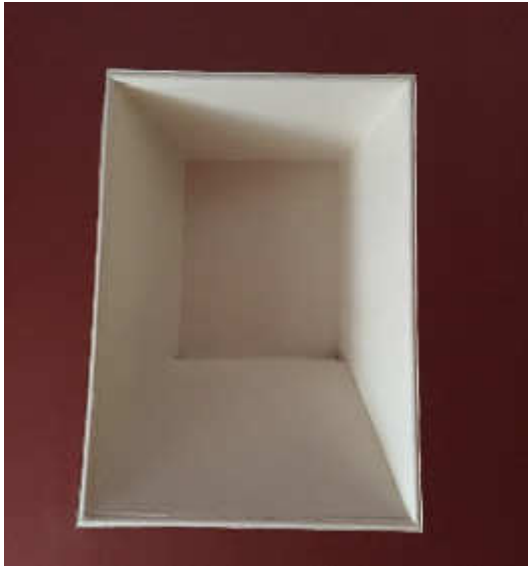
Illus 19 Window W31 on the stair between 1<sup>st</sup> and 2<sup>nd</sup> floors. This would have opened to the exterior of the SSE wall of the tower

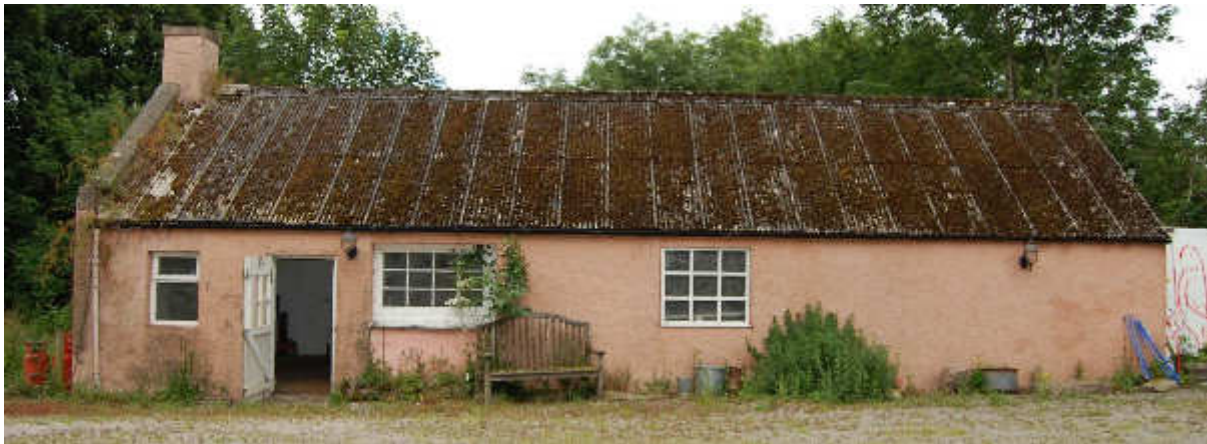
Illus 21 Building 2 WSW façade; facing ENE

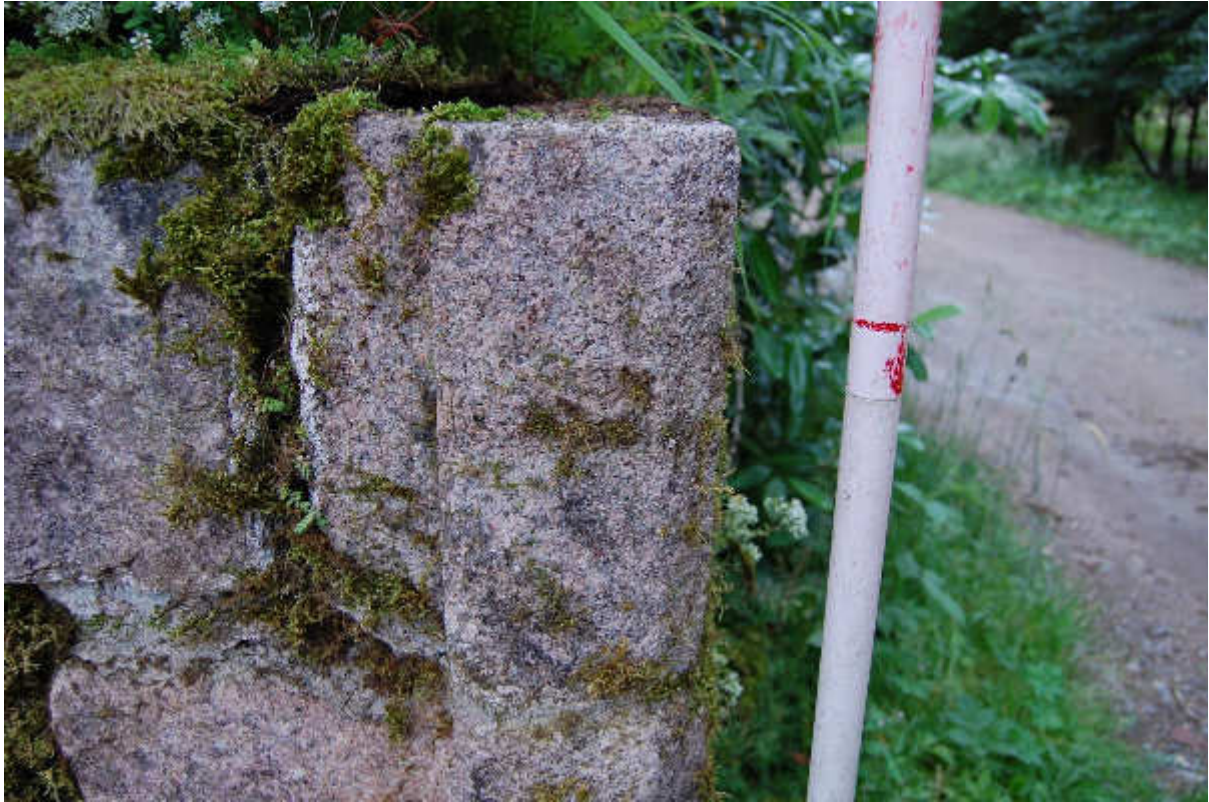
Illus 23 Chamfered pink sandstone gate jamb NE end SE wall of walled garden F10; the other jamb has been removed

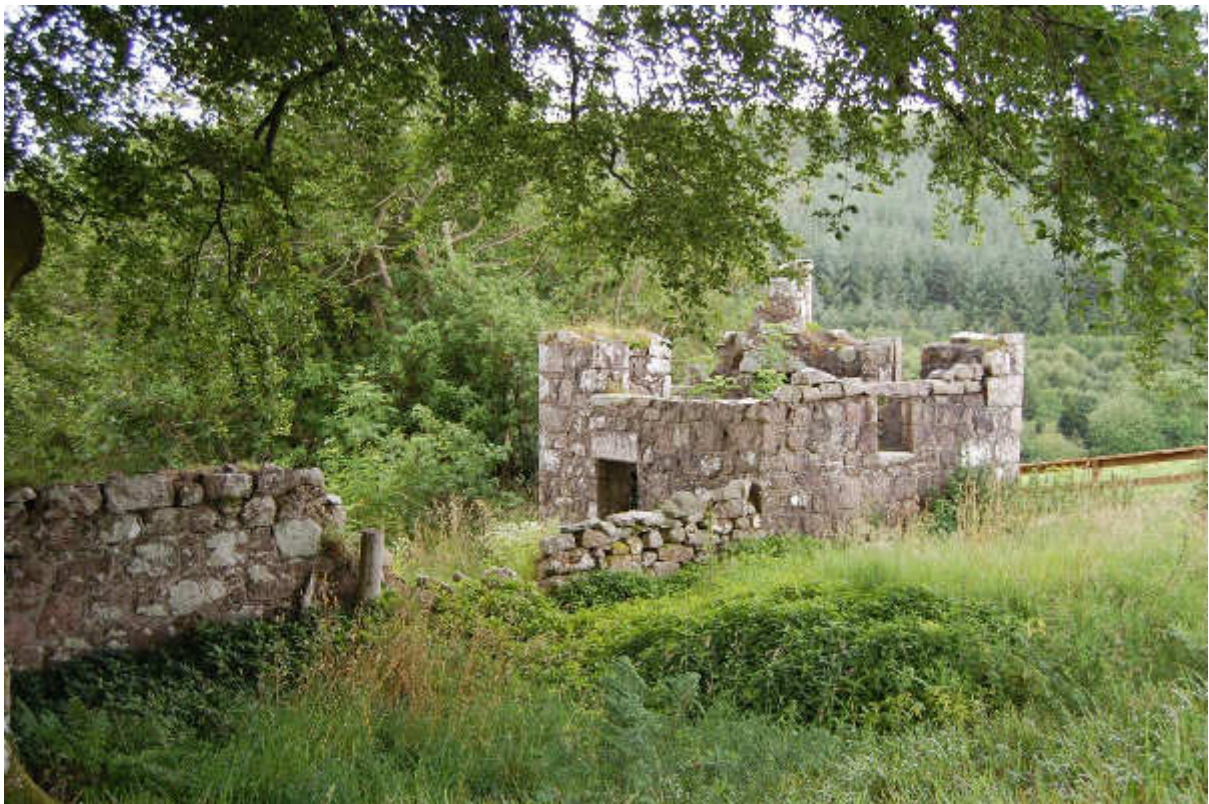
Illus 24 Garden House F11; facing SSE

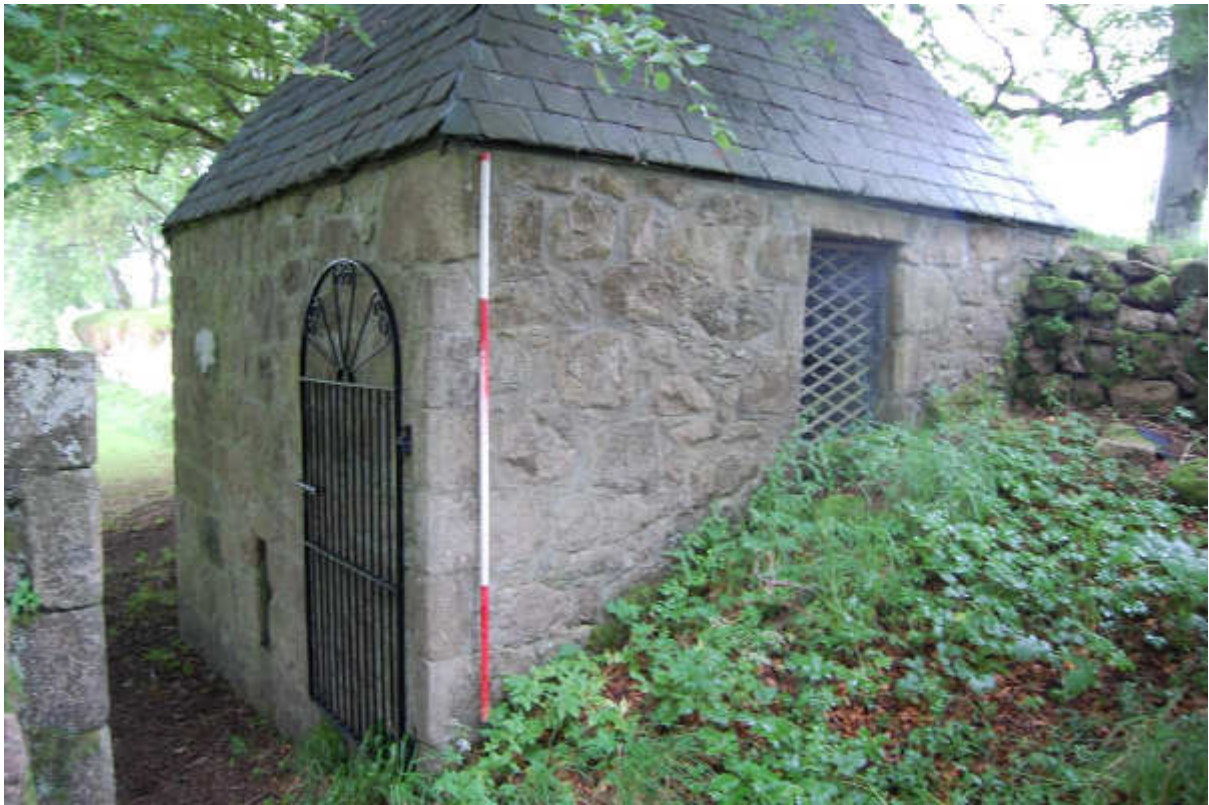
Illus 25 Garden House F12; facing WNW

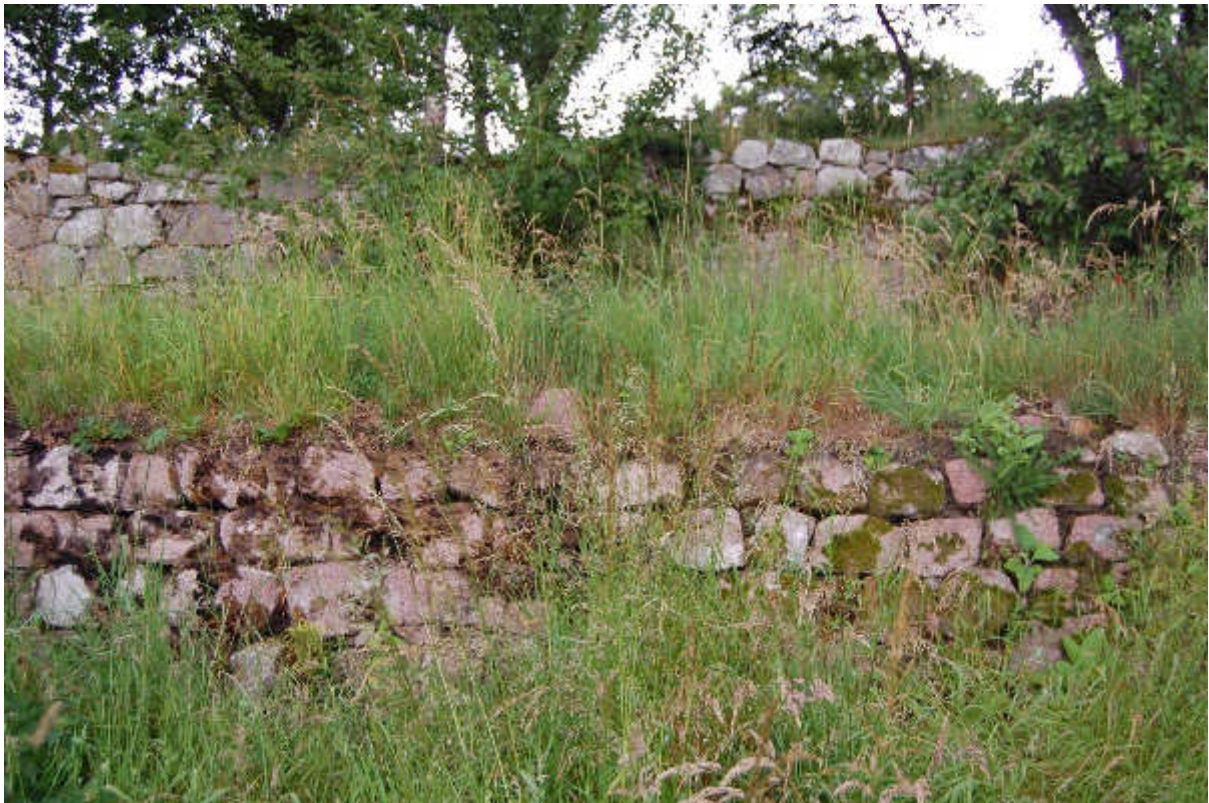
Illus 26 Overgrown and dilapidated terraced walled gardens between F11 and F12; facing NW

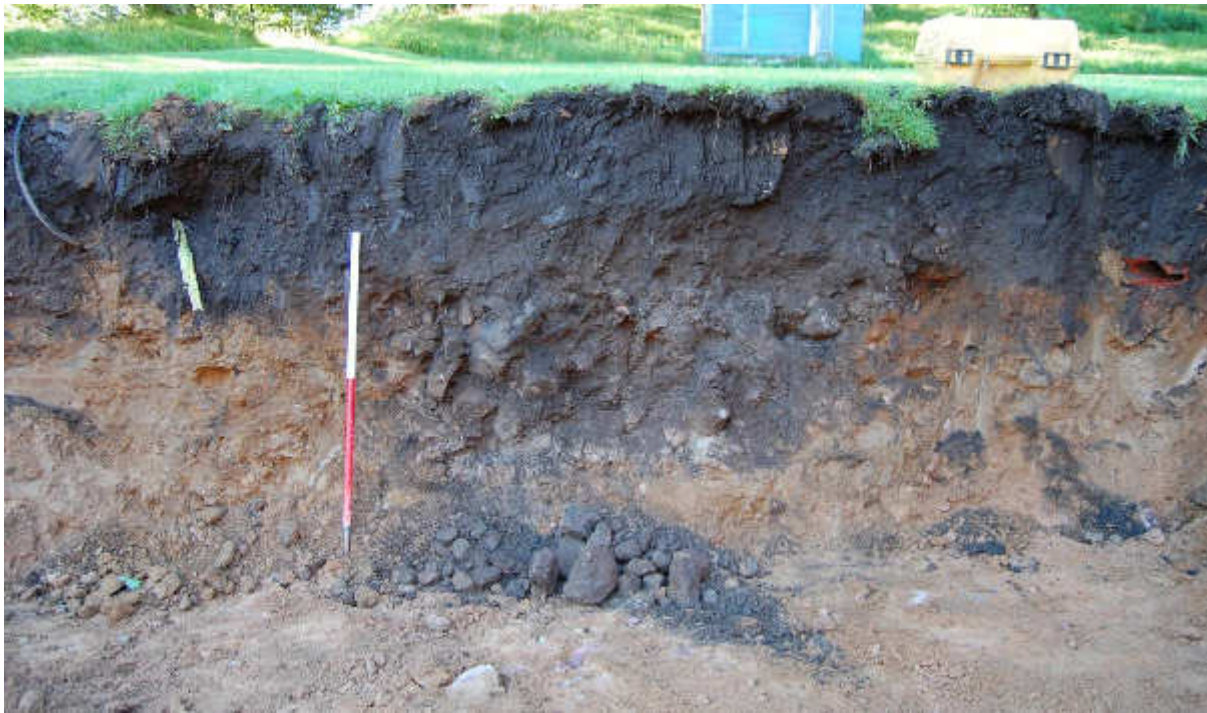
Illus 28 Stone and soil filled sump for ceramic drain (right) on the edge of the modern formal lawn; facing SSE

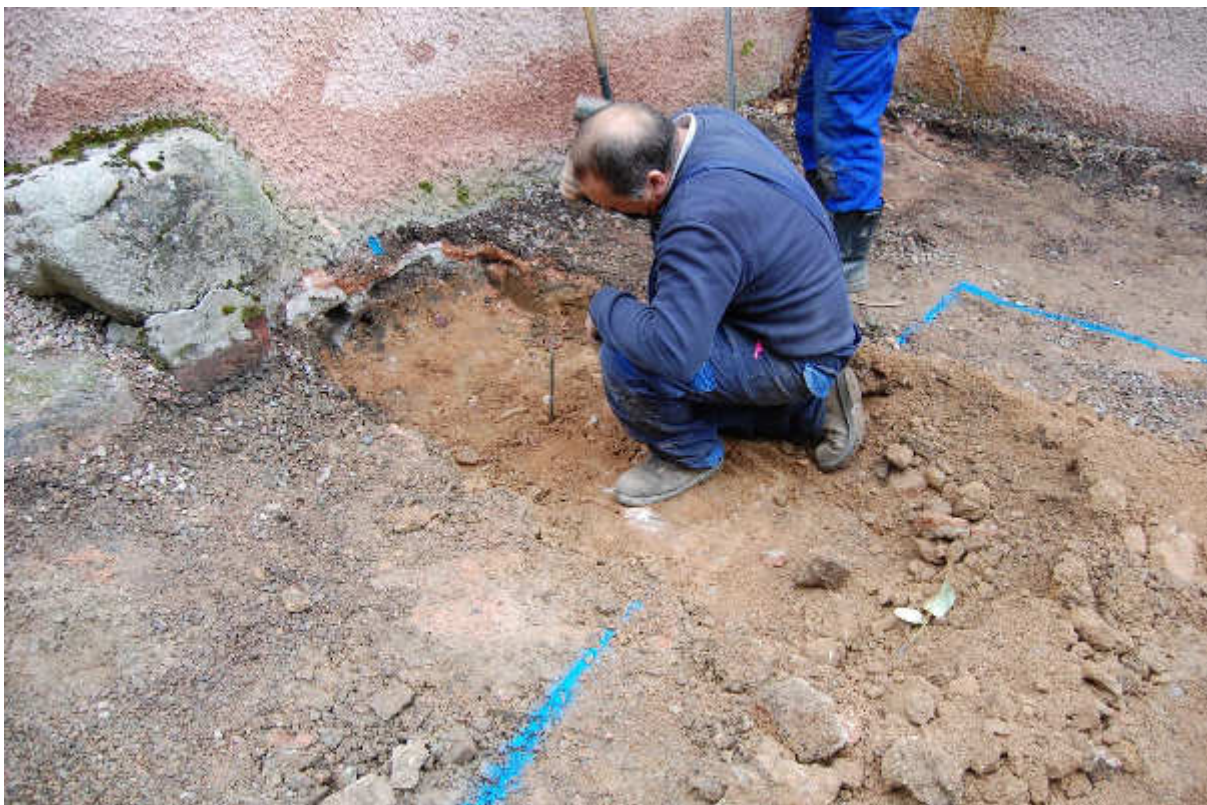
Illus 29 Shallow foundation trenches for the new extension; facing NW

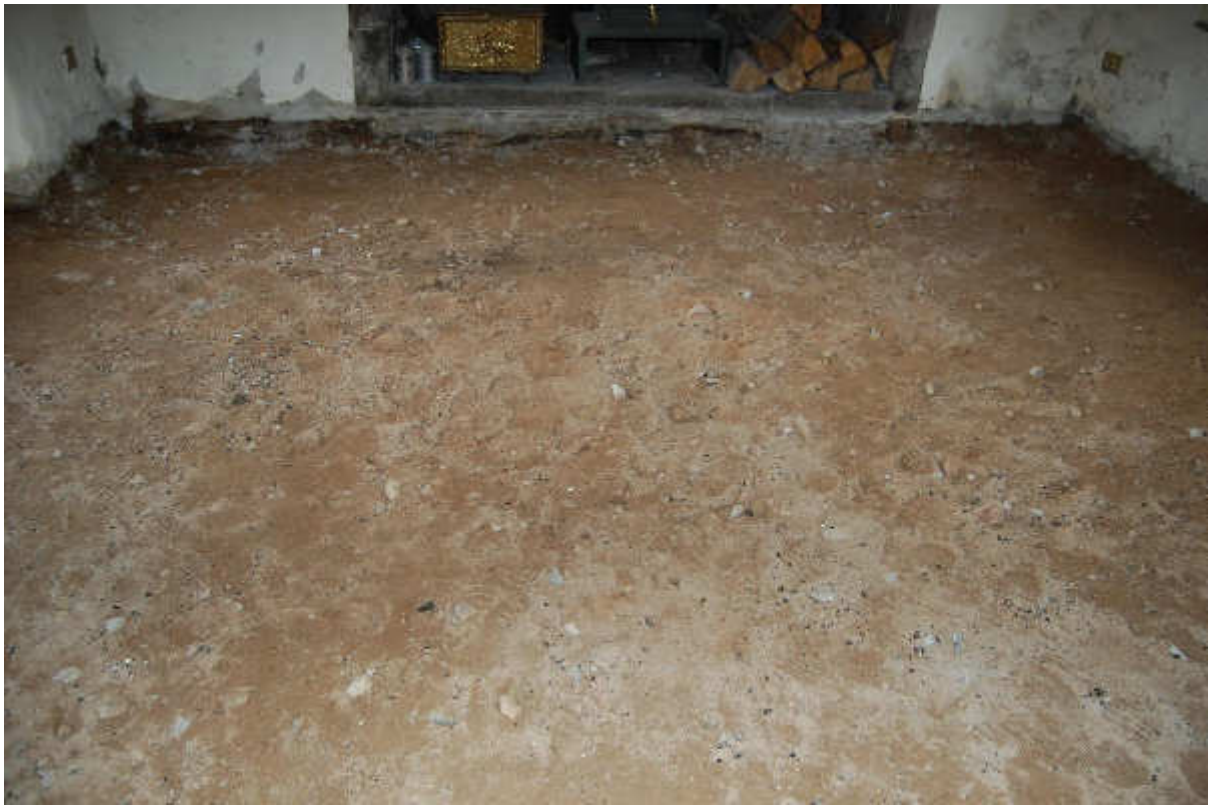
Illus 30 Room 2 concrete floors removed to reveal natural subsoil with fireplace F3 (top); facing SSE
