West Mains of Barras, Barras, Stonehaven AB39 2UE

Report on Level 1 Standing Building Survey

**Alison Cameron
Cameron Archaeology
11 September 2015**

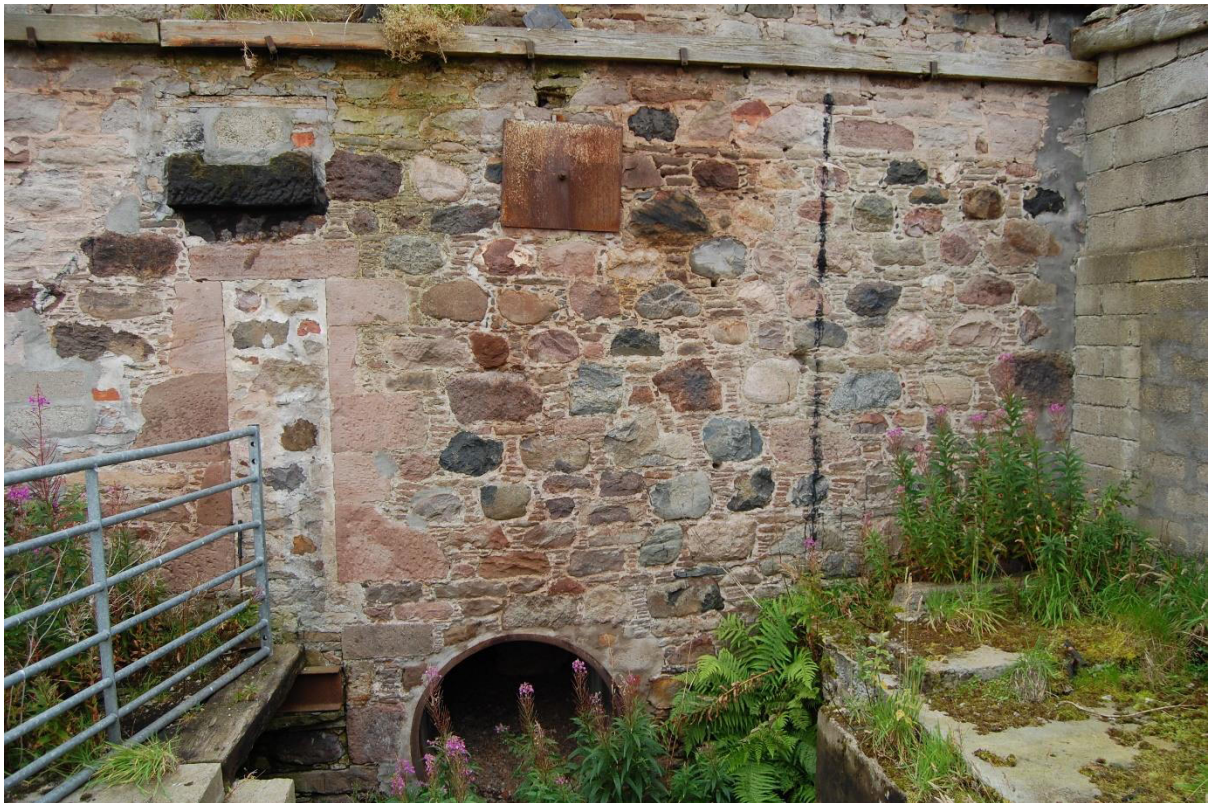
There is one large cart door in the NW façade (D14; Illus 8) and four cart doors on the SW façade (D15-18; Illus 7). There has been a waterwheel located on the SE end of the SW façade (F2; Illus 6 and seen on 1st and 2nd OS maps; Illus 20-21). The area around the former lade has been infilled and concrete floors and farm buildings constructed (and subsequently demolished). There is a metal channel (F2, Illus 4, 6) adjacent to D20 and this may have been associated with the mill; there is now a concrete ramp down to this aperture.

Illus 6 Building 1 SW wall with D20 (left) showing drop in ground level, former location of lade; facing NE

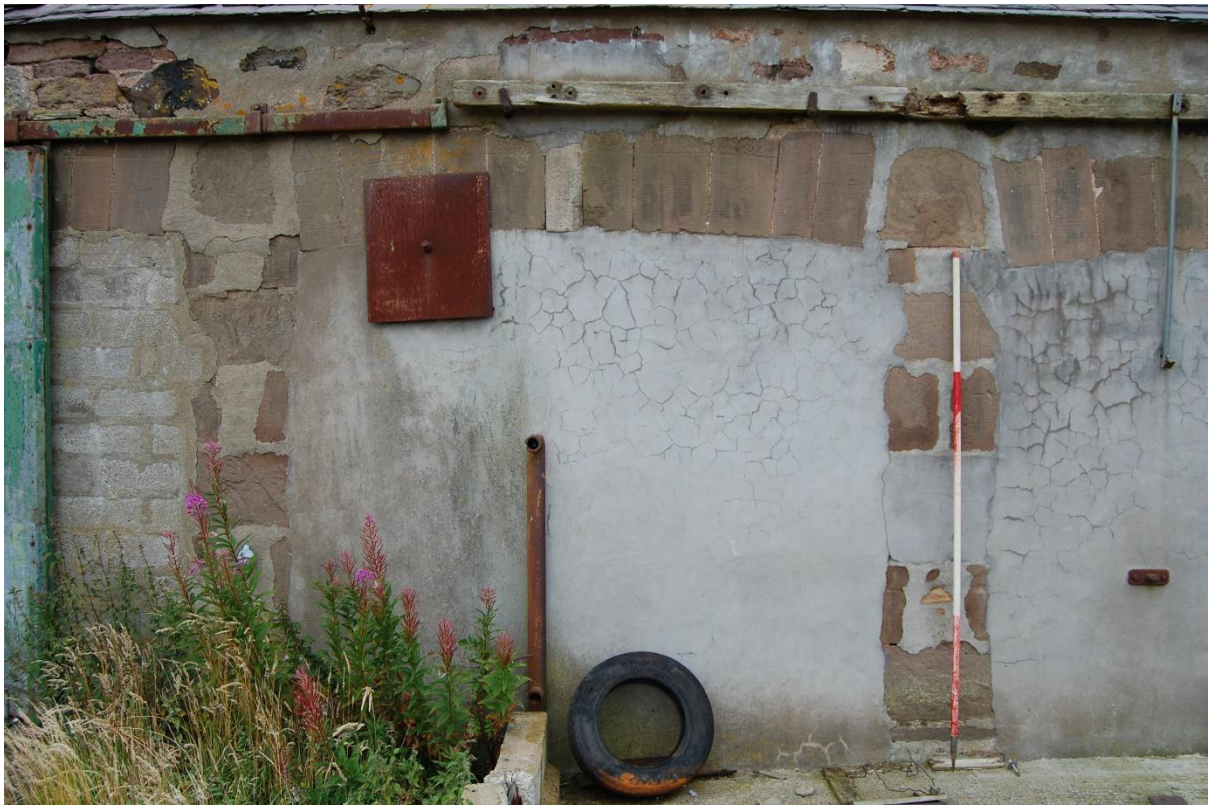
Illus 7 Cart door D16, one of four cart doors in SW wall Building 1; facing NE

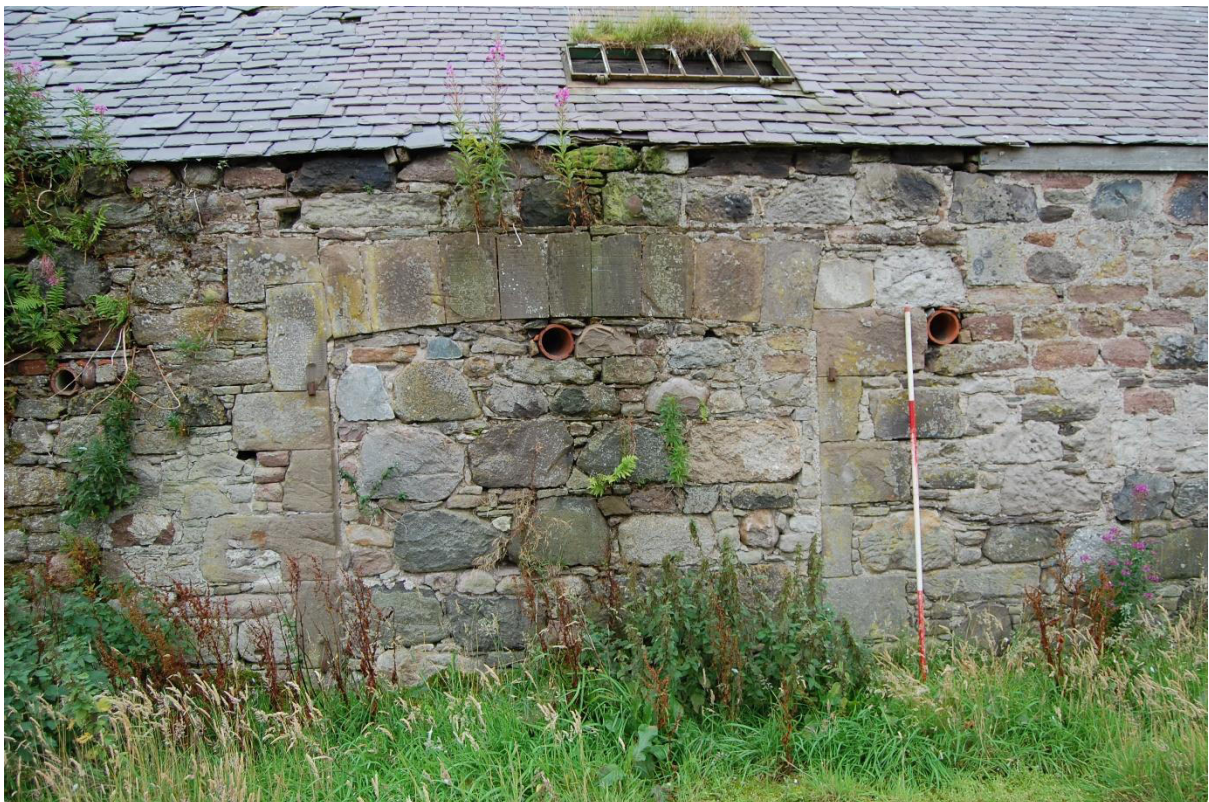
Illus 8 D14 cart door in NW wall Building 1; facing SE

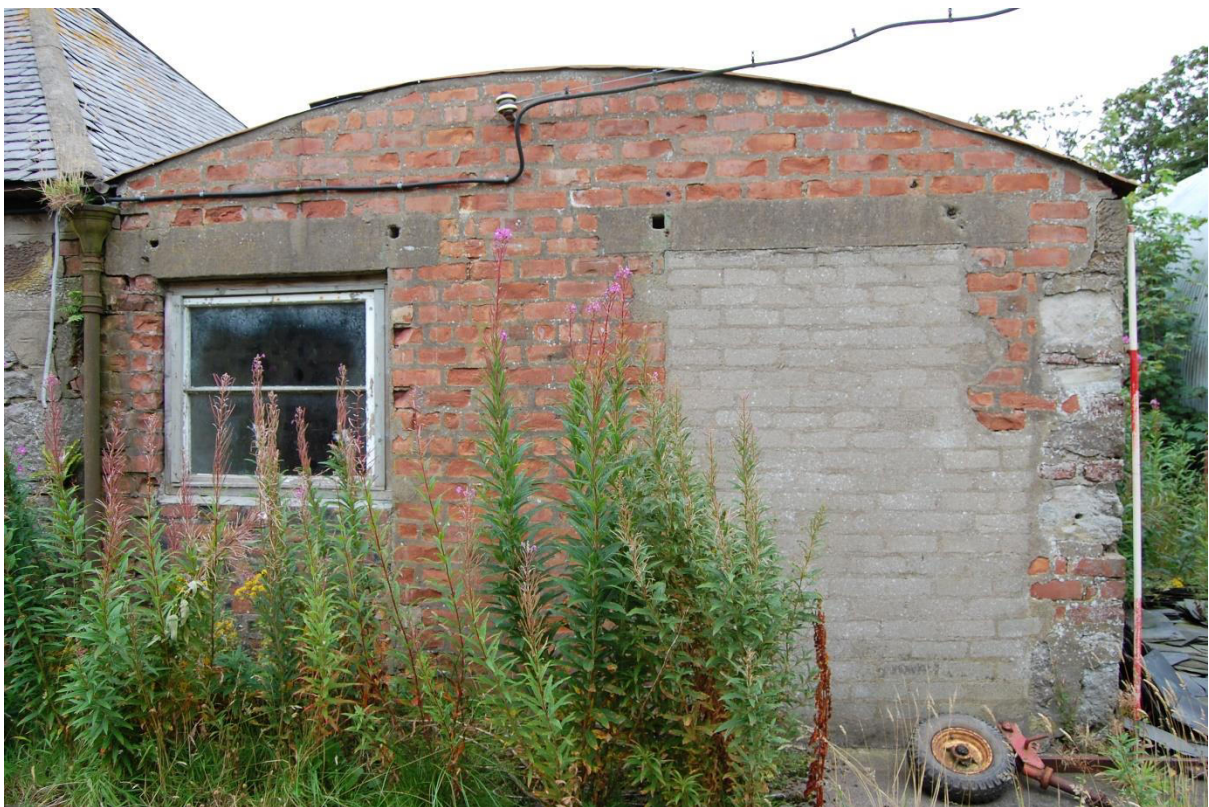
Building 3 is a small Nissen-type structure, built into an existing unroofed enclosure (retained in the SE wall; Illus 10) and infilled with brick on the SW front façade. It has infilled an unroofed enclosure on the 1st and 2nd OS maps. It is constructed of tin roof and red brick front SW wall (Illus 11). There is a window (W4) and door (D23) both with poured concrete lintels in the SW façade and these have subsequently been blocked and the interior lined with concrete for animal use.

Illus 11 Building 3 W4 (left) and door D23 (right); facing NE

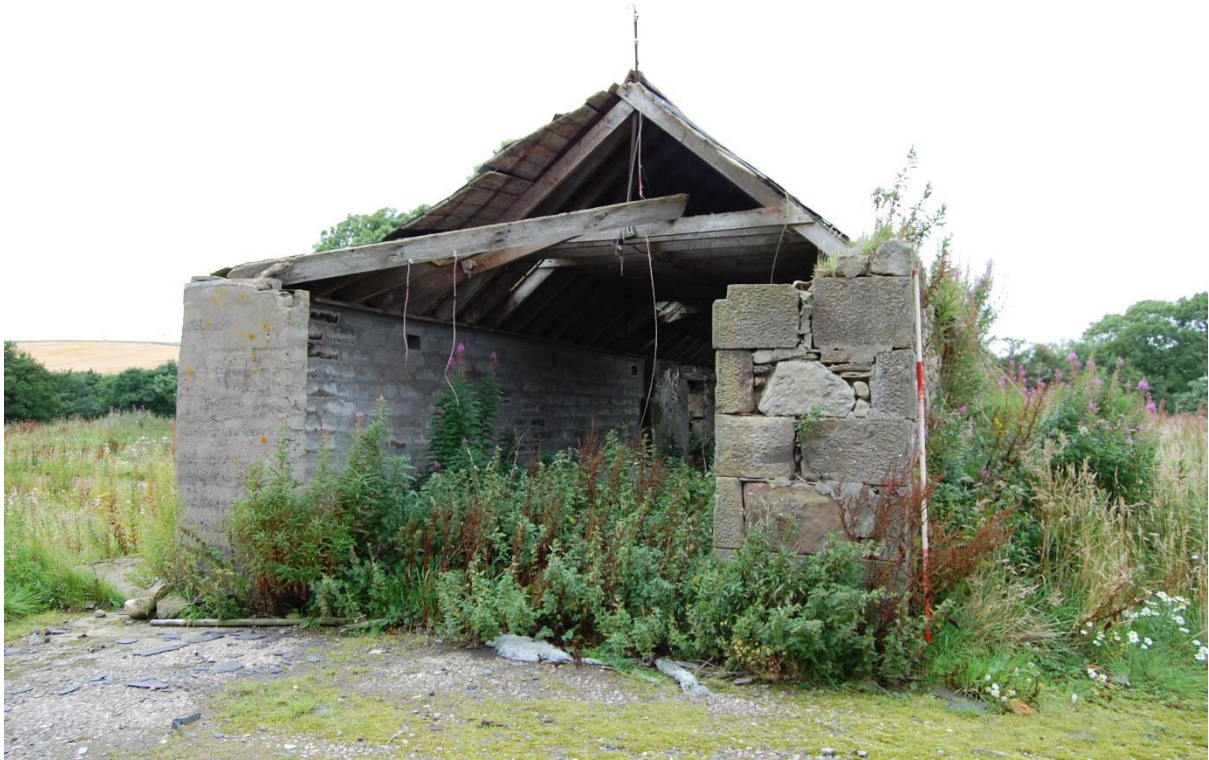
Building 5 is the 'bothy' building (Illus 14). It has been heavily rebuilt at the SE end (Illus 15), is heavily overgrown (Illus 16) and the roof is not safe for access to the interior. It is divided into two rooms (Illus 14) with windows W8 and W9 and doors D30 and D31 on the SW façade. The NW room has been for domestic use (bothy) with the SE room for agricultural use.

Illus 15 Building 5 SE gable with D29 showing SW wall rebuilt; facing NW

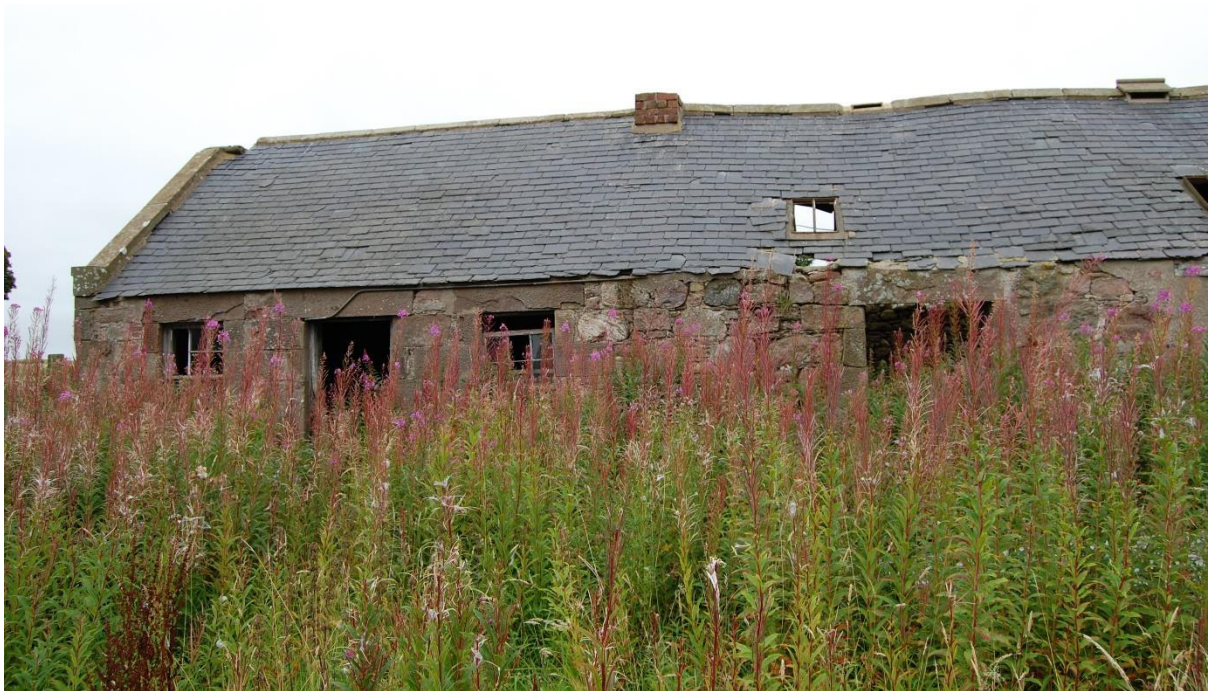
Illus 16 Building 5 SW façade showing overgrown state and poor condition of roof; facing SW

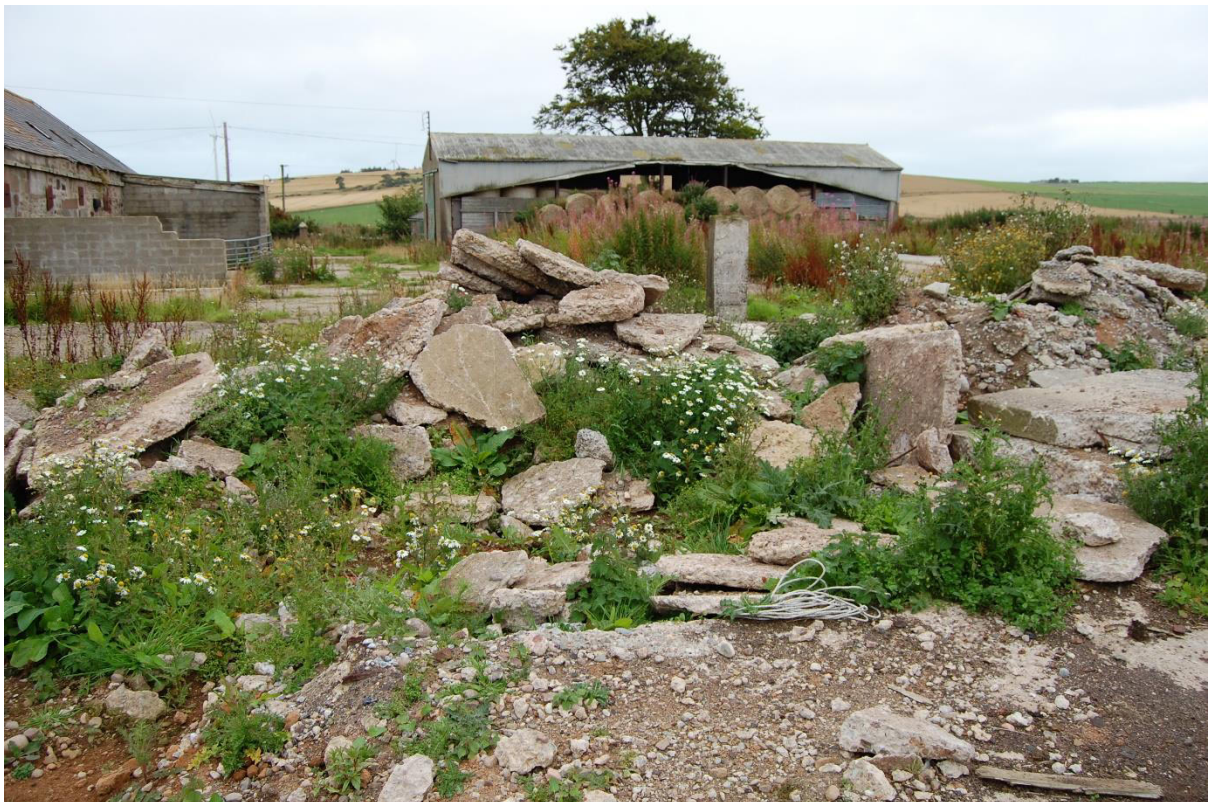
Building 7 is a modern barn; several modern buildings have also been demolished to the NW of this building and concrete floors survive.

Illus 18 Building 7 (centre background) with demolished concrete structures (foreground); facing SE
