**Steading At Mains of Duncanstone, Lazyfold Road,
Duncanstone, Inch, Aberdeenshire, AB52 6YX
Report on Level 1 Standing Building Survey**

**Alison Cameron
Cameron Archaeology
24 November 2015**

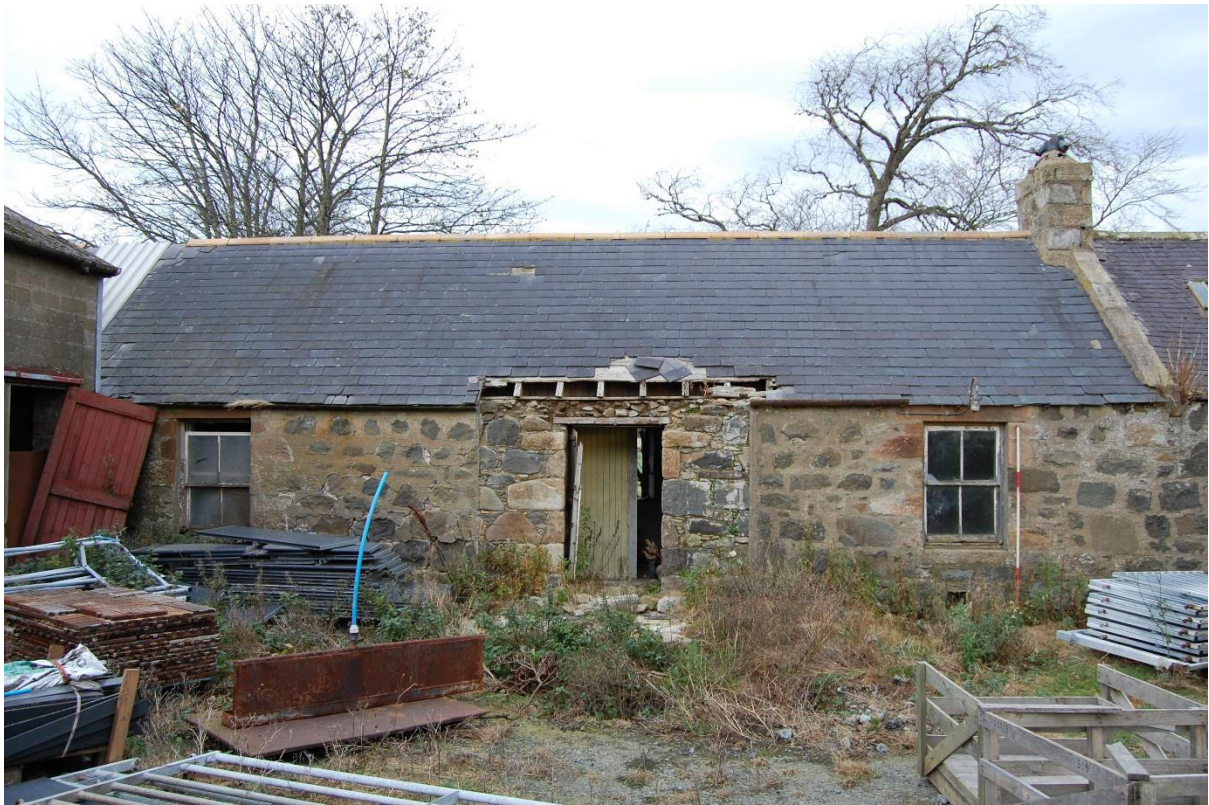
Illus 5 Phase 1 cottage S wall Rooms 3 and 4, W1, D1, W2; facing NNW

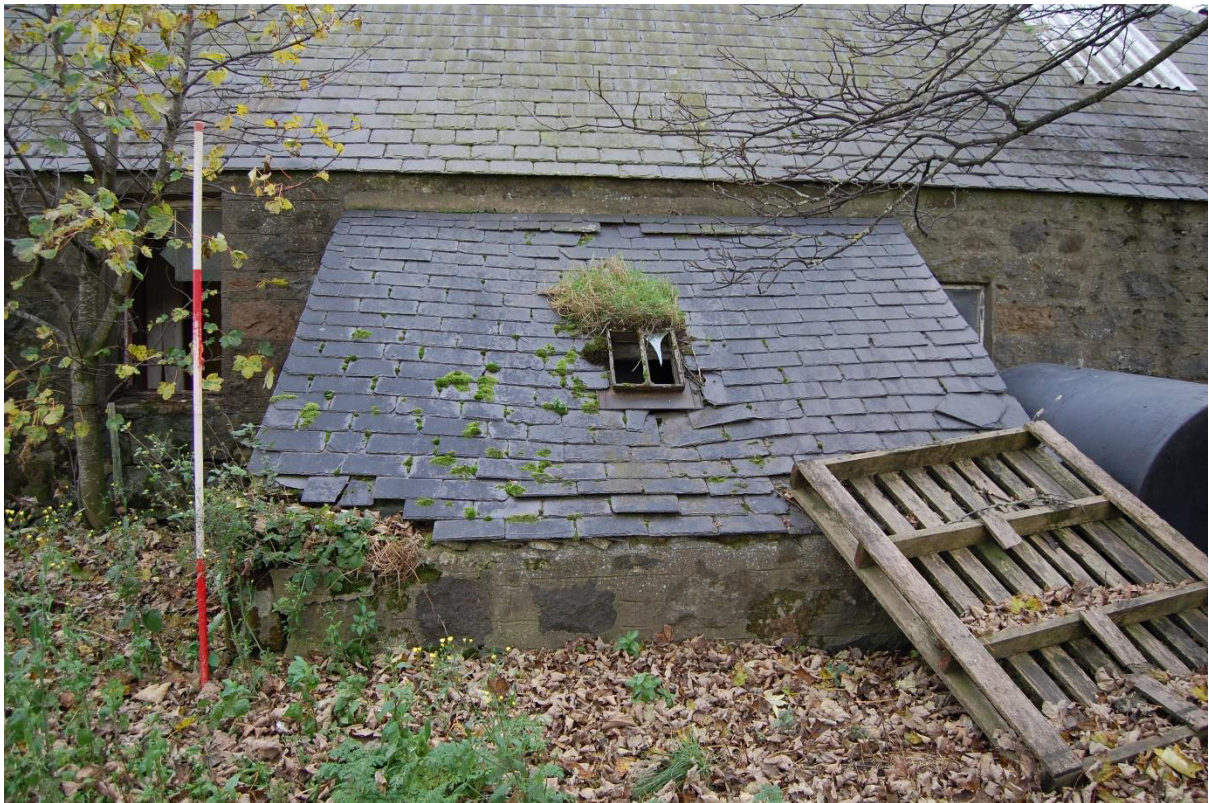
Illus 6 Room 1 cold store exterior; facing SSW

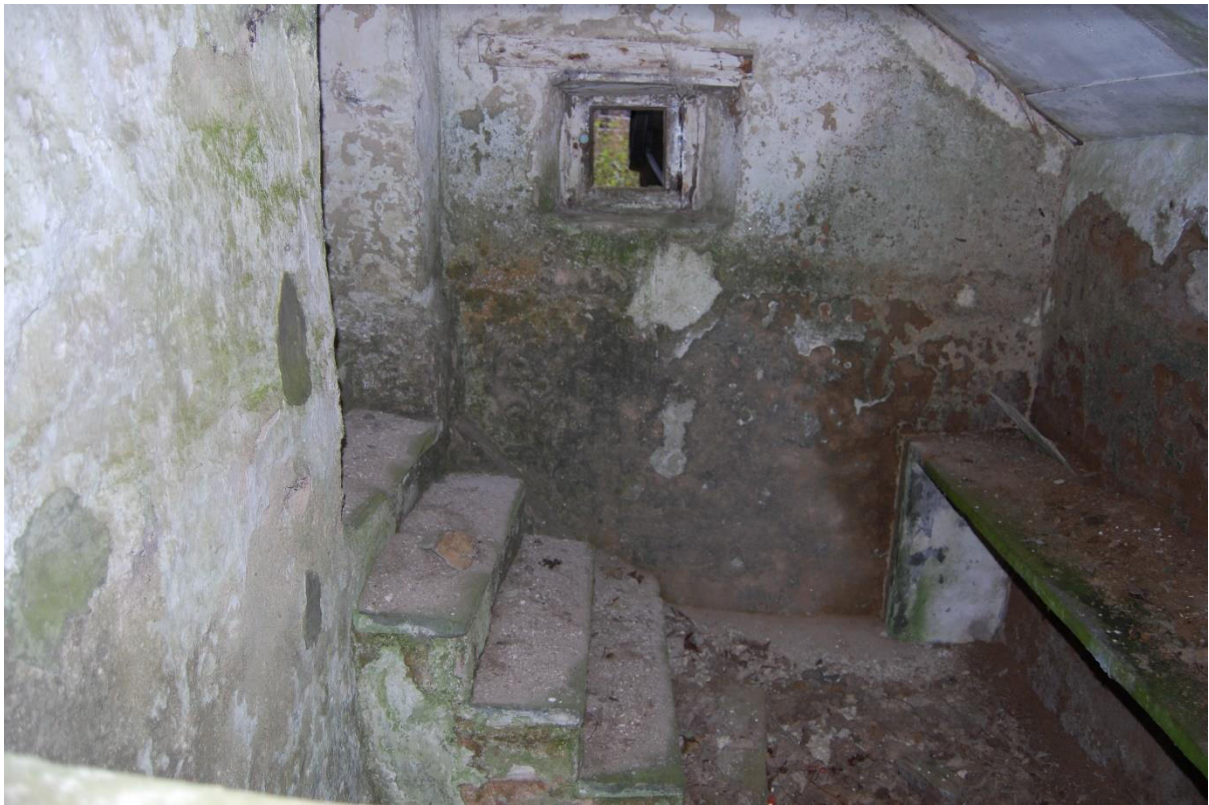
Phase 1 consisted of a C-shaped steading (Rooms 2, 3, 4 and 7) around a central courtyard and a bothy to the SE. The buildings are constructed of blocks of pink and grey granite blocks with cherry cocking. The roofs are slate and the lintels and sills are mainly granite with wood on the interiors. The N wing of the steading is 19m long and 5.1m wide. The E end consists of a cottage (Illus 5, Rooms 3 and 4) with a cold store/pantry on the exterior of the N wall (Illus 6, 7; Room 1). There was no access to the interior of this room but the room was accessed by steps into the partially underground structure and there is a stone shelf *in situ* (Illus 7). This building is 3.3m long and 2.3m wide.

Illus 7 Room 1 interior through window W8; facing WSW

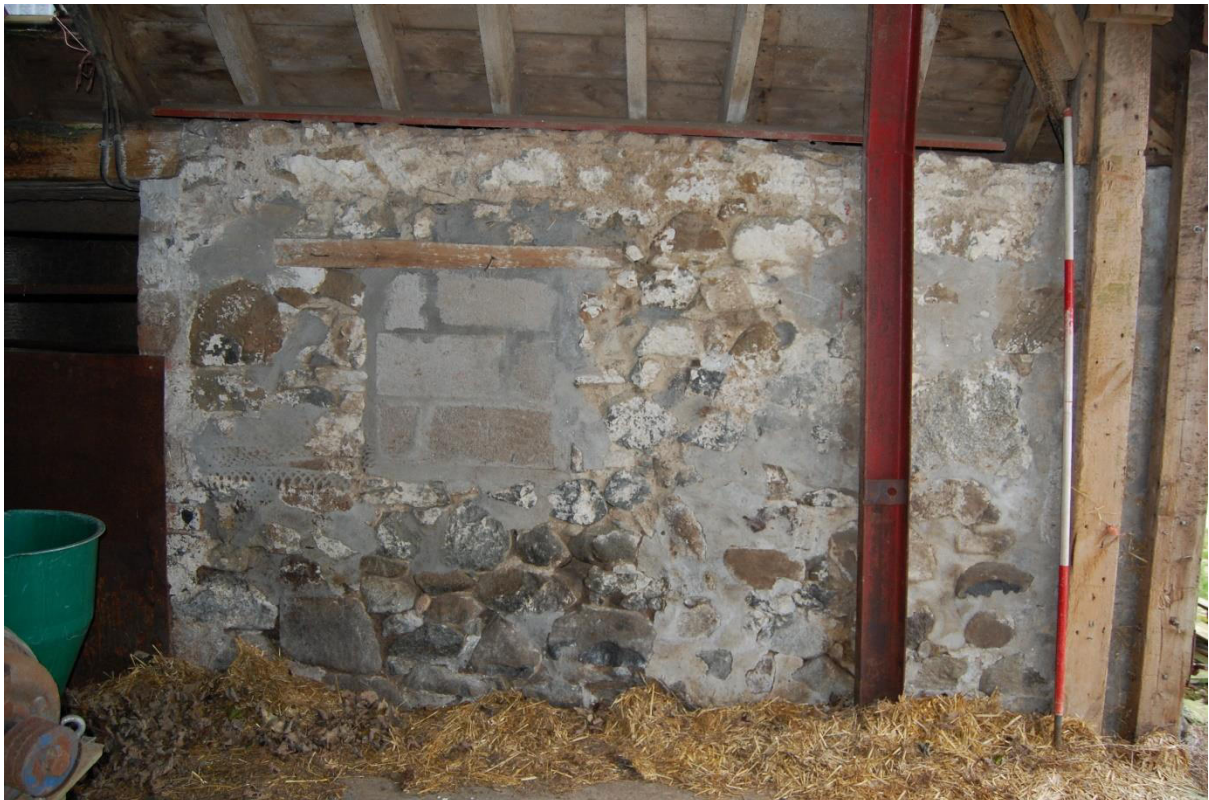
The W arm of the steading is 28m long and 5.1m wide. It has a series of blocked doors and windows on the W wall (eg W13; Illus 8), presumably when the modern dutch barn was added to the W. The S arm of the steading was 23m long and 5.4m wide. A series of doors and windows on the S wall are still open (eg W16; Illus 9) but the level of the ground on the exterior has been increased and some of these are not clearly visible from the exterior.

Illus 8 Room 7 W wall blocked window W13; facing WSW

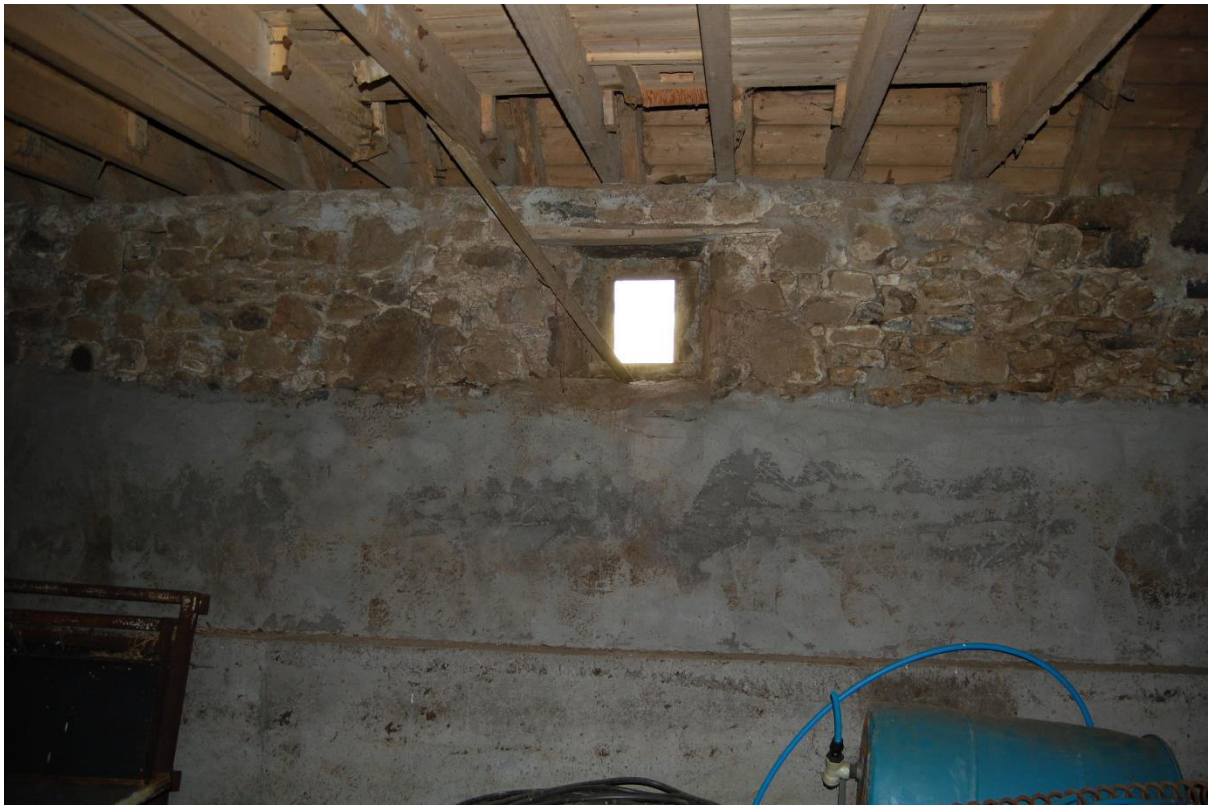
Illus 9 Room 7 S wall window W16 showing concrete lining when buildings modernized for animal use; facing SSE

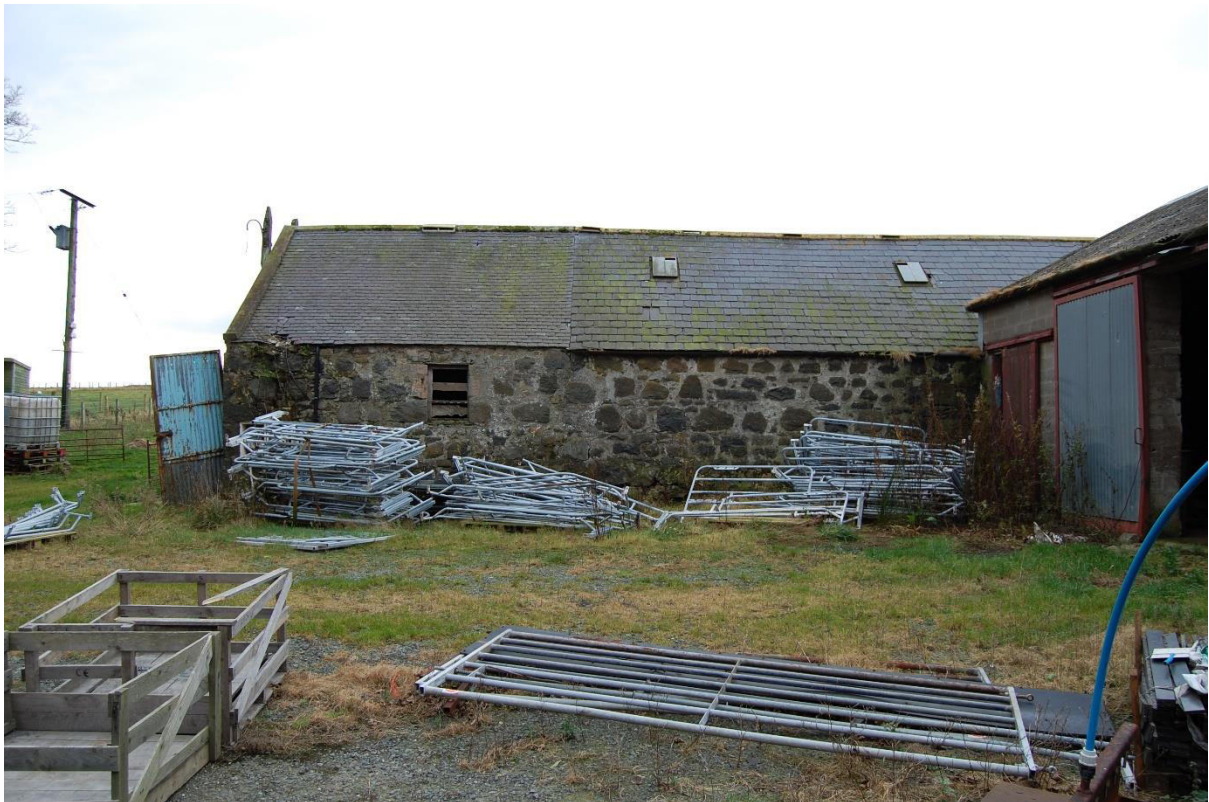
Illus 10 South arm of C shaped steading showing Phase 1 (right) and Phase 2 extension (left)

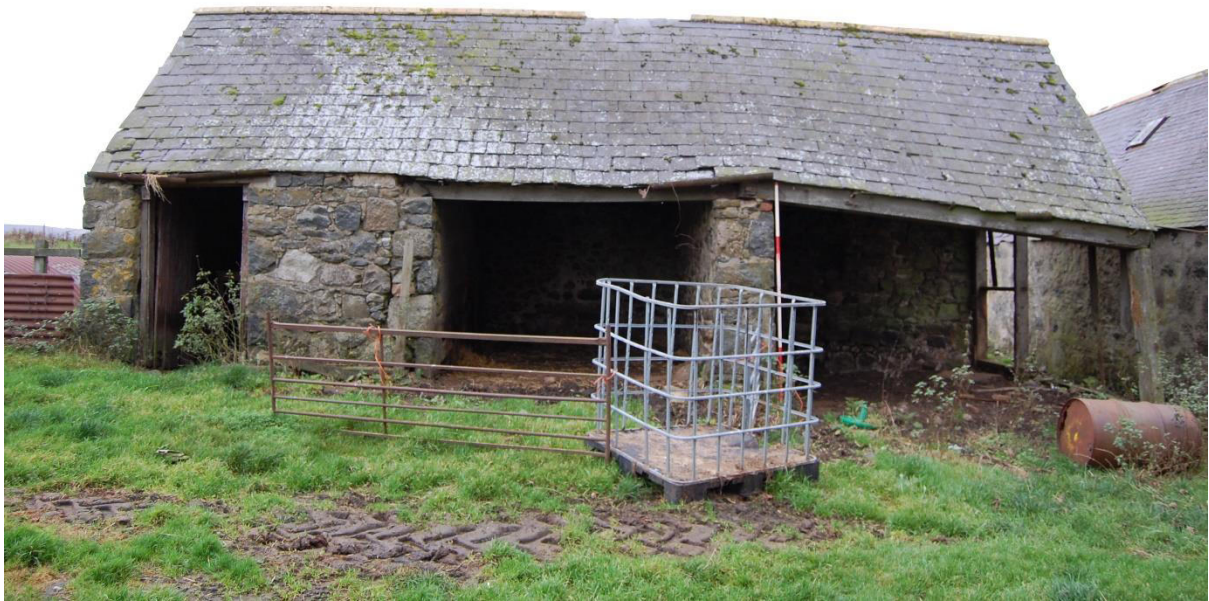
To the SE is a small separate building consisting of Rooms 8, 9, and 10 and partially demolished structure Room 11 which does not appear on the OS maps and may have been an unroofed enclosure.

Illus 11 Rooms 8-10; facing WSW

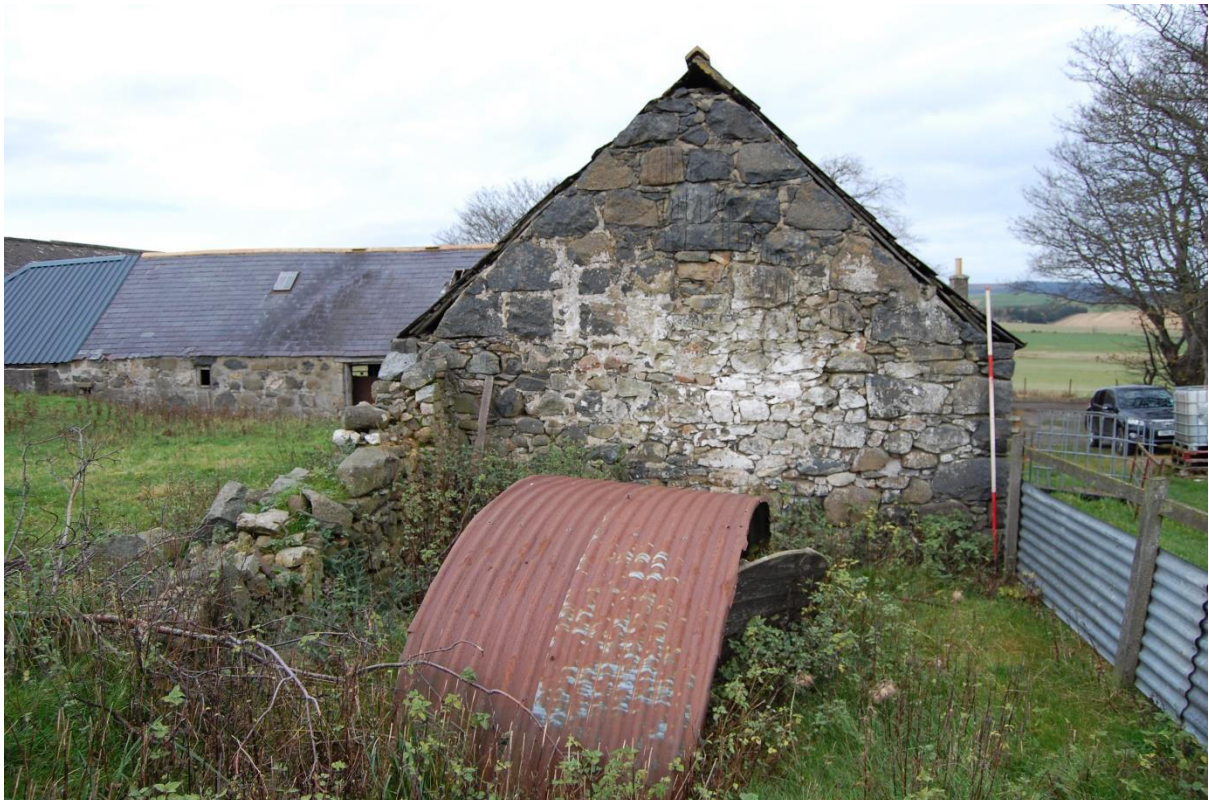
Illus 12 S gable Room 10 with blocked window W17 (first floor) and Room 11 as earthwork (foreground); facing NNW

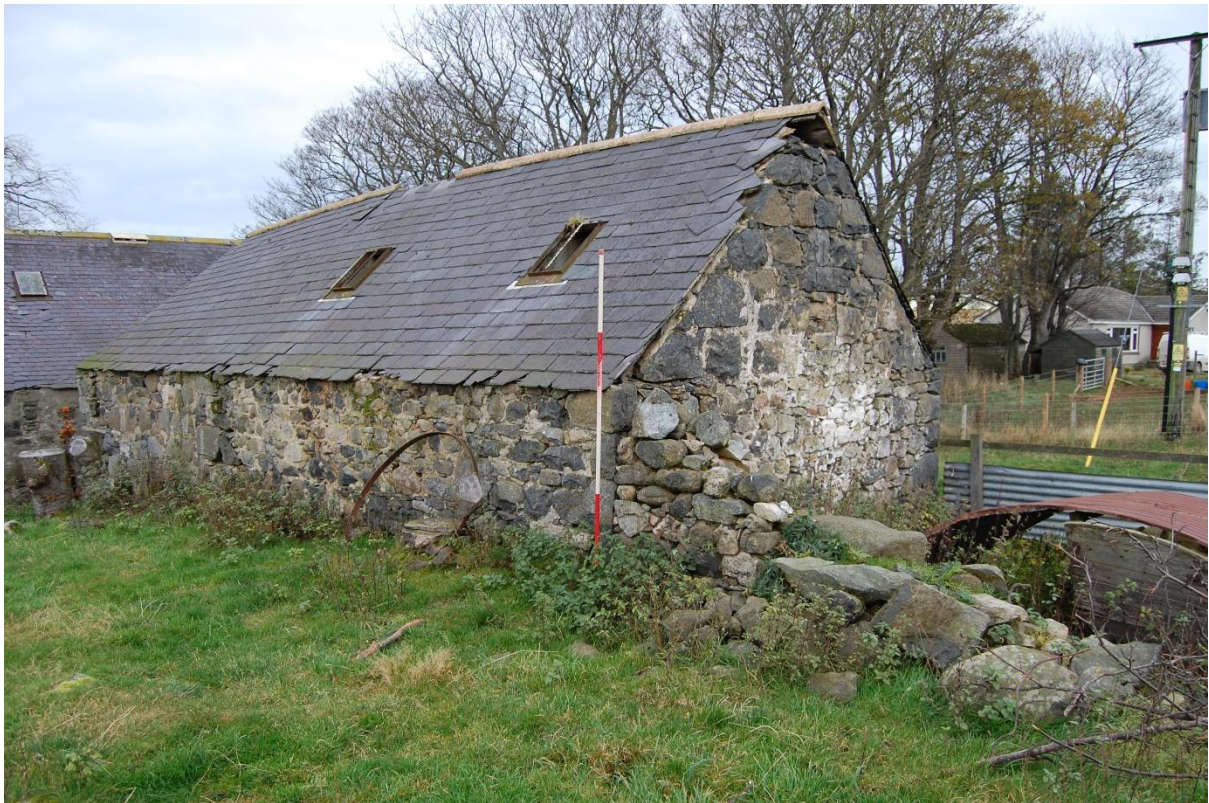
Illus 13 Rooms 8-10 with fragment of W wall Room 11 surviving (right); facing NE

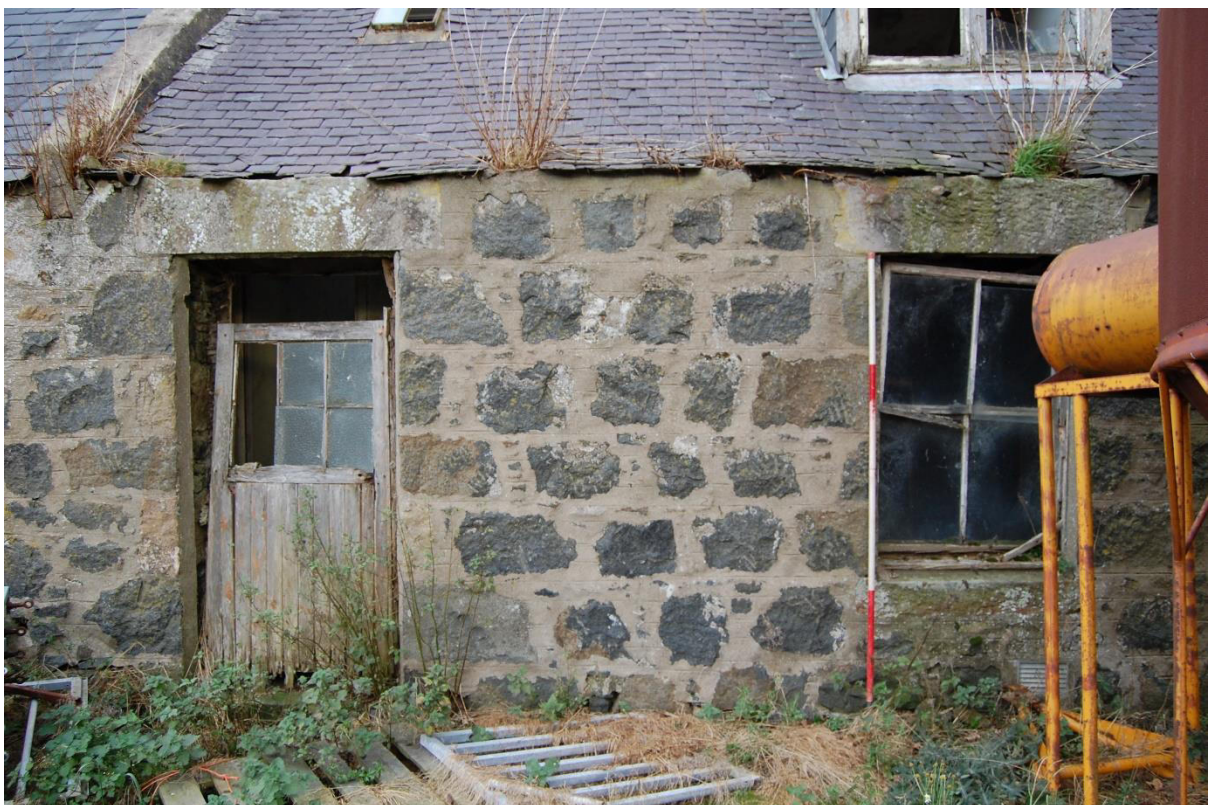
In Phase 2 an extension was built on to the E end of the N wing of the steading (Room 5; Illus 14, 15) which was an extra domestic accommodation and an extension on the E end of the S wing of the steading appears to have been extra agricultural building.

Illus 14 Phase 2 cottage added on to E of Room 4 with D2 and W3; facing NNW

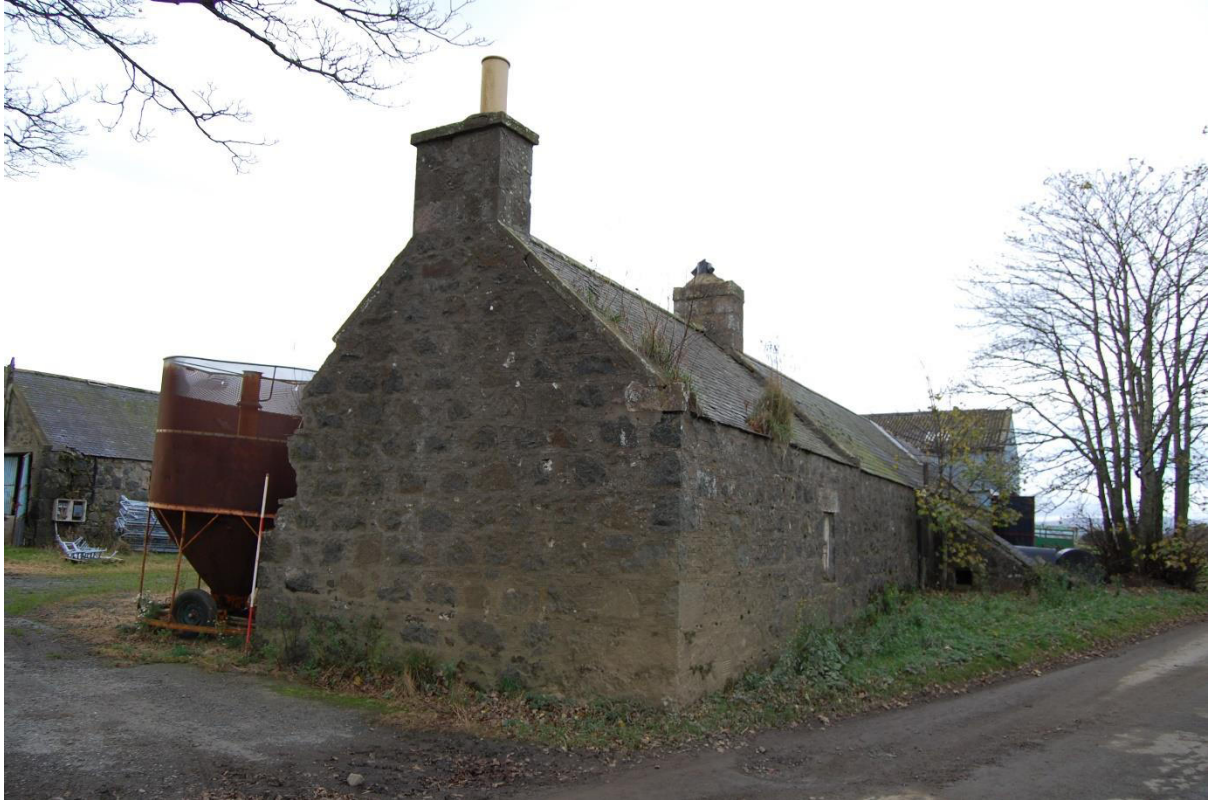
Illus 15 Phase 2 gable Room 5; facing SW

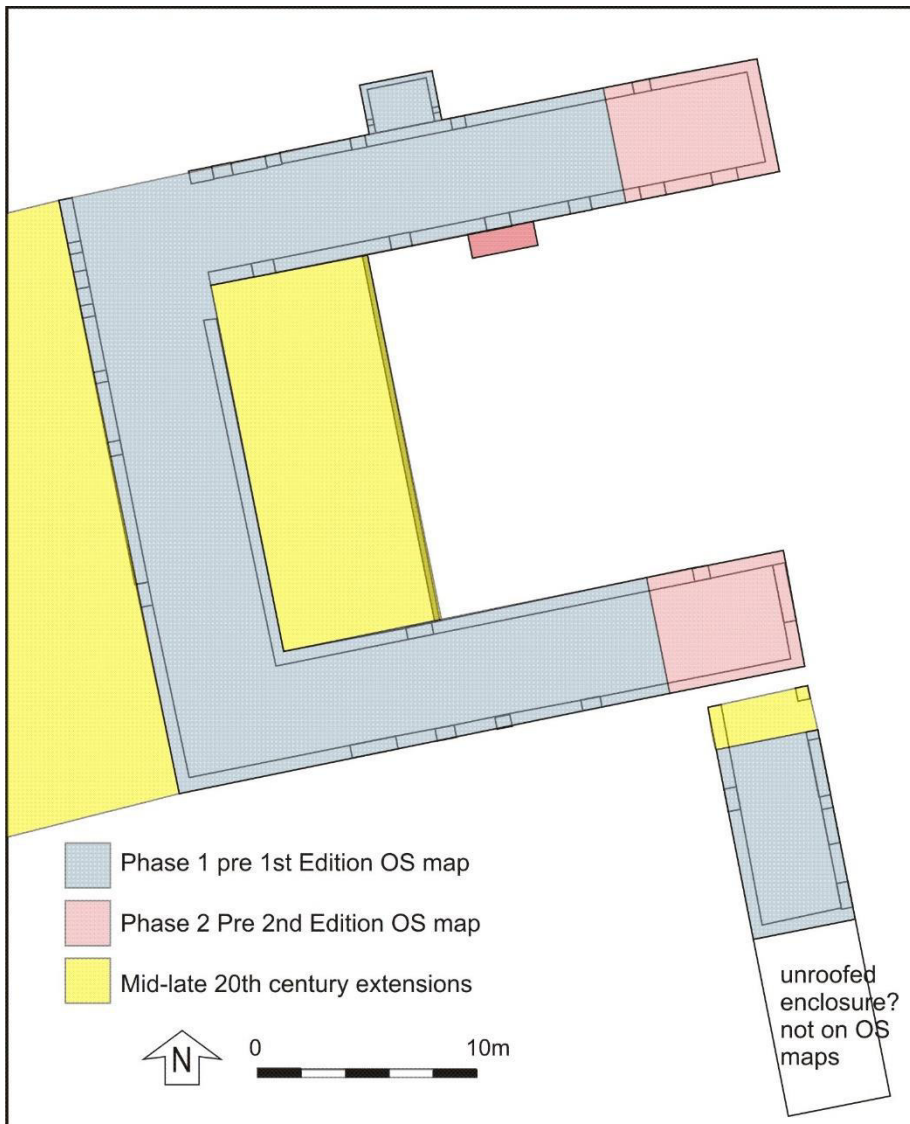
Illus 16 Phase plan showing main phases of development

A Level 1 standing building survey was carried out on 12 November 2015. The original C-shaped steading and separate bothy to the SE pre-date the First Edition OS map and there have been extensions to the stone building prior to the Second Edition as well as further additions, some of which have since been demolished, in the 20th century.
