**Potarch Hotel, Potarch, Banchory,  
Aberdeenshire AB31 4BD  
Report on Level 1 Standing Building Survey**

**Alison Cameron  
Cameron Archaeology  
19 November 2015**

A Level 1 standing building survey was carried out on 10 November 2015. At least 4 phases of development of the Inn have been recorded including the Phase 1 Inn constructed prior to 1822, a Phase 2 two-storey extension constructed around 1897 and further extensions in the 20<sup>th</sup> century. It is recommended that no further archaeological work is required during the current planning application.

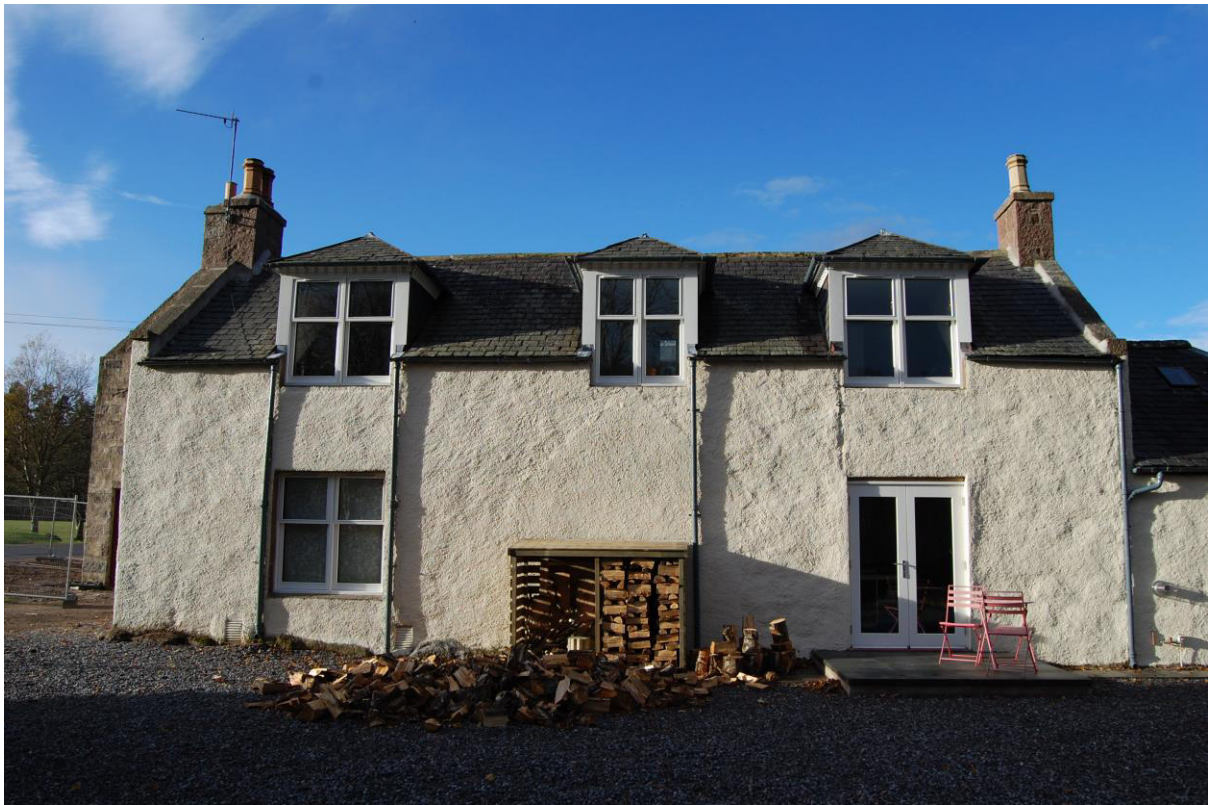
Illus 4 Phase 1 cottage, E wing of steading

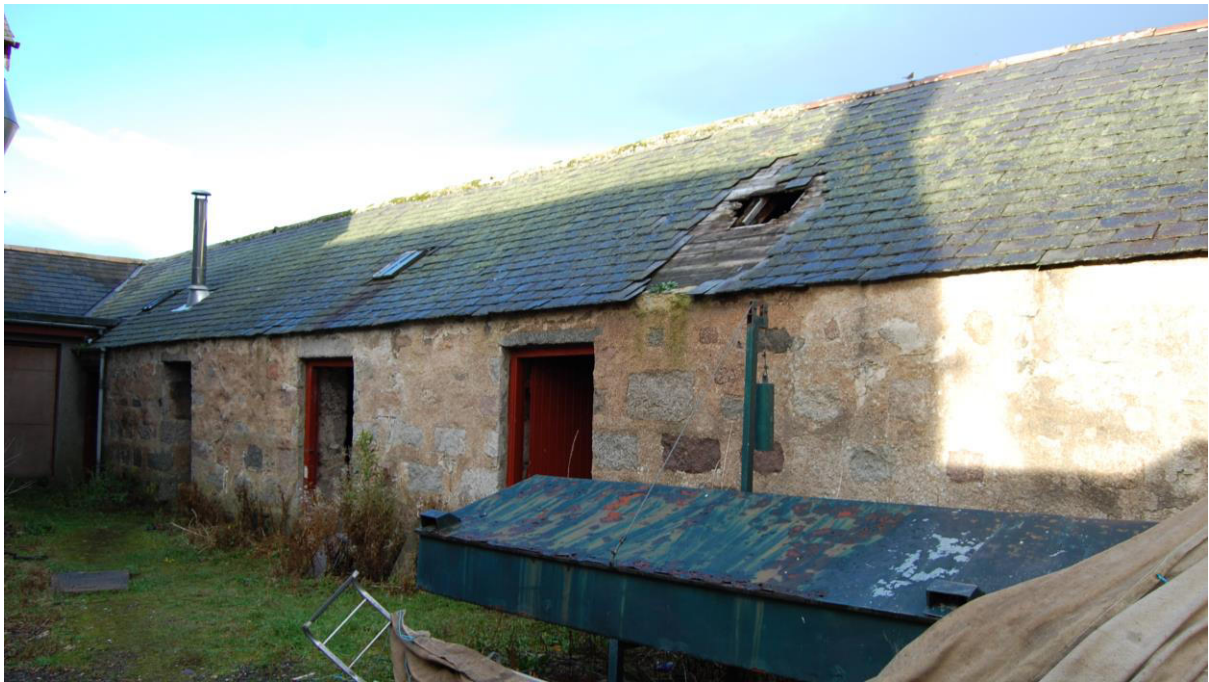
Illus 5 S wall of Phase 1 steading with doors D1-D4; facing NW

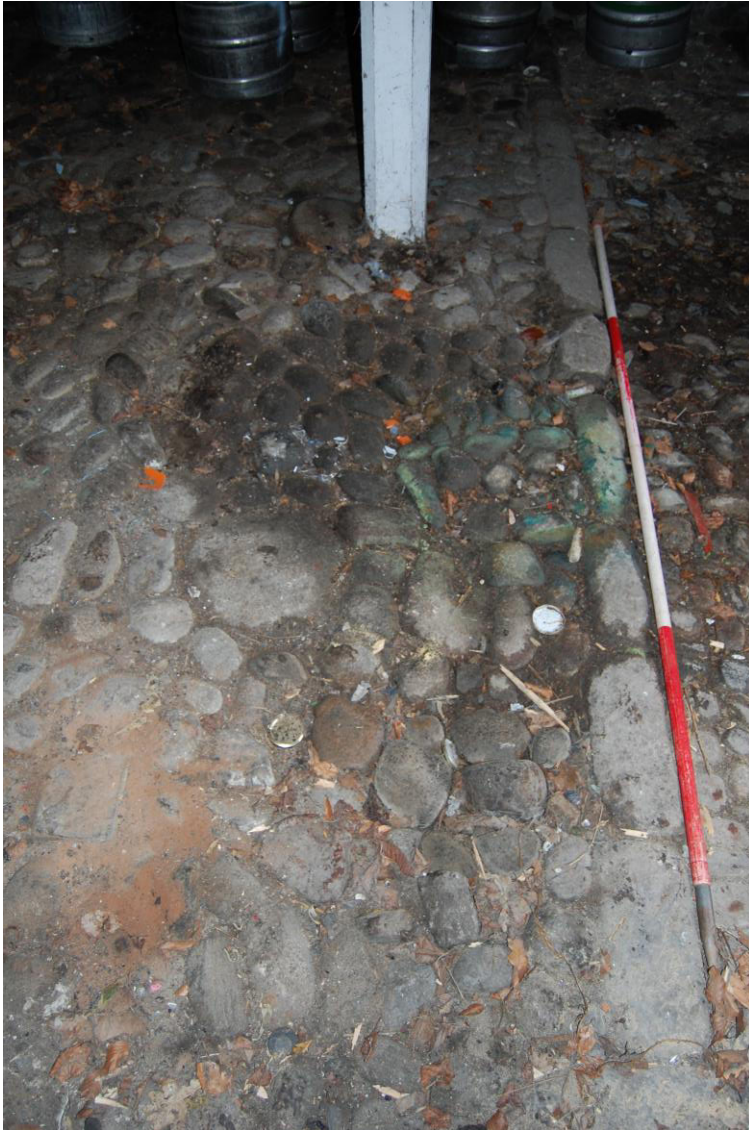
The C-shaped steading has a converted cottage forming the E wing and well preserved agricultural buildings and accommodation for animals (Rooms 4-6). Room 4 was a boiler room and the floor is concrete as is the floor of Room 6. Room 5 has original cobbled floors on several levels. The E end of the room is divided into cobbled area F3, 2cm lower than the NE corner of the room, F4 (Illus 6). There is a stone post-pad (F8), the base for a roof support and an octagonal wooden post (F9) adjacent. The W side of the room has a raised stone and concrete platform 0.6m wide and 0.15m high along the N wall, cobbled surface F5, 2cm above cobbles F10 and in the SW corner an area of raised cobbles, F7 (Illus 7) 2.2 x 0.95m in size, probably the base for a piece of equipment.

Illus 6 Room 5 Cobbled floor F4; facing E

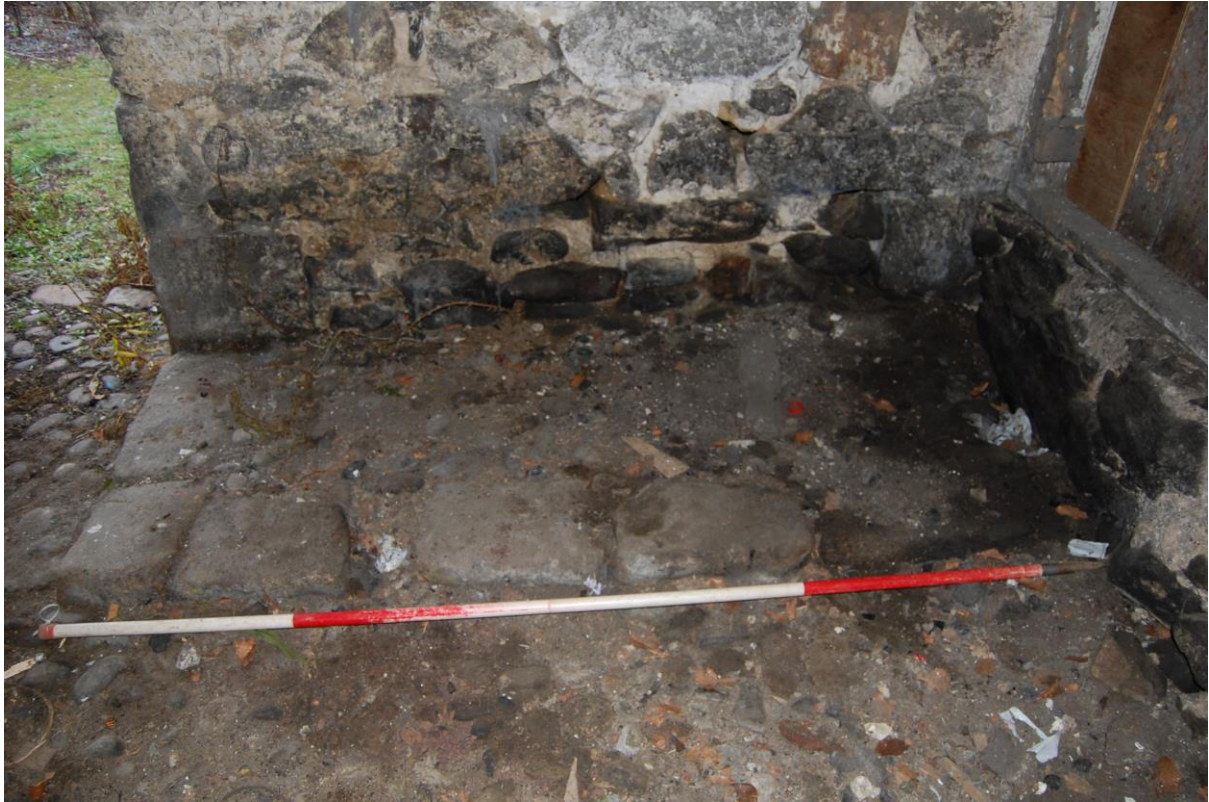
Illus 7 Cobbled base F7, facing S

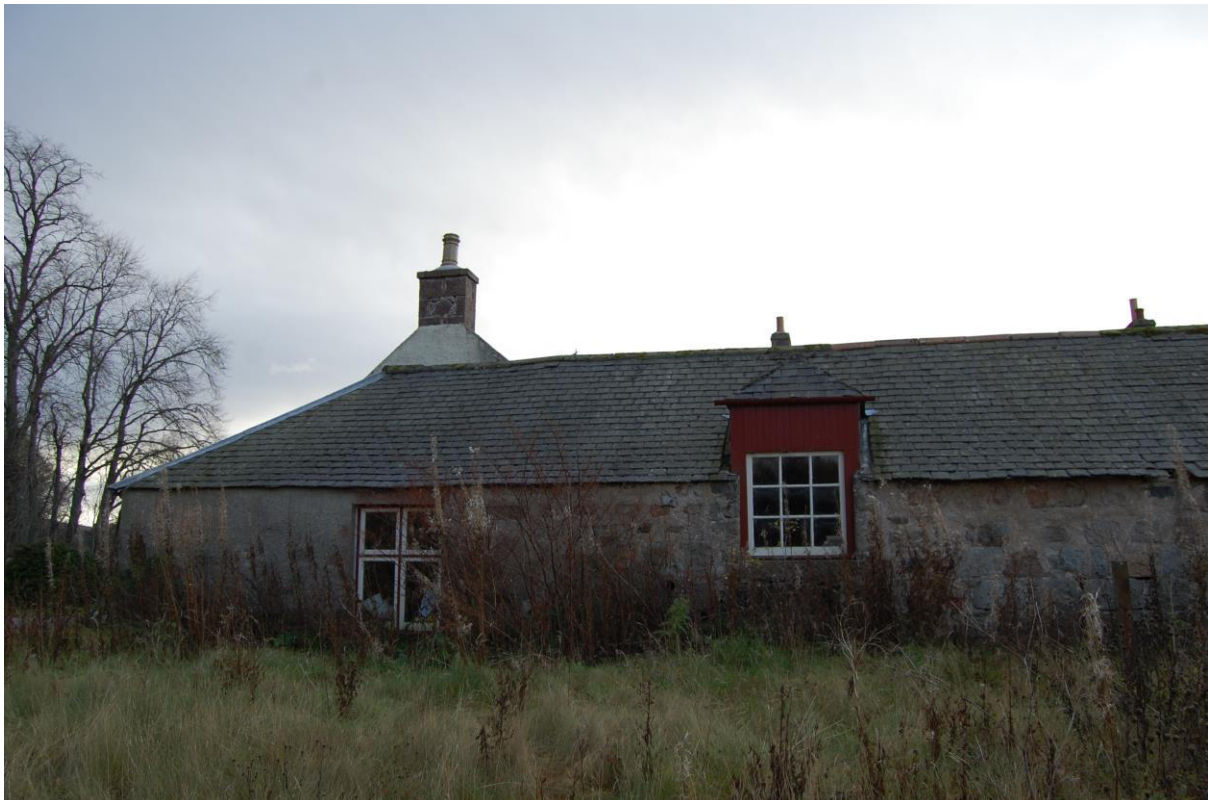
The W wing of the C-shaped steading was partially removed in Phase 2 to allow the extension of the Inn. On the 1<sup>st</sup> Edition OS map there is a horse mill attached to the N wall of Room 6 and this has been removed by the date of the 3<sup>rd</sup> Edition OS map. There are blocked apertures F2 and F1 in the N wall of Room 5 and these may be associated with the former horse mill. These features have been heavily remortared and are not visible on the exterior (Illus 8).

Illus 8 N wall Rooms 5 and 6; there is no evidence of the former horse mill on this wall; facing S

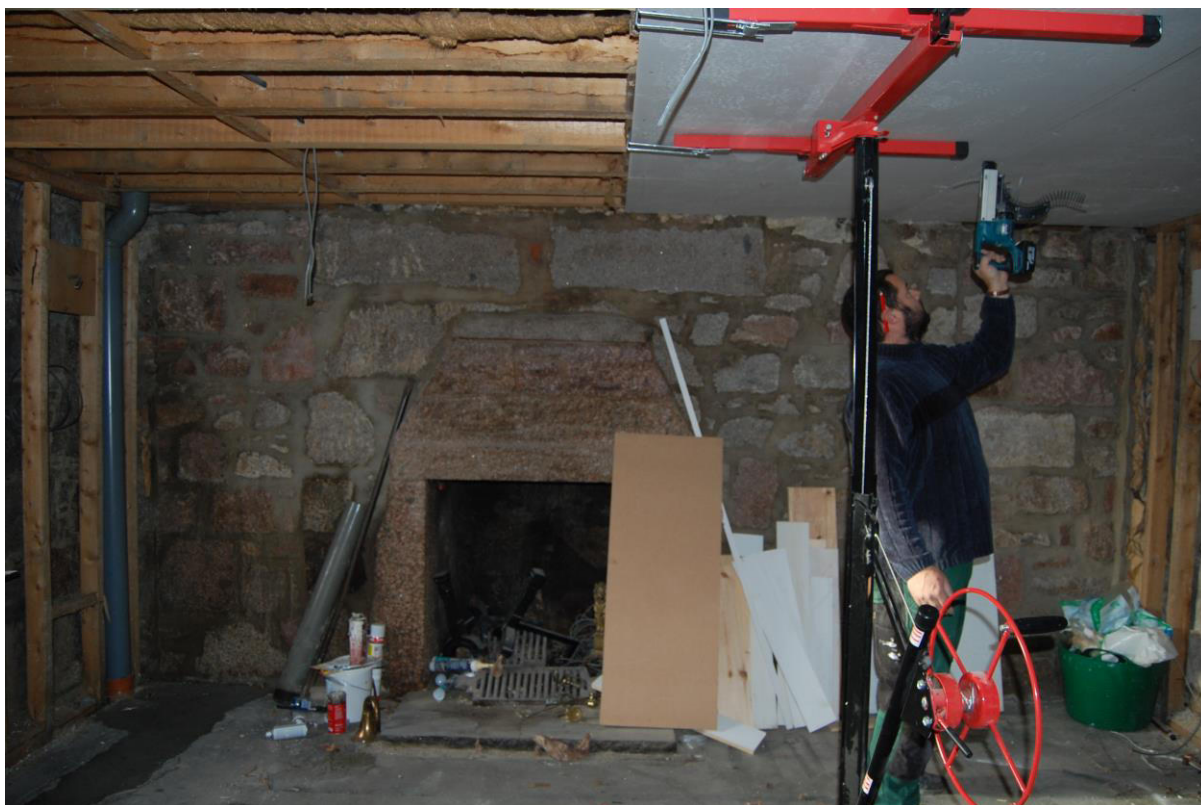
Illus 9 Room 1 W wall with fireplace; facing W

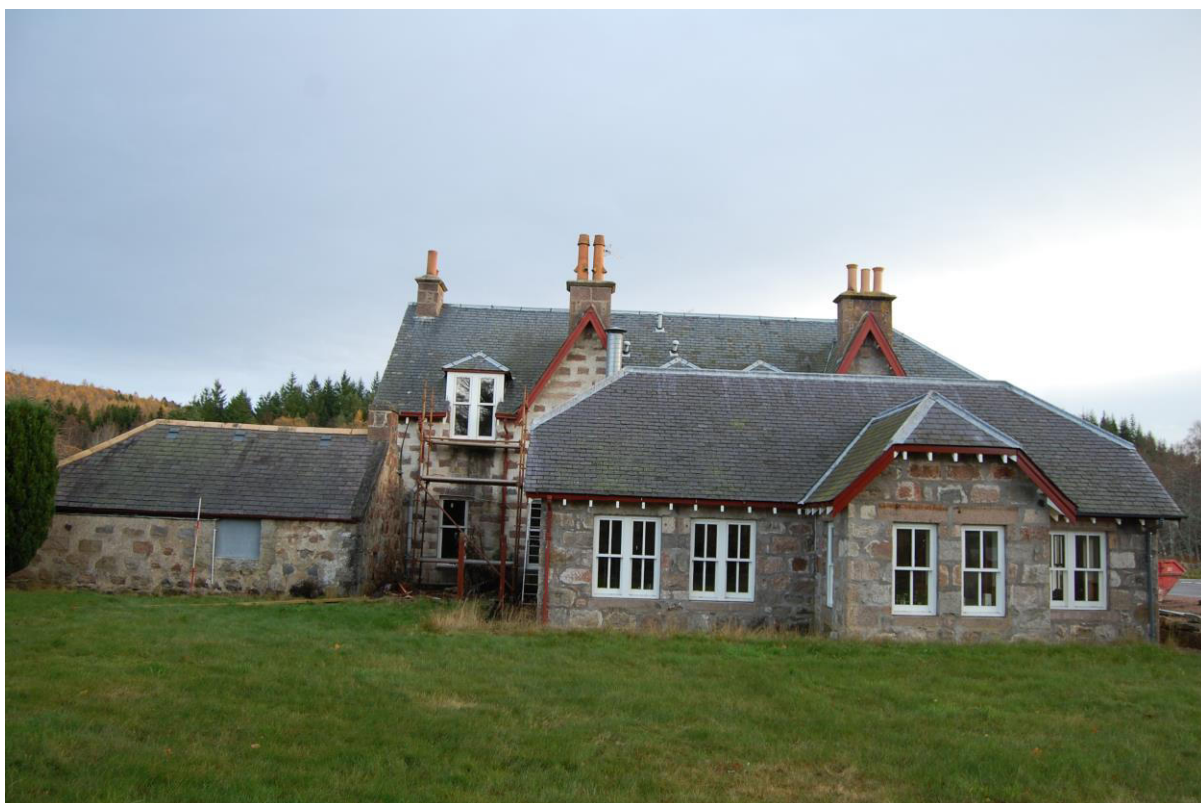
Illus 10 West façade showing Phase 1 steading (left) Phase 2 two-storey extension (middle) and 1990s extension (right)

In Phase 2 a two-storey extension was added to the N of the Inn (Room 7), a kitchen and extra bedrooms above (Illus 10). These are constructed of large granite blocks. A small extension (8.61m wide and 2m deep) on to the main south façade of the Inn including D11. It was constructed of large red granite blocks (see cover) with cherry cocking and added a vestibule on to the front of the Inn with decorative stained glass (Illus 11) with a tiled floor (Illus 12). The extension included a kitchen on the ground floor (Room 7, Illus 13-14).

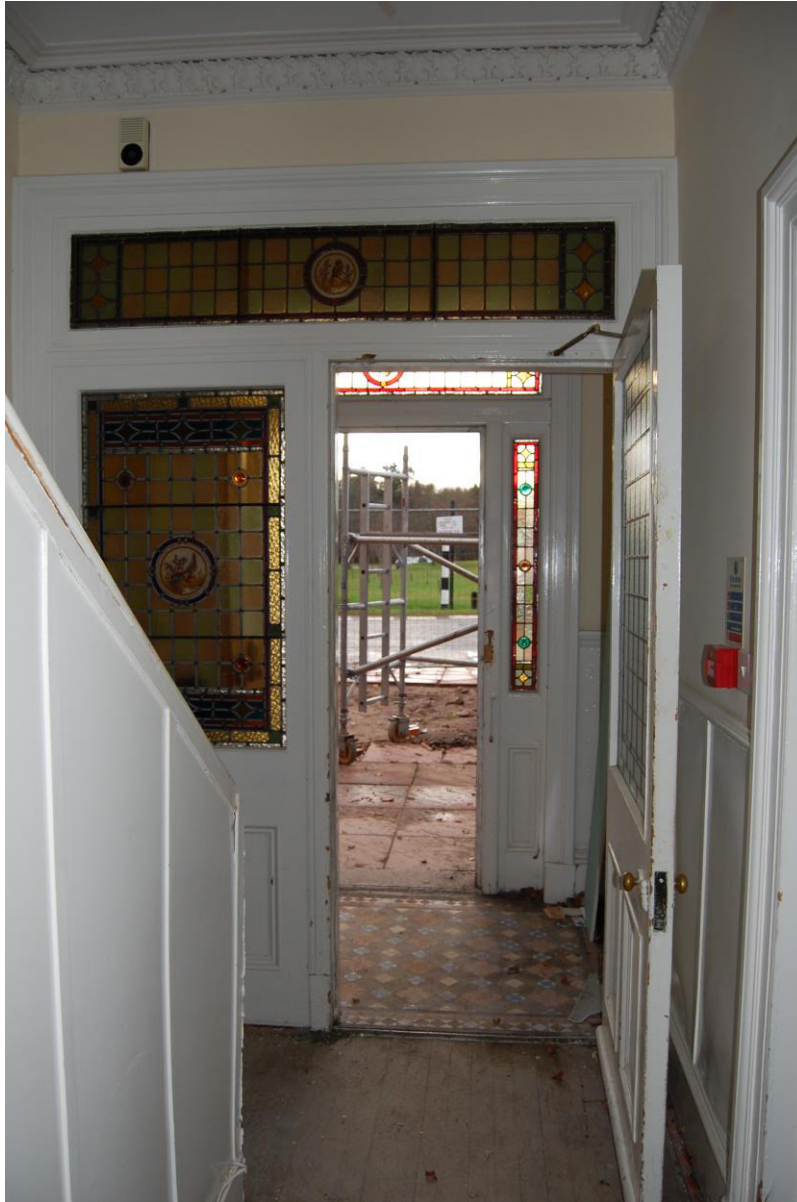
Illus 11 Phase 2 extension on front S façade with associated stained glass around door D11; facing S

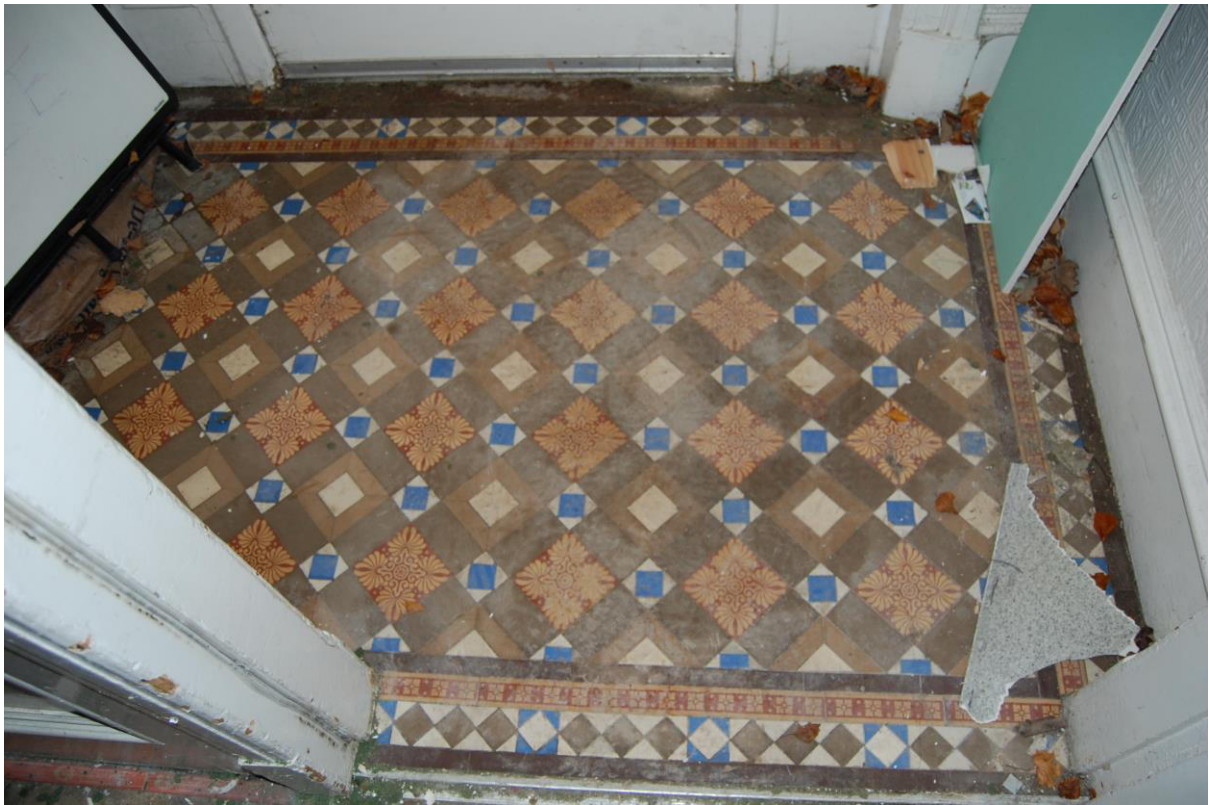
Illus 12 Phase 2 extension on front S façade with tiled entranceway; facing S

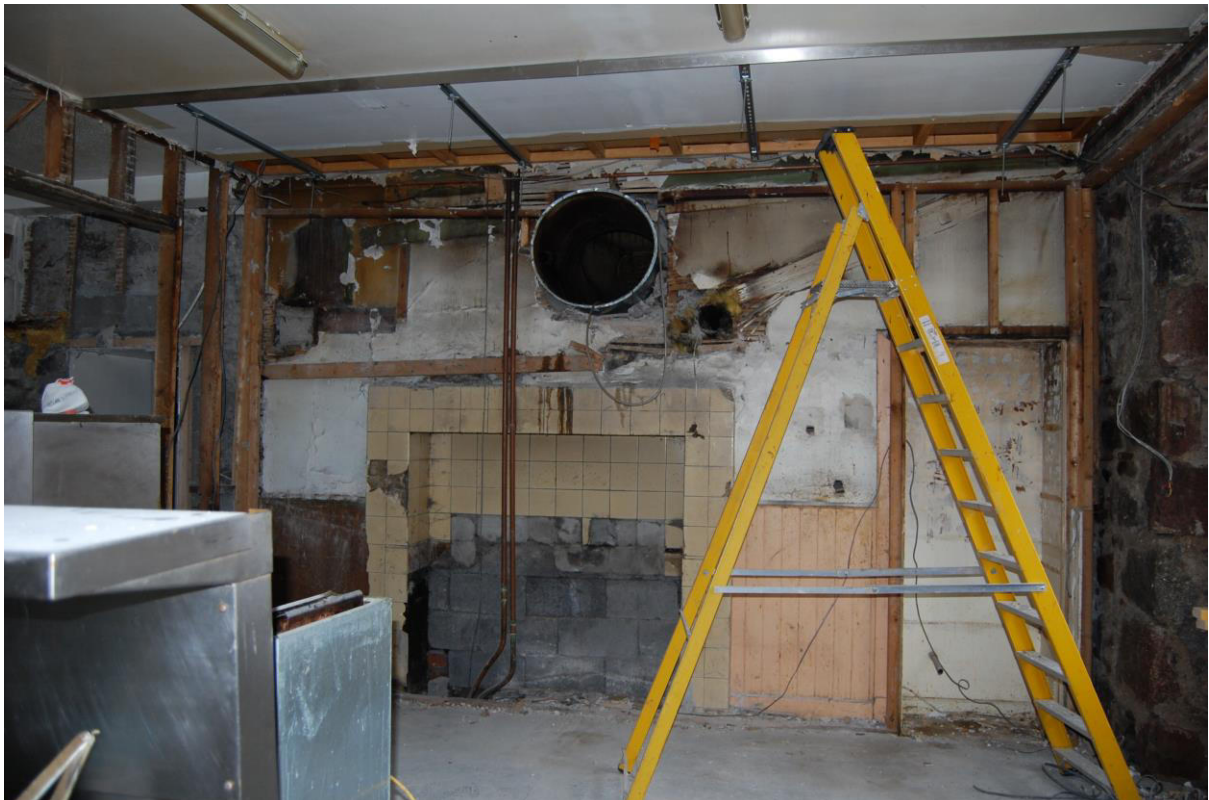
Illus 13 Phase 2 extension Room 7 kitchen; facing NNW

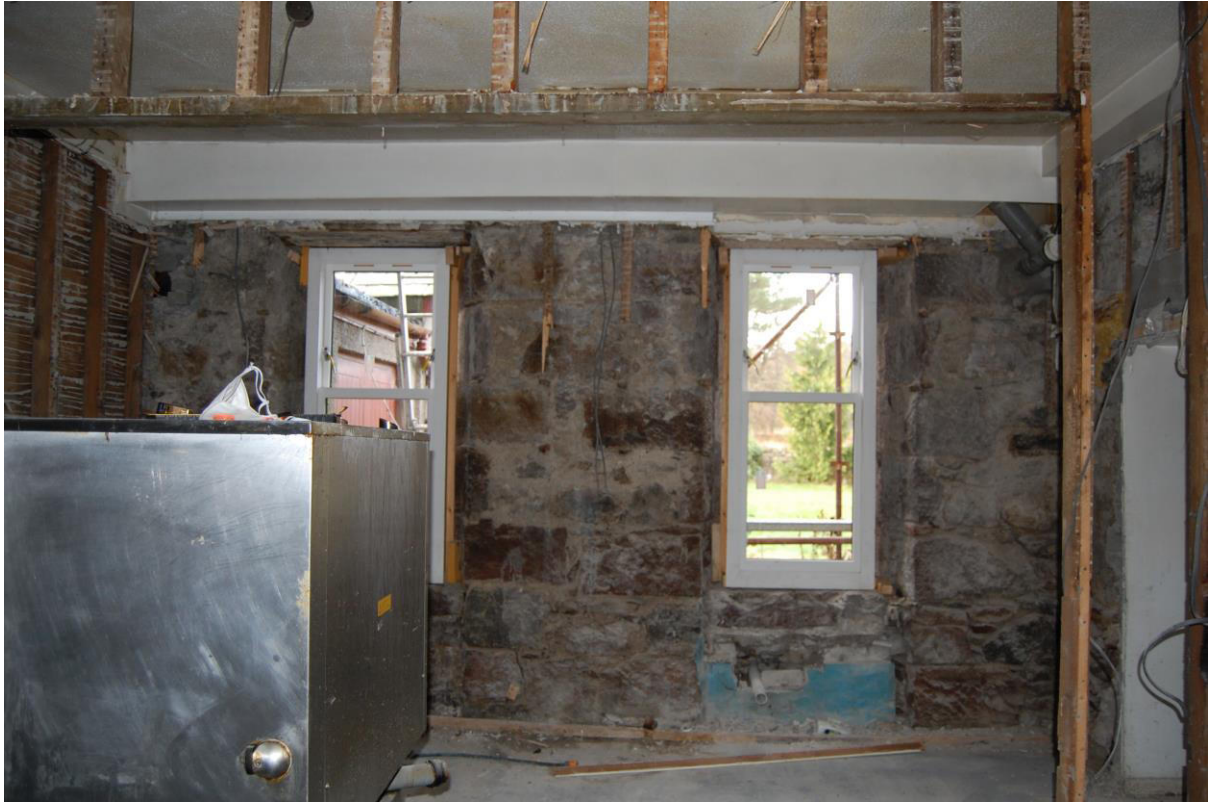
Illus 14 Phase 2 extension Room 7 kitchen W wall with windows W31 (left) and W3 (right); facing W

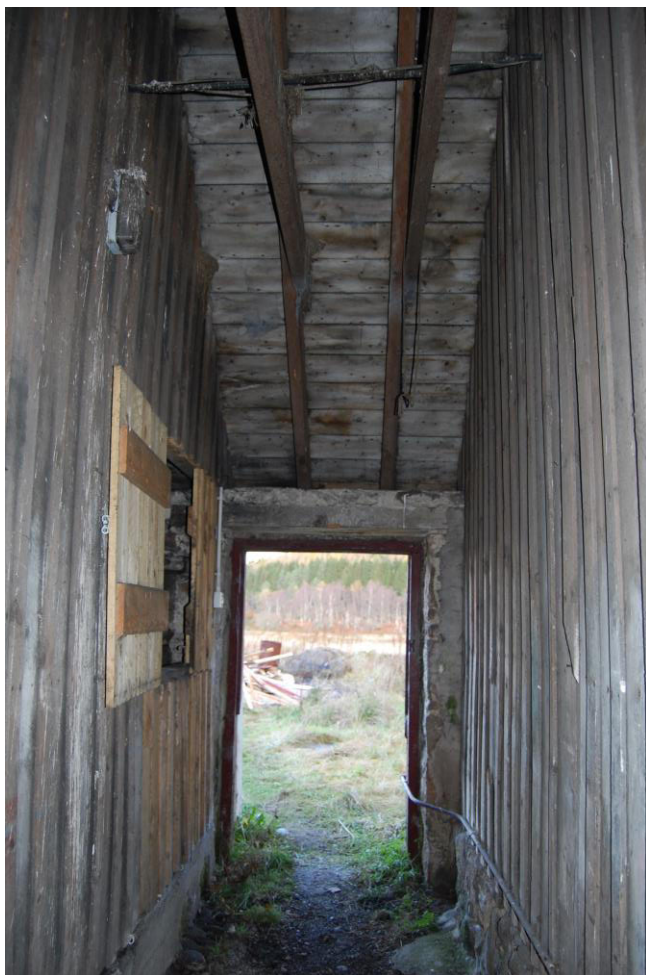
Further extensions were added in the 20<sup>th</sup> century including a single storey bathroom extension on the N side of the Inn and a large dining room extension on the W side of the hotel built in the 1990s. A wooden access between Rooms 4 and 5 was probably created in the 20<sup>th</sup> century to access the courtyard from the river and the N of the complex.

Illus 15 Wood paneled corridor between Room 4 (left) and Room 5 (right); facing N
