**Land at Mill Of Kelly, Tarves, Aberdeenshire, AB41 7EN
Report on Level 1 Standing Building Survey**

**Alison Cameron
Cameron Archaeology
25 February 2016**

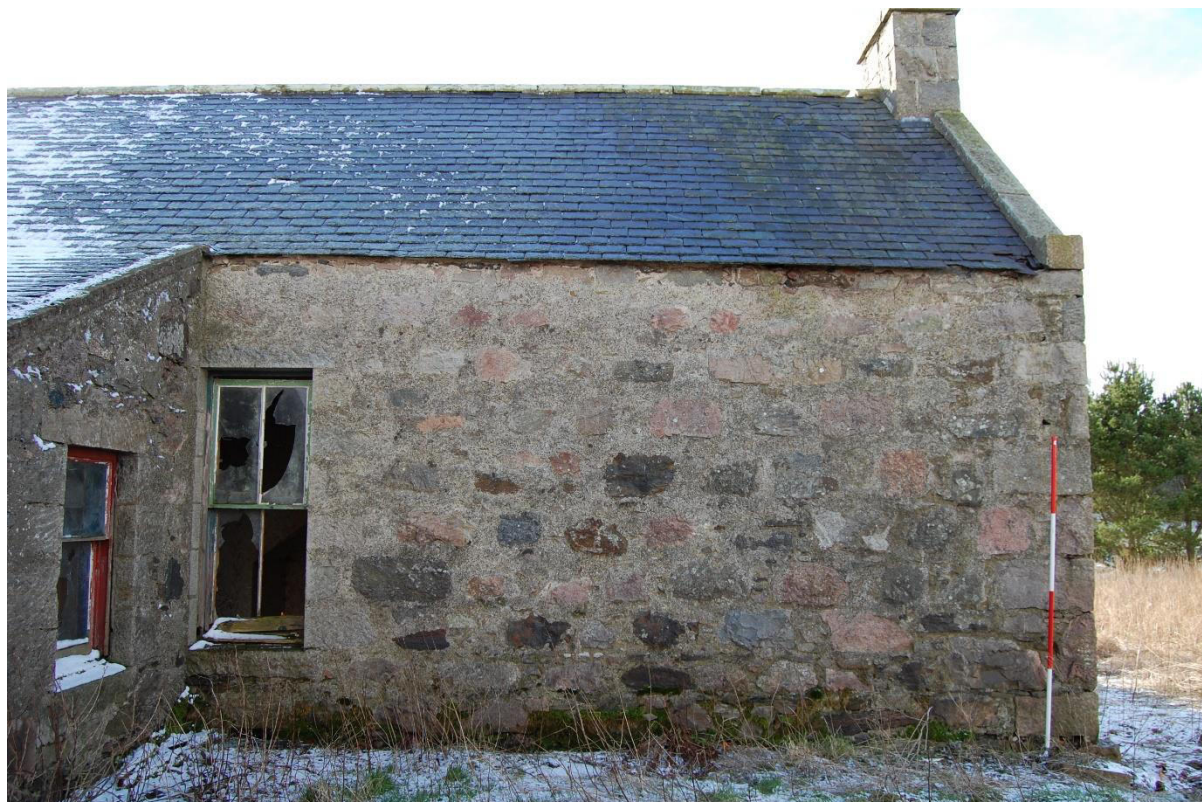
Building 1, the farmhouse is a two storey pink and grey granite rubble cottage 12.55m long and 5.7m wide with slate roof. There is a Phase 2 lean-to granite rubble extension on the N wall (Room 5) 4.1m long and 2.3m wide which covers the jamb of the Phase 1 window W6 (Illus 2). The lintels and sills are all granite. The main south façade faces the walled garden and has a central door (D1) and ground and first floor windows (cover photo). There was access to the ground floor E rooms only. There are chimneys on both gables (F1 and F2) and there a fireplace and range on the E wall of Room 6 (F16) as well as an alcove cupboard (F17). The floor of this room is concrete.

Illus 2 Building 1 Phase 2 lean-to extension (left) covering jamb of Phase 1 window W6; facing S

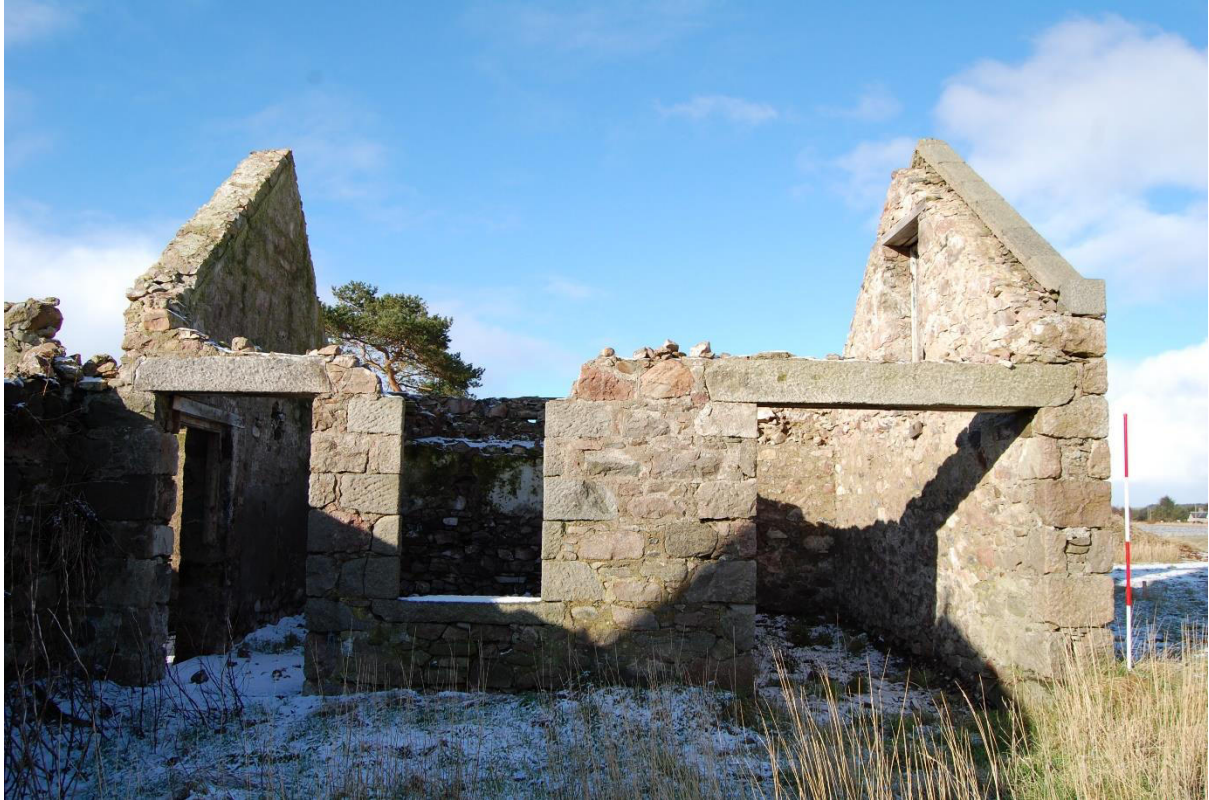
Building 2 is a two-storey stone blocks and rubble T-shaped steading. There is pink and grey granite, quartz and sandstone with granite lintels and sills. It consists of four rooms; the N arm consists of two small rooms, Room 1 with a cart door on the E wall (D8; Illus 7). Room 1 floor has been removed. There is a first floor door in the N gable (D4) and wood and iron bolts survive on the exterior under this door, possibly the remains of a wooden stair. Room 2 has a window and small door and was probably a bothy; it has a waterwashed cobbled floor (Illus 8). There are ventilation holes in the W wall (F10 and F11) consisting of a large block of granite with a rectangular notch cut out and a stone placed on top to create a small aperture. It is possible that these were the lintels of small first floor windows which were removed during re-roofing and capped with a large stone to create a ventilation aperture. Room 3 has a large cart door on the S gable (Illus 11) and apertures in the W wall (F12, F13 and F14; Illus 9, 10) associated with the horse mill which was attached to the exterior W wall on the 2nd Edition OS map (Illus 20). On the exterior of the west wall is a low mound c6m diameter and 0.3m high. It is presumably the demolition material and possibly the foundation for the horse mill which has been removed by 1926, the date of the 3rd Edition OS map.

Illus 7 Rooms 1 and 2 E wall D7, W7, D8; facing W

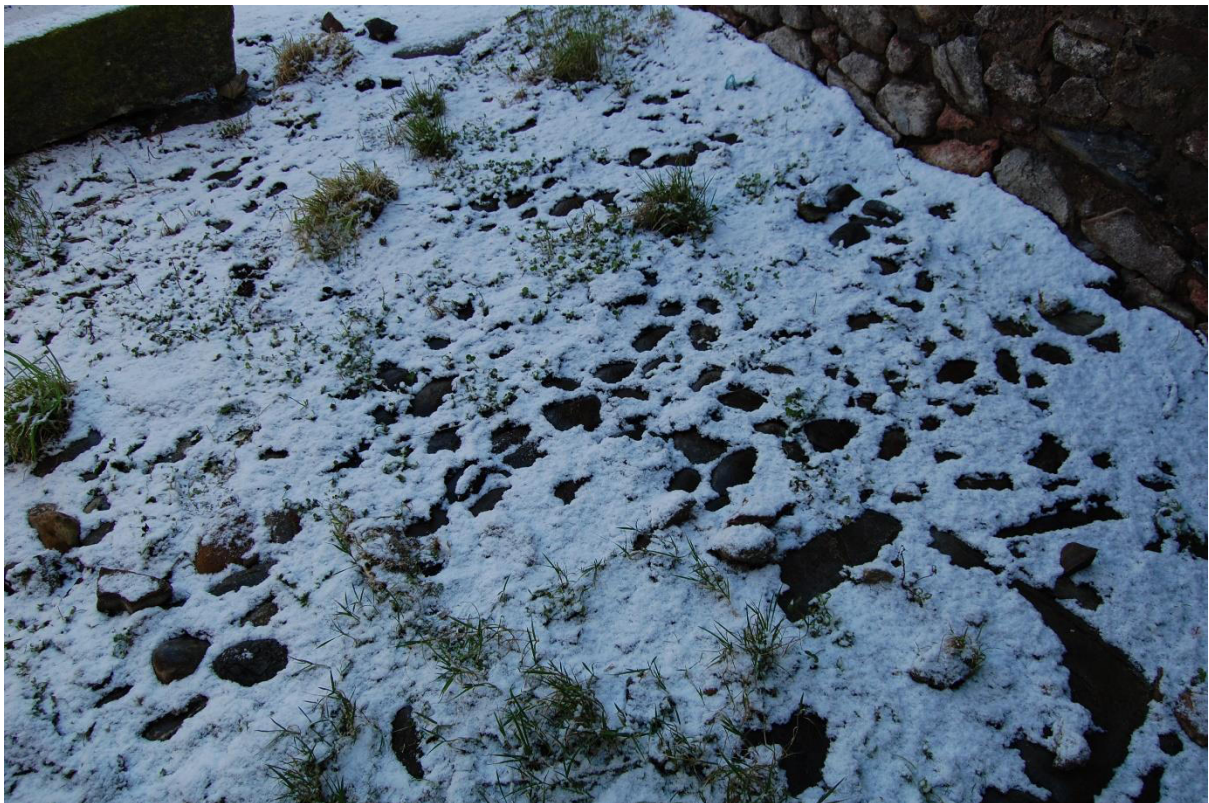
Illus 8 Room 2 cobbled floor F21; facing SE

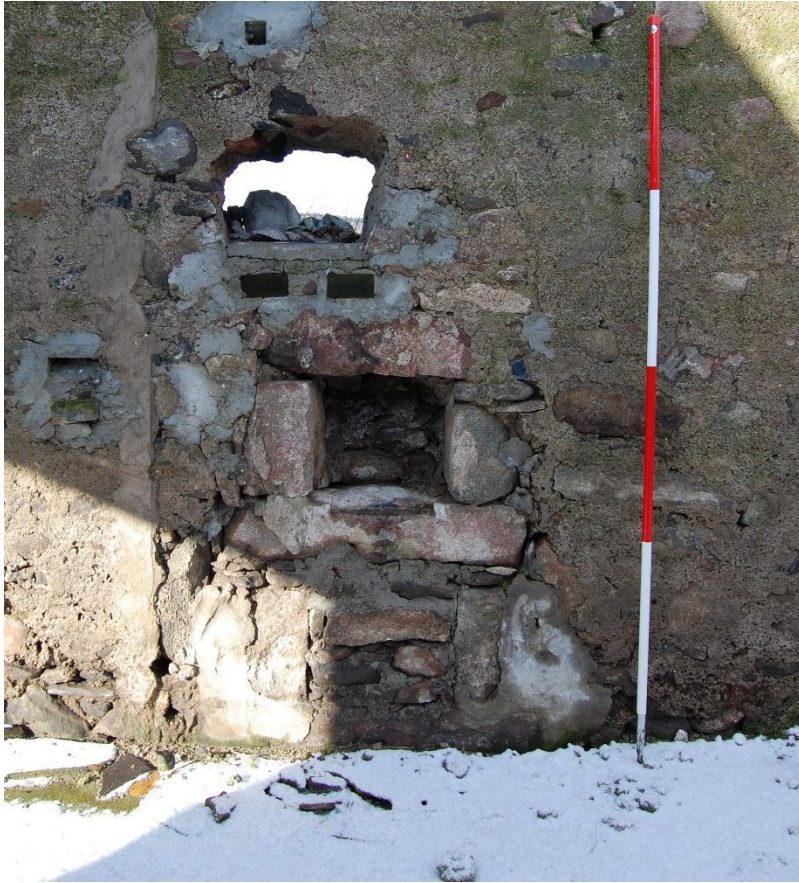
Illus 9 Room 3 interior apertures F13 top and F14 below; facing W

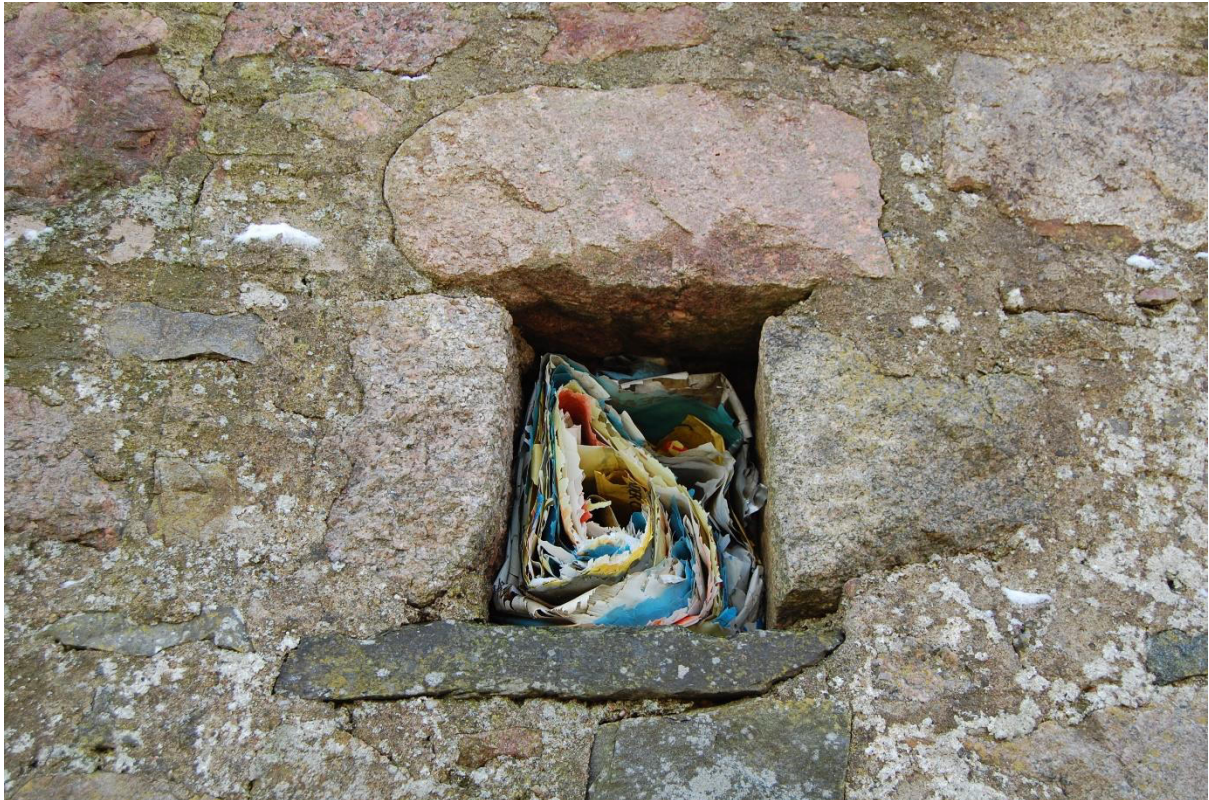
Illus 10 Room 3 exterior aperture F12; facing E

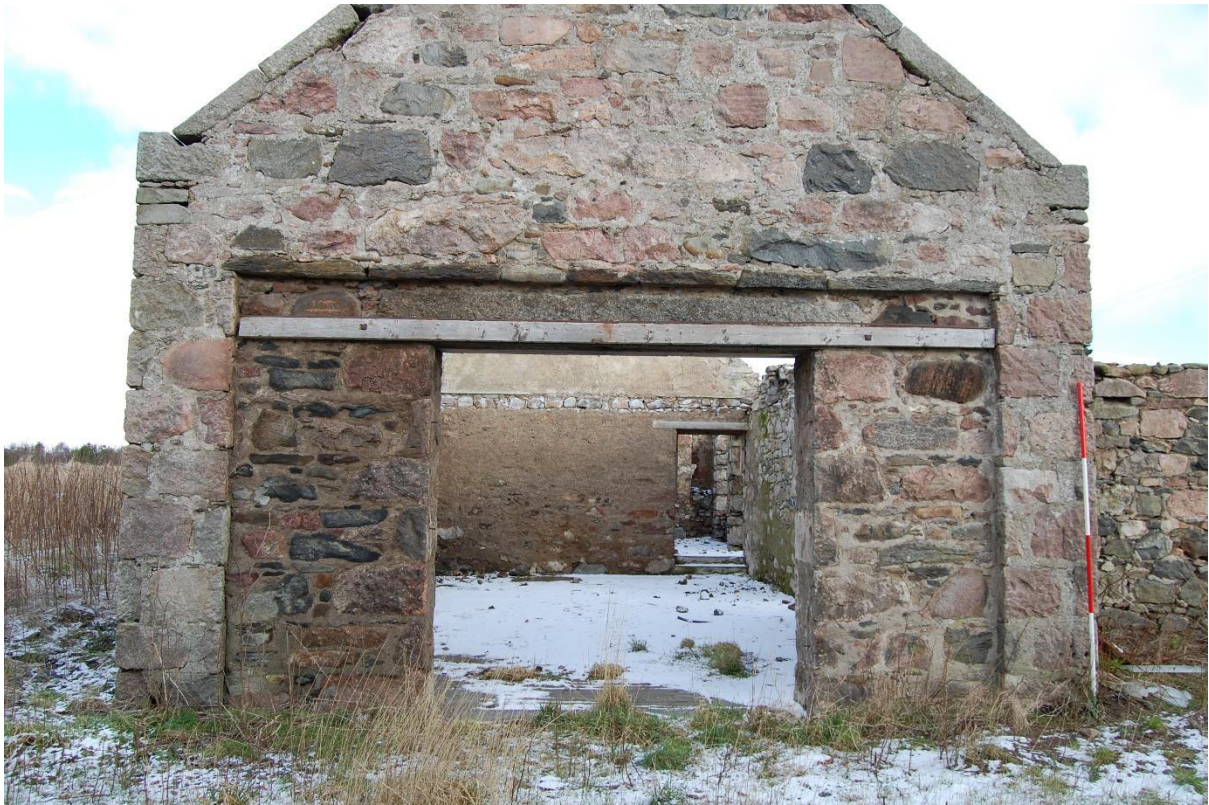
Illus 11 Room 3 S gable cart door D5; facing N

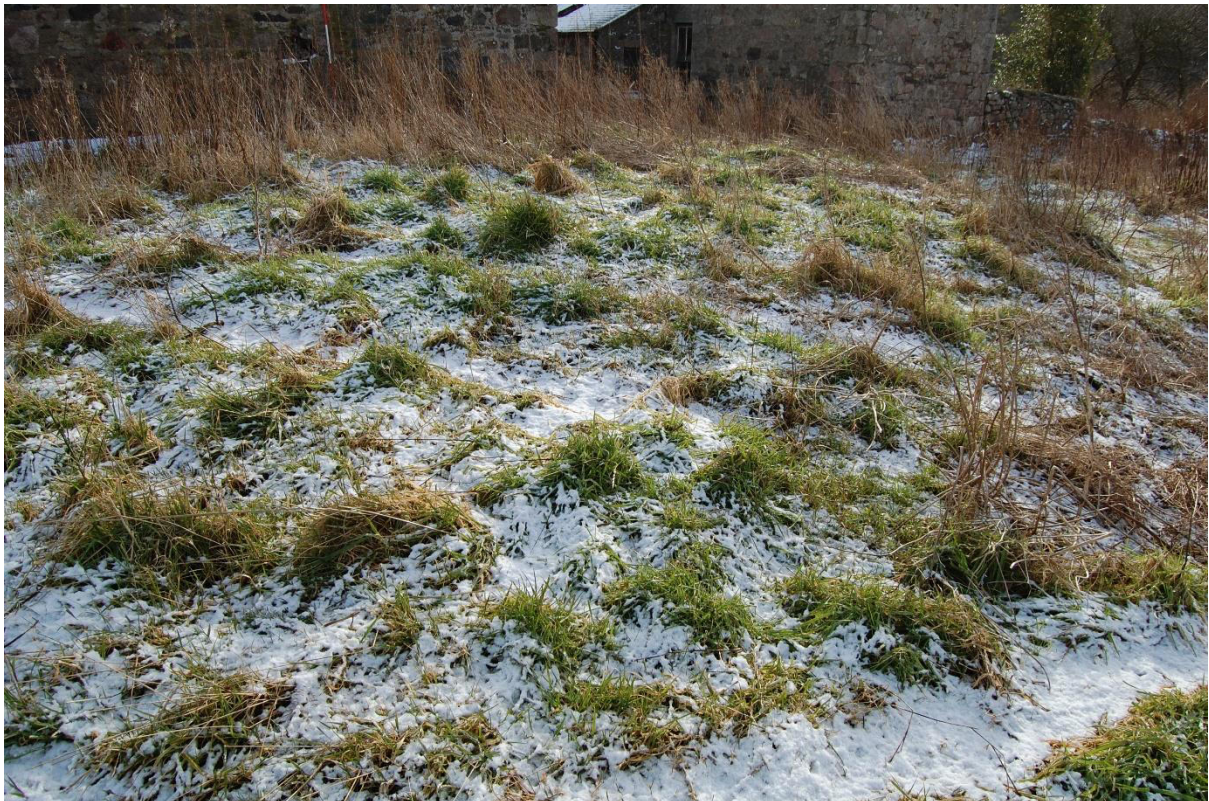
Illus 12 Circular mound on W side Room 3, foundation for, or rubble from horse mill; facing E

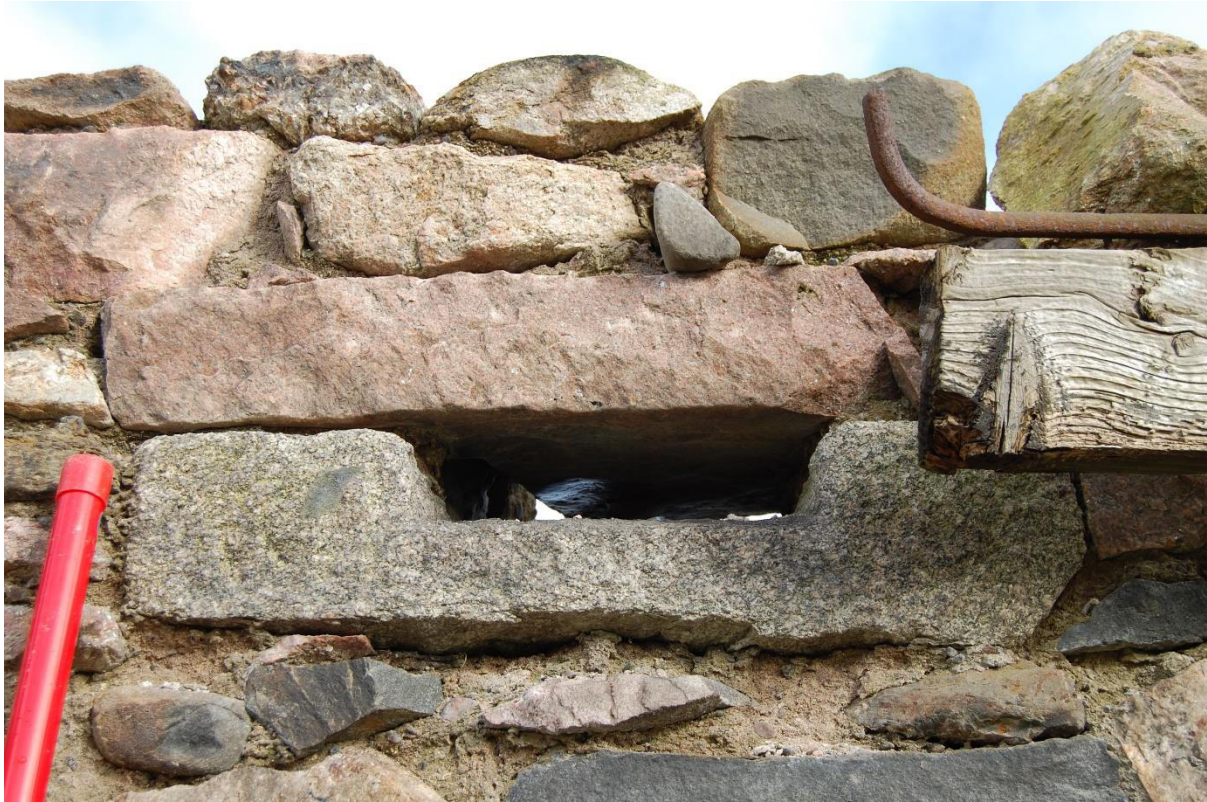
Room 4 is attached to the E wall of Room 3 and there is a connecting door D12. Room 4 has a waterwashed cobbled floor which has been removed between Doors D12 and D3 where a service has been laid underneath a concrete path. The N and S walls have ventilation holes in the upper walls (F3-F5 in N wall and F6-F8 S wall) identical to F10 and F11 (above; Illus 13).

Illus 13 Room 4 S wall ventilation aperture F7, possibly a small first floor window lintel reused after re-roofing; facing N

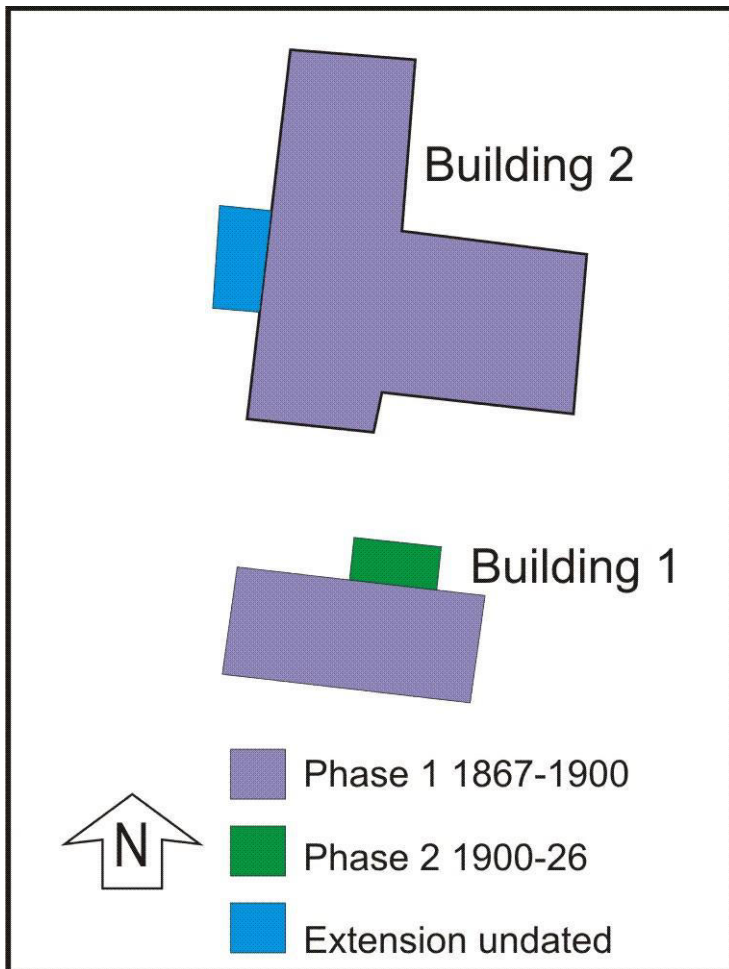
Illus 14 Phase plan

The buildings were primarily built in one phase with minor additions (Illus 14). 'Kelly' and 'Mill of Kelly' appears on the pre OS maps (Illus 15-17) and it is possible that the C-shaped structure on the 1st Edition OS (Illus 19) is much earlier but it was completely demolished before the 2nd Edition map (Illus 20) when this complex was constructed. The mixture of stone used for these building may have come from the demolition material from earlier buildings occupying the site.

It is recommended that no further archaeological work is required during the current application.
