**Balnabreich Farm Steading, Careston, Brechin, Angus,
DD9 6RT
Report on Level 1 Standing Building Survey**

**Alison Cameron
Cameron Archaeology
18 March 2016**

SUMMARY

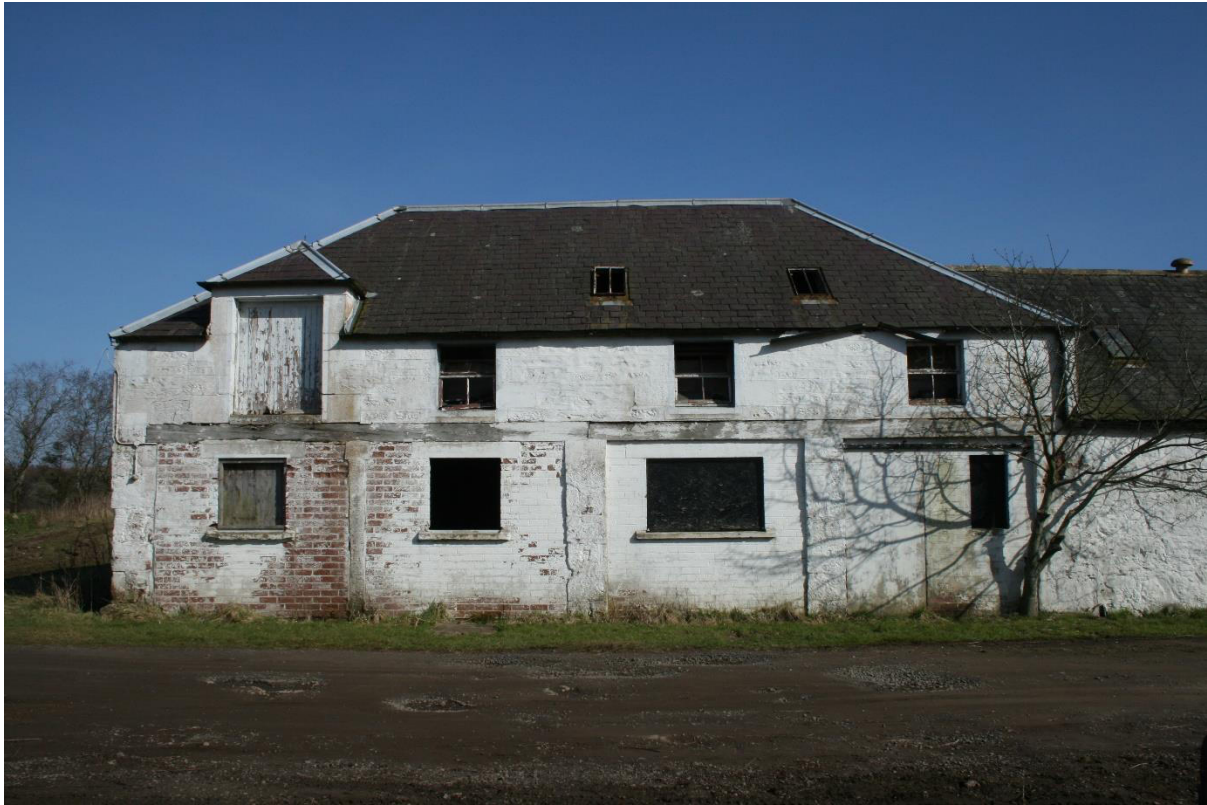
Illus 6 Building 1 W wall N end four cart doors D16-D19 infilled and with smaller apertures opened; facing E

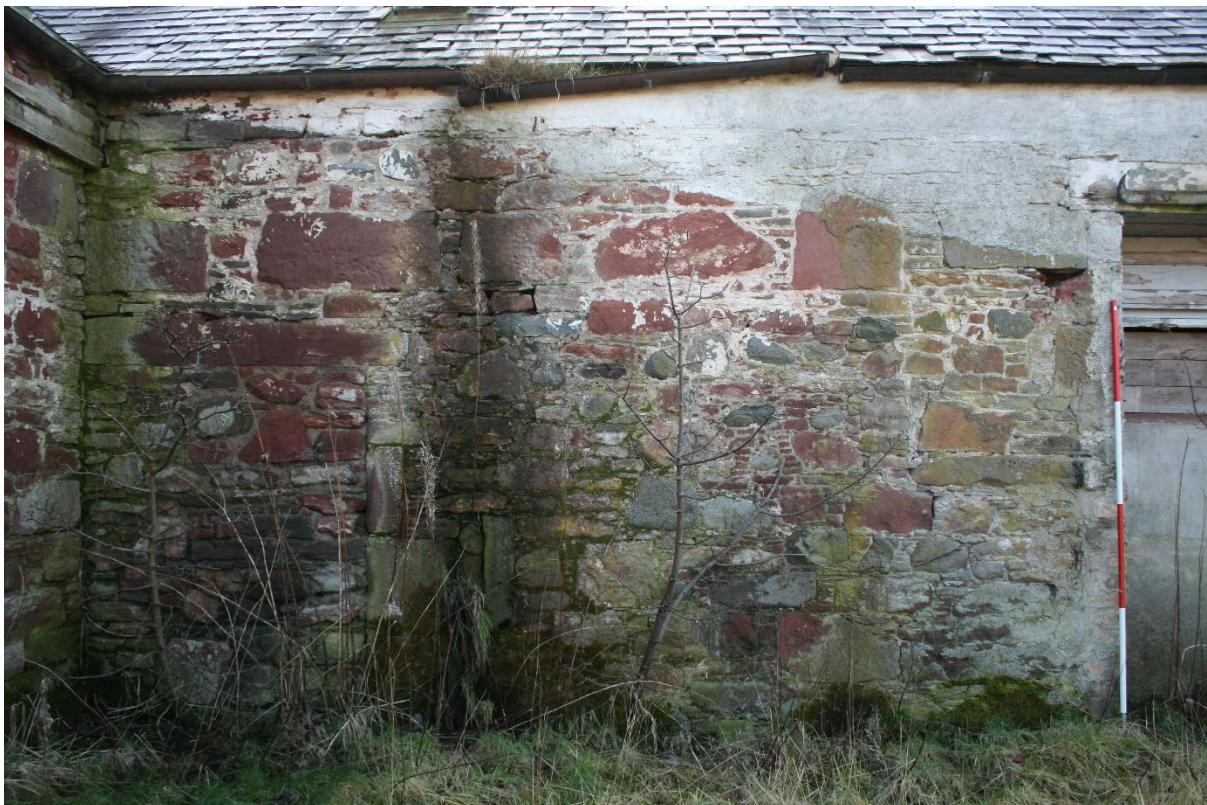
Room 7 has two large doors in the N wall (D12, D13) and two blocked doors D14 at the W end and D11 at the E end (Illus 7). There is a small stone aperture adjacent to D11 (F1). The S wall has a large door D23 which has been widened and three smaller doors D22, D24 and D25. There are a series of stone corbels on the N and S walls (Illus 8) for Phase 1 wooden beams and a series that have been utilized to support the current roof beams. The interior and much of the exterior of these rooms have been whitewashed.

Illus 7 Building 1 N wall blocked door D11 (left) and small aperture F1 (centre) with D12 (right); facing S

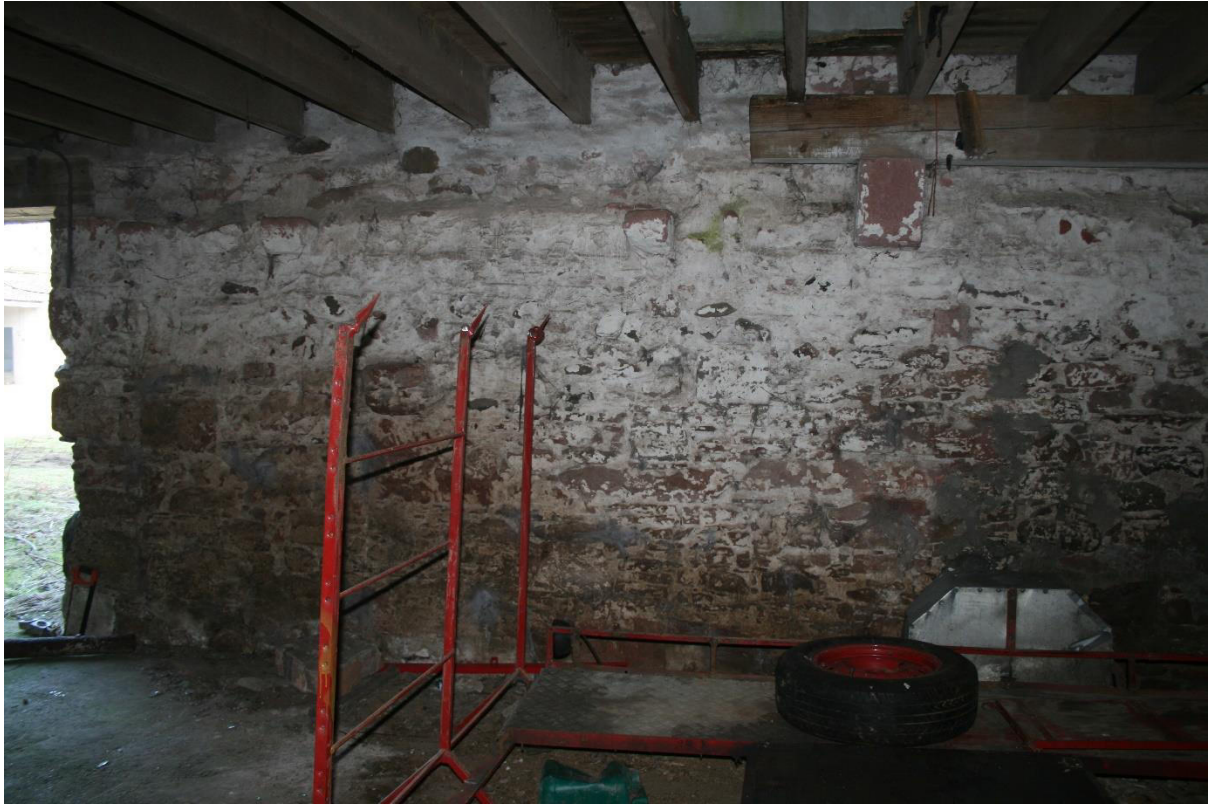
Illus 8 Building 1 Room 7 N wall showing smaller corbels (left) and larger corbel supporting current roof timbers (right)

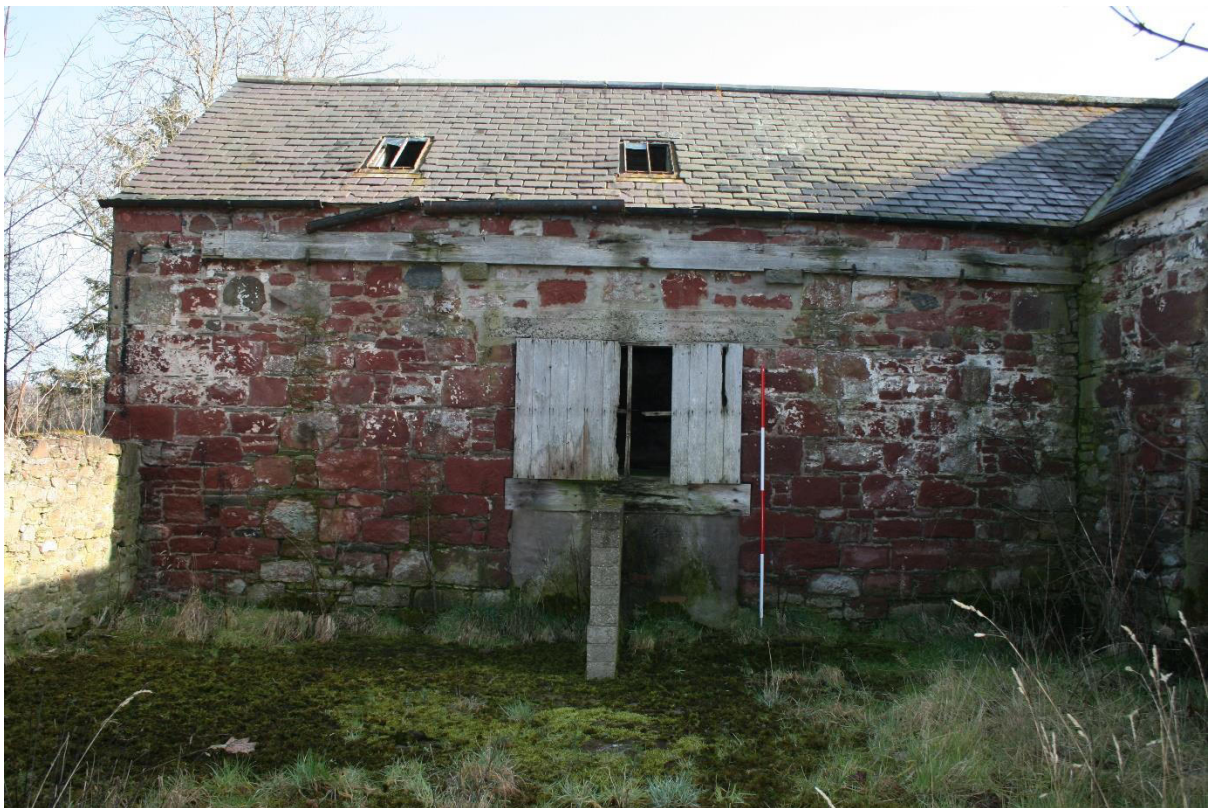
Illus 9 Building 1 Room 6 W wall with D15 (centre); facing E

In Phase 2 Room 6 is two-storey and was constructed of large red sandstone blocks with cherry cocking and grey sandstone block foundation (Illus 9). There is one door in the W wall

(D15) and a large door in the N gable (D10). There is little access to this building as the wood floors are rotten but there are internal doors connecting it to Room 5 (D37 on ground floor level and D36 on first floor level). There is a small aperture on the E wall (W1) where a small extension had been attached to this wall on the 2nd and 3rd edition OS maps which has since been demolished.

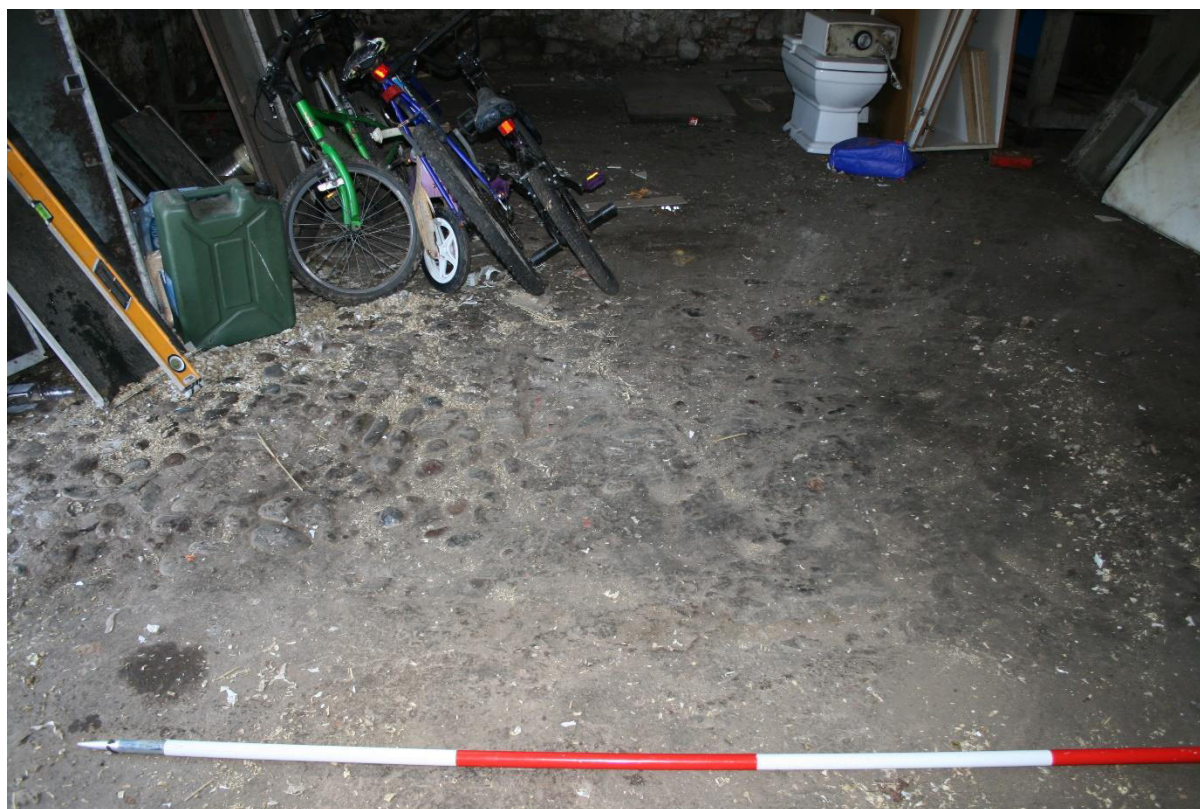
Illus 12 Cobbled floor F3, facing S

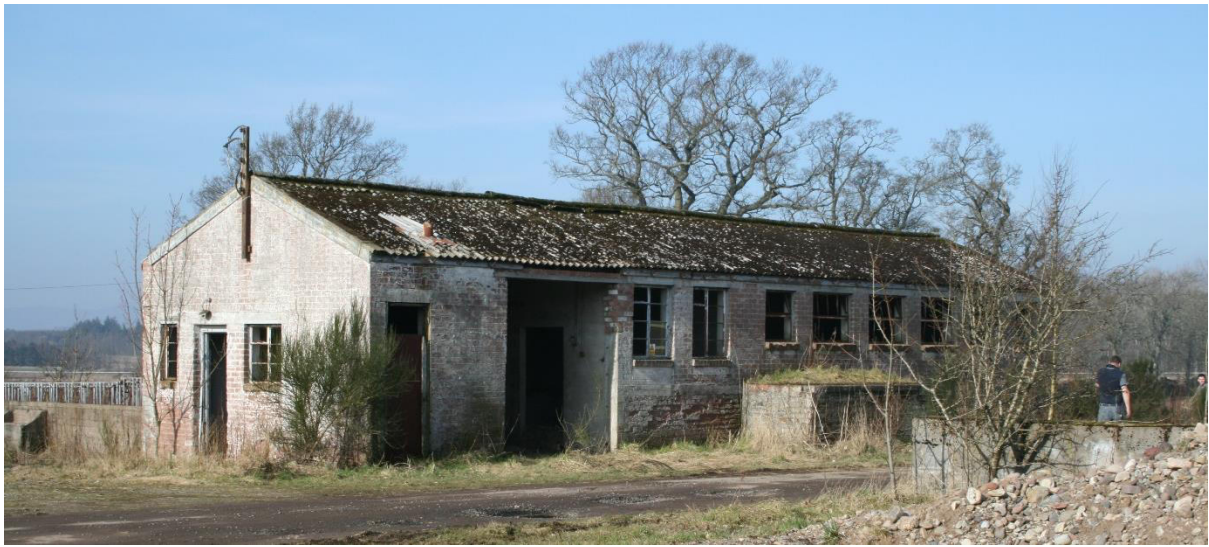
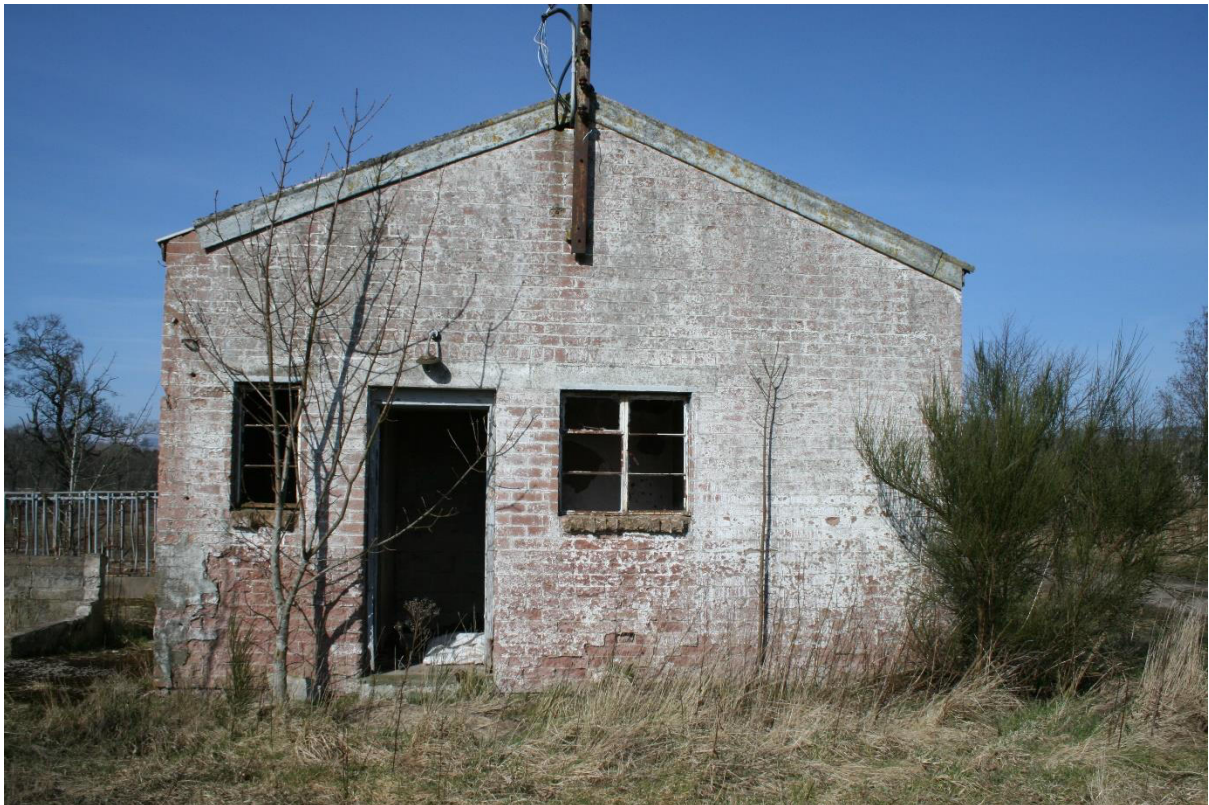
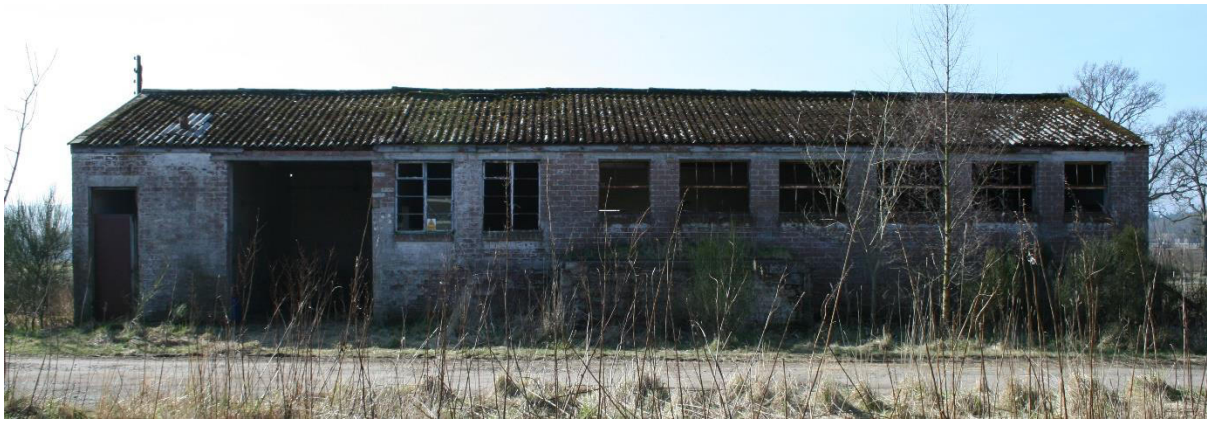
Building 3 (Illus 13-15) appears to be a WWII military building but there is no record of this and Mr Jamie Adamson, Careston Ltd was born on the estate in 1948 and has no knowledge of any military activity in the area (J Adamson pers comm). The building is not included in this proposed development. A photographic record was made of the building only.
