**Learney Arms Hotel, The Square, Torphins,
Aberdeenshire, AB31 4GP
Report on Level 1 Standing Building Survey**

**Alison Cameron
Cameron Archaeology
21 June 2016**

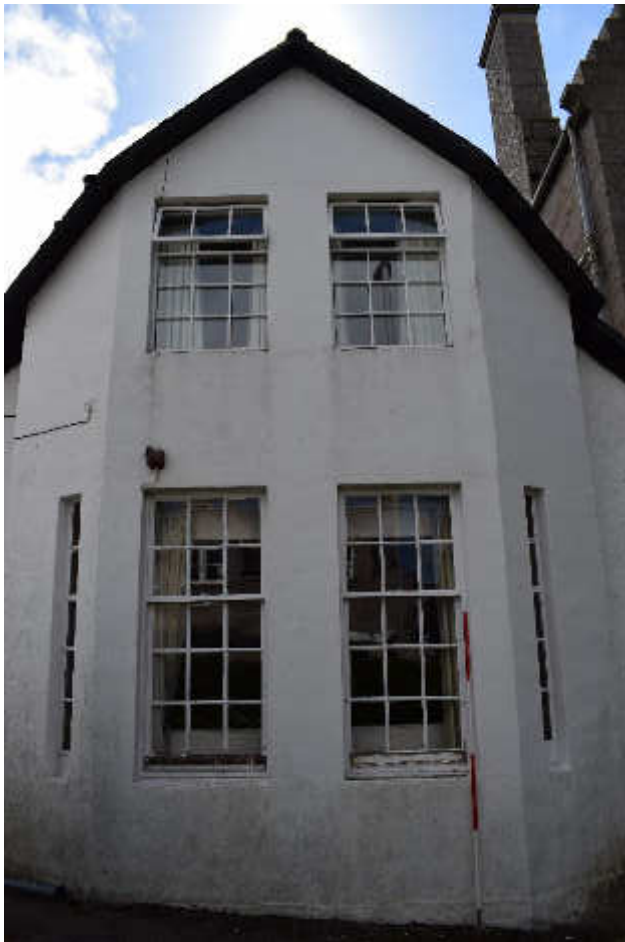
Illus 2 Phase 1 NW façade with windows W25-W30; facing SE

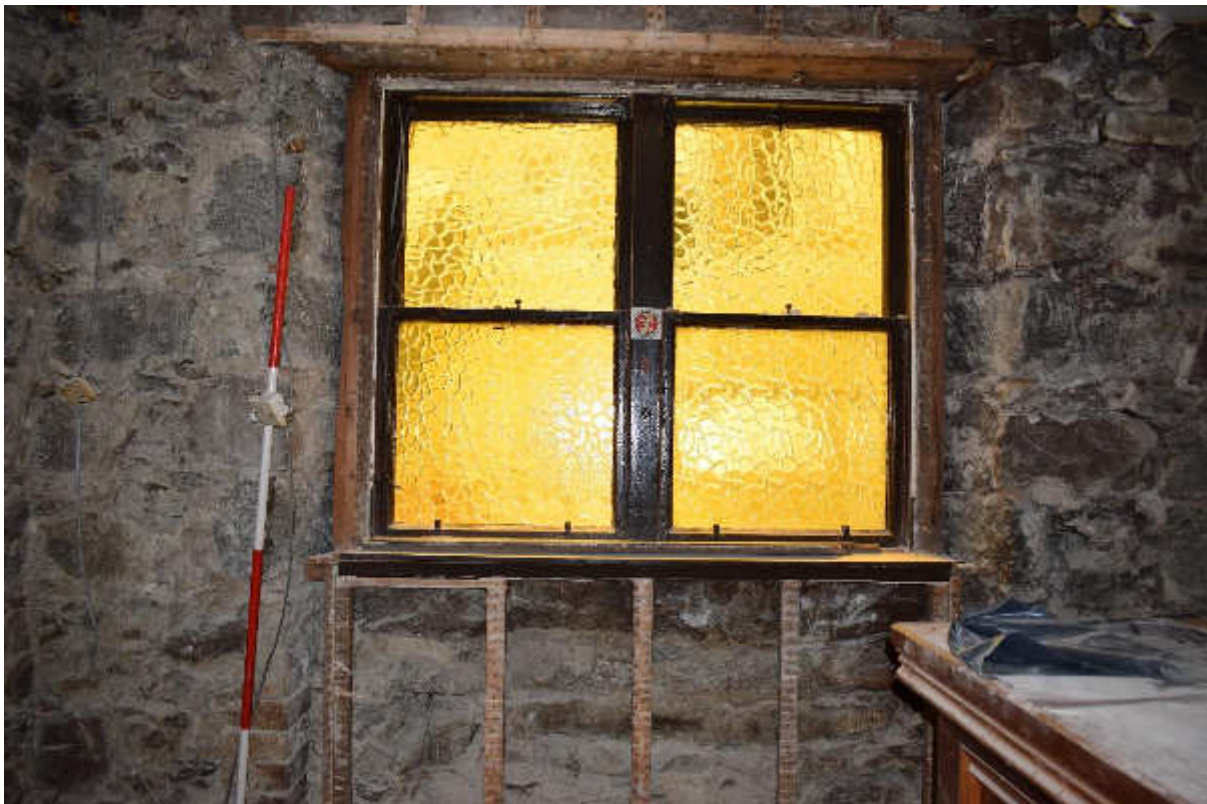
The NE section of the building (the public house) is mainly harled. The ground floor interior has been soft stripped and the walls are all granite rubble construction (Illus 3).

Illus 3 Blocked window W66 in the SW wall Phase 1 Room 26; facing SW

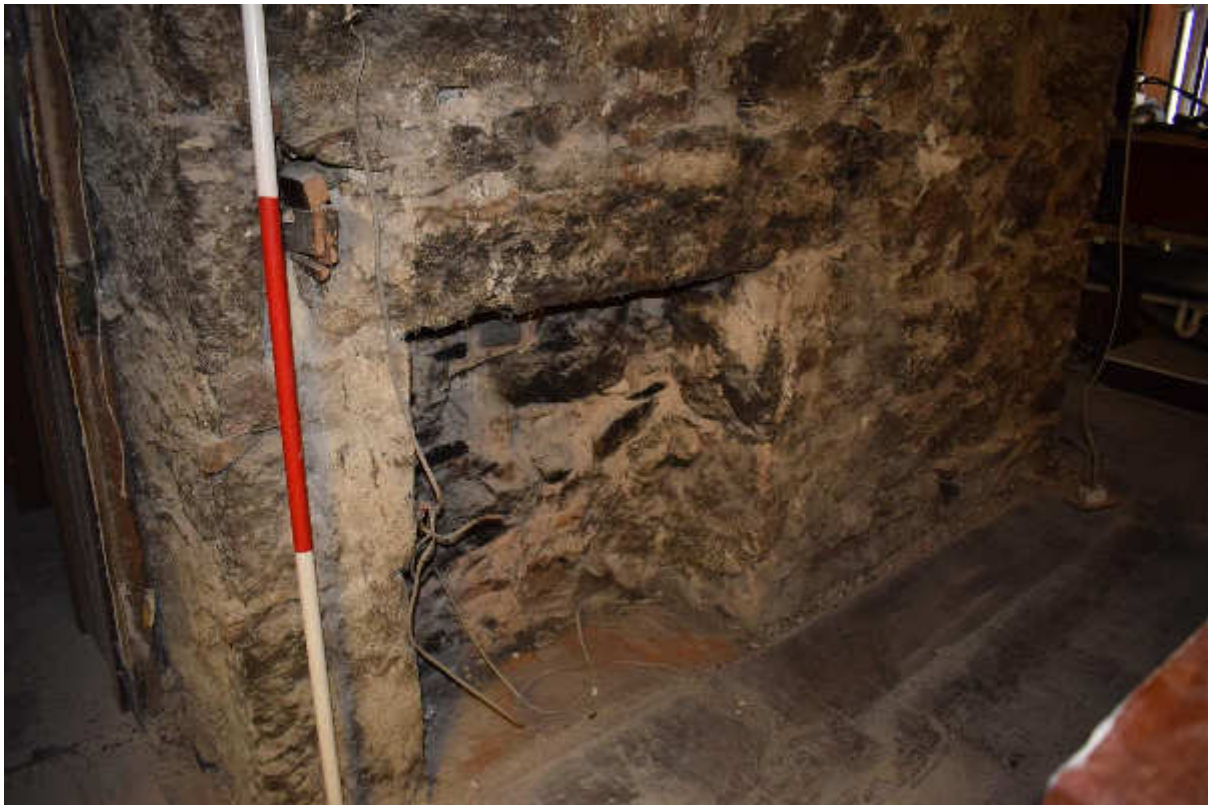
Illus 4 Fireplace F19 in Phase 1 room 27; facing N

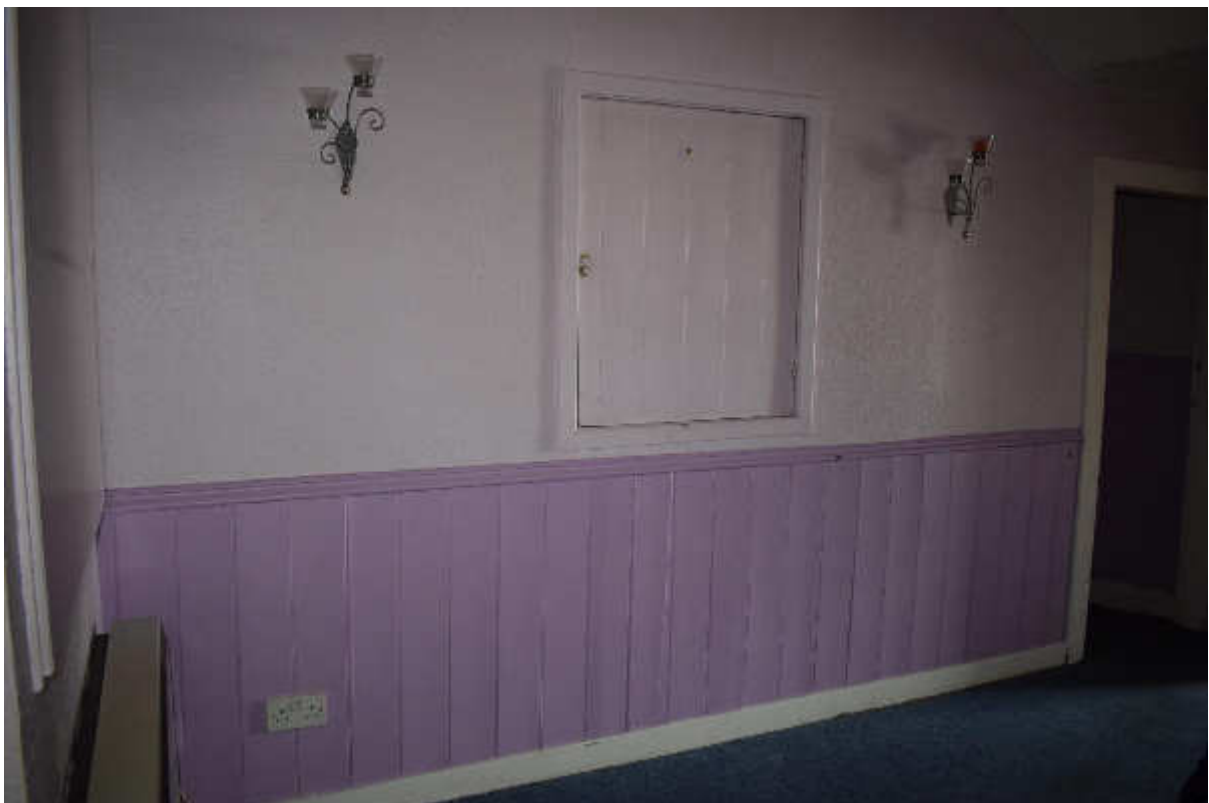
On the first floor a blocked window on the NE wall (W67; Illus 5) has been built into the Phase 2 extension and windows W25 and W26 (Illus 6) in the NW wall may be original.

Illus 5 First floor window W67 originally an exterior window on NE wall Phase 1 building; facing W

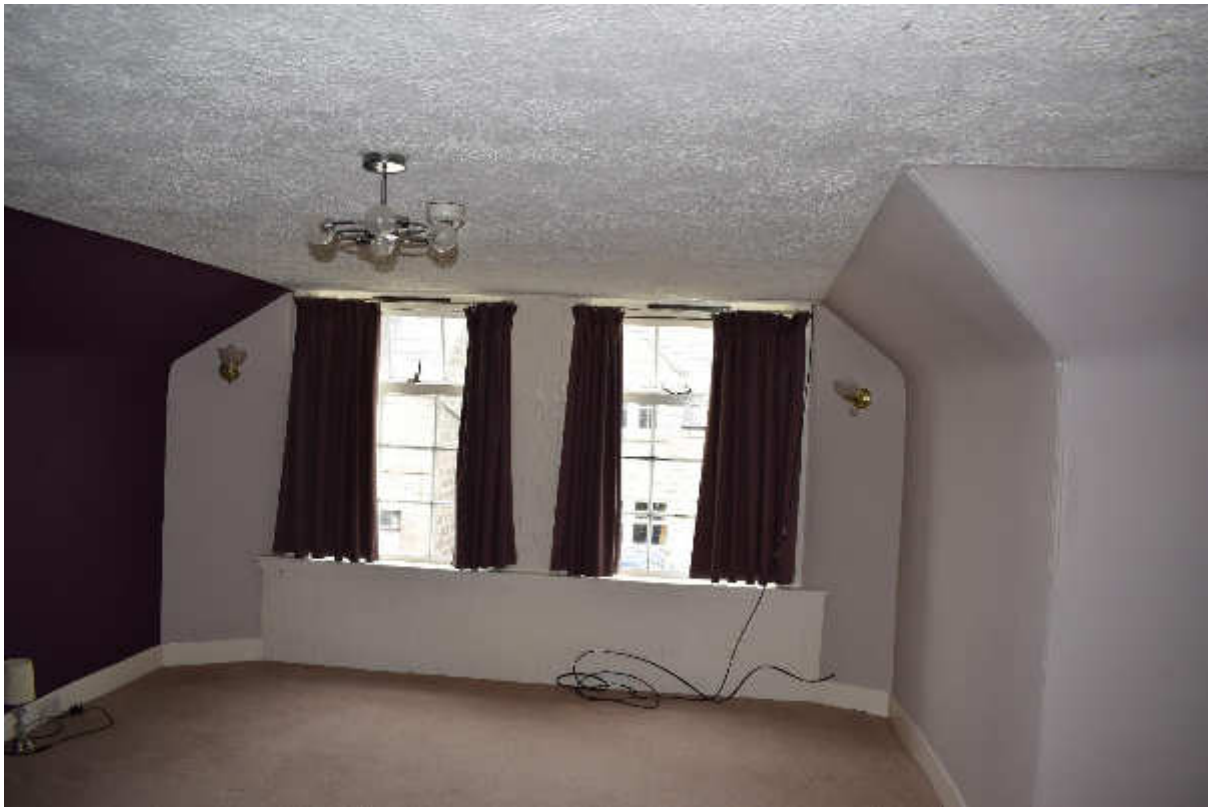
Illus 6 Phase 1 NW wall W25 and W26

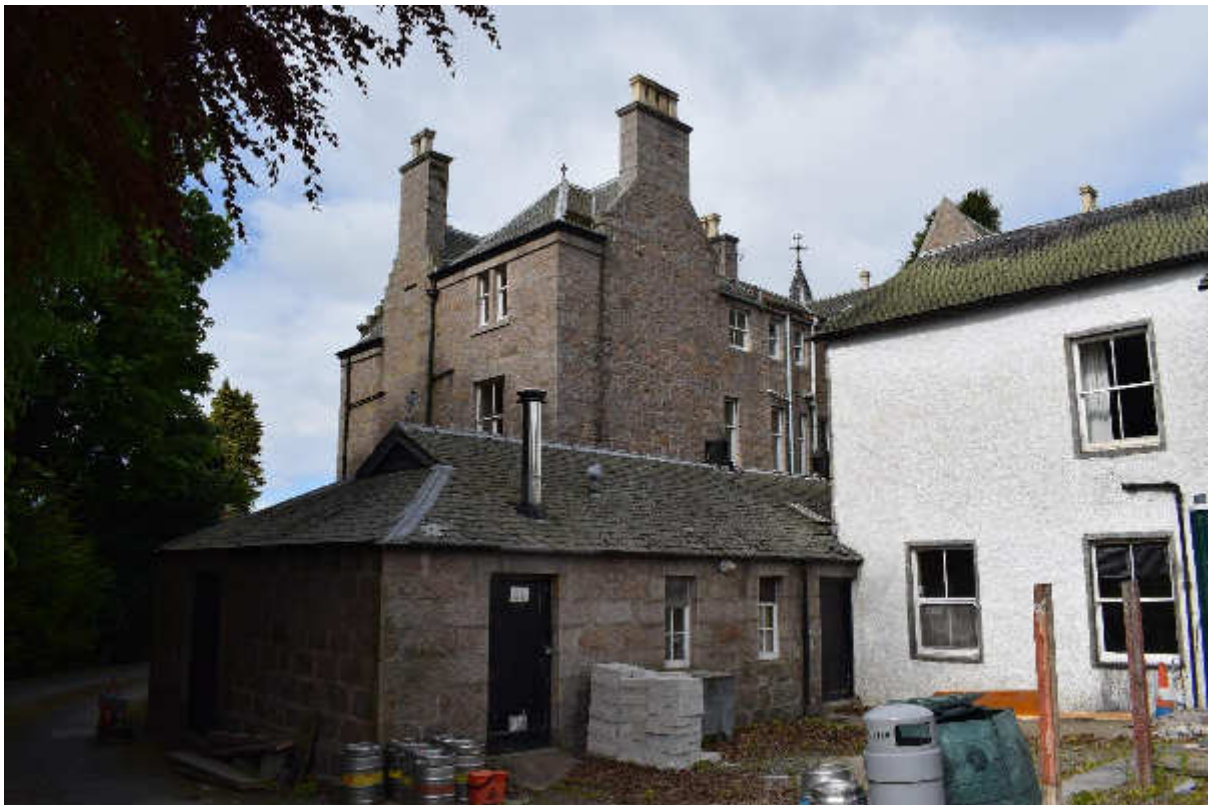
A single story building may also be part of the Phase 1 building. Rooms 21-23 (Illus 7) have stone flagged floors and stone steps with doors D2 and D7 and windows W42 and 43 in the NE wall.

Illus 7 Part of Phase 1 building (left) showing Phase 2 hotel (centre and right); facing

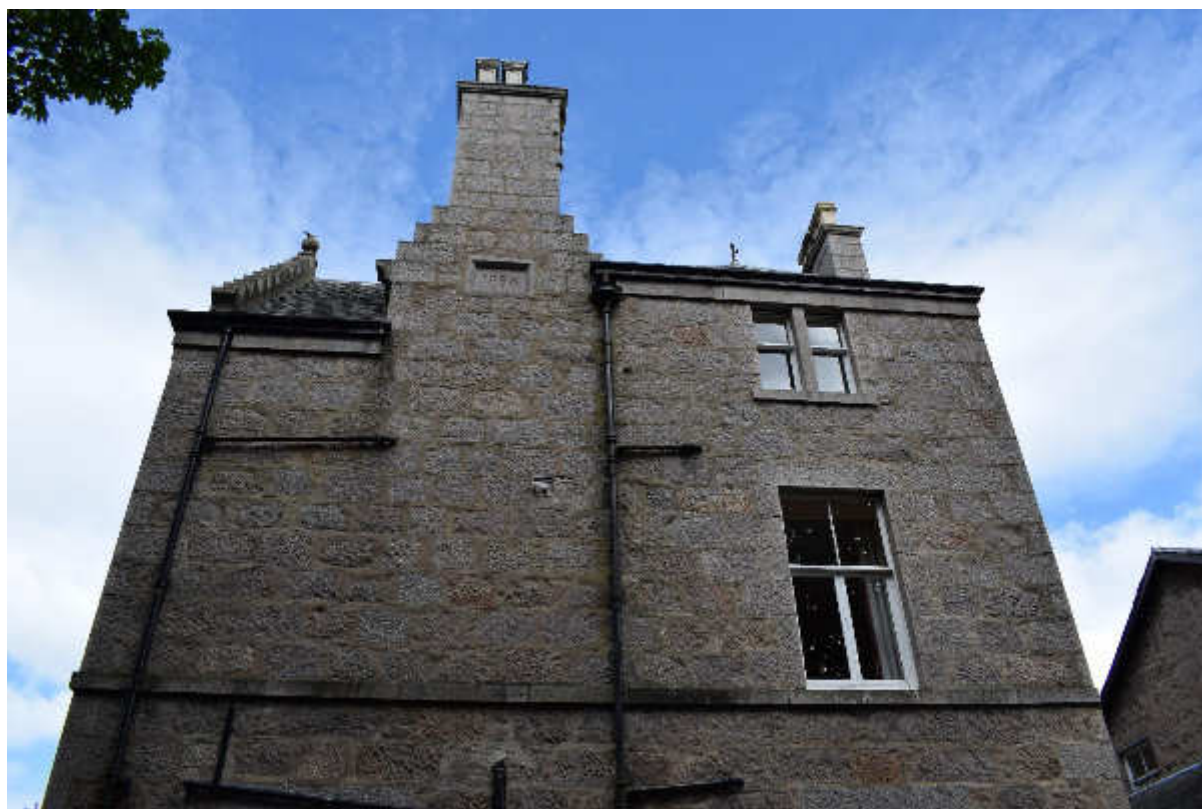
Illus 8 Phase 2 hotel SE façade with 1874 date stone; facing

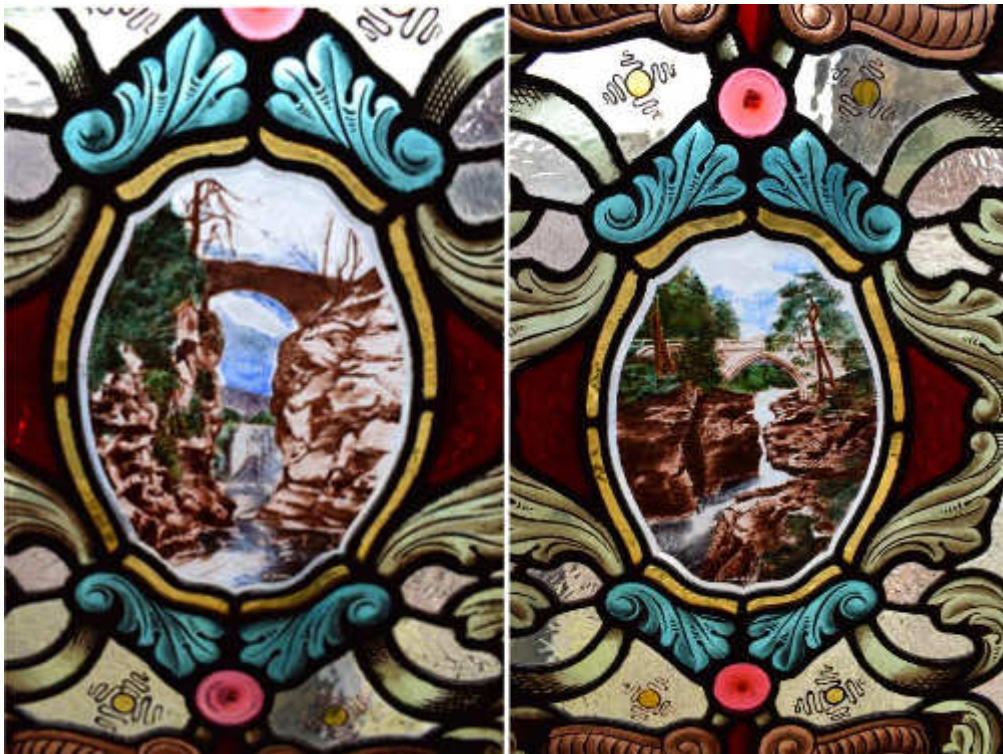
There are several late 19TH-century stained glass windows; W53 in the NE façade on the main stairwell, has scenes from the local area including Falls of Foyers (Illus 9, left) and Linn of Dee (Illus 9, right). There are wood and plaster fireplaces in three of the upper bedrooms (F22, Illus 11, F23 and F24). Fireplace F65 in Room 15 has been recently replaced and F25 appears more recently installed. There are decorative plaster swags around the windows in room 18 the main dining room (Illus 12). Both reception rooms are light with windows on both SW and adjacent facades. Phase 1 windows W66 and 67 and aperture F18 have all been infilled or converted into internal apertures when the Phase 2 structure was added on to the earlier building.

Illus 9 W53 details; facing NE

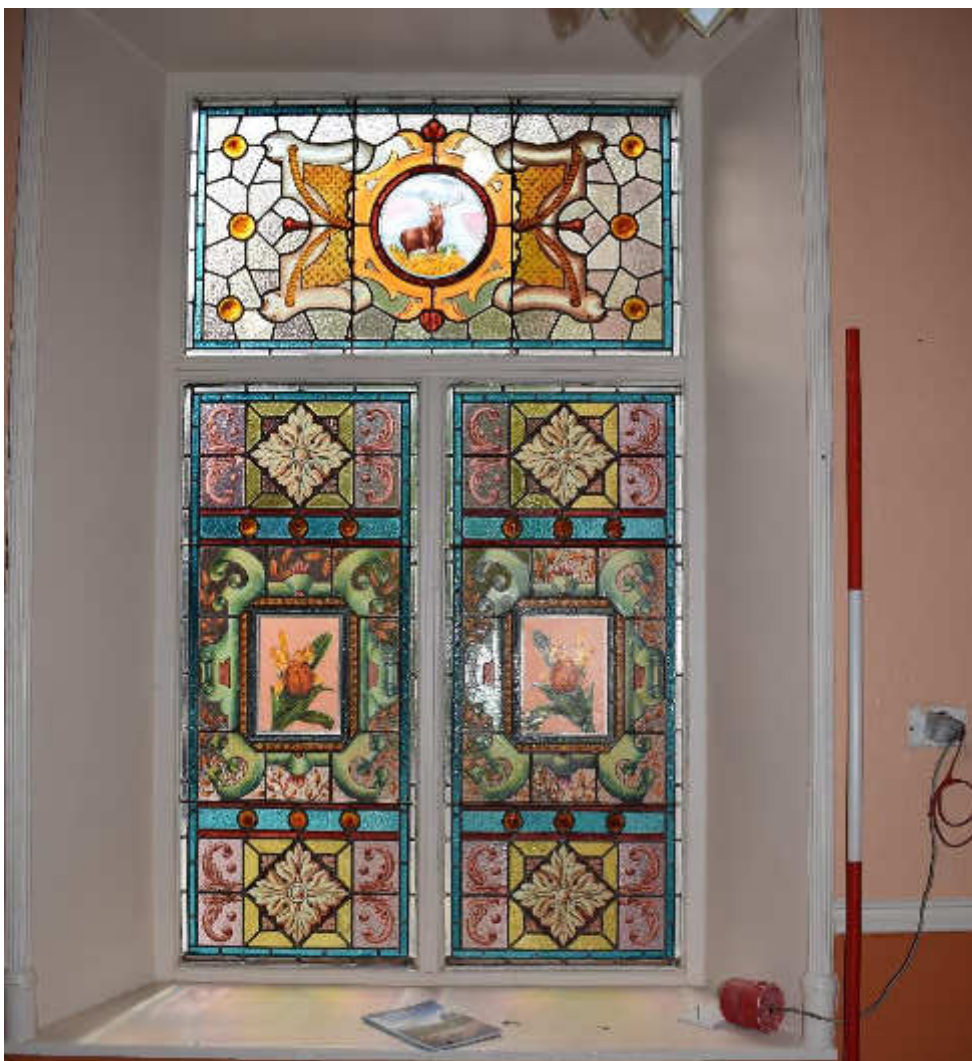
Illus 10 W60; facing SE

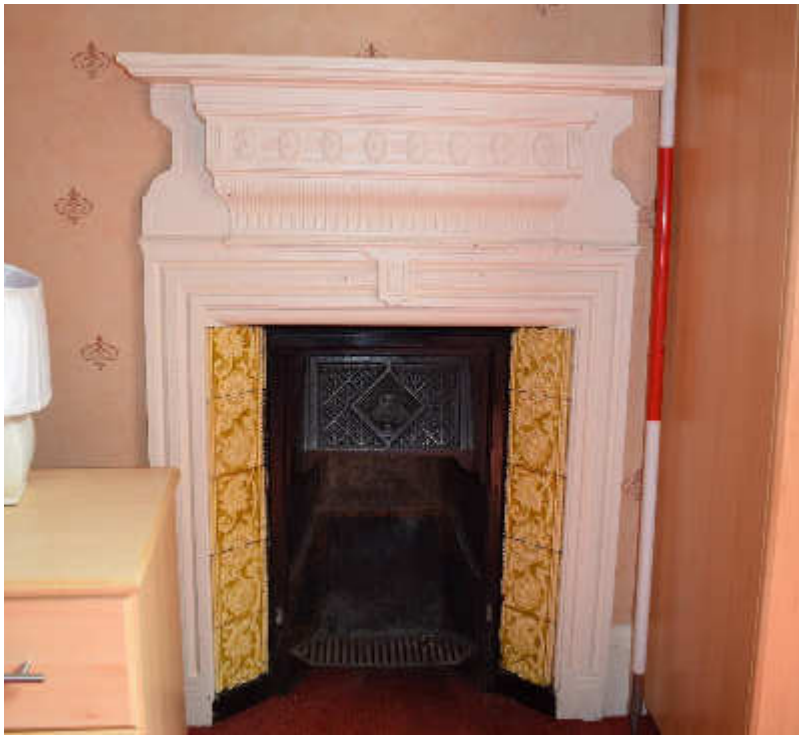
Illus 11 Room 8 fireplace F22; facing NE

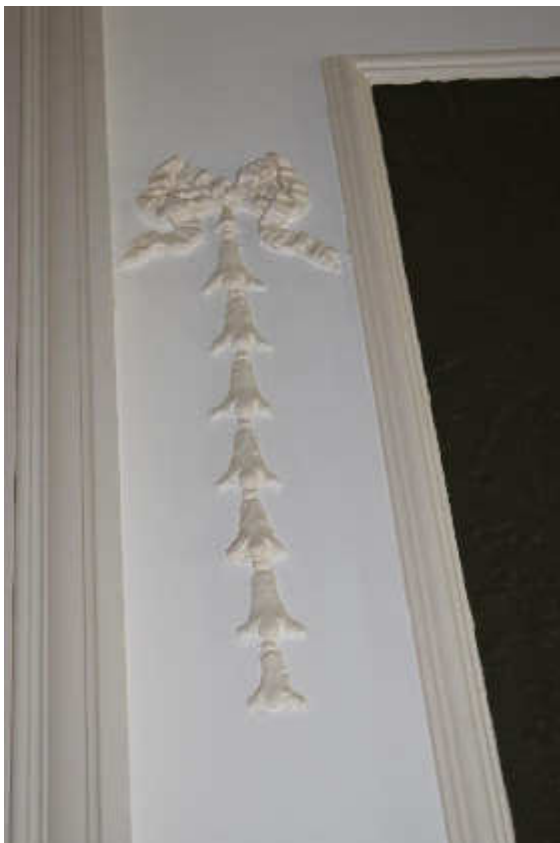
Illus 12 Decorative plasterwork in Room 18 the S reception room; facing SE

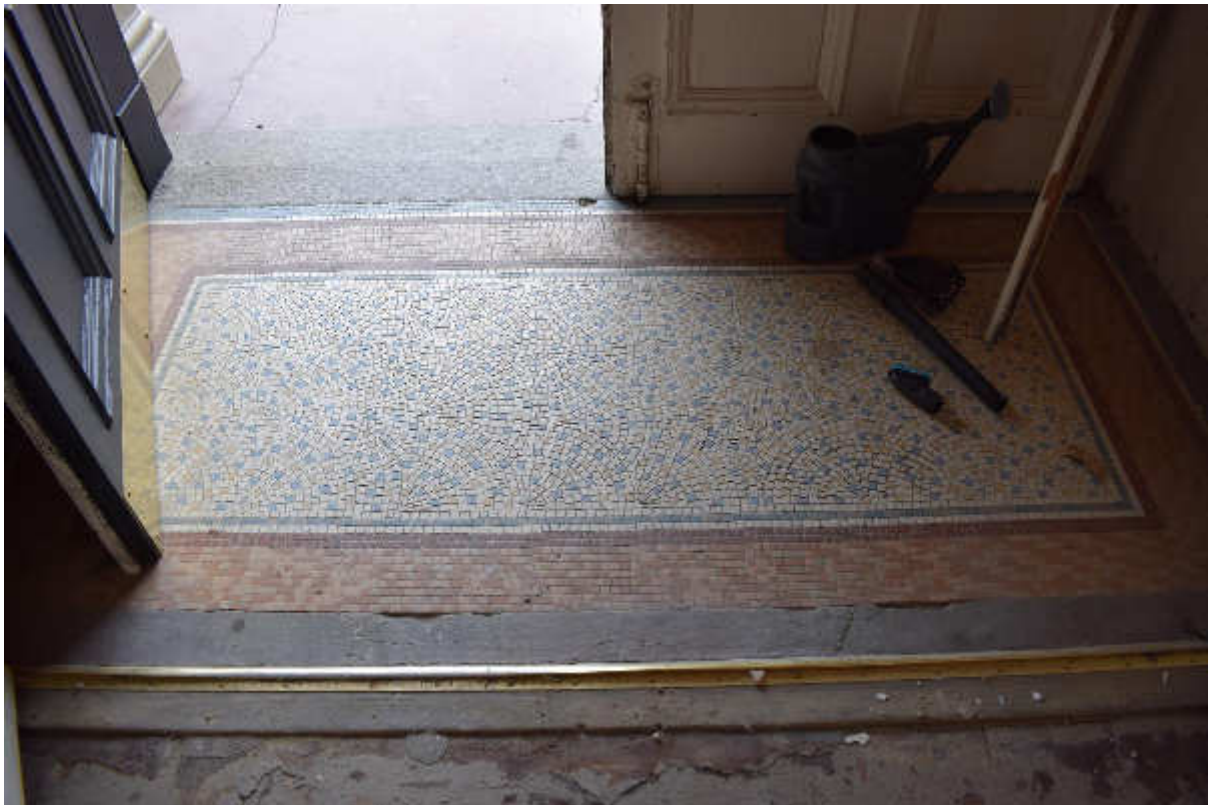
The main door (D1) has a small tiled entranceway with mosaic tiled floor (Illus 13) and a large hallway, Room 16, with wide stairway with cast iron and wood fittings.

Illus 13 Tile entranceway F37, inside main door D1; facing SW

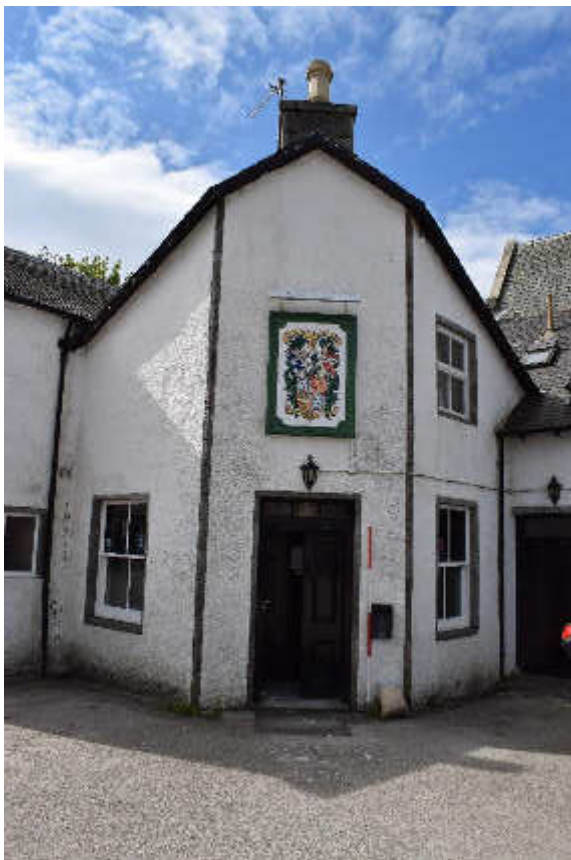
Illus 14 Phase 2 public house entrance

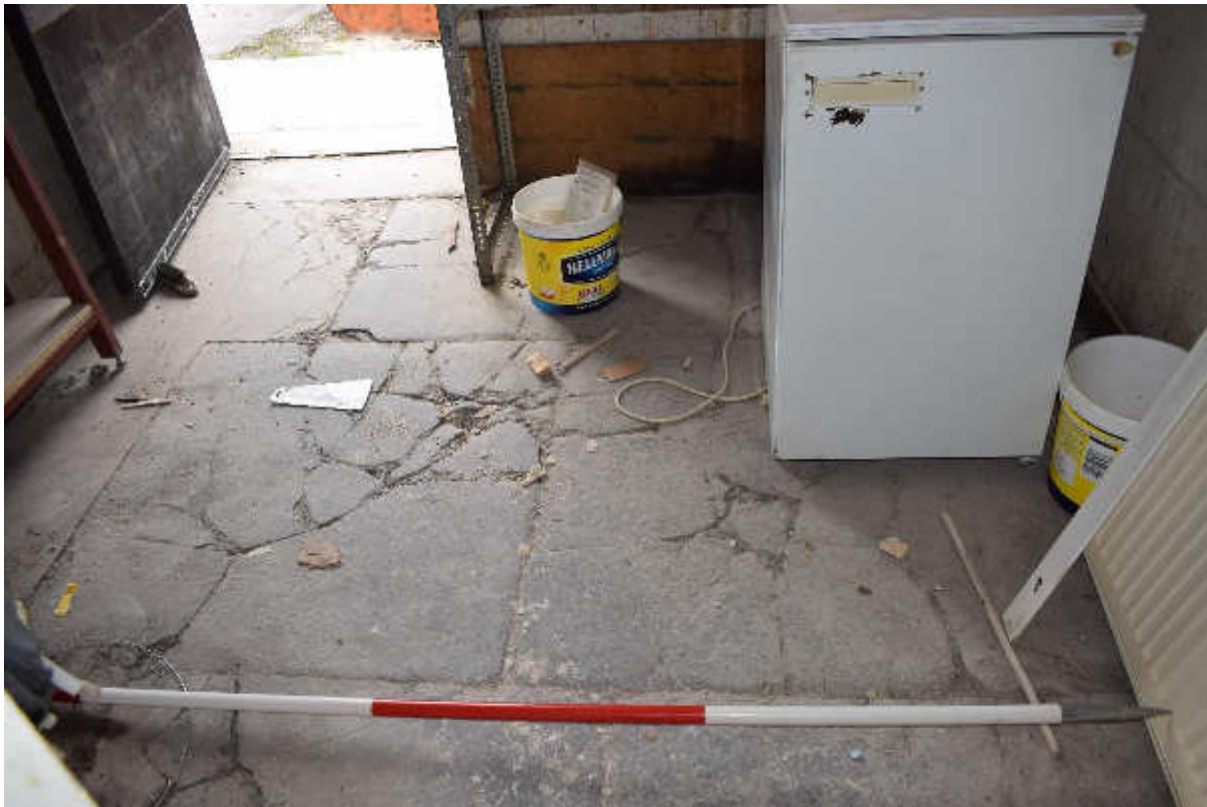
plain granite window and door mouldings. The interiors have all been converted for public house and hotel use. There is a stone flagged floor in Room 36 (illus 15)

Illus 15 Room 36 stone flag floor; facing SE
