**Kepplestone Mansion, Viewfield Road,  
Aberdeen, AB15 7AW  
Report on Level 1 Standing Building Survey**

**Alison Cameron  
Cameron Archaeology  
14 July 2016**

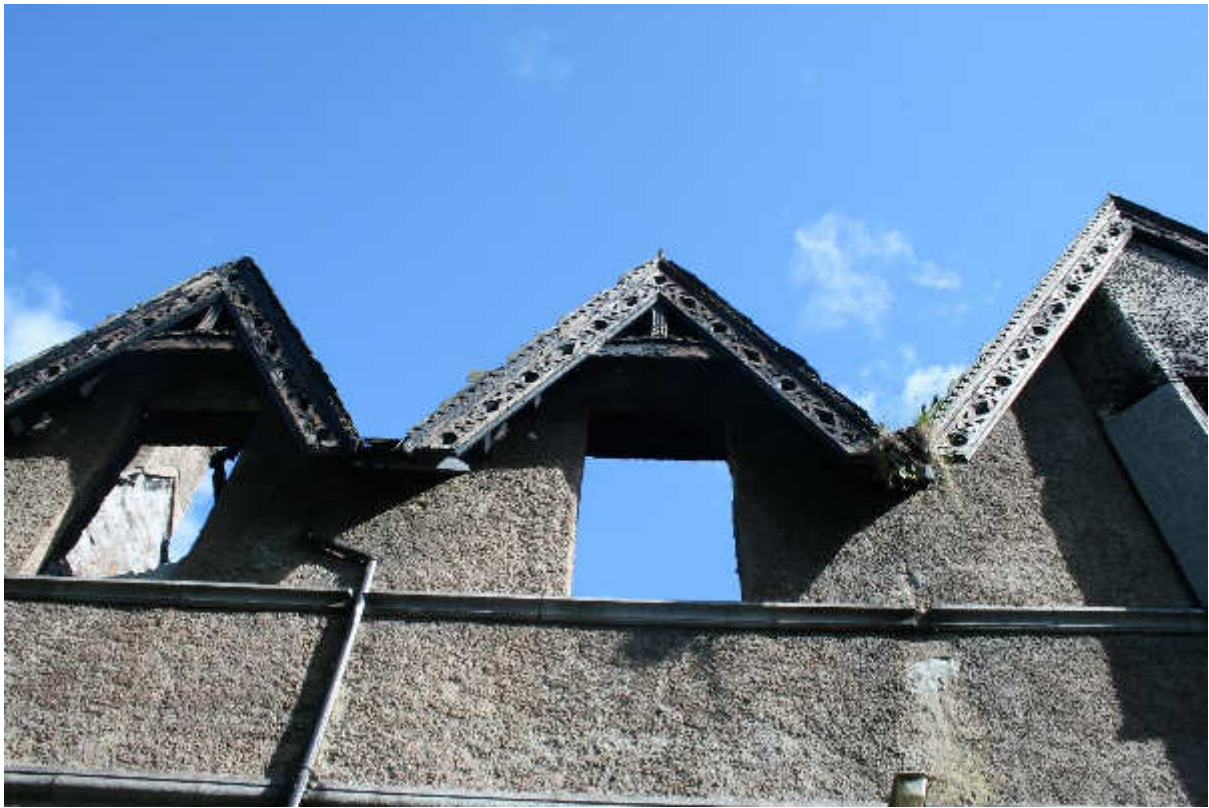
Illus 8 Building 1 S façade with decorative pierced timber bargeboards above gablets; facing N

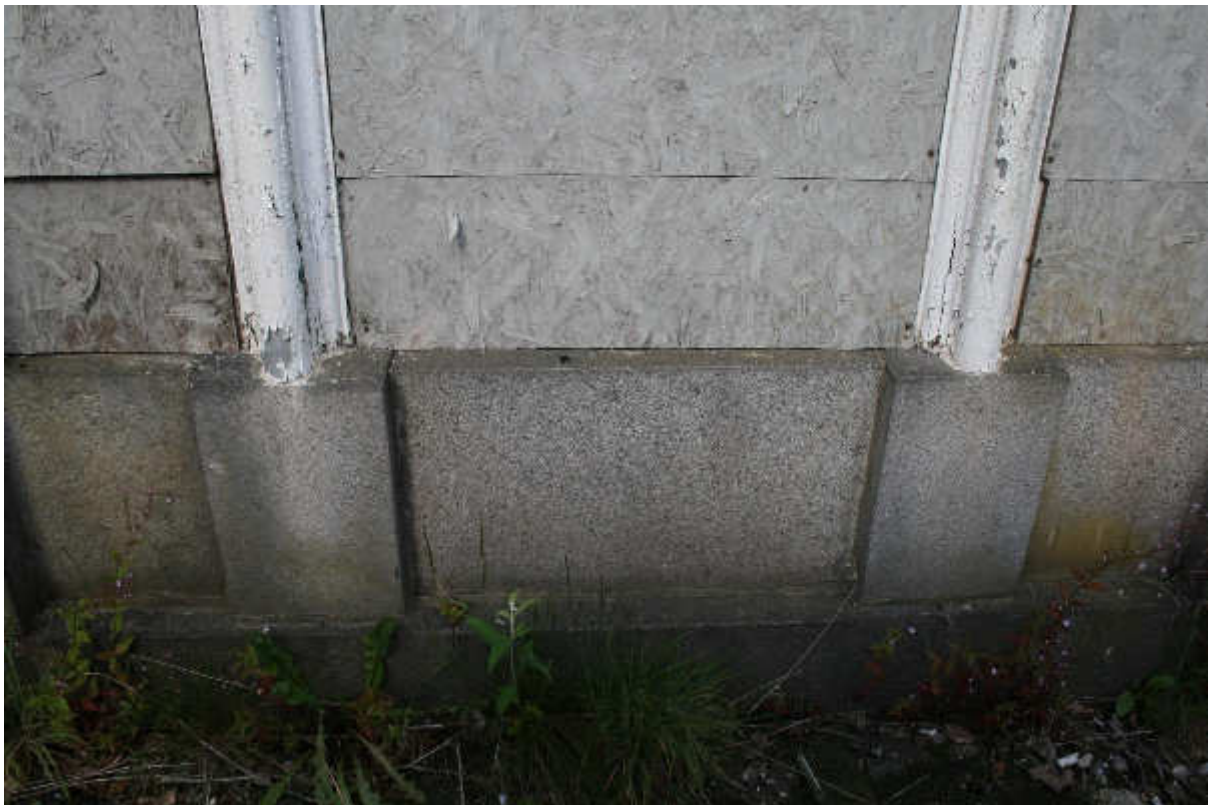
Illus 9 Granite base course under W33; facing W

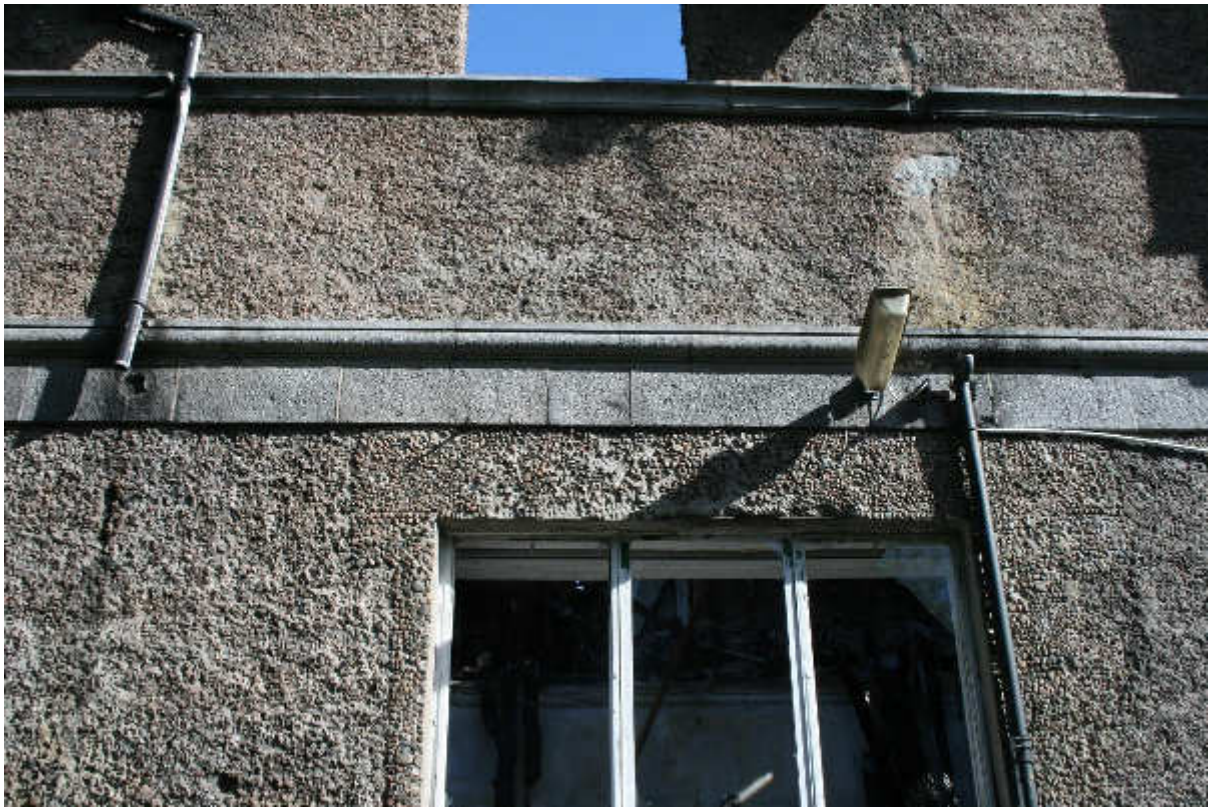
Illus 10 Granite dividing band course with W24 below and W20 above; facing N

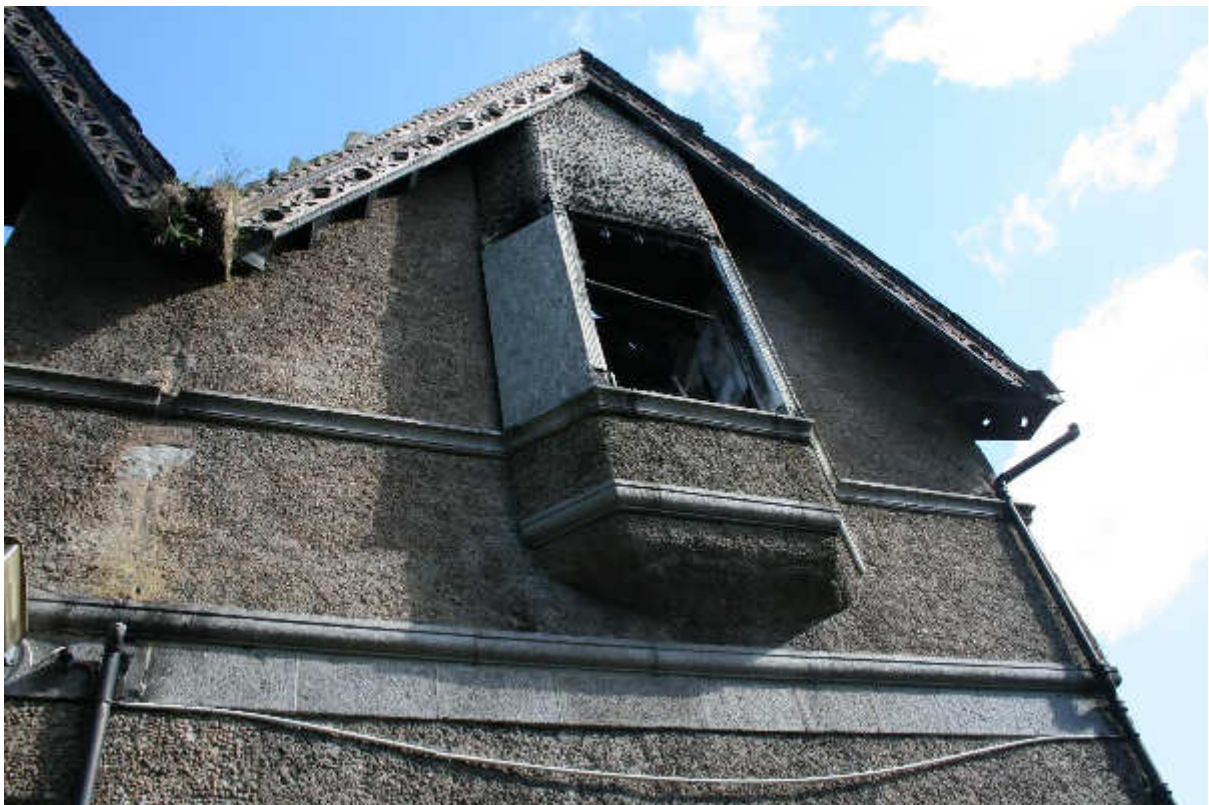
Illus 11 Building 1 S façade oriel window W21 facing NNE

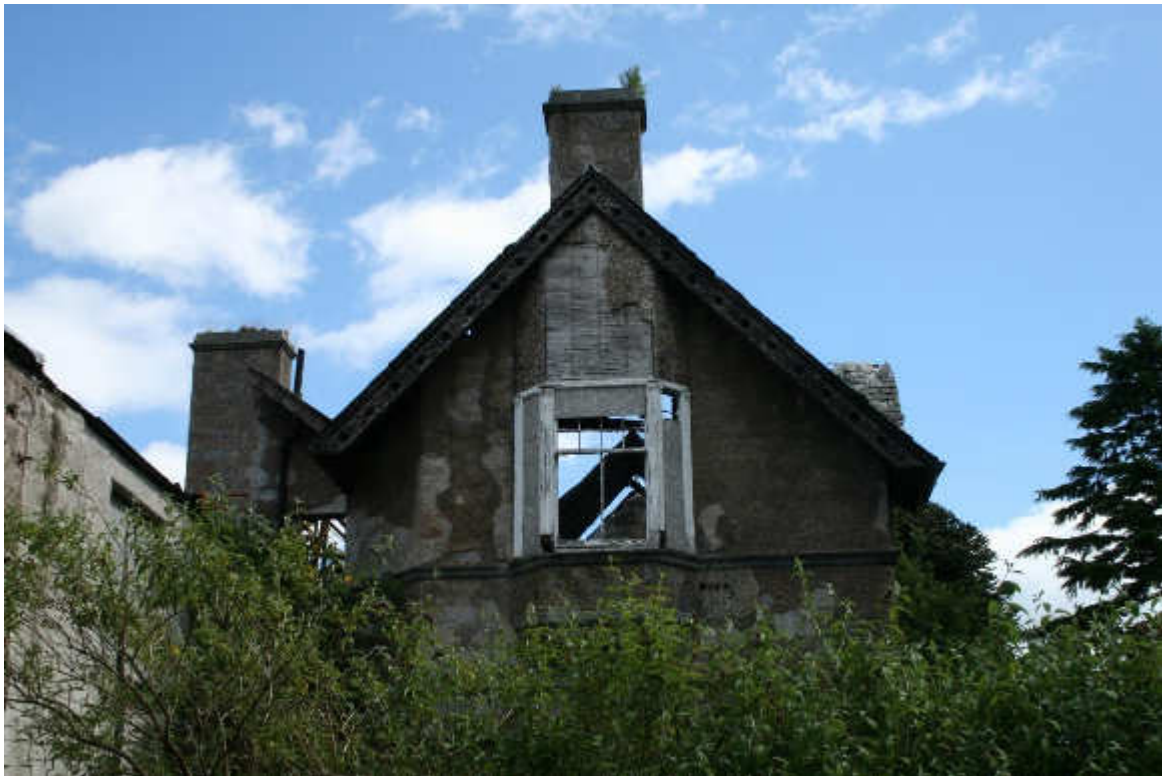
Illus 12 Building 1 W façade W38 with large pebble dash around over granite rubble construction and decorative pierced timber bargeboards above; facing E

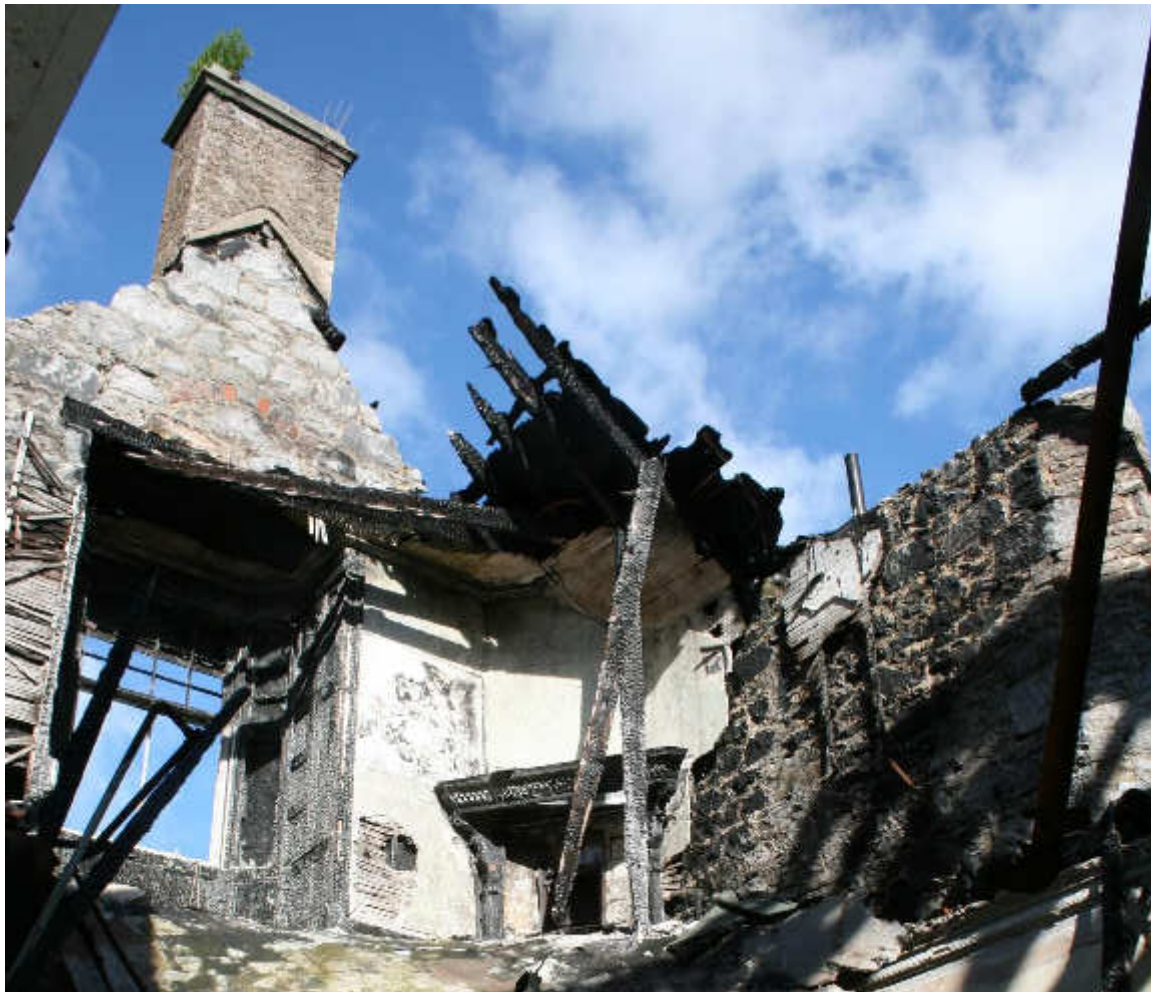
Views through W24 reveal first floor fireplaces with tile surrounds F6 (Illus 13) and F7 (Illus 14) and photos in Appendix 1 show F6 prior to the fire (Illus 27, 28). The interiors were not accessible during this survey but photographs taken in the late 19<sup>th</sup> century (Melville 2000) and photos taken by staff of Stewart Milne Homes prior to the fire are included in Appendix 1.

Illus 13 View into Building 1 first floor window W38 (left) and fireplace F6 (right); facing WNW

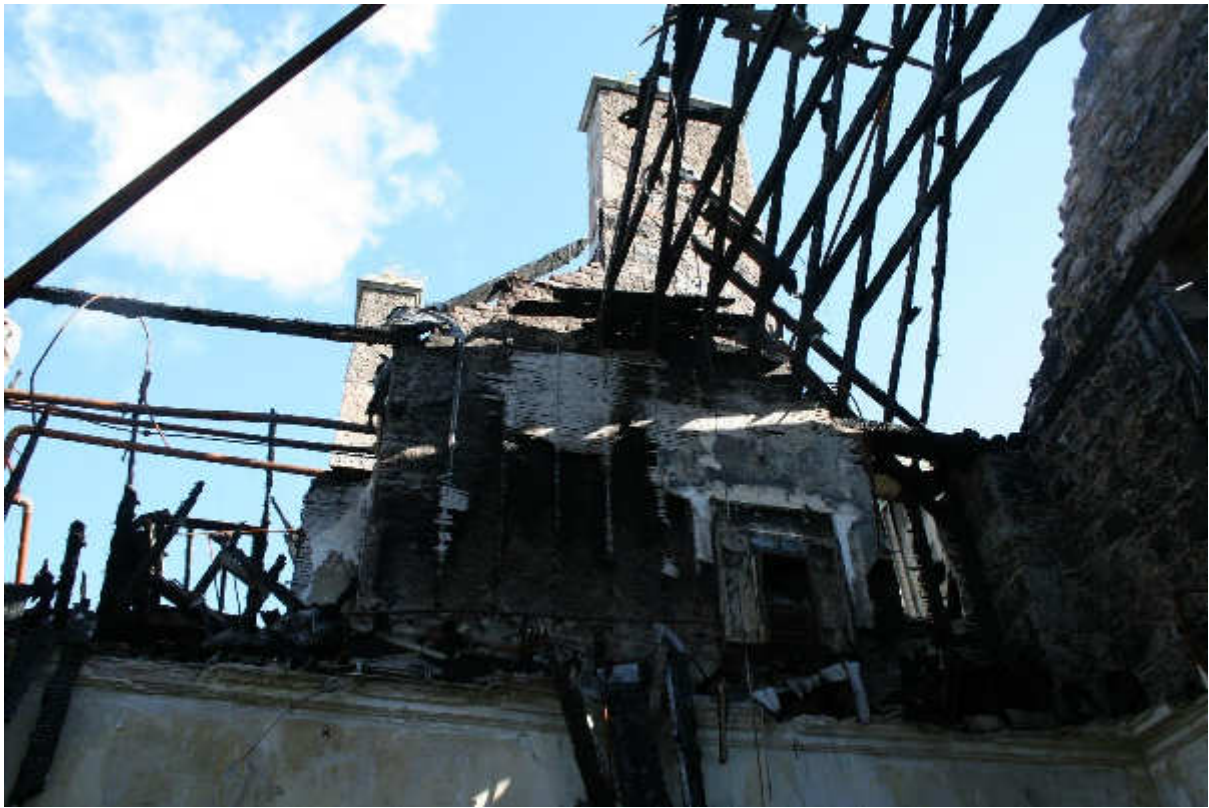
Illus 14 Interior through W24 showing fireplace F7 with chimney F1 above and burnt roof timbers; facing NNE

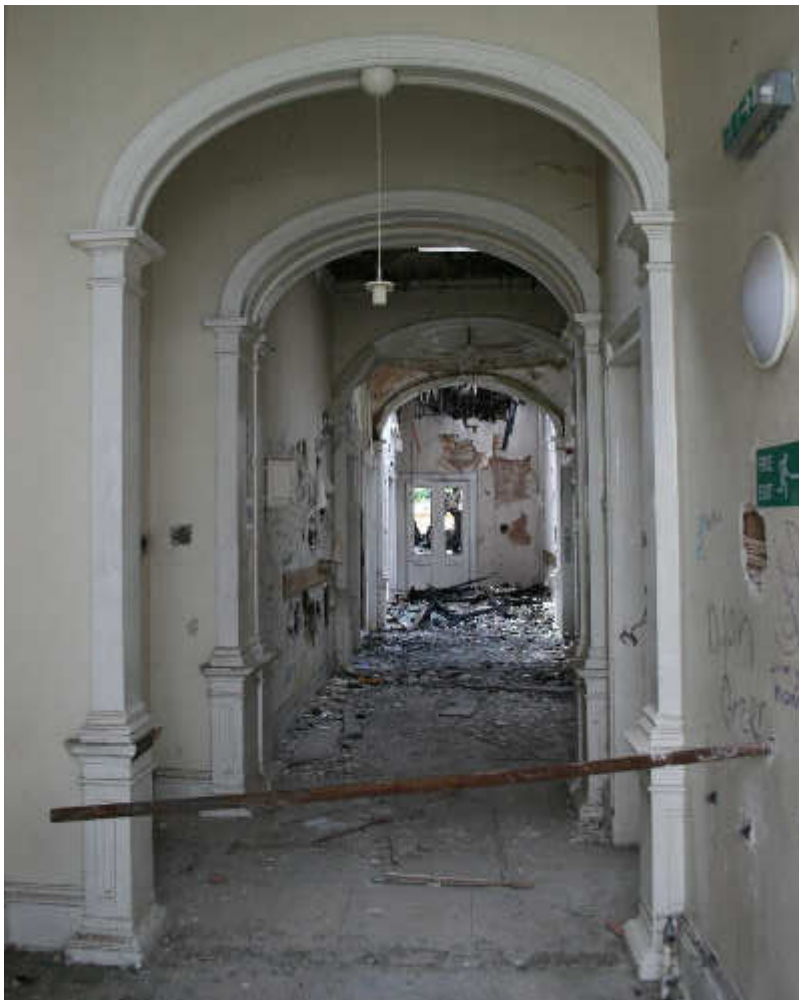
Illus 15 View into building through D5; facing S

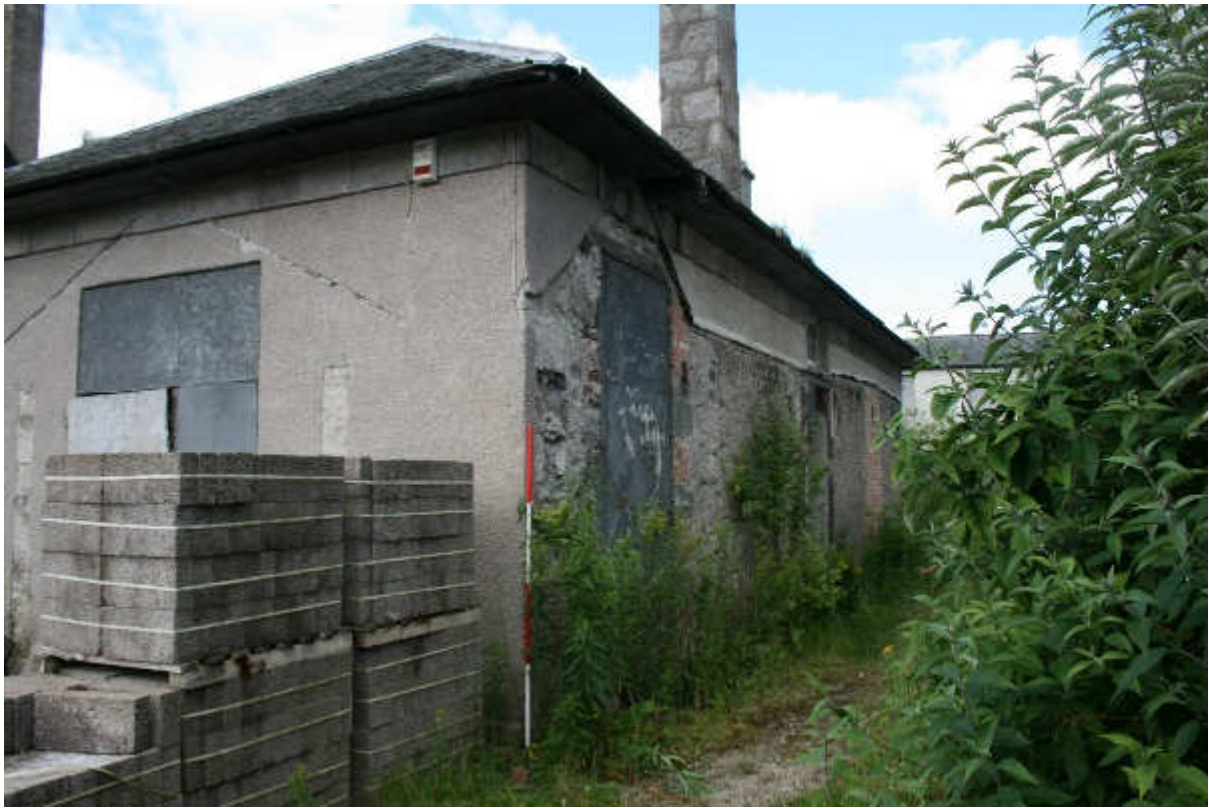
Illus 16 Building 1 NE corner; the 3<sup>rd</sup> Edition OS map shows an extension to this façade which has since been removed; facing WSW

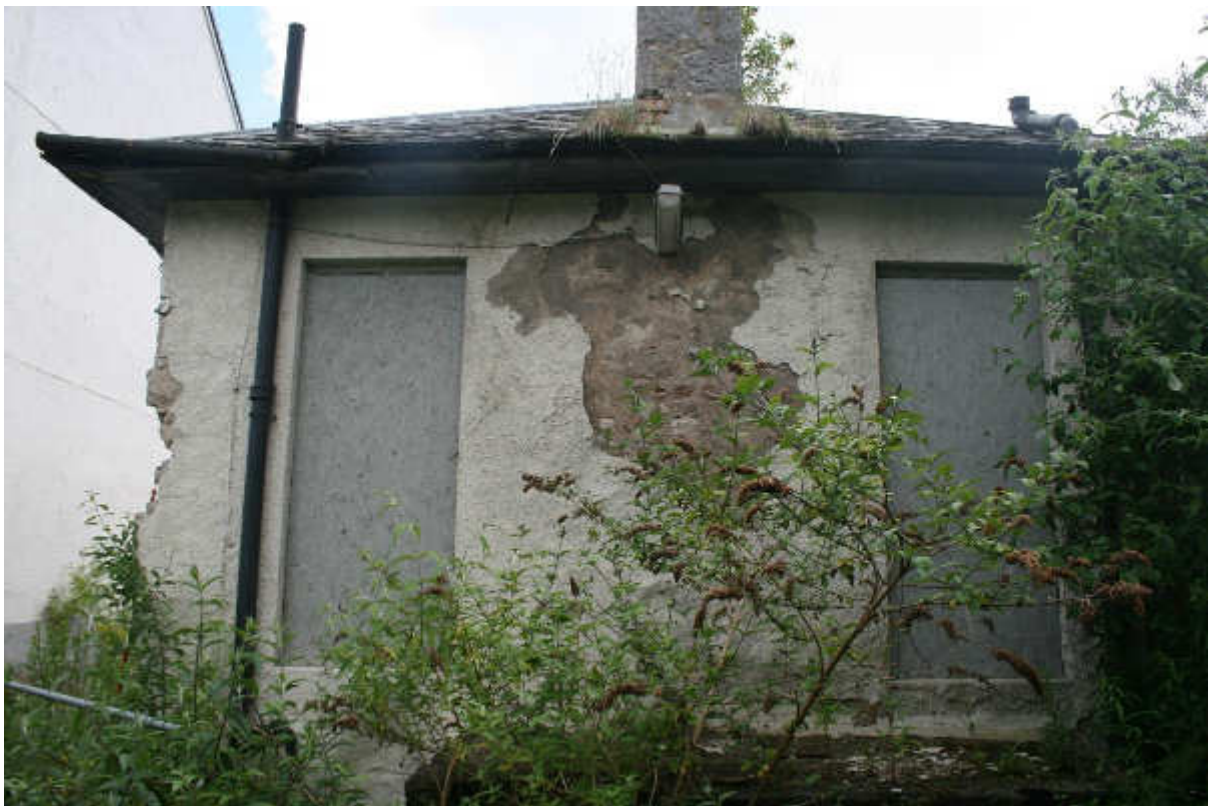
Illus 17 Building 1 W wall N end W26 (left) W27 (right) facing into small central courtyard; facing E

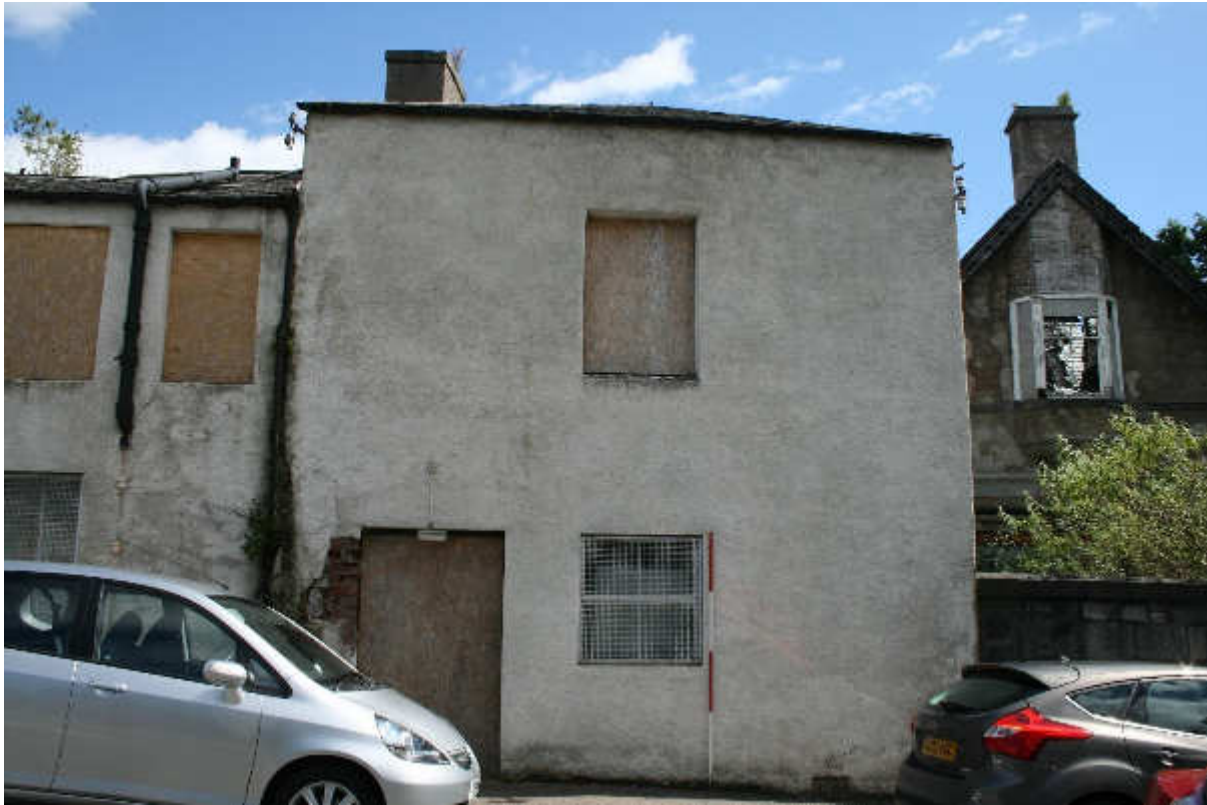
Illus 18 Building 2 W wall Room 6 on Viewfield Rd; facing E

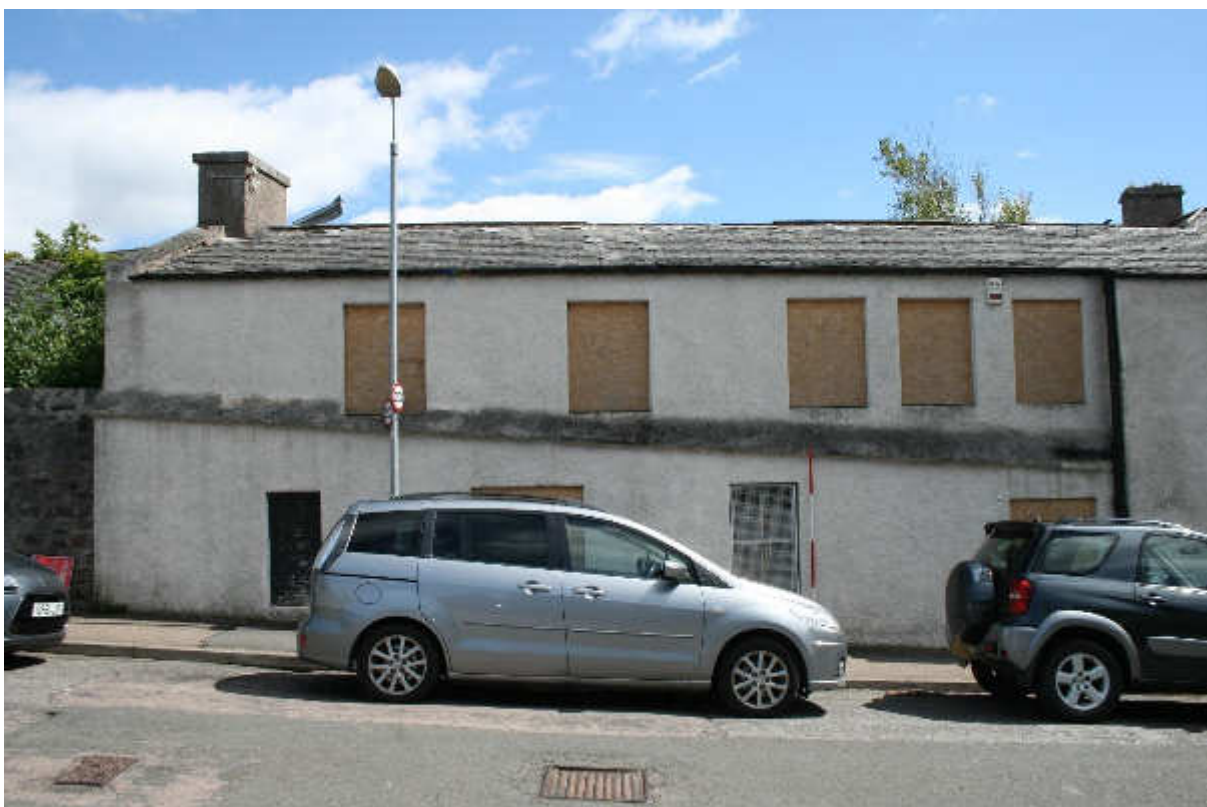
Illus 19 Building 2 Rooms 3-5 W wall on Viewfield Rd; Facing E

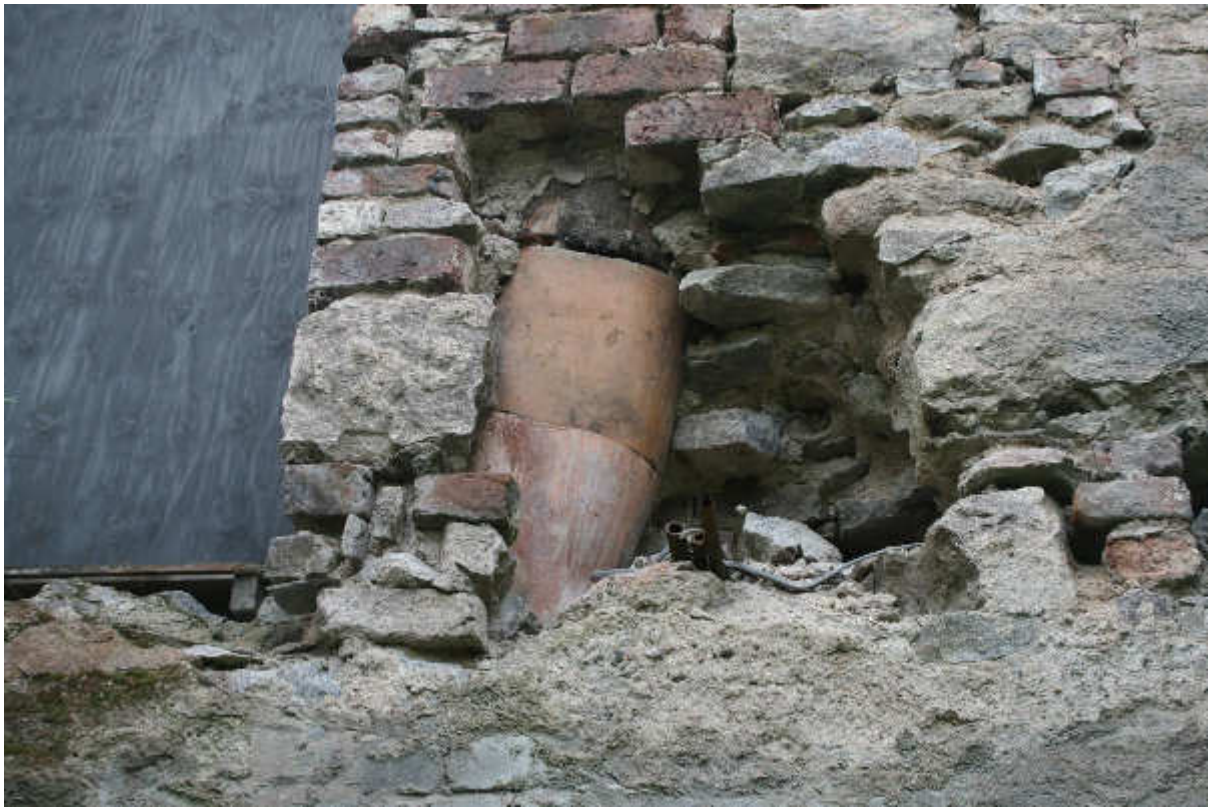
Illus 20 Building 2 N wall Room 8 ceramic flue F17; facing S

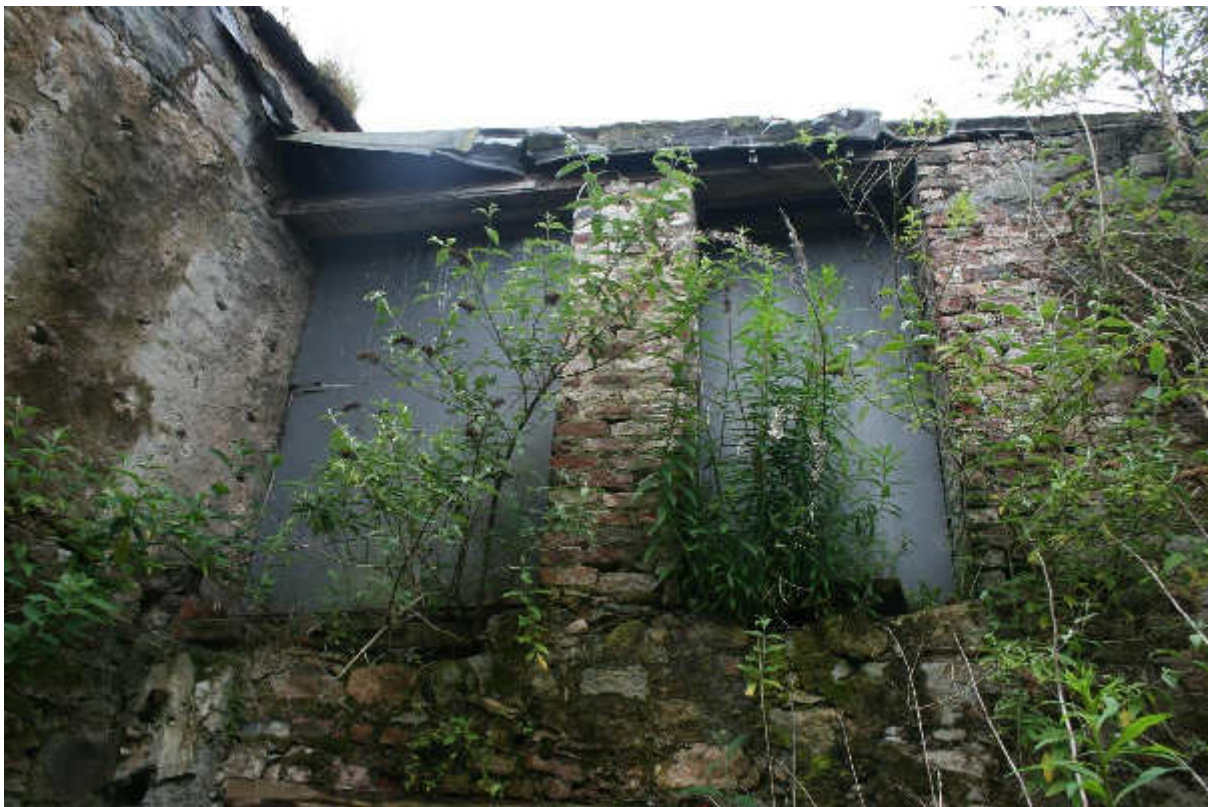
Illus 21 Building 2 Room 5 E wall D7 (left) D9 (right); facing W

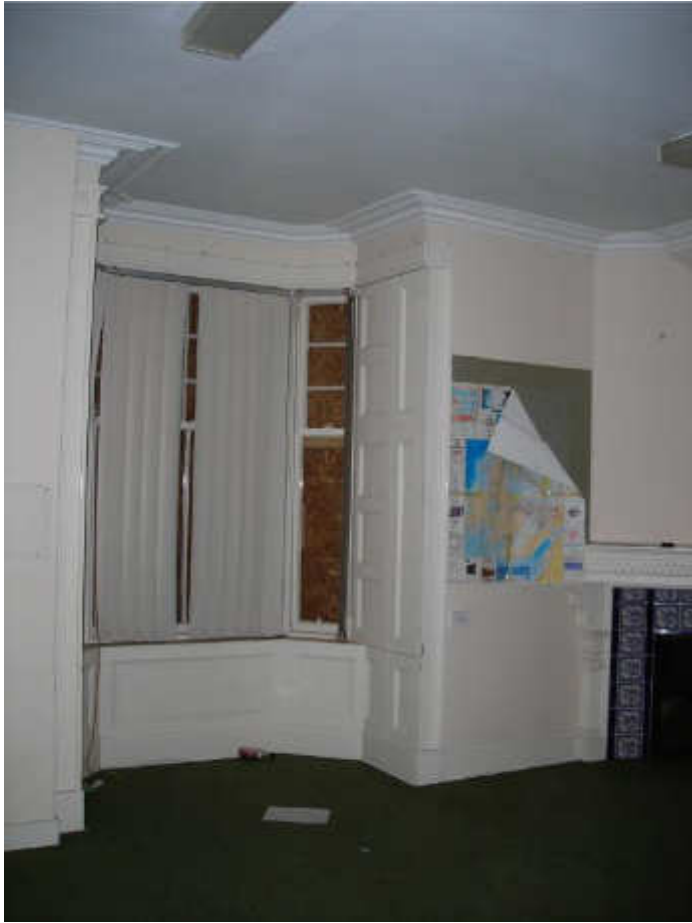
Illus 27 Probably W38 interior with fireplace F6 (right). Photo taken prior to the fire (copyright Stewart Milne Homes).

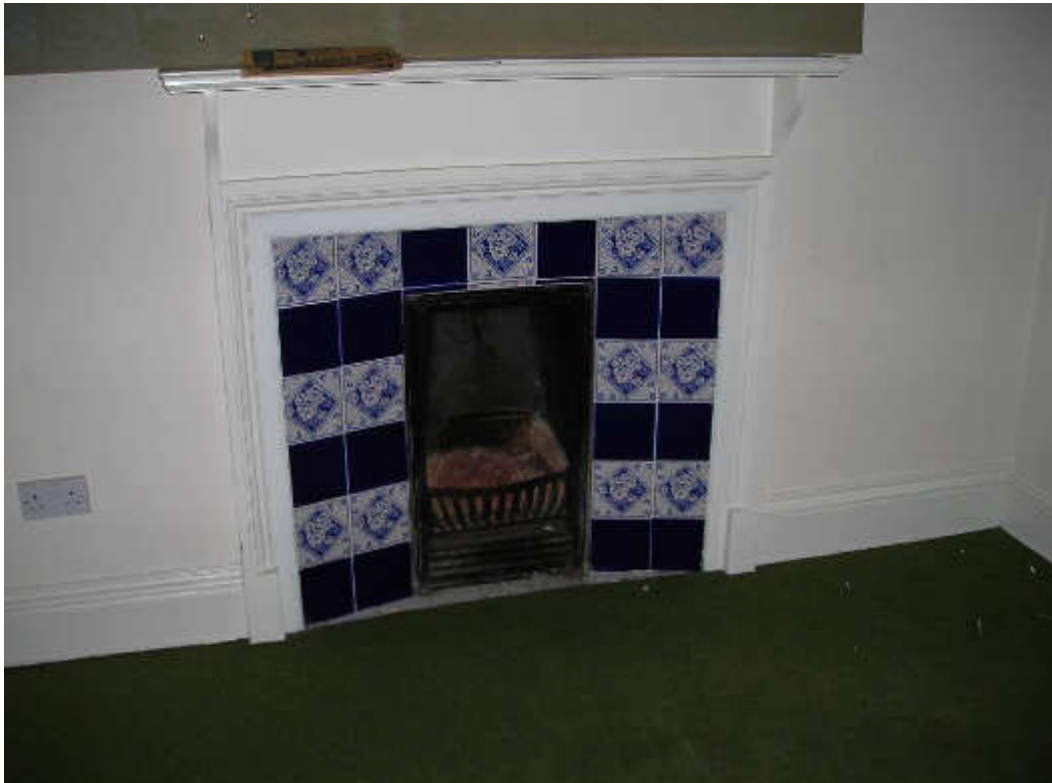
Illus 28 Probably fireplace F6. Photo taken prior to the fire (copyright Stewart Milne Homes).
