**Broombrae, Newmachar, Aberdeenshire, AB21 7PZ  
Report on Level 1 Standing Building Survey**

**Alison Cameron  
Cameron Archaeology  
14 September 2016**

A Level 1 standing building survey was carried out on 12 September 2016. A plan and elevations were drawn and a full photographic survey carried out. The steading is probably early 19<sup>th</sup>-century in date and was altered by the current owners around 65 years ago to create a piggery. It is recommended that no further archaeological work is required during the current planning application.

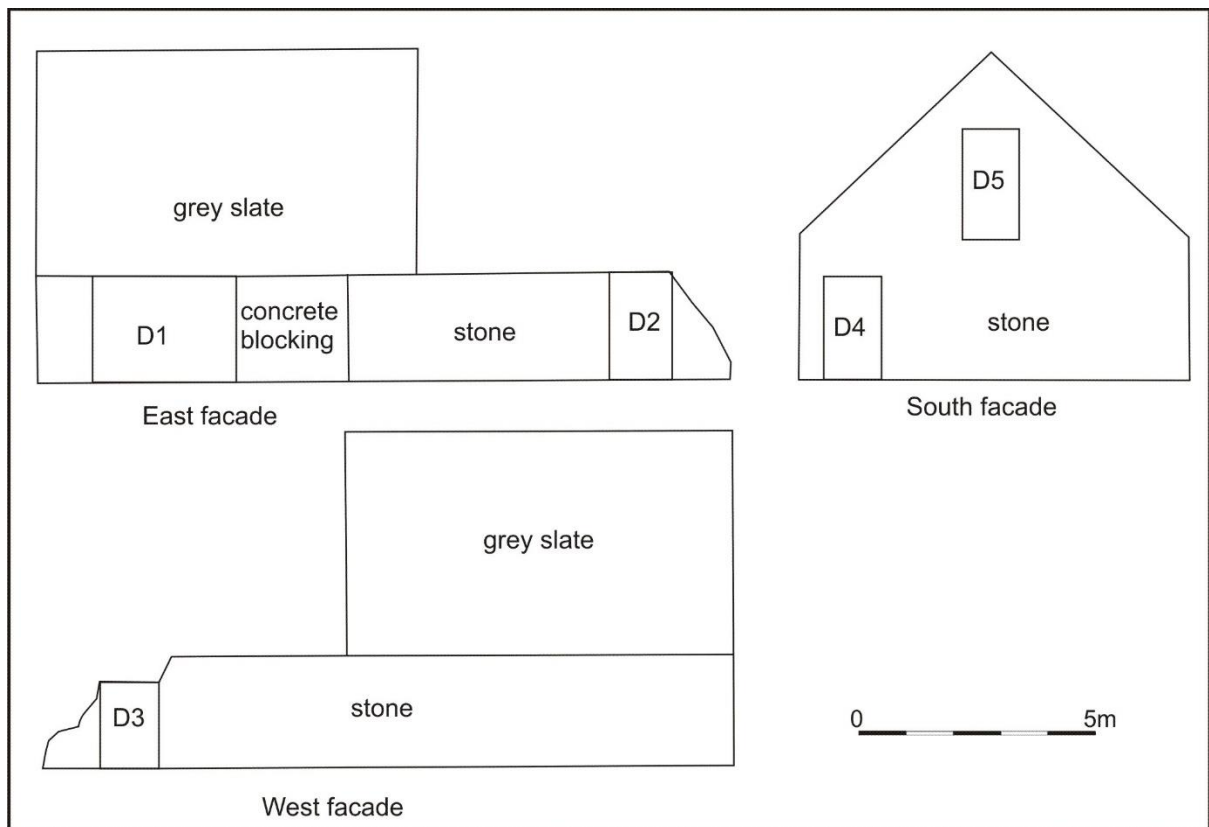
Illus 3 Elevations of Building 1 annotated with numbers used in this survey

The extant south end of the steading was 8.05m wide and survived to 14.6m long. Room 1 was intact and part of Room 2 survived. Room 1 had a door in the S gable at ground level (D4; Illus 4) and one at first floor (D5) and a large door in the E wall (D1) which had been partially infilled with concrete blocks. There is a blocked door in both the W and E walls of Room 2. The walls of the steading are 0.6m thick (Illus 5) and constructed of large granite blocks with cherry cocking. The surviving roof is grey slate and has been replaced since the current owner purchased the property (Illus 6). The floors are concrete and the lintels are all granite.

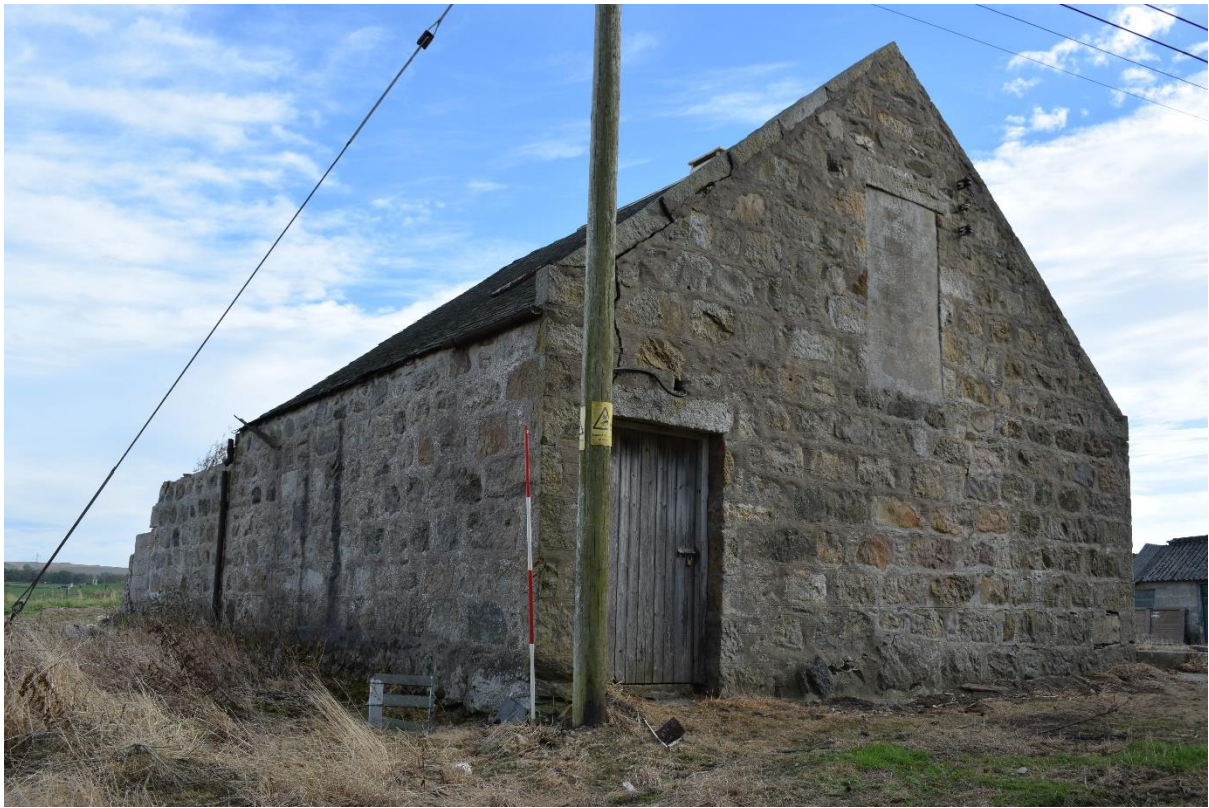
Illus 4 SW corner of steading with S gable doors D4 (bottom left) and D5 (top); facing NNE

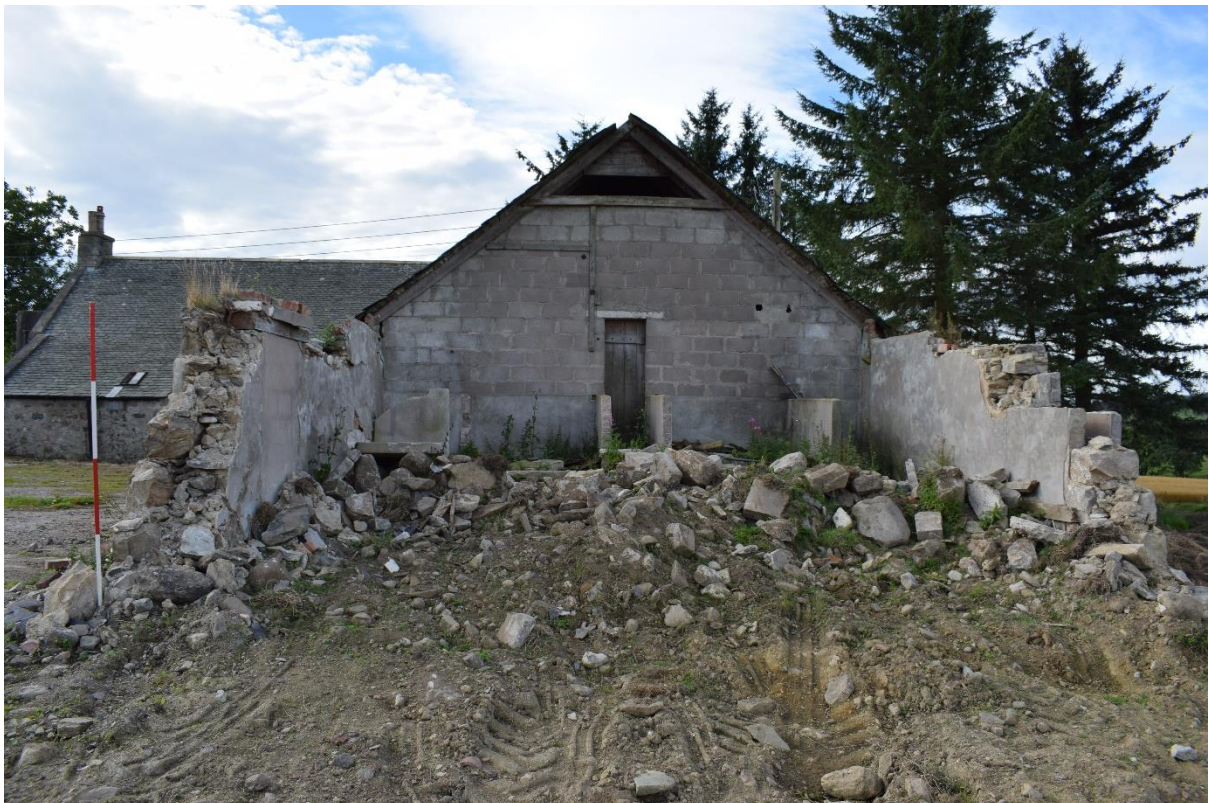
Illus 5 The interior of the demolished steading showing concrete lining, stalls and wall; facing S

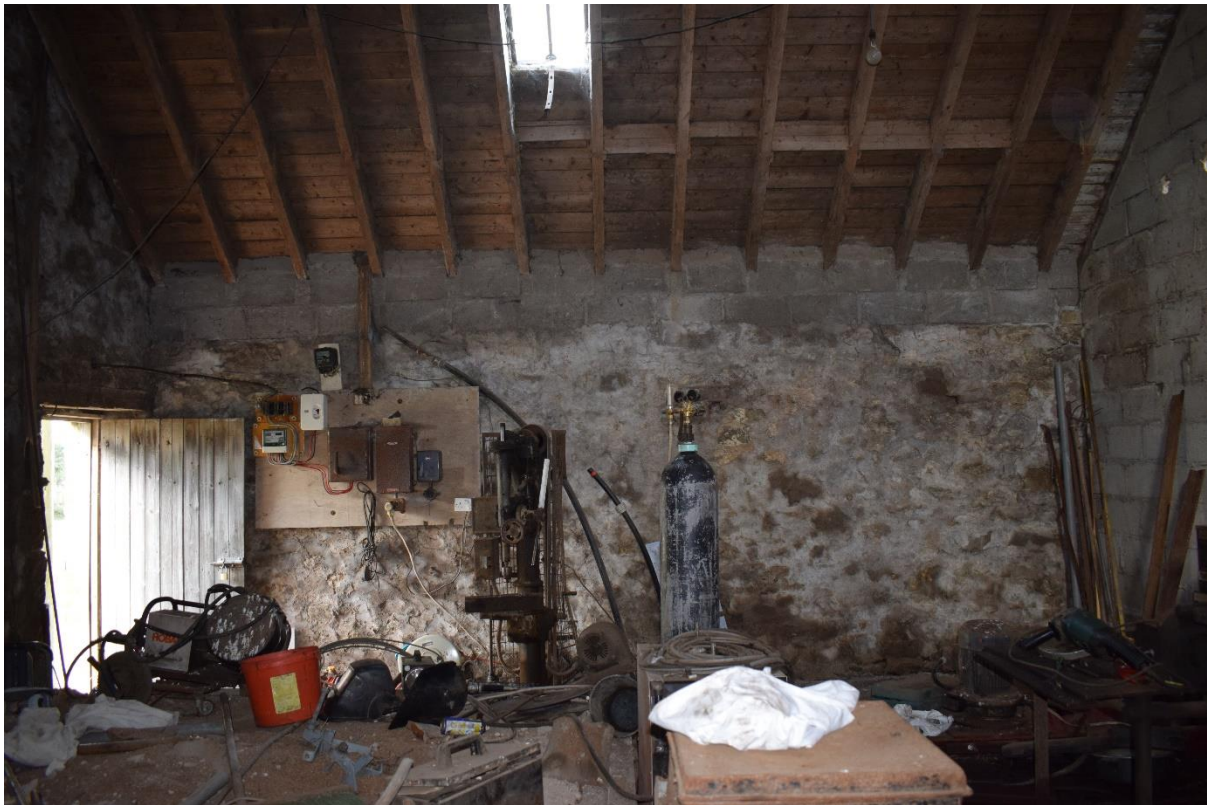
Illus 6 Interior of W wall S end with S4 (left); facing W
