**Lochmill Steading, Forfar, DD8 1TG
Report on Level 1 Standing Building Survey**

**Alison Cameron
Cameron Archaeology
23 September 2016**

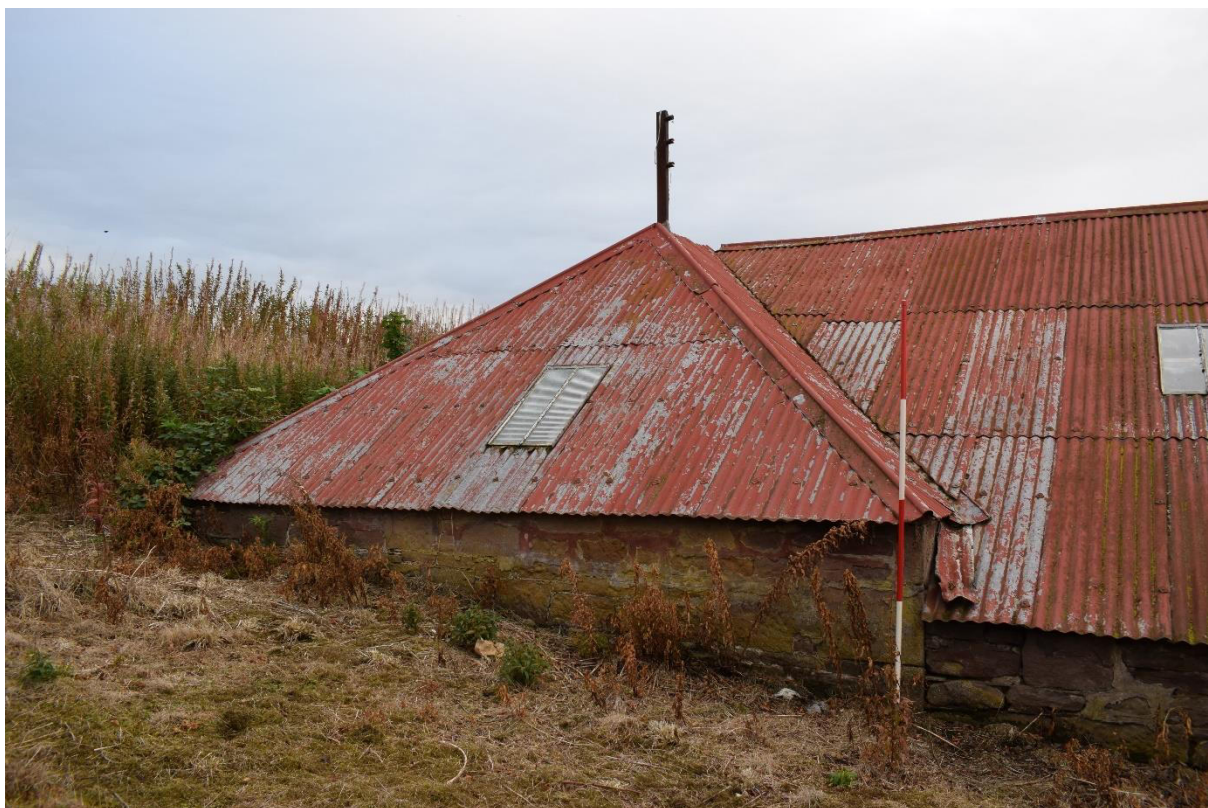
Illus 9 West wall Phase 1 Room 1 showing Phase 2 Room 1 butted on; facing ENE

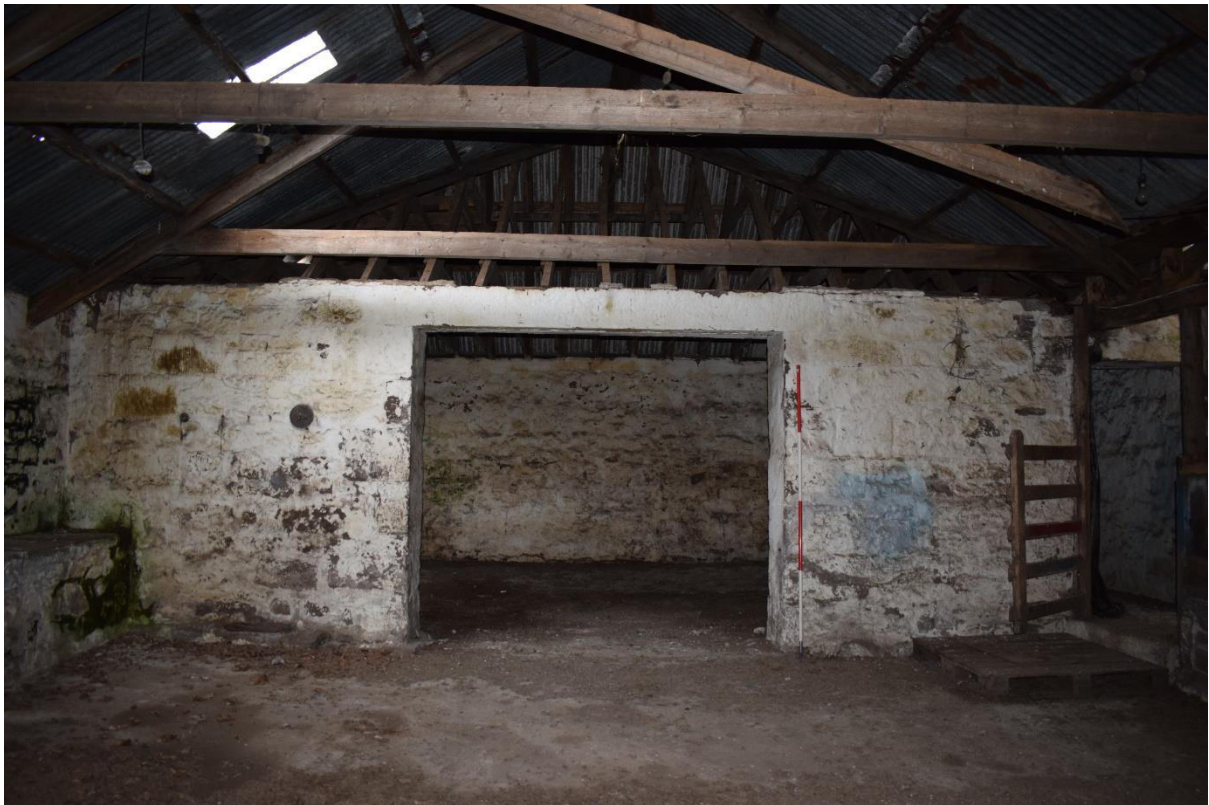
Illus 10 Phase 1 cart door D1 on S wall Room 3; the area in the foreground was an open courtyard surrounded by a low wall in Phases 1 and 2; facing NNW

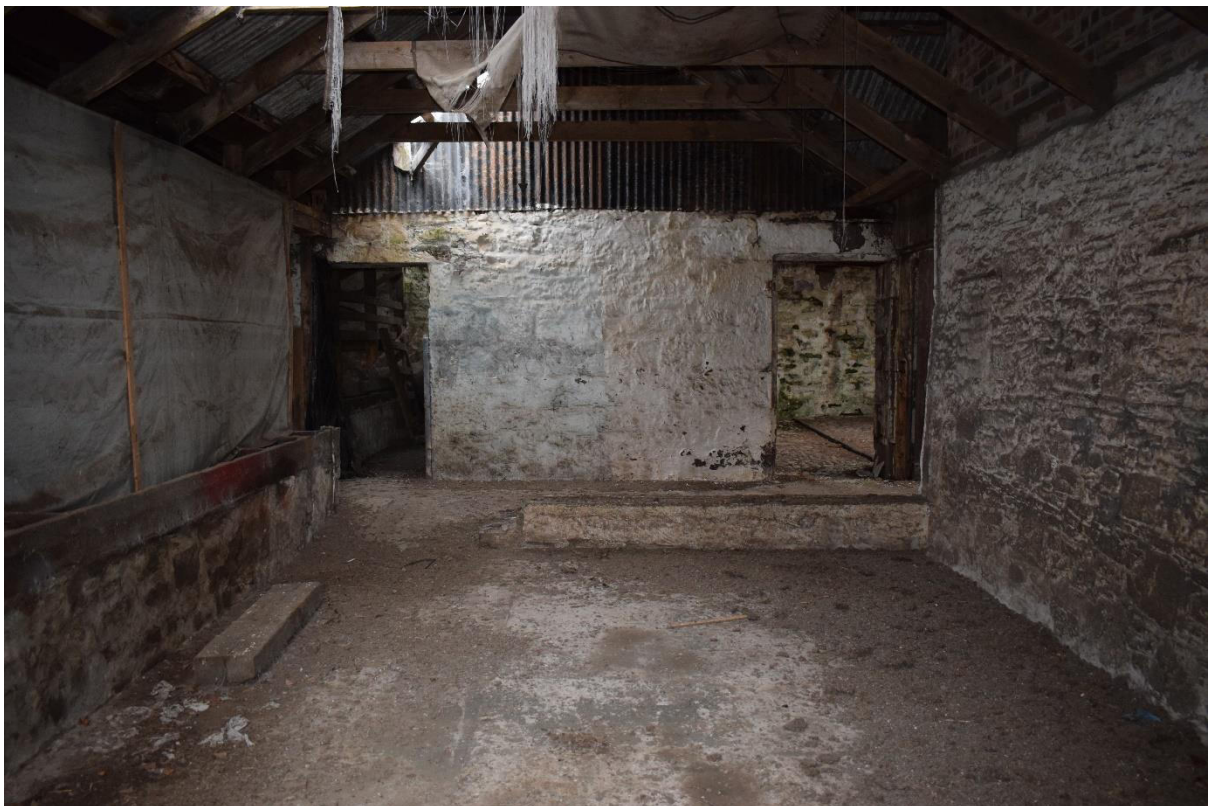
Illus 11 Phase 1 S wall Room 4 (centre, D2 left, D3 right) and courtyard Room 1 later enclosed in Phase 2. The low wall on the left is the slighted W wall of Room 2; facing NNW

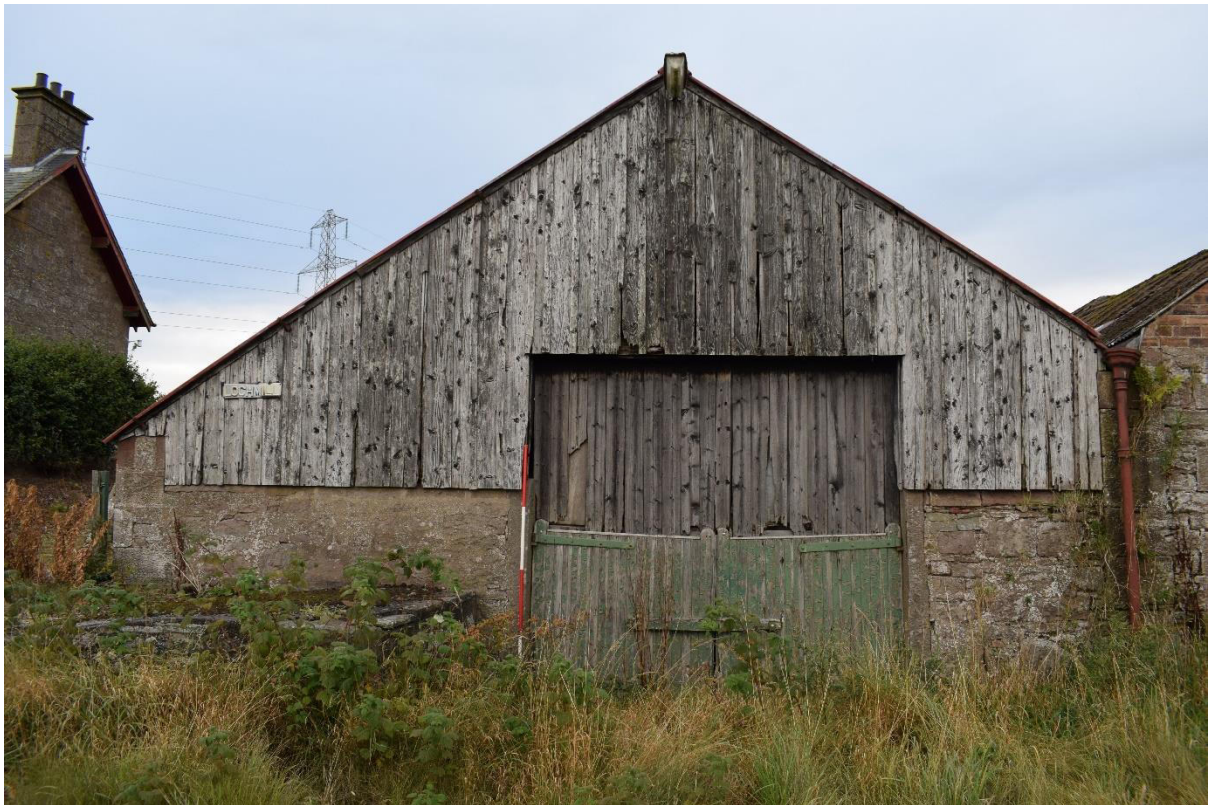
Illus 12 Phase 1 Room 1 S wall; this low wall originally surrounded a courtyard and was covered with wood and tin roof in Phase 2

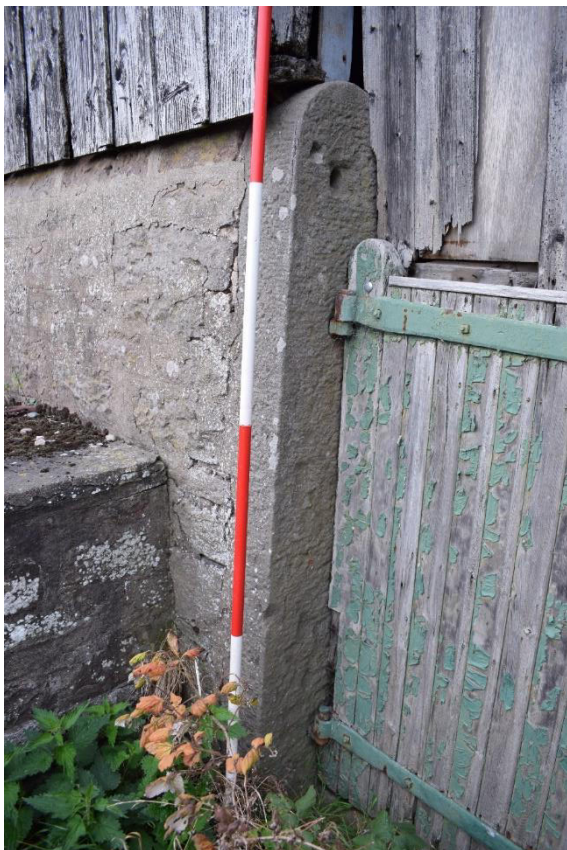
The gateposts on the S side of the courtyard F16 and F17, are rectangular blocks of grey sandstone, tapering to a rounded top; there are holes on the interior faces where gate fittings were inserted (Illus 12, 13). In Phase 3 this gate was converted into a door when a wooden superstructure and tin roof were added enclosing the courtyard.

Illus 13 Gatepost F16 W side of former gateway D8; facing NW

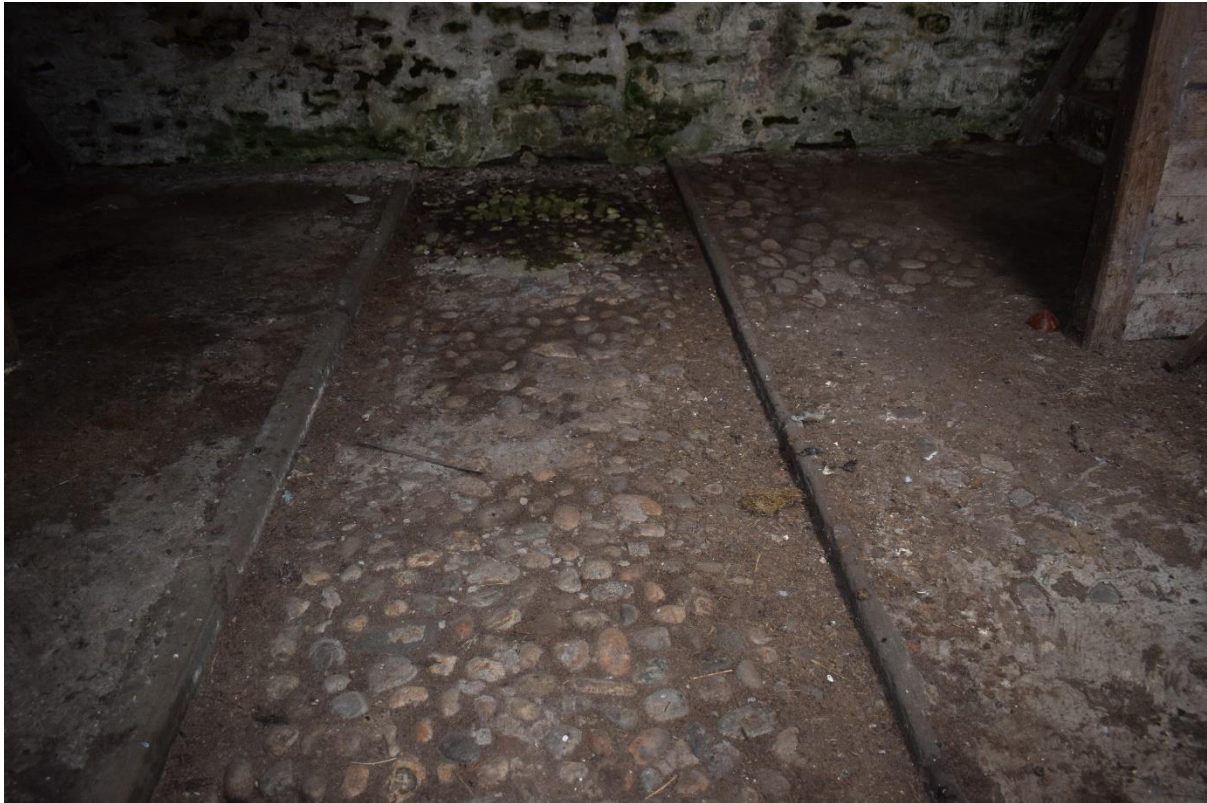
Room 4 has a well-preserved waterwashed cobbled floor (F10; Illus 14, 15) with central drain; the wooden stall dividers are *in situ* and there are low walls along the interior of the W and E walls which form the base for stoneware feed and water troughs. Room 5 also has these fittings but the floor has been covered in concrete.

Illus 14 Phase 1 Room 4 with cobbled stone floor, F10 and wood stall partitions (right, F11); facing NNW

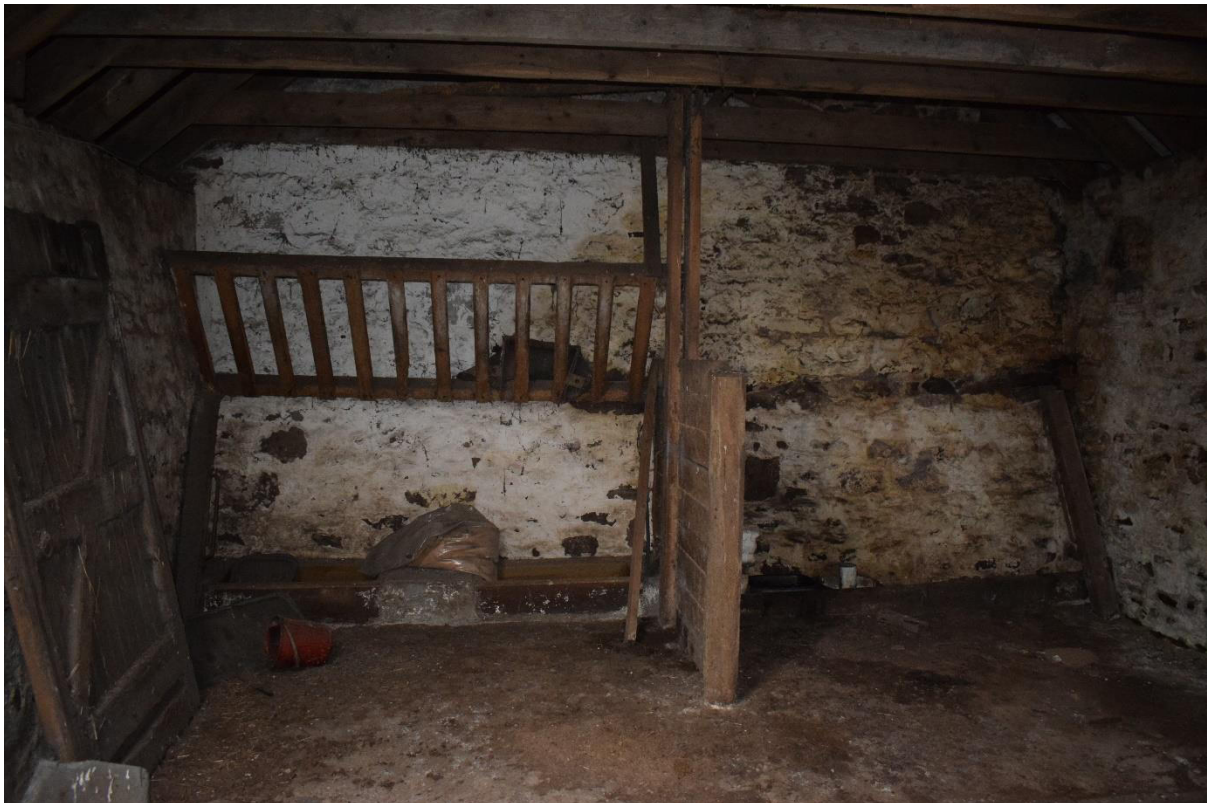
Illus 15 Phase 1 Room 4 wooden stall partitions, F11 and base for stoneware troughs F12 below; facing W

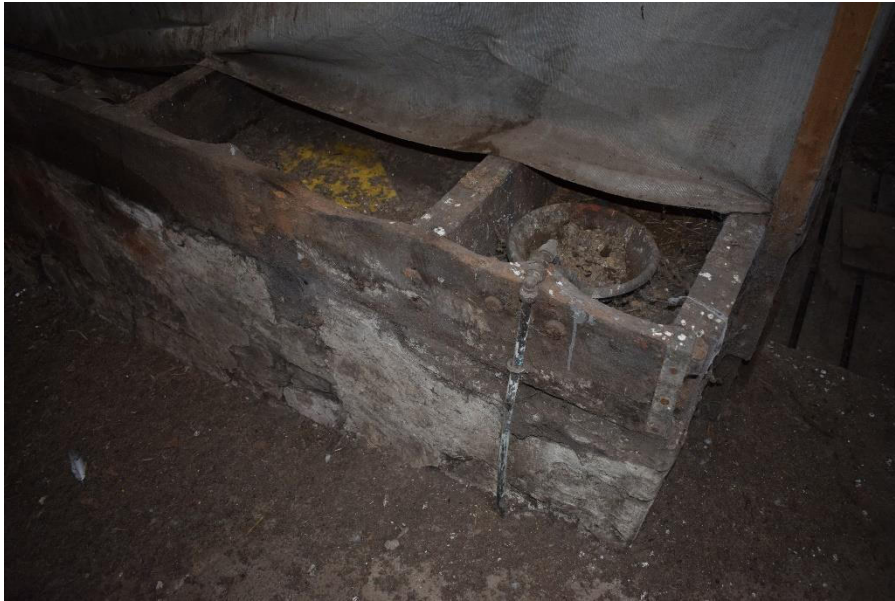
Illus 16 After reduction in height of W wall Room 2, the wall stub was used as a base for wooden feed and water troughs , F18; facing SW

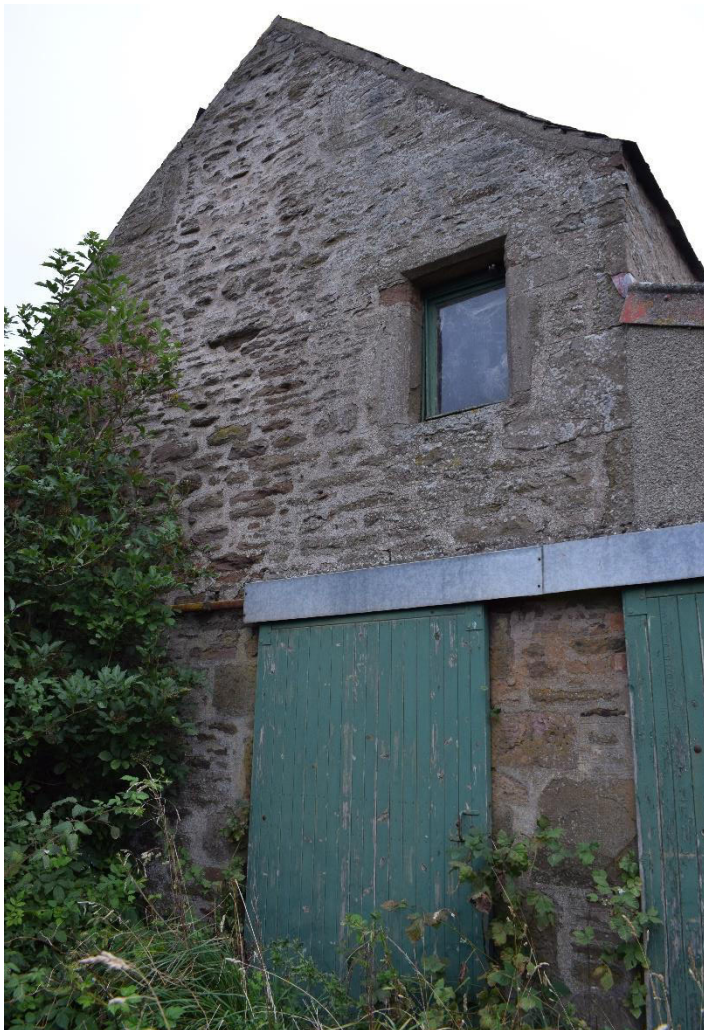
Illus 17 Room 6 W wall with D9 (bottom) and W10 (above, open); there are the remains of two windows which have been blocked and the new roofline cut through them, F3 and F4 (top). The original large sandstone quoins can be seen between the two green wooden doors; facing NE

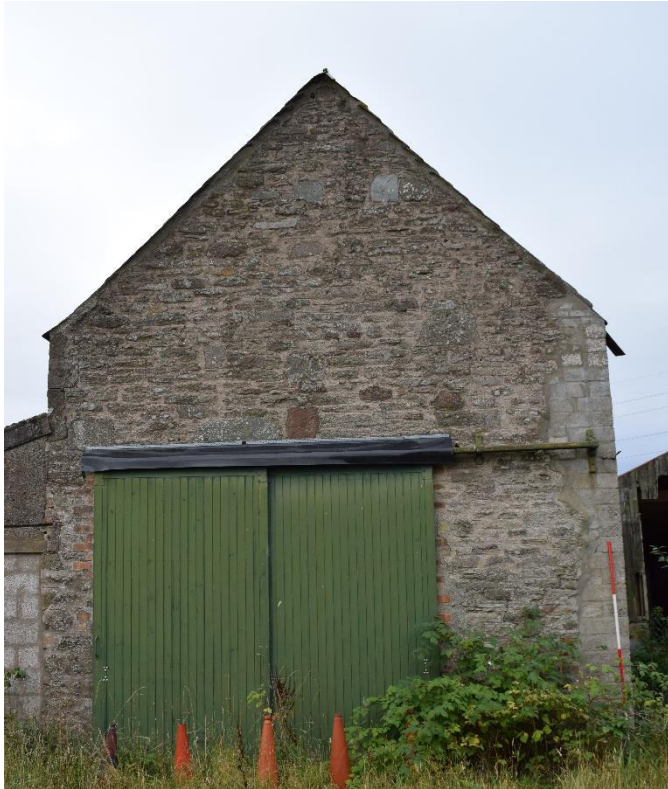
Illus 18 Room 6 E wall with D25; an extension on the N side of this building was removed in Phase 4 and the wall rebuilt with concrete bricks; this wall has been heavily rebuilt; facing WSW

A horse mill at the E side of the farm was removed and replaced with a brick shed, Room 13. A small extension on the E end of Room 6 was demolished and the wall was rebuilt (Illus 18).

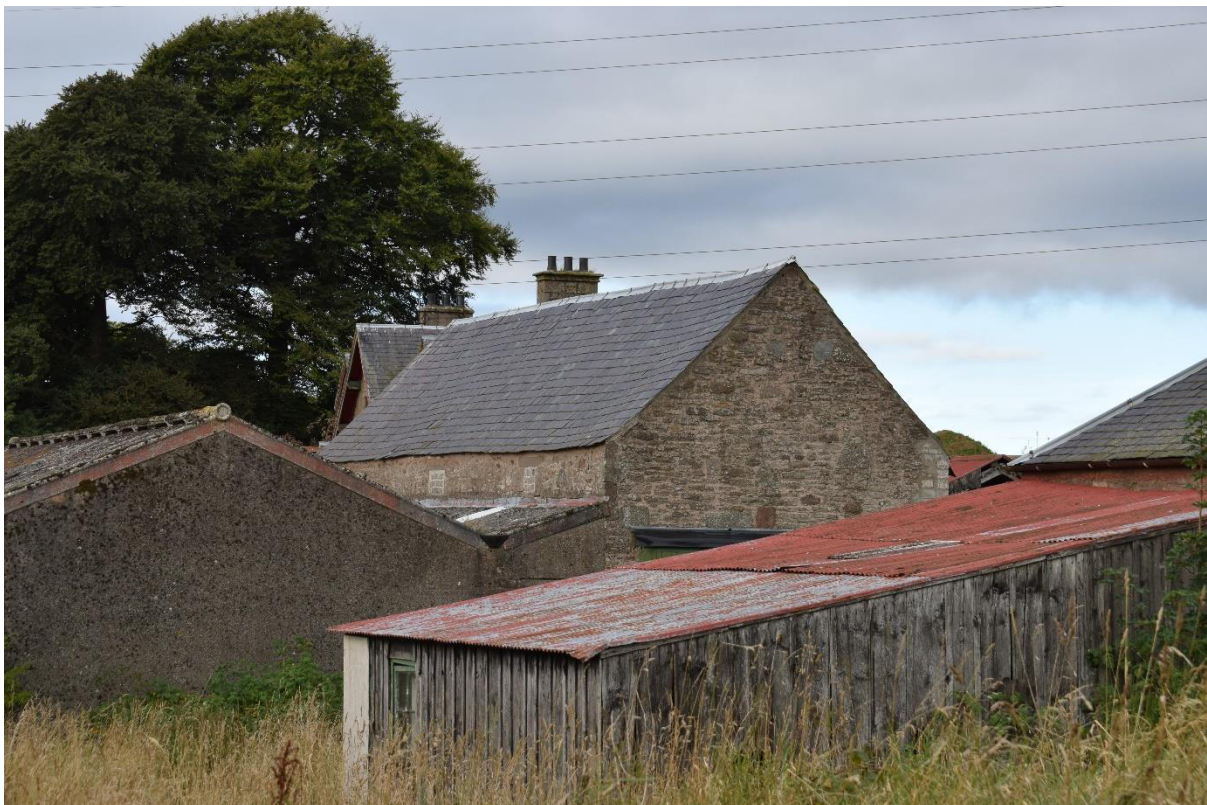
Illus 19 Room 6 (centre) view of S wall (left) with upper windows W11, W12, W13 (l-r) and E gable (right); facing WNW

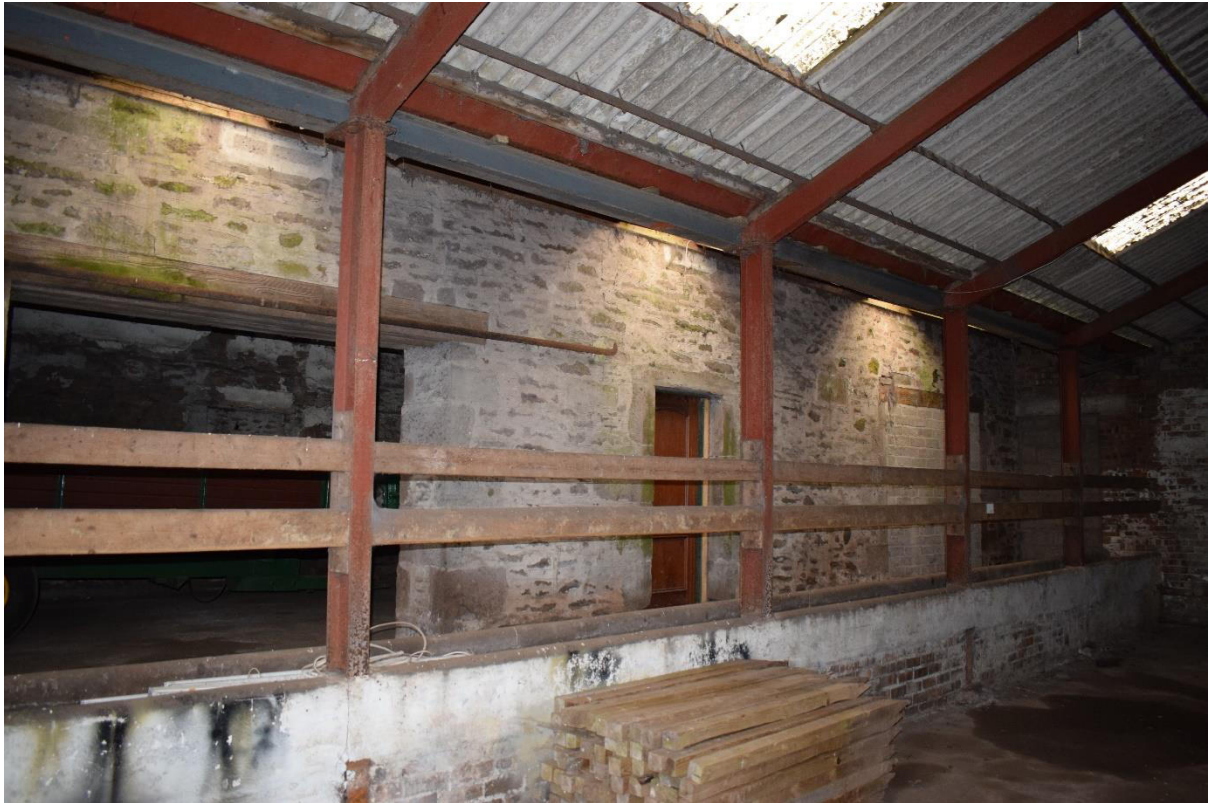
Illus 20 Room 6 S wall, D11, D12, D13 (l-r) later built into brick shed Room 7 in Phase 4; facing NE

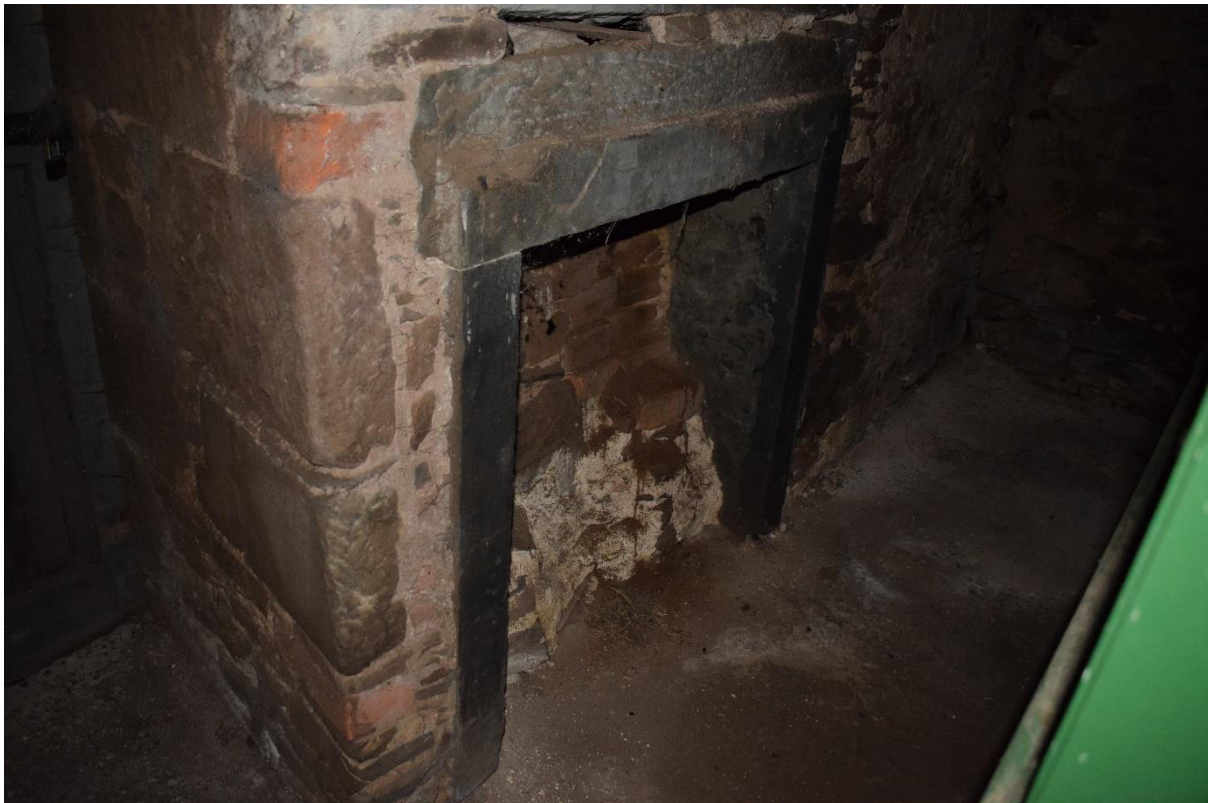
Illus 21 Room 6 W wall fireplace F1; there was poor access to this room; facing NW

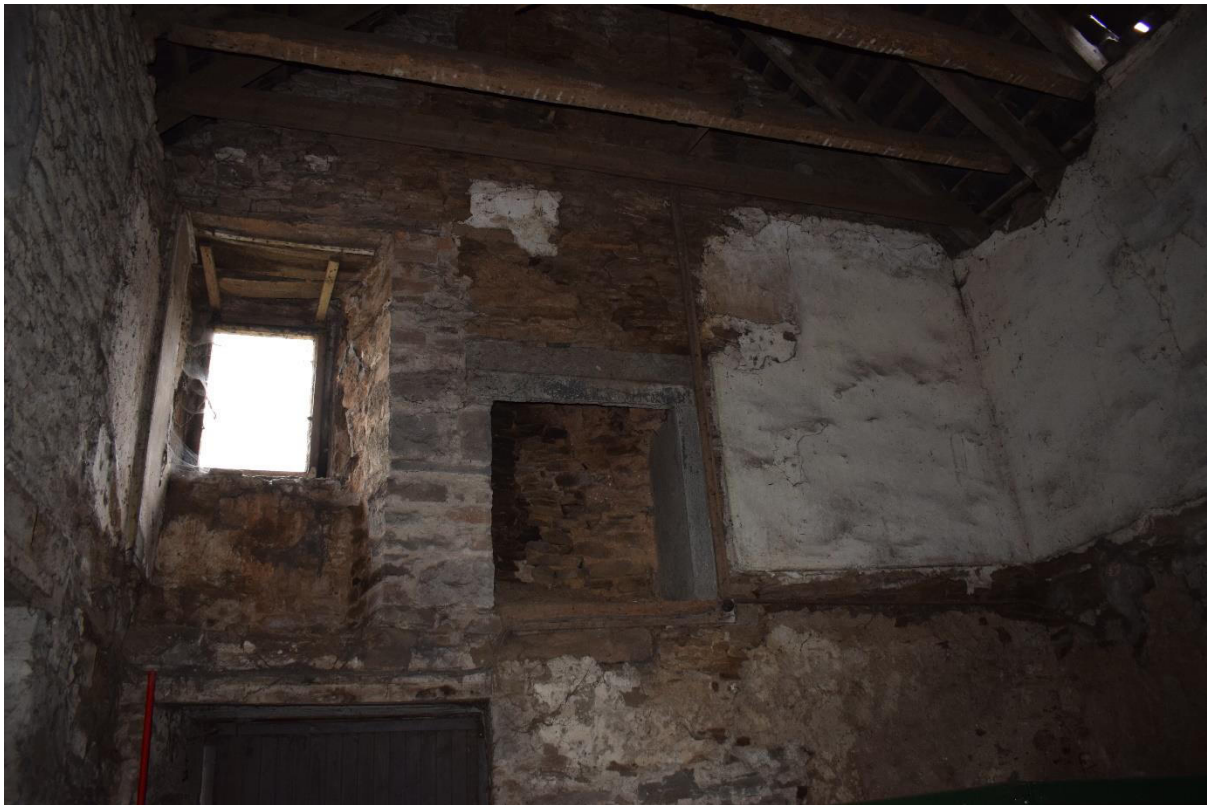
Illus 22 Room 6 W wall fireplace F2 on first floor above F1 with window W10 (left) and door D9 (bottom left); facing WNW

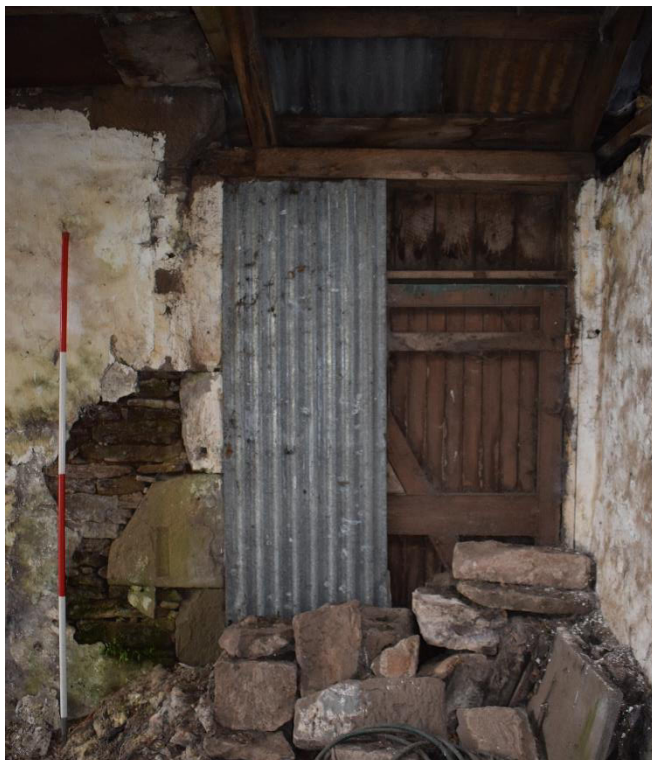
Illus 23 Sandstone quoins forming NW corner Room 6 (left) and E wall Room 2 (right); this wood door was inserted in the void and the room enclosed and roofed in Phase 2 forming Room 13; facing SSE

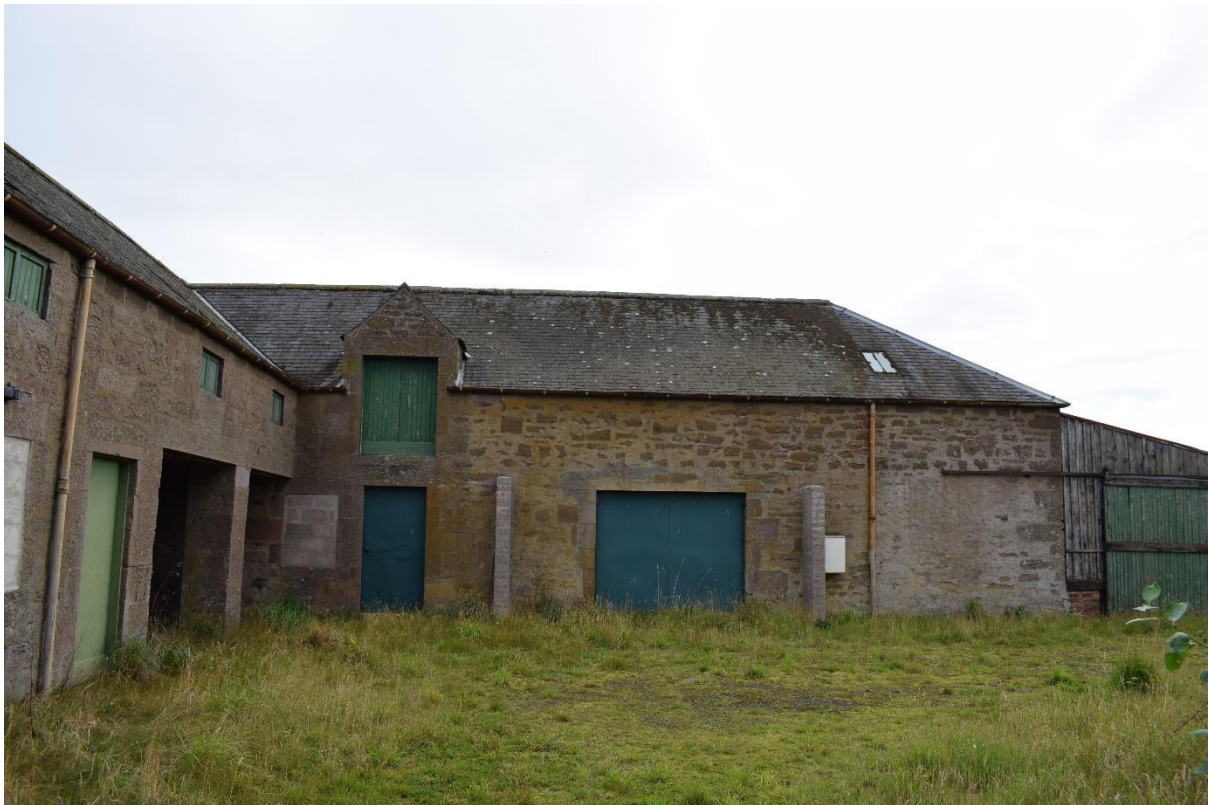
Illus 24 Phase 1 W wall Room 9 (right) with Room 8 and cart doors D21 and 22 (left); facing ENE

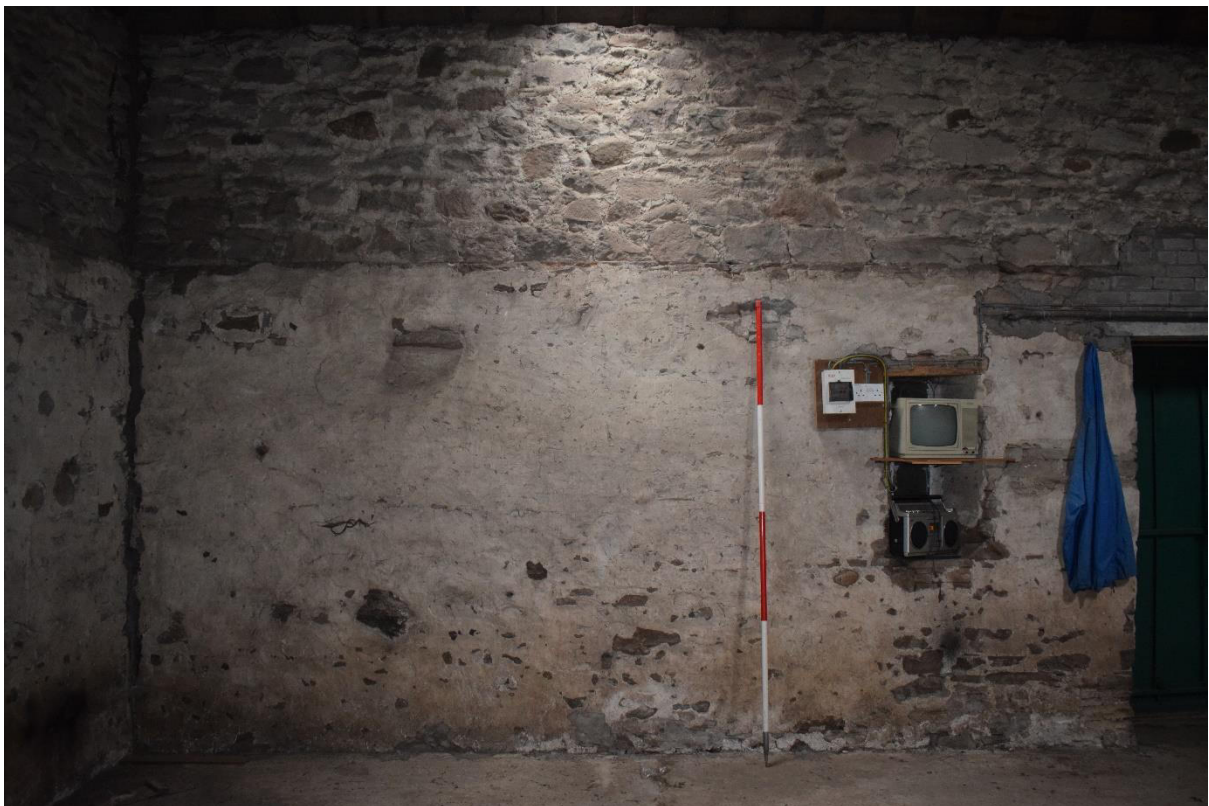
Illus 25 Phase 1 Room 9 W wall showing original height of walls, corbels F6 (centre), window W8 and D18 (right). The stone at the top has been added when the roof height was raised and new roof added; facing W

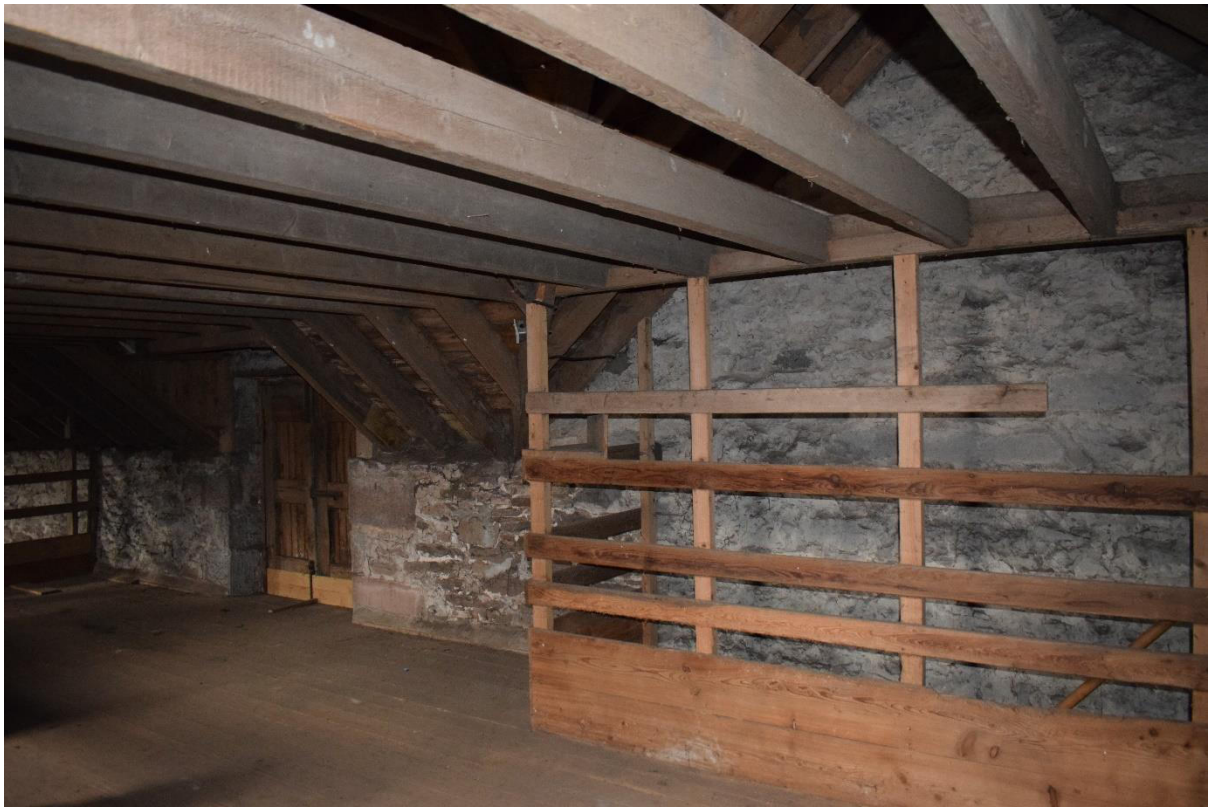
Illus 26 Phase 1 room 9A first floor door D16 (left); facing SW

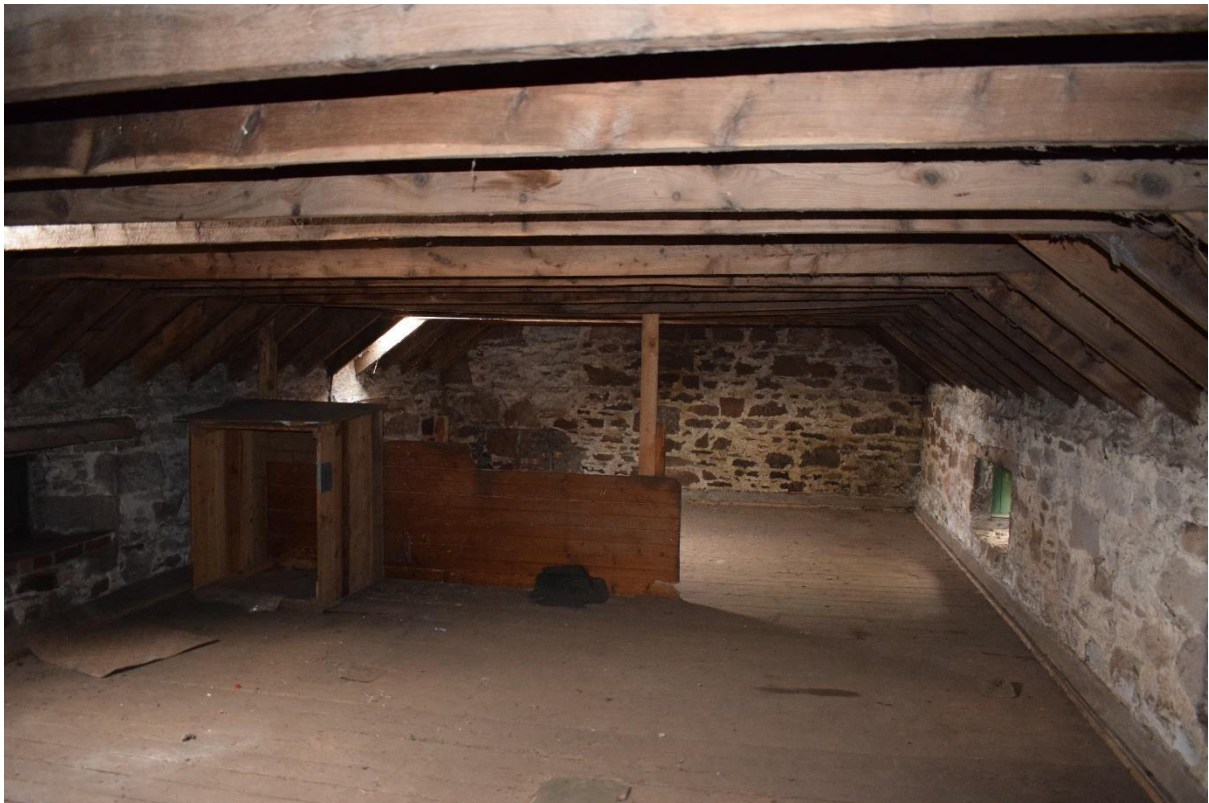
Illus 27 Phase 1 Room 8a first floor with small ventilation windows (eg W16; right); facing W

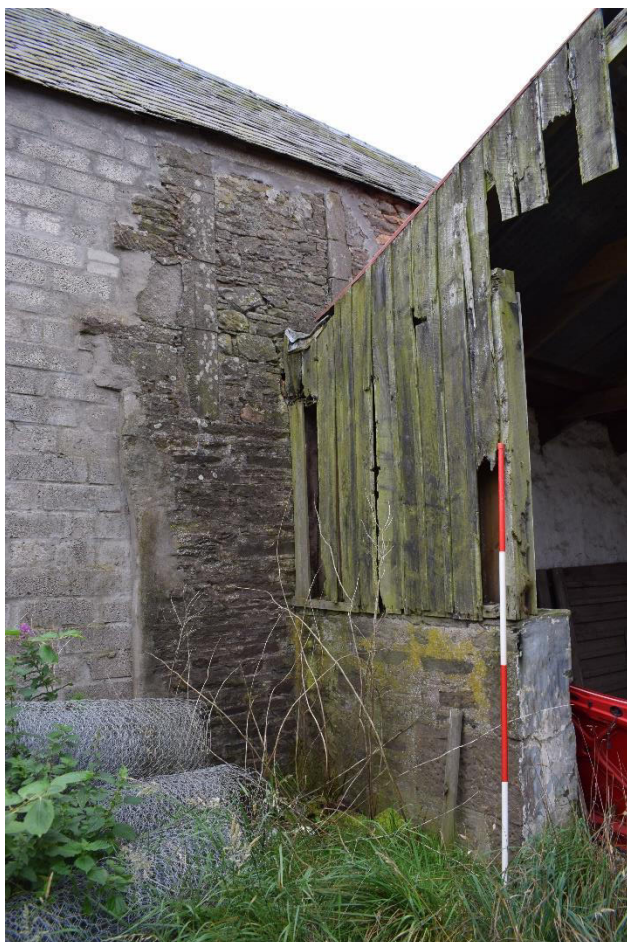
A wood shed Room 11 was added to the S end of Room 9 and an extension on the N side of Room 6 was demolished and wall rebuilt (see Illus 28).

Illus 28 N wall Room 6 with blocked window W15 (top); the low wall on the right was originally probably a courtyard wall and this was then enclosed in Phase 3 when the wood superstructure was constructed forming Room 13. The breeze blocks on the left were used to rebuild the wall when a small extension was taken down in Phase 3; facing SW
