**Mill of Kelly Sawmill, Tarves, Aberdeenshire, AB41 7EN
Report on Level 1 Standing Building Survey**

**Alison Cameron
Cameron Archaeology
9 October 2016**

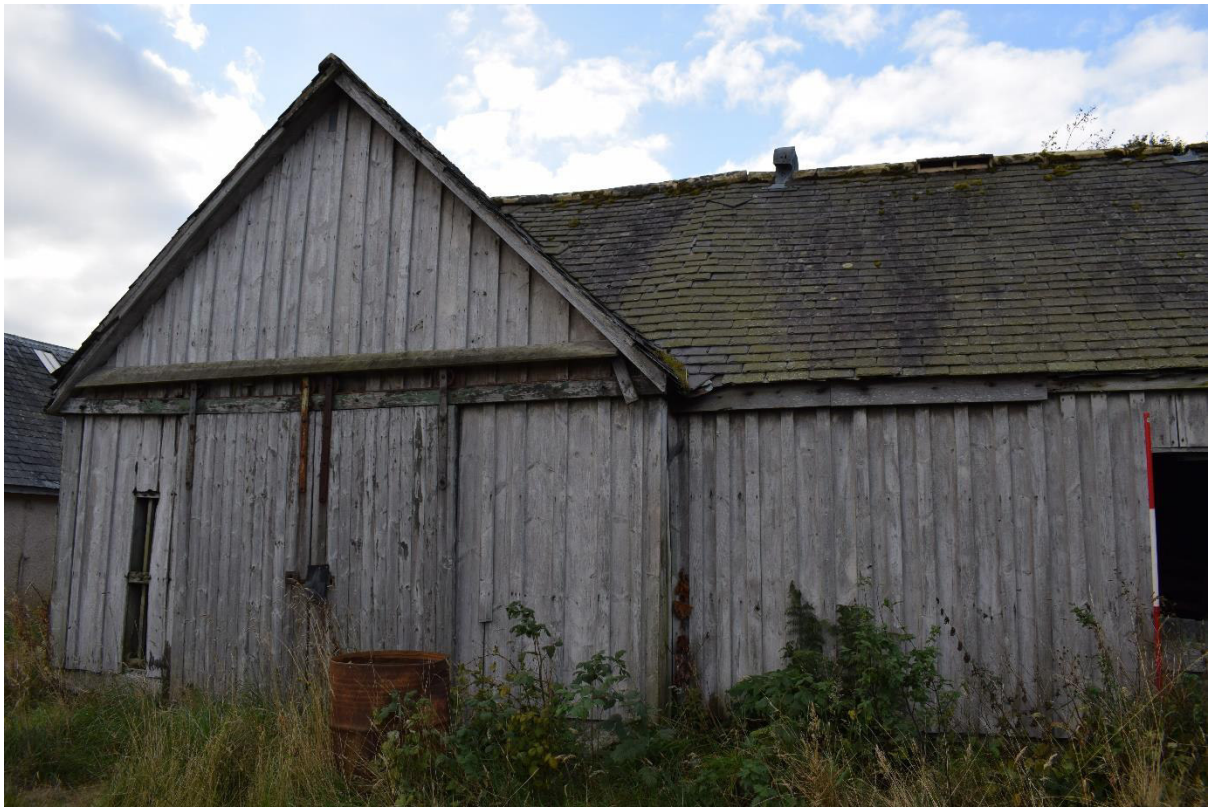
Illus 5 Building 1 N wall showing wood plank construction; facing SSE

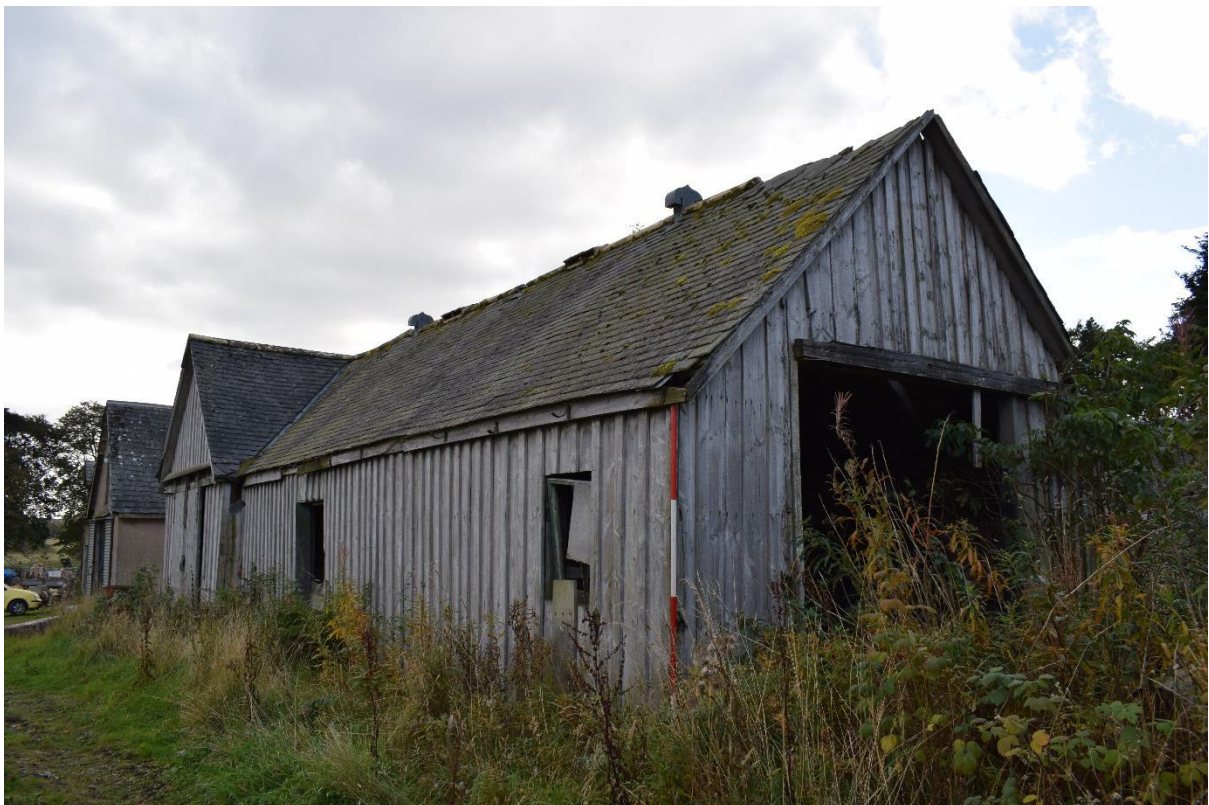
Illus 6 Building 1 from NW showing D7 (right); facing ESE

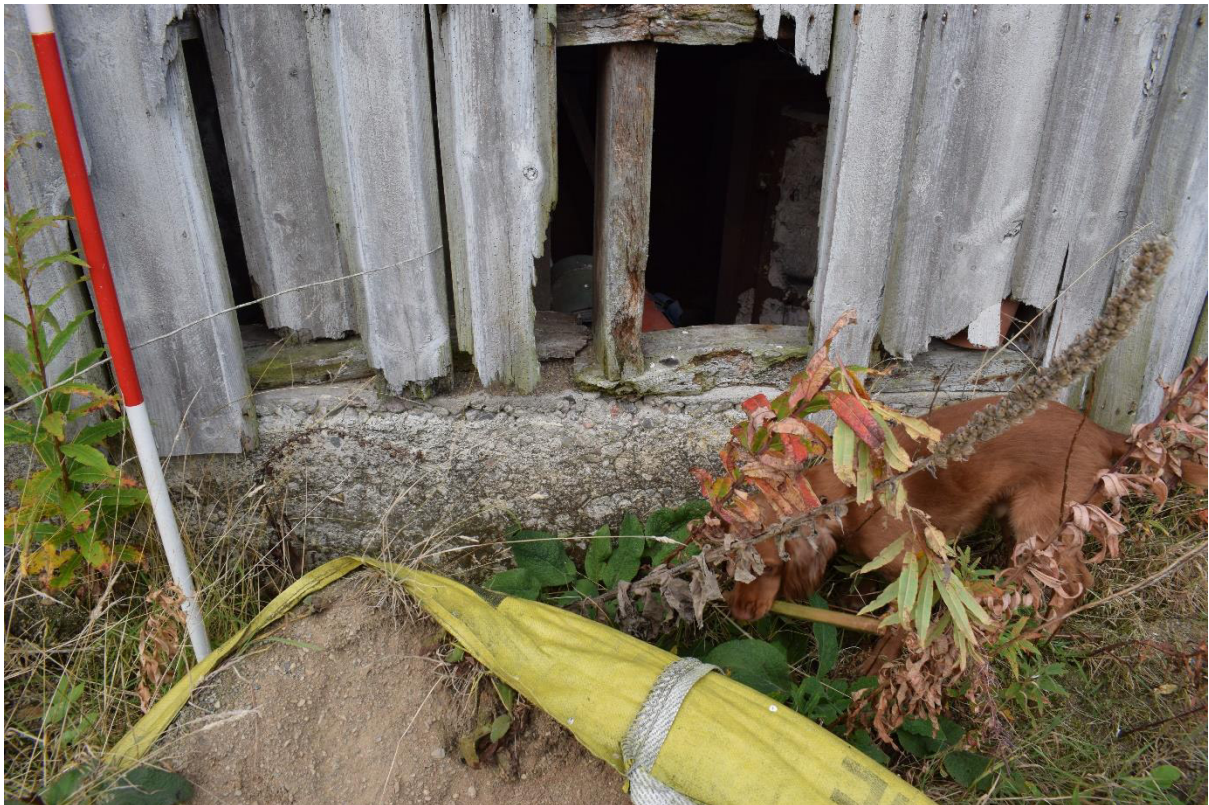
Building 1 is L-shaped, 15m W-E and 11.5m N-S (Illus 4-7). There are large doors in the W and N gables and the S end of the E wall and smaller doors and windows in other walls. The W end has been slightly extended since the Second Edition OS map. There is a concrete foundation (F1, Illus 8) 0.5m deep under the E wall which is not visible on the N wall; access to the W wall was not possible to determine whether there was a similar foundation on other walls. The walls are of wooden planks which have been repaired many times (Illus 9). The roof appears in moderate condition (Illus 10) suggesting this has been replaced since the original construction.

Illus 8 Building 1 E wall showing concrete foundation F1; facing W

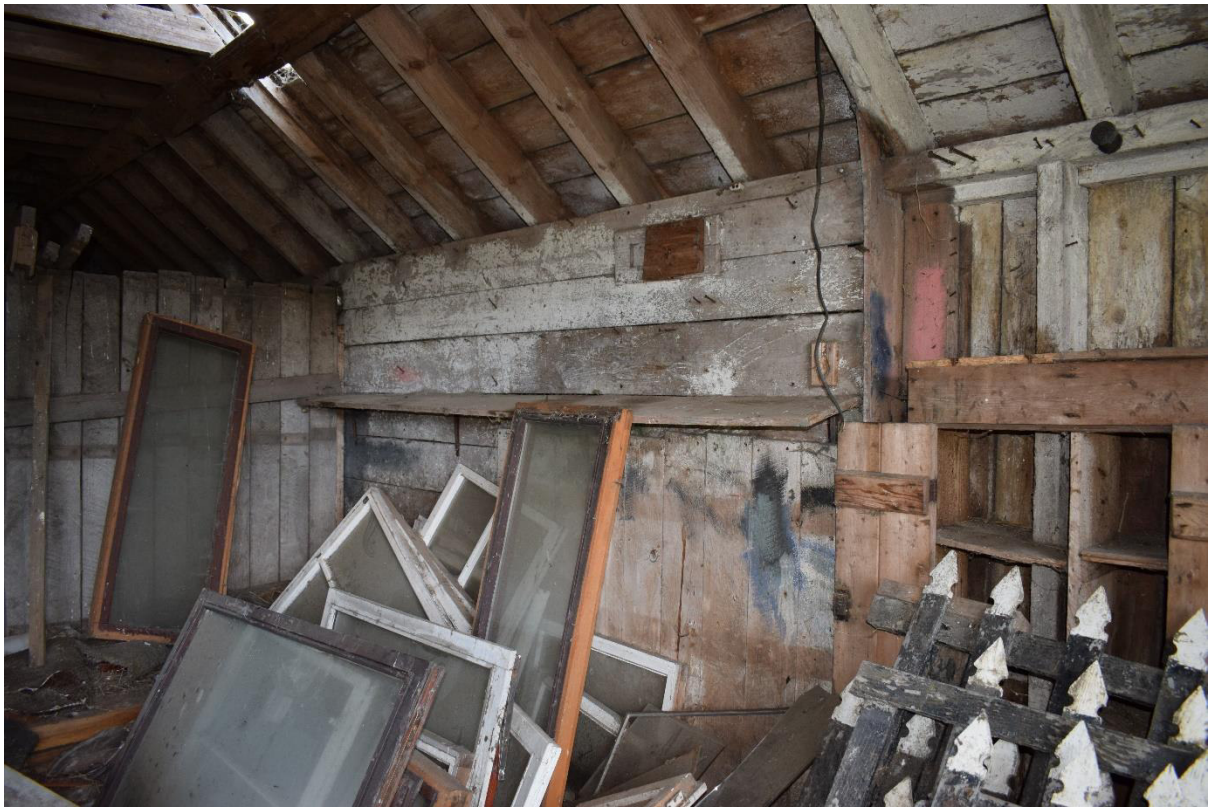
Illus 9 Building 1 interior S wall of W room from D7 showing repairs and alterations; facing SE

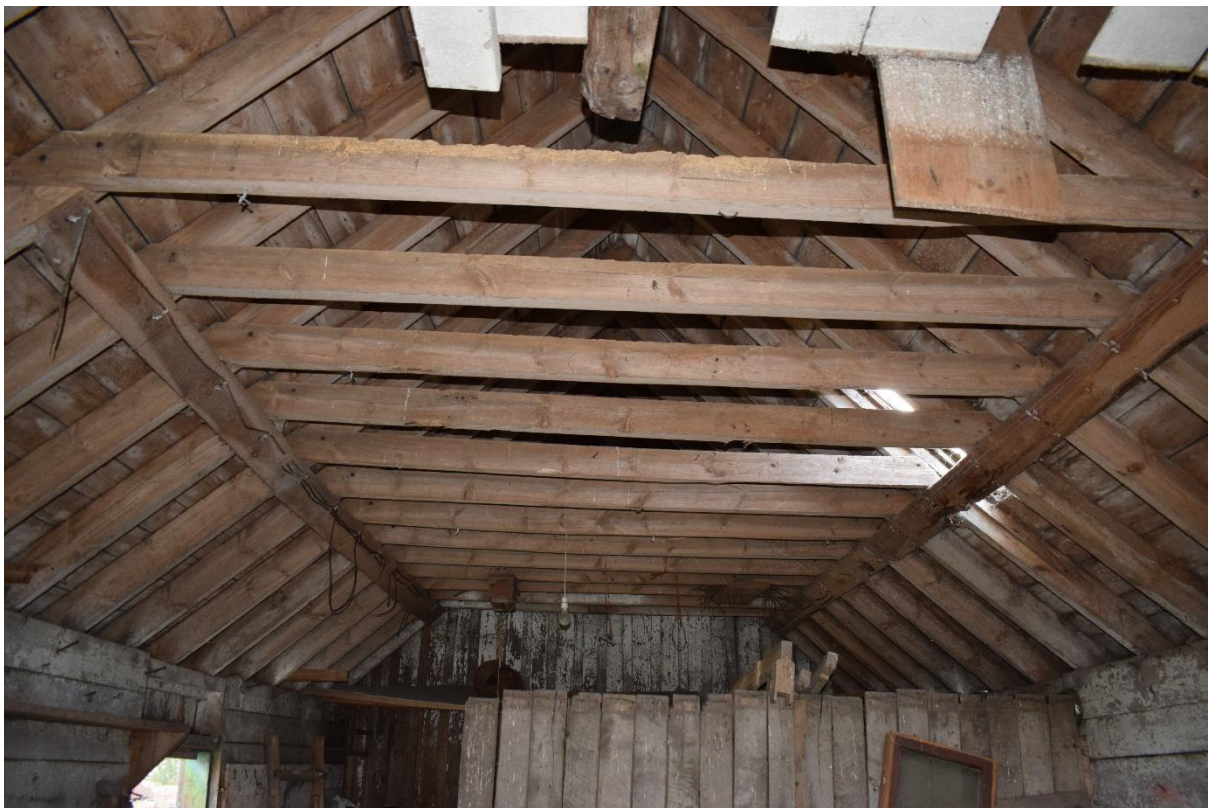
Illus 10 Building 1 wooden roof timbers from D7; facing E

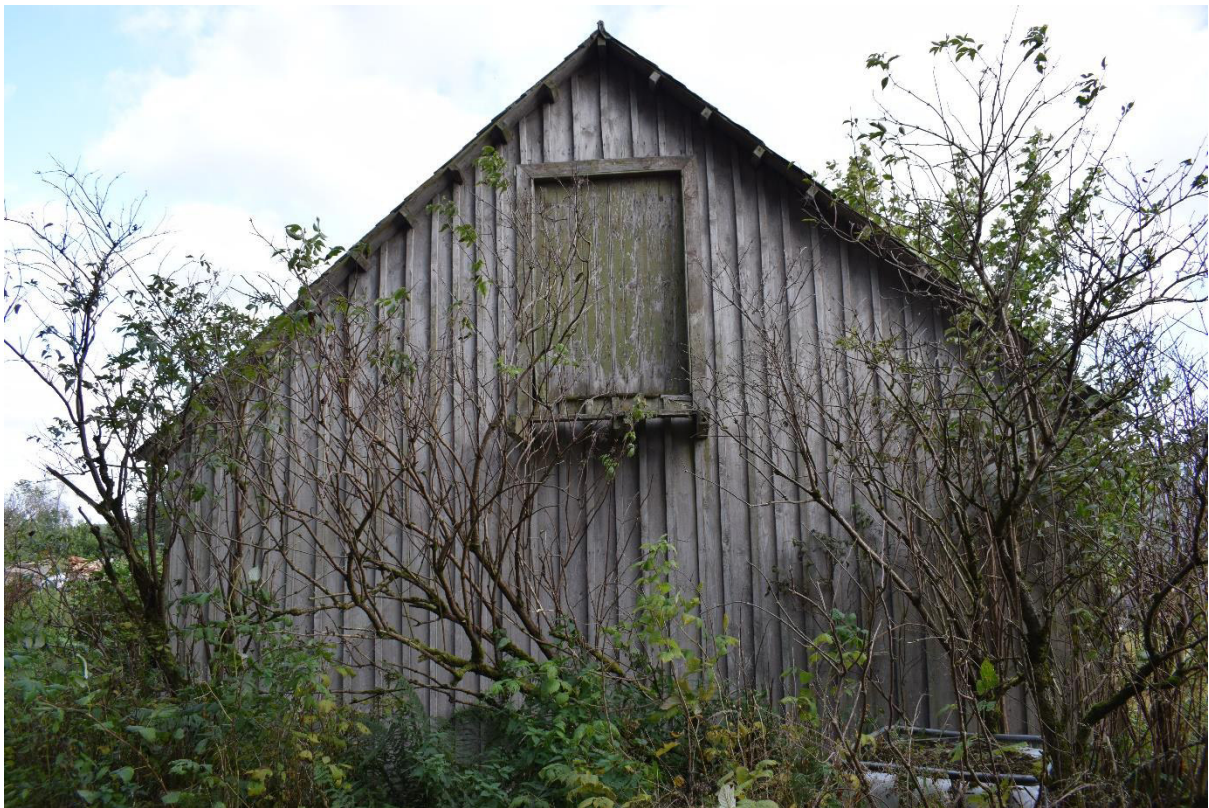
Building 2 is rectangular, 25m N-S and 7.5m W-E. There are 3 rooms (N, centre and S). The centre and S rooms are constructed from wood planking with grey slate roof (Illus 12-13) and wood planking floor (Illus 15). There are large doors in the E wall and windows in the W wall (not accessible). There is a first floor window in the S gable with the remains of a wooden platform (Illus 14).

Illus 14 Building 2 S gable with first floor D9; facing N

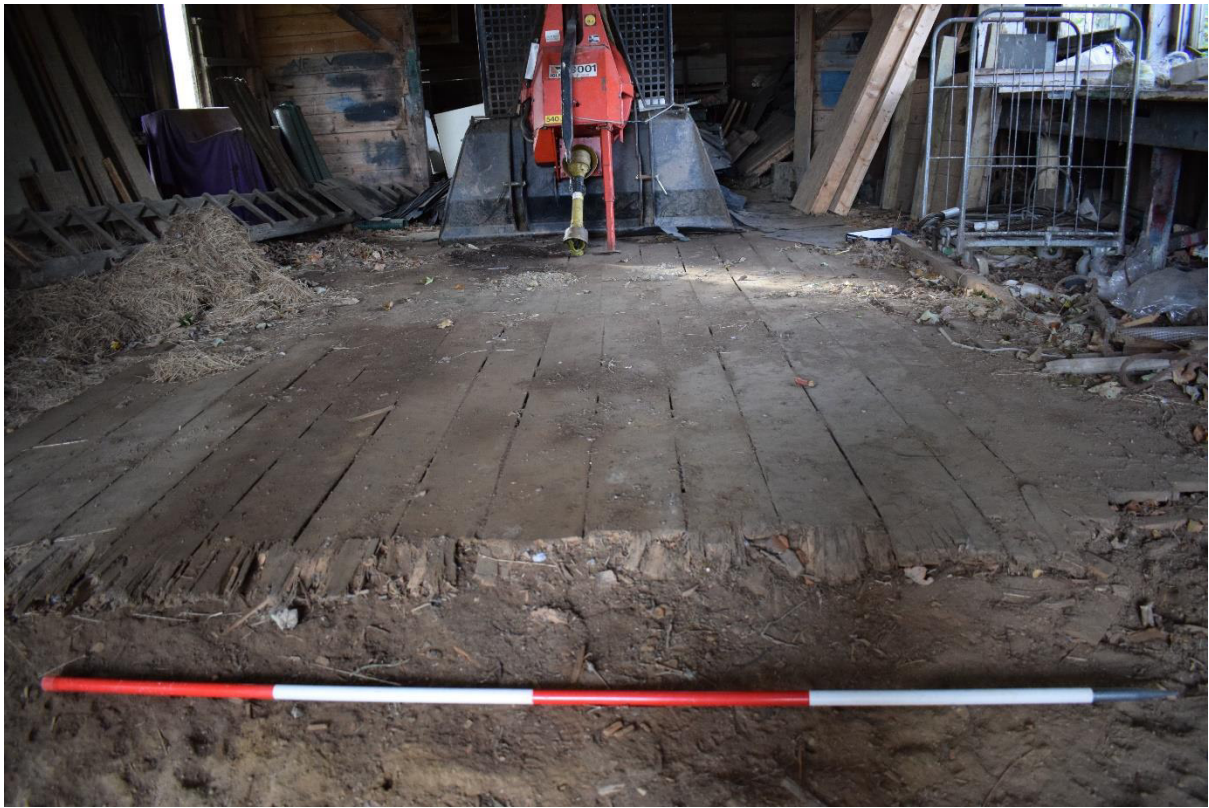
Illus 15 Building 2 wood planking floor in central room; facing S

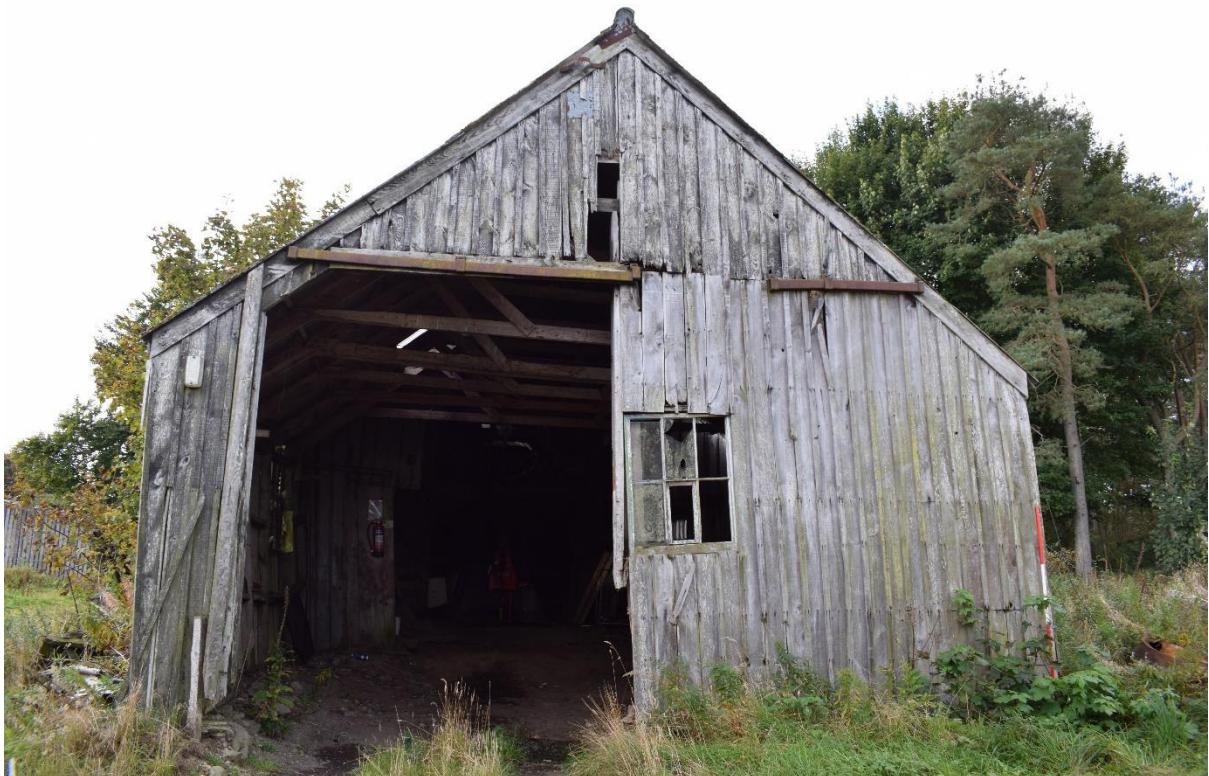
The N room has been added later and the W and E walls and roof are constructed from asbestos cement roofing panels on a wooden frame (Illus 19), the N gable is constructed from short wooden panels secured with iron nails (Illus 16) and the floor is earthen (Illus 17-19). There are stone foundations under the E wall (F2; Illus 17) and the N wall (F3, Illus 18).

Illus 16 Building 2 N gable D4 and W4; facing S

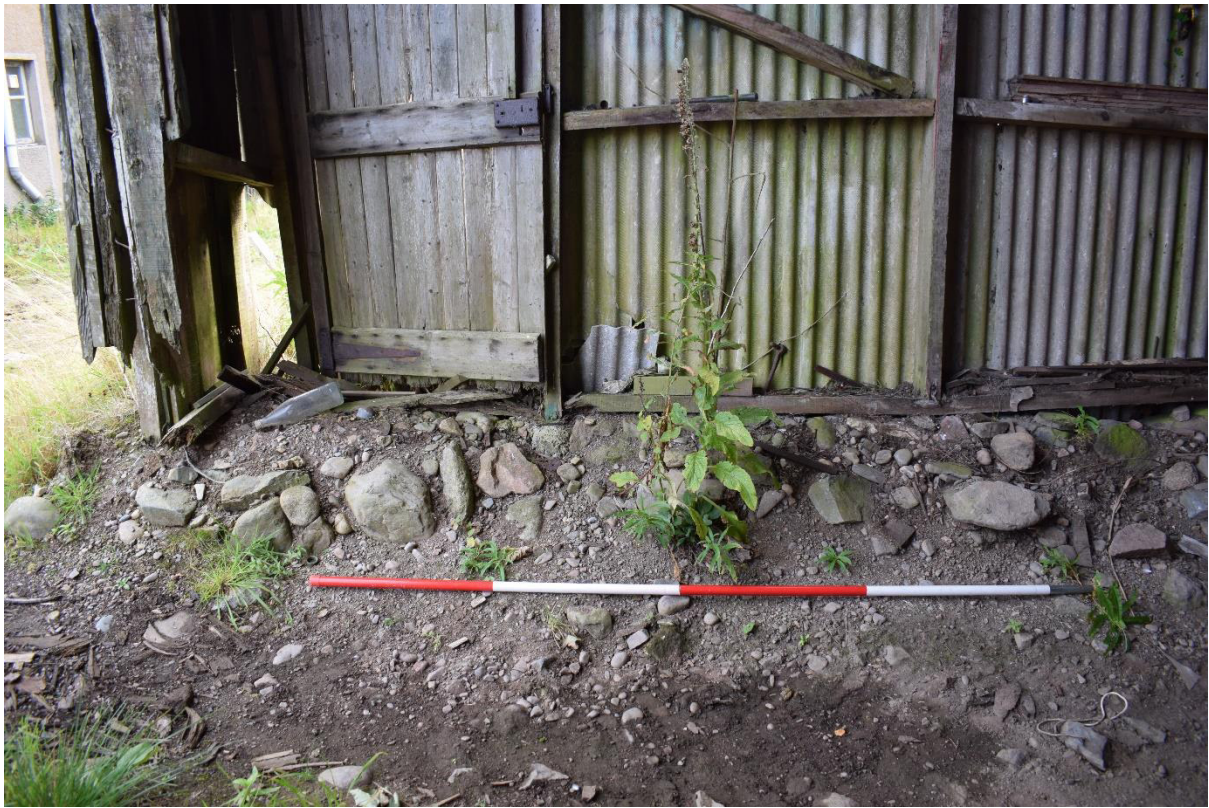
Illus 17 Building 2 stone foundation F2 under E wall; facing E

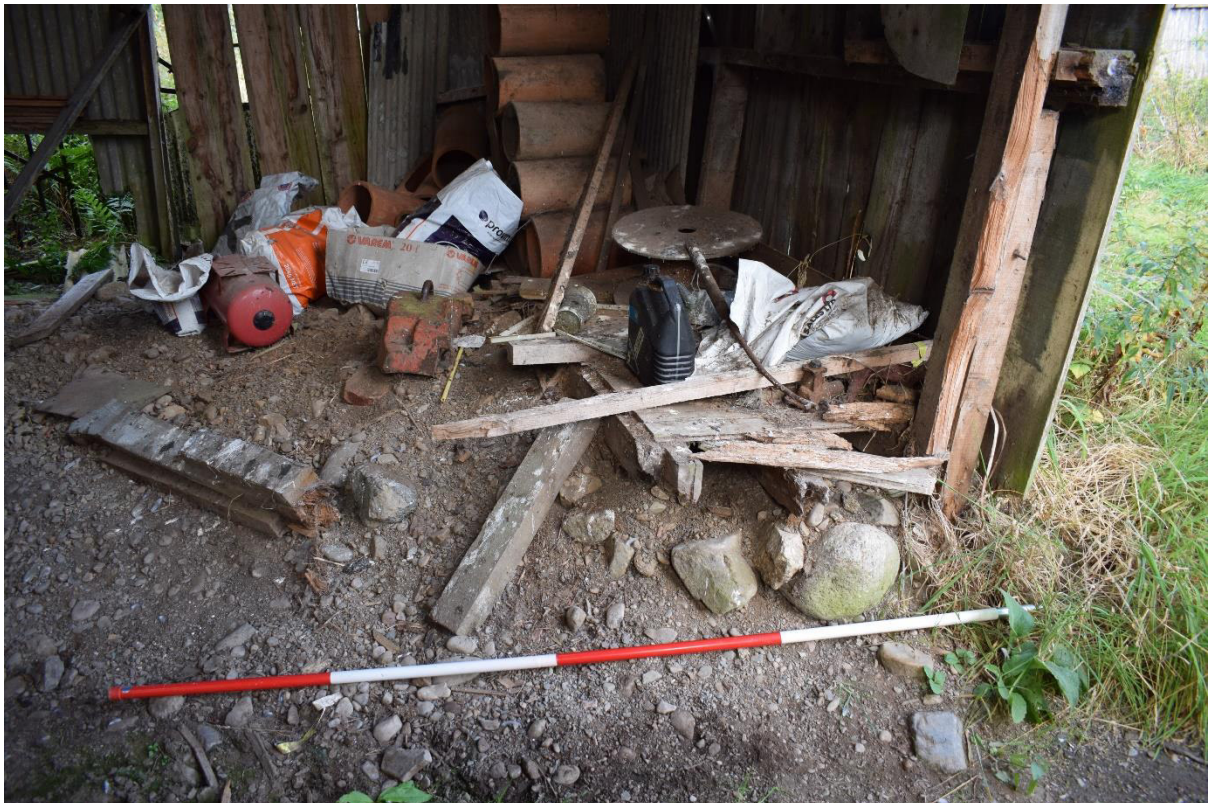
Illus 18 Building 2 stone foundation under N wall, F3

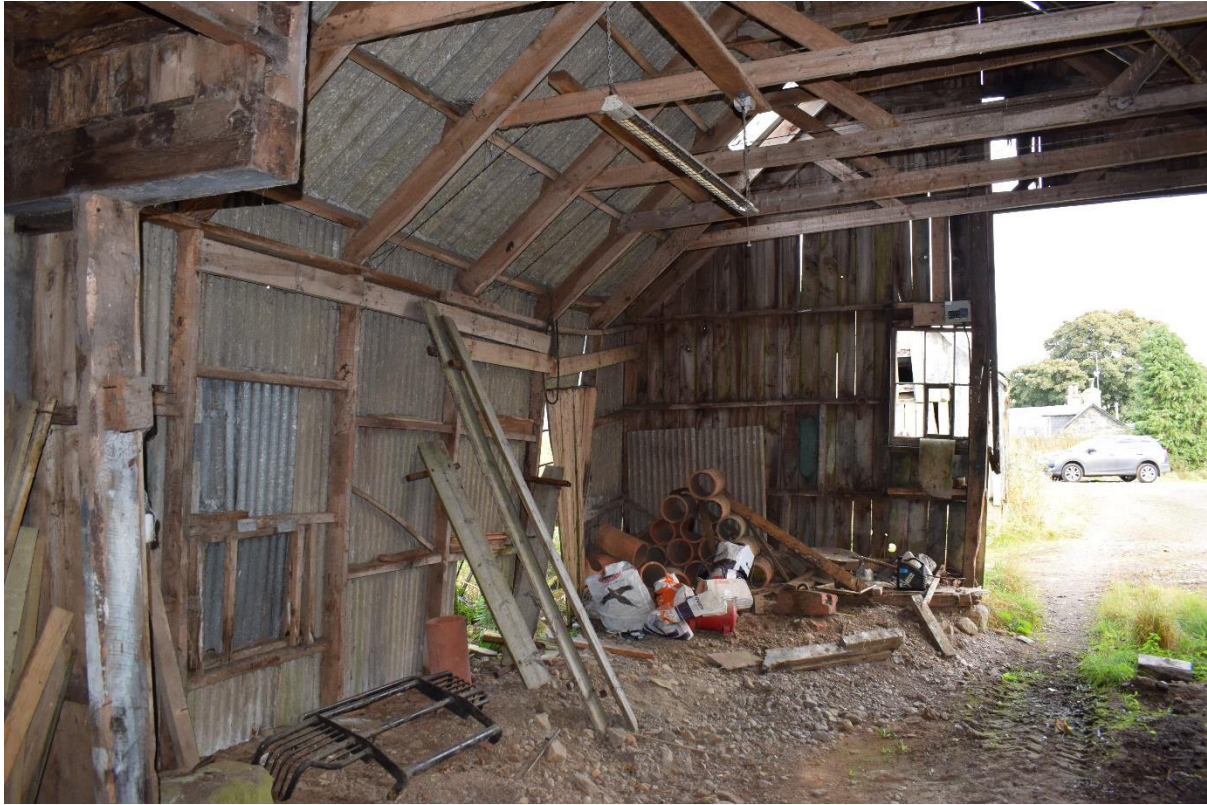
Illus 19 Building 2 extension constructed from asbestos cement roofing panels; facing NNW
