**Mearns Coastal Church, Castle Street, Johnshaven,
Aberdeenshire, DD10 0JA**

Report on Level 1 Standing Building Survey

**Alison Cameron
Cameron Archaeology
24 October 2016**

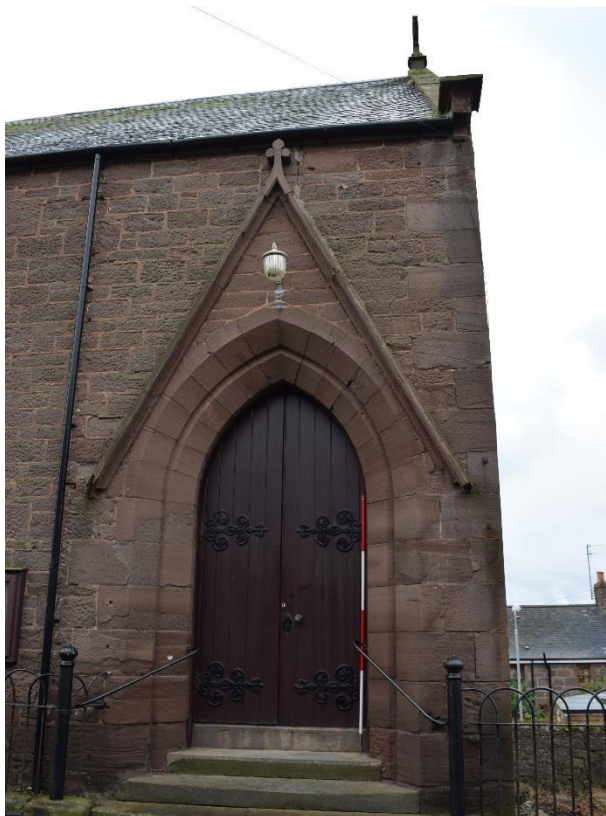
The pointed arch door and windows in the WNW façade on the basement level were built in Phase 1 and reflect the slope into which the church was built. The principal door on the NNW facade (D1) would have been the main access for church services and D2 would have been the main access into the vestry and session house. These apertures have sandstone mouldings around the pointed arch door D2 and windows W7 and W8 (Illus 6, 9)

Illus 7 Principal doorway in N wall (D1) showing a recessed pointed arch doorway with decorative pediment above; facing SSE

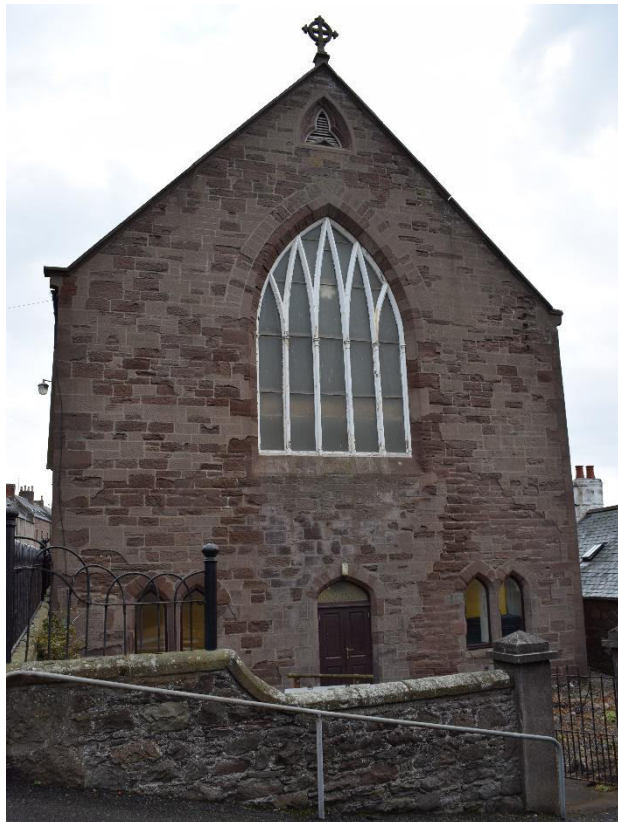
Illus 8 WNW gable with stone celtic cross finial (F11, top) small window W5, main window W6 and basement floor access door D2 with W7 (left) and W8 (right); facing ESE.

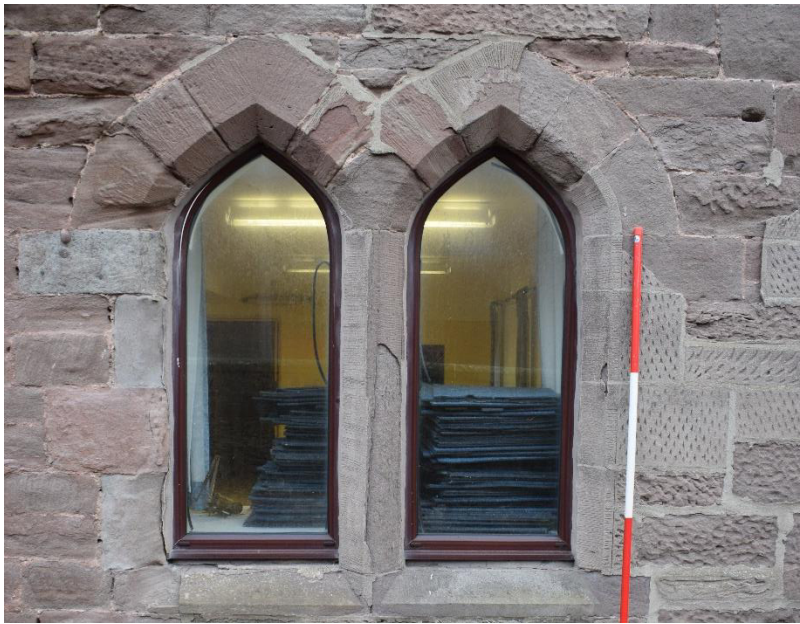
Illus 9 W8; facing ESE

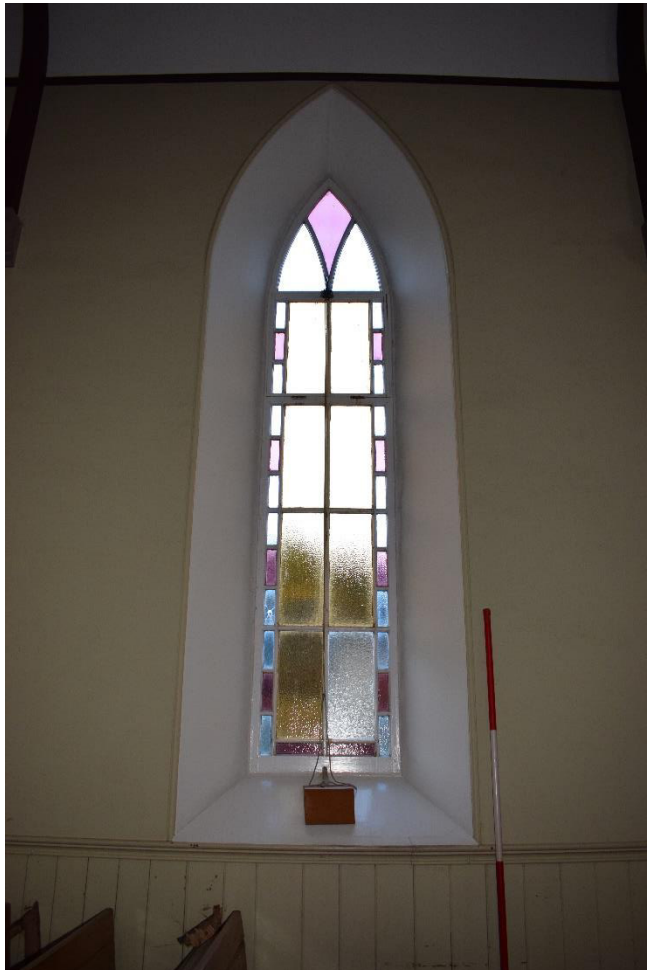
During this period there may have been a smaller roof space with small windows W5 and W20 lighting this area; there is now no evidence of this division as there is no access to the majority of the current roof space. Door D1 appears to date to this phase and allows access directly to the main body of the church. The windows have stained glass (Illus 10) which may date to this earliest phase.

Illus 10 W2 showing stained glass and wood paneling below with some pews still in situ; facing NNW

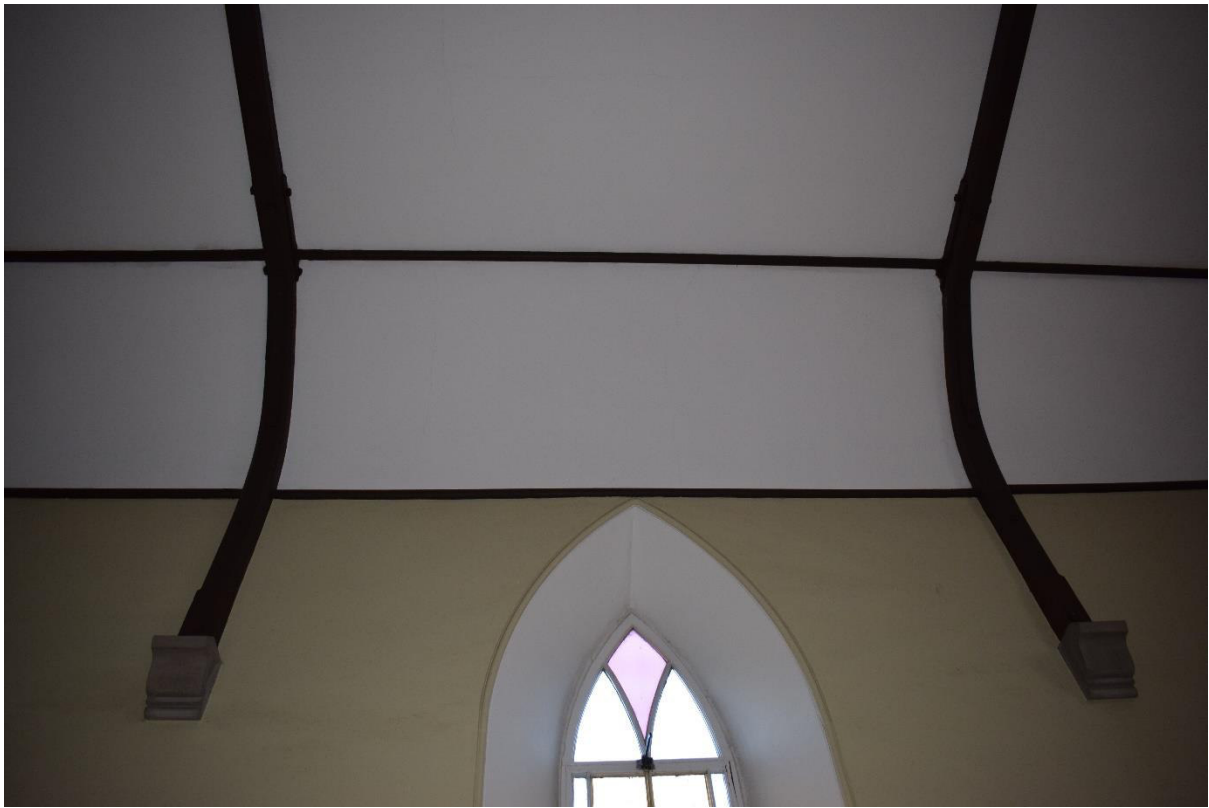
Illus 11 W2 (below) with mock wooden beams and corbels (F5, left; F6, right); facing NNW

The floor was inserted on the attic level dividing W6 at the WSW end. Decorative corbels and roof beams F4, F5 and F6 were added at this time (Illus 11).

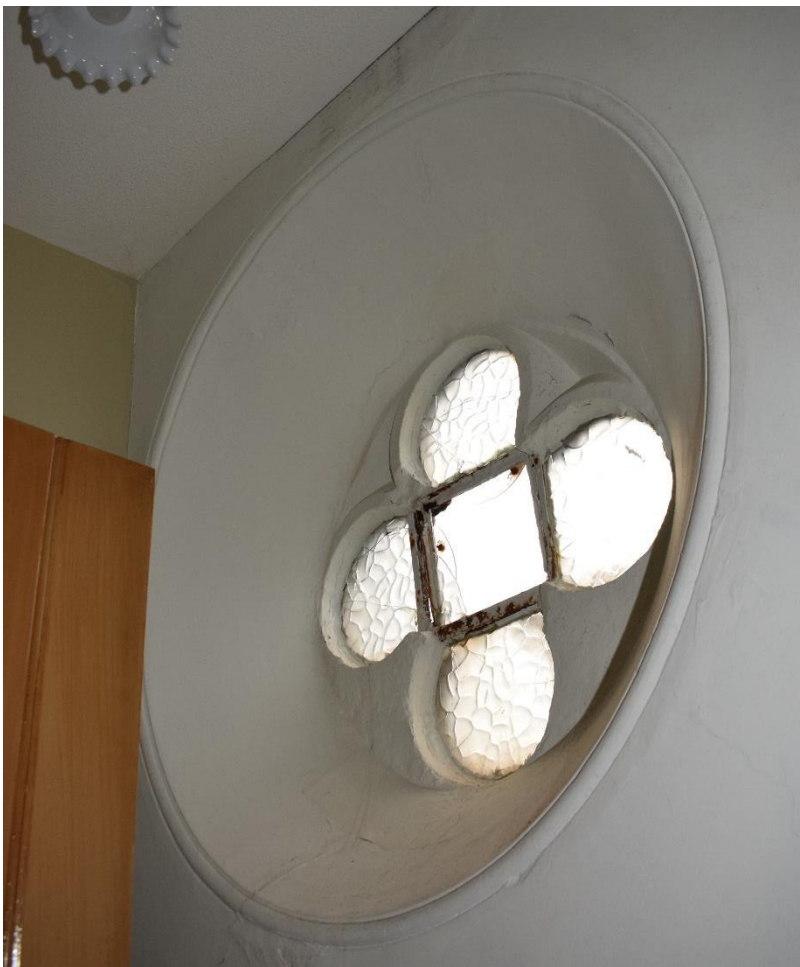
Illus 12 Phase 1 quatrefoil window W9 built into Phase 2 toilet; facing SE.

After the conversion toilets and a cupboard were added on the ground floor in the SW corner. The quatrefoil window W9 was built into a small toilet cubicle. A partition was also constructed (F3) creating a vestibule at the W end of the church dividing it from the main body of the church.

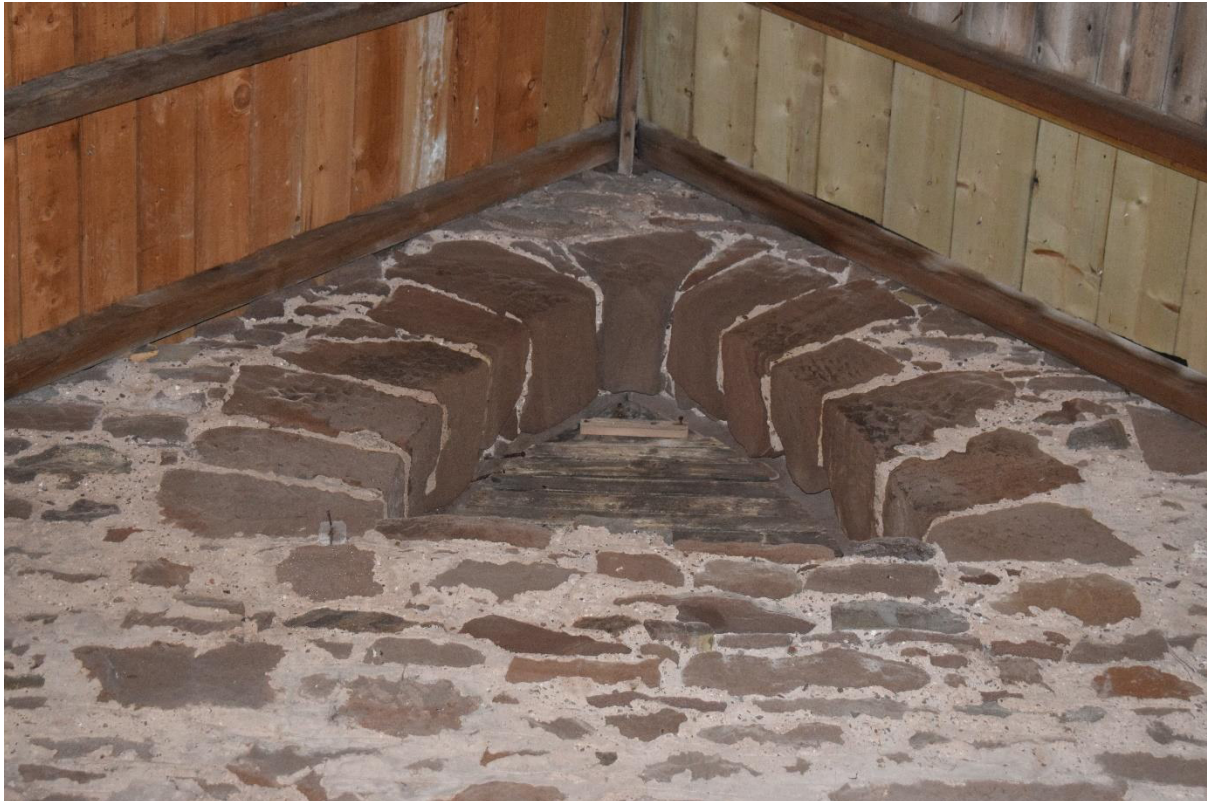
Illus 13 Phase 1 small window W5 (later blocked) in the top of the W gable; facing WNW

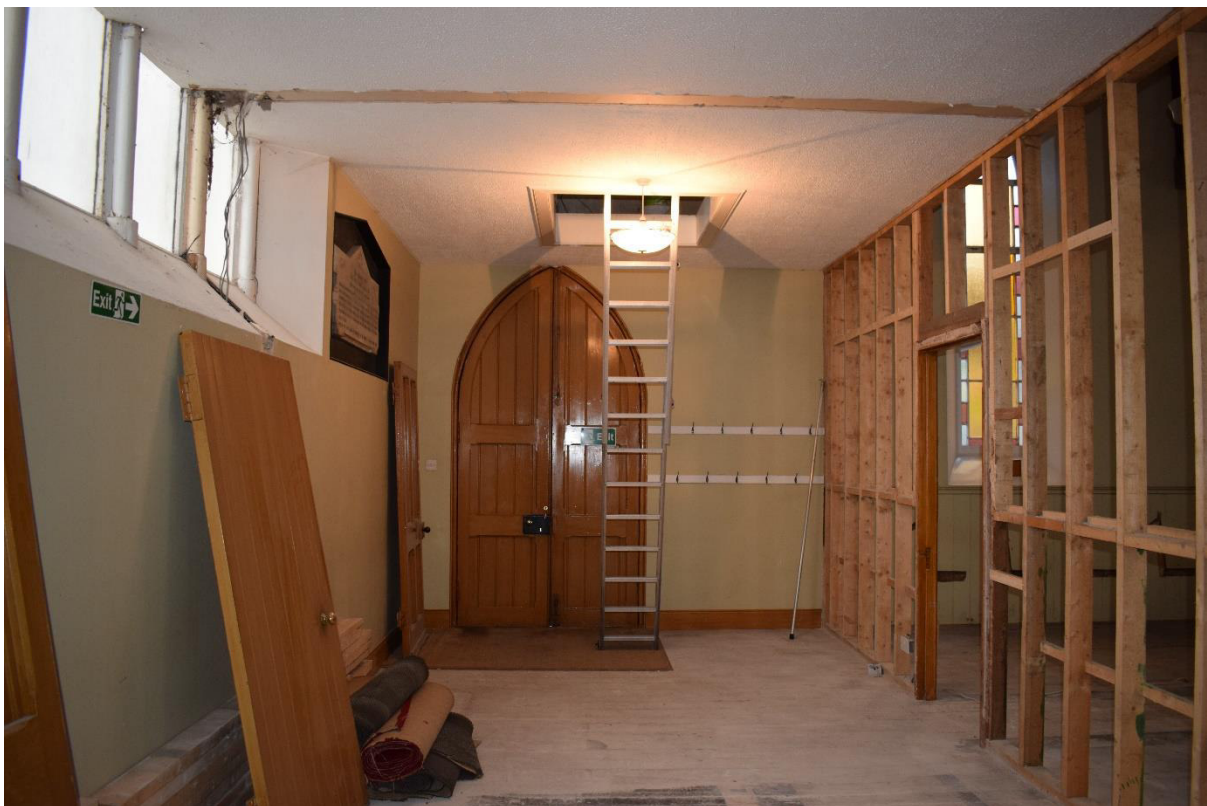
Illus 14 Vestibule with Phase 2 wooden partition F3 (right), D1 to Castle Street (centre); Rev James Glen memorial (F7) left of D1 and bottom of W6 (left), truncated by Phase 2 partition floor above; facing NNW

W23 built into the Phase 2 first floor partition to allow light from the main W window W6 into the church (Illus 14, 19).

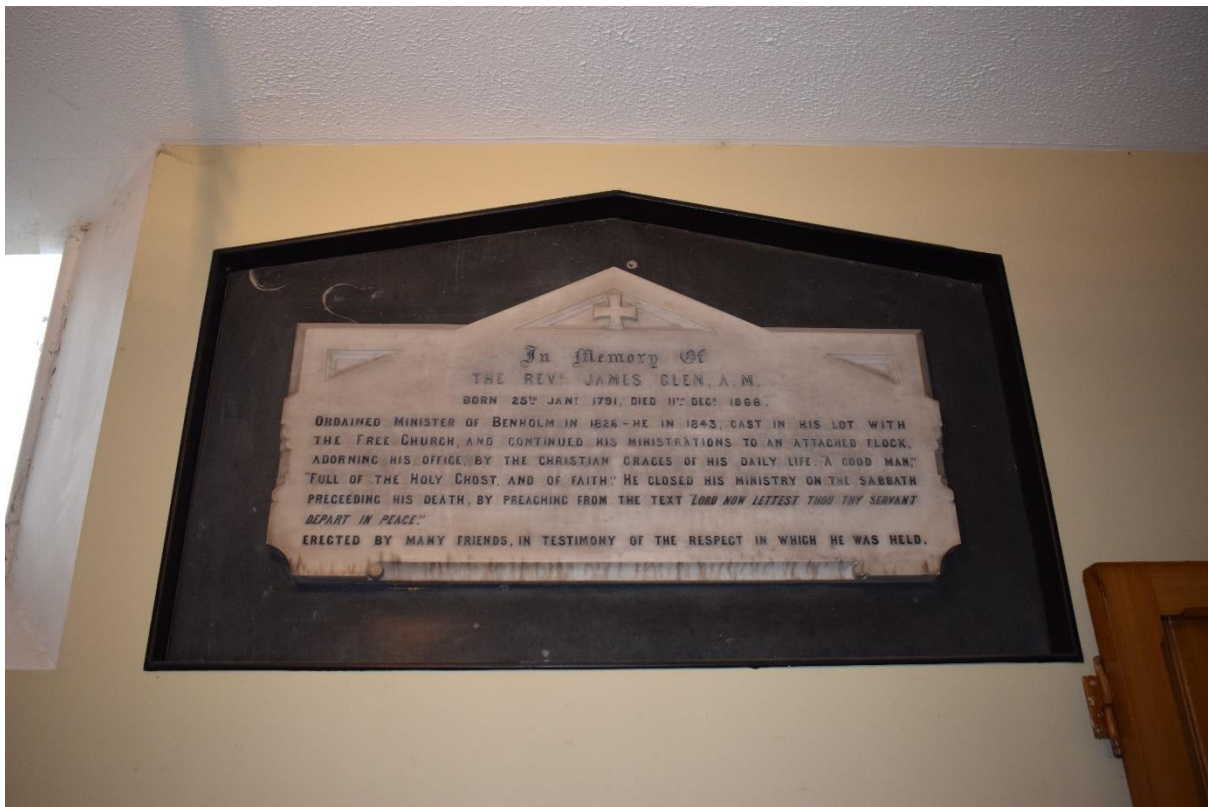
A memorial to Rev James Glen memorial (F7) was added into a recess on the interior of the WNW wall on the NNW side of W6, probably during this phase (Illus 15).

Illus 15 Rev James Glen memorial (F7); facing WNW

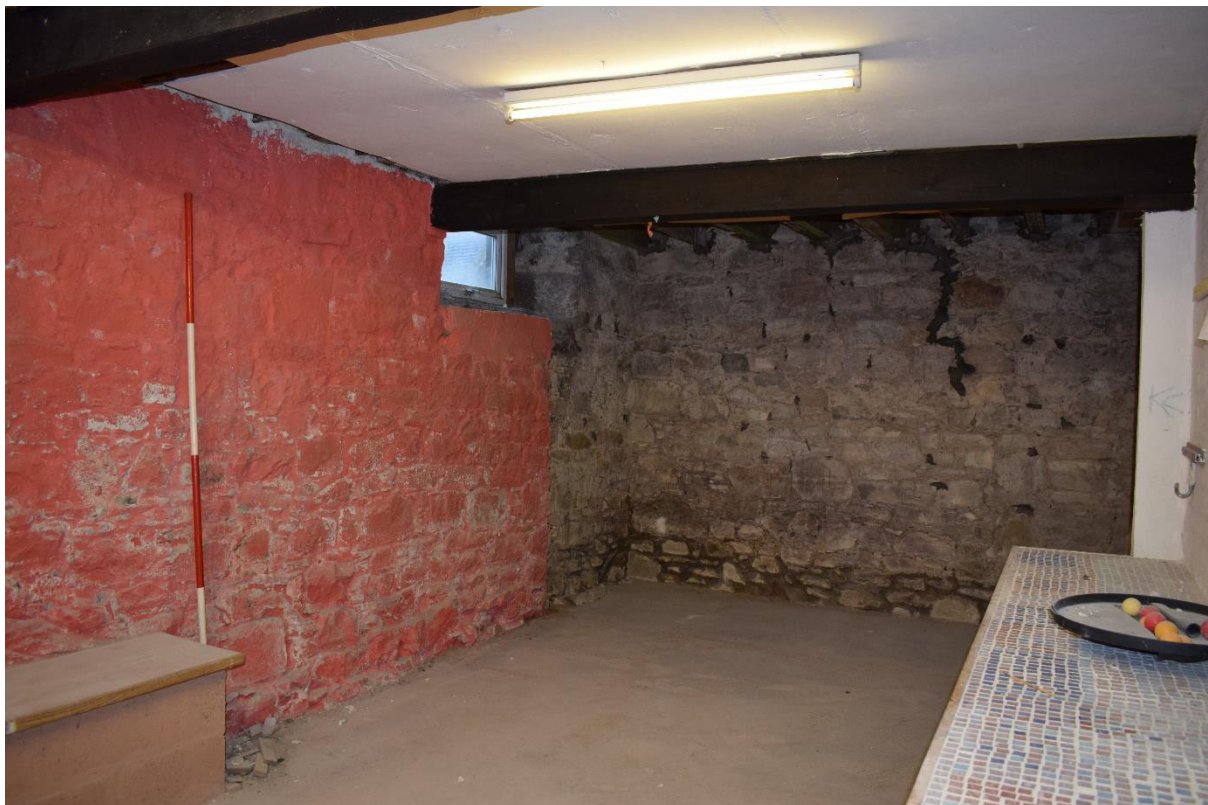
Illus 16 SE corner of basement which was probably created in Phase 1 with W22; facing SE

W22 (Illus 16) was added at the SSE end of the ESE gable and a door added on the stair (D3).

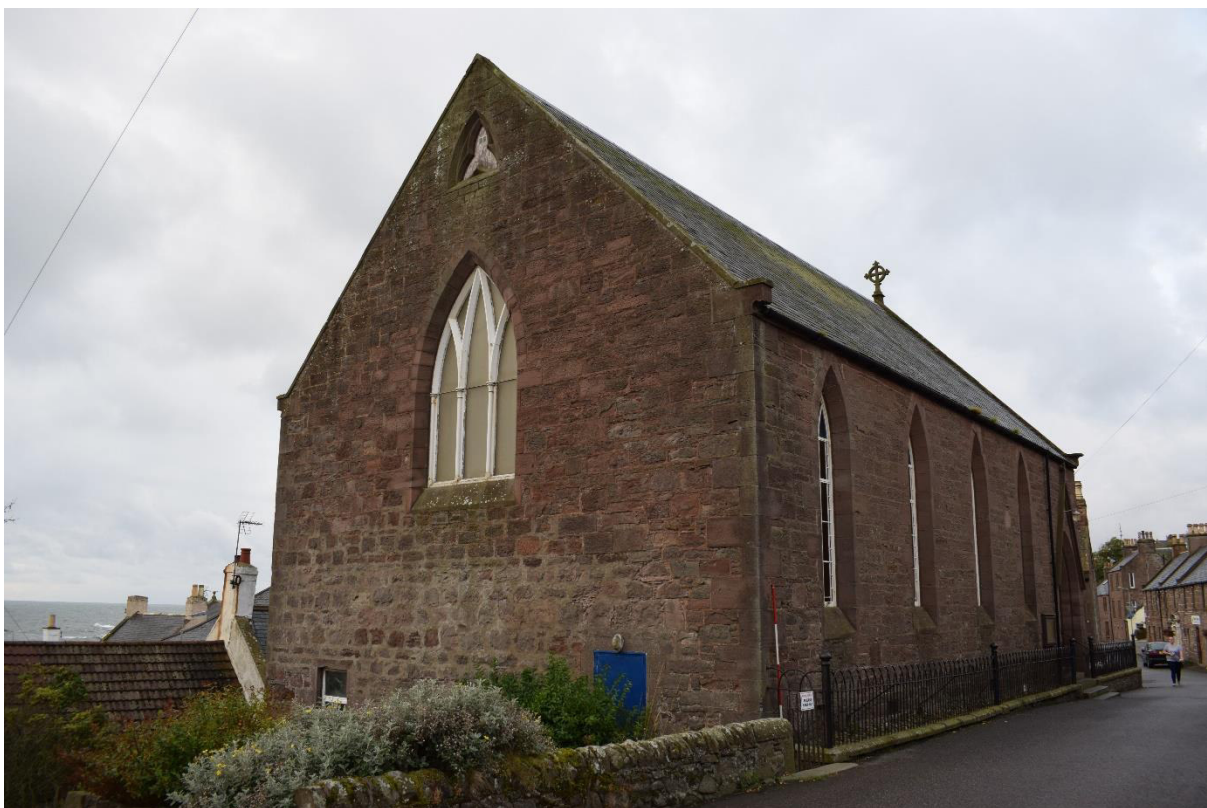
Window W15 appears to be original and probably built in this phase when the basement was redeveloped. W14 was probably originally inserted in this phase but rebuilt with concrete jambs, possibly in Phase 3. The ENE gable wall has been altered and heavily mortared and this may have occurred at this period (Illus 17). The poured concrete stairs (F9) were inserted at this time to allow direct access into the NE corner of the church adjacent to the pulpit.

Illus 17 ESE gable showing repointing of lower section with W20 (top), W6 (centre) and small window W22 and D3 (below); facing SW

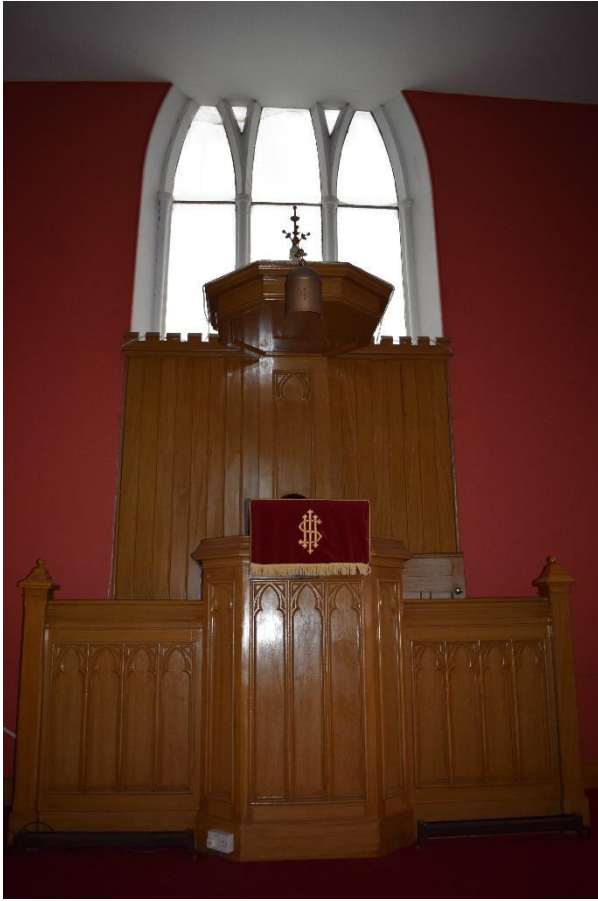
The pulpit was built in the centre of the E wall partially covering W21 and the lowered ceiling also covered the top of this window (Illus 18).

Illus 18 Phase 2 pulpit (F2) and lowered ceiling covering Phase 1 window W21; facing ESE.

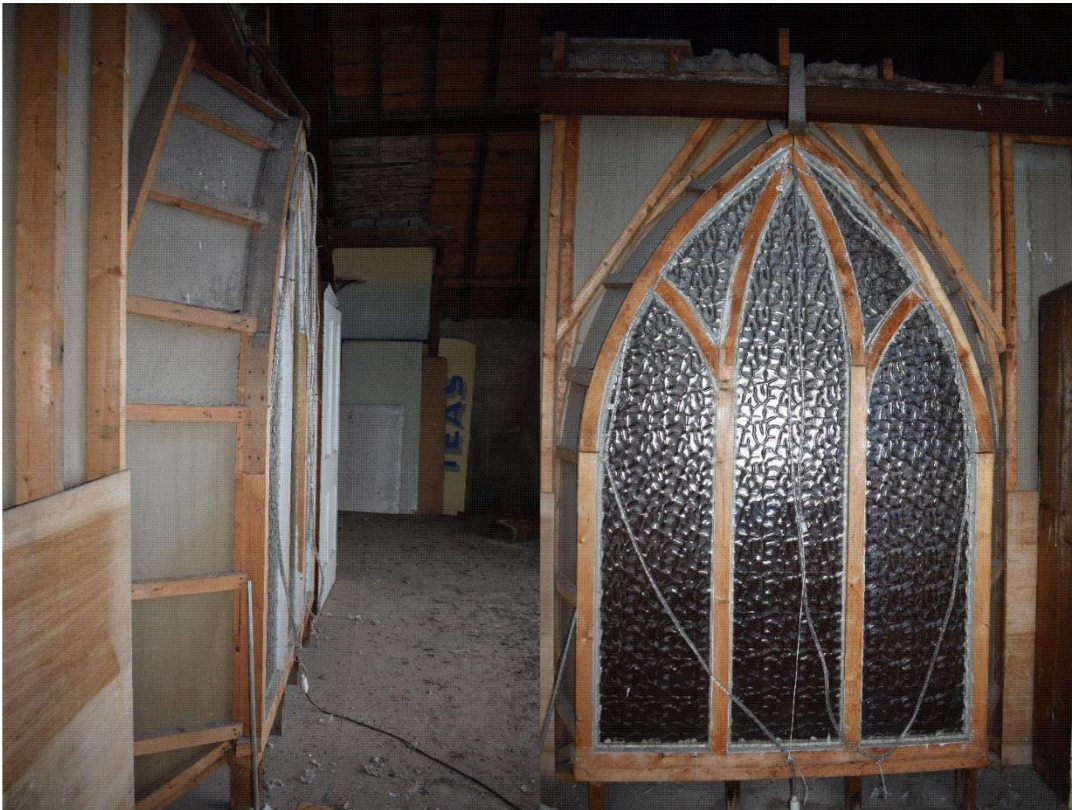
Illus 19 W23 built into the Phase 2 first floor partition to allow light from the main W window W6 into the church; left facing SE. right facing ESE

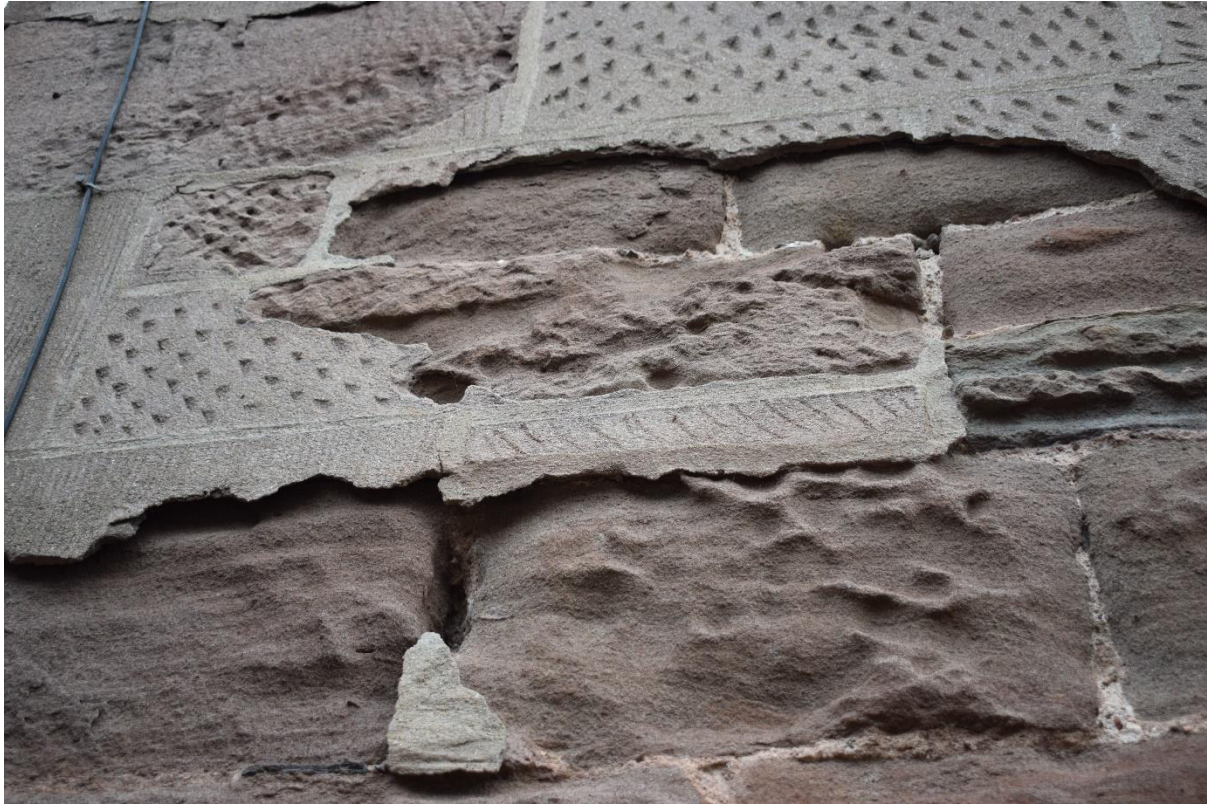
Illus 20 Layer of concrete over worn sandstone blocks, WNW end of church; facing ESE

A layer of concrete was applied over worn sandstone blocks on the W and S facades of the church may have occurred during Phases 2 or 3 (Illus 20).

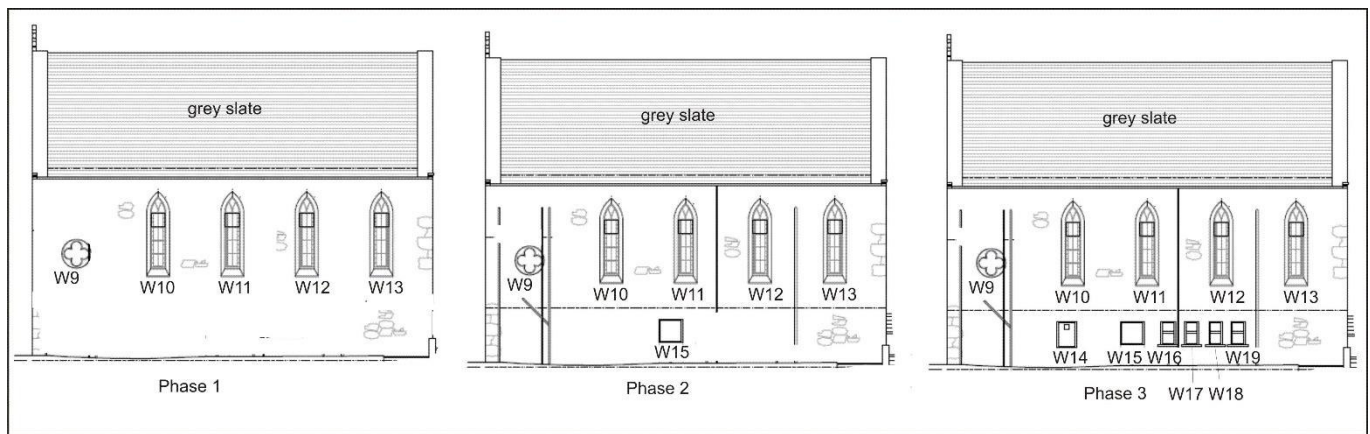
Illus 21 South elevation phased (copyright kerry smith architects)

A Level 1 standing building survey was carried out on 12th October 2016. At least three phases of development of this church were recorded (Illus 21). The church was originally built in 1860 and was altered when the basement was developed; the ceiling of the main church was lowered, the pulpit located on the E wall partially covering a Phase 1 window and internal partitions built including adding toilet facilities on the ground floor. A kitchen and toilets were added into the basement which was eventually turned into a games area and a flat. It is recommended that no further archaeological work is required during the current planning application.
