**Land At Blackness Farm, Banchory,
Aberdeenshire, AB31 6LD**

Report on Level 1 Standing Building Survey

**Alison Cameron
Cameron Archaeology
17 October 2016**

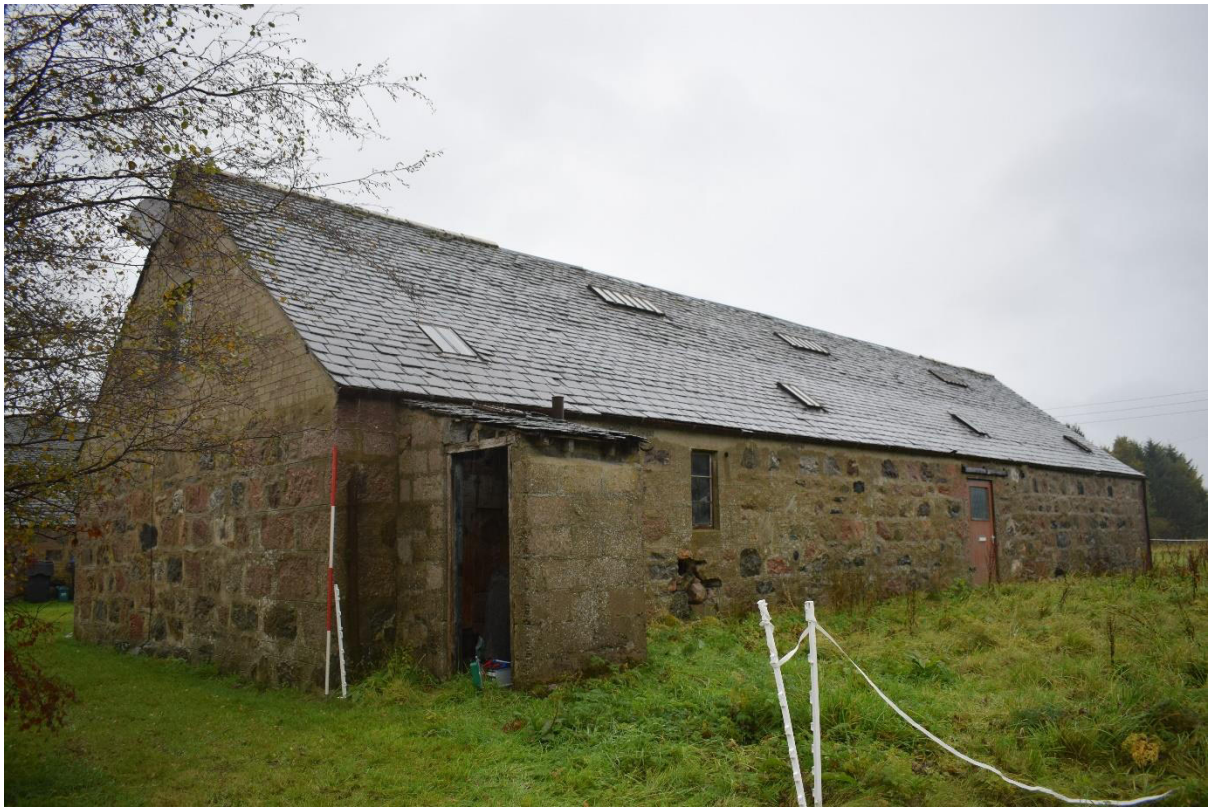
Illus 6 Room 4 from the SE; facing NW

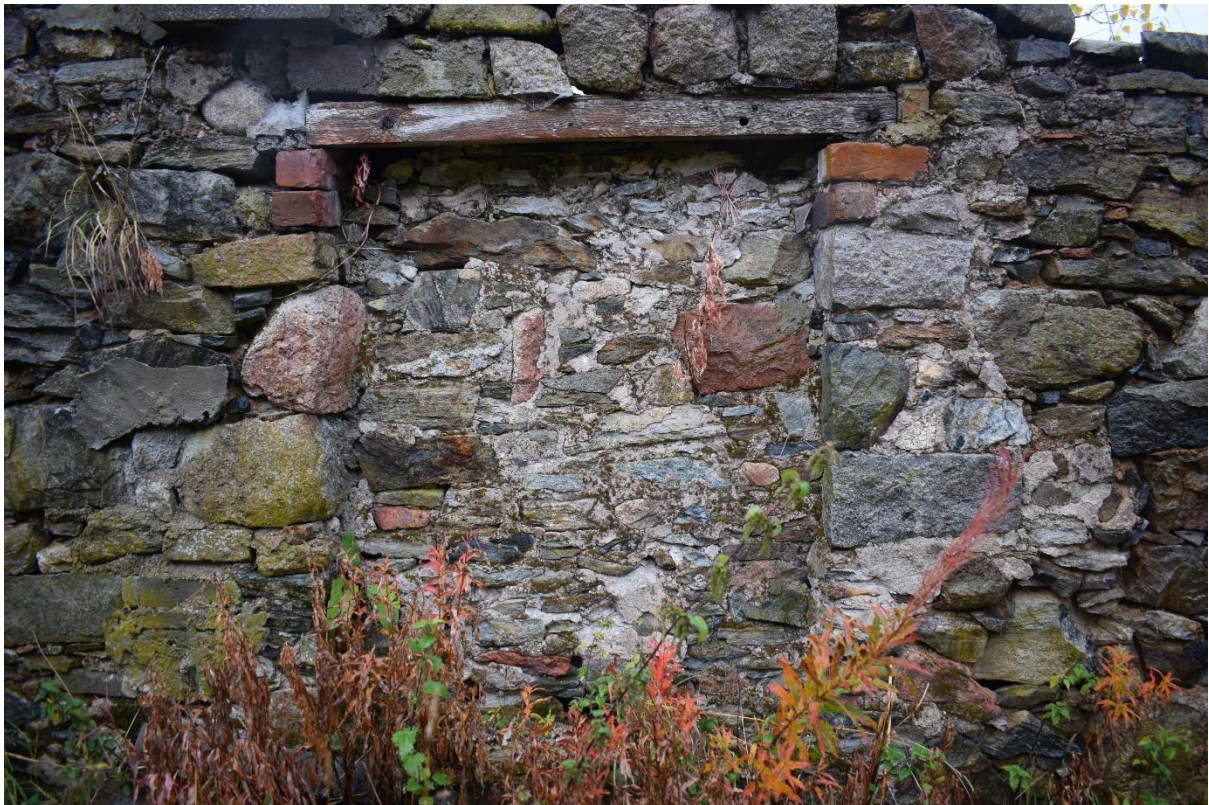
Illus 7 Room 5 blocked door D3; facing NNW

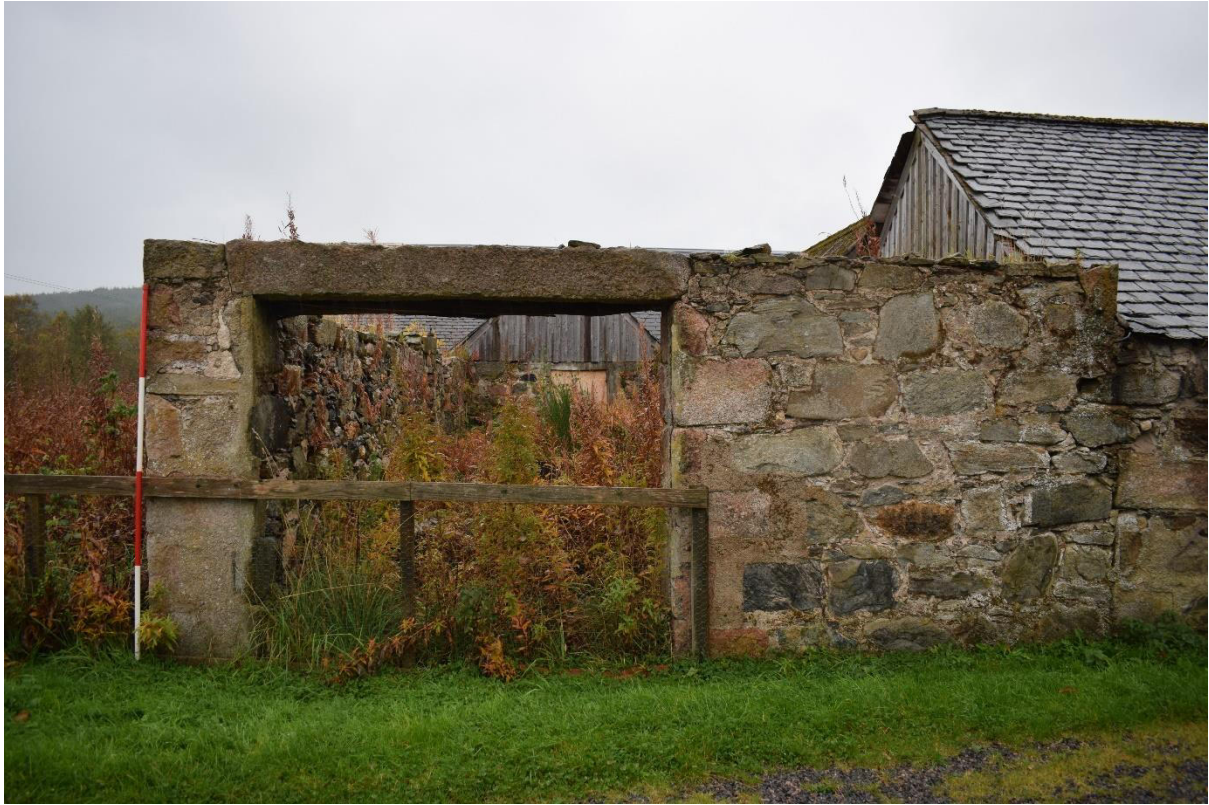
Illus 8 Room 5 WSW gable with D6 showing overgrown interior and exterior; facing ENE

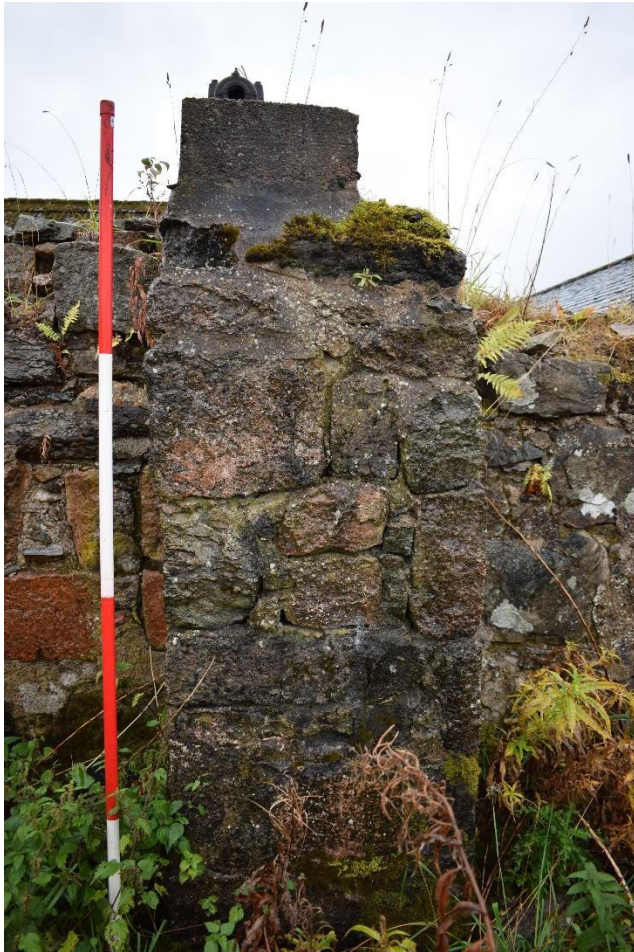
In Phase 2 an extension was added at the NNW end of Room 4 and other additions made to the farm. A stone rubble 'buttress' F1 was added to the exterior of D3 as a support for a concrete plinth and metal support for a shaft, probably associated with the later use of Room 5 as a mill.

Illus 9 Stone plinth F1 built after blockage of D3 to support concrete block and metal shaft; facing SSE

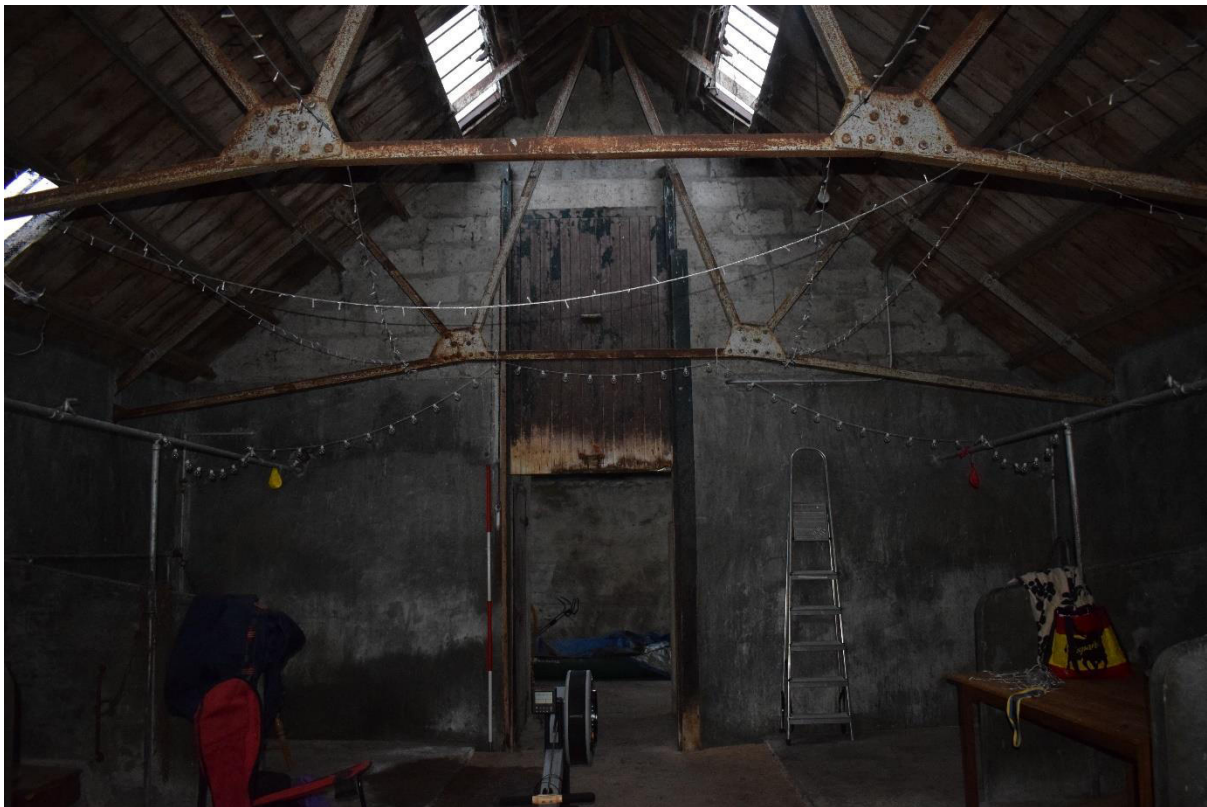
Illus 10 Room 4 SSE wall showing reroofing and conversion for dairy; facing SSE

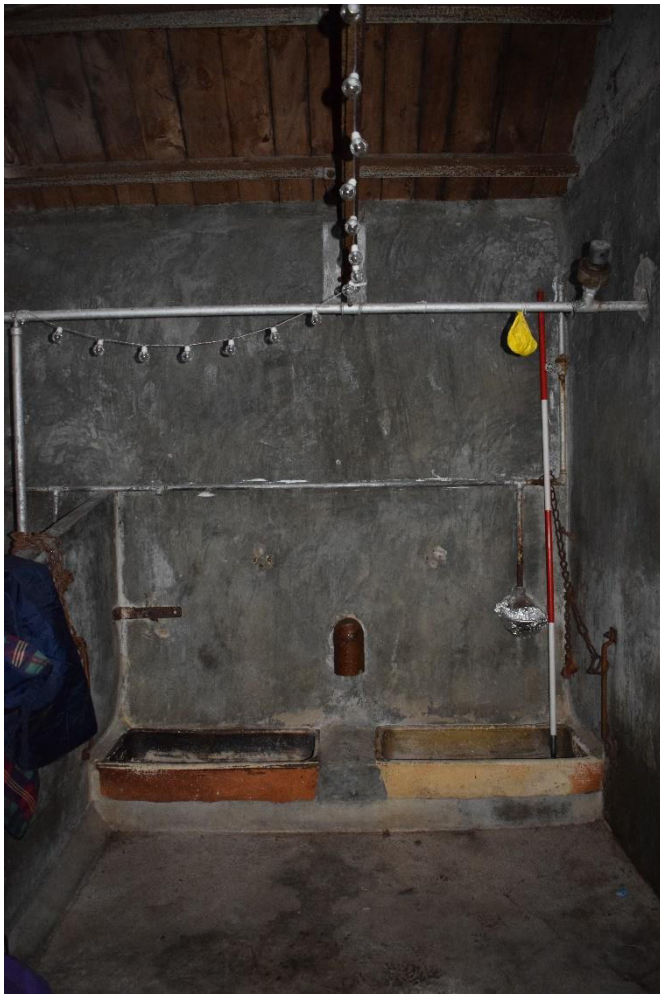
Illus 11 Dairy stalls including stoneware troughs; facing ENE

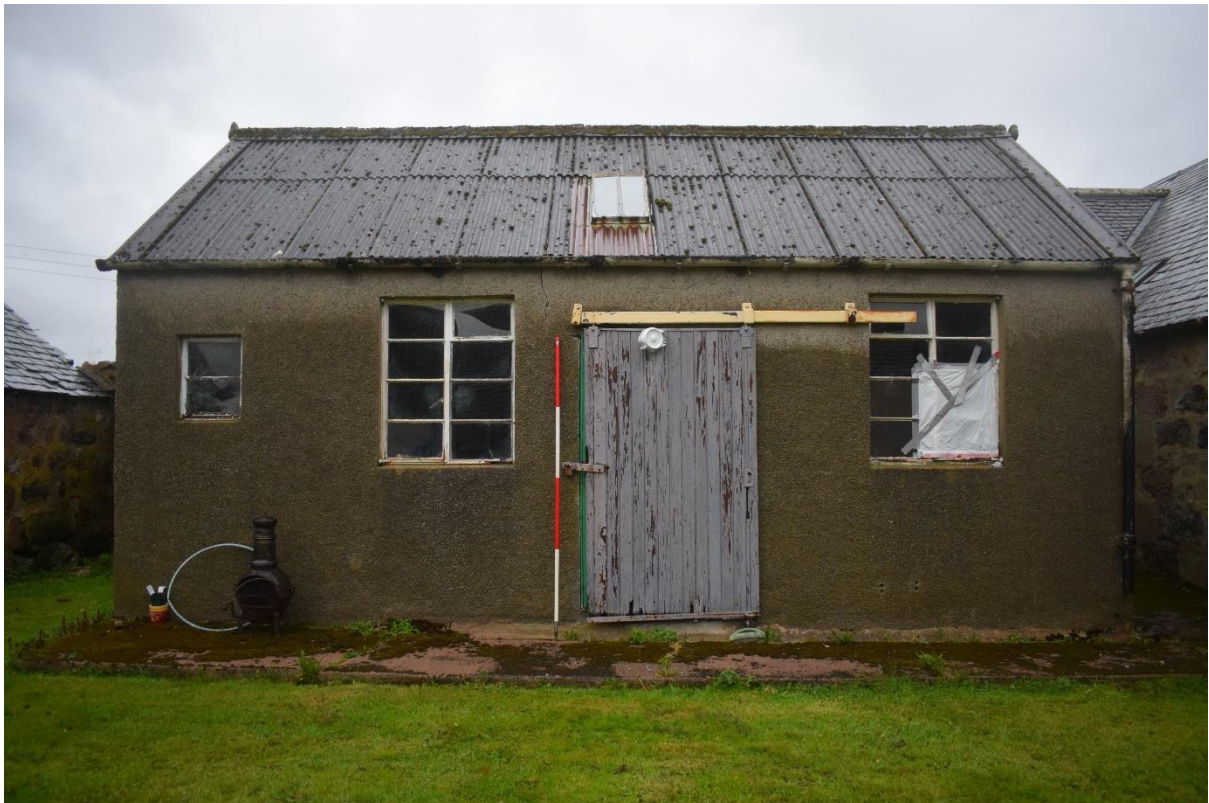
Illus 12 Concrete building Rooms 6 (left) and 7 (right)
