**Meikle Midmar, Midmar, AB51 7LR
Report on Level 1 Standing Building Survey Site B
(APP/2014/4282) and Photographic Survey Site A
(APP/2014/3572)**

**Alison Cameron
Cameron Archaeology
30 November 2016**

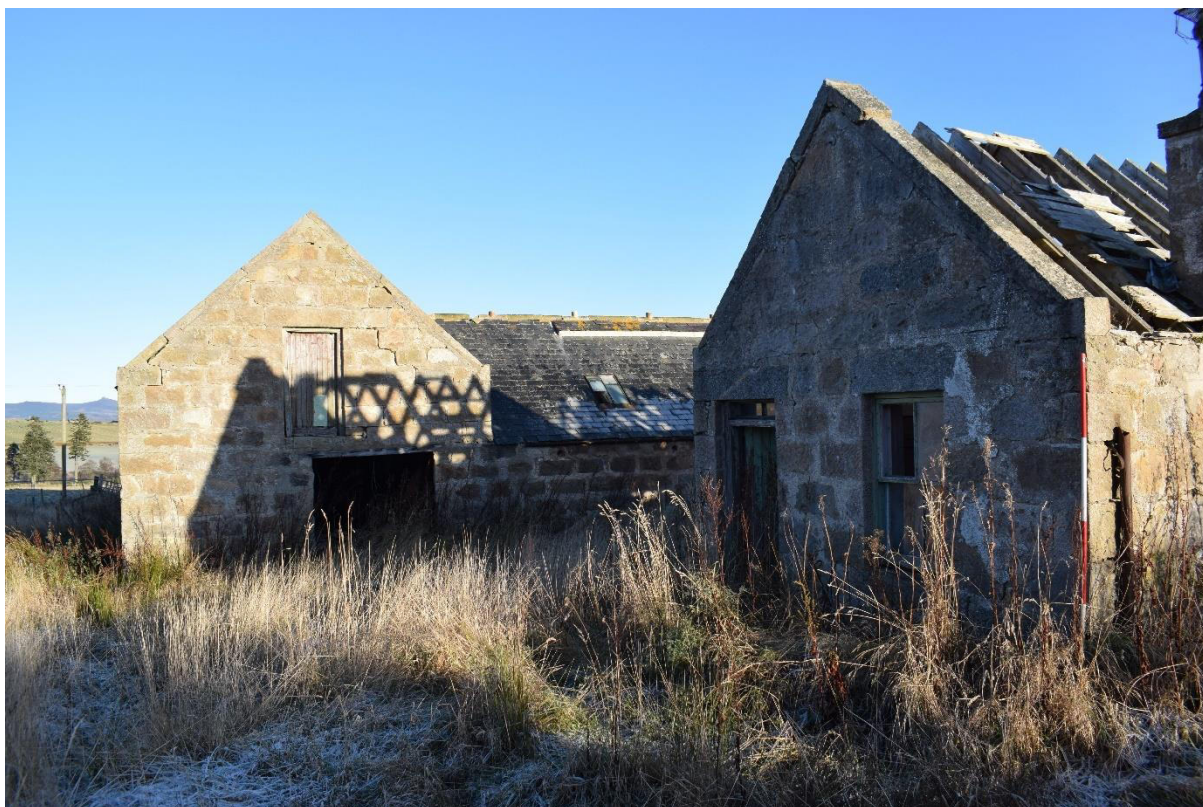
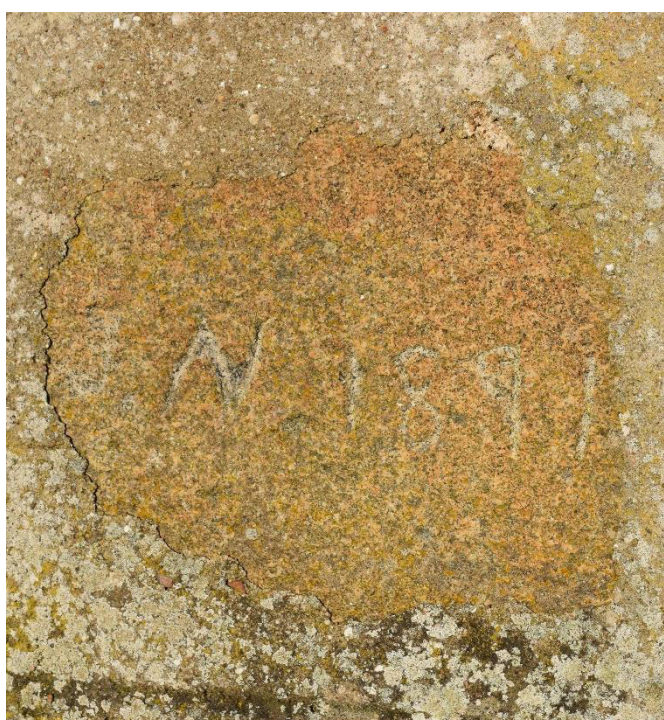
Cover: top Building 1 (left) Building 2 (right; facing N. Bottom: Initials and date (JN 1891) scratched on stone on exterior of S wall Building 1; facing N

There are initials (JN) and a date (1891) scratched into one of the stones on the S exterior wall of Building 1 (F1; cover illus).

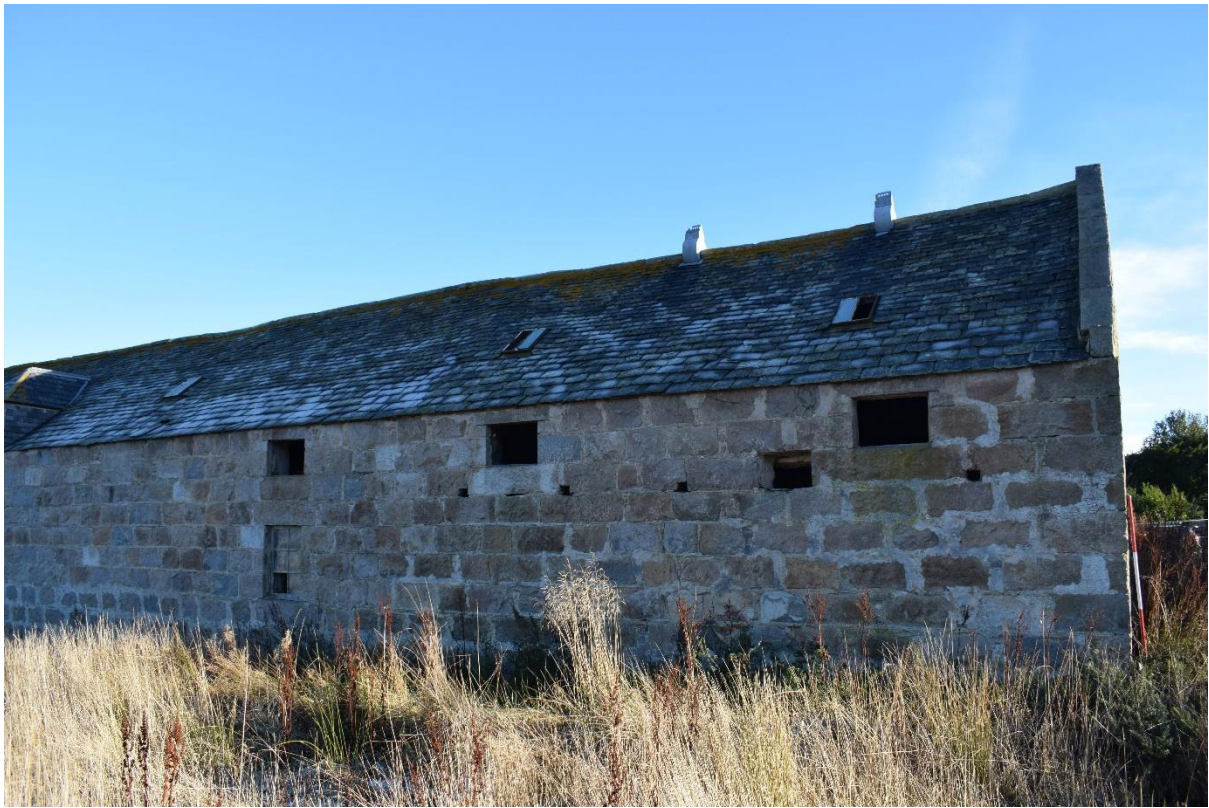
Illus 4 Building 1 W wall W1 (right), W2, W3, W5 (left); facing ENE

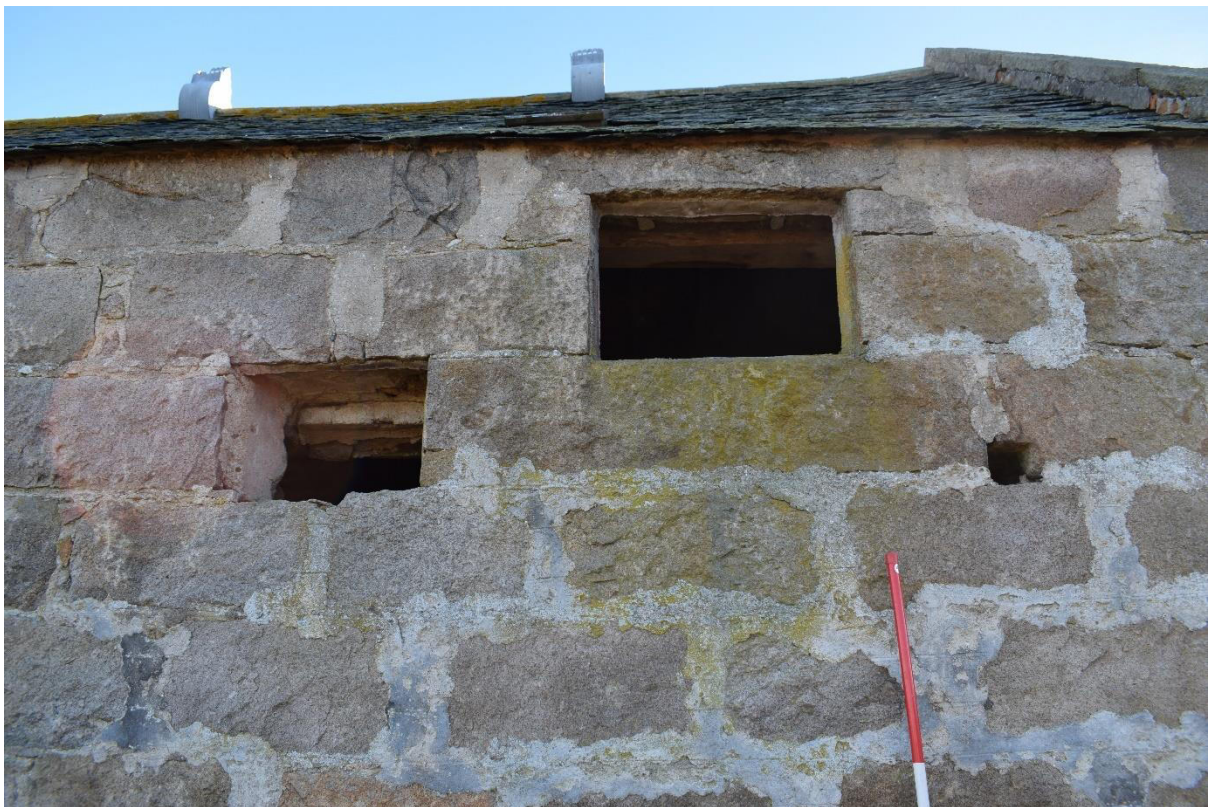
Illus 5 Building 1 W wall W2 (left) W1 (right); facing E

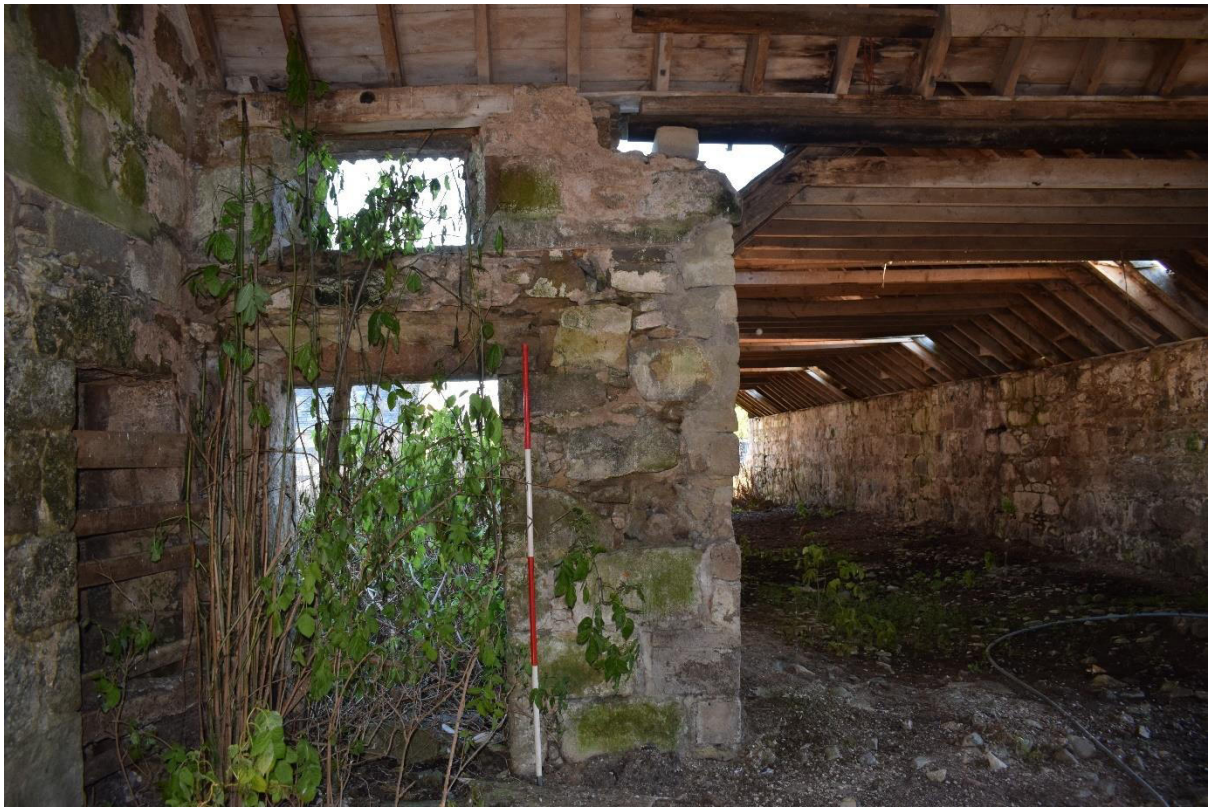
Illus 6 Building 1 W room E wall with D6 with W15 above; facing E

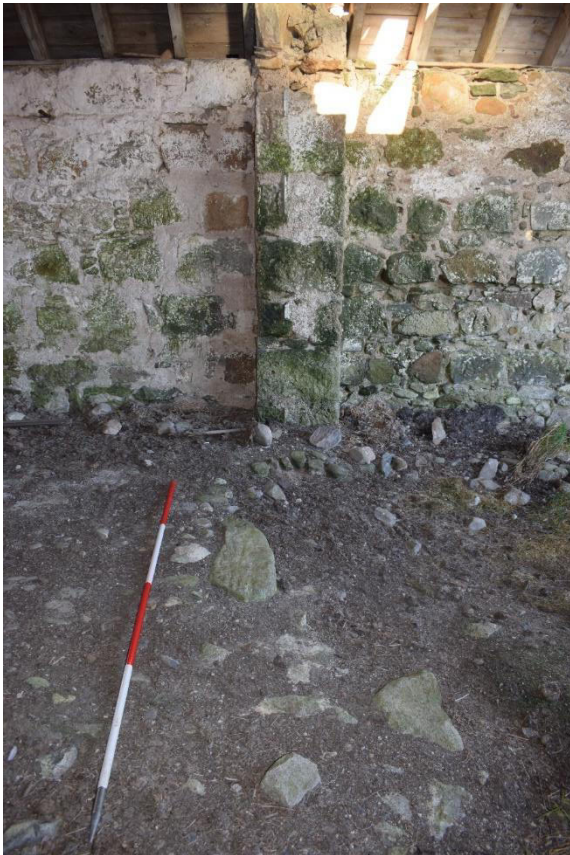
Illus 7 Wall stub F2 (top), wall foundation F3 (bottom), facing N

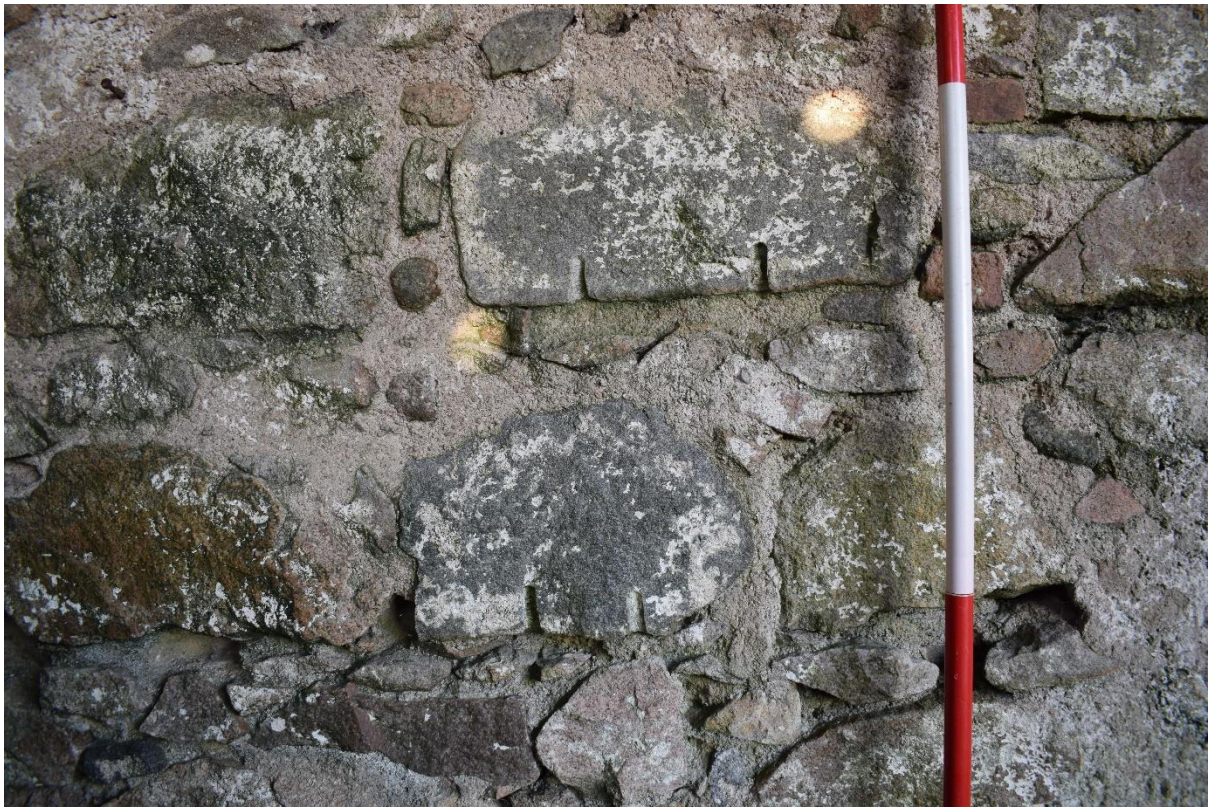
There is a socket stone at the N end of the building (F6; Illus 8) a stone platform against the W wall (F7; Illus 9) and the wall contains stones that have been quarried (Illus 10).

Illus 8 Building 1 N wall showing drilled granite blocks; facing N

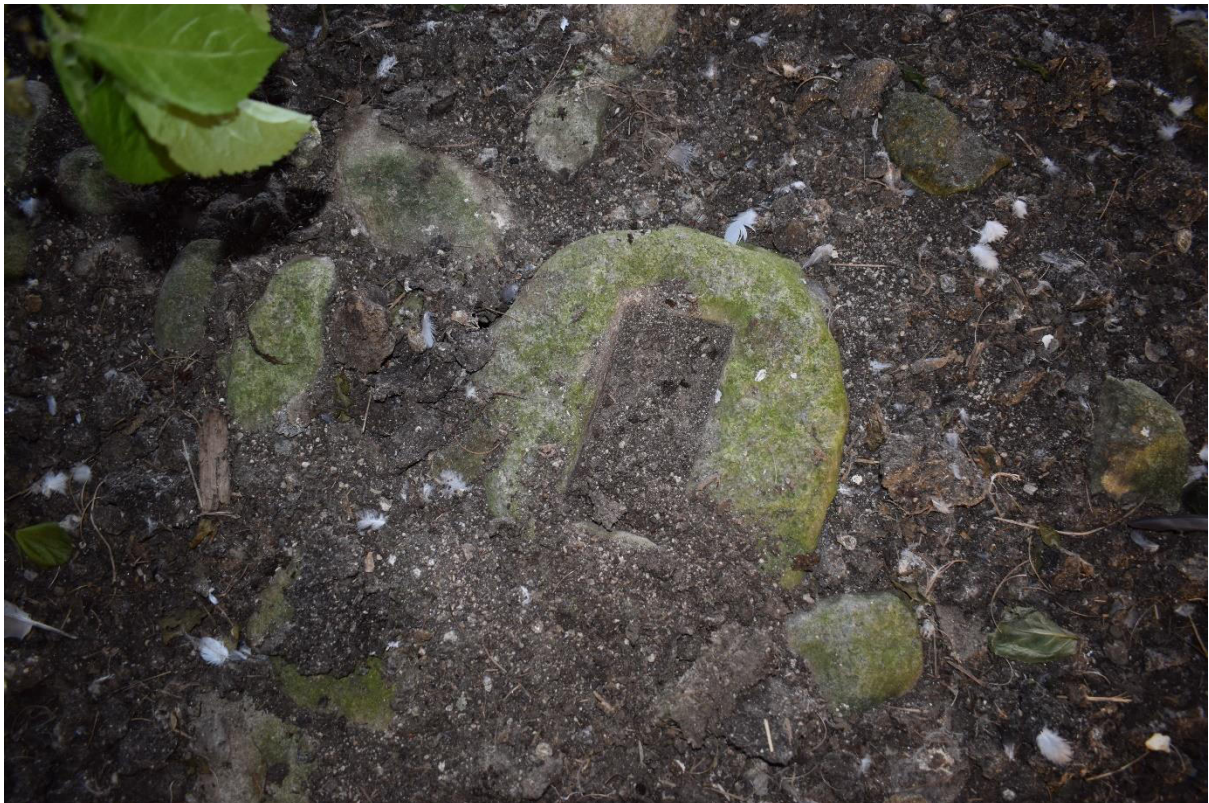
Illus 9 Building 1 W room socket stone F6, facing S

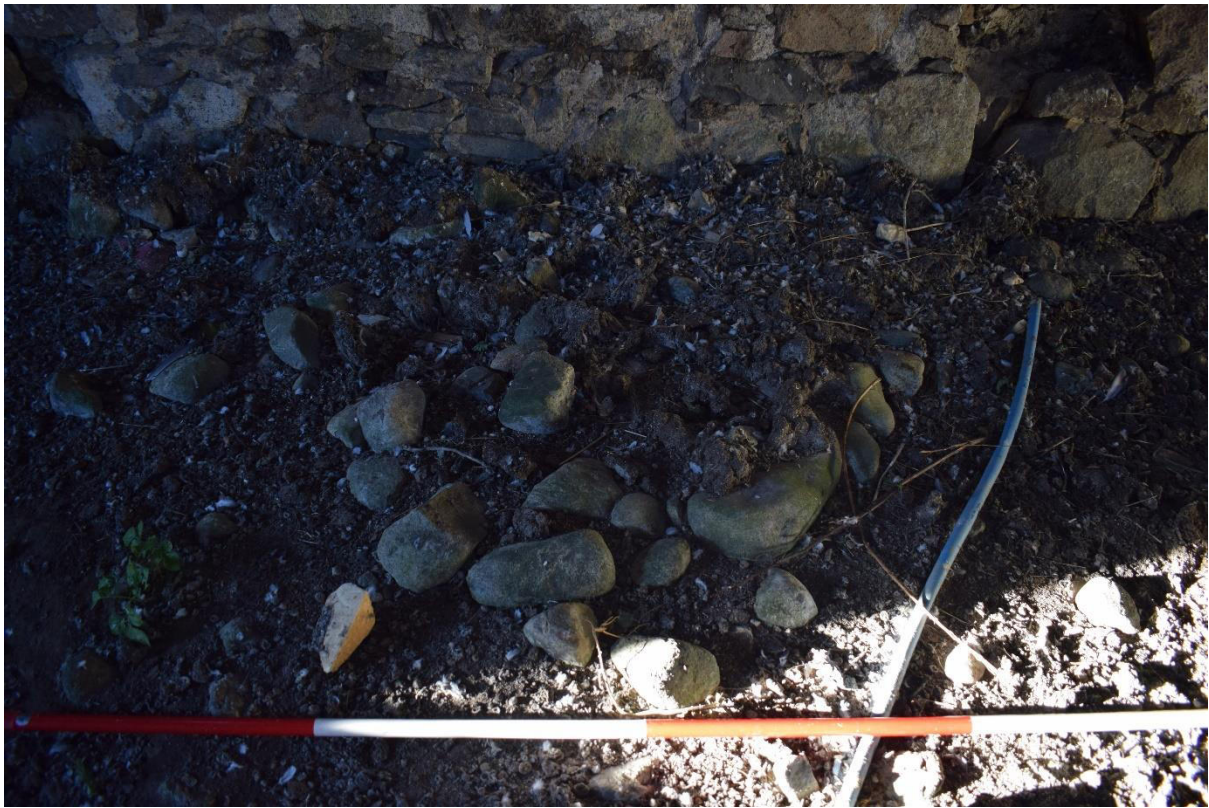
Illus 10 stone platform F7, facing W

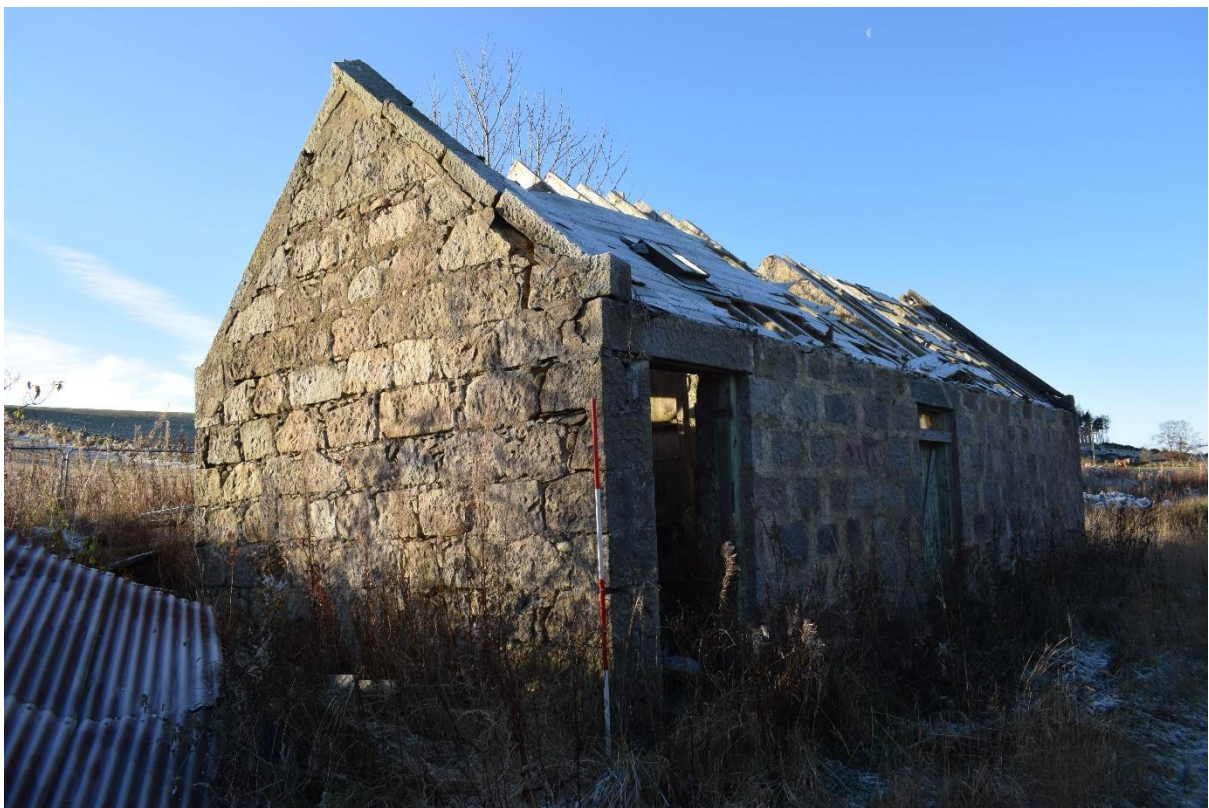
Illus 12 Building 2 from NE; facing SW

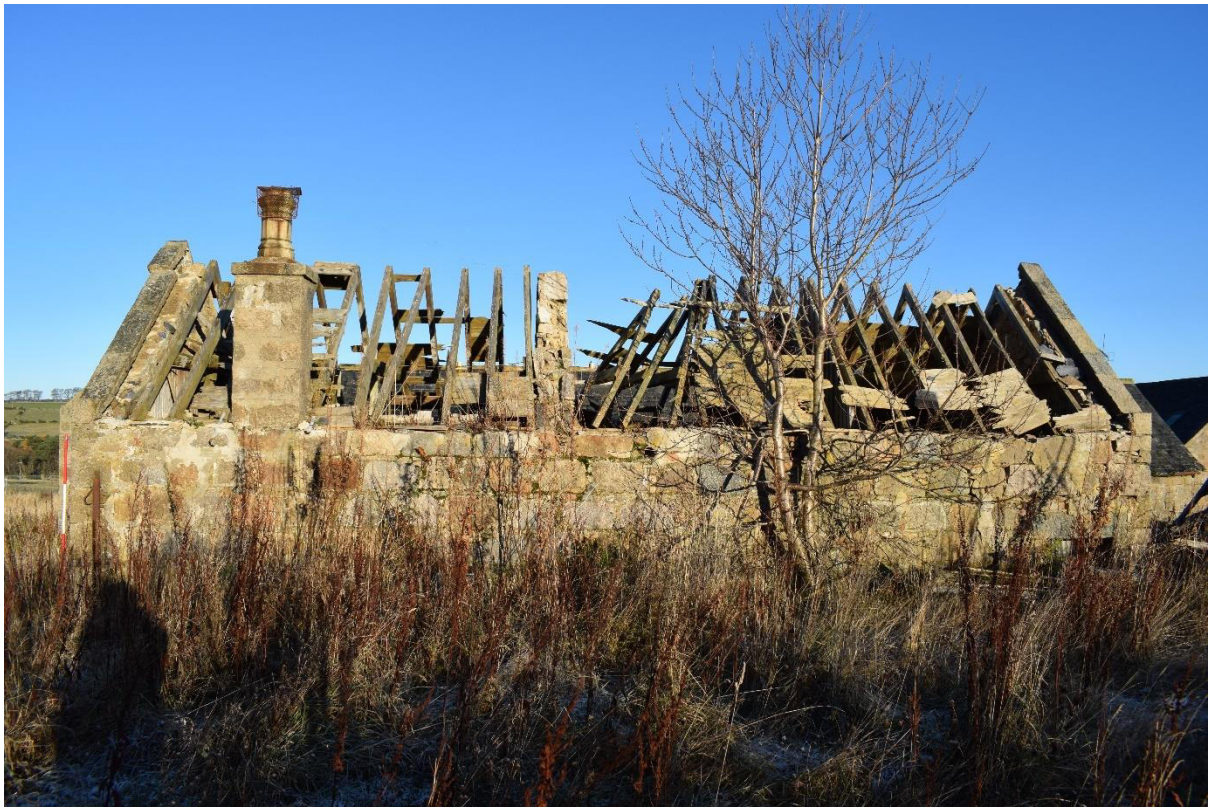
Illus 13 Building 2 S wall; facing N

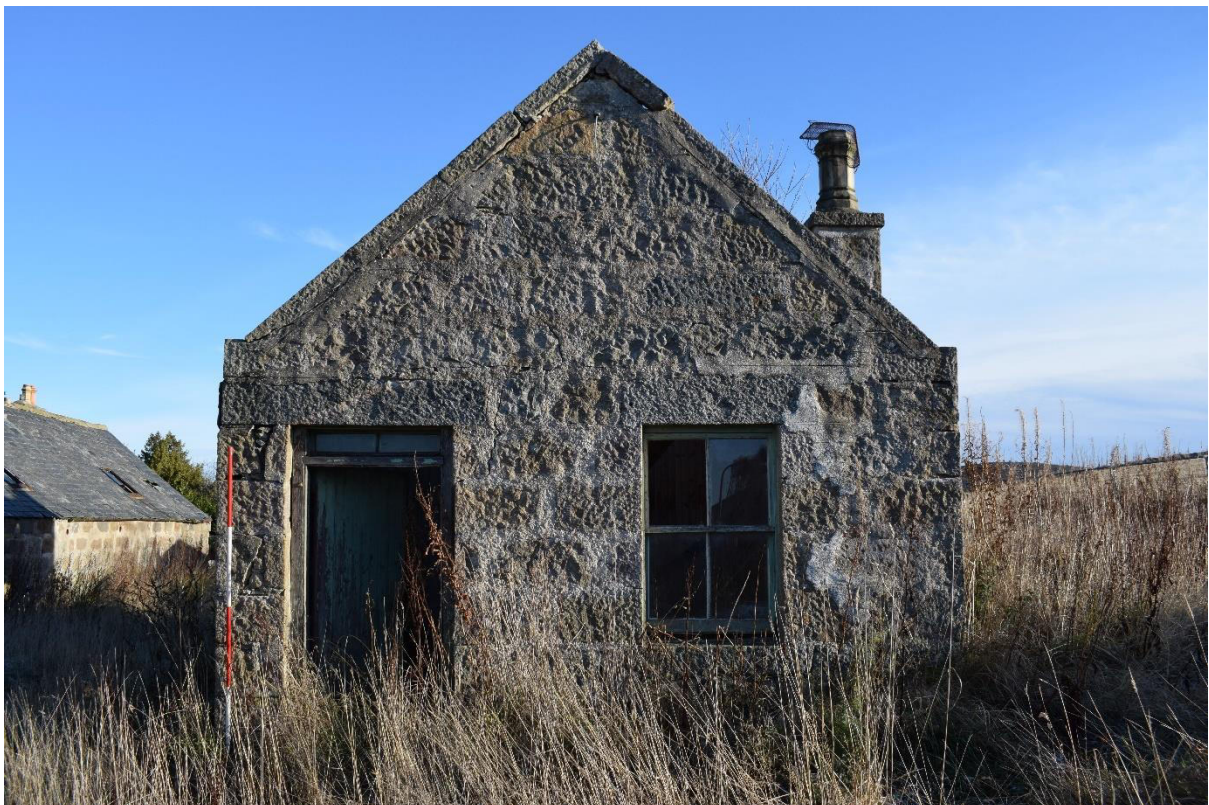
Illus 14 Building 2 W gable with D10 and W4; facing E.
