**Land to North West of Seggieden Farm,
Kennethmont, Huntly, AB54 4NW
Report on Level 1 Standing Building Survey**

**Alison Cameron
Cameron Archaeology
30 January 2017**

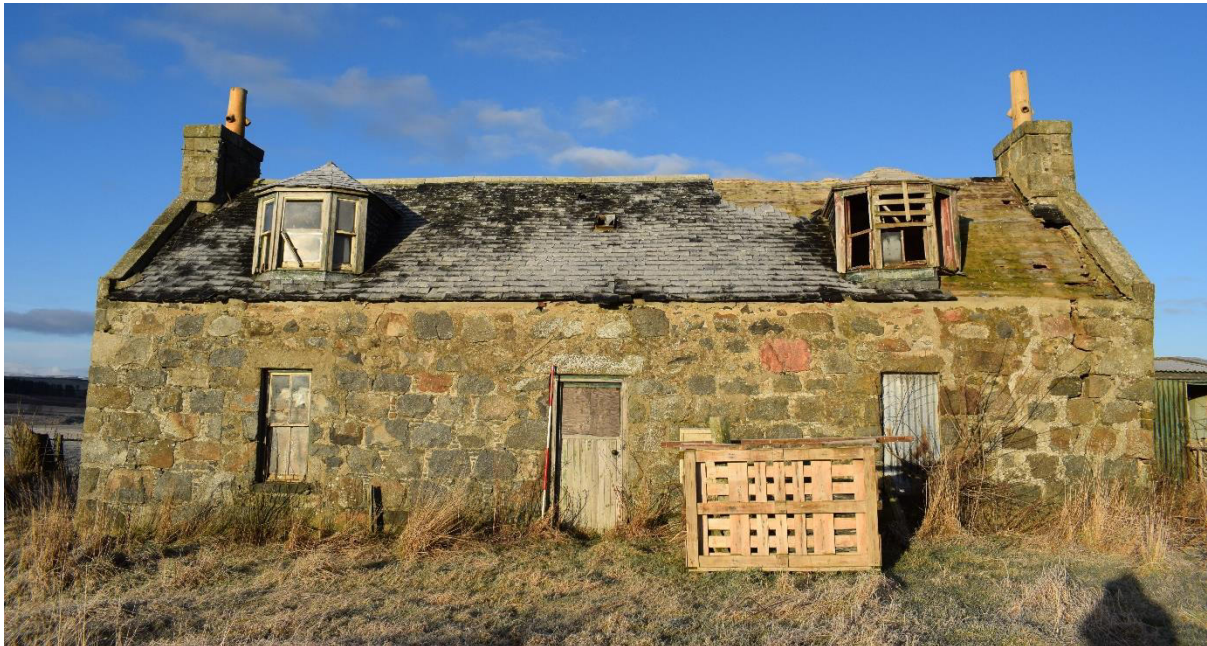
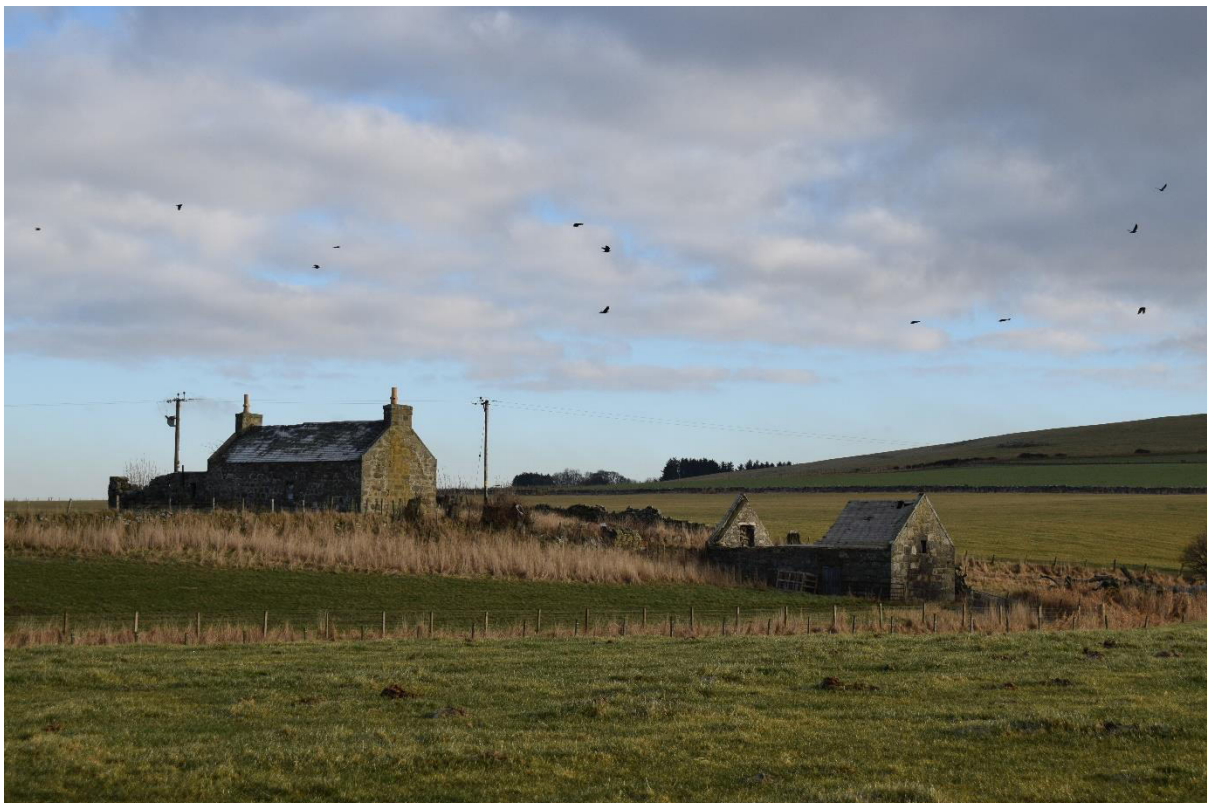
Cover: (top) SE front façade of cottage; facing NW (bottom) cottage (left) from access road; facing NE

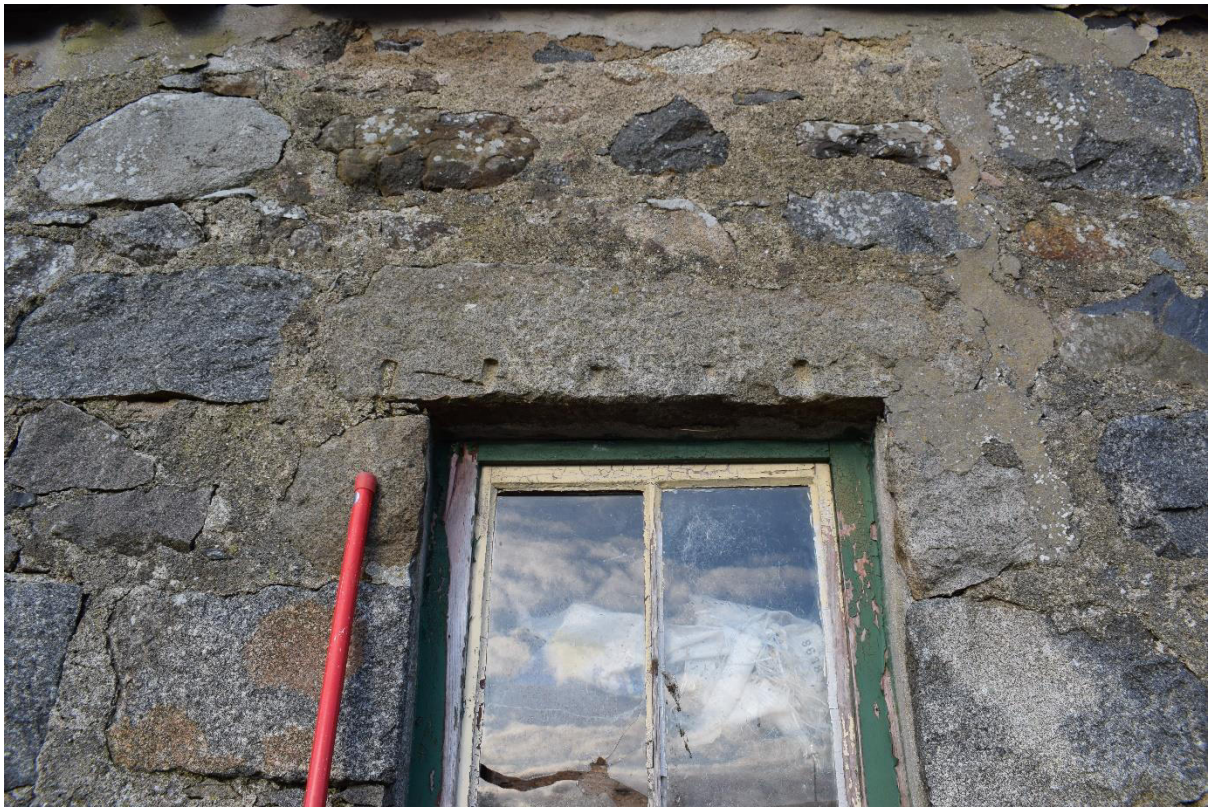
The two-storey cottage is 13.5m long and 5.15m wide (see cover). It is constructed of quarried grey (and a few pink) granite blocks with cherry cocking, the roof is of grey slate and the lintels and sills are granite. The lintels of W1 and W2 have several quarry drill marks (Illus 3). The main 'front' façade faces SE and there is a central door (D1) with flanking ground and first floor windows. There is a blocked window (W3) in the SW gable (Illus 4, 5) and after this was blocked the interior was converted into an alcove cupboard (F8) in Room 1 (Illus 6).

Illus 3 W1 lintel with drilled granite block lintel; facing NW

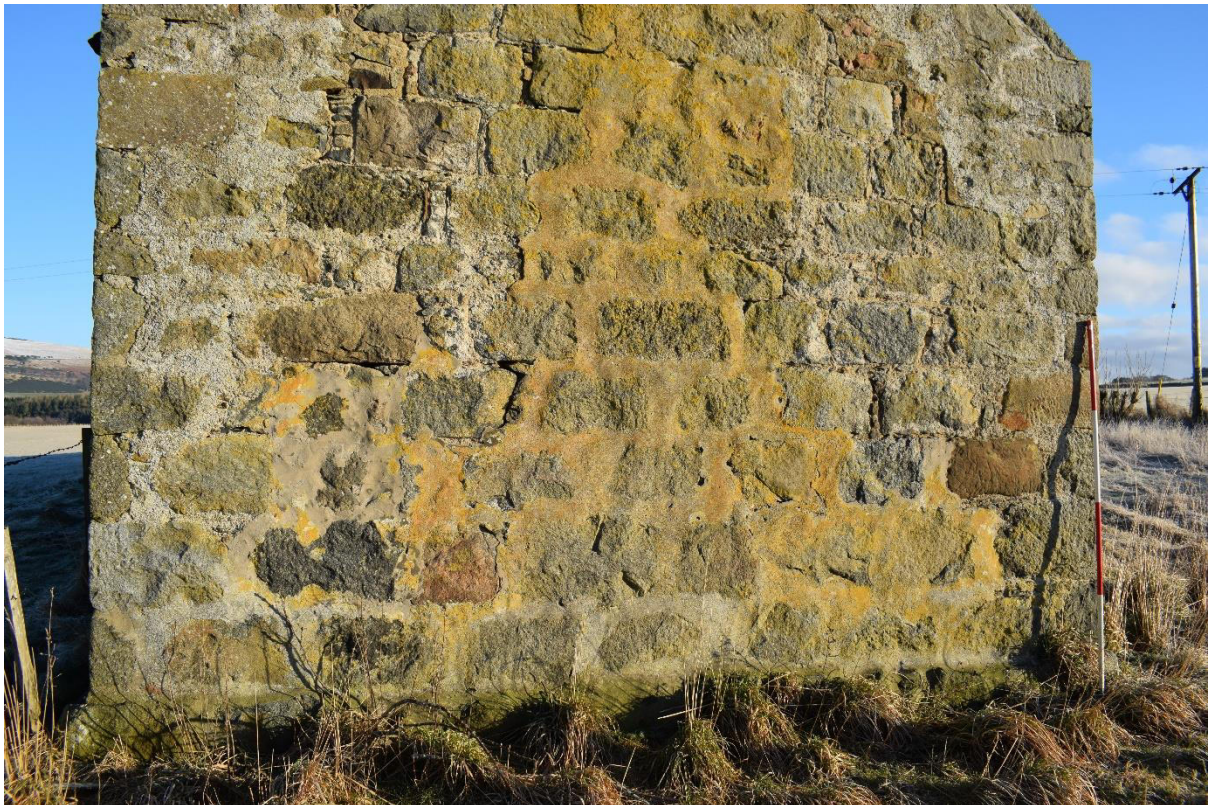
Illus 4 SW gable with blocked window W3 (left); facing NE

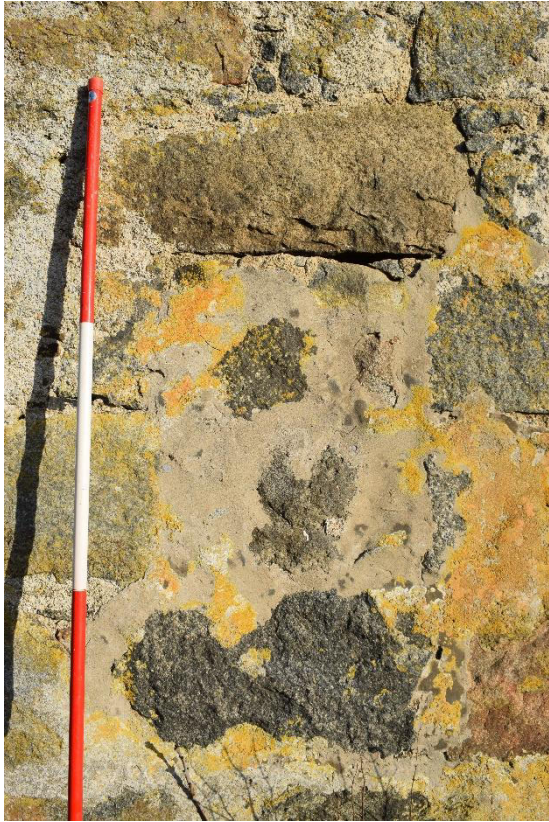
Illus 5 W3 detail; facing NE

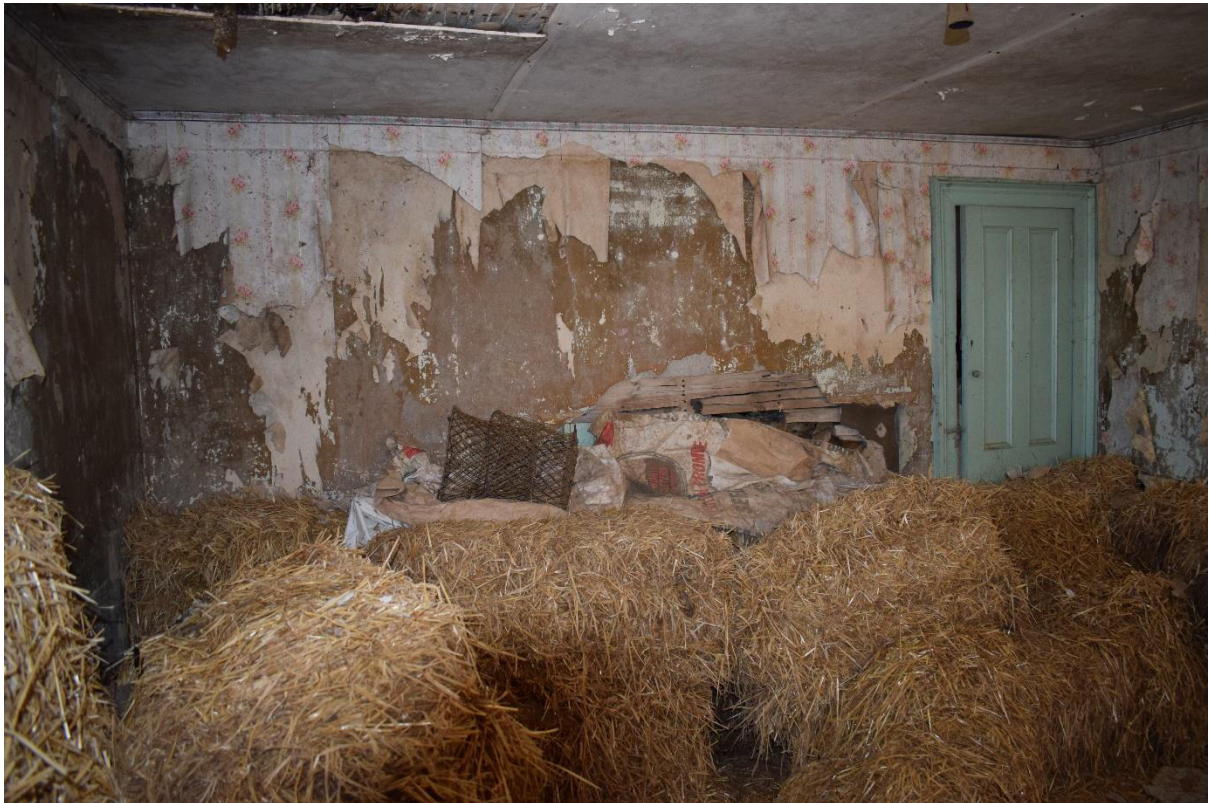
Illus 6 Room 1 interior SW wall showing alcove cupboard F8 (right) which was built in after blocking W3; facing SW.

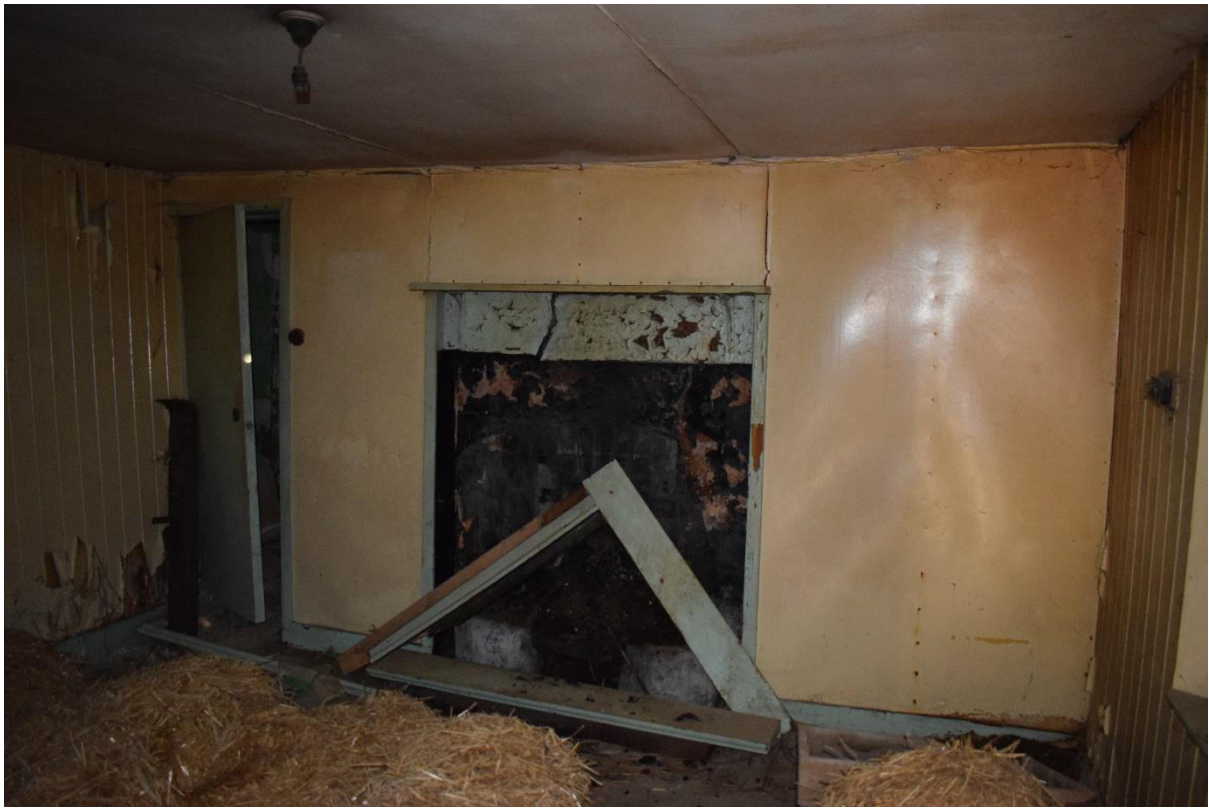
The building has two main reception rooms the full width of the house, Room 1 in the SW and Room 2 in the NE. Room 2 has a large fireplace on the NE wall (Illus 7) and a central alcove shelving in the centre of the SW wall flanked by doors to the hall (D6) and to Room 3 (D3). There is a room under the stairs (Room 3) with large sinks and a window to the NW.

Illus 7 Room 2 interior NE wall with fireplace F9; facing NE

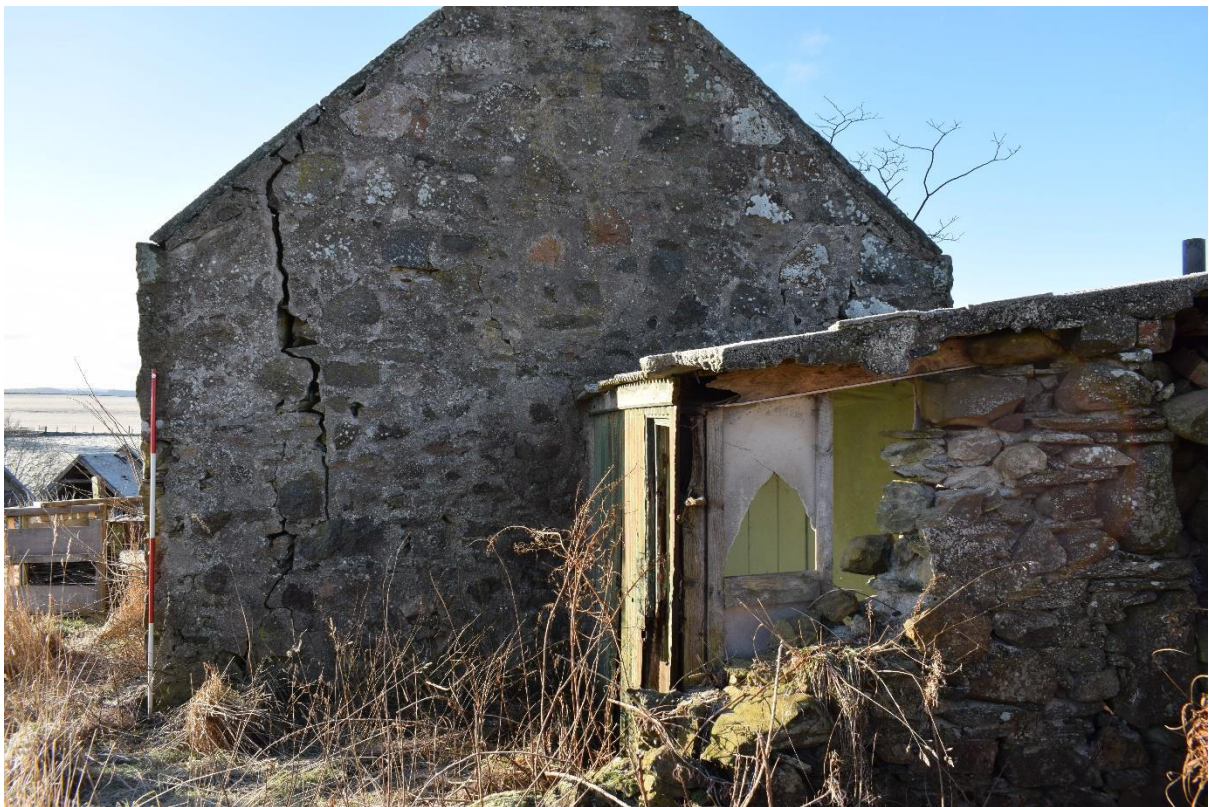
Door 4 leads to the extension, now mainly corrugated iron construction with corrugated roof (Illus 8) but this would have been a stone extension and there are remains of this stone structure (F2, F3 and F4; Illus 9).

Illus 8 NE gable with tin shed (Rooms 4/5) added later; stone wall F2 (right) remains from demolished building and scar (F7) on the left side of the gable where a wall has been demolished; facing SW

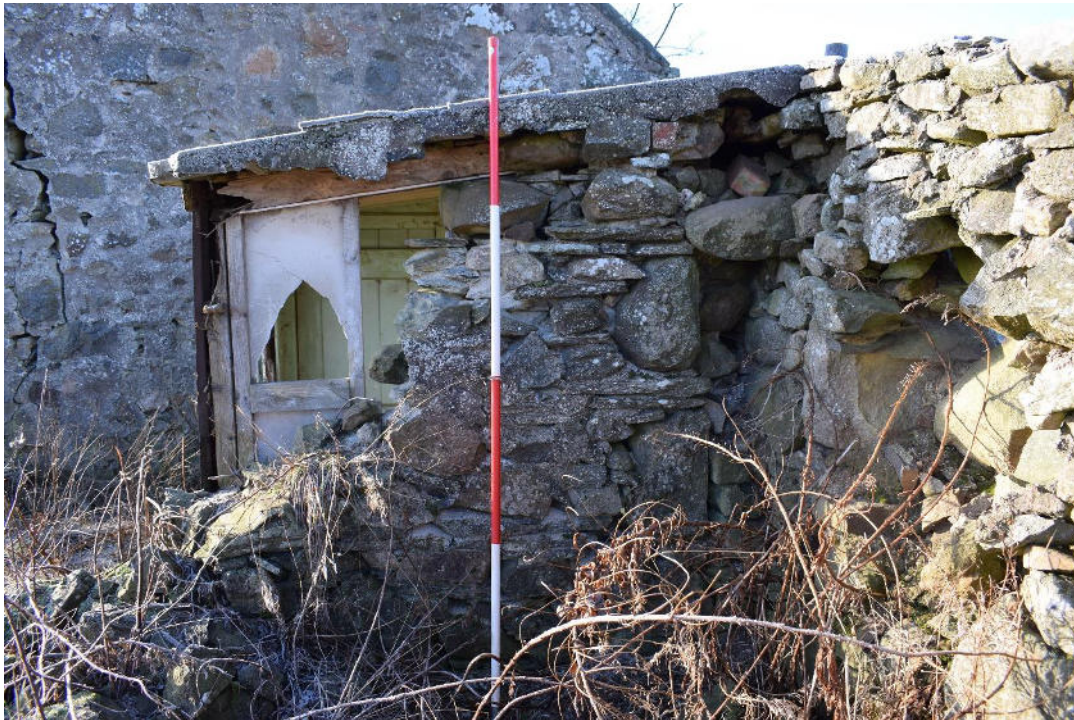
Illus 9 Wall F2 part of the original stone range of buildings, now mainly demolished; facing SE

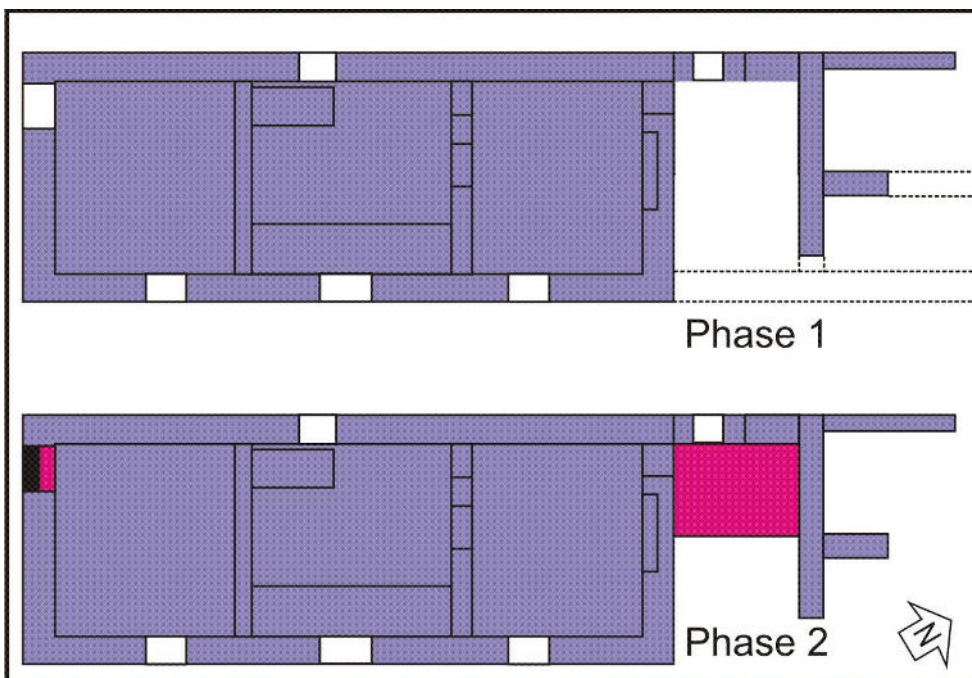
Illus 10 Phase plan showing Phase 2 corrugated iron shed and blocked window and alcove opening.
