**Former Andover School, Nursery Lane,  
Breachin, DD9 7DL  
Report on Level 1 Standing Building Survey**

**Alison Cameron  
Cameron Archaeology  
23 February 2017**

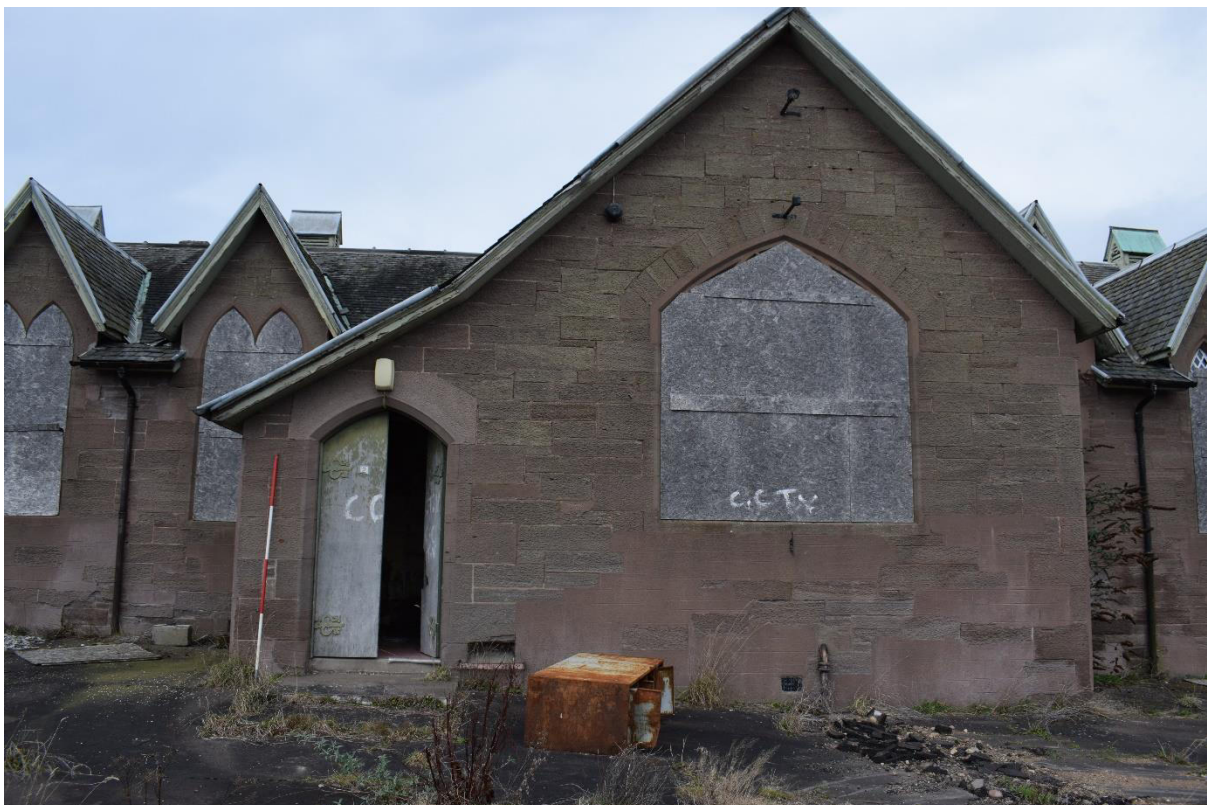
Illus 6 Phase 1 D1 and W7 on S façade; facing N

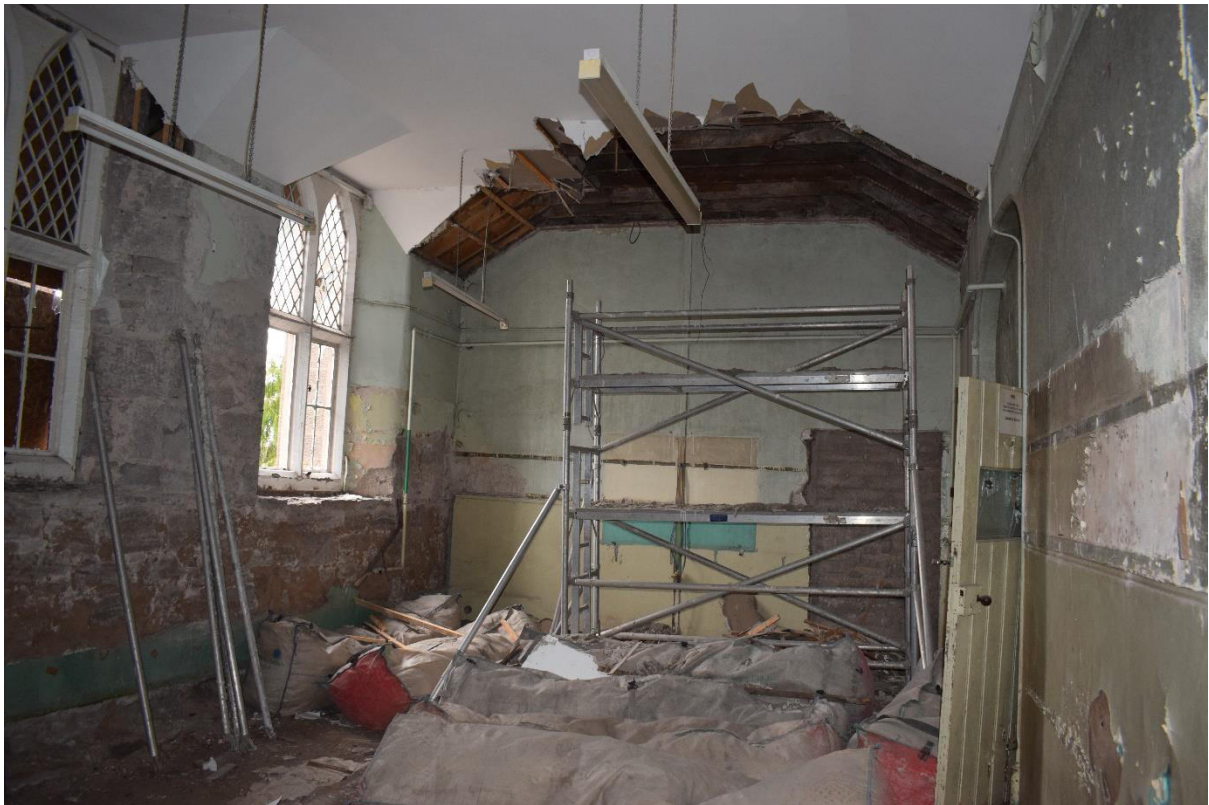
Illus 7 Phase 1 Room 3; the S wall and windows (left) is original and the N wall (right) was rebuilt in Phase 2; facing W

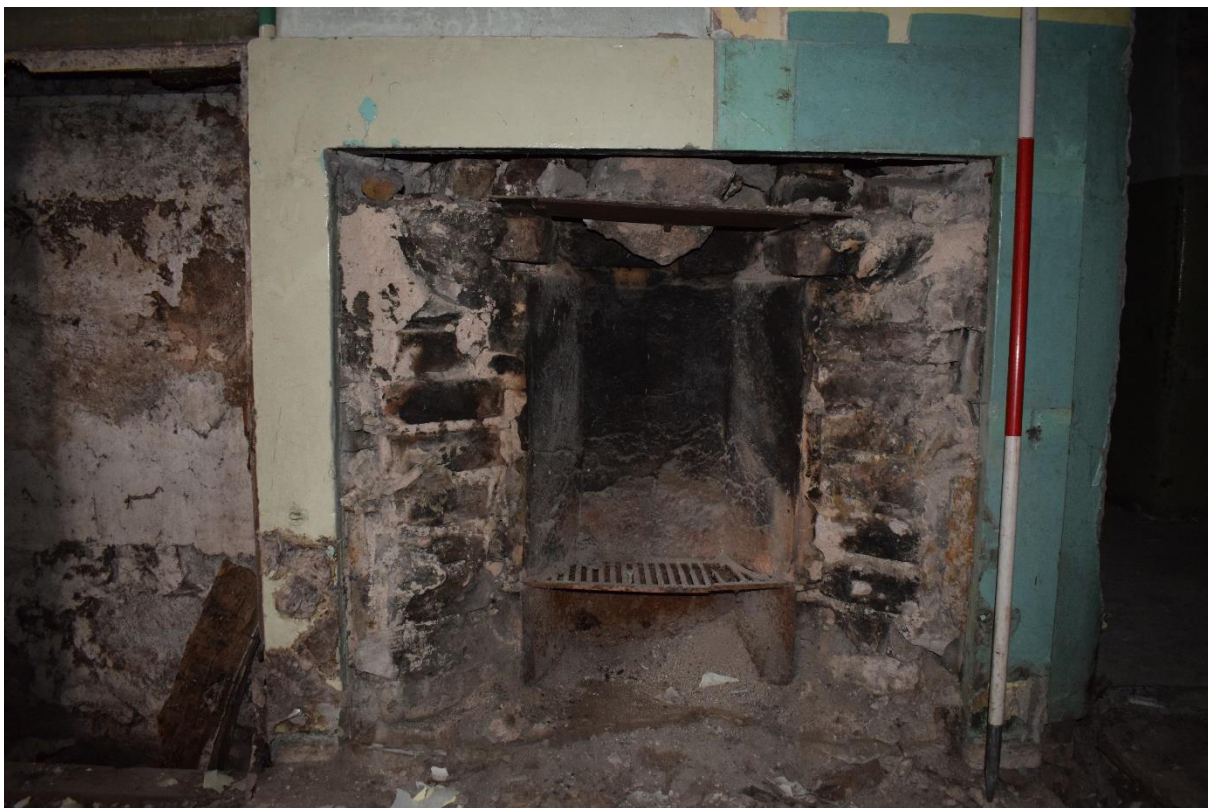
Illus 8 Room 3 N wall fireplace F7 with concrete surround; the tiles have been removed; facing N

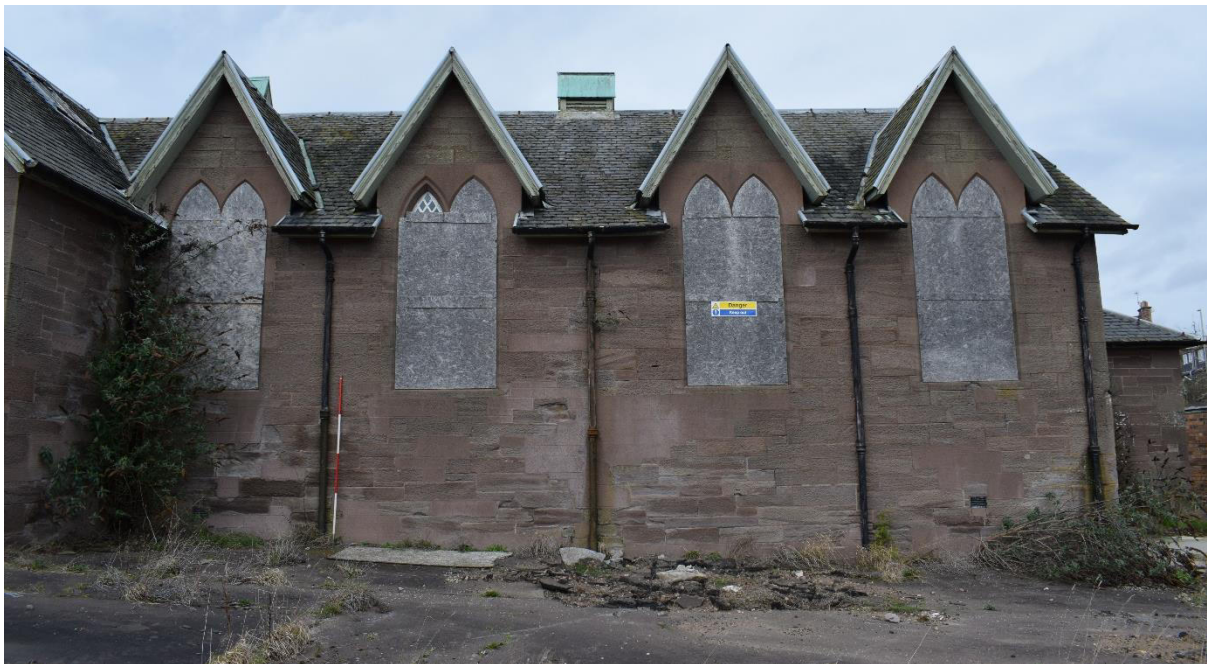
Illus 9 Phase 2 S façade W8, W9, W10, W11 (l-r); facing N

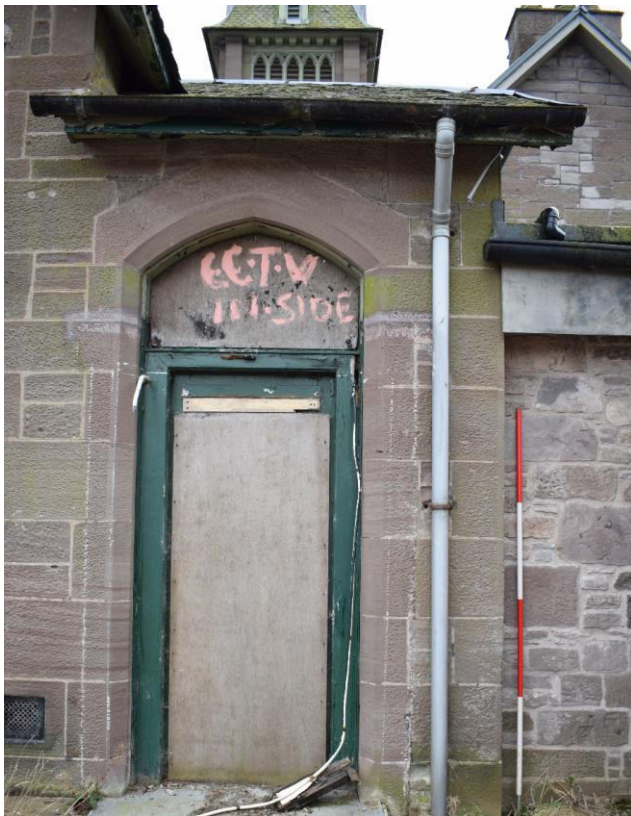
Illus 10 Sandstone doorway into Phase 2 school from N D4; facing S

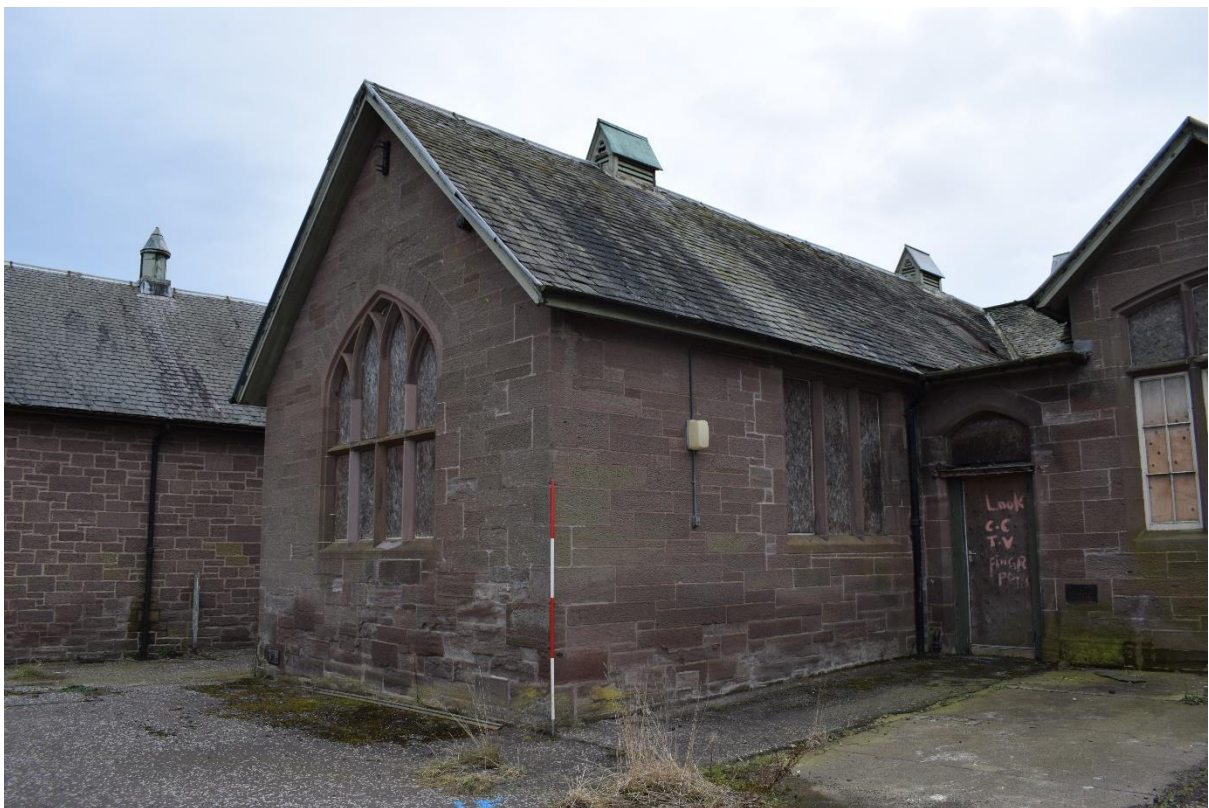
Illus 11 Phase 2 Room 4 N wall W20 (left); facing SE

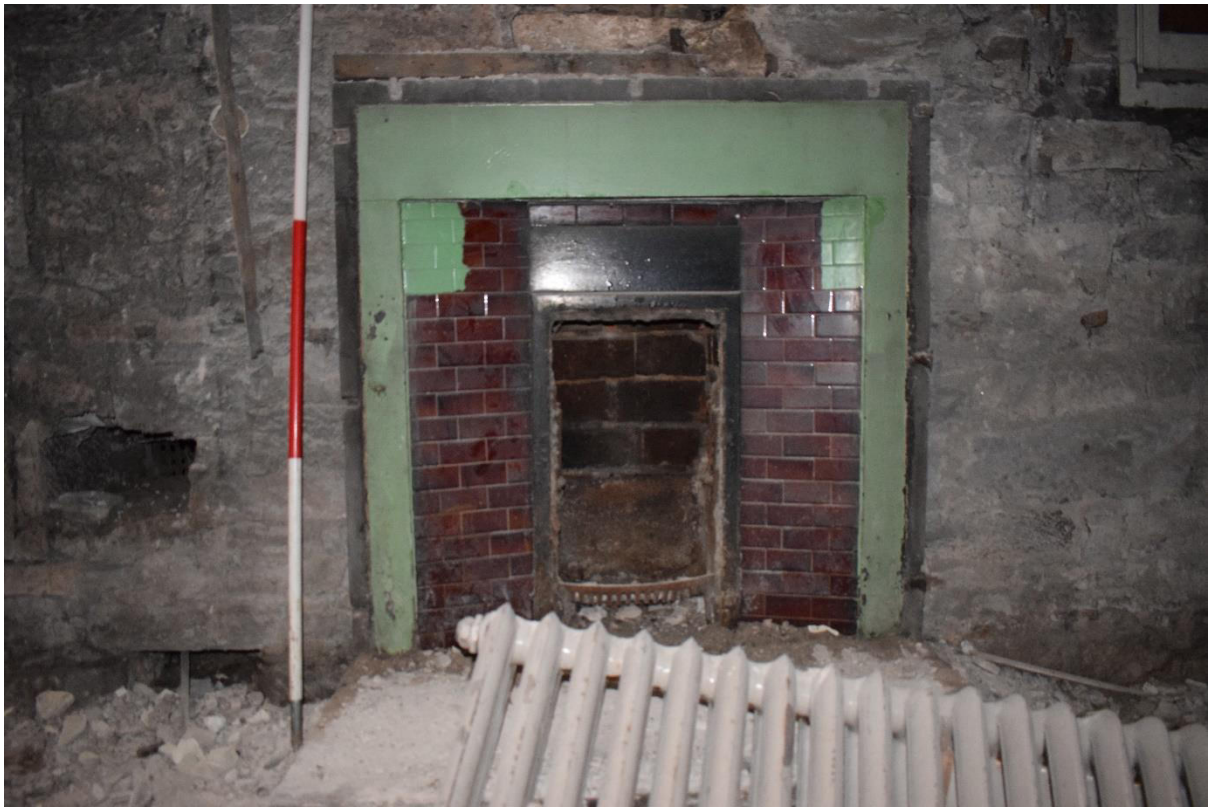
Illus 12 Room 8 Phase 2 fireplace F5; facing W

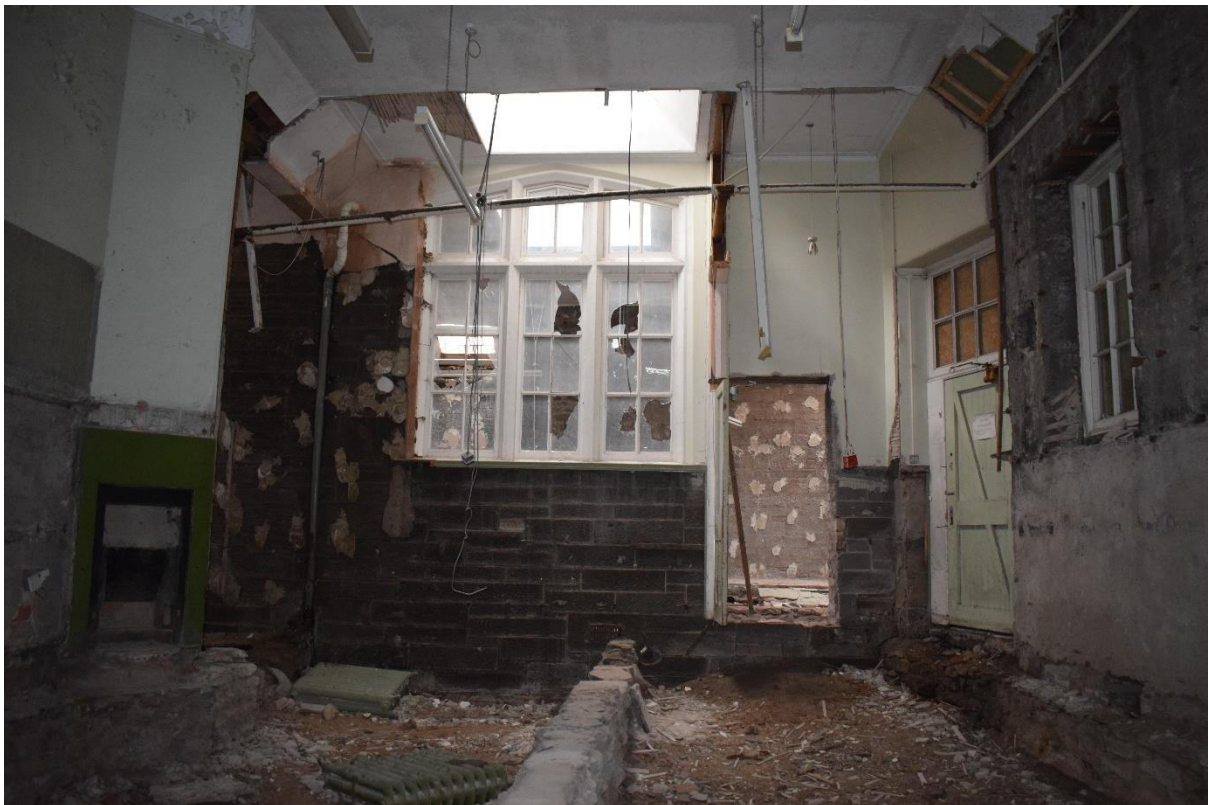
Illus 13 Room 5 south wall which was originally an outside wall with W36 (centre) with fireplace F9 (left) and D5 (right)

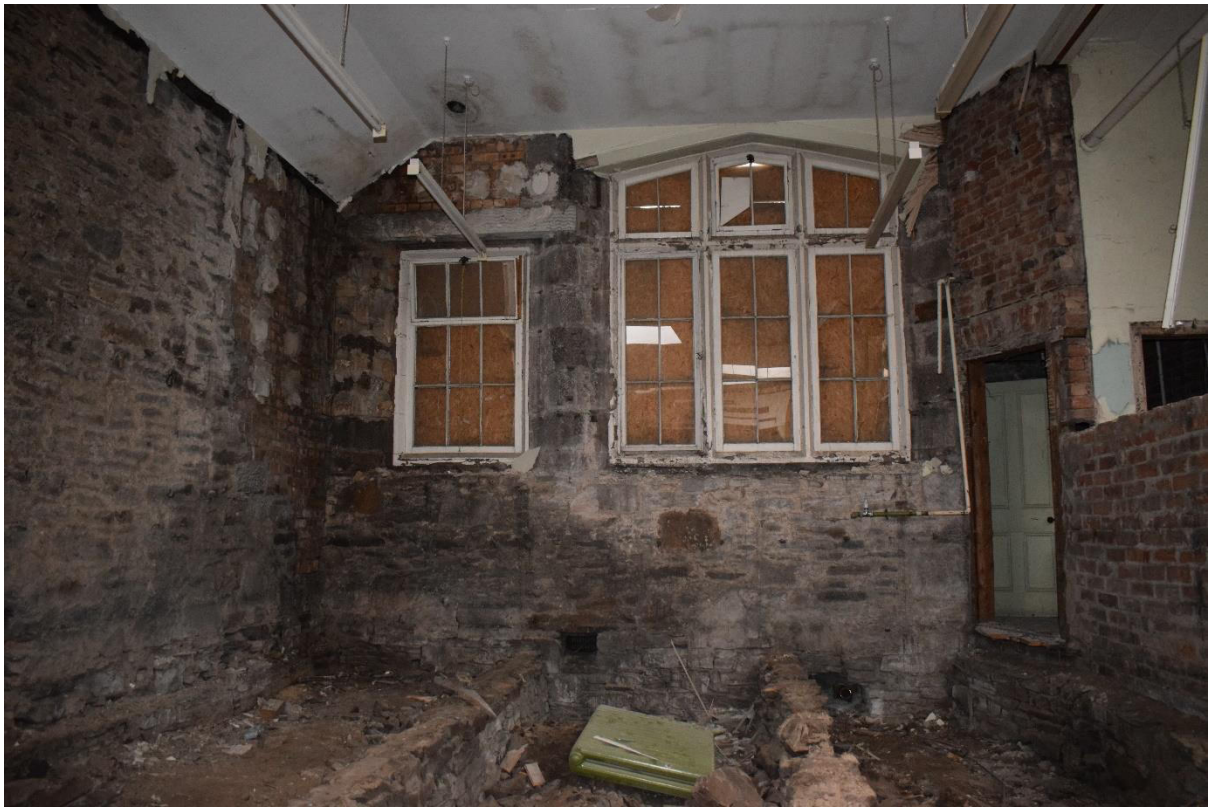
Illus 14 Room 7 E wall windows W30 (left) W29 (right) with sleeper walls and vent; facing E

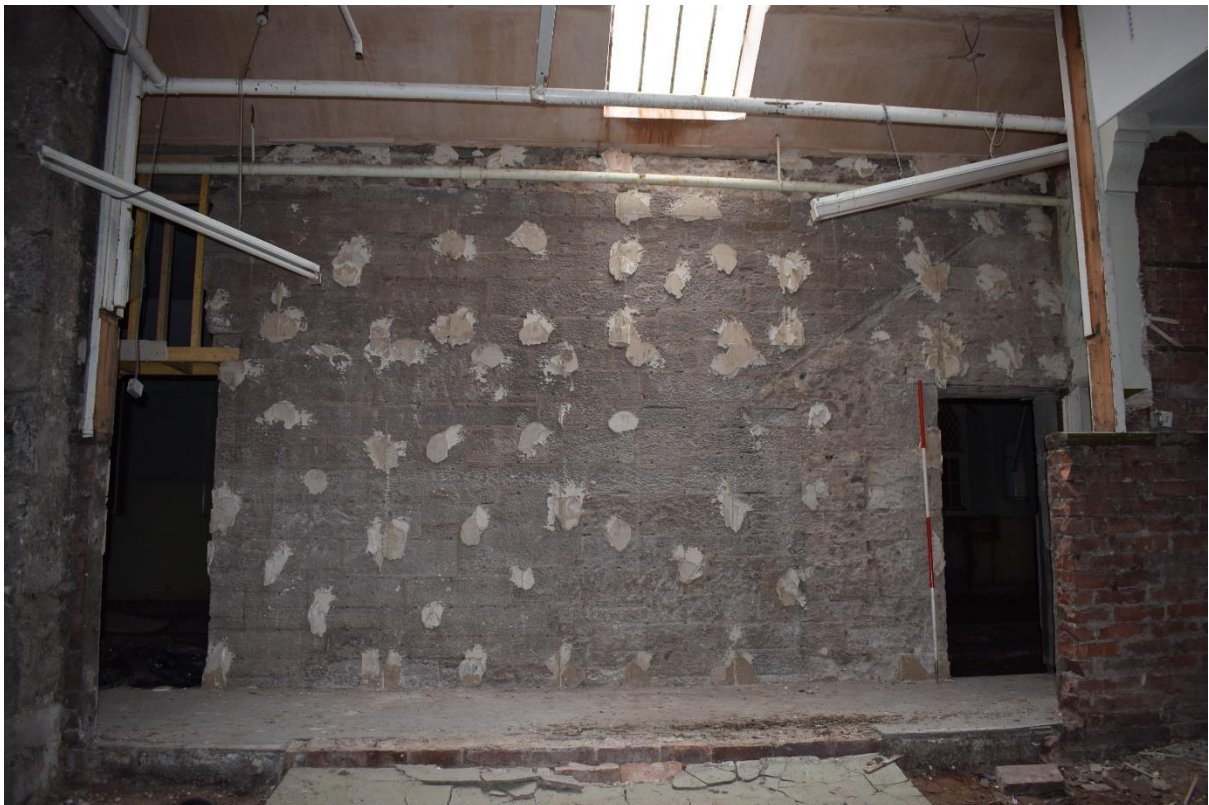
Illus 15 S wall Room 9 D20 (left) D19 (right) showing brick corridor inserted between rooms; facing S

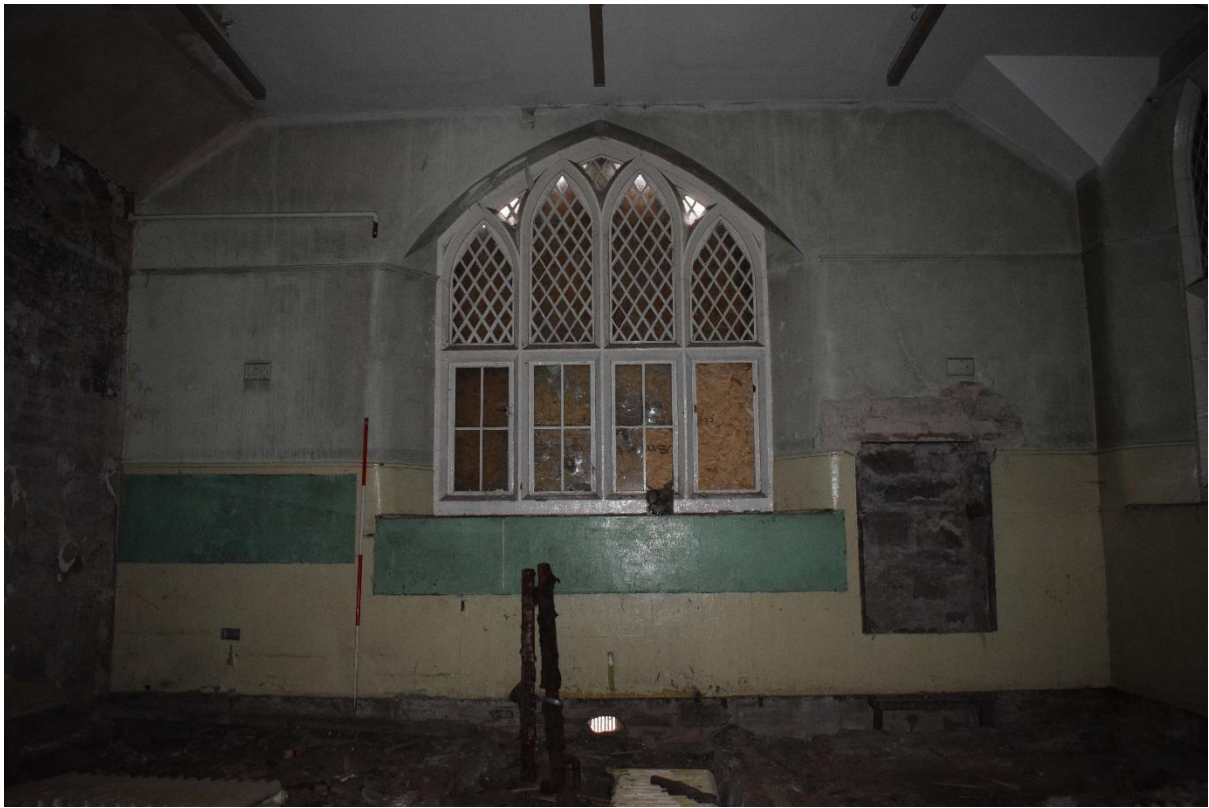
Illus 16 Room 9 E wall Phase 2 window W12; facing E

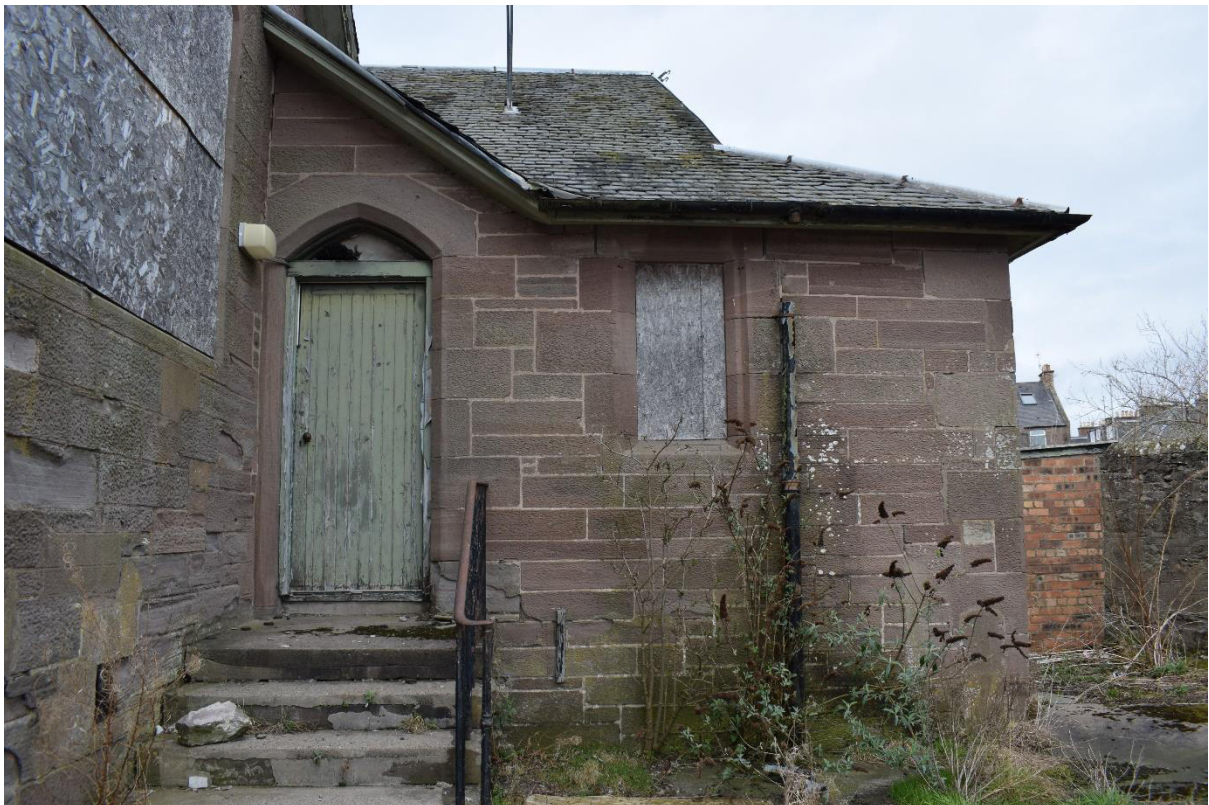
A toilet block (Rooms 11 and 12) was added on to the E of the building, probably in Phase 2 or 3. It replaced the outside toilet block (Building 2).

Illus 17 Phase 2 or 3 toilet block extension on E side of school to replace outside toilets (Building 2) D2 (left) W13 (right) and steps (left); facing N

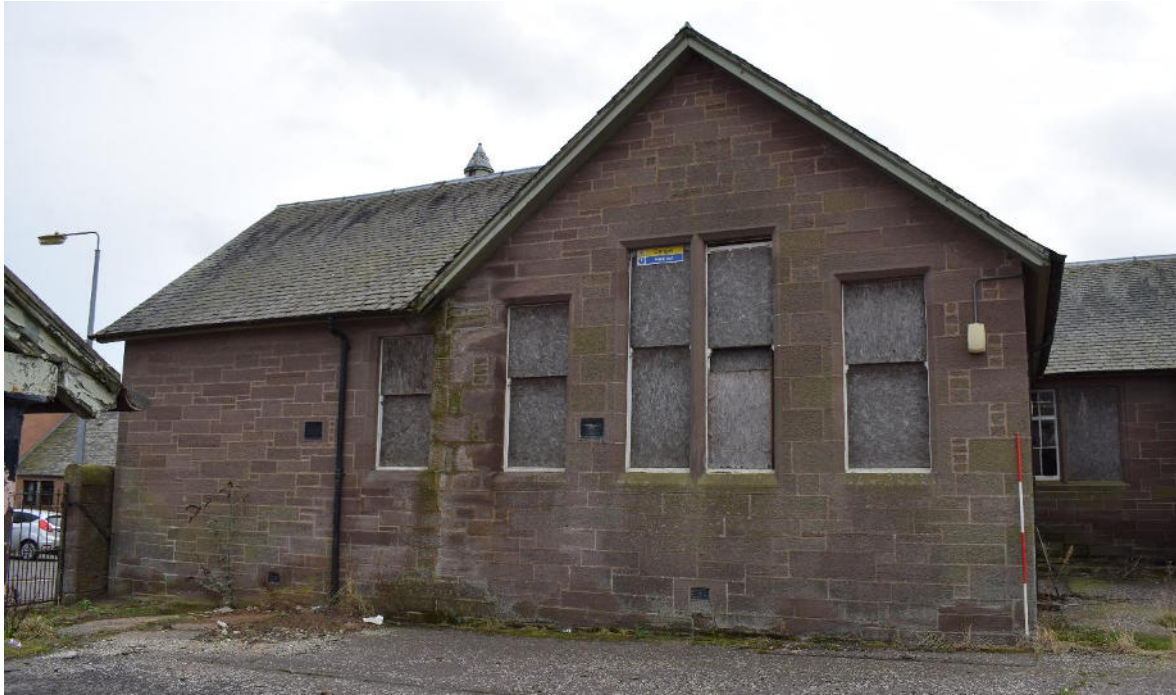
Illus 18 Phase 3 N extension W15, W16, W17, W18 (l-r); facing SSE

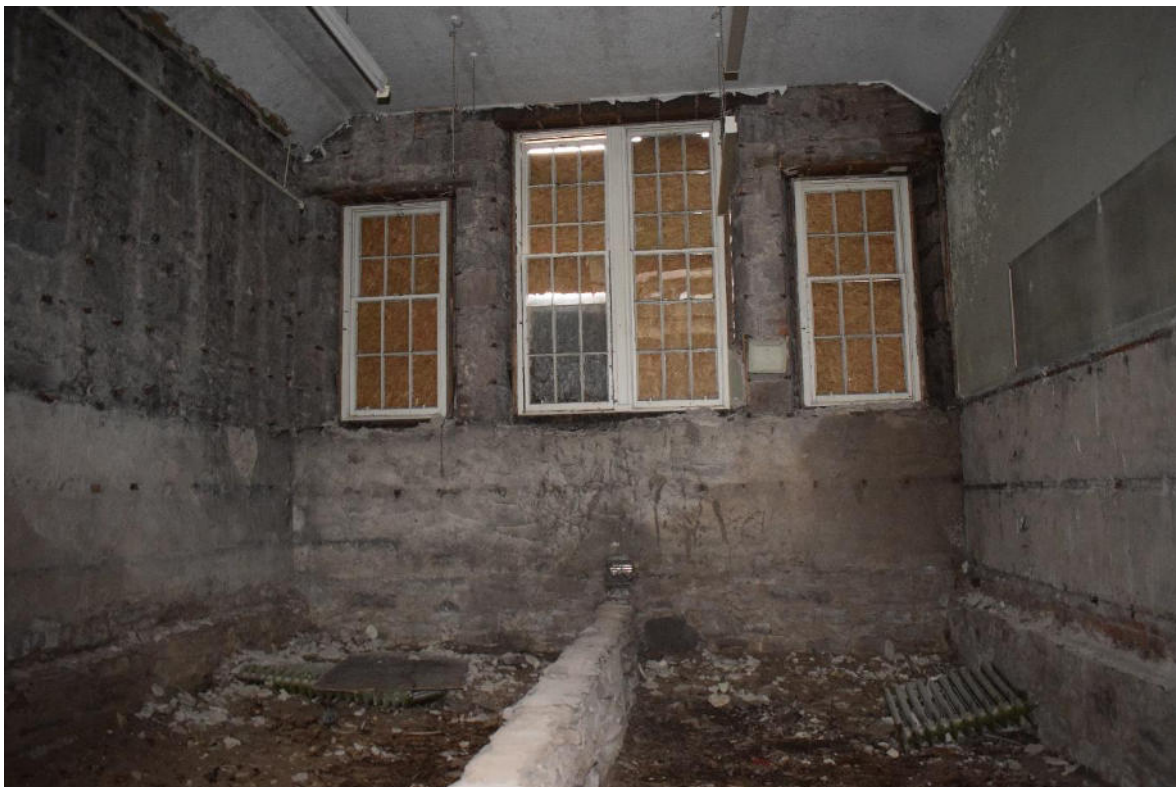
Illus 19 Room 5 N wall windows W18, W17, W16 (l-r) showing sleeper wall in centre for supporting wooden flooring and vent (above sleeper wall); facing N

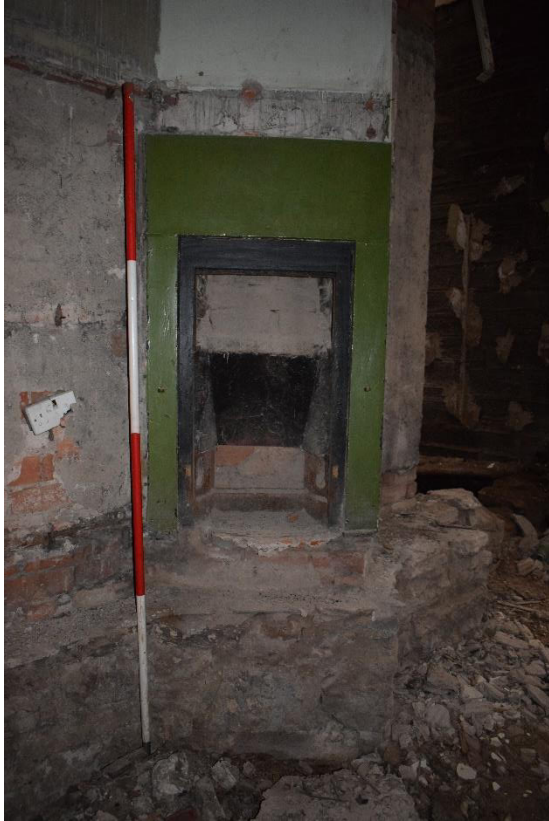
Illus 20 Room 5 corner fireplace F9; facing SE

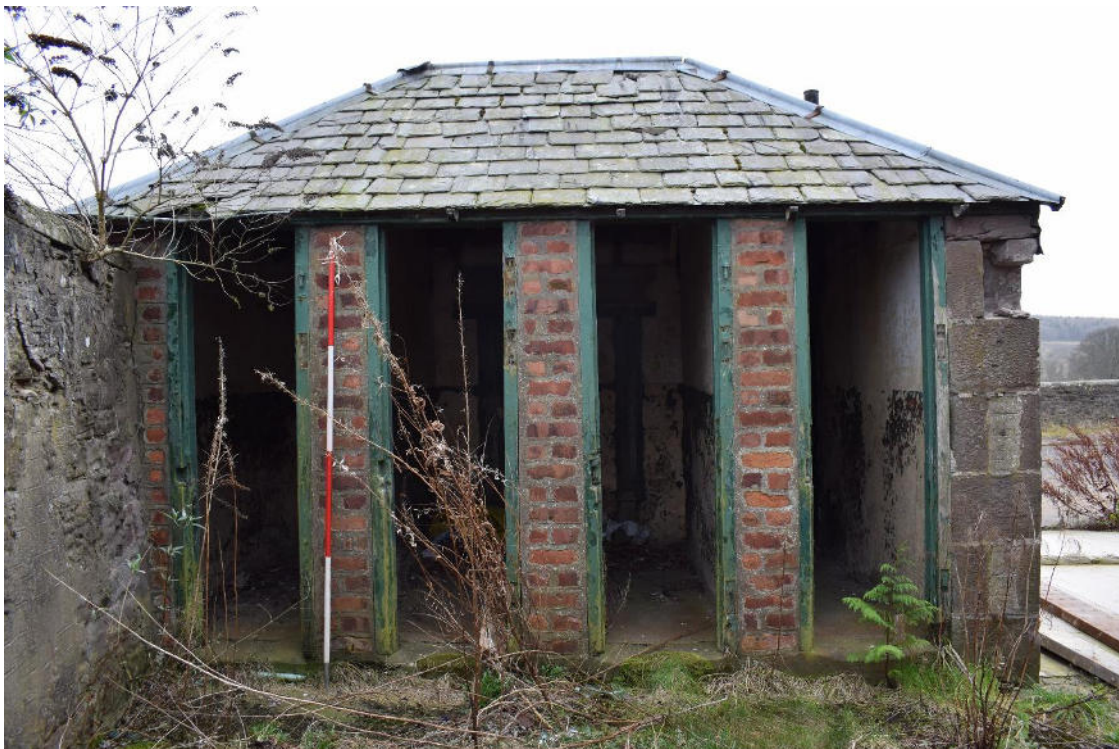
Building 2 is 2 x 4m in size and was a block of four outside toilets built by the 2<sup>nd</sup> Edition OS map (Phase 2). It has a sandstone rubble W and S walls and is built into the E school boundary wall. The N wall has four narrow doors with brick infill in between with concrete walls and floors (Illus 20).

Illus 21 Building 2 N wall stone walls with brick partitions between four cubicle doors; facing S

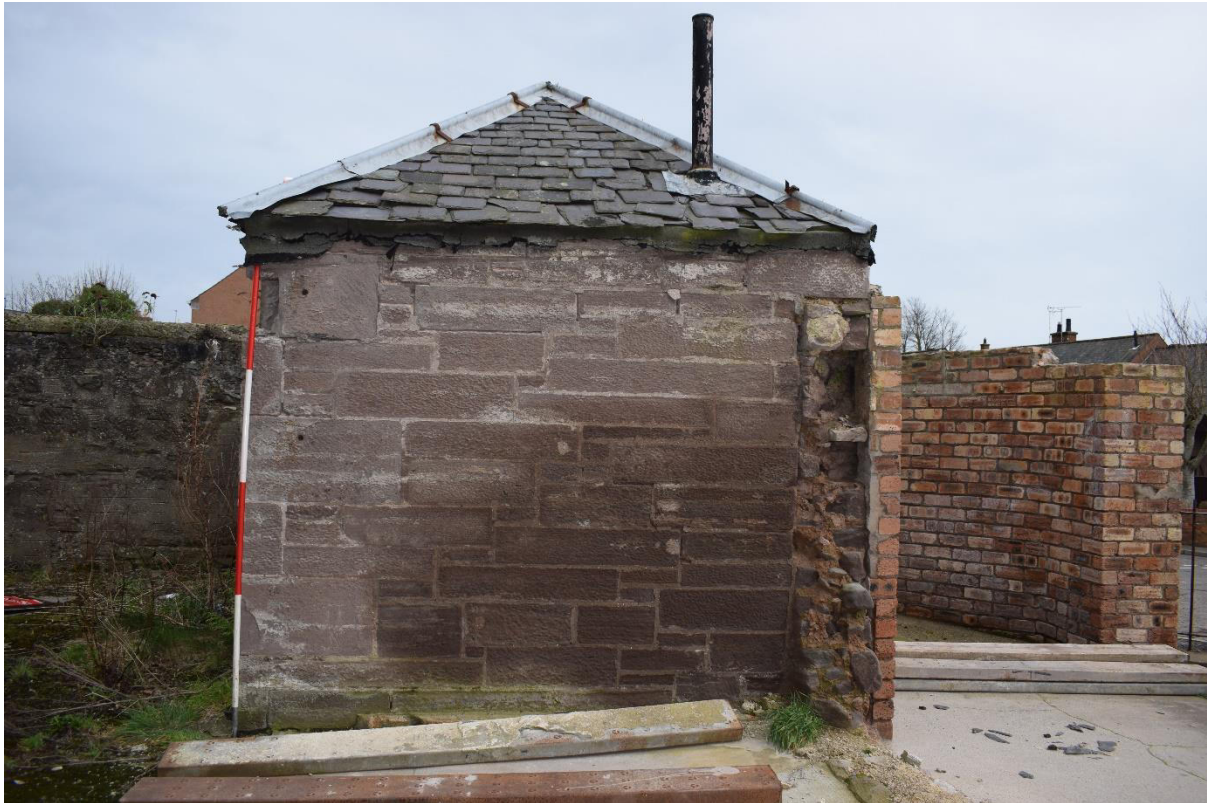
Illus 22 Building 2 W wall showing scar (F11; right) where wall has been removed; facing E

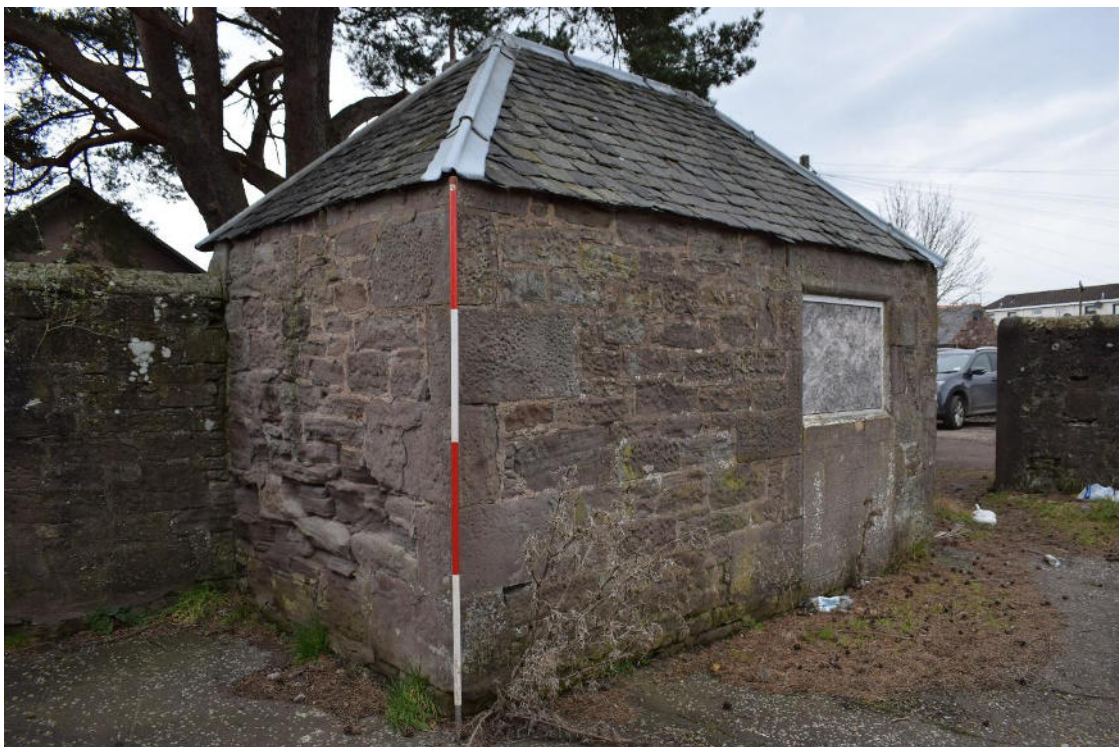
Building 3 is a sandstone blocks and rubble structure in the NW side of the school grounds (Illus 23). It has sandstone quoins and lintel and is 2.1m W0E and 4.4m N-S. It had one door on the E wall which has been infilled and formed into a smaller window. It appears on the maps on the 2<sup>nd</sup> edition OS map (Phase 2).

Illus 23 Building 3 showing D26 (blocked and reopened as window); facing NW

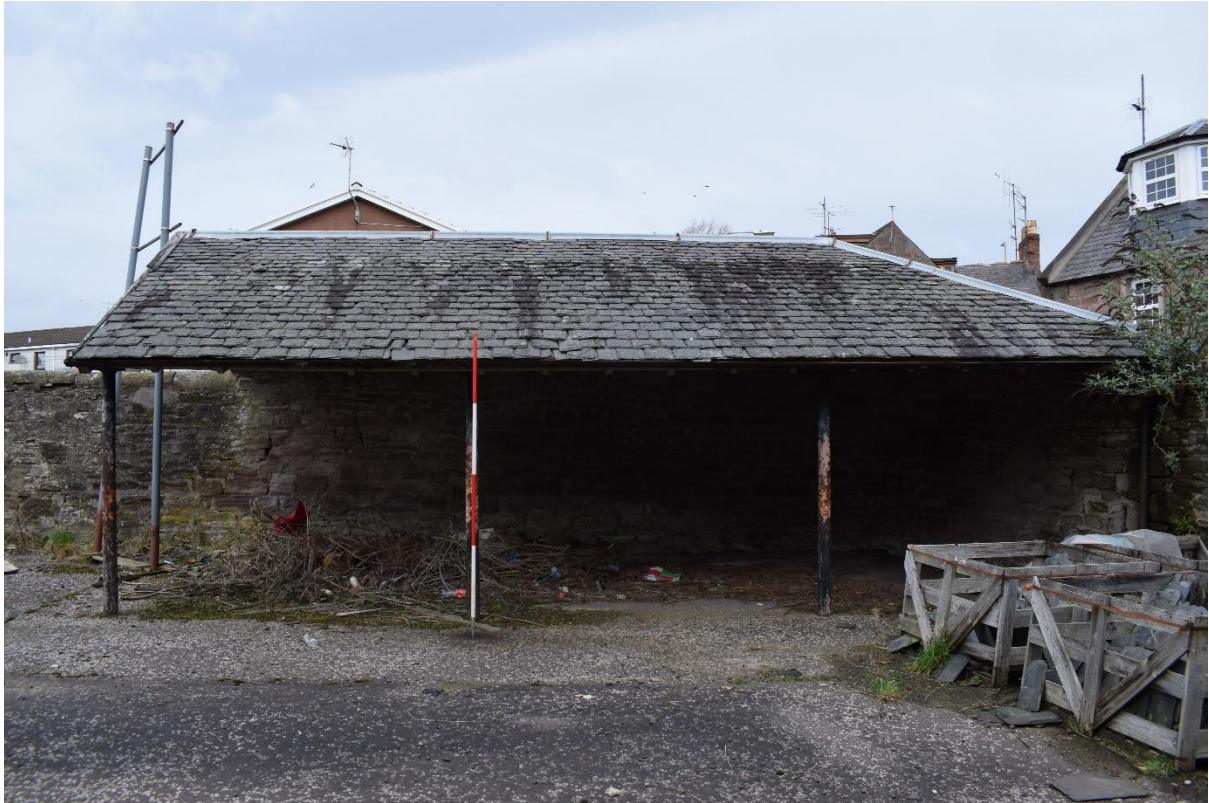
Illus 24 Cast iron pillar construction with slated wooden roof; facing N

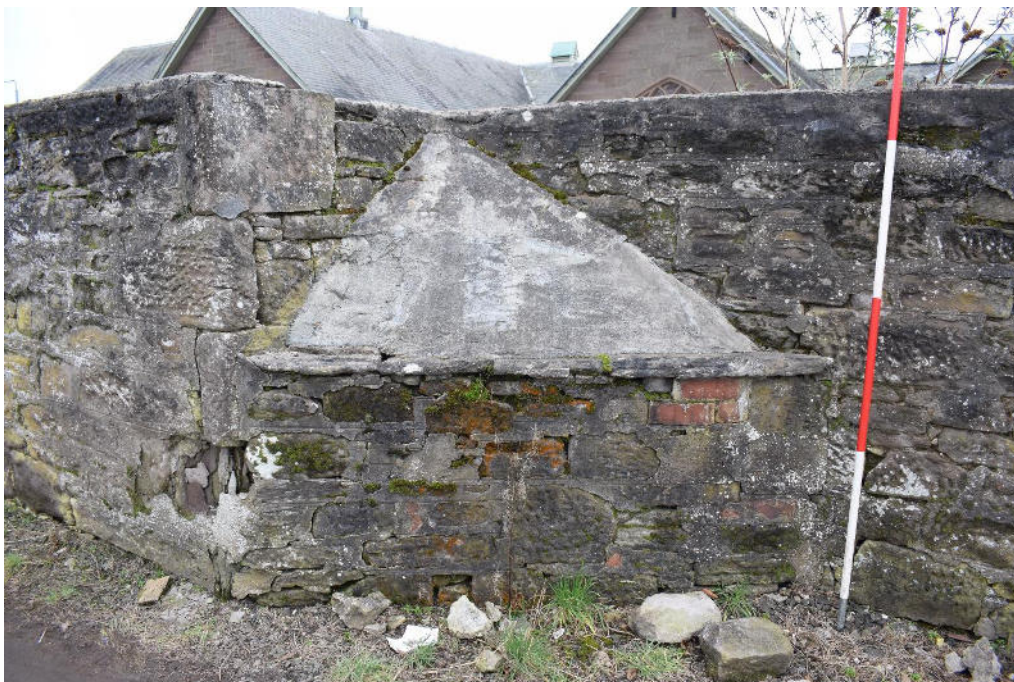
Illus 25 F17; facing SE

A small enclosure appears on the 2<sup>nd</sup> Edition OS map and this survives as a small triangular brick structure topped with a concrete cap.
