**24 Bogie Street/2 New Road, Huntly,
Aberdeenshire, AB54 8HE
Report on Level 1 Standing Building Survey**

**Alison Cameron
Cameron Archaeology
8 March 2017**

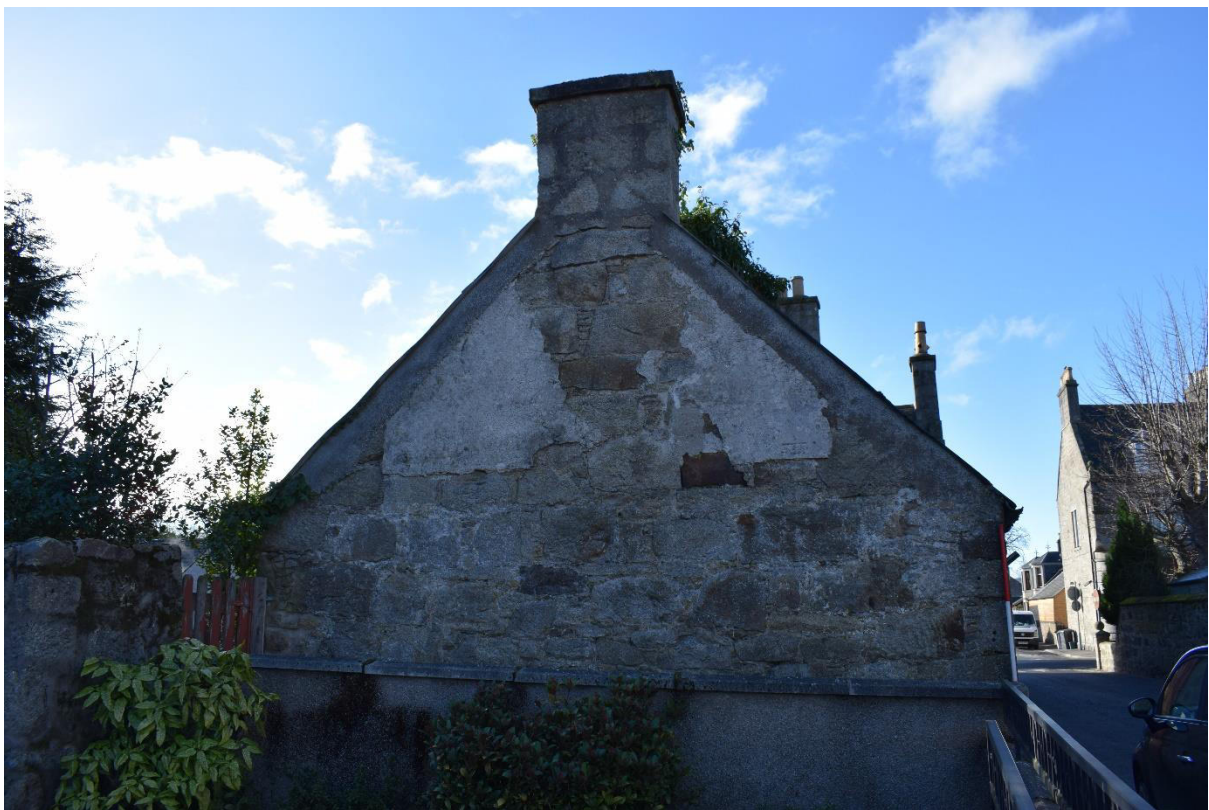
Illus 6 NNE gable Building showing plaster from interior of room (now demolished); facing SSW

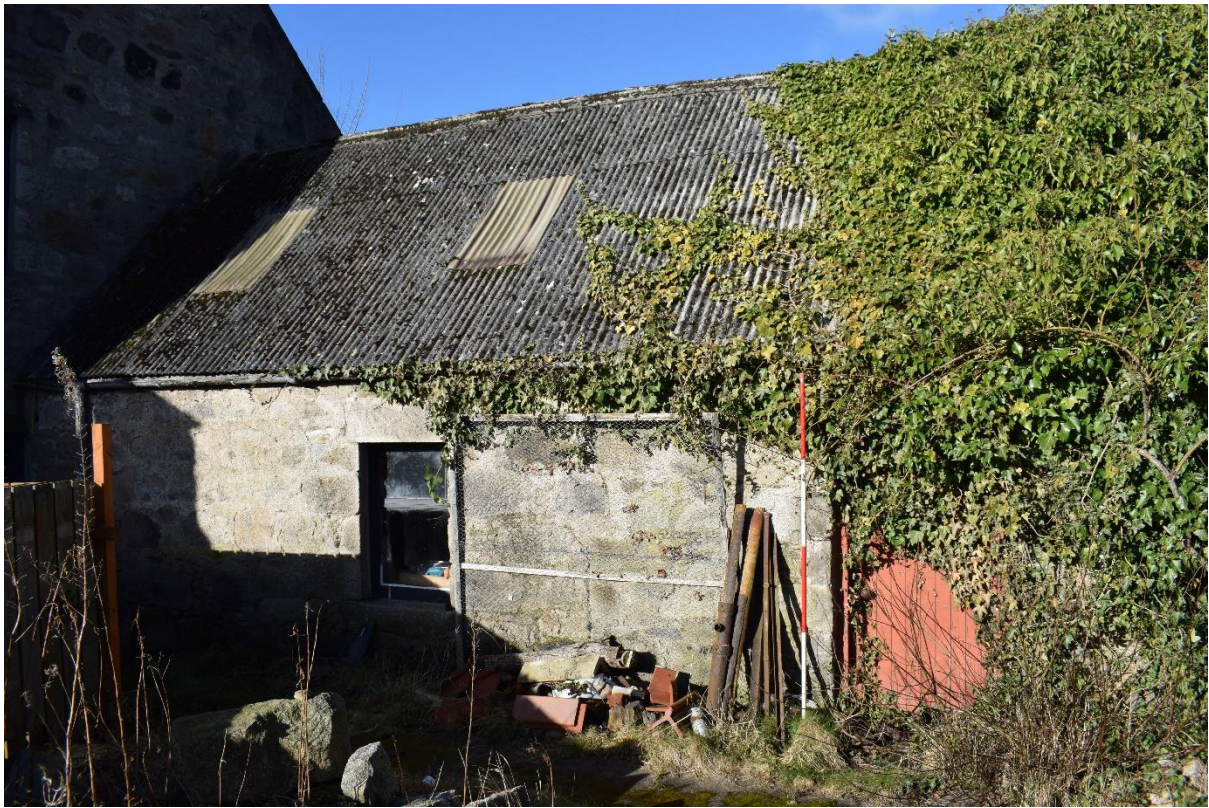
The E wall of the building is very overgrown with ivy (Illus 7) but the remainder of the building was fully accessible. There are large stone fireplaces on the ground floor (Illus 8-10) and smaller fireplaces on the former first floor (Illus 8-10). A partition across Room 2 has been removed (Illus 11) and the floor joists can clearly be seen on all walls (Illus 12). Two windows on the W wall of this building have been infilled with rubble (Illus 4, 11).

Illus 7 Building 1 E wall showing door D7 and W21 and ivy covering N end of wall; facing WSW

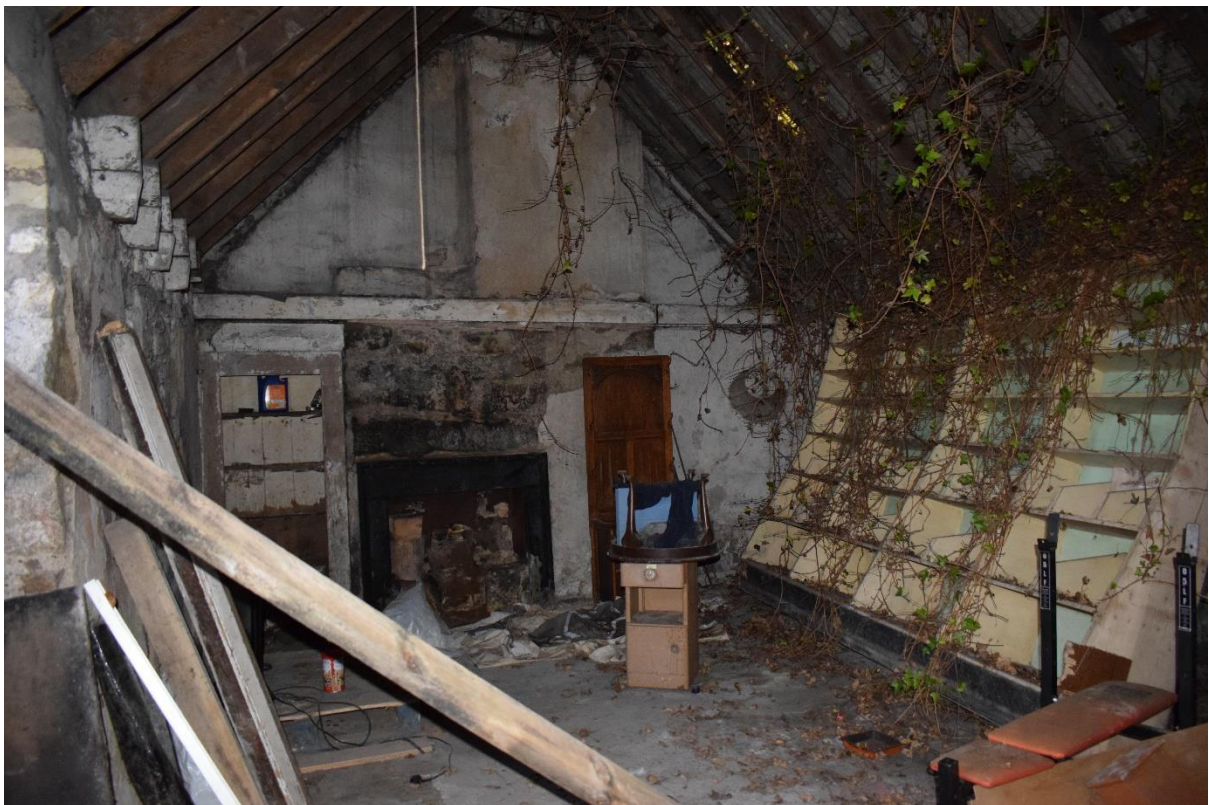
Illus 8 Room 1 interior showing ivy growing in building, alcove F13 (left) fireplace F12 (centre); facing NNE

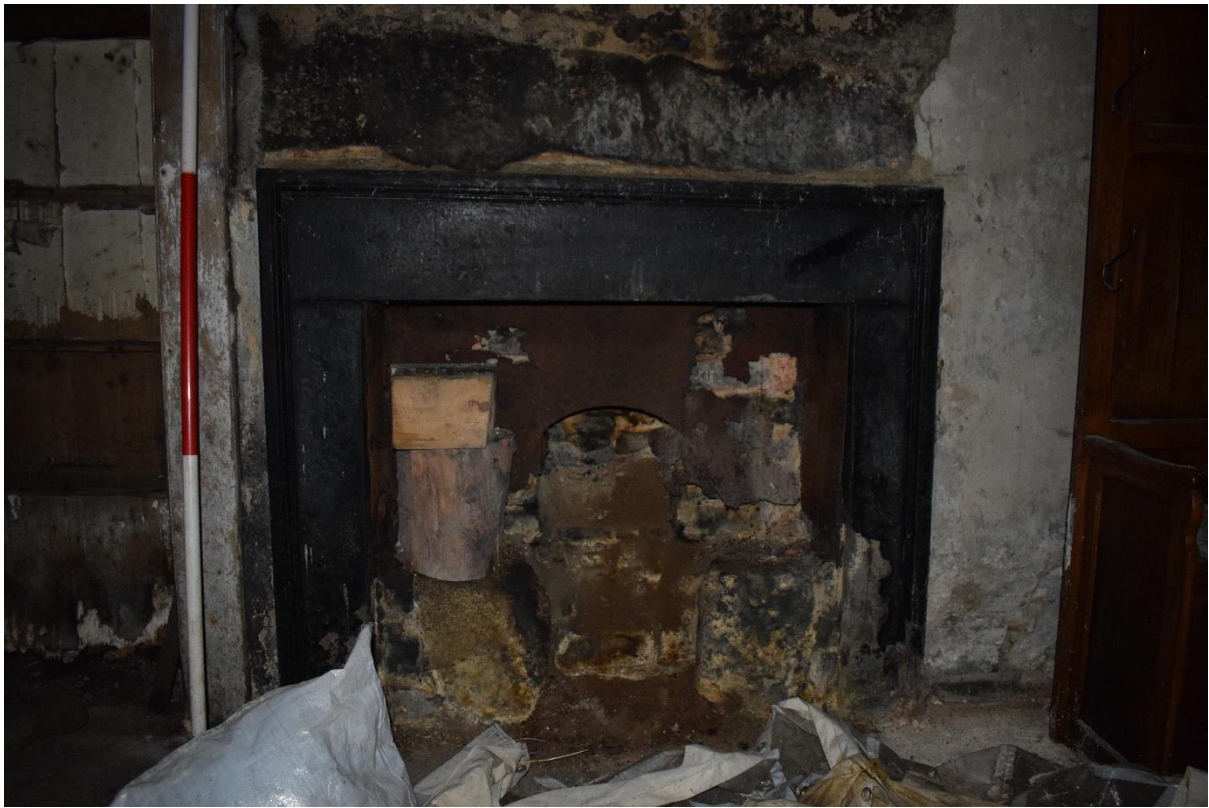
Illus 9 Room 1 fireplace on NNE wall F12; facing NNE

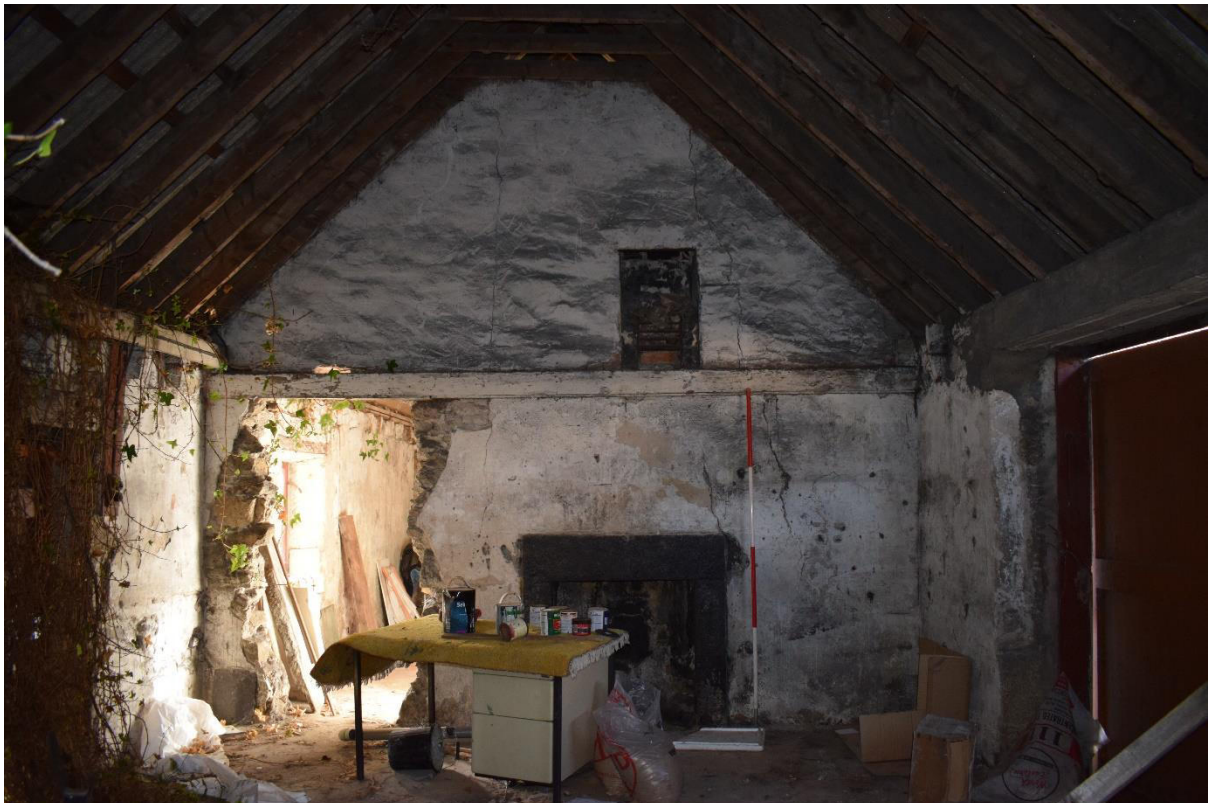
Illus 10 Room 1 SSW wall fireplace F11 (ground floor) and small fireplace F23 (first floor); facing SSW

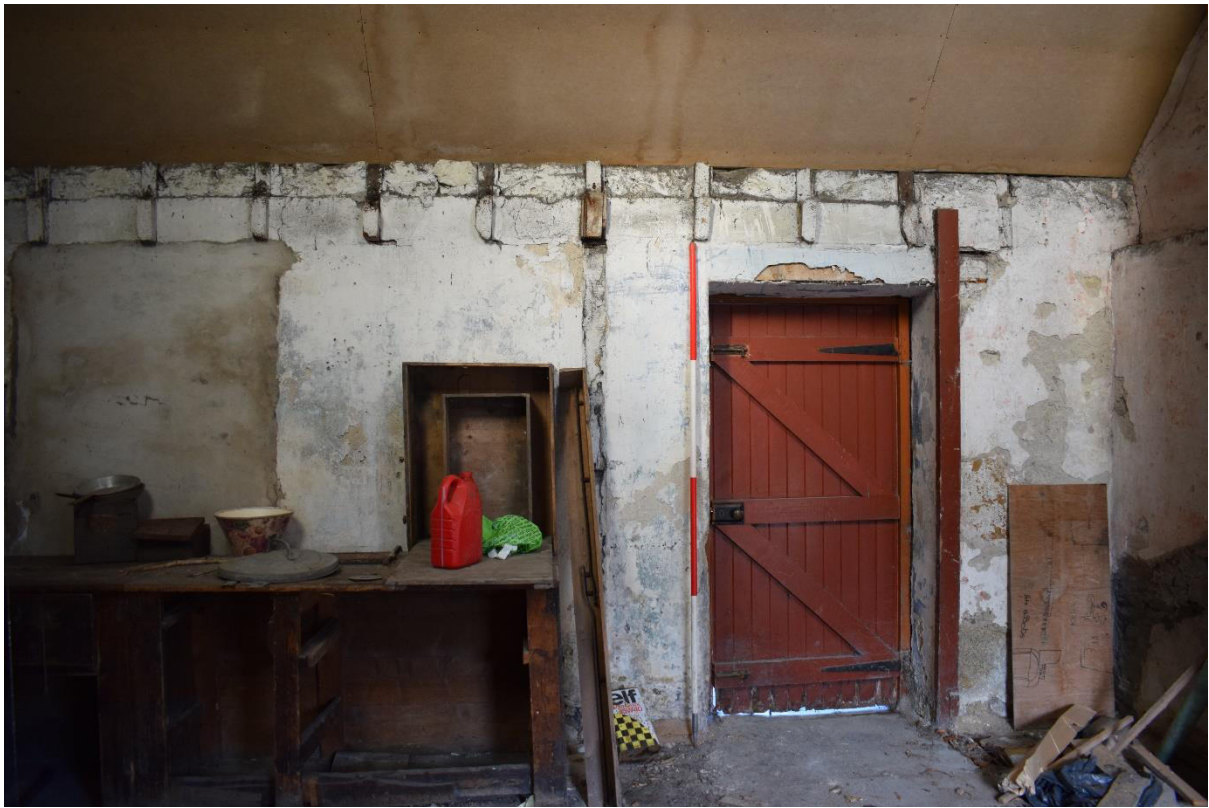
Illus 11 Building 1 Room 2 WNW wall blocked window W2 (left) D2; facing NW

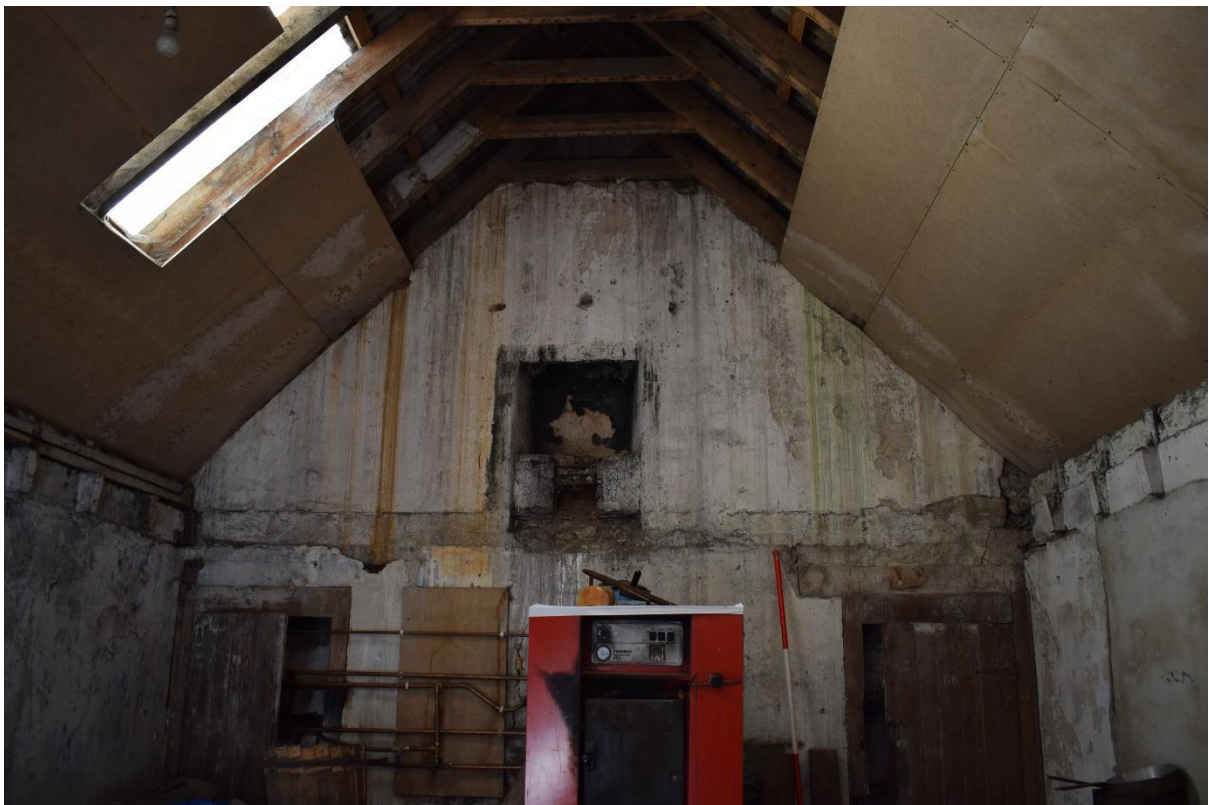
Illus 12 Building 1 Room 2 SW wall 1st floor fireplace F22 (top) and wood alcoves F15 (left) F14 (right)

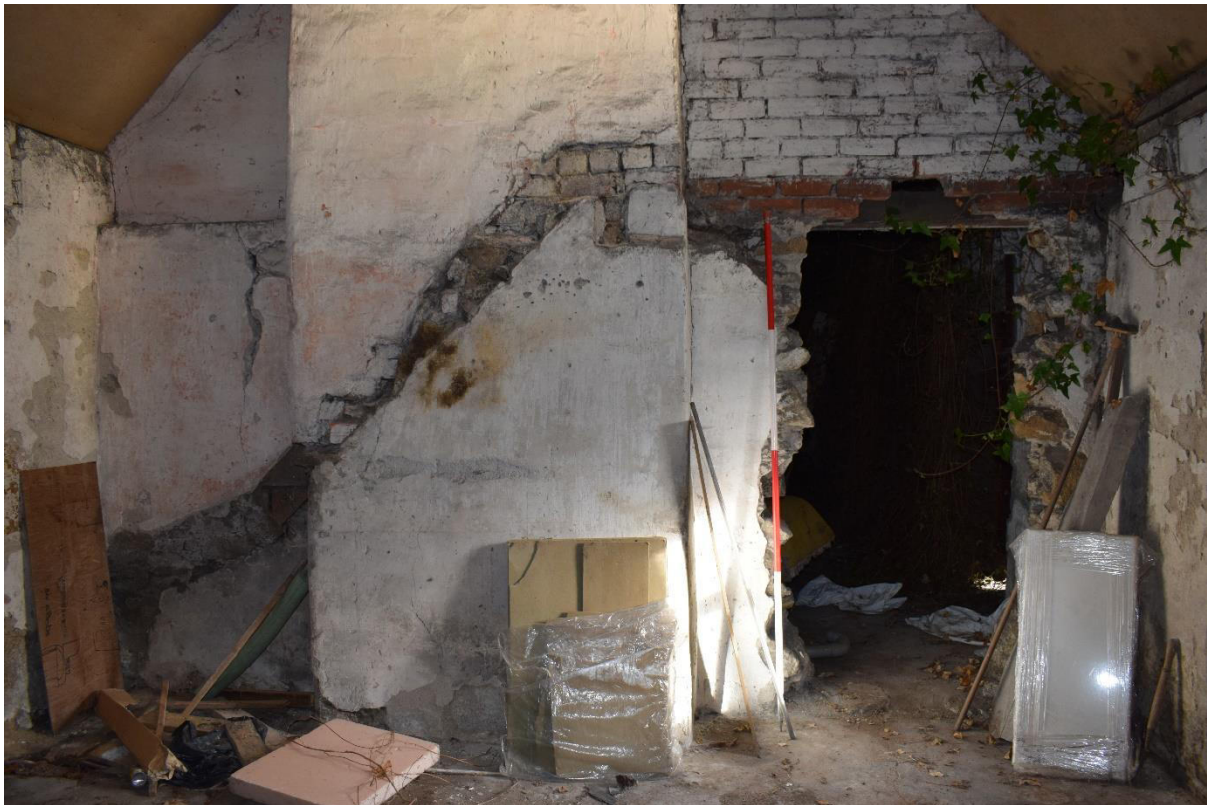
Building 1 is the earlier of the two structures and is 5.5m wide and 16m long. It is constructed of granite blocks and rubble with granite lintel and sills and an asbestos corrugated roof. It consists of two rooms although a third room was added to the NNE of the building between the 1st and 2nd Edition OS maps and has since been demolished (Illus 6). The building is now one story; it originally had an upper floor and there are cut joists and a scar where wooden floor and stair has been removed (Illus 13).

Illus 13 Room 2 NE wall with chimney breast F10 and scar where stair was removed; facing NE

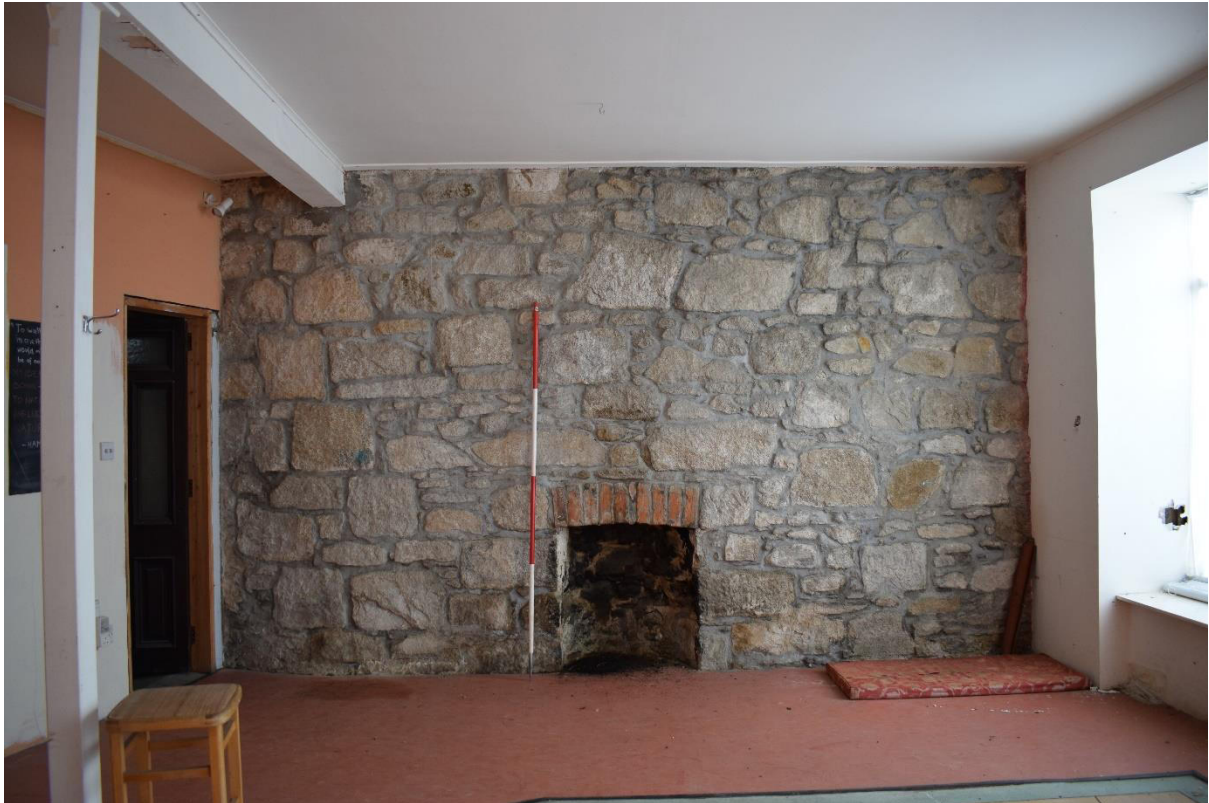
The exterior wall of 26 Bogie Street formed the SE wall of this room (Illus 18). The shop (Room 7) was originally two smaller rooms each with a fireplace (F9 and the now blocked F8, Illus 19). The first floor of this building has 4 large living and bedrooms (Rooms 8, 9, 10, 11 and 12) all with large windows to the street and fireplaces (Illus 20). The 2nd floor has two rooms in the roofspace; a large room on the bogie Street frontage (Room 15; Illus 21) and two rooms above the New Road section of the building Illus 24).

Illus 18 Room 7 ESE wall showing outer face of wall of cottage next door (26 Bogie St) with 24 Bogie St attached later with fireplace F9; facing ESE

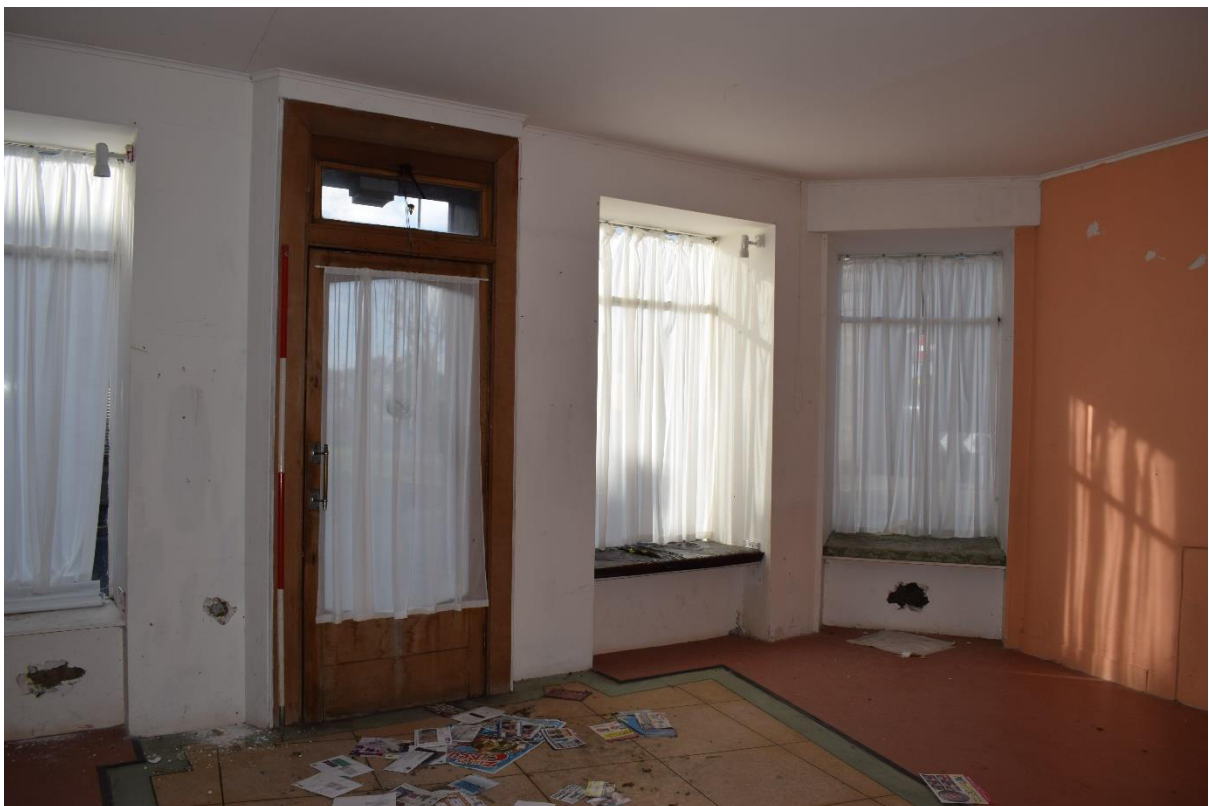
Illus 19 Room 7 front wall with shop windows W16, D6, W15 and W14; facing WSW

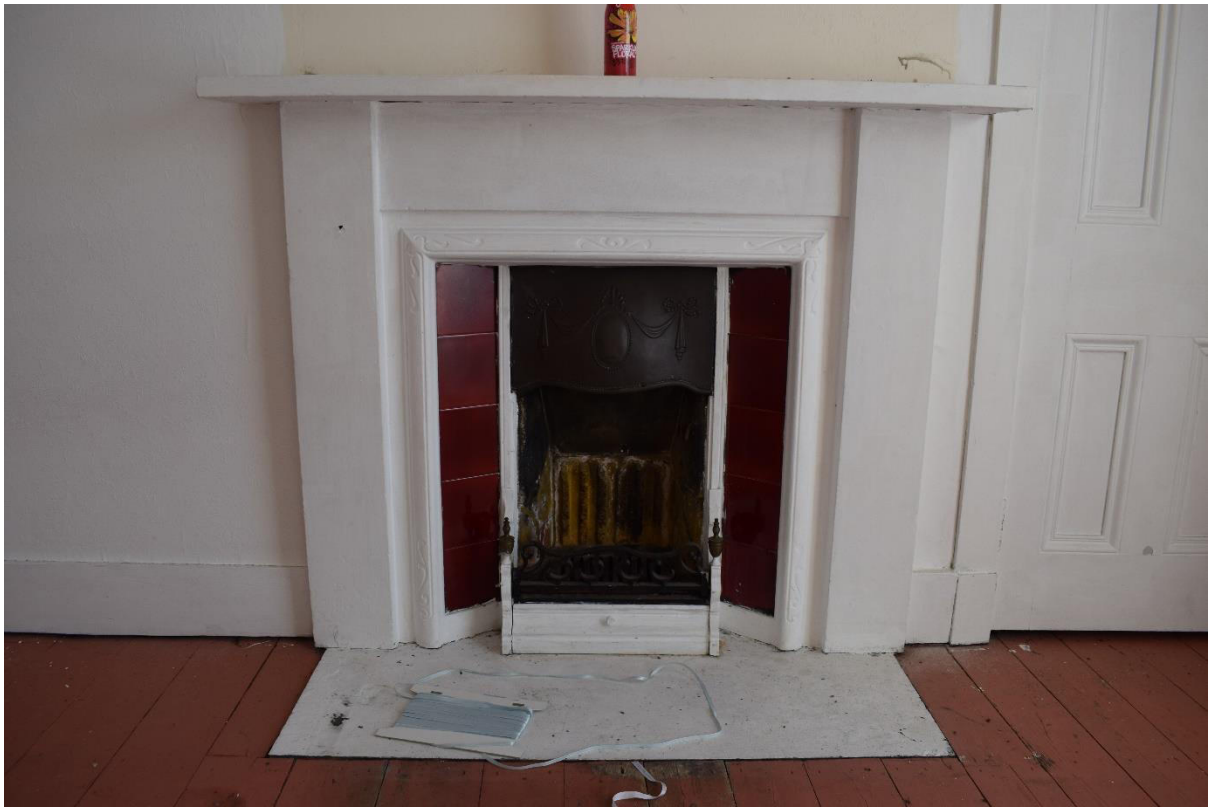
Illus 20 First floor Room 12 fireplace F19 ; facing ESE

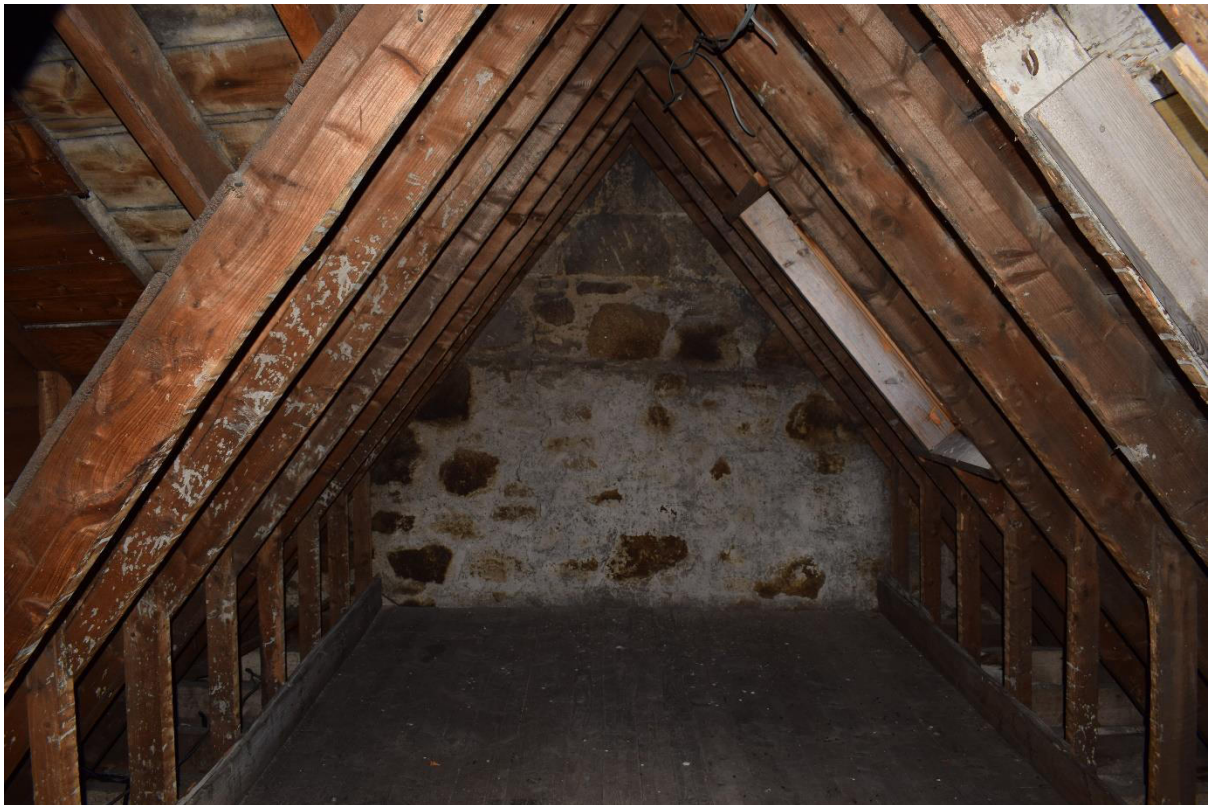
Illus 21 Second floor Room 15 showing granite wall of 26 Bogie St; facing ESE

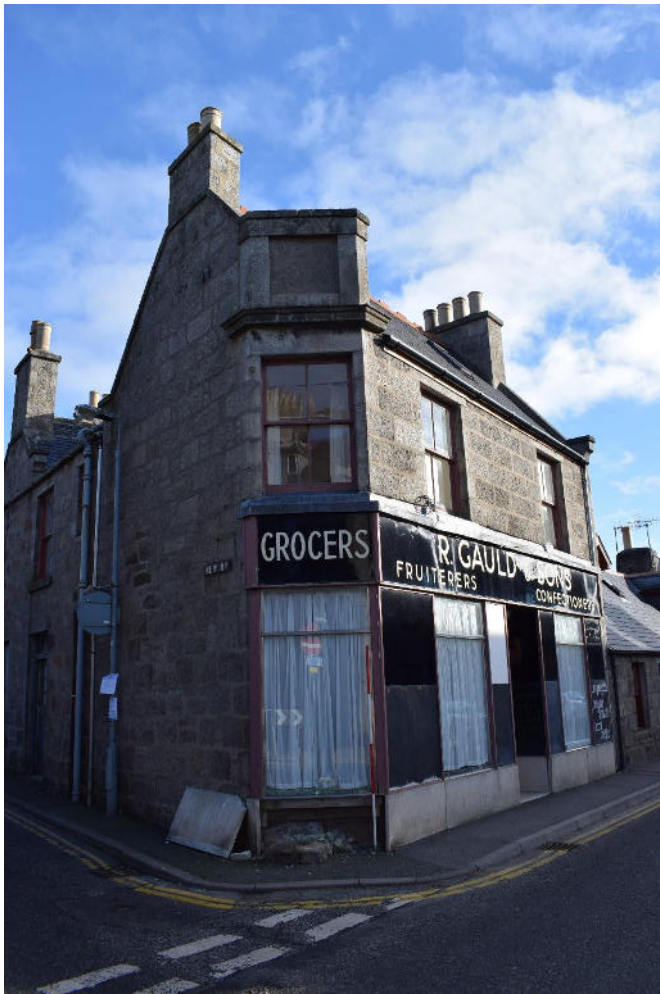
Illus 22 Building 2 junction of Bogie Street (right) and new road left) showing angled wall with W8 (ground), W7 (first) and recess F4 (top); facing E

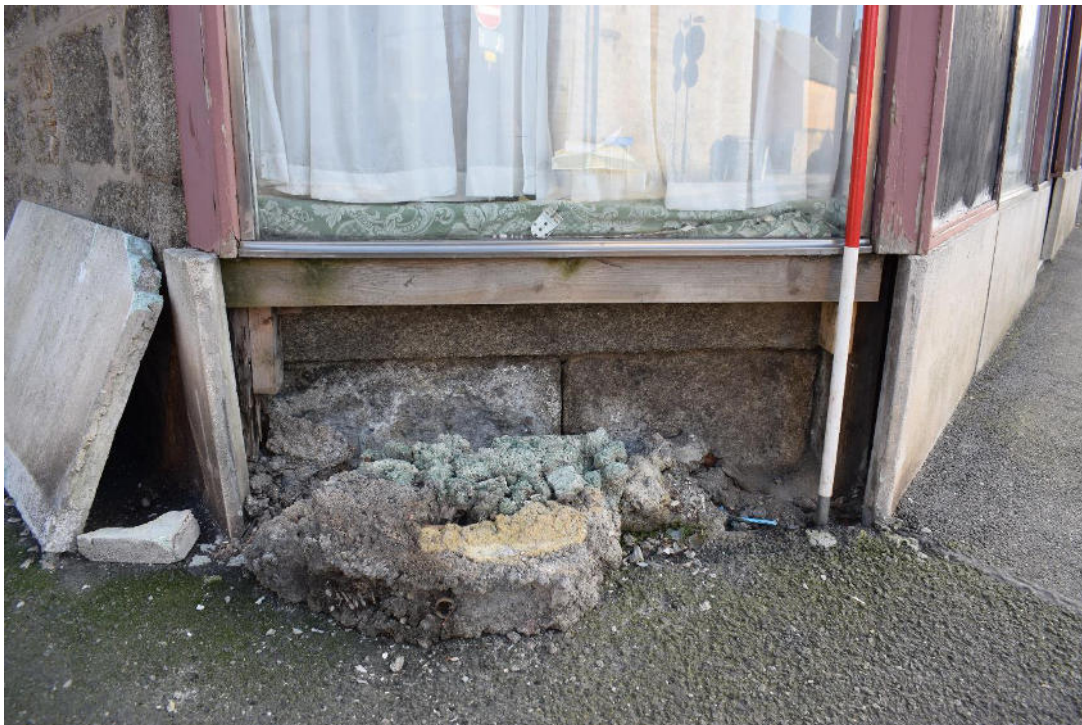
Illus 23 Building 2 W corner at junction of streets showing concrete shop frontage removed and granite building behind; facing E

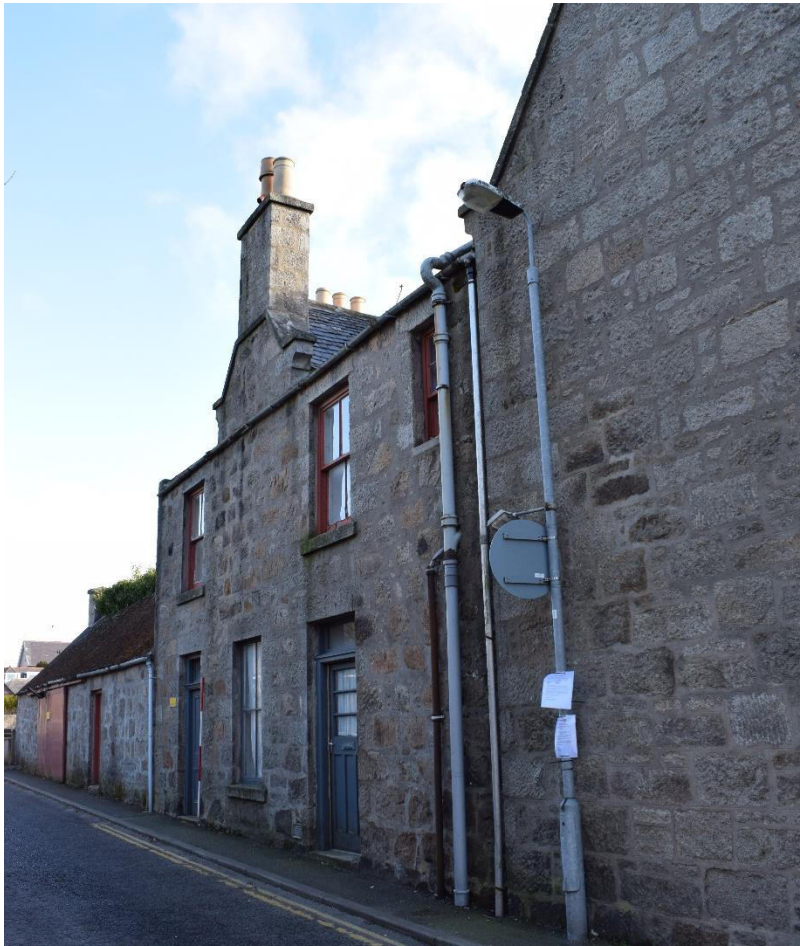
Illus 24 Building 2 (right) Building 1 (left) frontage on to New road; facing ENE
