**Land At Upper Oldmill Farm, Turriff  
Aberdeenshire, AB53 8BU  
Report on Level 1 Standing Building Survey**

**Alison Cameron  
Cameron Archaeology  
19 April 2017**

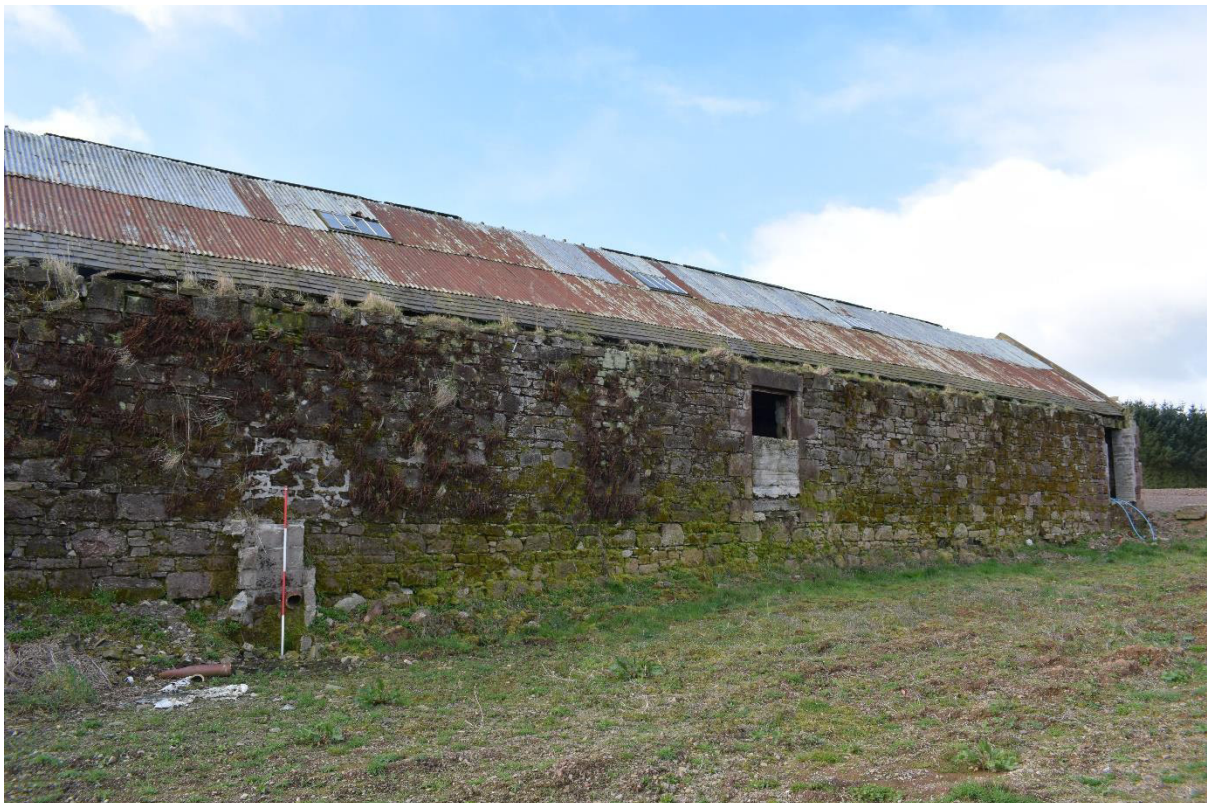
Rooms 1 and 2 form the N and NW sides of the C-shaped steading (Illus 8). There is no access to the interior as the roof is in poor condition. There is a main door on the S wall (D18) and a central door off the courtyard (D9) and 3 doors in the N wall D7, D17 (later converted to a window W8) and D6 (Illus 9).

Illus 8 Room 2 N wall with D17 (centre) and D7 (right); facing SW

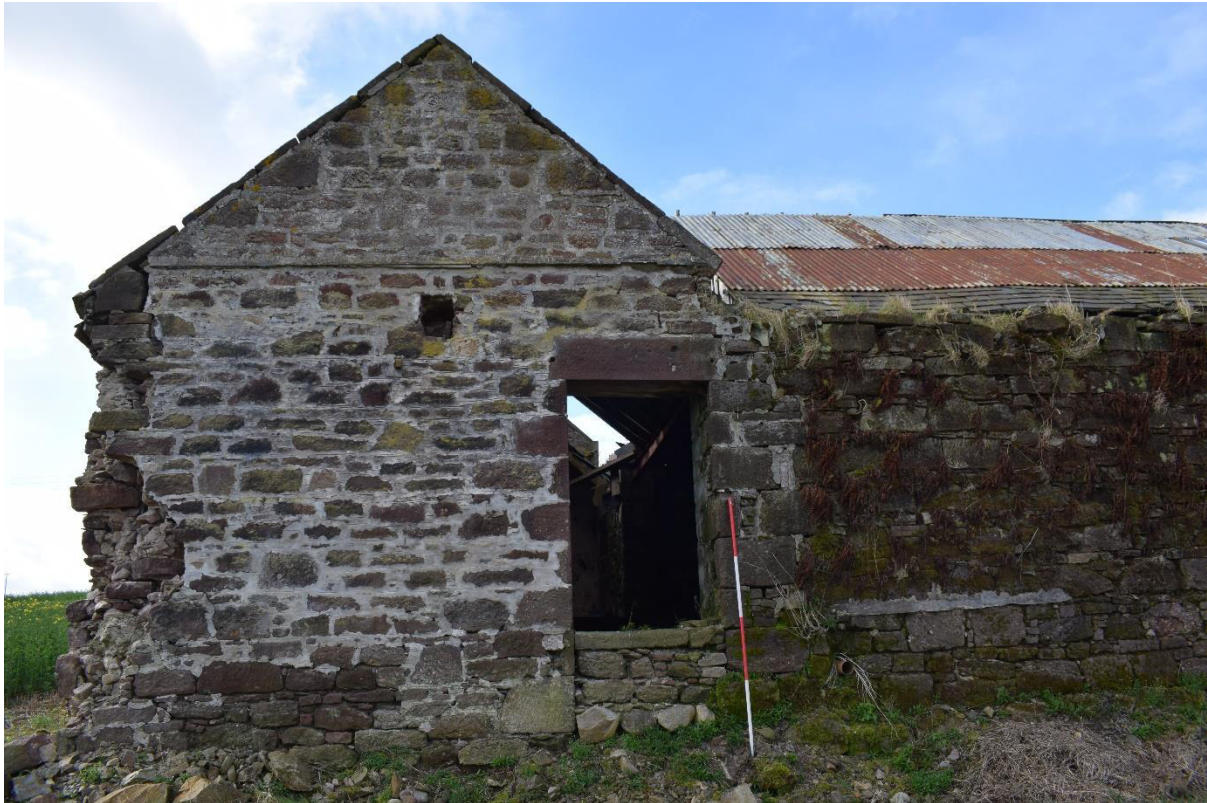
Illus 9 Room 2 N wall E end gable with D6; facing S

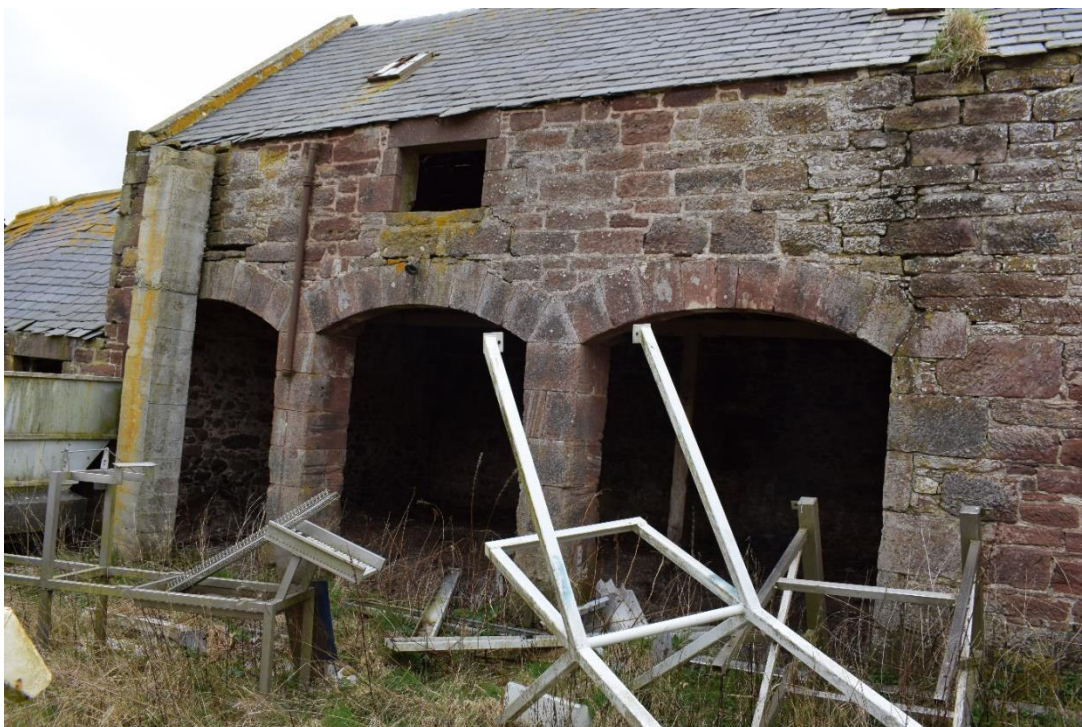
Room 3 is a cart shed with three cart doors on the W wall into the inner courtyard (D12, D13, D14; Illus 10). The doors are 2.2-2.3m wide and 2.5m high and there is graffiti on the sandstone blocks (Illus 11). There is a recess in the E wall (F3; Illus 13) and three sandstone corbels (F6, 7, 8; Illus 12) where an original first floor level and been located. There is now a slightly higher wooden floor.

Illus 10 Room 3 cart shed doors D12, D13, D14 (l-r) on E wall of inner courtyard

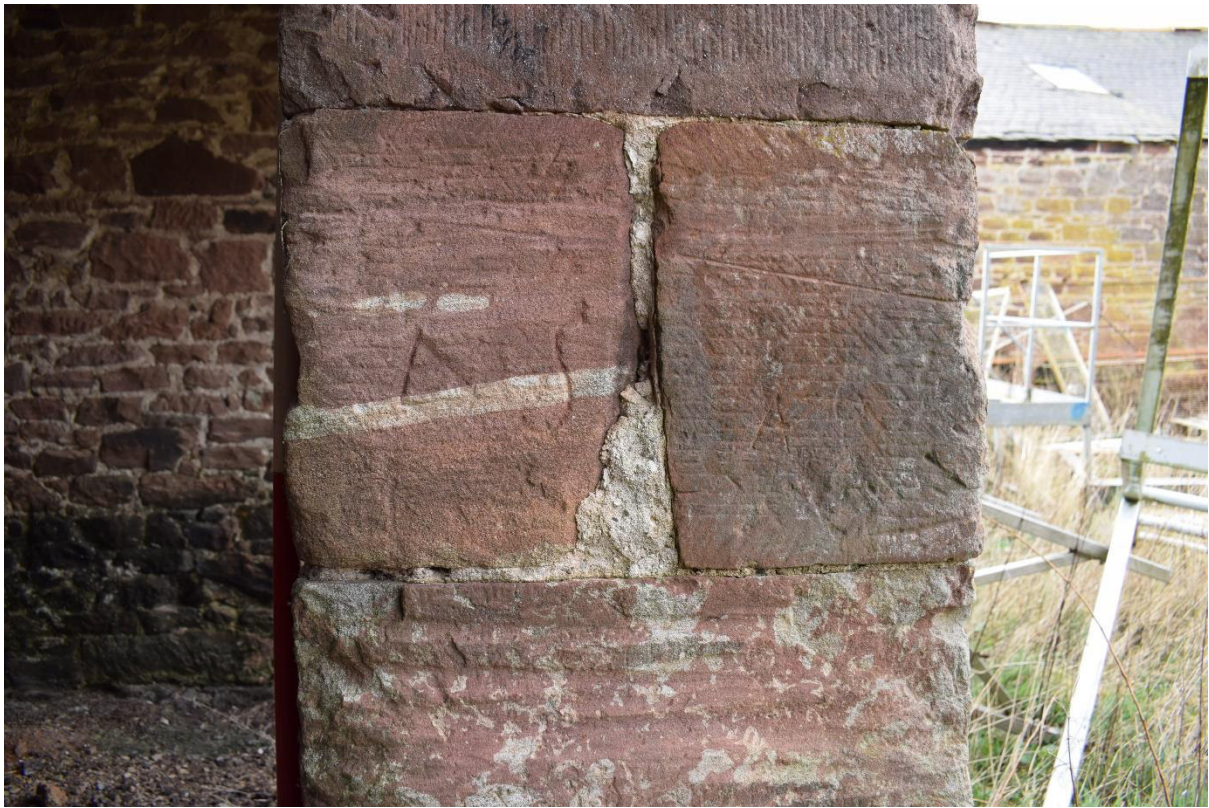
Illus 11 D13 S jamb pillar with graffiti in sandstone blocks

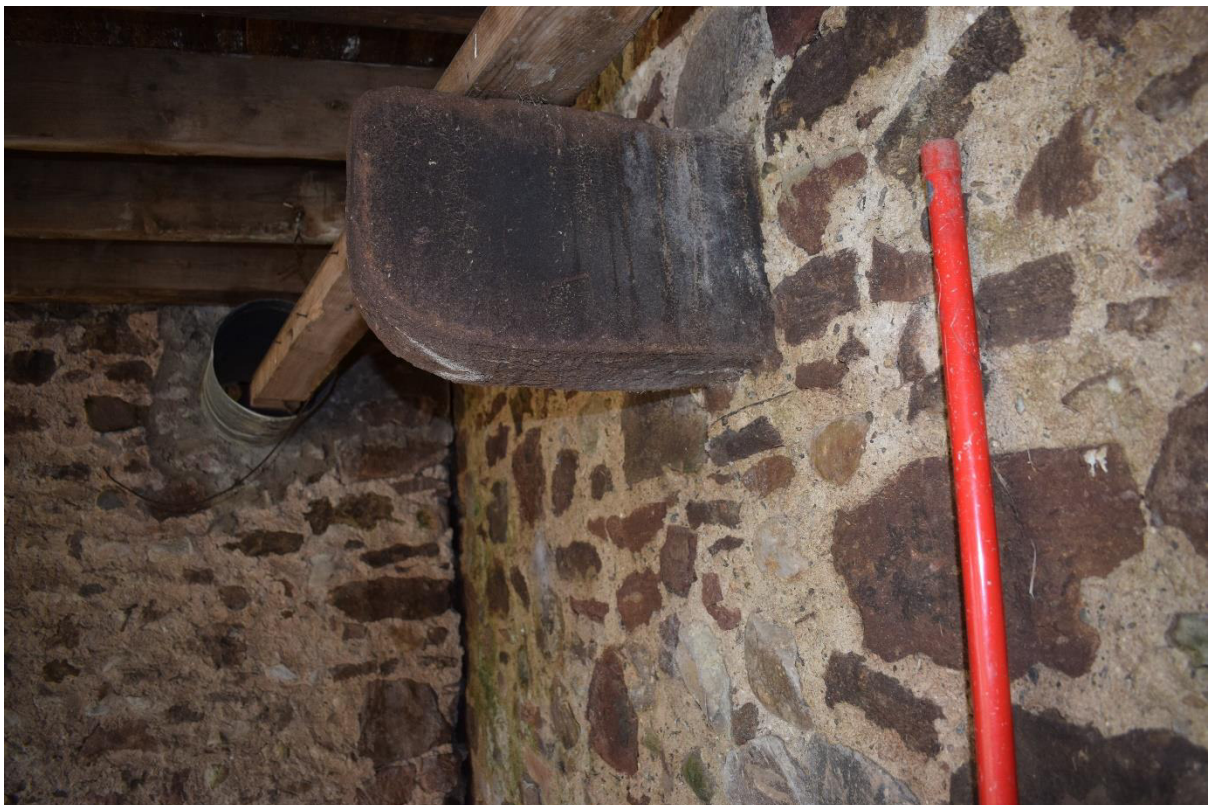
Illus 12 Room 3 sandstone corbel F6; facing NNE

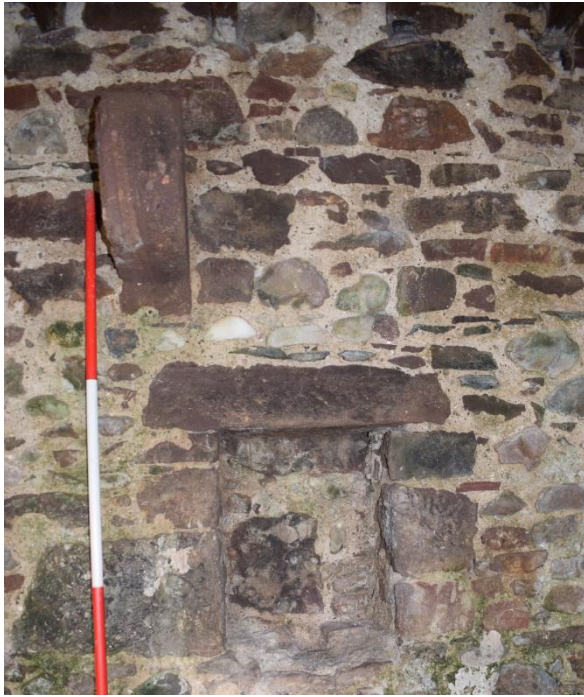
Illus 13 Room 3 E wall niche F3 with corbel F7 above; facing E

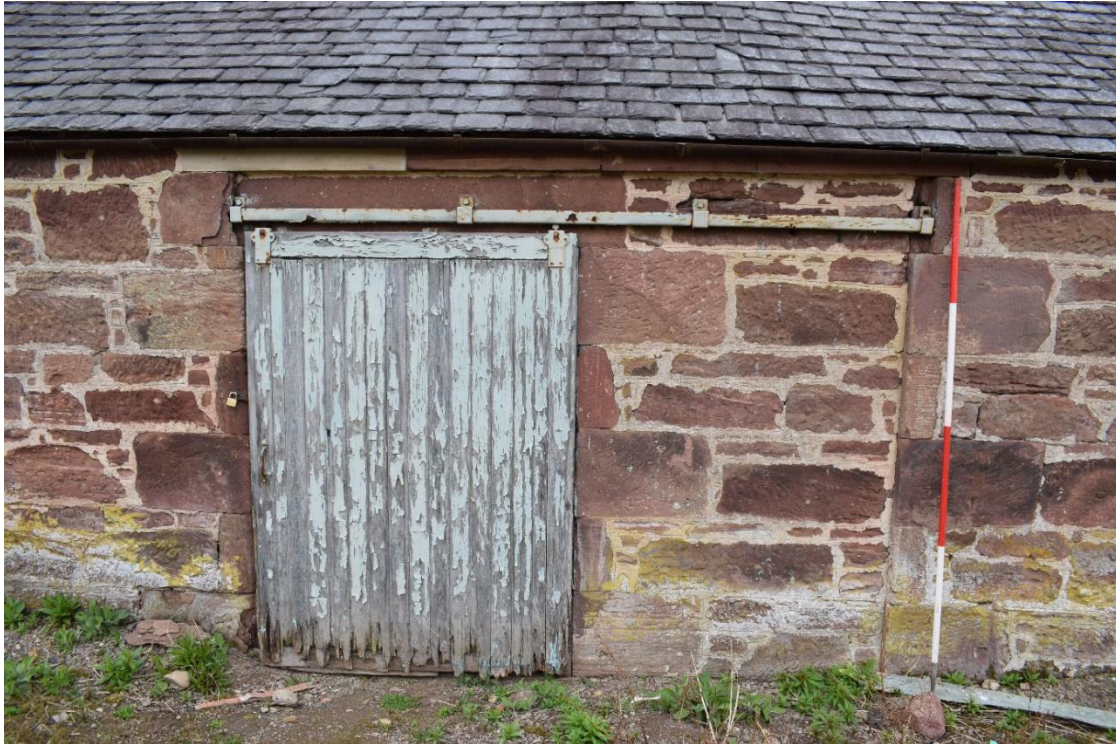
Room 5 forms the south side of the steading complex (Illus 16). There is no access to the interior. There is a door in the S wall (D4 which was later partially blocked and made into a smaller door (Illus 15) and a door into the inner courtyard (D16).

Illus 15 D4; facing N

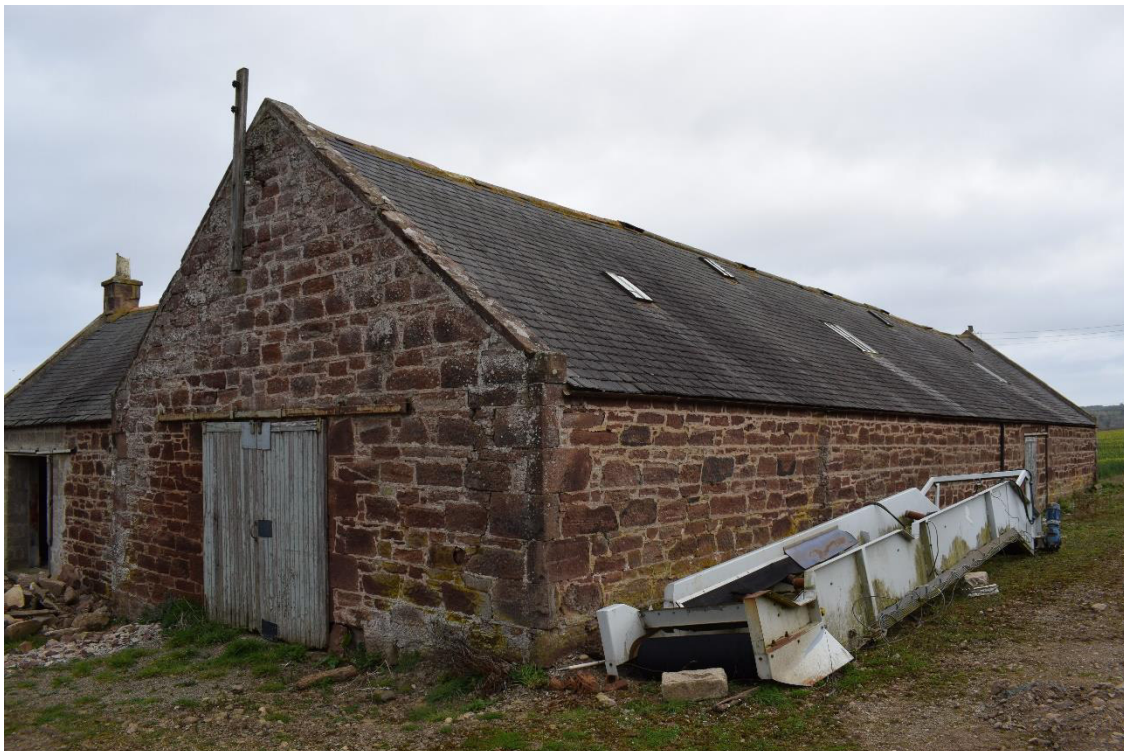
Illus 16 Room 5 (right) and Room 6 (Left); facing NE

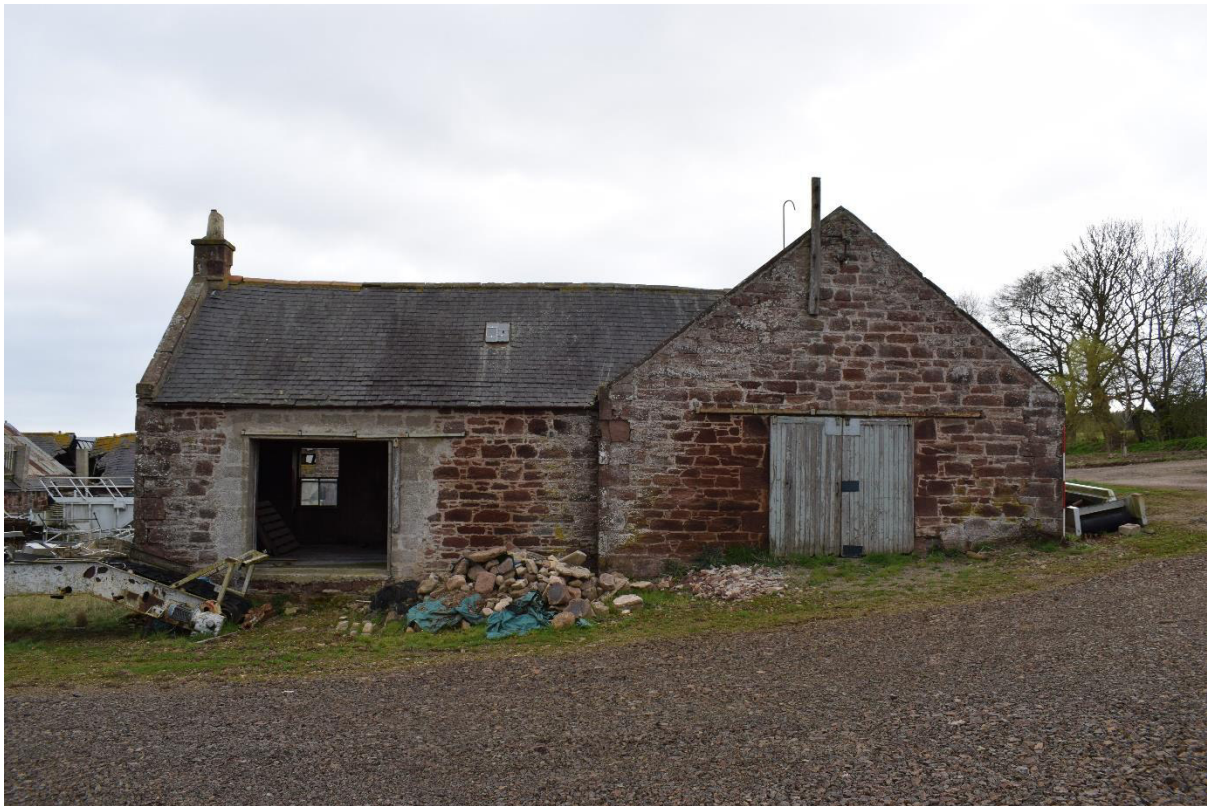
This single storey cottage has a door and two windows onto the inner courtyard (W9, W10, D8; Illus 18, 19). There is a large door in the W wall but this has been inserted in Phase 3 (Illus 17).

Illus 17 Room 5 (right) and Room 6 (left) with D2 W façade; facing E

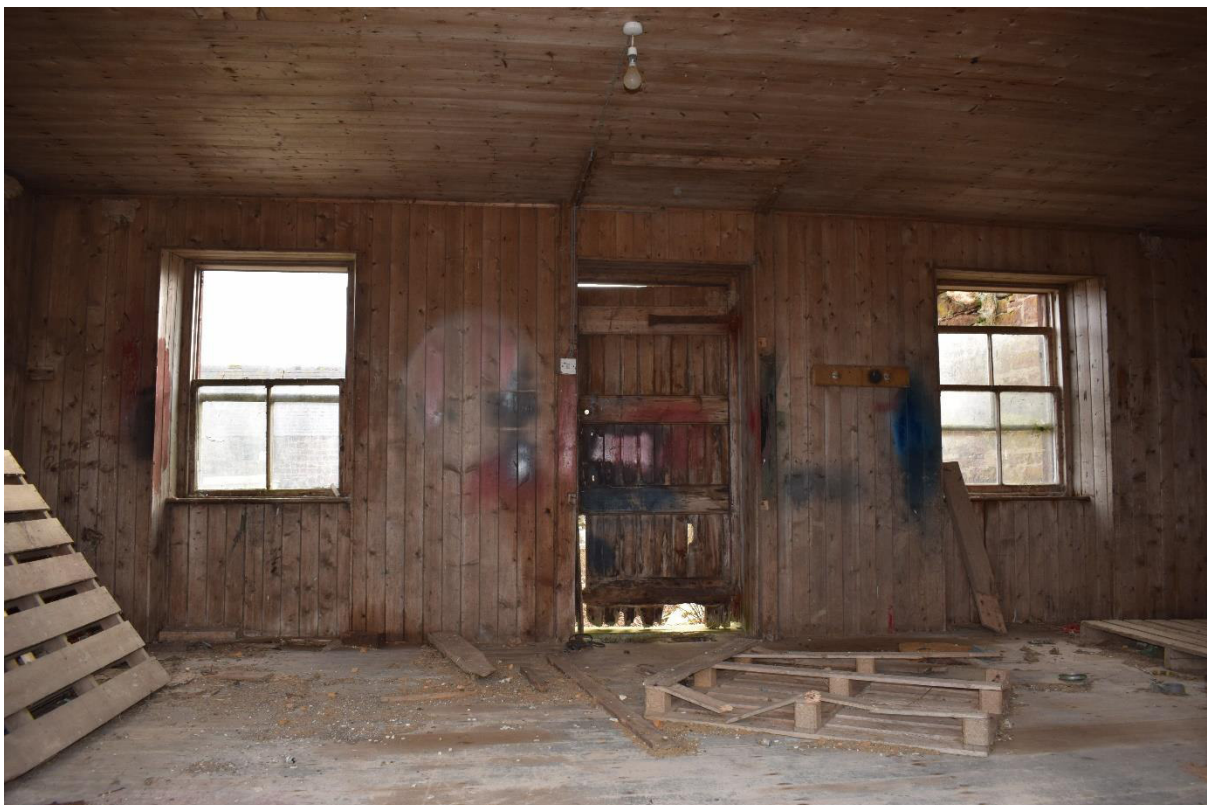
Illus 18 Room 6 the bothy interior with W10, D8, W9 (l-r); facing E

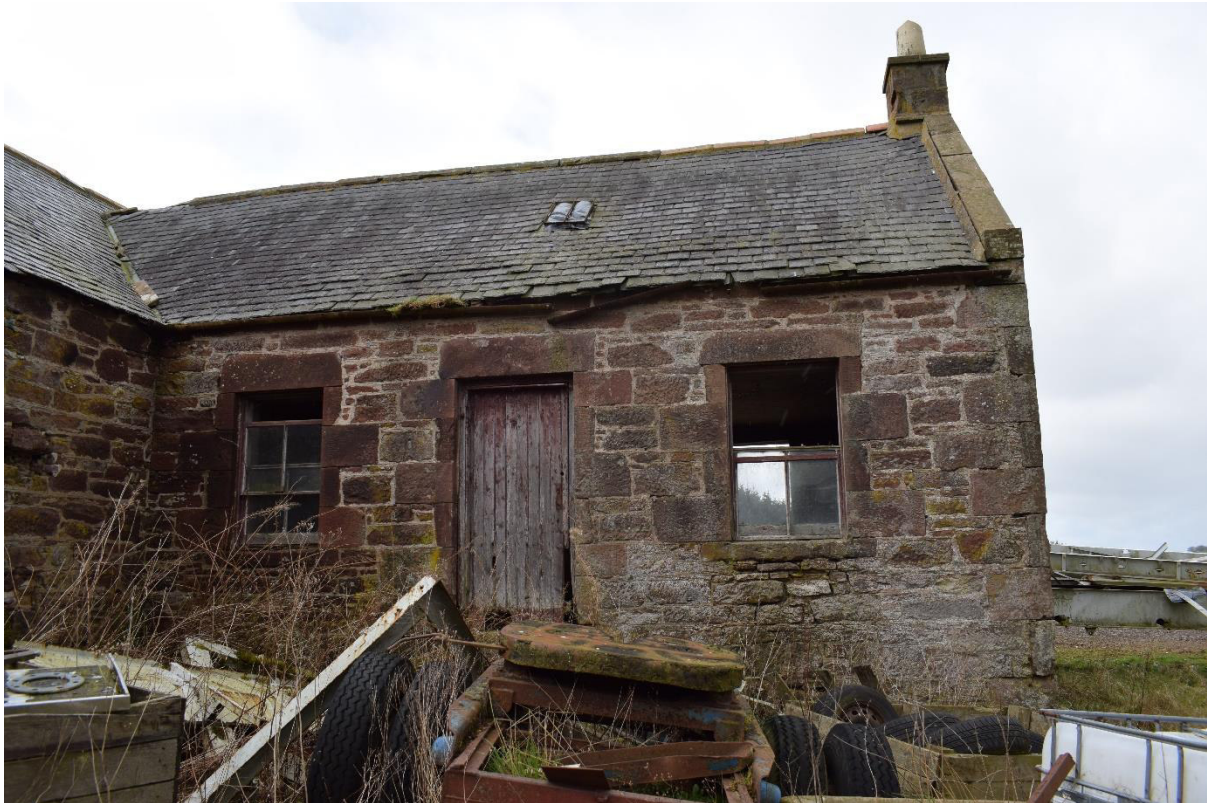
Illus 19 Room 6 the bothy exterior E wall onto inner courtyard W9, D8, W10 (I-R0 facing W)

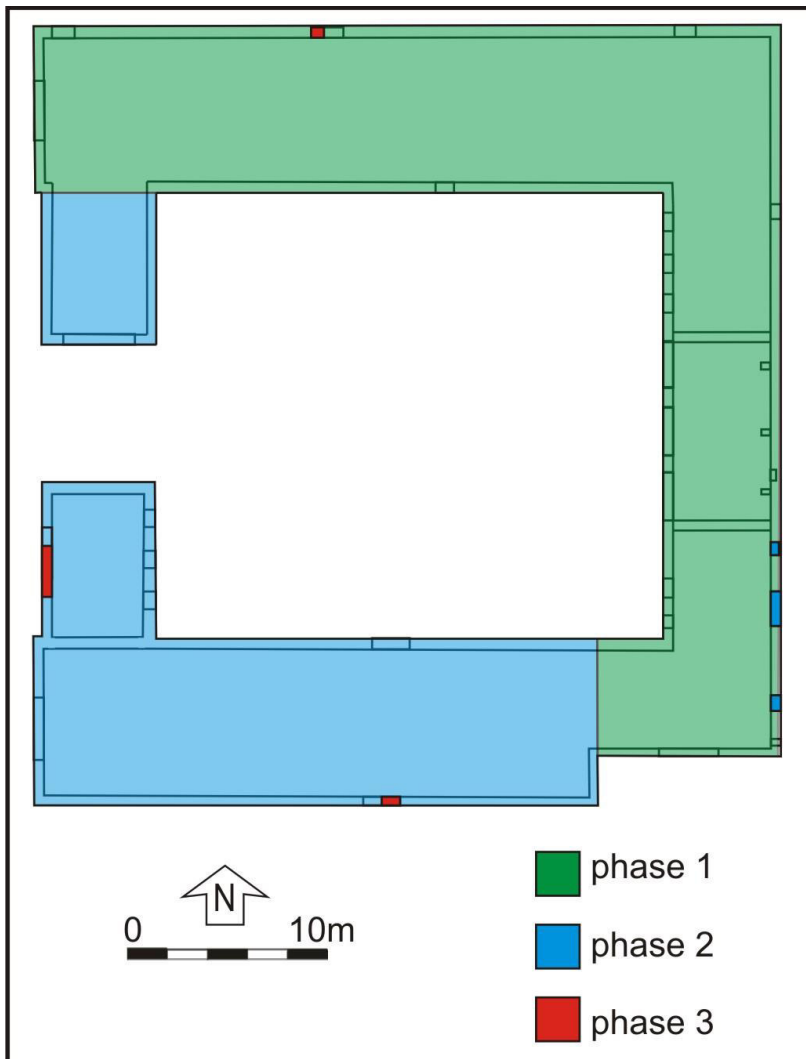
Room 4 on the SE corner of the complex had been a mill and a millwheel can be seen attached to the E wall on the First Edition OS map (Illus 23). In Phase 1 the complex was C-shaped with the access from the south opposite the mill pond and the farmhouse but by the Second Edition map the W and S wings had been rebuilt and the access changed to the west wing. Room 3 was a cart shed with three large cart doors accessed from the central courtyard and Room 6 a bothy with access into the inner courtyard. A later door was added in the W wall to allow access to the exterior. Large doors in the N and E facades were also reduced in size to create windows more suitable for general agricultural use and the door in the S façade was reduced in size to create a smaller door (Illus 20).

Illus 20 Phase plan showing main developments of the buildings (based on copyright Ian Duncan Architects)
