**Greyfriars (John Knox) Church, Broad St/Queen St,  
Aberdeen, AB10 1AP  
Report on Level 2 Standing Building Survey  
and Watching Brief**

**Alison Cameron and Dr Robert Lenfert  
18 April 2017**

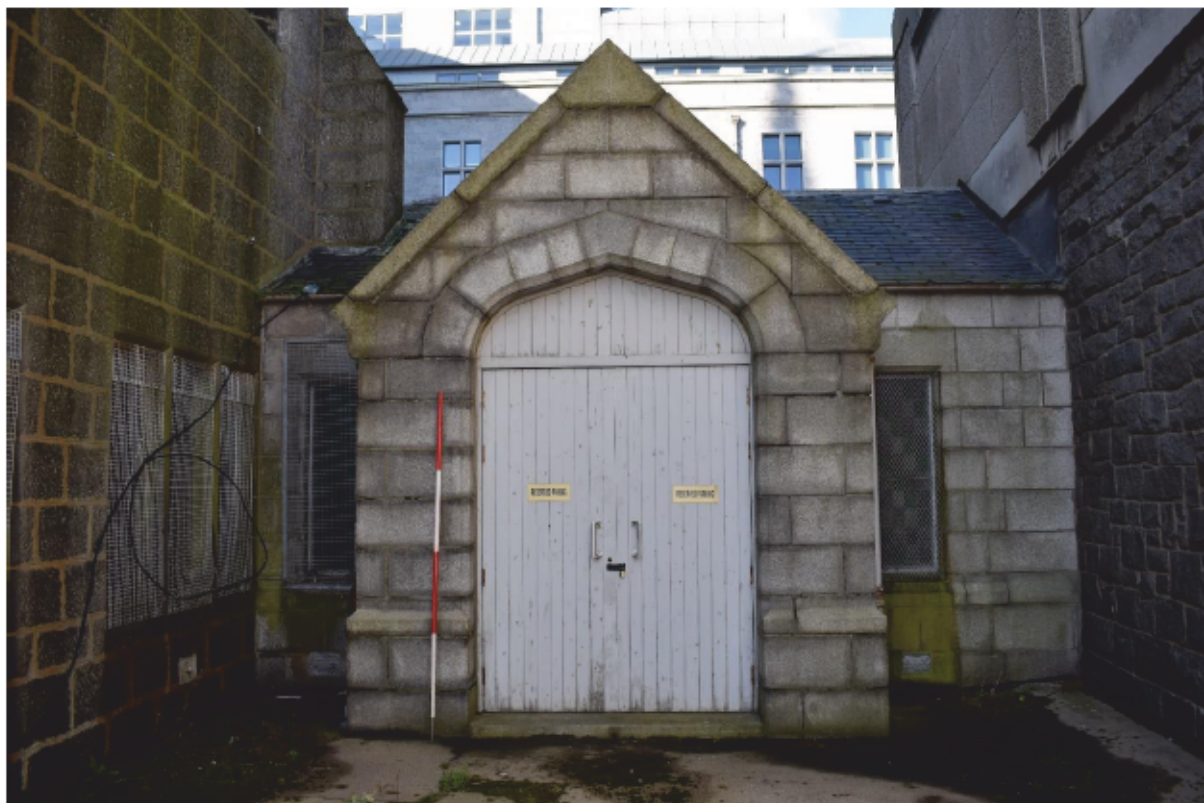
Room 1 is a small hall at the SE end of the church which appears to have been a Phase 2 addition (Illus 5). There is a porch on the SW wall with main door (D1) on the SW wall with pointed arch lintel; there are flanking windows W29 and W30 (1.5m high; 0.45m wide with modern stained glass; Illus 6) on the main hall. This addition is built using granite blocks to match the main church.

Illus 5 Room 1 small hall and porch with door D1 (centre) and flanking windows W29 (left) and W30 (right); the lower section of buttress F37 (top left) was removed when this hall was added; facing NE

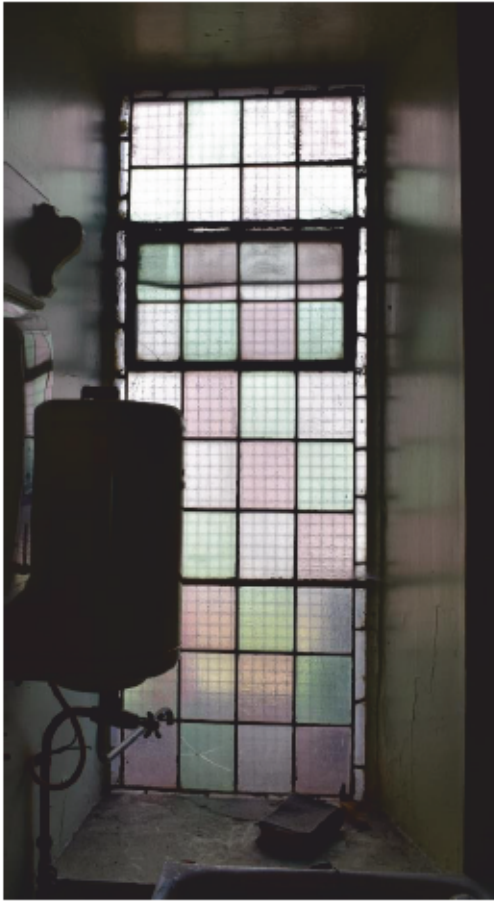
These toilets appear to have been built in a second phase of development of the building. The ladies toilet bisects W15 on the SW wall (Illus 10) and the gent toilet cubicles bisect W31 on the SE wall (Illus 9).

Illus 9 W31 SW half in Gents toilet cubicle

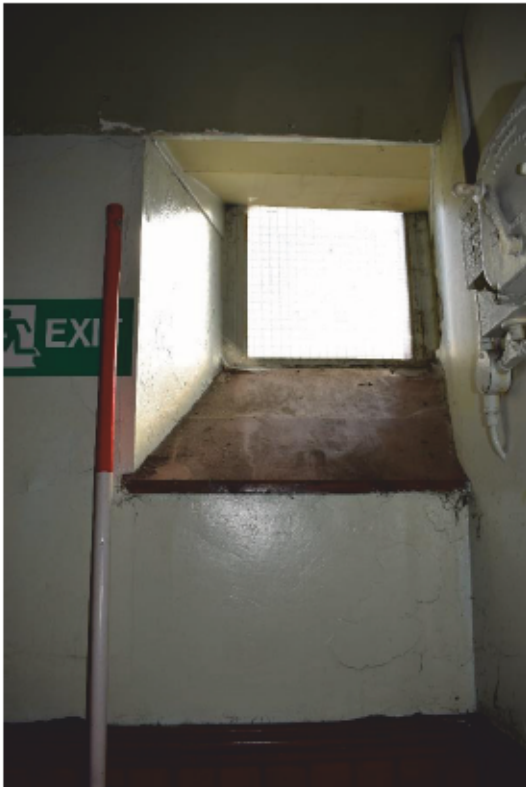
Illus 10 SW end of corridor Room 6 with W15 SE half; the window was divided by inserting wall for Ladies toilets (right); facing SW

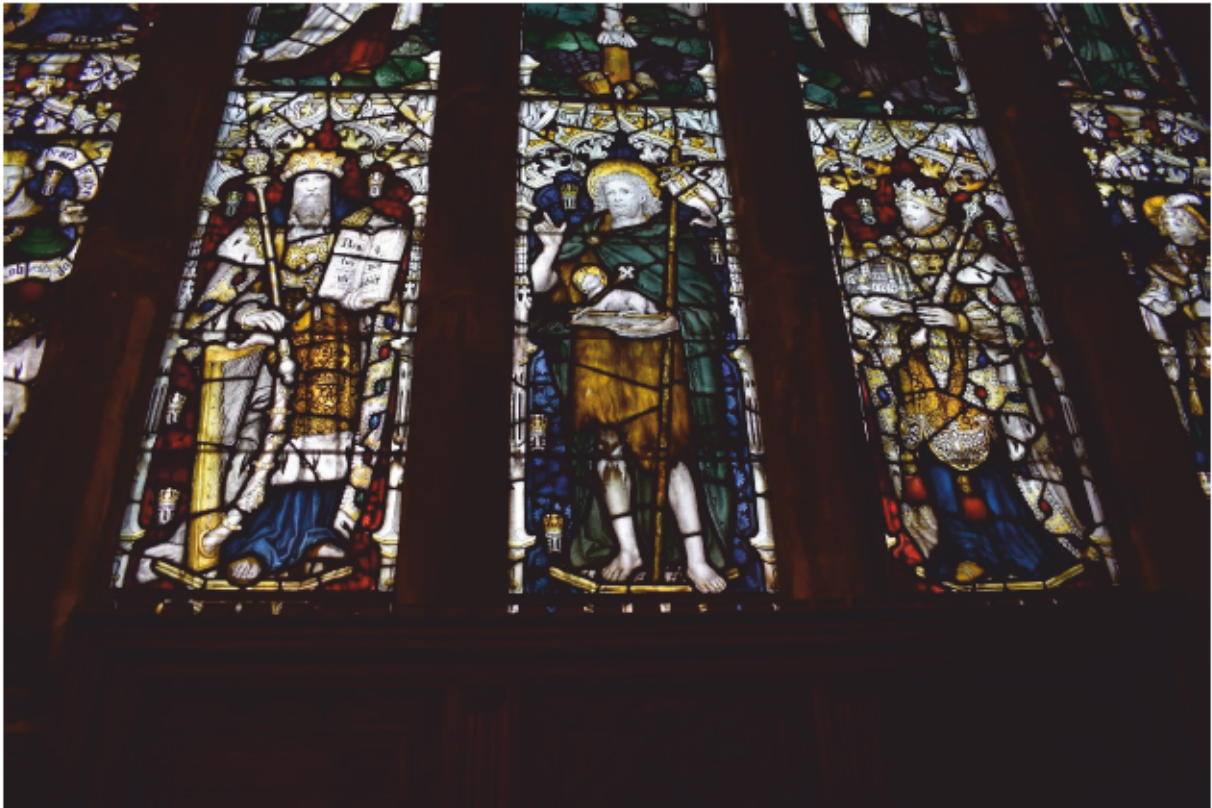
Illus 14 Detail of lower half of W34 showing stained glass; facing SE

W34 sandstone tracery removed from SE window old greyfriars and rebuilt into SE window of this church with new glazing celebrating Greyfriars church and other religious scenes

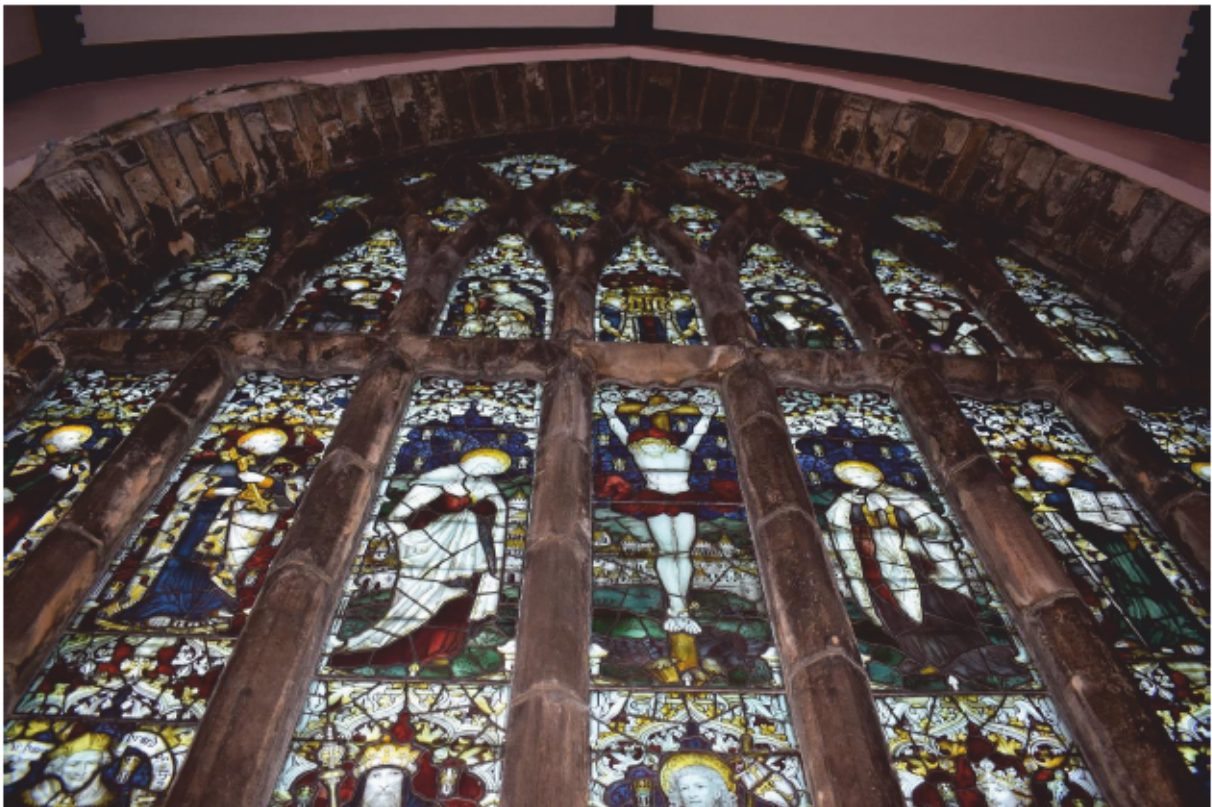
Illus 15 Detail of upper section of D34 showing sandstone tracery removed from SE window Old Greyfriars and rebuilt into SE wall of new church; facing SE

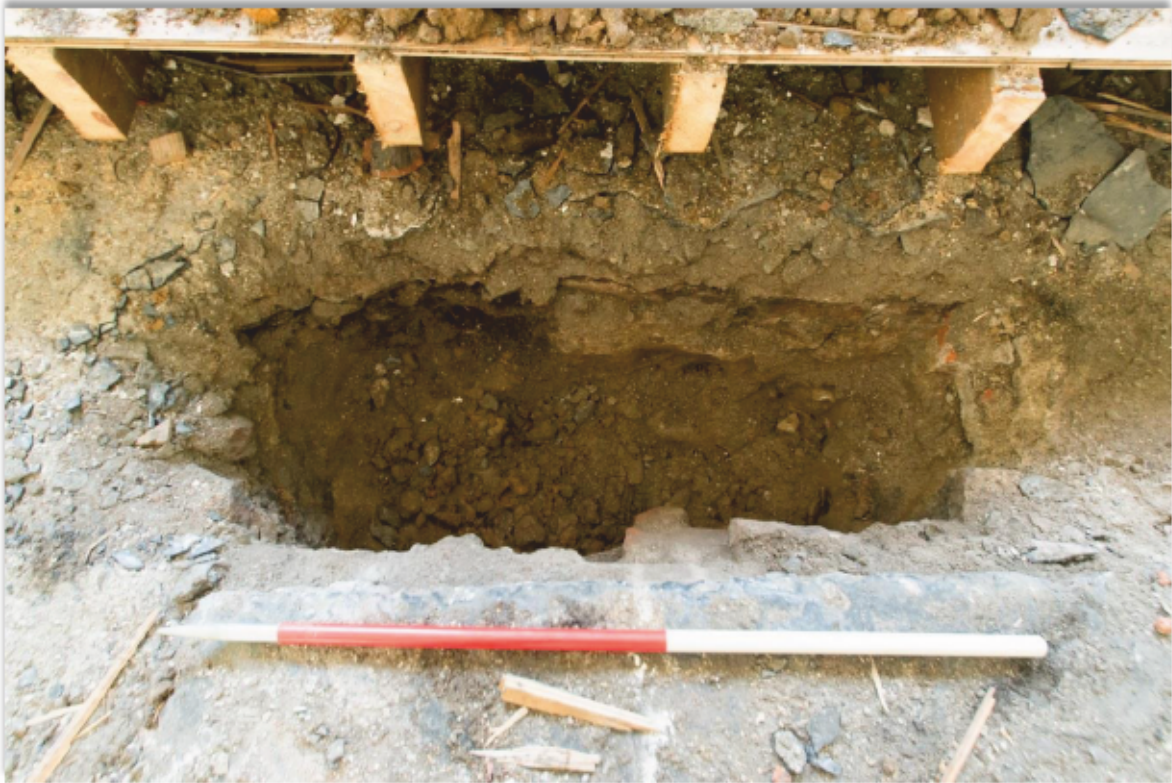
The first pit (TP1; Illus 25, 26) was hand-excavated and was located in the basement in an offset mid-point location towards Queen Street to the east. TP1 measured 1.2m in overall length by 0.55m in width, and reached a maximum depth c. 0.75m. Fill consisted of a mid-brown sandy-clay containing moderate amounts of small stones, gravel and drain tile, along with remnants of bitumen used to waterproof the sub-flooring.

Illus 26 Test Pit 1 (TP1) located in the eastern basement area of Greyfriars Church.

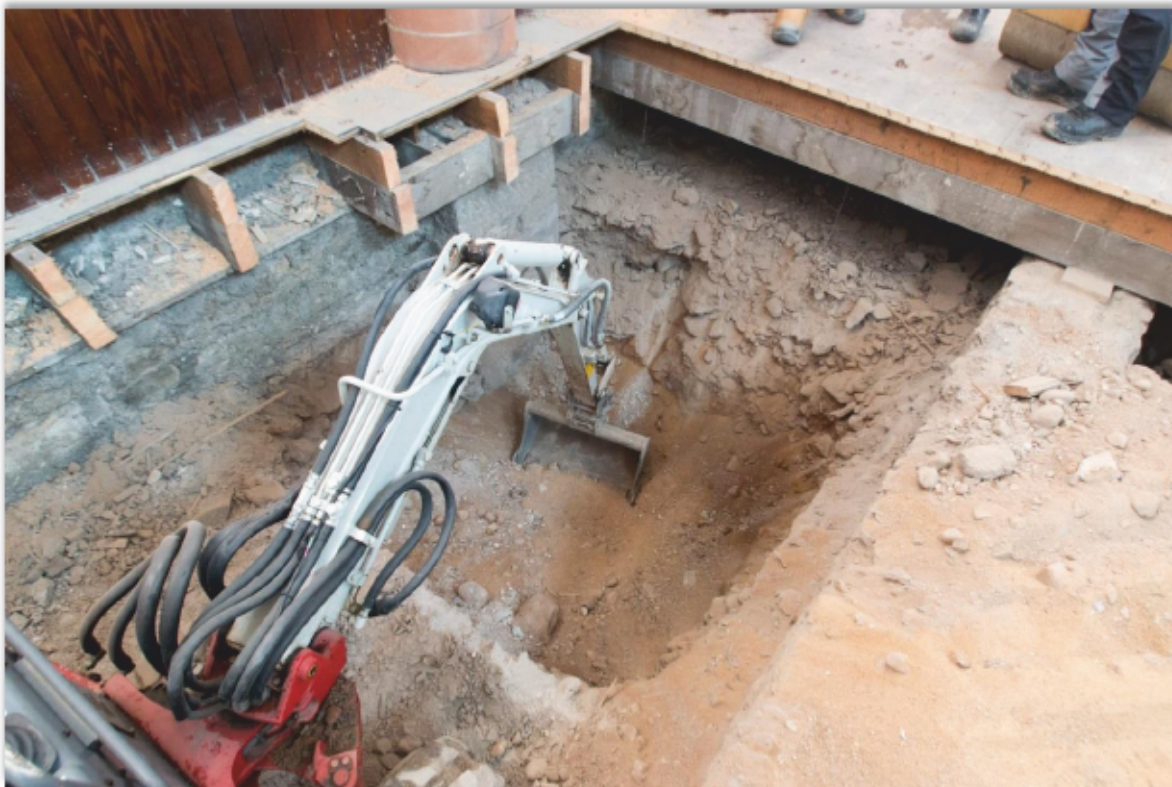
TP2 (Illus 27) and TP3 (Illus 28) were located below the sub-flooring on the ground level within the western half of the church itself, adjacent to the eastern wall of Marischal College (Illus 25). TP2 measured approximately 1.5m in width by 2.0m in length and reached a maximum depth of some 1.6m. It was bordered on the eastern side by a partial retaining wall, implying that this area had been previously partially excavated during construction. Fill consisted of a sandy-silt interspersed with stone and small cobbles. The fill, as to be expected in such an environment, was extremely dry and powdery after lying protected from the elements and moisture for over a century.

Illus 27 Test Pit 2 (TP2) adjacent to foundations of Marischal College (walling in upper left corner).

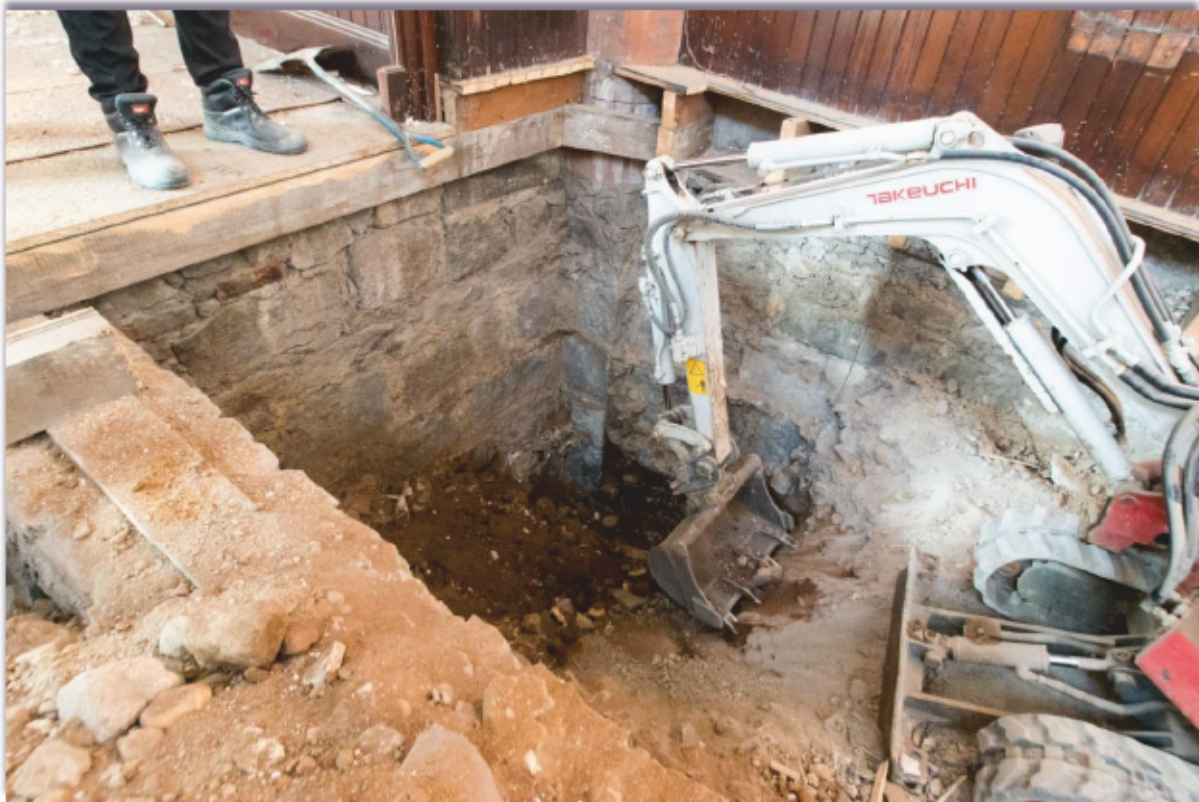
Test Pit 3 (TP3) was located in the SW corner of the project area, on the right as one enters the church. Dimensions were 2.0m wide by 2.8m in length, and reached a maximum depth of c.2.4m. It also bordered the same foundation/retaining wall to the east as TP2. The foundations of Greyfriars were exposed and revealed to stop short of the full depth of those at neighbouring Marischal College. Work was halted at this point. Similar to TP2, fill consisted of a fine, dusty sandy-silt, also interspersed with stones and small cobbles, though at depths below c1.5m, it transitioned into a wetter, more compact fill. No finds or features were noted.

Illus 28 Test Pit 3 (TP3) nearing completion.
