**Drum Castle, Drumoak, Aberdeenshire
Cameron Archaeology
Report on a Watching Brief**

**Dr Robert Lenfert
Cameron Archaeology
8 May 2017**

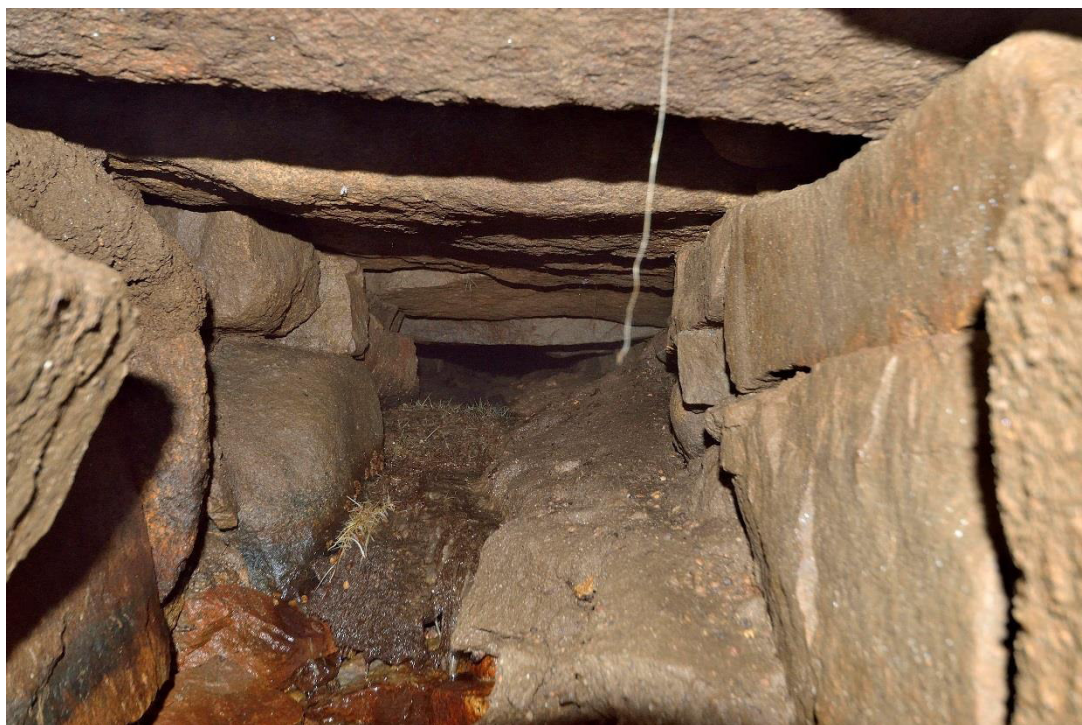
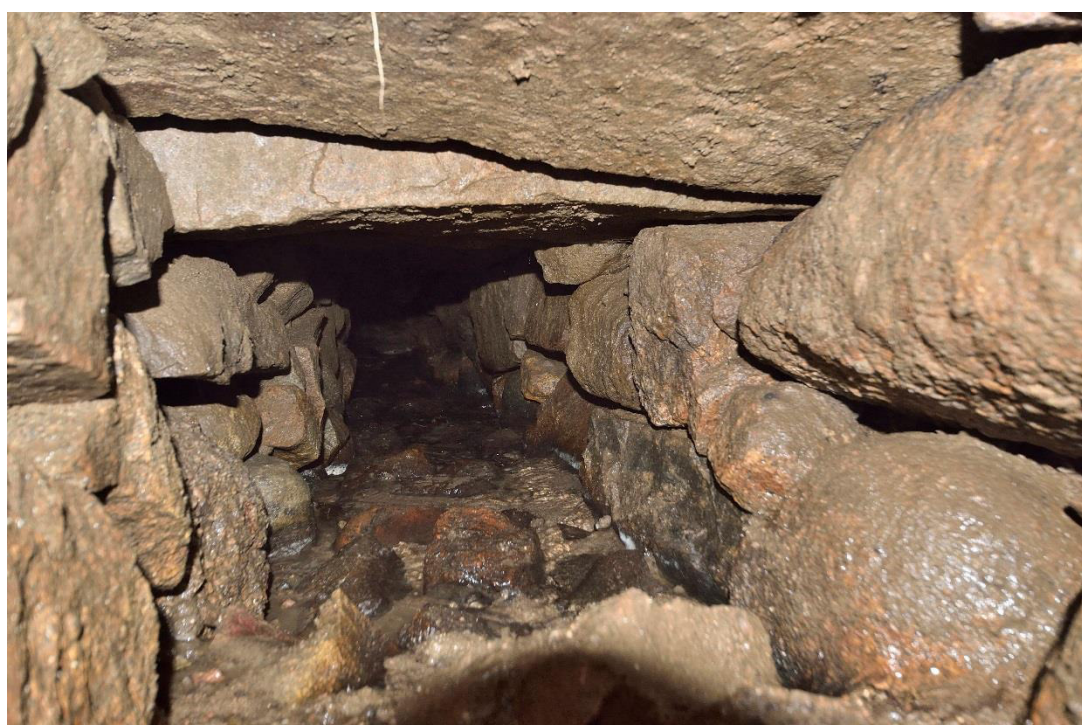
Cover stone culvert details, top facing W, bottom facing E

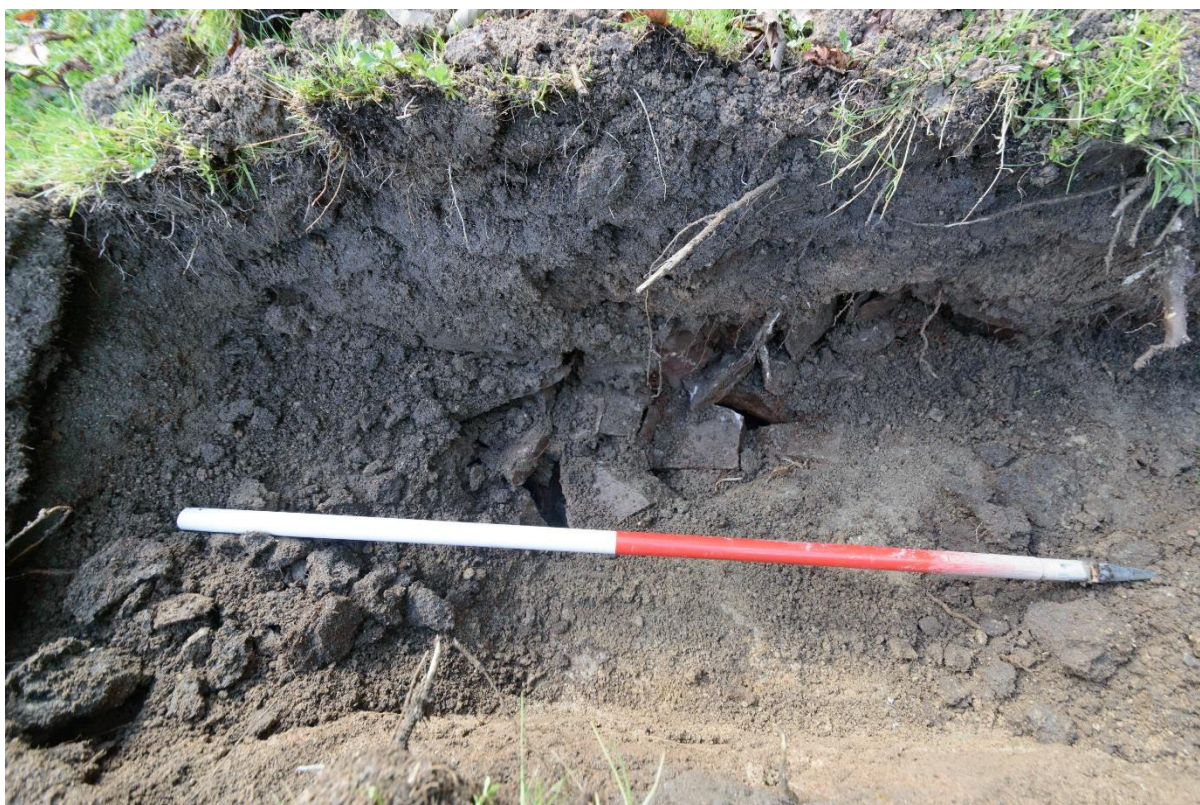
The drainage trench started in a SE-NW direction at the western end, before making two turns before heading east along the south lawn. The western terminus has previously seen some level of archaeological investigation during drainage works (Murray 2013: Illus 10). This work appears to have overlapped to a small degree with this current project, as indicated by disturbed stonework lying within the lower portions of the trench (Illus 2).

Illus 2: Disturbed stone lined drain near western terminus previously noted by Murray 2013; facing NE.

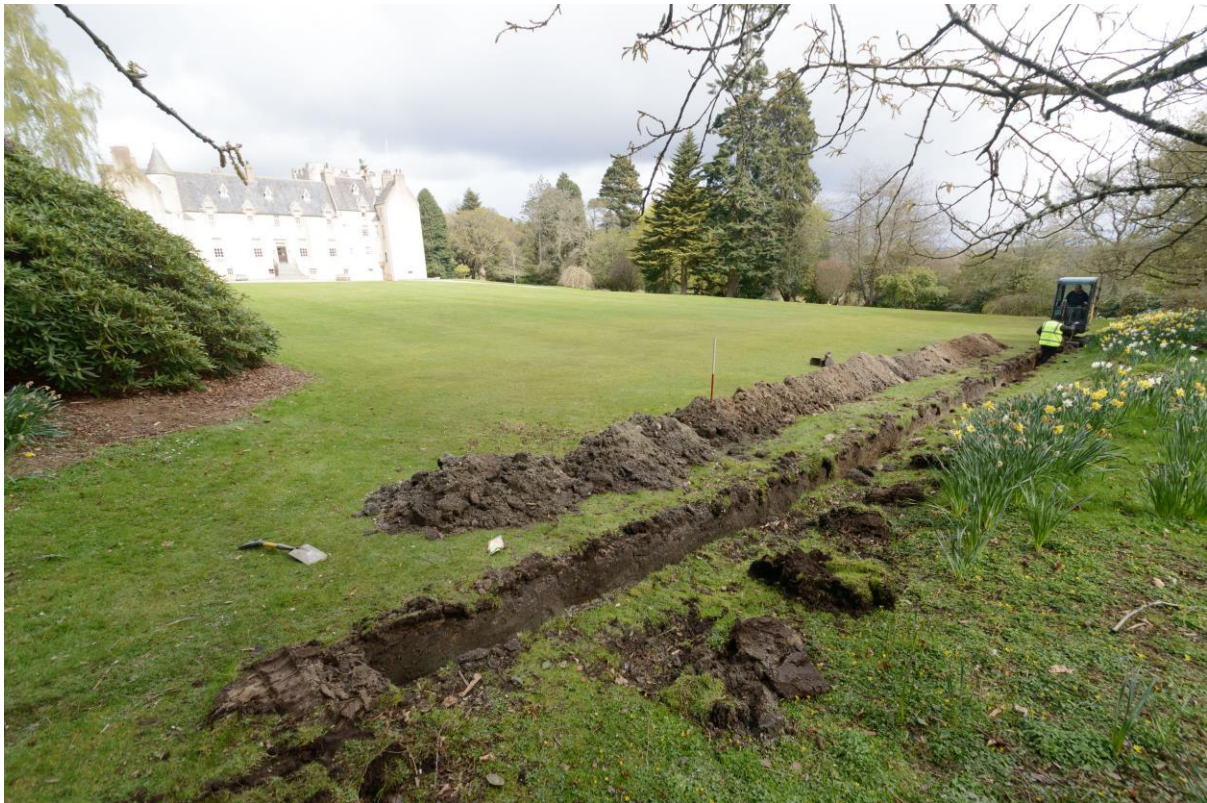
Illus 3 Main segment of E-W trench running across south boundary of south lawn; facing NE
