**Cross St/Frithside St/Mid St/Manse St,
Fraserburgh, AB43 9JB
Report on Level 2 Standing Building Survey**

**Alison Cameron
Cameron Archaeology
16 June 2017**

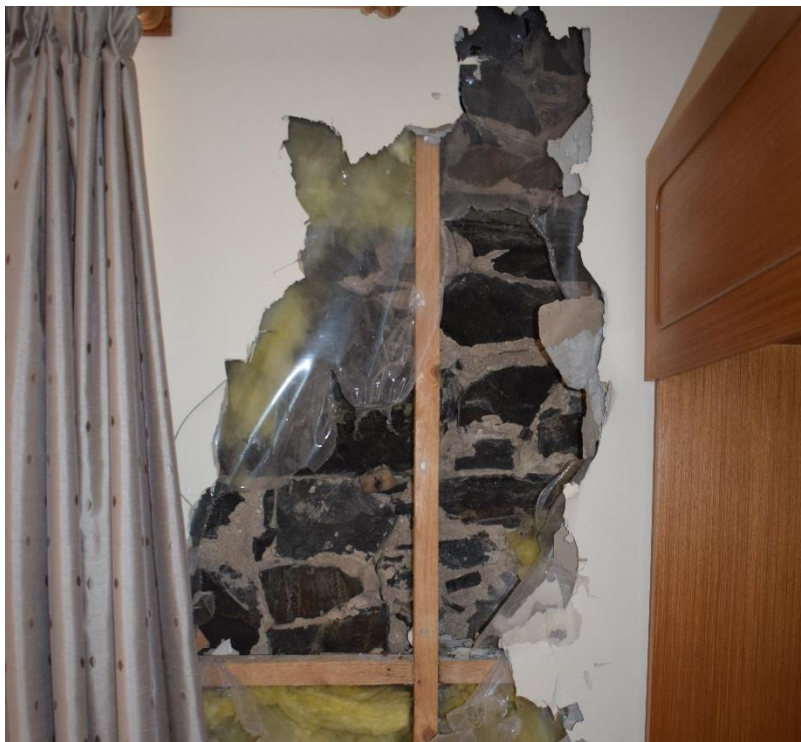
Illus 9 Interior first floor Building 1 showing original stone w wall uncovered by asbestos contractor; facing E

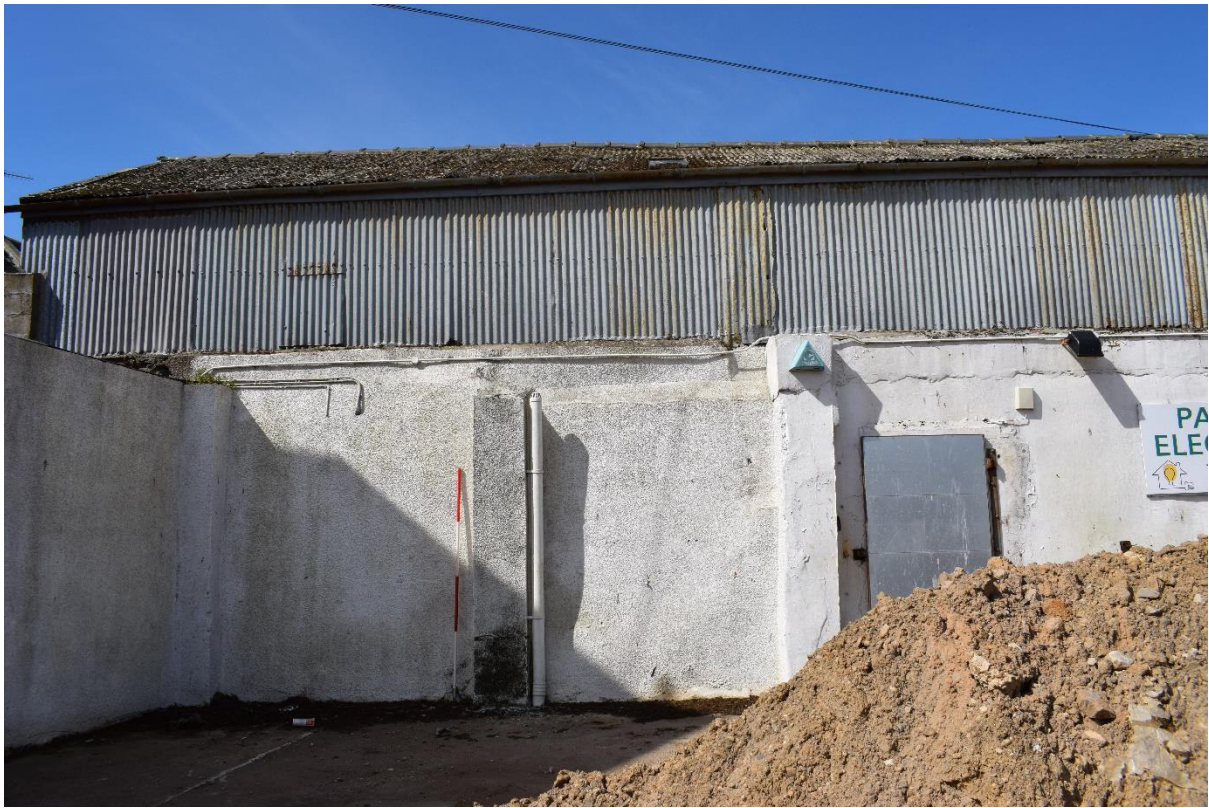
Illus 15 Building 2 E wall with buttresses F17, F4, F5, D4; facing W

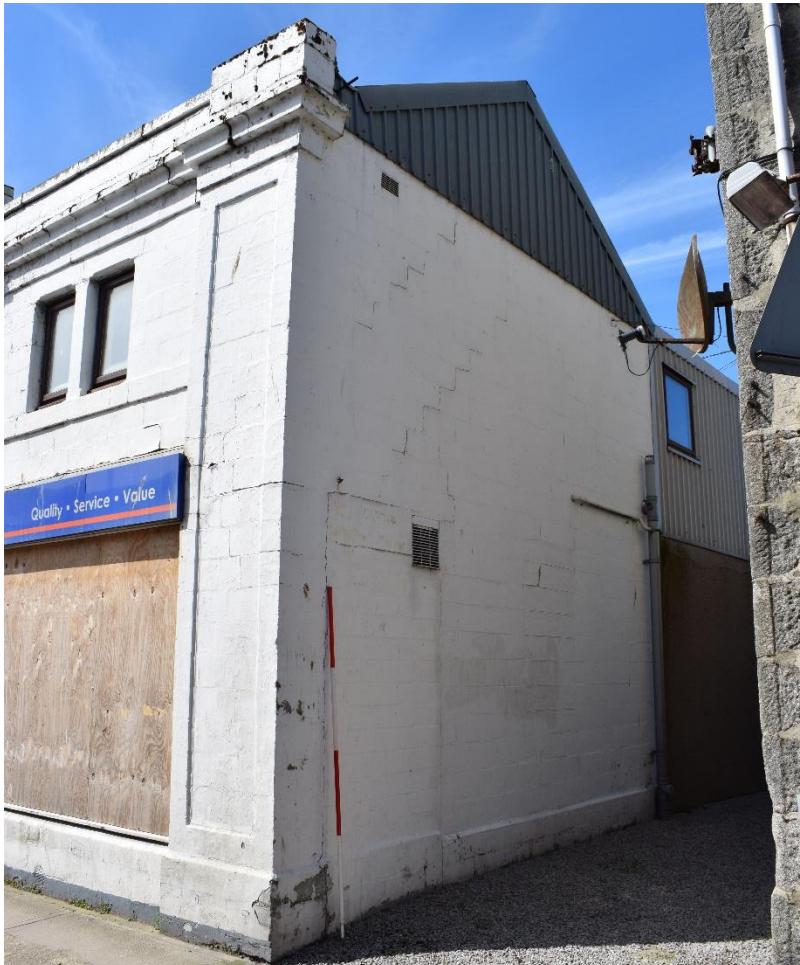
Illus 22 Building 3 N wall with blocked door D11; facing SW

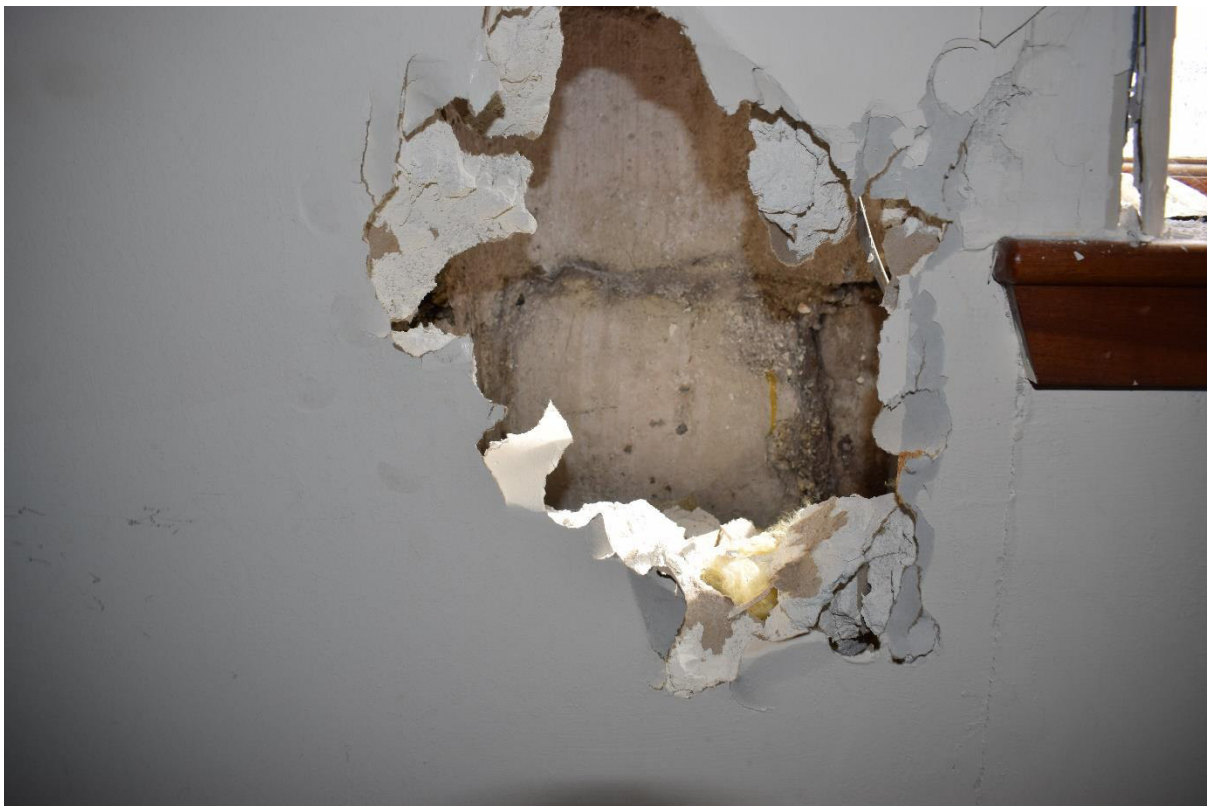
The concrete blocks used in the construction can be seen on the first floor level where asbestos contractors have removed plasterboard (Illus 24).

Illus 24 Concrete block construction seen on interior were asbestos contractor had removed plasterboard wall coverings

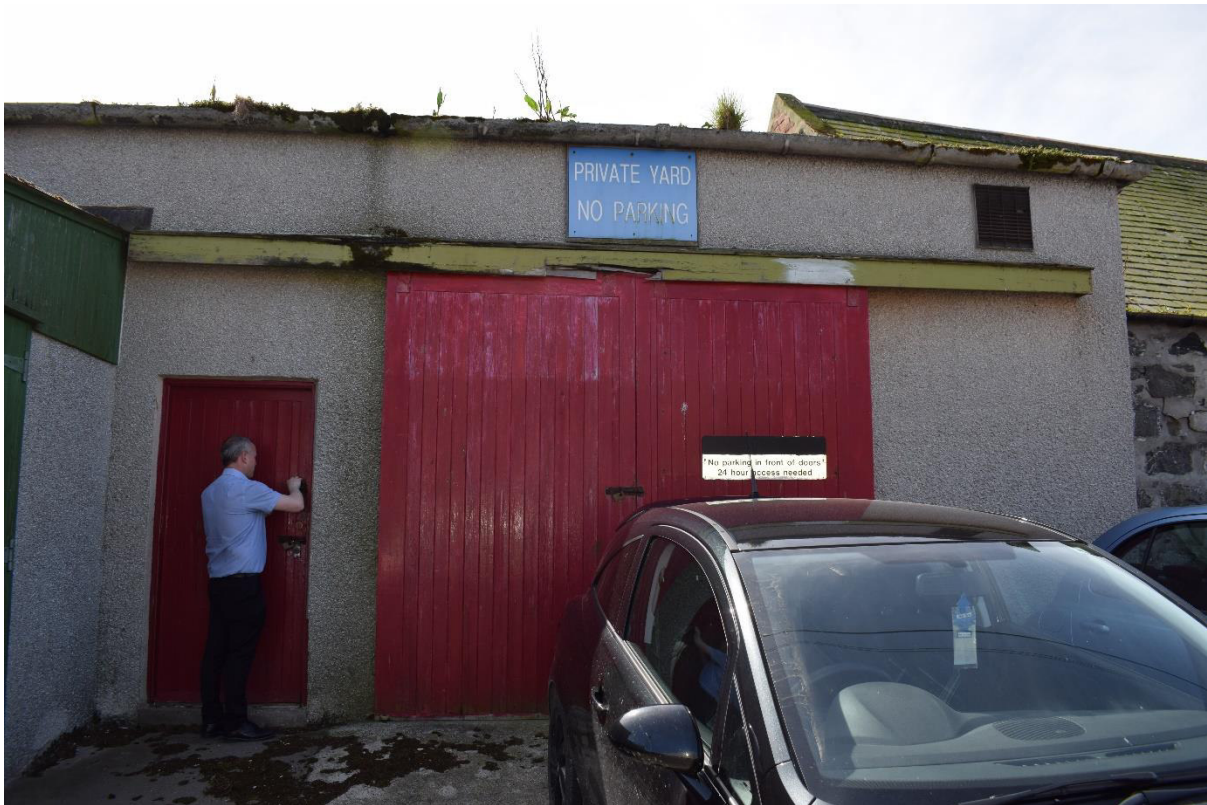
Building 4 is 16m W-E and 10.5m N-S (Illus 25). It has been constructed of granite rubble but the N wall has been rebuilt in the middle of the 20th century using concrete blocks and internal buttresses (Illus 25-28). The exterior of this wall is harled (Illus 27).

Illus 27 Building 4 N wall showing replacement wall in harled concrete block; facing S

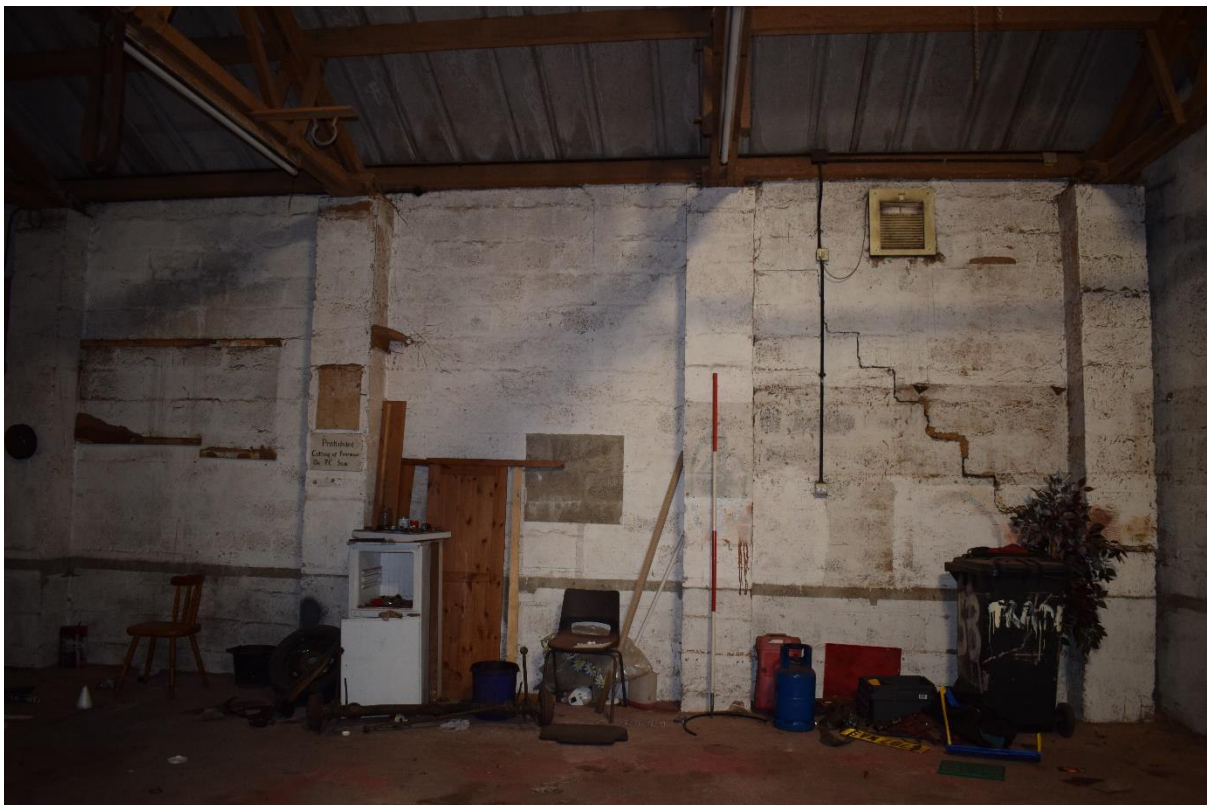
Illus 28 Building 4 N wall interior showing buttresses constructed of concrete blocks; facing N

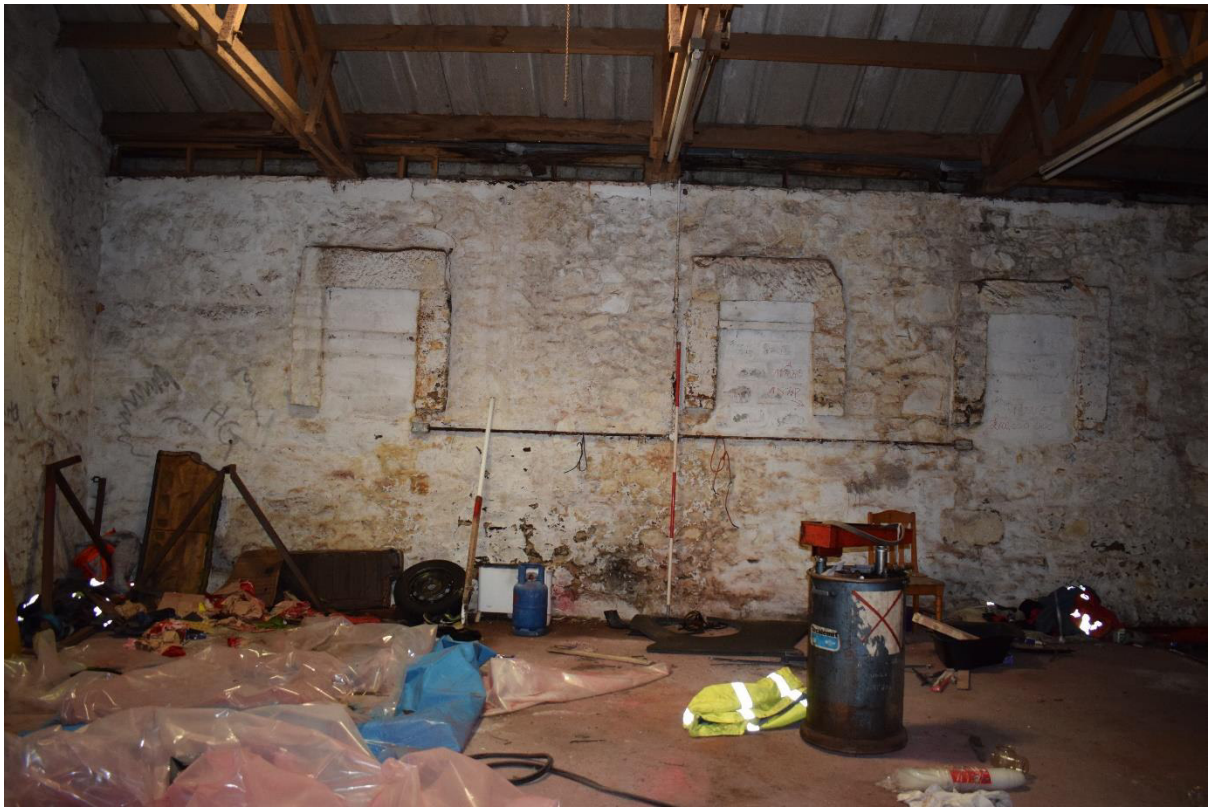
The interior of the S wall has four fireplaces (Illus 29-31) built into the upper level of the wall (F12-16). The fireplaces are constructed of red brick and stone lintel and are 1.3m wide and 1.8m high. It was originally two storeys and these fireplaces are on the first floor level. They have probably been within small upper rooms, possibly living accommodation and the walls of these rooms have been removed and the interior walls whitewashed removing all evidence of them.

Illus 29 Building 4 S wall interior showing older section of building and fireplaces F12, F13, F14 (l-r); facing S

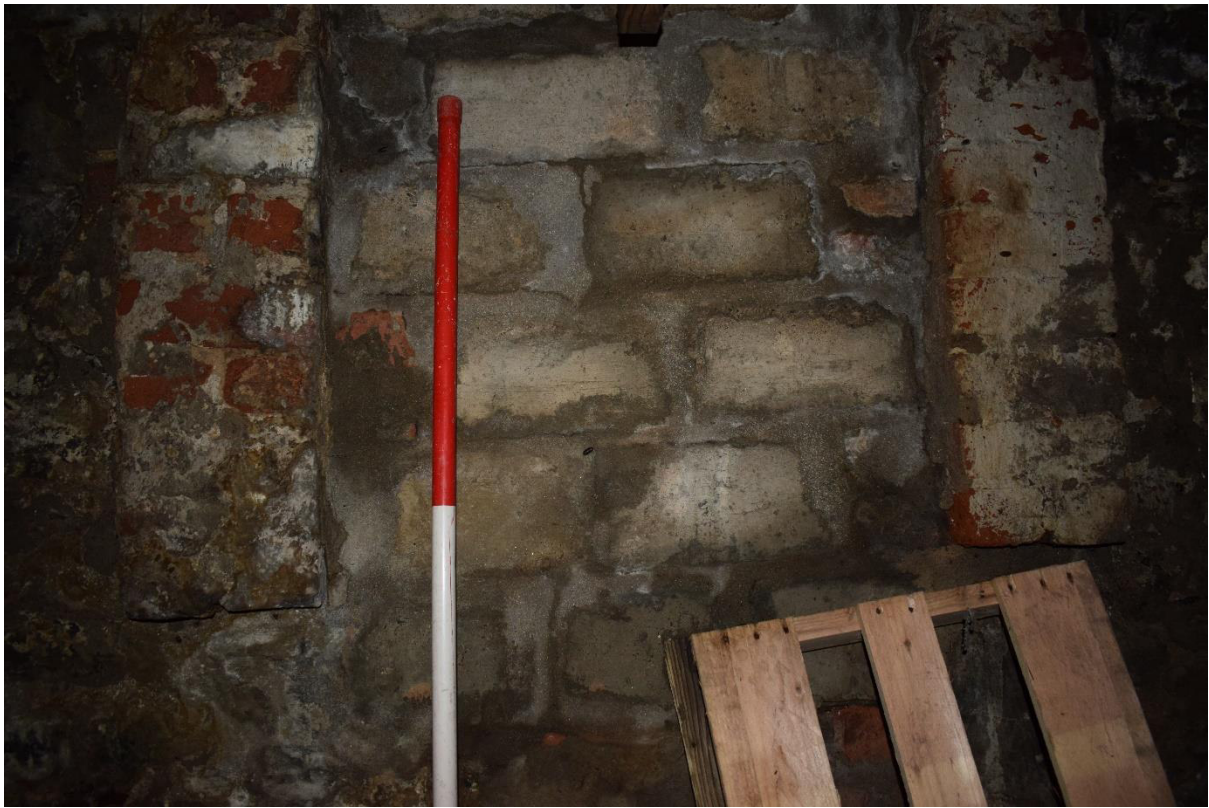
Illus 31 Detail of blocked fireplace F16 which is unpainted, showing brick construction; facing S

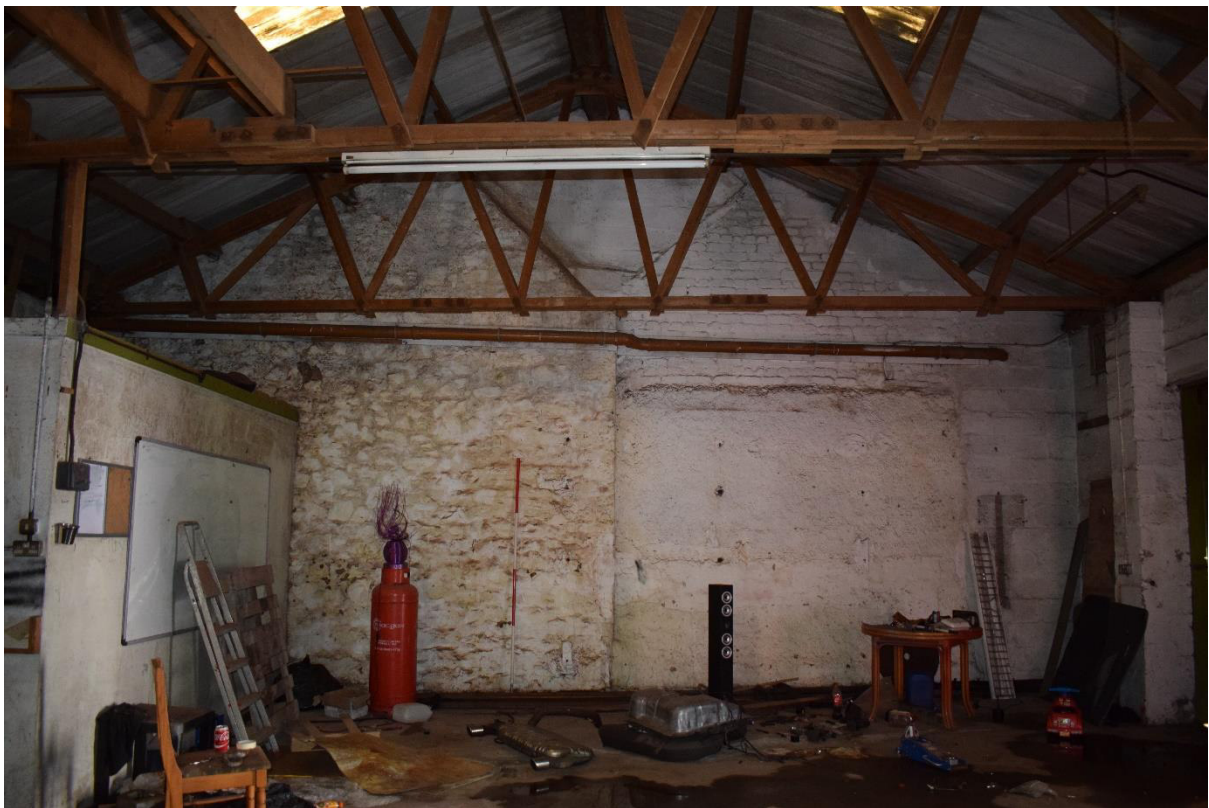
The W wall of the building has a double gable (Illus 26); the S one is built in stone, the N one in brick and then the N wall of the building was then rebuilt in concrete block. The building has then been reroofed in metal and asbestos cement roofing.

Illus 32 Building 4 W wall showing that the building was originally two structures and the N wall has been rebuilt (right); facing W

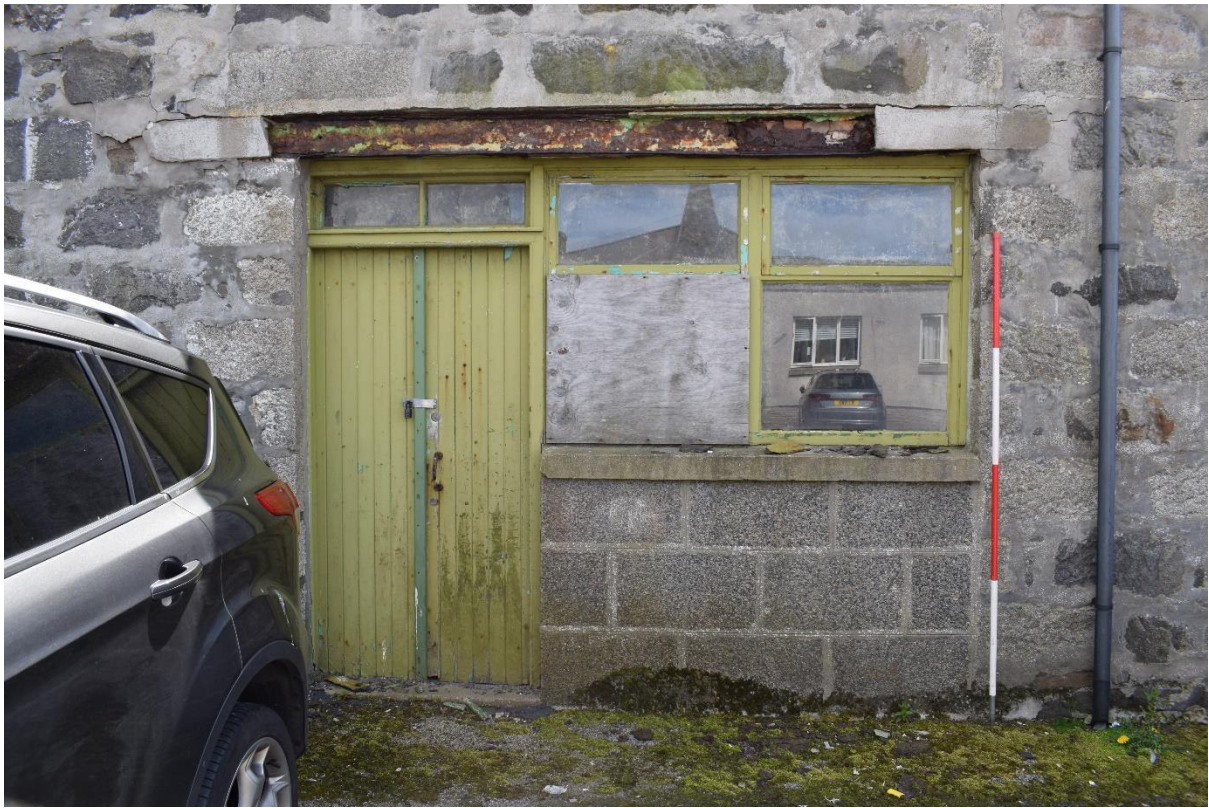
Illus 36 Building 6 N wall D4 reduce in size with glass and breeze blocks; facing S

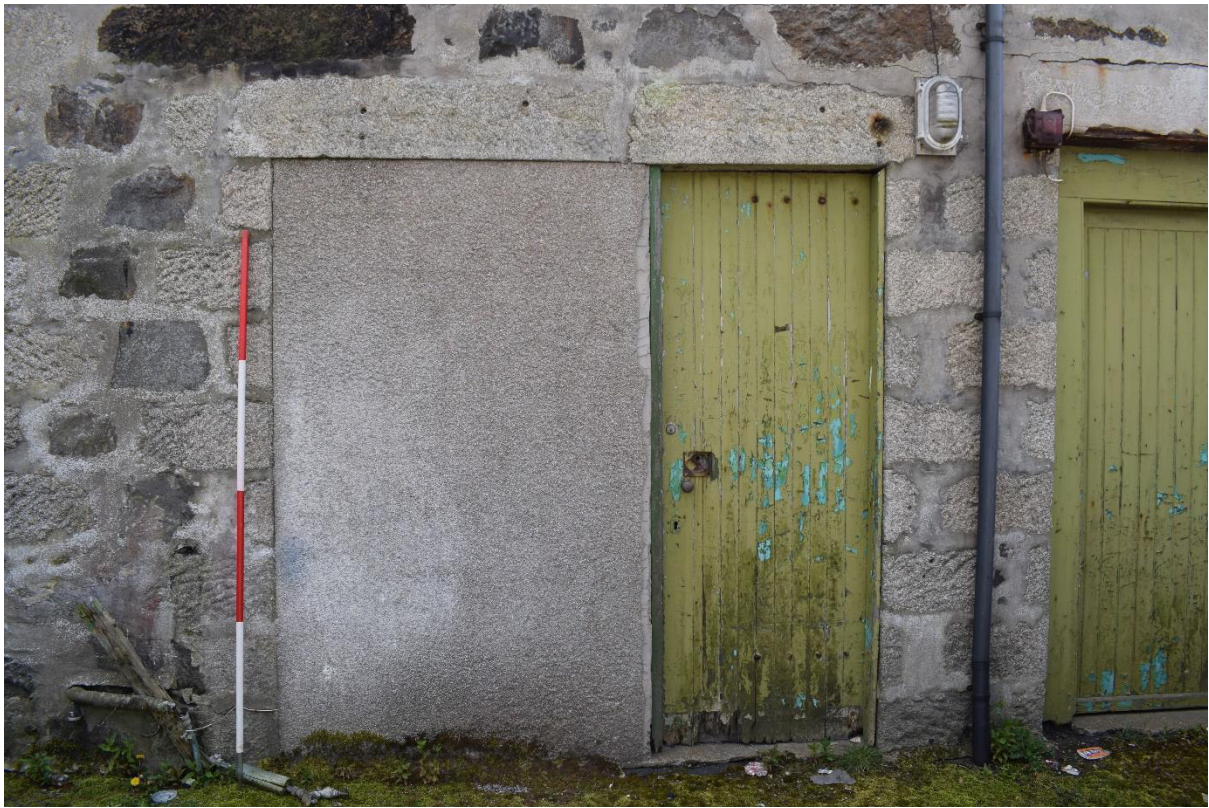
Illus 38 Building 6 N wall D5 showing reduction in with using harled concrete blocks; facing S

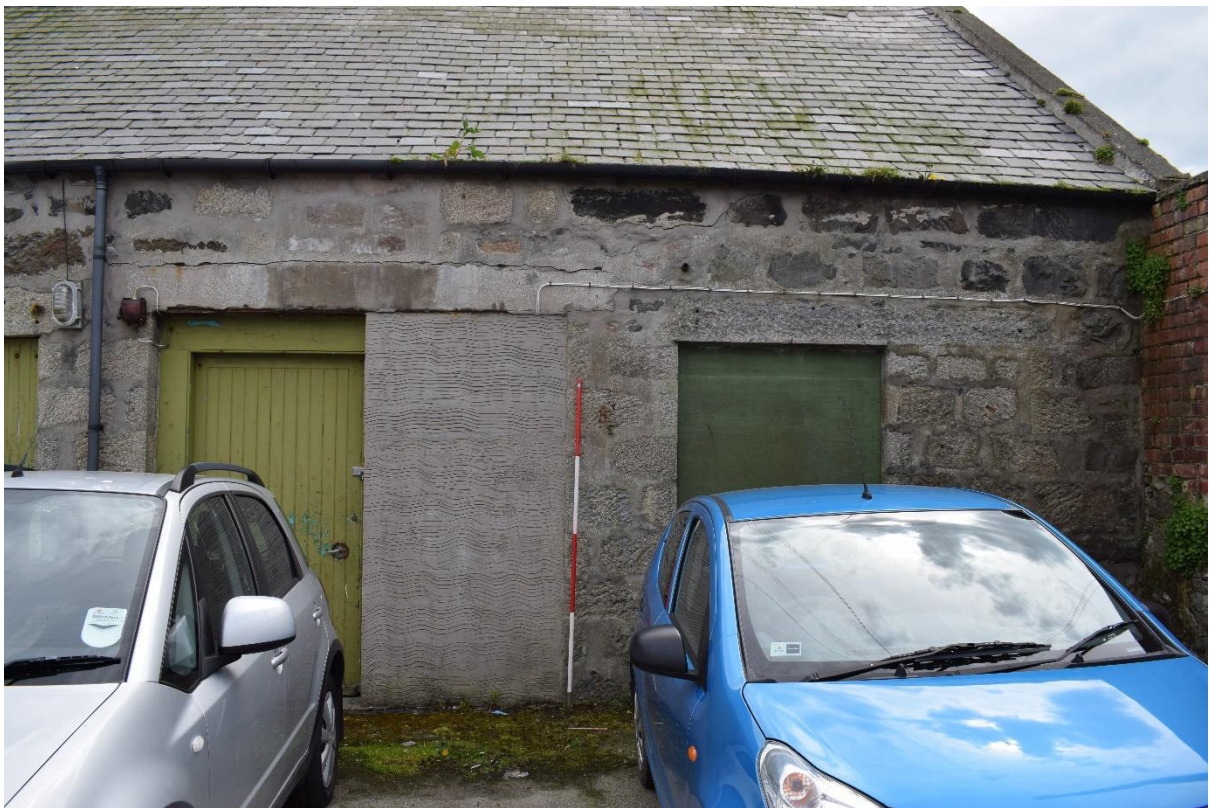
Illus 39 Building 6 N wall D6 (left) showing reduction in with using harled concrete blocks and w34 (right); facing S
