**Tennant Arms, 15 St Andrew's Road,
Lhanbryde, Elgin, Moray, IV30 8NZ
Report on Level 1 Standing Building Survey**

**Alison Cameron
Cameron Archaeology
6 September 2017**

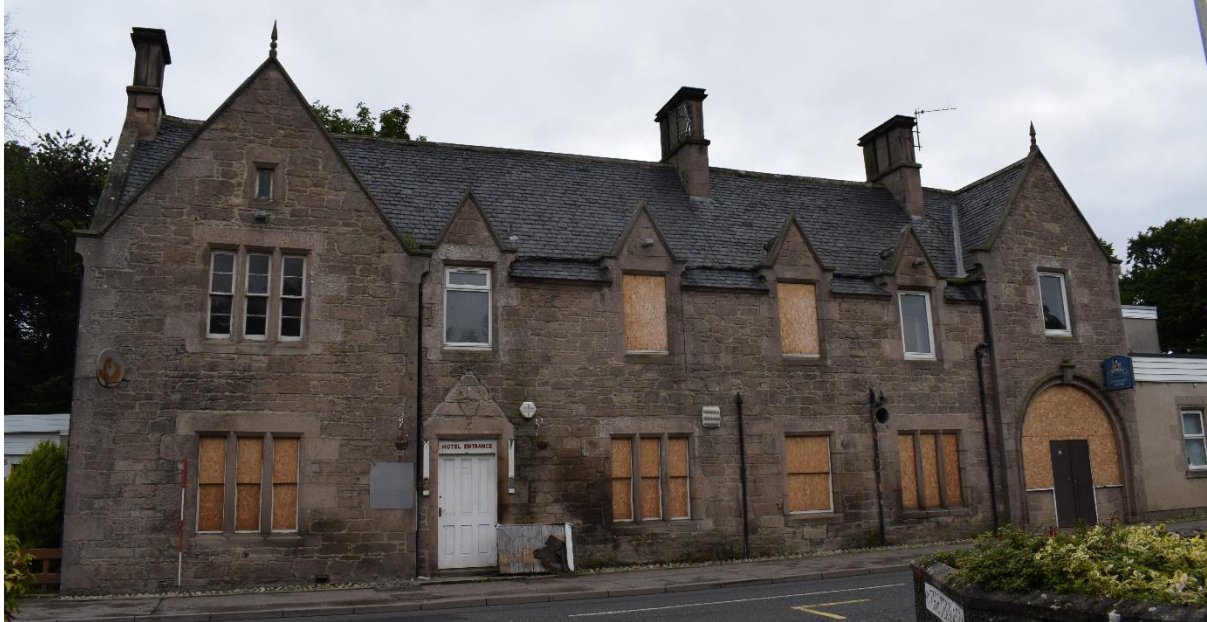
Cover: top Phase 1 front SW façade of hotel; facing NE. Bottom Cart door D2 SW front façade; facing NE

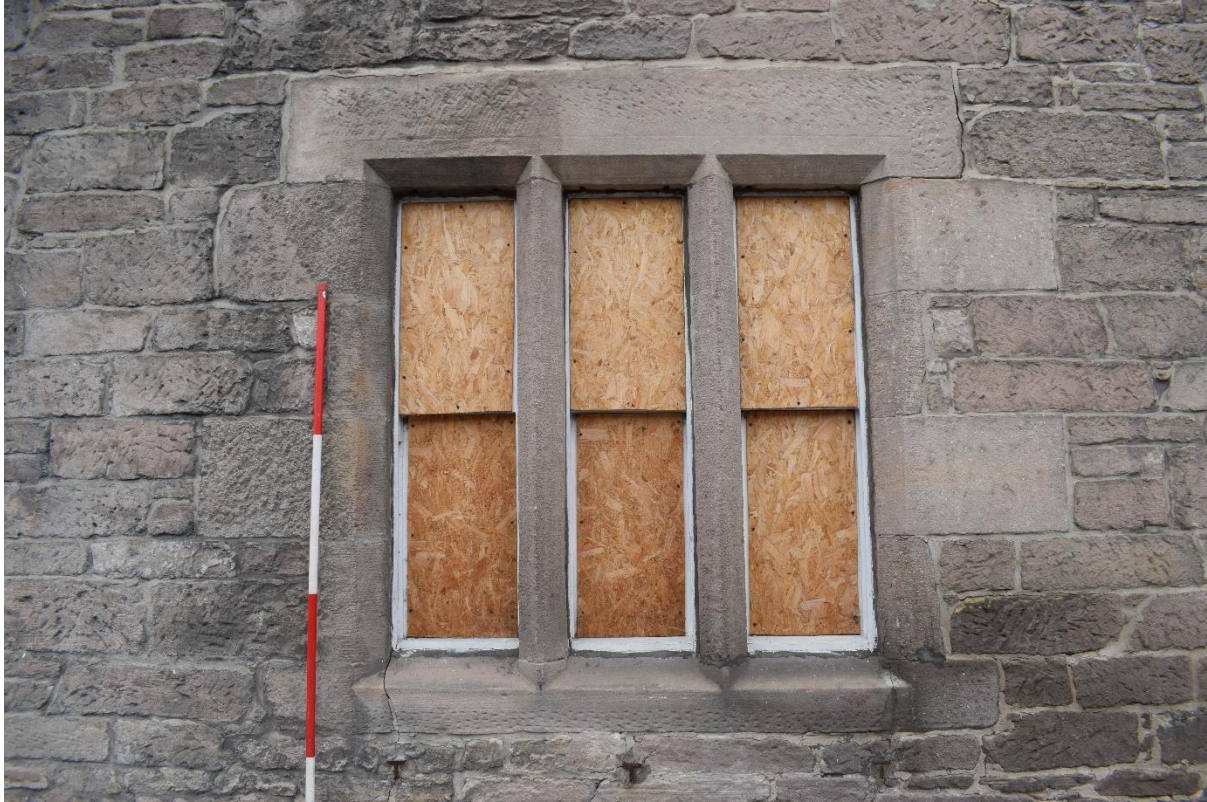
Illus 7 Tooled sandstone lintels, sills, mullions, W3; facing NE

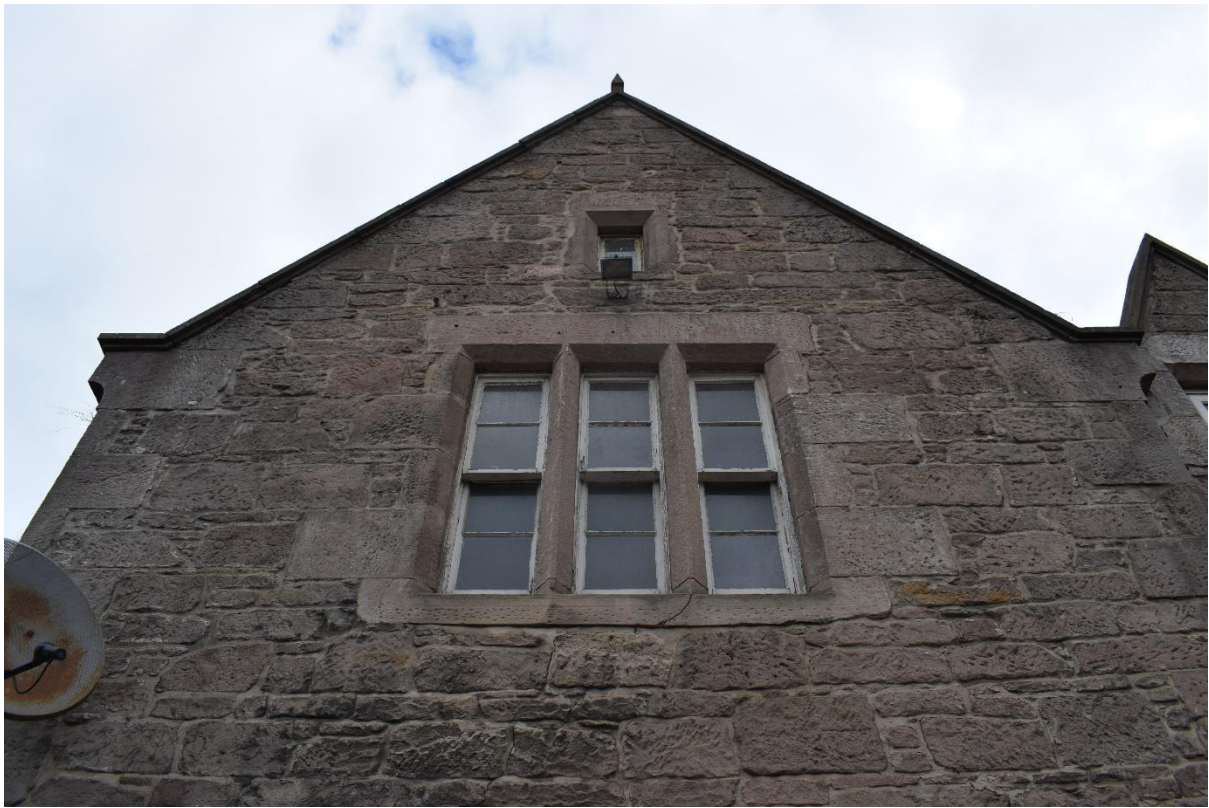
Illus 8 W2 with W1 above; facing NE

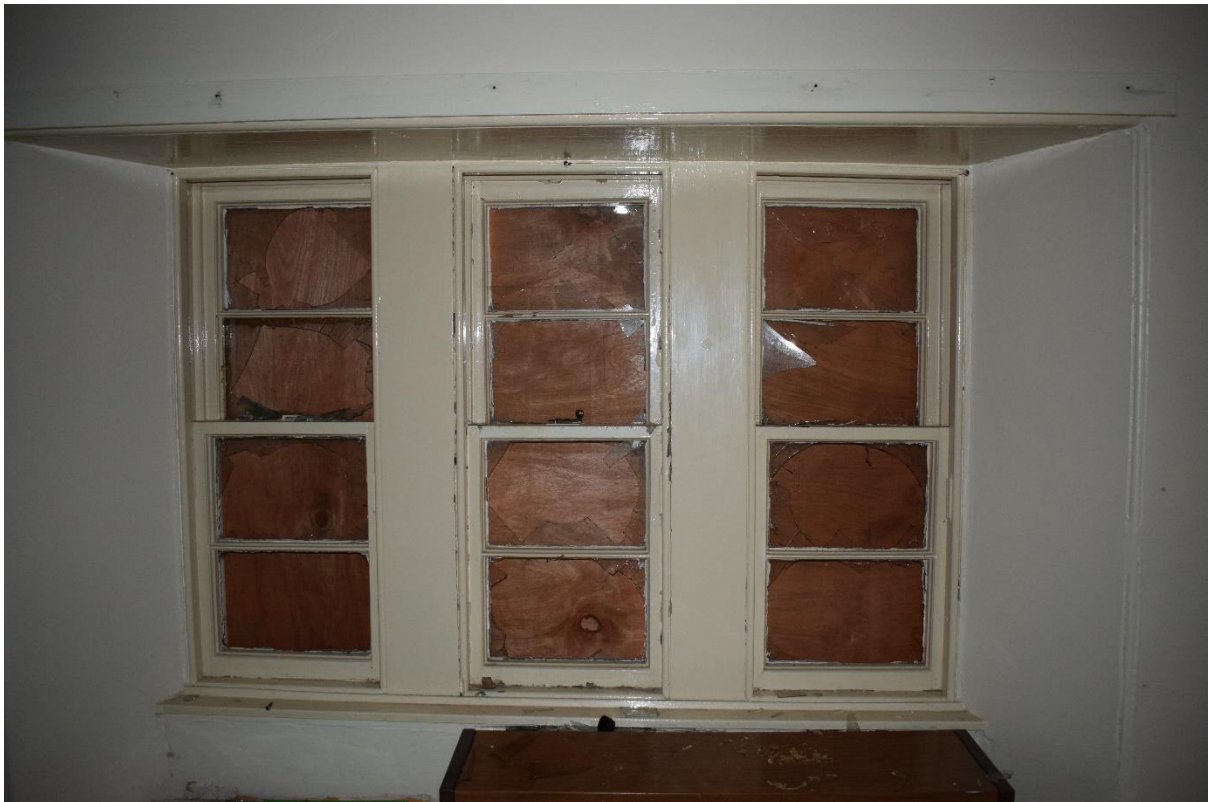
Illus 9 First floor corridor Phase 1 window W14 interior

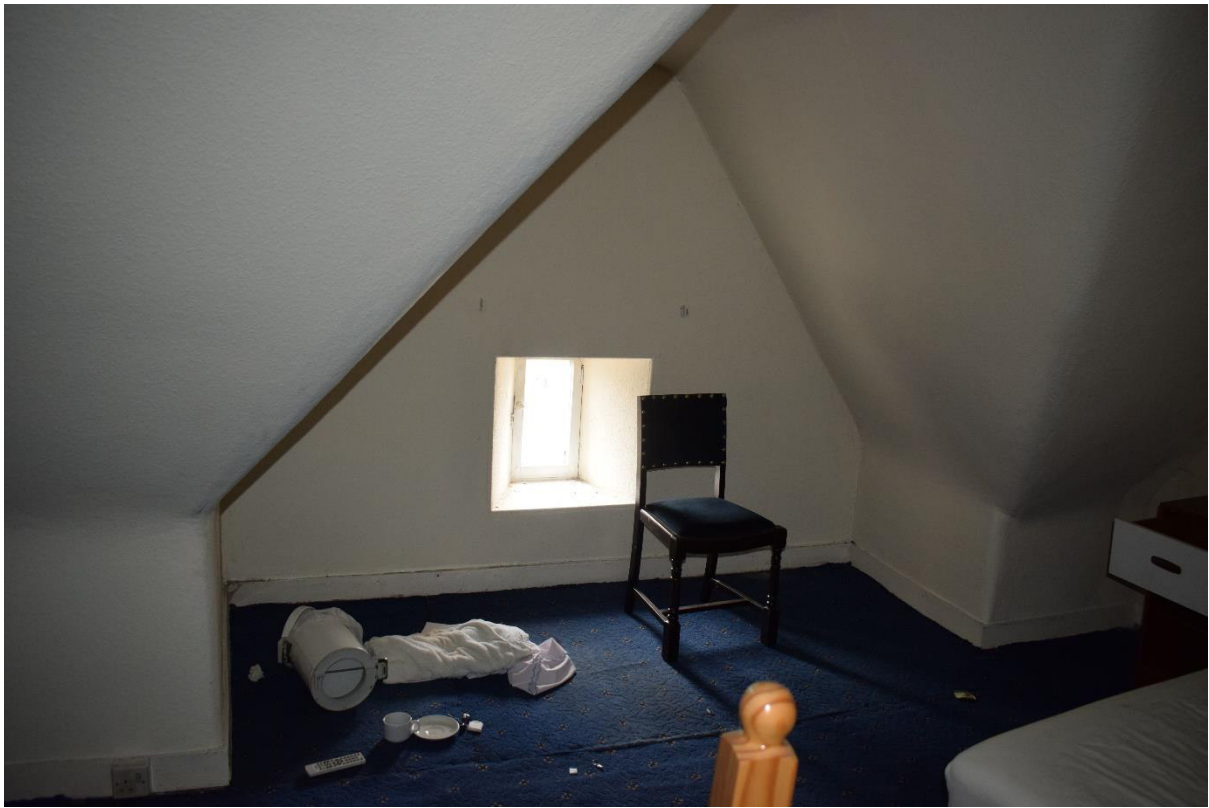
Illus 10 Second floor Room 28 SW wall W1; facing WSW

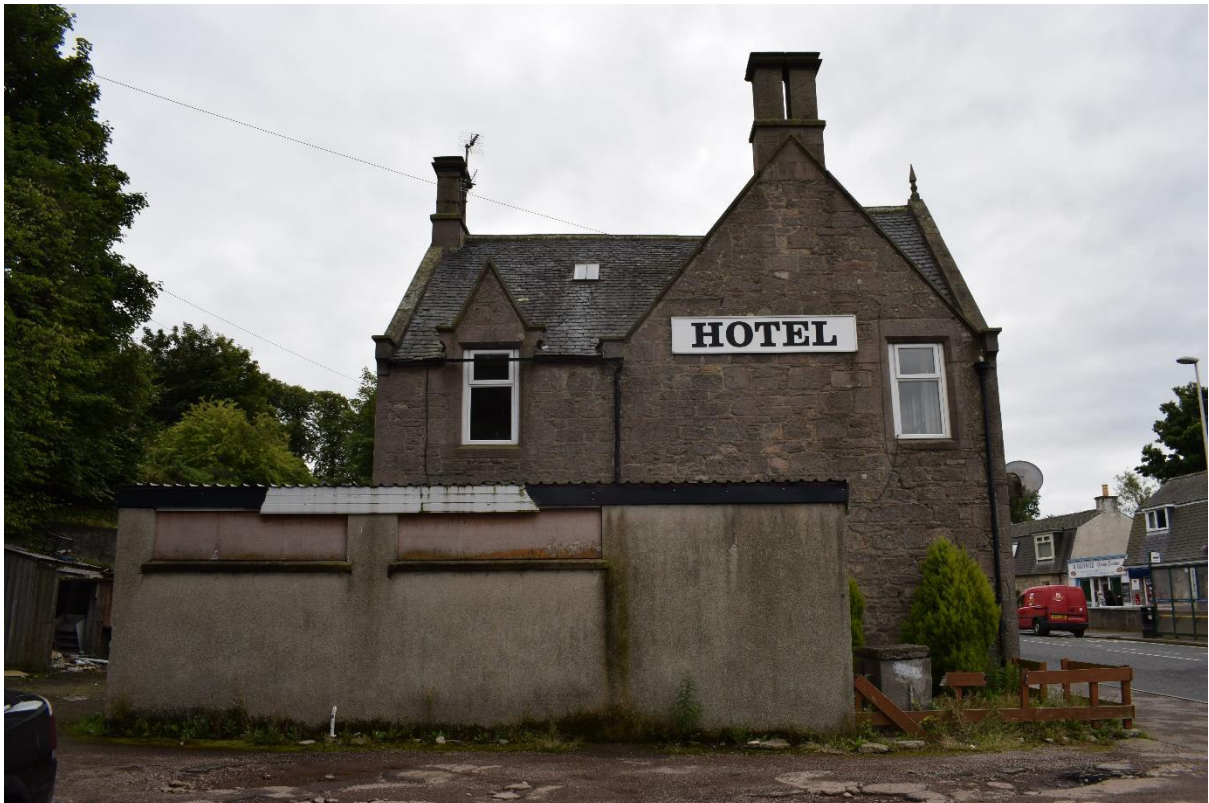
Illus 11 NW façade with W12 (top left) W13 (top right) and late 20th-century shop extension (bottom); facing SE

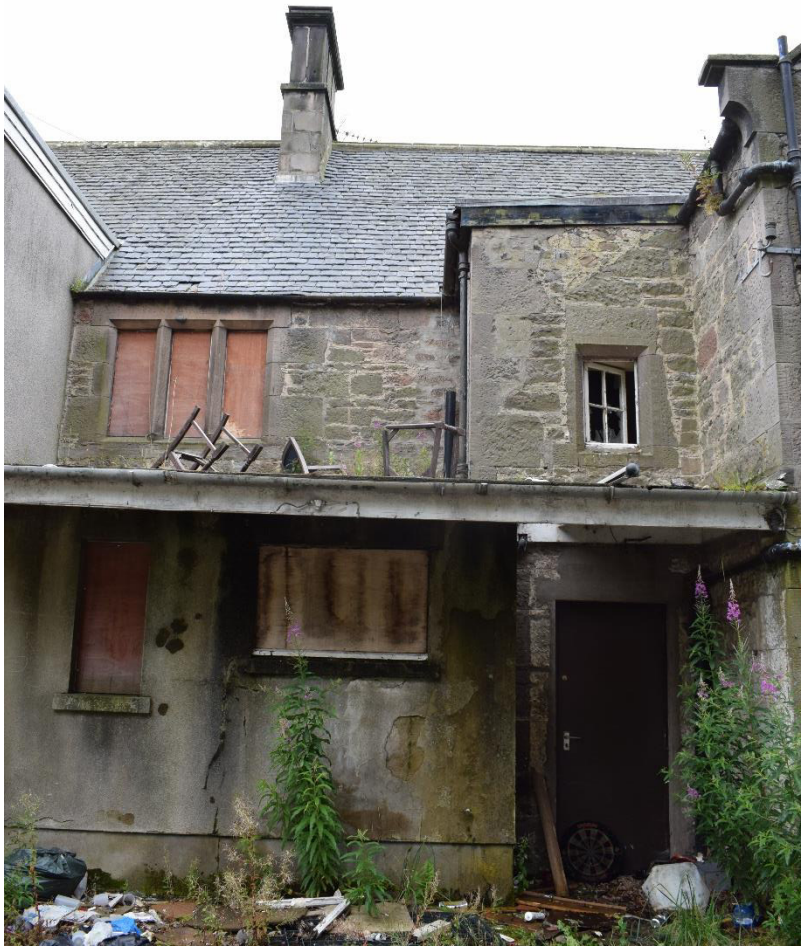
Illus 12 Phase 1 NW façade W14 (top left) W15 (top right) with later additions below; facing SW

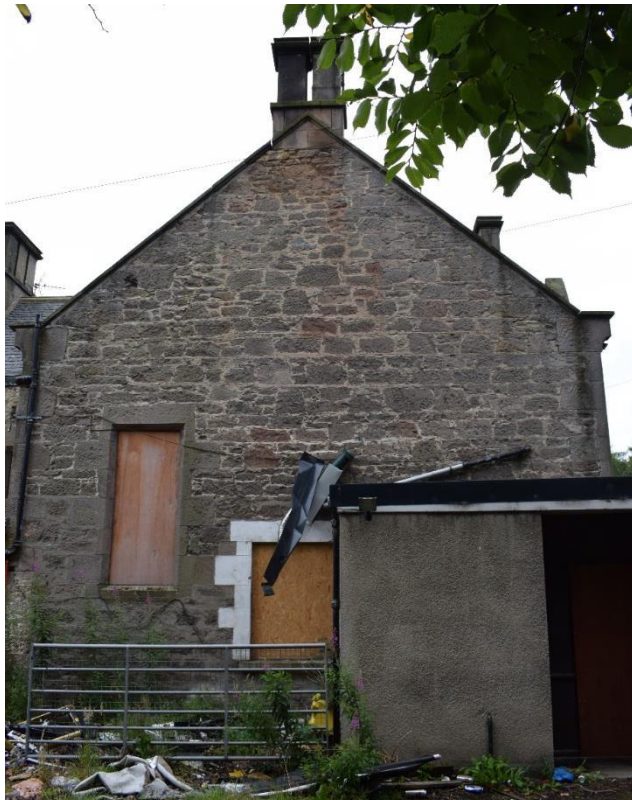
The Phase 1 hotel is 22.5m long and 7-8m wide at the W end of the building (Rooms 3-14 on ground floor and upper floors all rooms). There are large windows on the front S facade on the ground and first floors (Illus 7-9) and one small window on the second attic floor (Illus 10, 10). An extension has been built on the W and N sides and the E end covering some phase 1 facades. There are windows on the first floor W gable (W12, W13; Illus 11). The rear (N) of the building has been heavily altered but a section of the Phase 1 building can be seen with large sandstone windows W14, W15 (Illus 12) and W16; W17 (Illus 13) has concrete lintel and sill and has been inserted probably in Phase 2. The chimney pots are

Illus 13 Phase 1 NE gable with W16 (left) and later insertions white-painted concrete window W17; facing SW

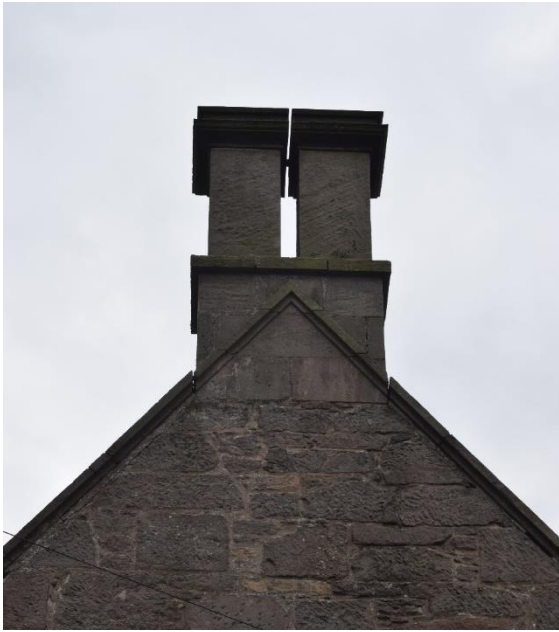
square sandstone blocks (Illus 14) and the finials over the front gables are metal ball and spike.

Illus 14 Square sandstone chimney pots F8 above NW gable' facing SE

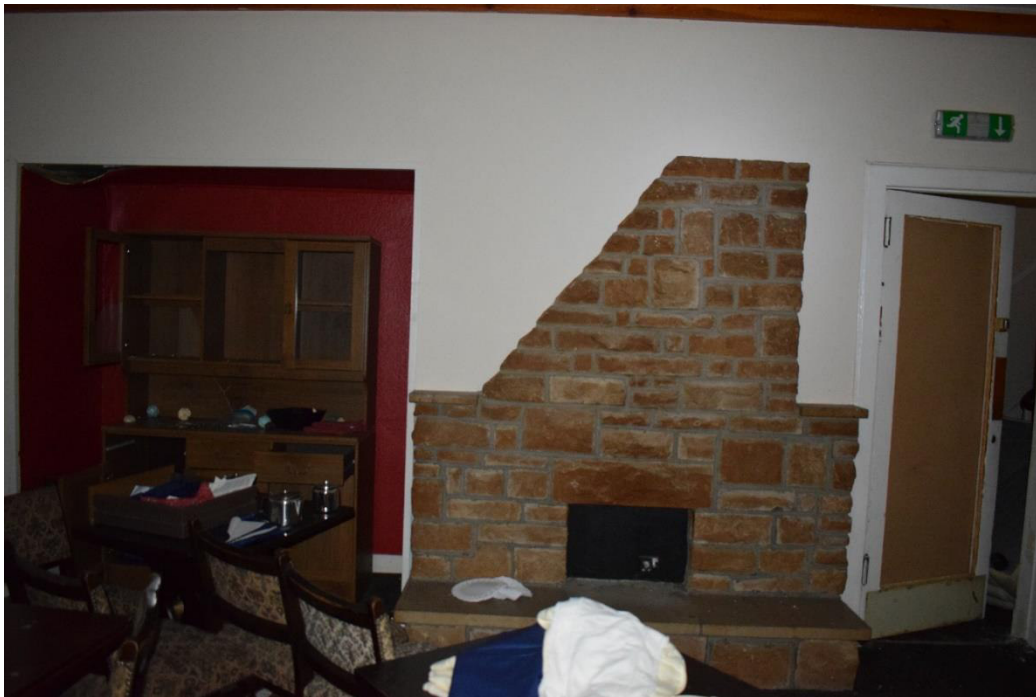
The building has been modernised throughout with fireplaces in ground floor Room 8 and first floor Rooms 17, 19, 21 and 24 (Illus 15, 16) but other fireplaces must have been present and have been removed or covered. There is a large cart door (D2), 3m wide, 3.3m high and with a highly decorative sandstone hood moulding (cover illus).

Illus 15 Room 8 NW wall with chimney breast and fireplace F15; facing NW

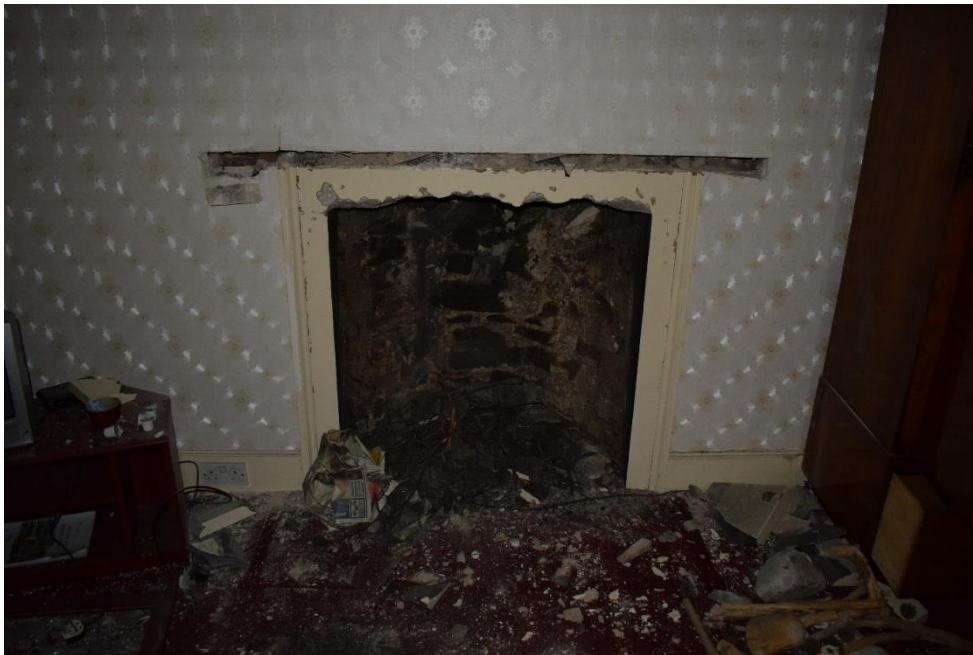
Illus 16 First floor bedrooms Room 21 fireplace F9; facing SE

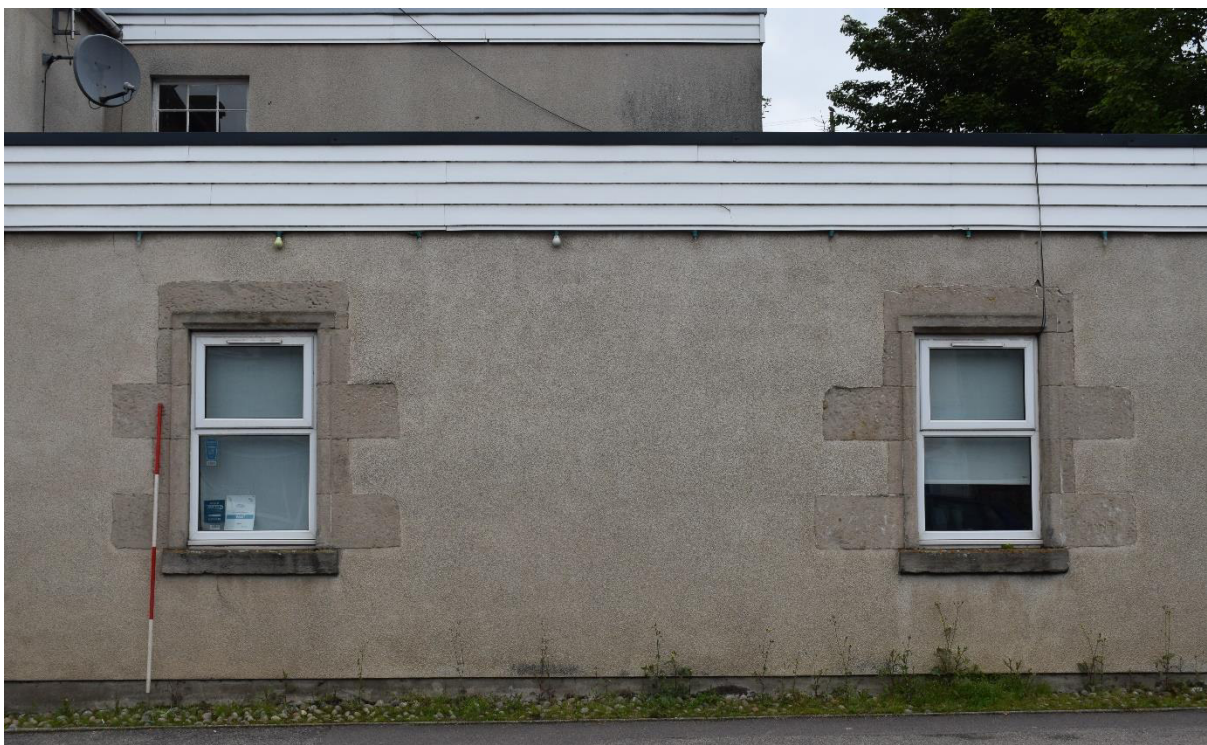
Phase 2 has been added on to the E end of the hotel prior to the First Edition OS map (Illus 17). It is c9.5m long and 6.5m wide. Two sandstone windows are visible in the S façade (W18 and W19) but the wall around these windows has been harled (Illus 17) and other extensions added to the E, and N sides to create large bar and dance floor areas. No other original walls of this extension are visible.

Illus 17 Phase 2 extension SW front façade sandstone windows W18 and W19

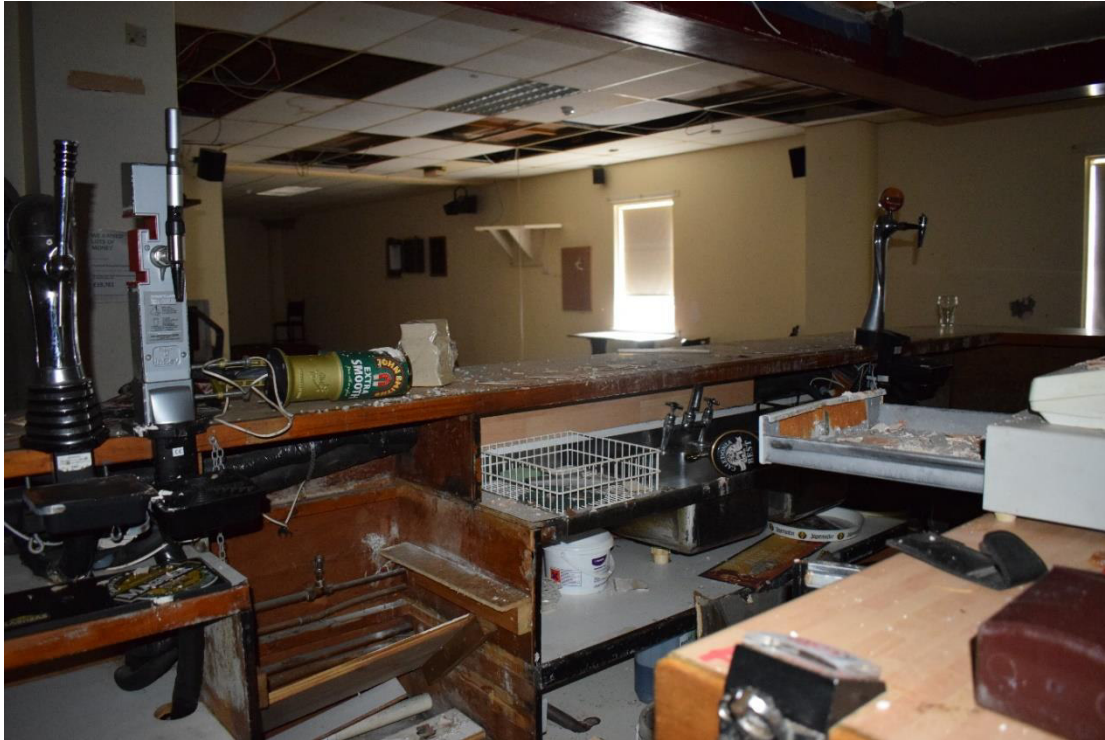
A further extension on the E end and the NE and NW of the building were added in the mid-late 20th century. A dance floor was added on the E end of the building (Room 16; Illus 18). Toilets were added on the N of the building in this phase (Rooms 10, 12, 13 and the N end of Room 15) and an extension on the NW corner was latterly used as kitchen and shop (Rooms 1-3; Illus 8-9).

Illus 18 Phase 3 bar and dancefloor extension Room 16; facing S
