**Parish Kirk, Kirkton Of Kingoldrum, Kirriemuir, DD8 5HW
Report on Level 1 Standing Building Survey**

**Alison Cameron
Cameron Archaeology
17 November 2017**

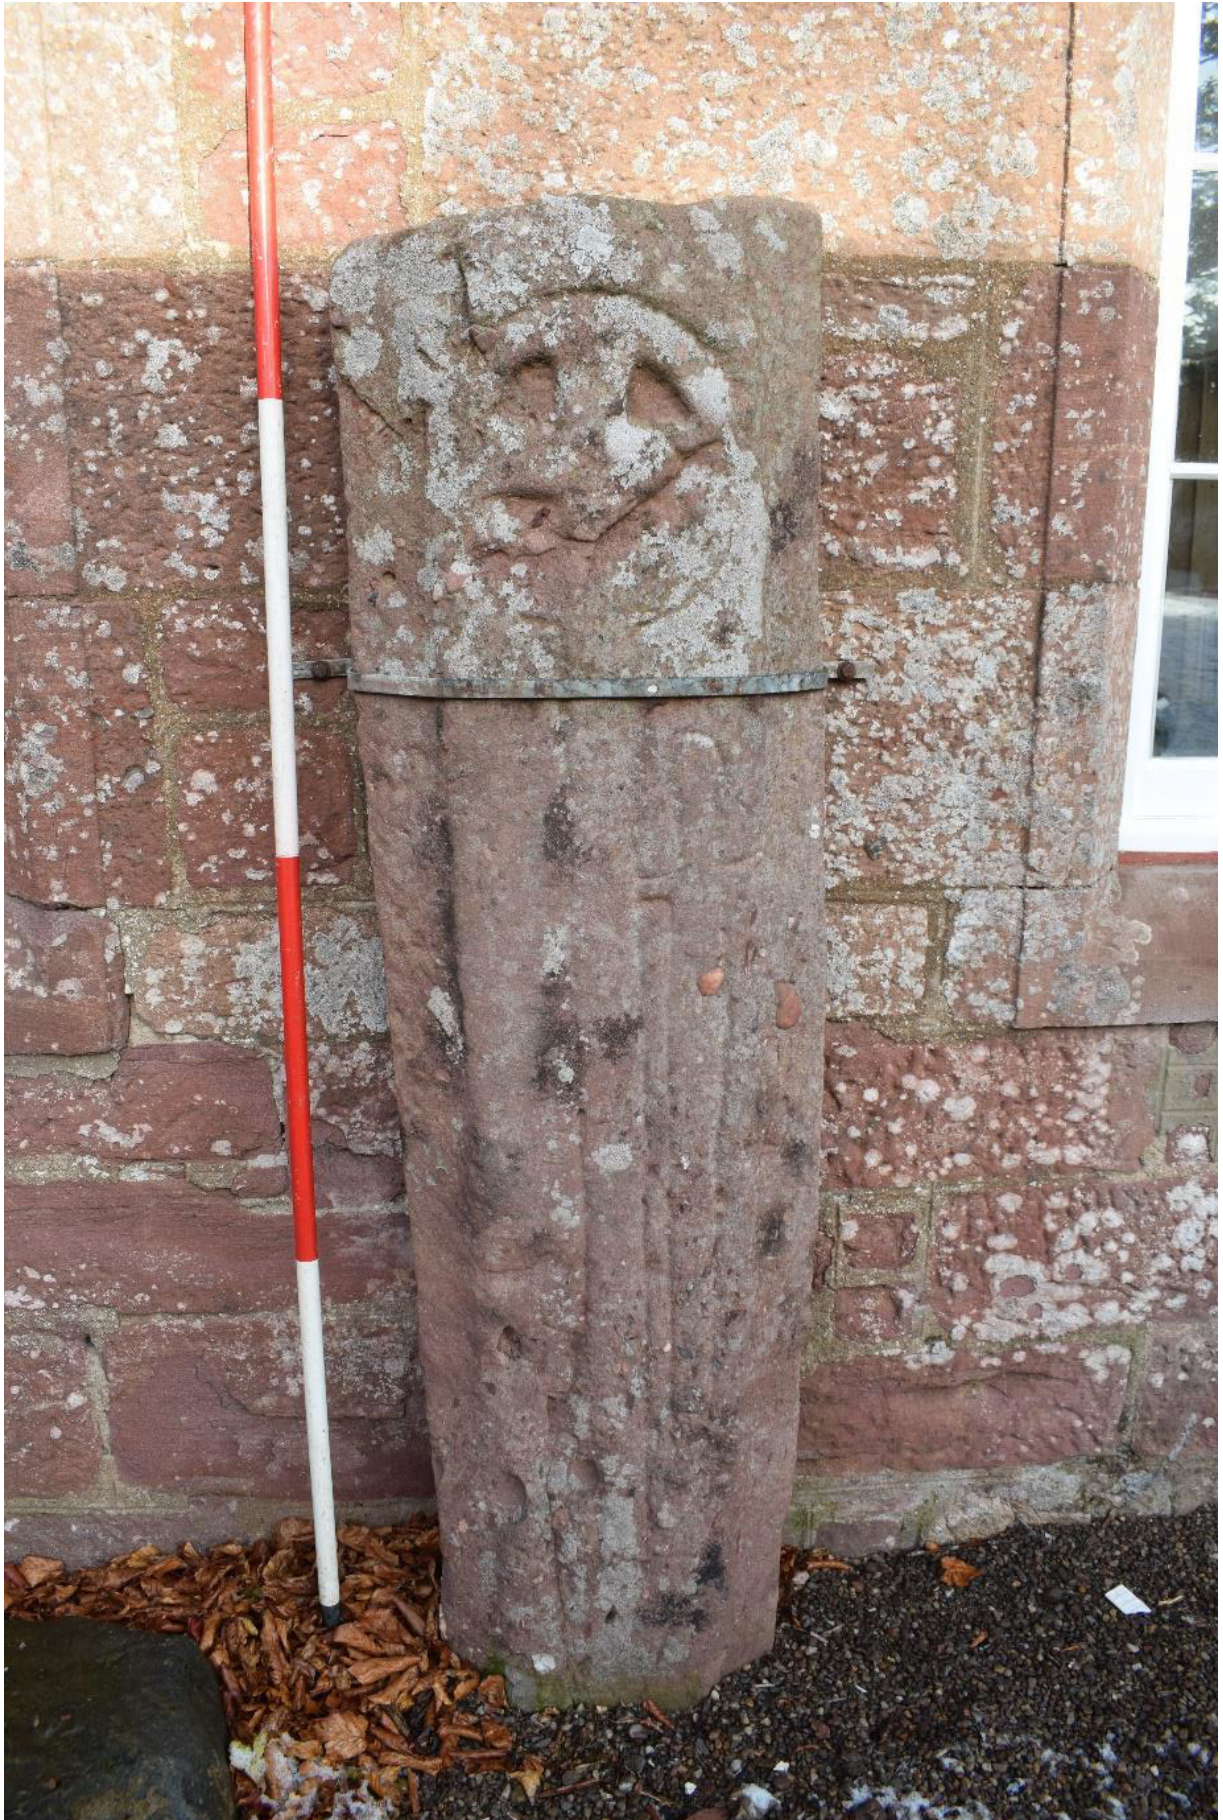
There is no trace of a church earlier than the present 19th century structure. A complete, Early Christian, stone coffin cover, with a wheel-headed cross incised upon it, was formerly lying in the graveyard, and is now set up against the S wall of the church (Illus 3). The base of the coffin is reputedly in the farm of Mr McIntosh (R Turnbull pers comm). According to Mr Mackintosh, session clerk, St Medan's Well (name verified) was a spring well situated on a hill-slope "some 50yds S of the cottage of the SW of the church (area: NO 333 549). The ground was improved within living memory, and there is now no trace of the well. There is also a stone font in the graveyard (Illus 4).

Illus 3 Sandstone coffin lid (F7) supported with copper alloy band against the south wall of the church (not affected by this planning application)

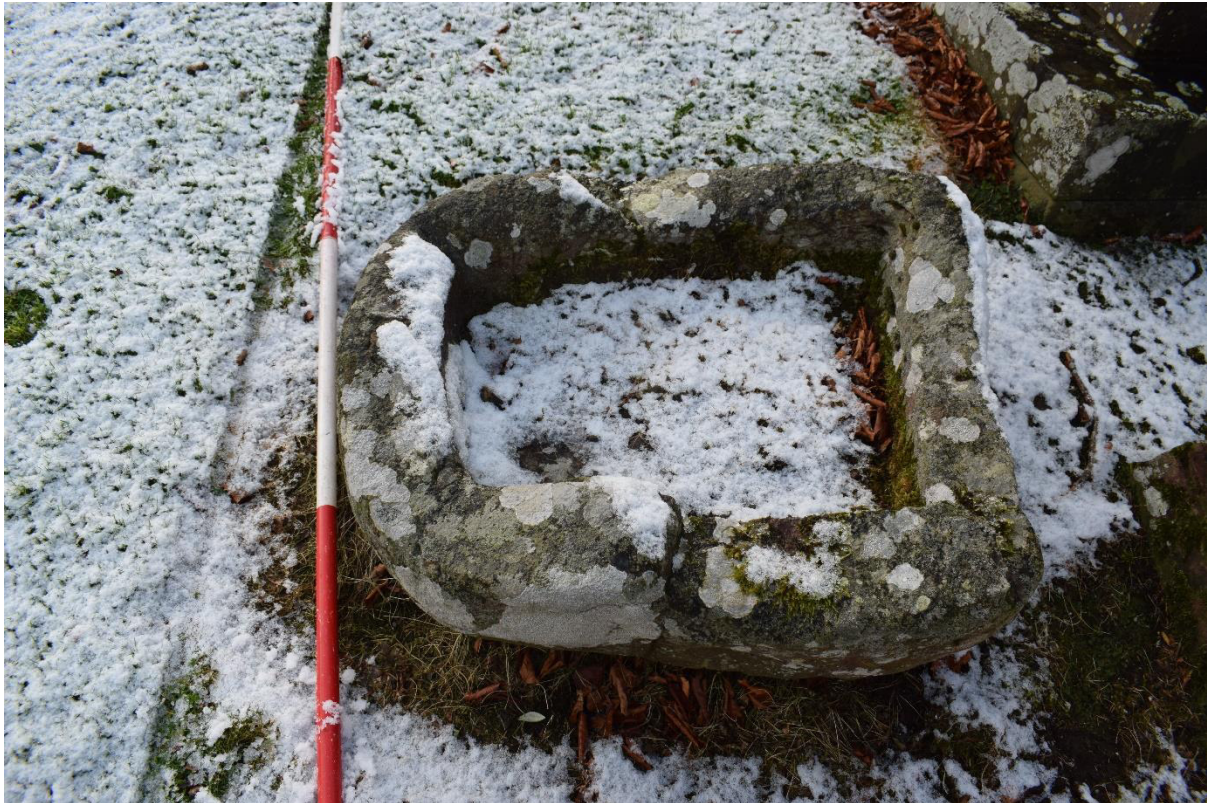
Illus 4 Stone font in graveyard (not affected by this planning application)

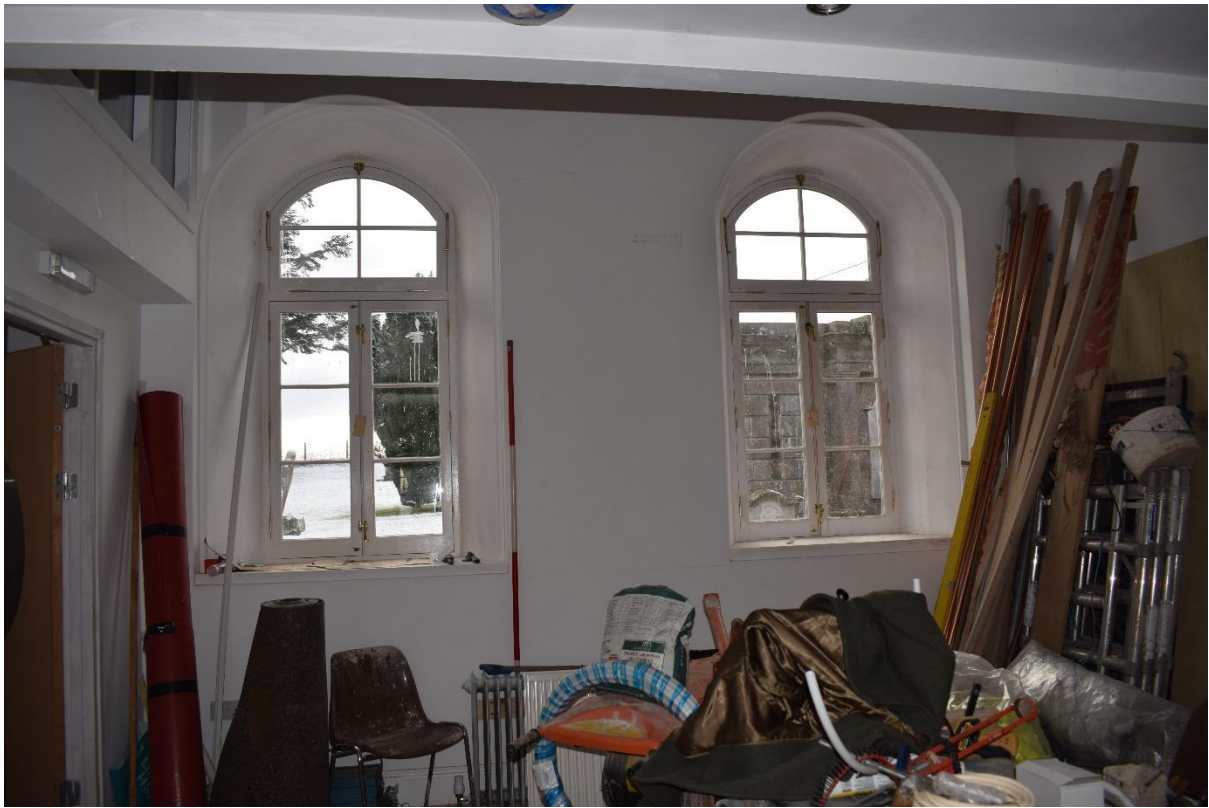
Illus 11 W5 (left) W4 (right); facing S

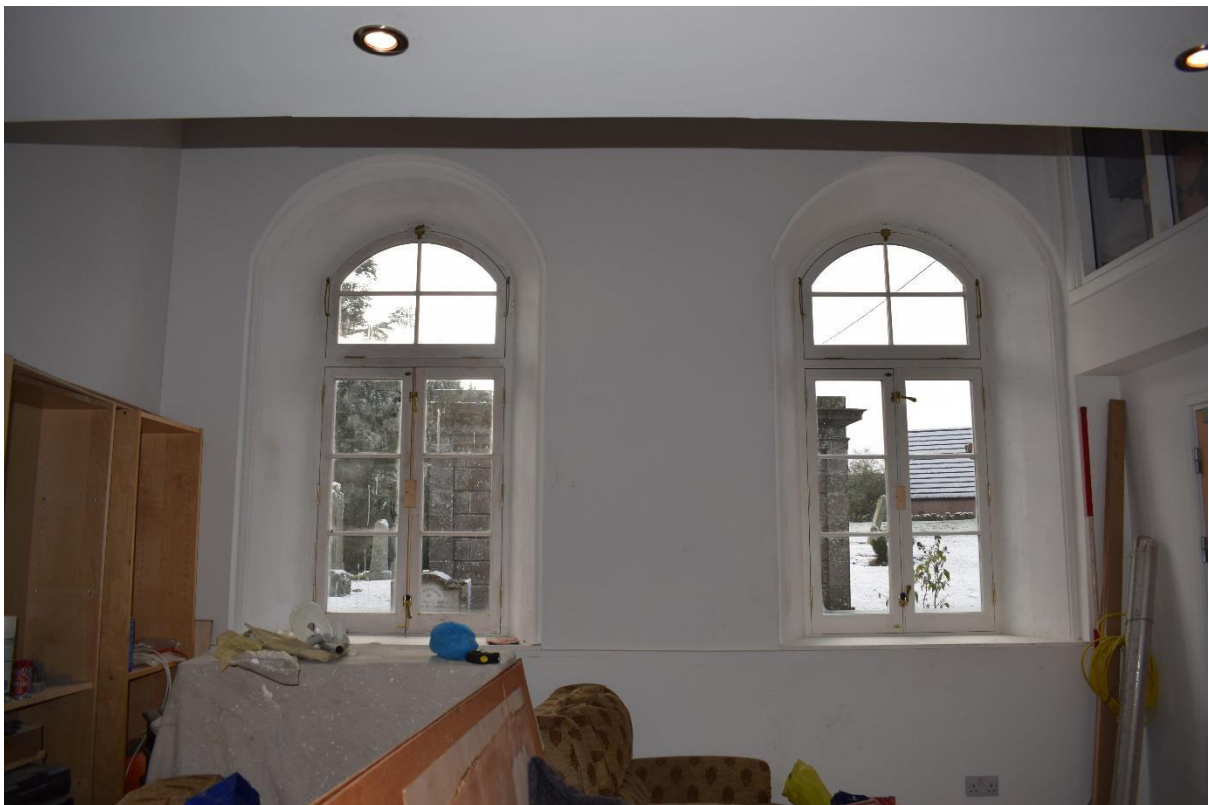
Illus 12 W2 (right) W3 (left); facing S

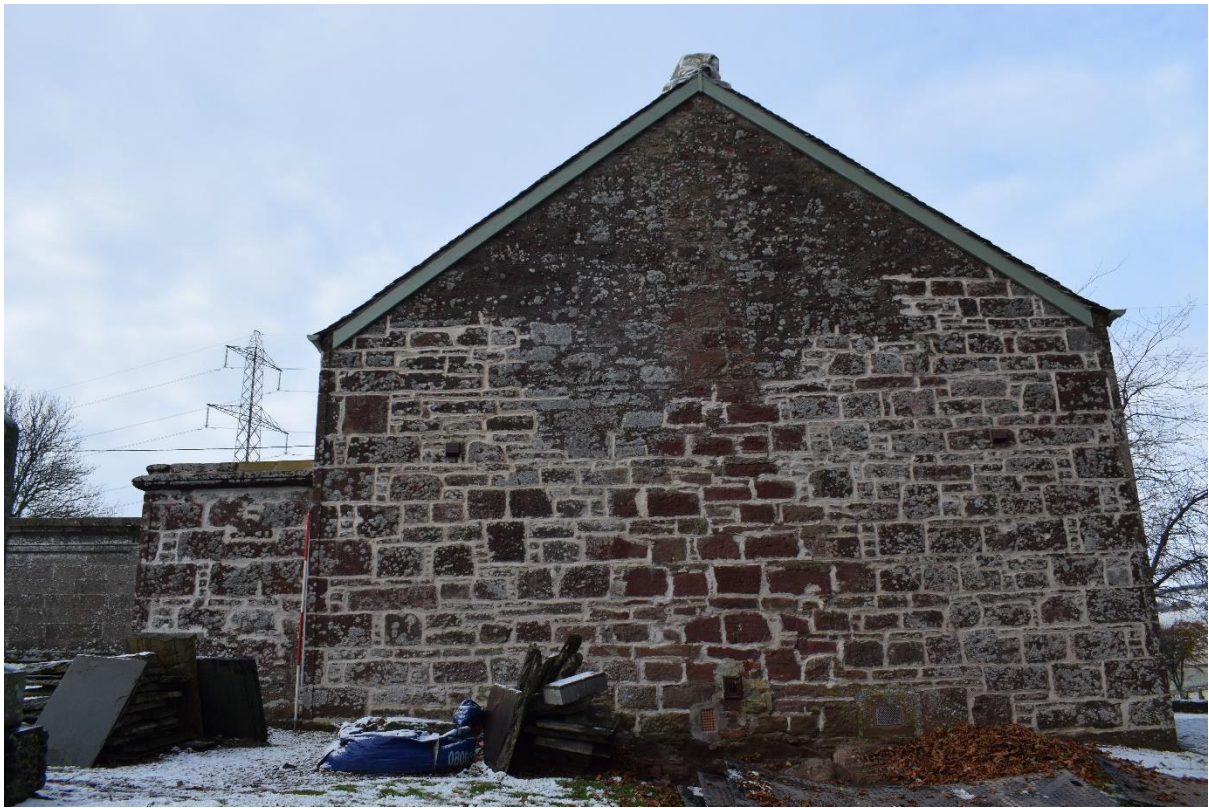
Illus 13 East gable; facing W

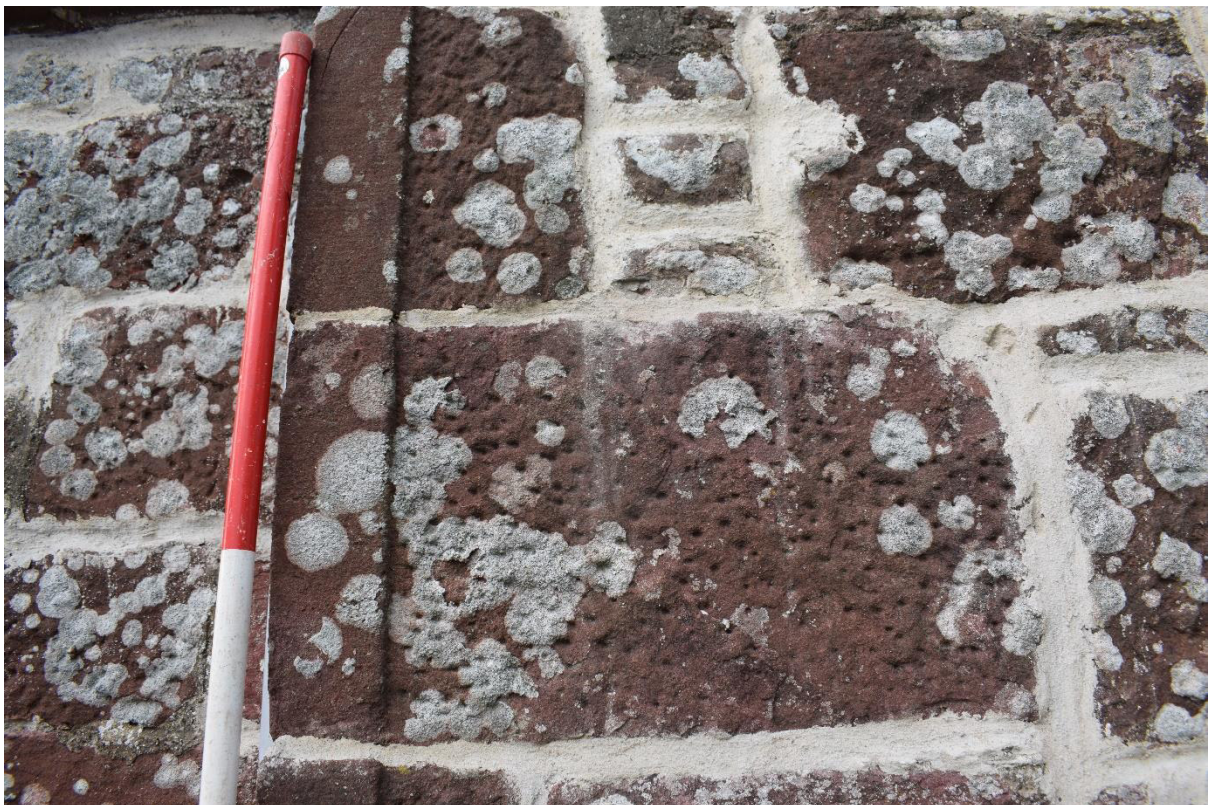
Illus 14 Sandstone quoin with pecked dressing, SE corner of church; facing W

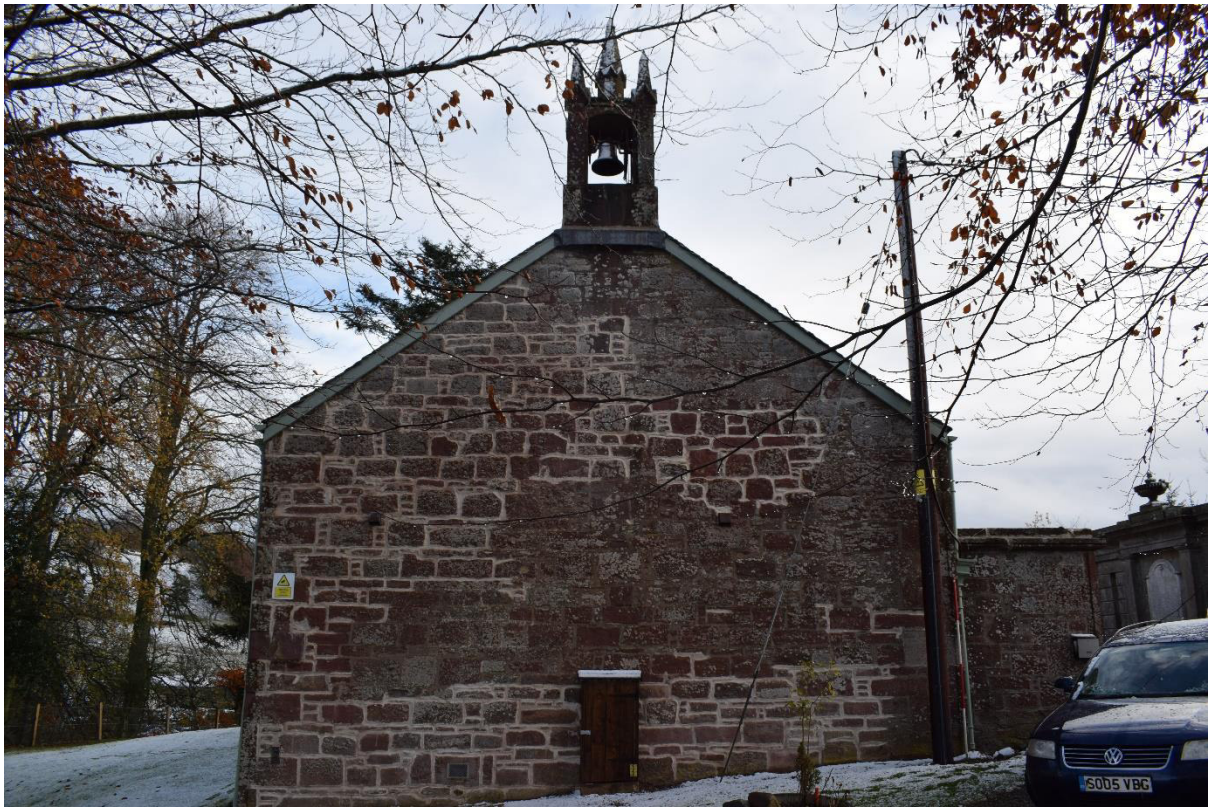
Illus 15 West gable; facing E

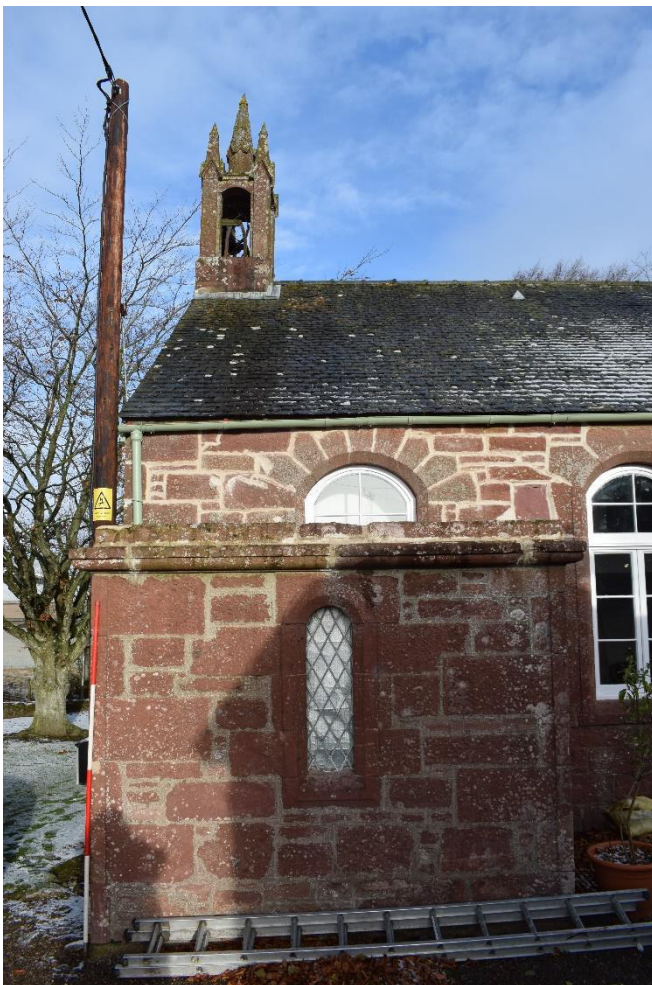
Illus 16 South façade west end with bell-cote F1, W1 above porch W7; facing N

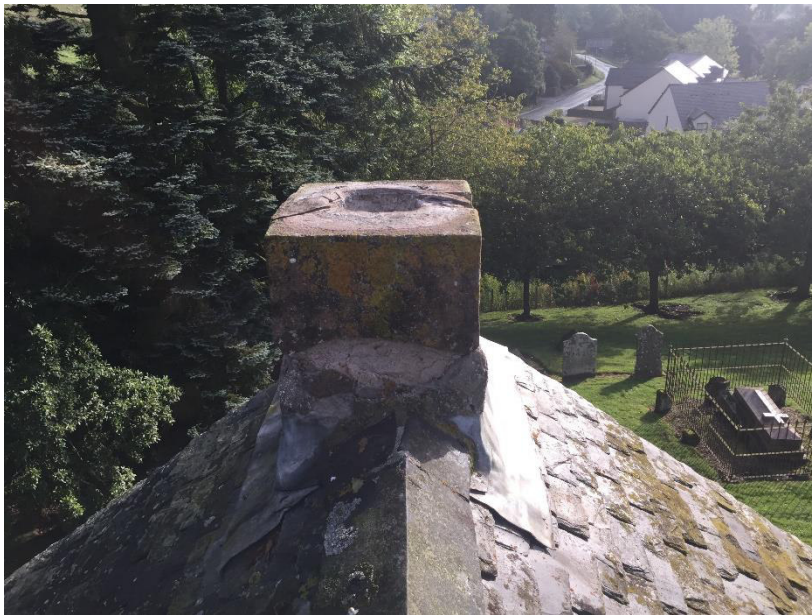
Illus 17 Chimney base F3 (copyright Ronnie Turnbull)

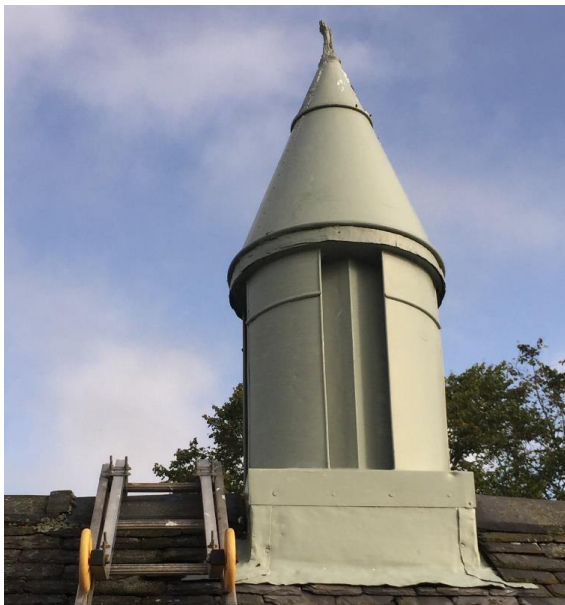
Illus 18 Ventilator F2 (copyright Ronnie Turnbull)

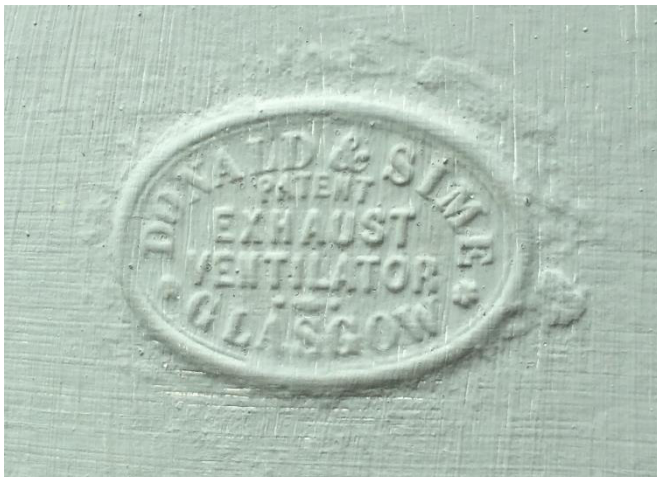
Illus 19 Maker's mark on ventilator F2 (copyright Ronnie Turnbull)

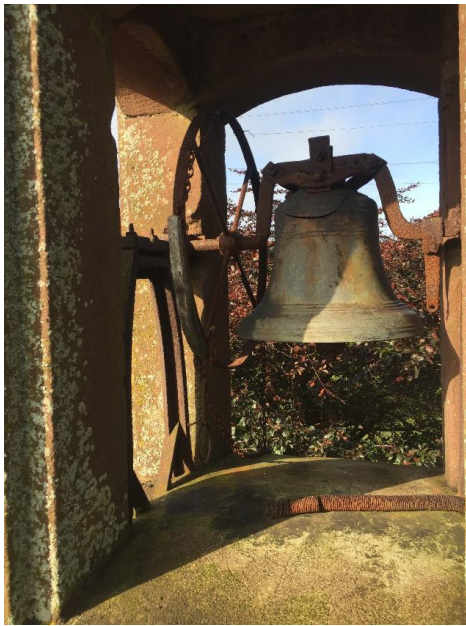
Illus 20 Bell in bell-cote F1 (copyright Ronnie Turnbull)

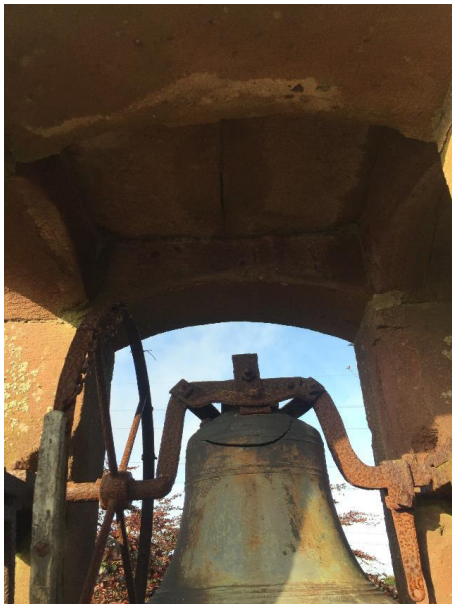
Illus 21 Bell in bell-cote F1 (copyright Ronnie Turnbull)

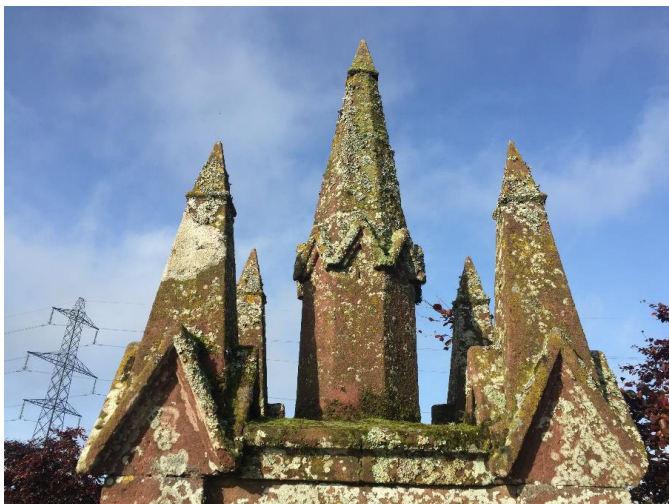
Illus 22 Sandstone pinnacles on top of bell-cote F1 (copyright Ronnie Turnbull)
