**Land Adjacent to Haremuir, Benholm,
Johnshaven, Aberdeenshire, DD10 0HX
Report on Level 1 Standing Building Survey
Aberdeenshire planning application APP/2017/3248**

**Alison Cameron
Cameron Archaeology
19 April 2018**

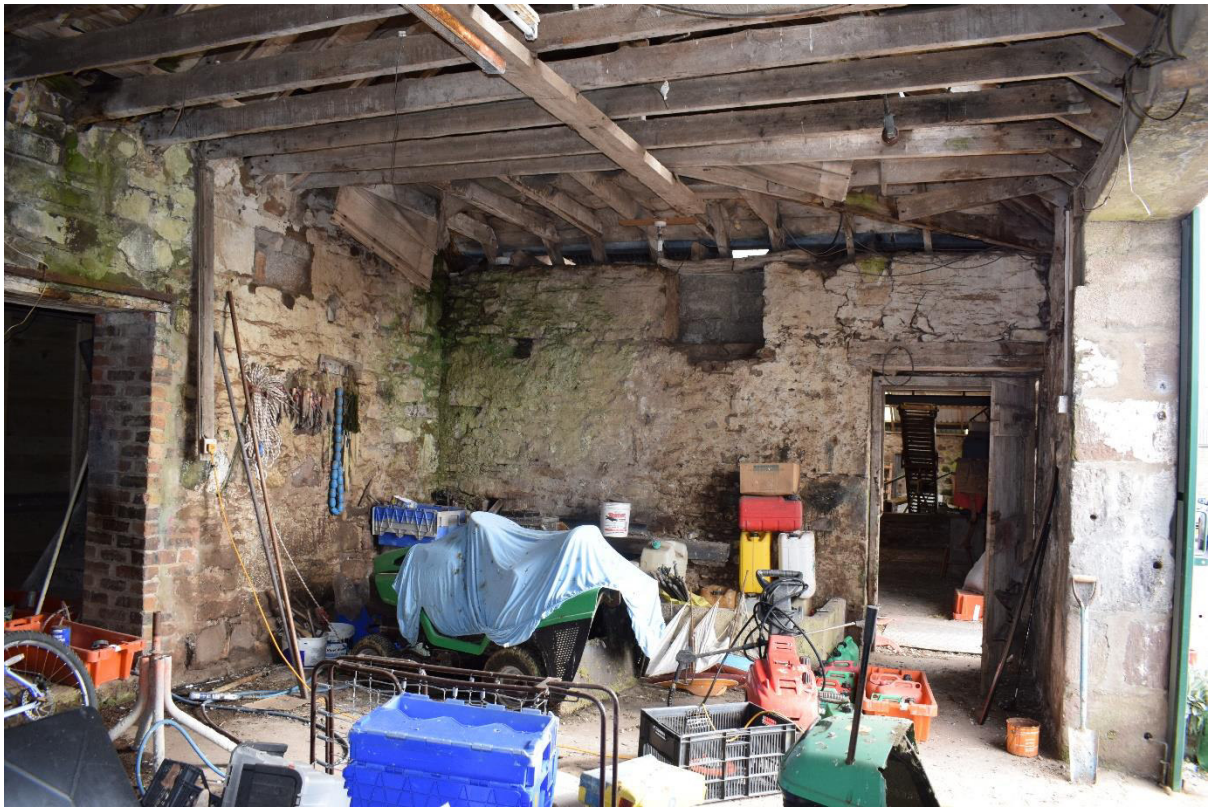
Illus 6 Room 1 interior; facing NNE

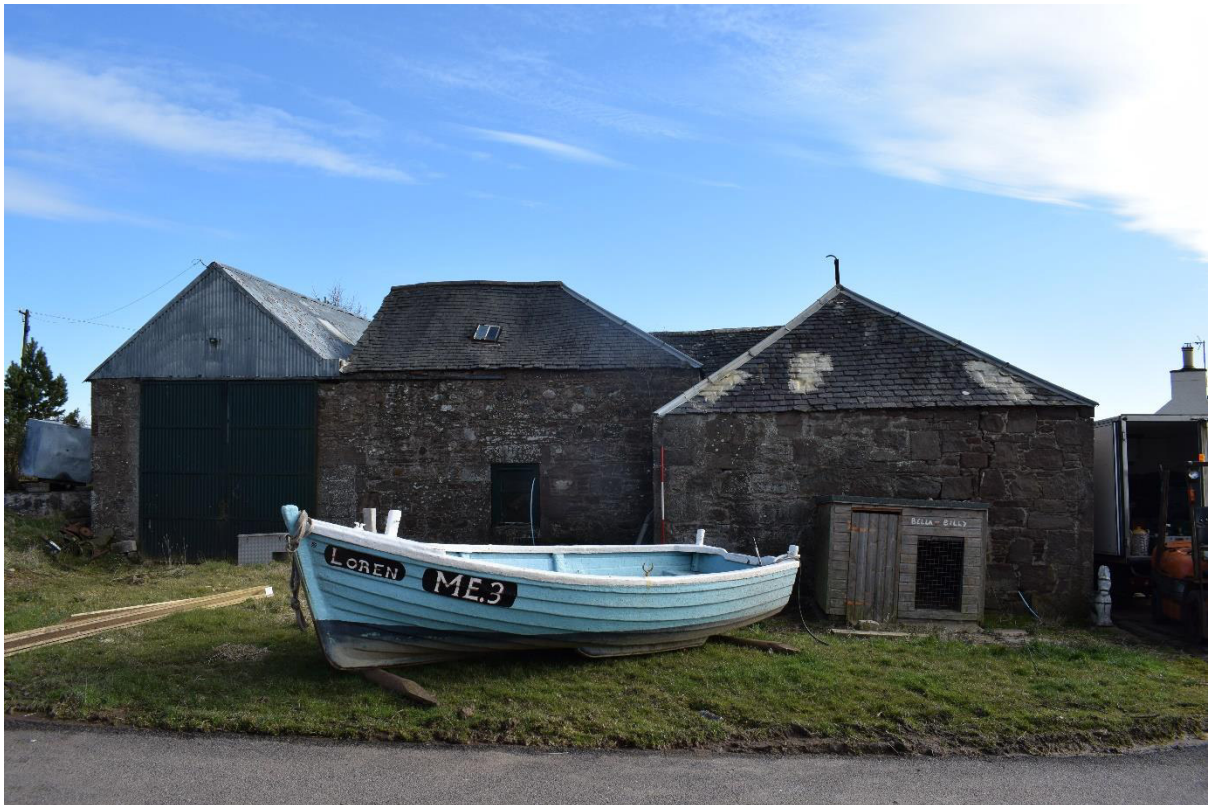
Illus 7 SW elevation D1 (left) W1 (centre); facing NE

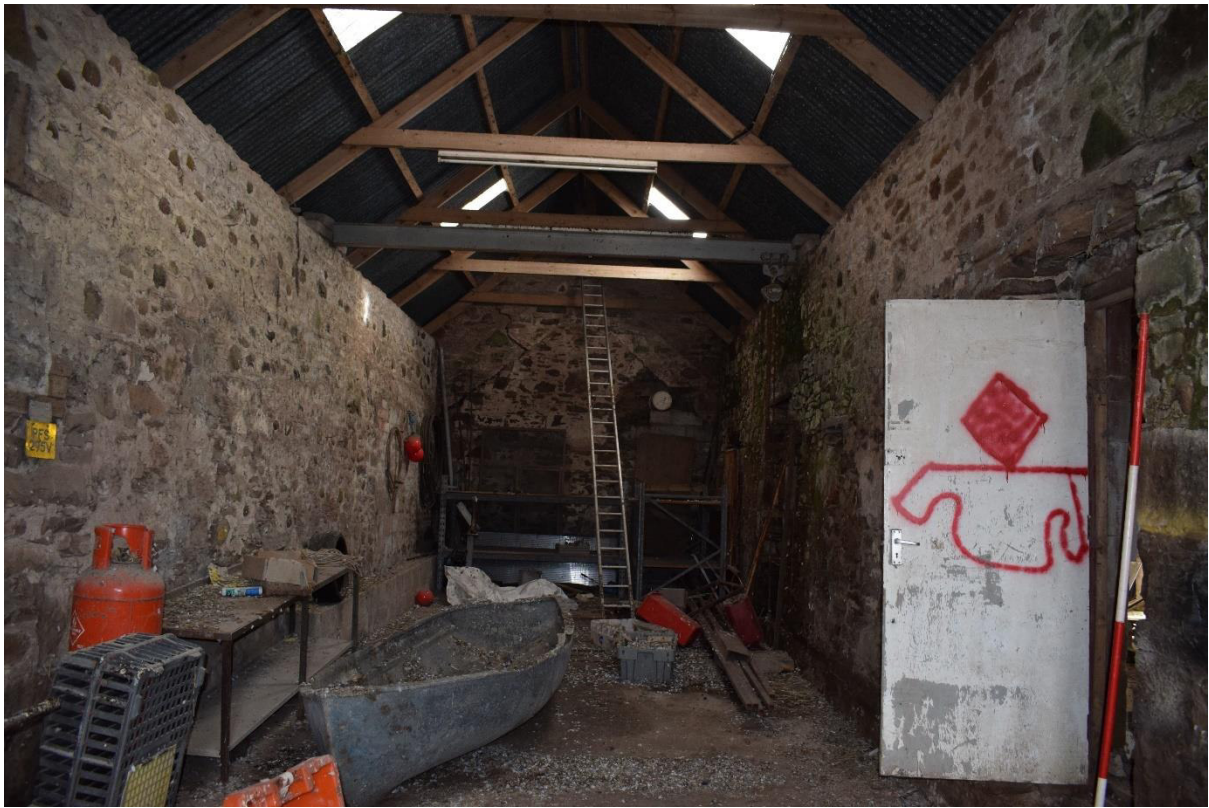
Illus 8 Room 3 interior; facing NE

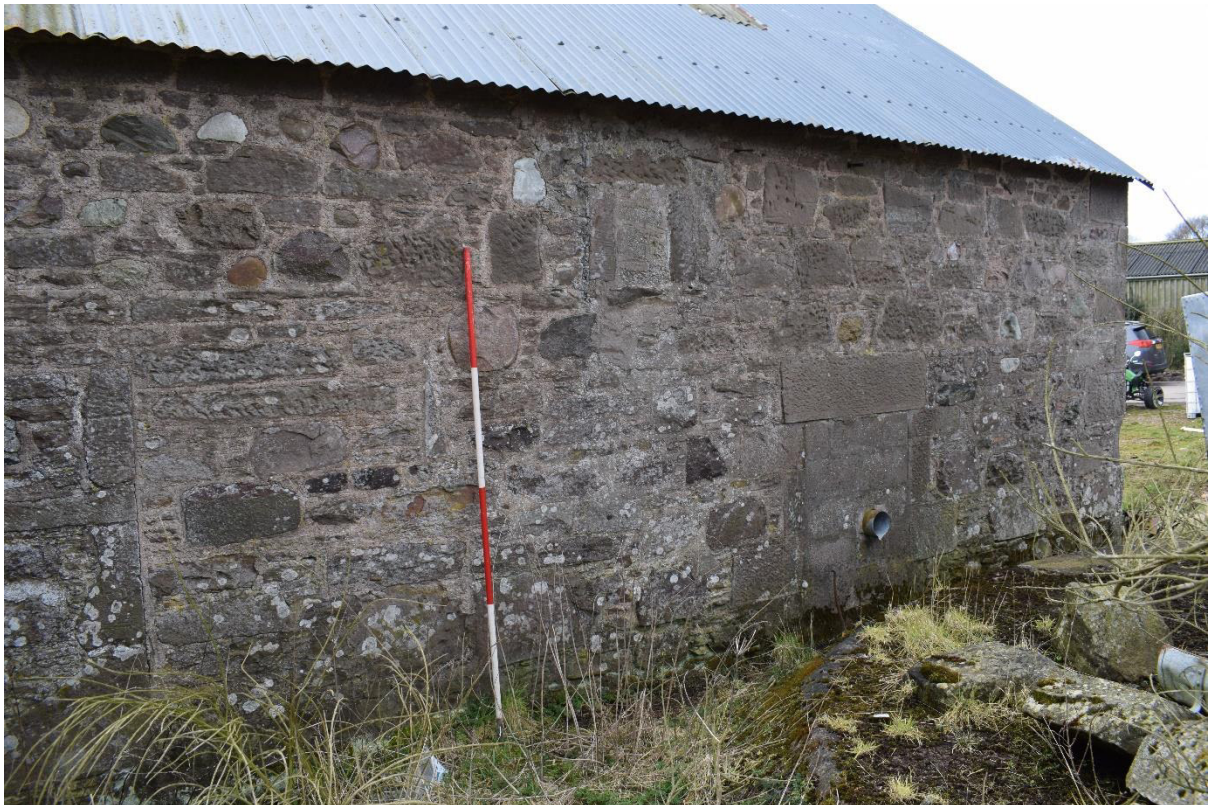
Illus 9 SW range NW wall SW end D7 (left) and D6 (left), location of former horse mill; facing S

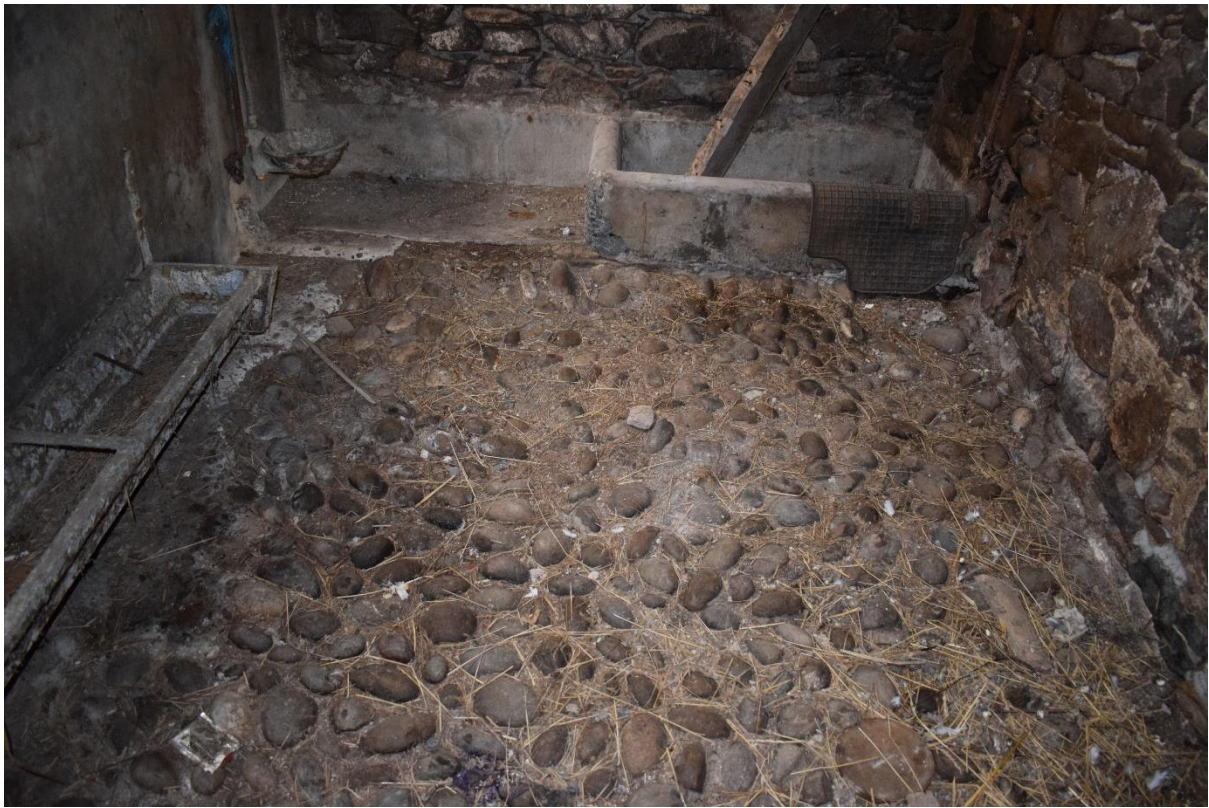
To the NE of Room 3 is Room 4 which has a waterwashed cobble floor (F4; Illus 10), indicating that this room was for stabling of animals from Phase 1. It has now blocked doors D3 and D4 to the NW and D24 and D25 to the courtyard. Room 5 is 20m long and 5m wide and forms the NE arm of the steading. It has a blocked door D8 (Illus 11) in the NE wall and doors to the courtyard (D27 and 28) and a door to room 4 (D26) and a large door in the SE gable (D11). Windows F10 and F11 (Illus 12) also opened into the courtyard. There is a shallow depression on the exterior of the NE wall (F3) which may indicate that a building has been located there and demolished.

Illus 10 Room 4 cobbled floor F4; facing NW

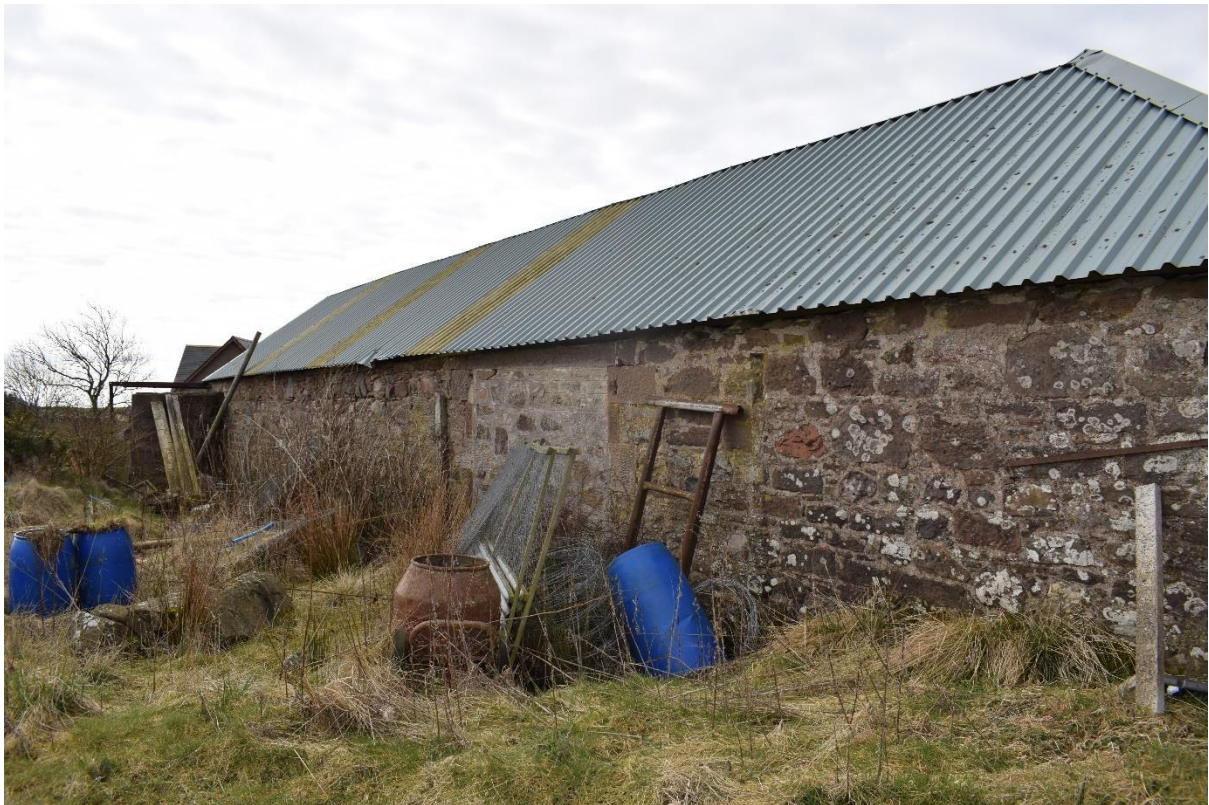
Illus 11 NE range NE wall NW end D8 (centre); facing S

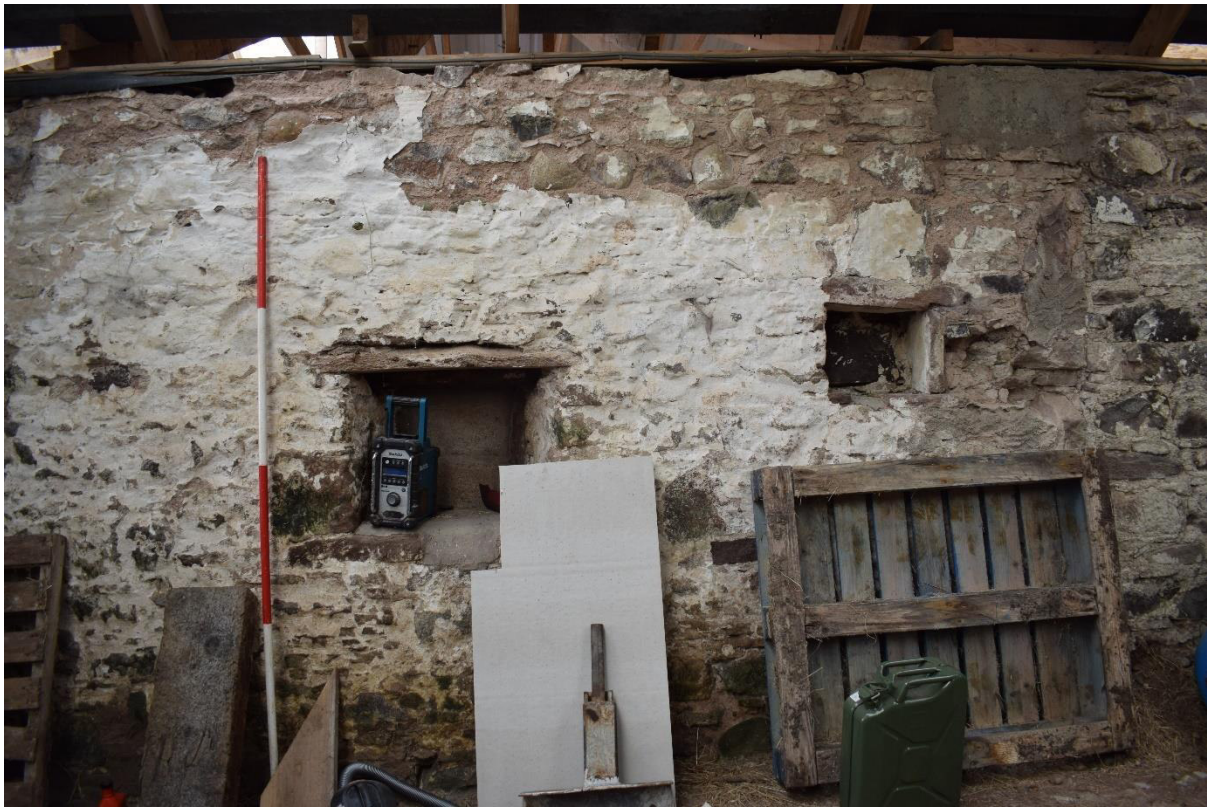
Illus 12 Room 5 SW interior wall W11 (left) W10 (right); facing SW

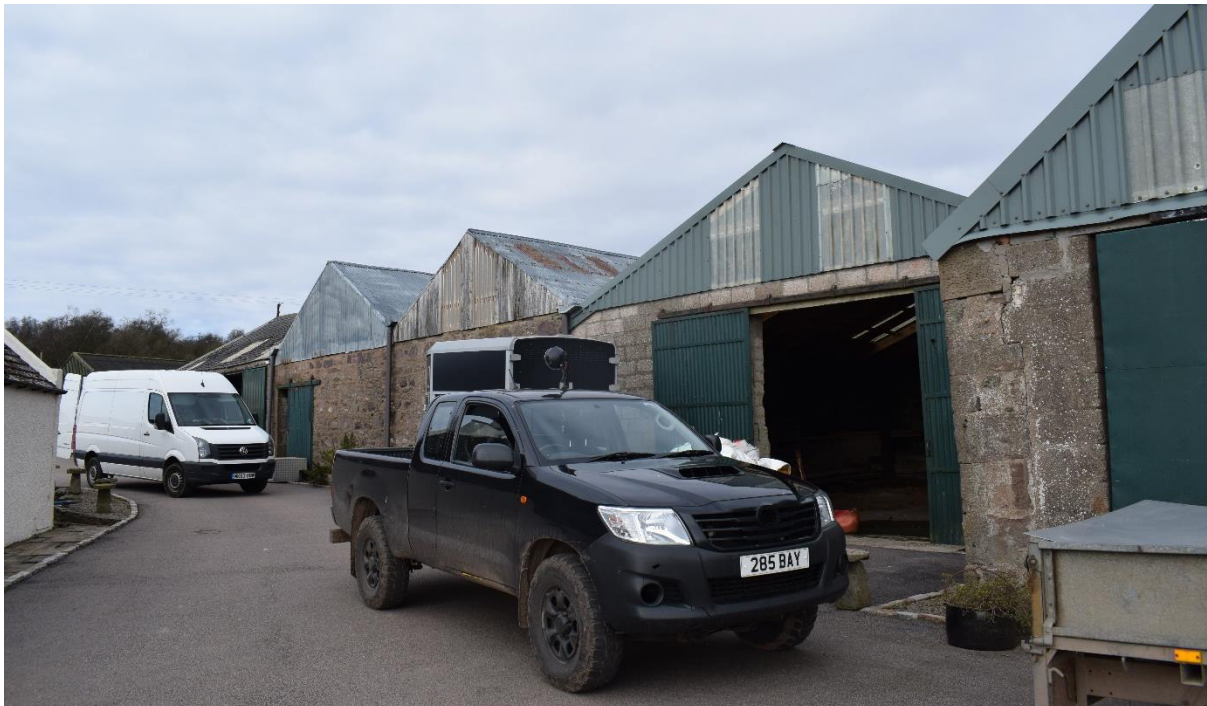
In Phase 2 the SW half of the central courtyard was enclosed with a sandstone rubble wall (Illus 13). Doors in the NW wall may have been blocked in this phase as the Second Edition OS map shows that the horse mill has been removed by that date.

Illus 13 SE façade with Phase 2 Room 5 SE gable (right), Phase 3 breeze block infill (centre), Phase 2 granite wall (left of centre) and Phase 1 SW wing (left); facing W

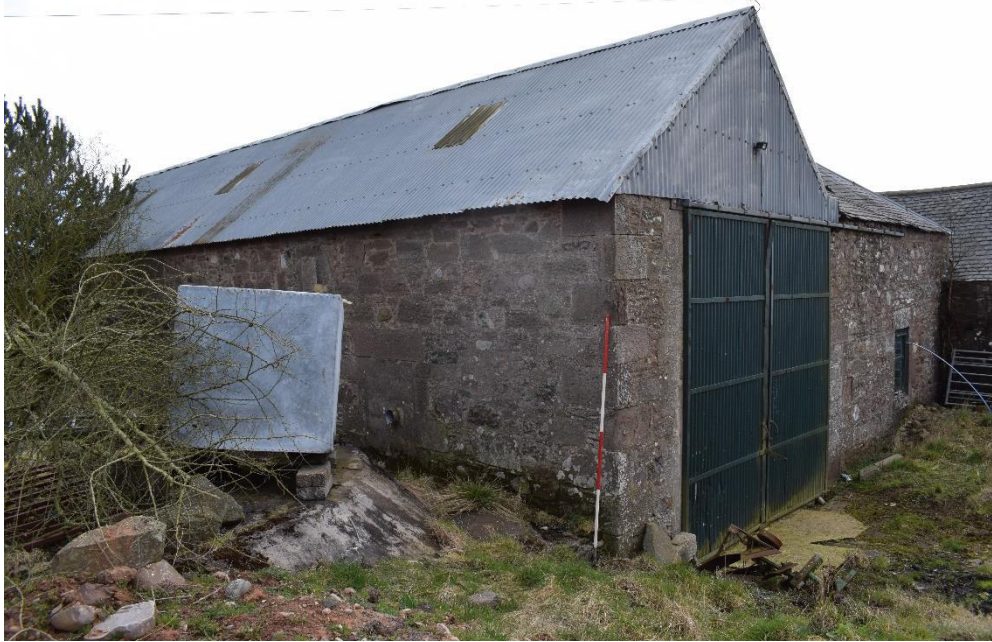
In Phase 3 the remainder of the courtyard SE wall was enclosed with breeze blocks and a small breeze block lean-to shed attached to the E corner of the farmstead. A concrete tank or platform (F2; Illus 14) was built onto the site of the Phase 1 horse mill but there is no trace now of an earlier structure. F2 is thought to have been for an oat bruiser (Mr McBay pers comm). The wall between Rooms 2 and 3 may have been demolished in this phase (Illus 15).

Illus 14 Farm from the W showing D1 (right) and former location of horse mill (left) with concrete tank under metal tank (left); facing E

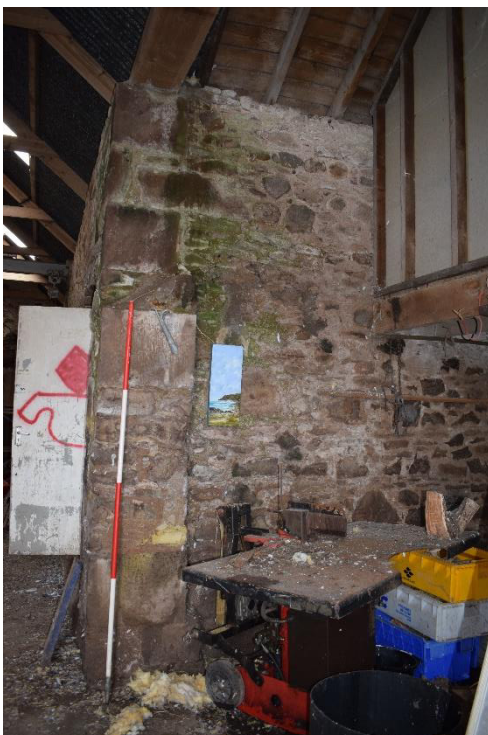
Illus 15 D31 (behind ranging rod) showing location of wall removed between Room 3 (left) and Room 2 (right); facing E
