Mill of Lethnot, Edzell, Brechin, DD2 7UG
Report on Level 2 Standing Building Survey

Alison Cameron
Cameron Archaeology
17 April 2018

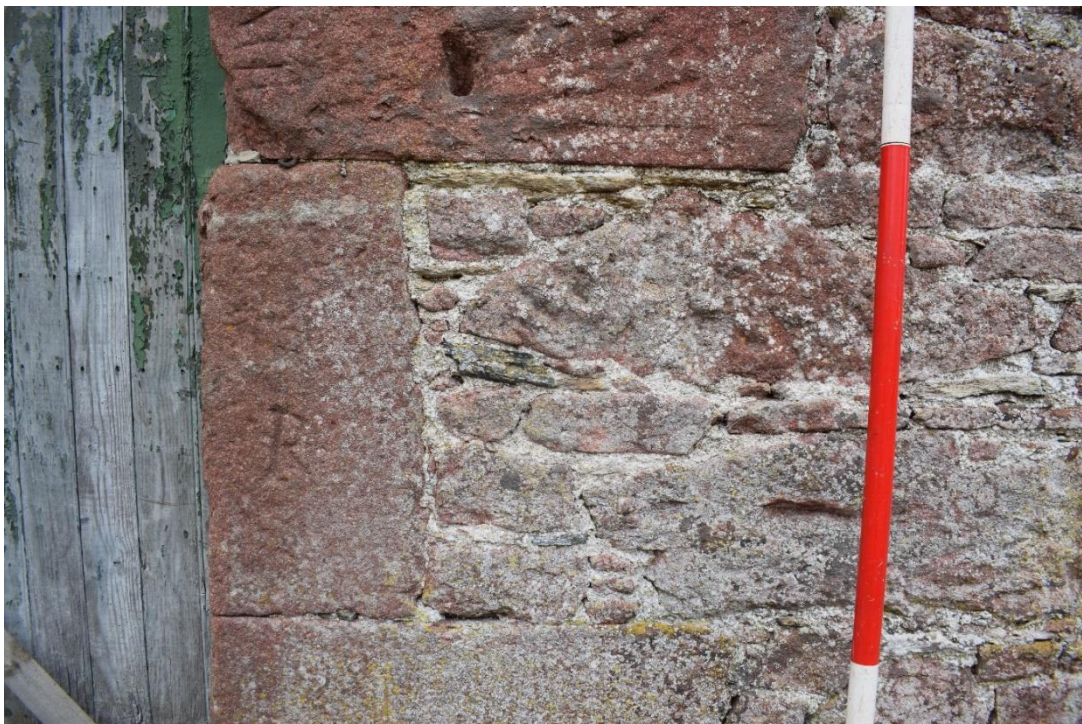
Illus 8 SE jamb door D1 showing tooled red sandstone blocks and inscribed 'R'; facing NE.

The aperture F8 for the waterwheel drive shaft is probably part of the original construction of this building as is door D1 and windows W1-W4 and W5-W8 as they all have red sandstone lintels, jambs and sills. D1 is of tooled red sandstone and one of the jamb stones is incised with an 'R' (Illus 8). There are red sandstone blocks incised with 'IY/17' (F4) and 'IS/72' (F5) (see cover illustrations); these appear integral to the constructions of the building, do not appear to have been inserted later and therefore give an indication to the date of the original construction of the building around 1772.

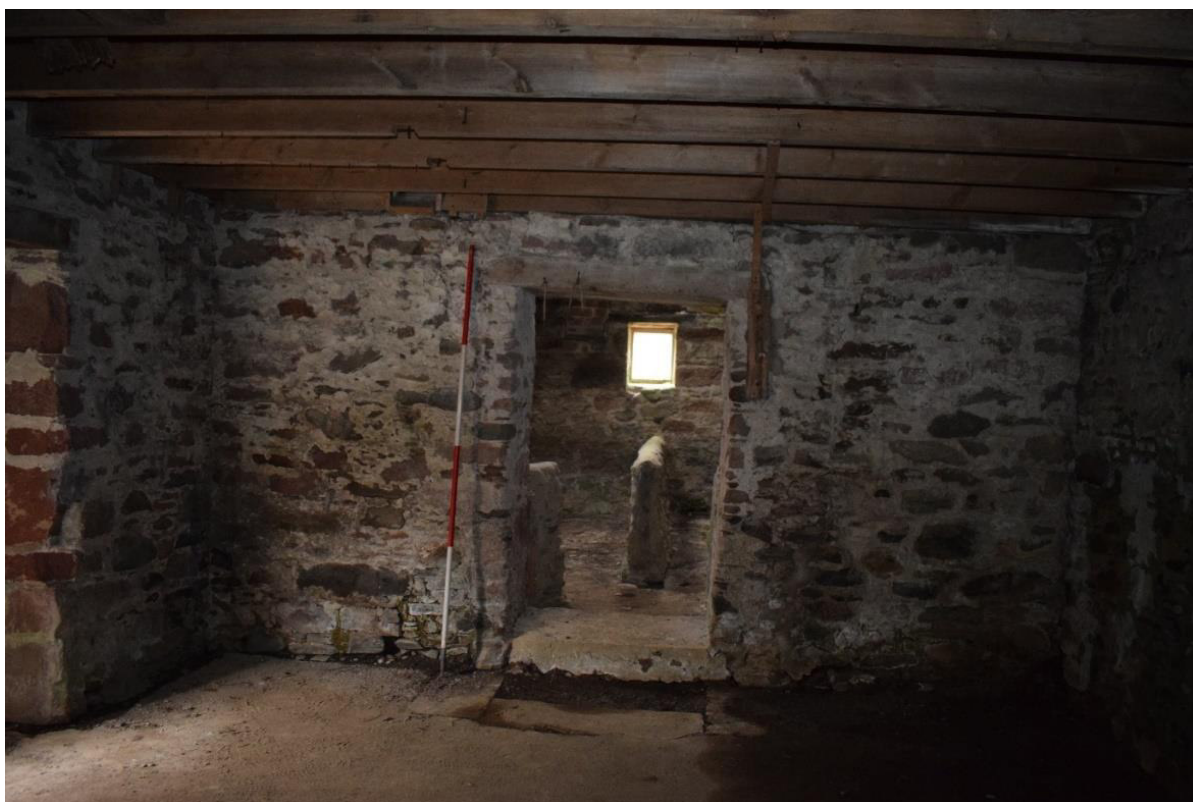
Room 1 is 9 x 4m in size on the ground floor. It is likely that Rooms 1 and 2 were originally one room as the internal dividing wall is not tied in to the main walls (Illus 9). The NE wall of this room is slightly bowed as it has had historical water damage and has been repaired several times (Illus 5).

Illus 9 Room 1 NW wall, probably a Phase 2 division with D2 (centre); facing NW

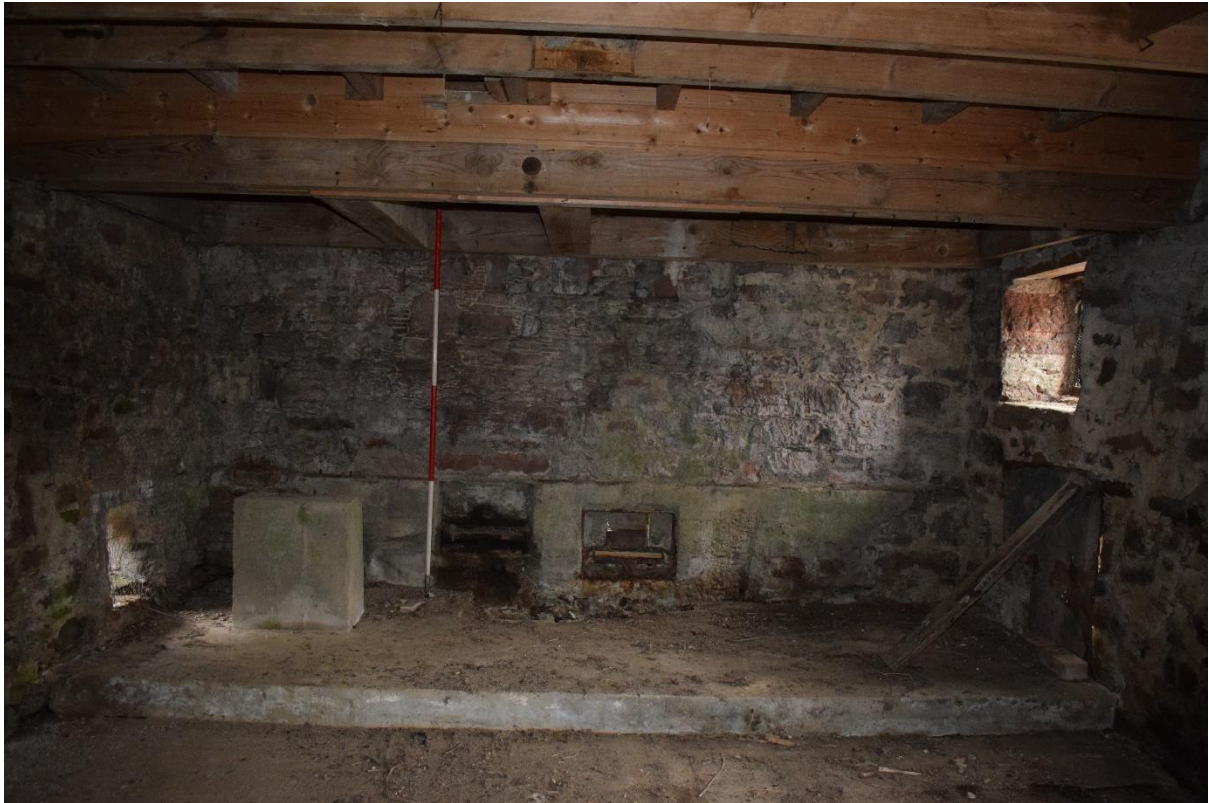
During refurbishment of the mill, probably in the late 19th or early 20th centuries, concrete plinths F17 and F18 were added at the SE end of the room as was hearth or boiler F20 and concrete block F19 which had 2 iron bolts in the upper surface for attaching part of the waterwheel inner mechanism (Illus 10; 11). At this time apertures F1 (Illus 13-14) and F6 were added; they are rectangular apertures lined with iron plate 2cm thick and with an iron bar and bolts, possibly for attaching a support for the internal mechanisms of the milling mechanism. The wooden floor above Room 1 has an extra platform at the SE end (F28; Illus 12) for supporting the upper mechanisms of the mill wheel mechanisms including the hoppers and the mill wheels. A wooden stair (F22, Illus 15) now leads to the first floor. Shallow recesses F23, 24 and 25 (Illus 7) are behind the wooden framing for the floor above and may be associated with the first phase of the millwheel mechanism.

Illus 10 Room 1 SE wall F1 (left), concrete block F19, hearth F20, F21, W6 (right); facing SE

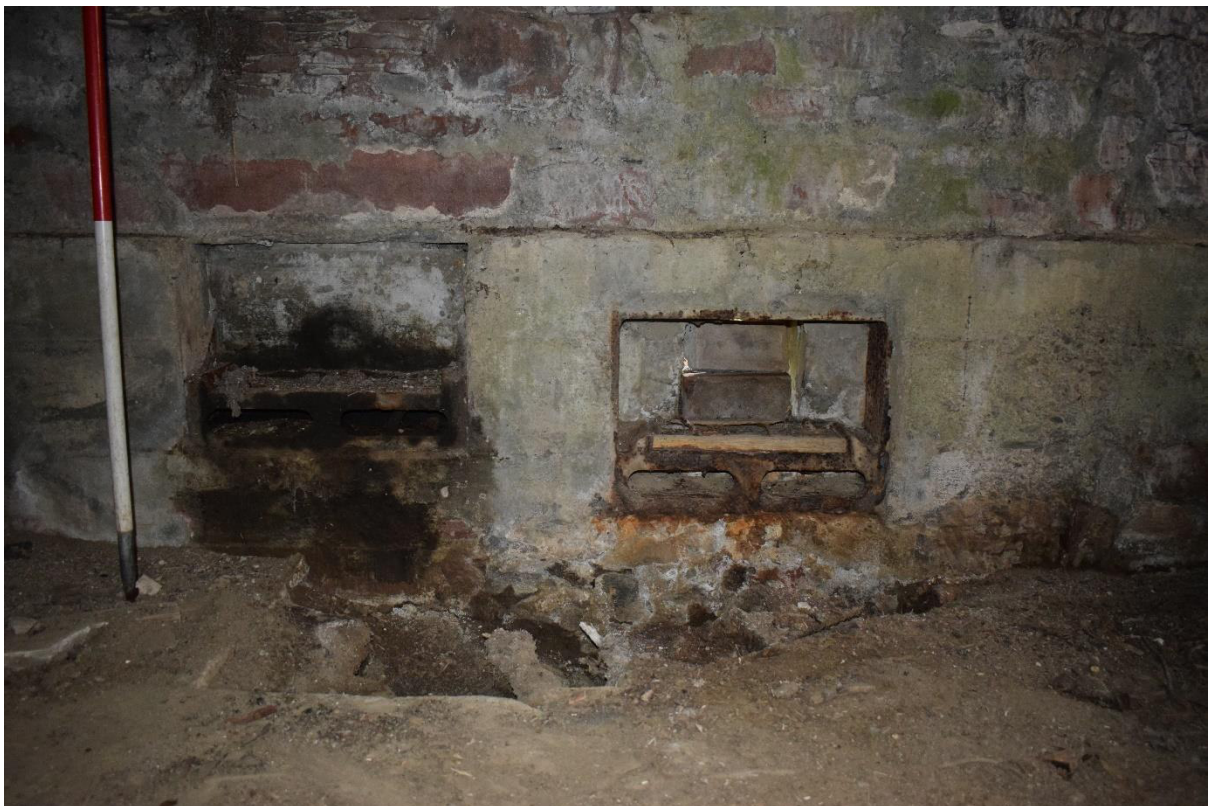
Illus 11 Detail of hearth F20 (left) and F21 (right) set in concrete plinths (F18; centre) and F17 (bottom); facing SE

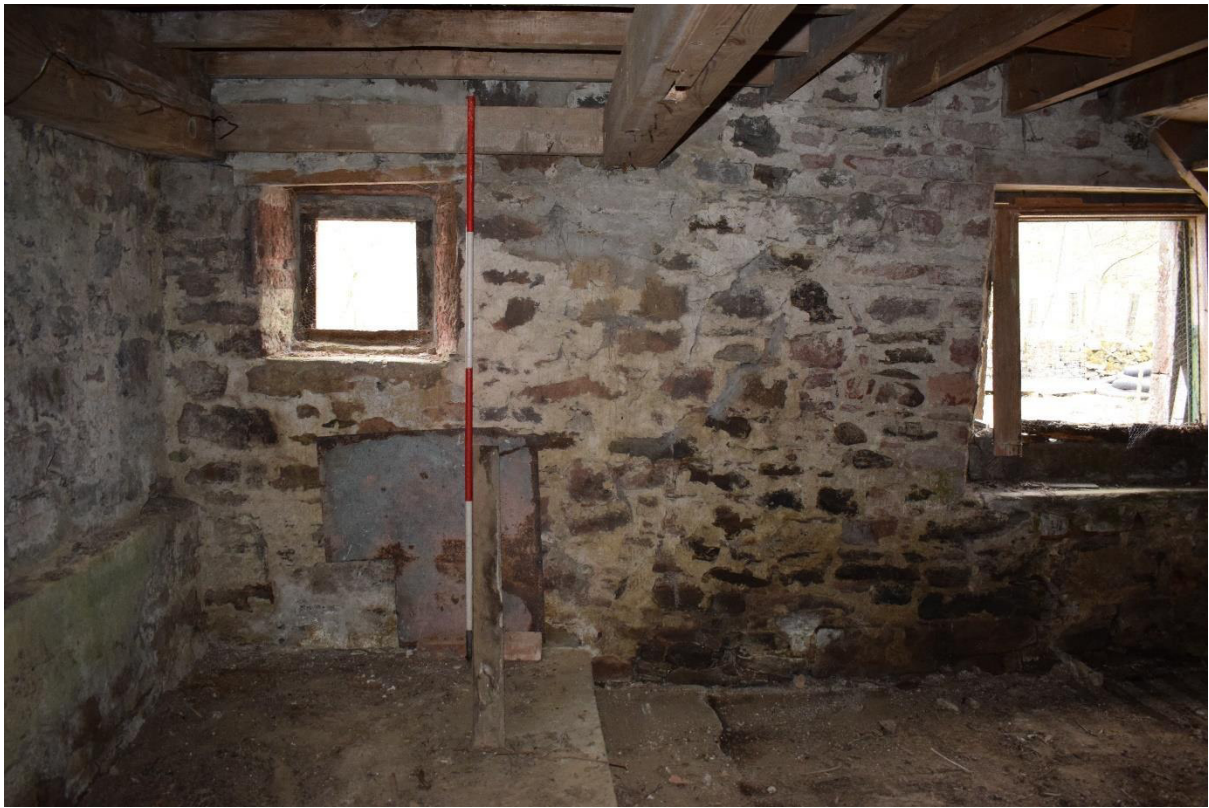
Illus 12 SW wall SE end W6 (left) F6 (behind metal sheet), concrete plinth F17 (bottom) and W5 (right) with wooden platform F28 (above); facing SW

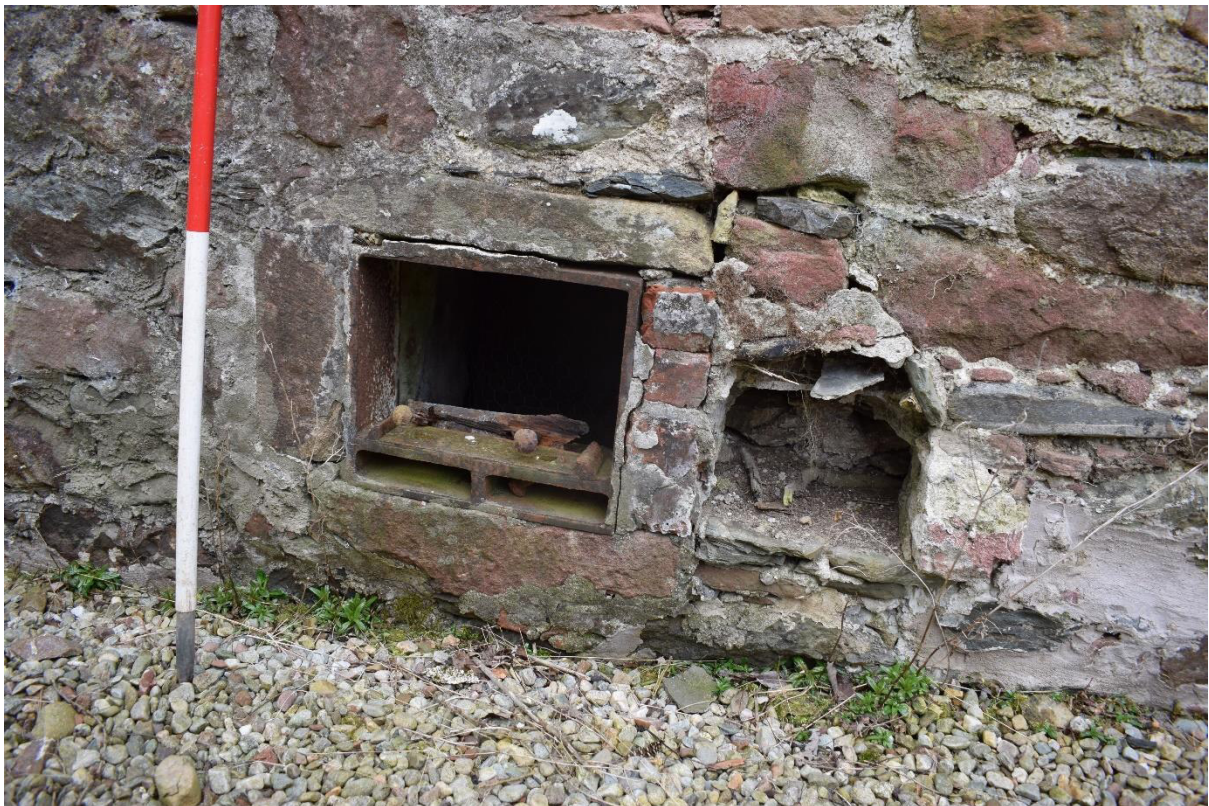
Illus 13 F1 (left) F2 (right); facing SW

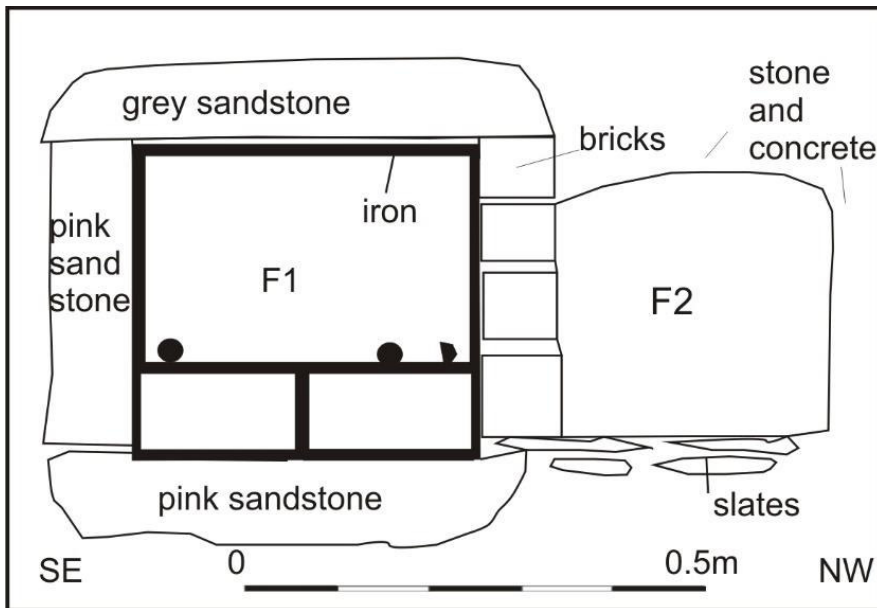
Illus 14 SE-NW exterior elevation F1 and F2

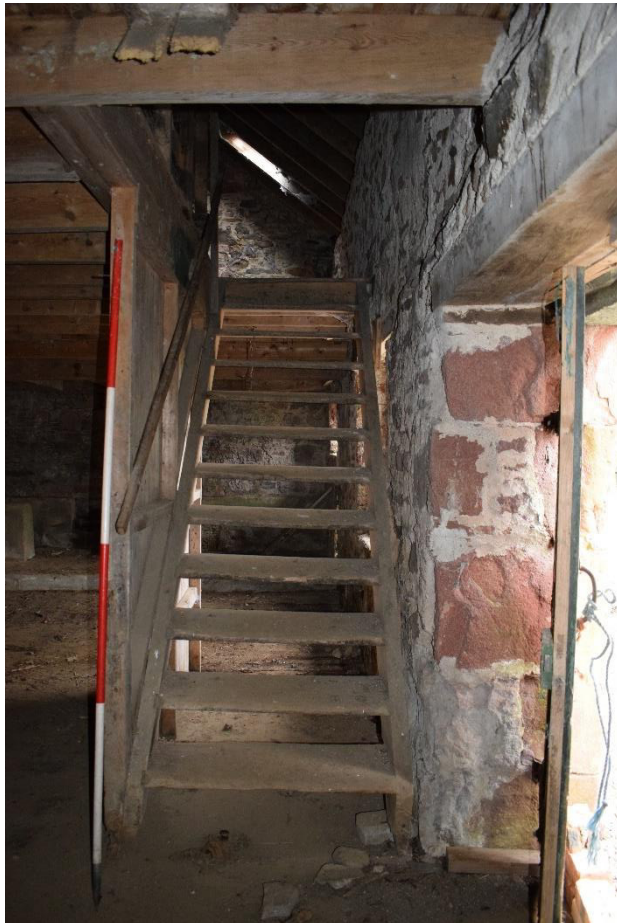
Illus 15 Wooden stairs F22 with D1 (right); facing SE

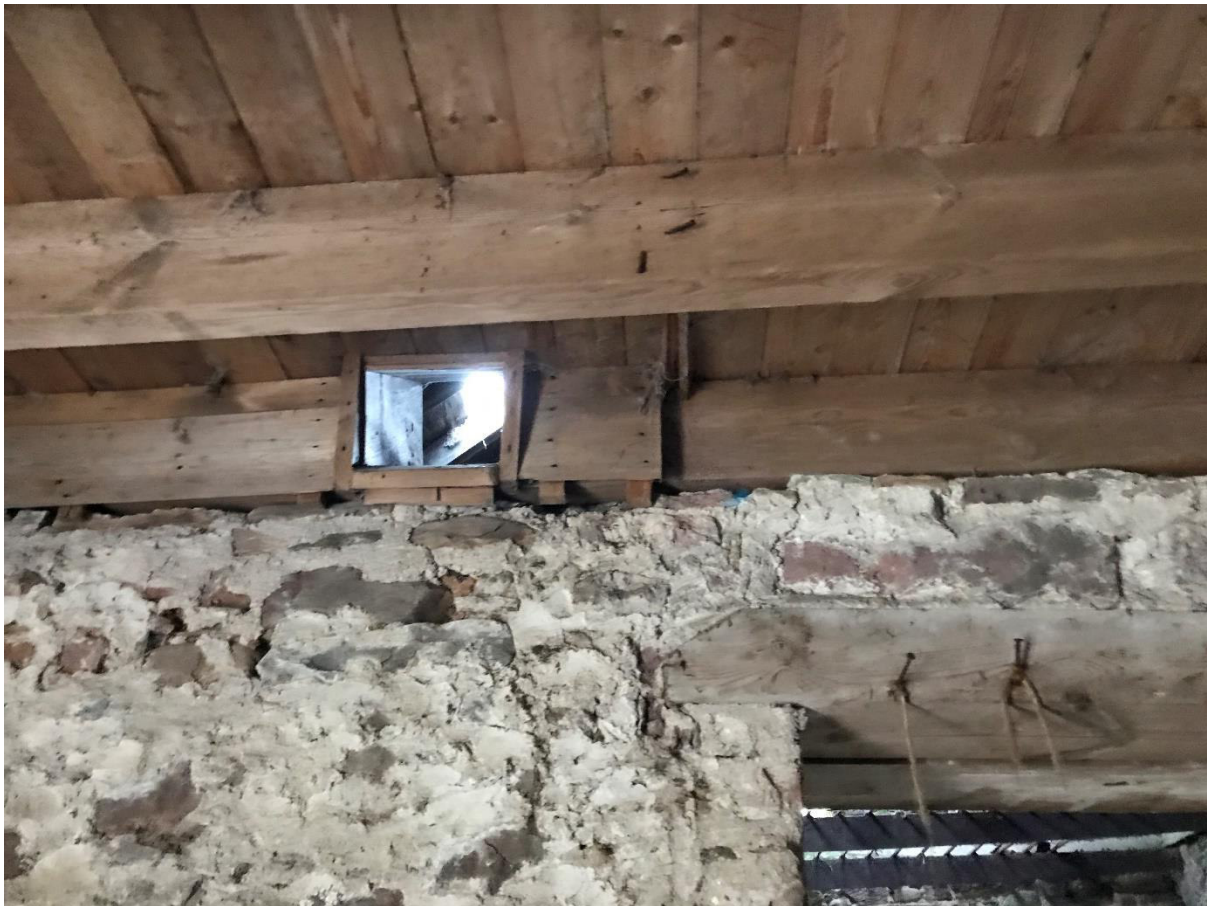
W5 was probably added in Phase 2 as it has grey sandstone pecked mouldings. Apertures F1 and F6 were probably added in Phase 2 and are associated with the later use of the mill. Wooden chute F11 (Illus 16) allowed the dried grain to be transferred from the kiln (see Room 2 below) to the hopper and into the grinding mechanism.

Illus 16 Wooden chute F27 NW wall Room 1 above D2.

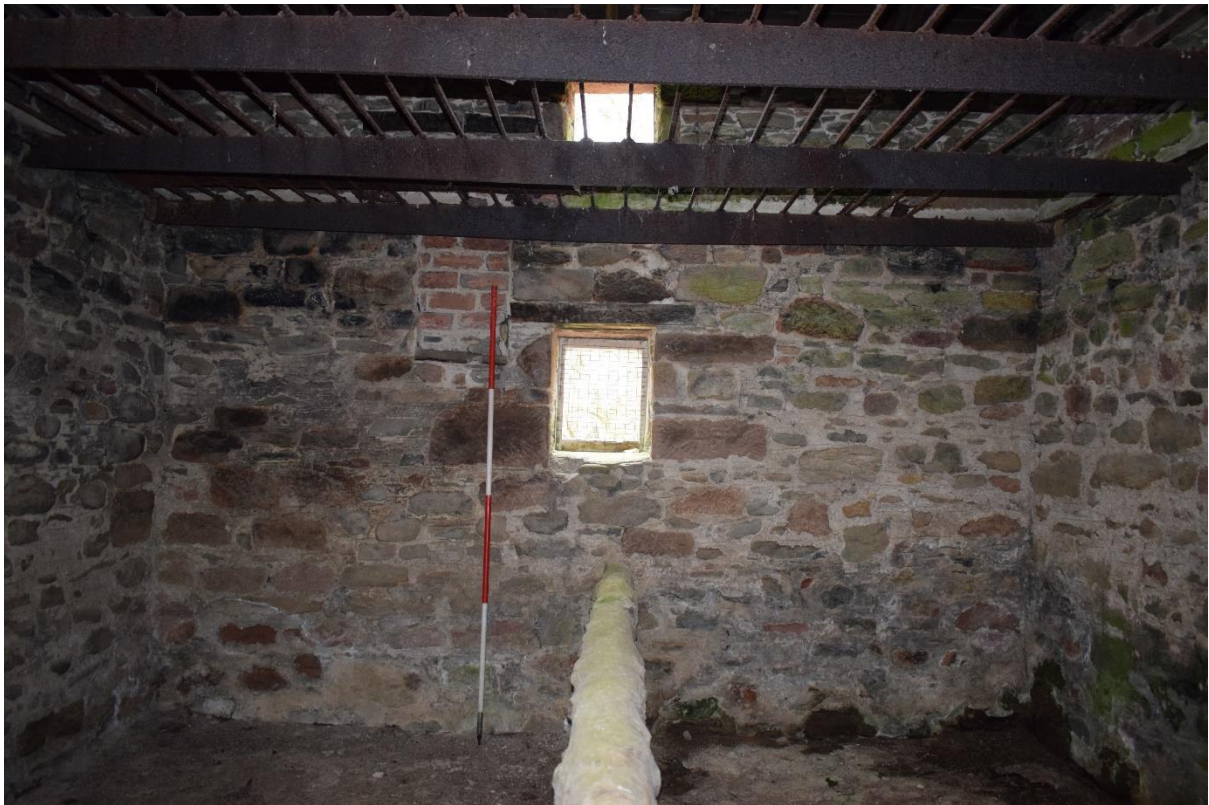
Illus 17 Room 2 NW wall showing burnt stonework and iron frame and mesh with W8 (centre) and brick-blocked aperture F10 (left) probably grain chute and Phase 3 wall F12 (bottom); facing NW.

Room 4 is 4 x 4m in size on the first floor and is presumably the kiln area of the original mill. There is no access to this room but it has a metal frame F26 (Illus 17, 18) with iron mesh on top, for grain drying. It has a door D3 on the SE wall, W1 on the NE wall and window W7 in the NW wall. There is blackening on the interior of the NW wall of the building and the iron frame and mesh are heat-blackened.

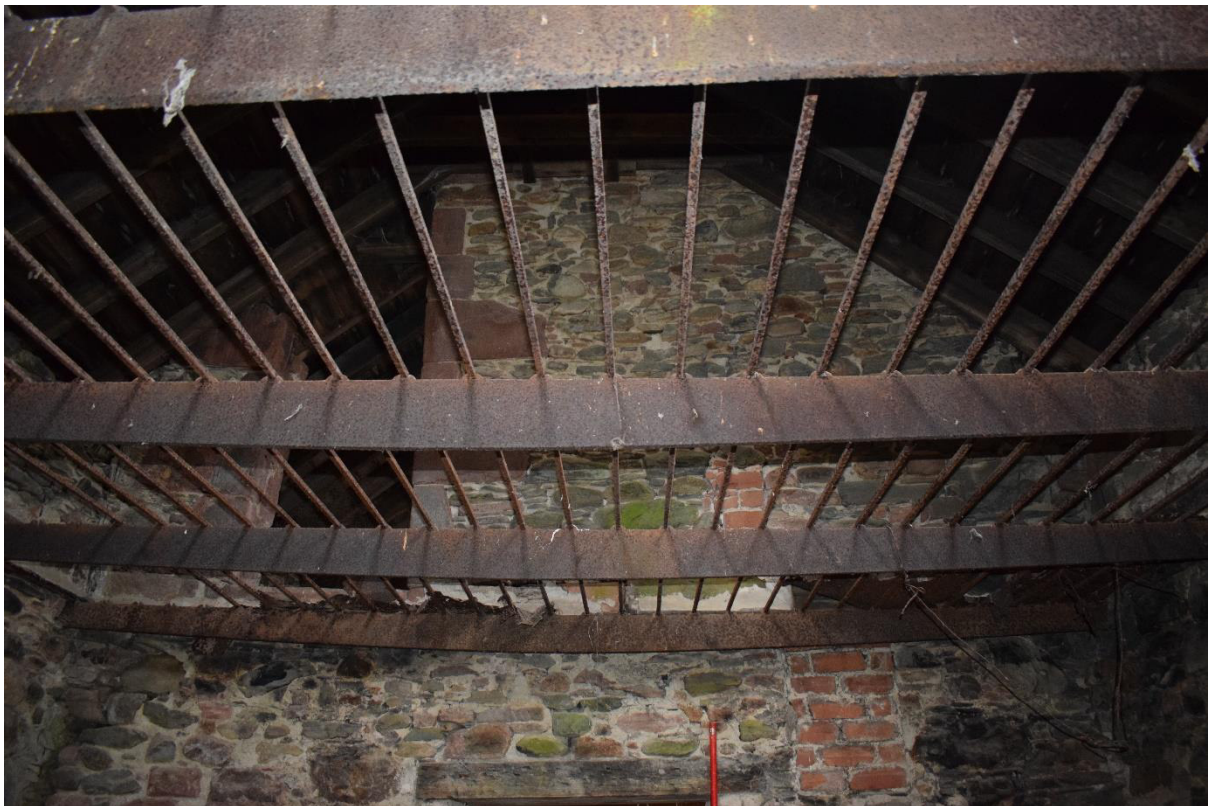
Illus 18 Room 2 iron frame and mesh F26 for drying grain with D3 (left) and blocked aperture F11 (right) grain chute leading to wooden chute in Room 1; facing SE

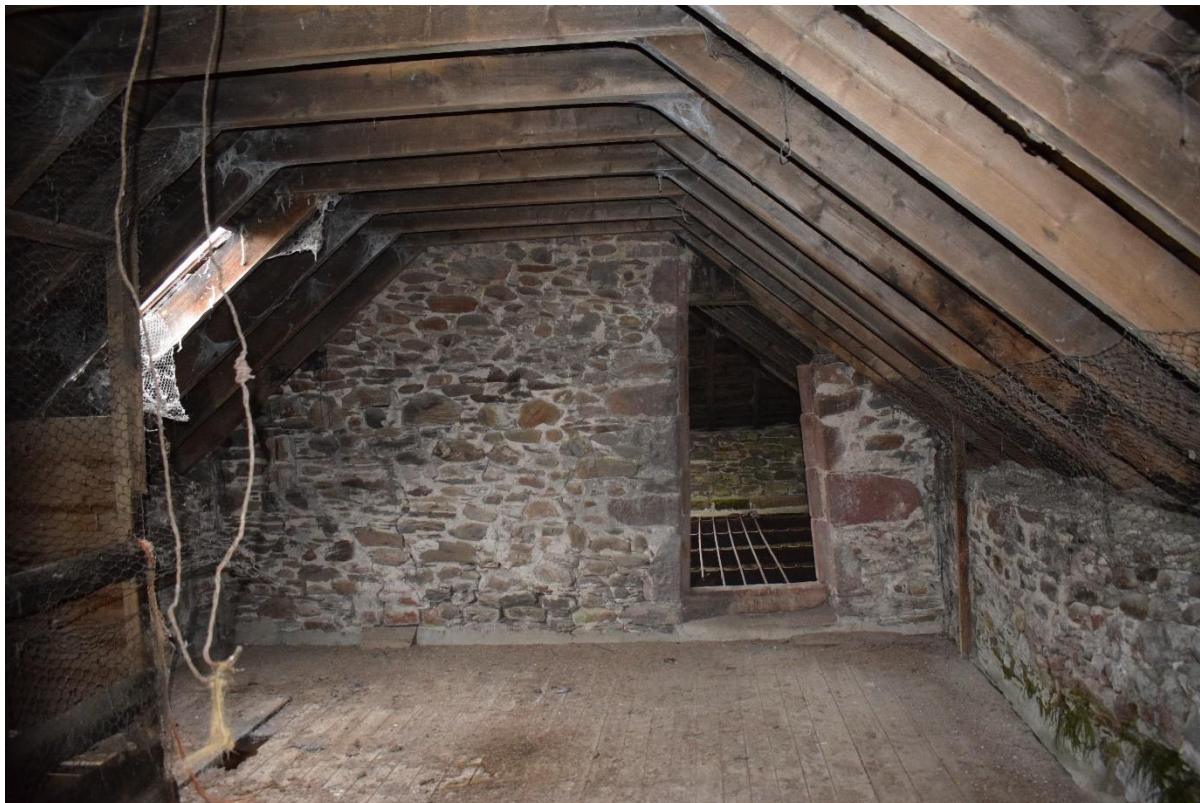
Room 3 is 9 x 4m in size on the first floor. It was not fully accessible because of the poor condition of the floor but had a door D3 to Room 4 in the NW wall. This room would have housed the hoppers, millwheels and associated mechanisms.

Illus 19 Room 3 NW wall with D

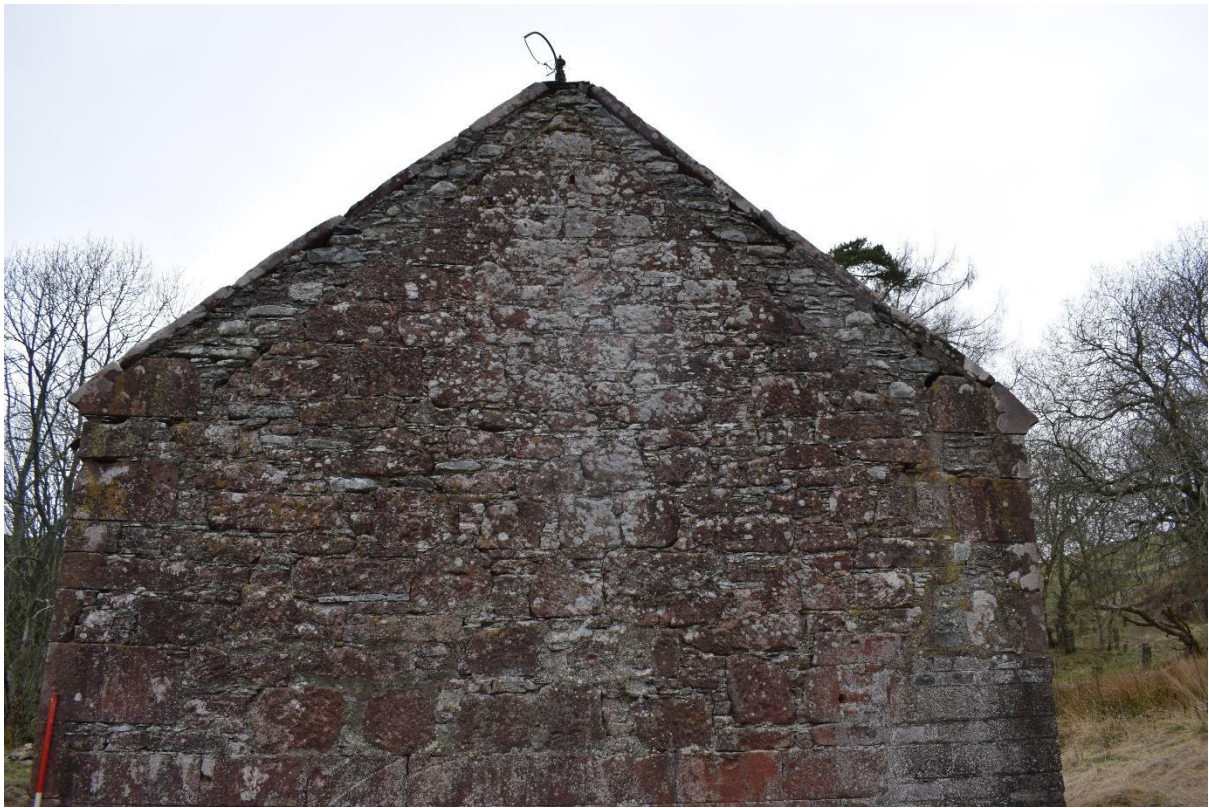
A small roofed building had been attached to the SE end of the building (see 2nd and 3rd edition OS maps; Illus 29-30) and there is a scar under the roofline, probably where this building had been sited (Illus 20).

Illus 20 SE gable upper section showing grey sandstone scar under roofline where structure was attached for mill wheel; facing NW

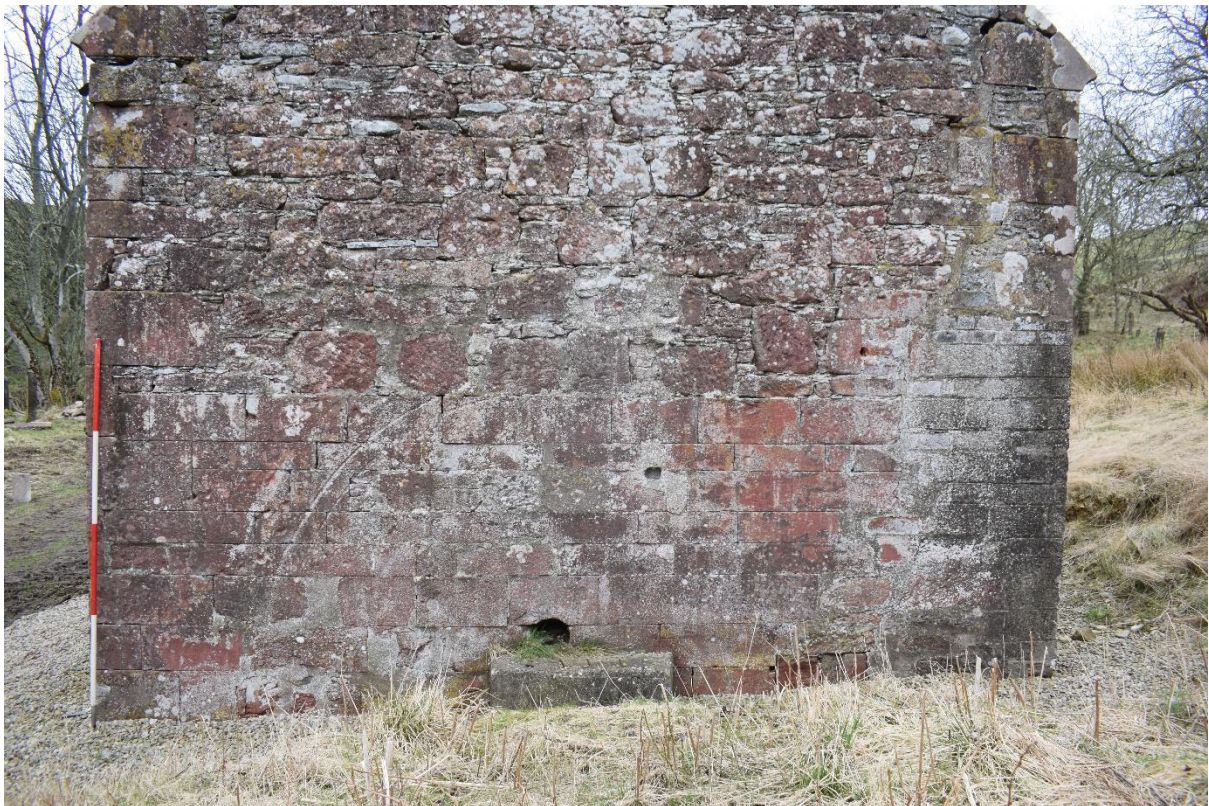
The wheel pit and lade have been infilled but there is a concrete block (F9) 1m long and 0.42m high and 0.3m deep with iron fittings on the upper surface. This may be the outer headstock (Illus 21-23), usually located on the exterior of the millwheel. There are scars on the ashlar lower section of the SE gable (F7; see cover illustration) where the millwheel created grooves in the stone suggesting a diameter of about 2.5m for the millwheel.

Illus 21 SE gable lower section showing concrete outer headstock (F9) and circular axletree aperture (F8; centre) and three incised circular scars (F7; left) on red sandstone ashlar where mill wheel has scored the ashlar; facing NW

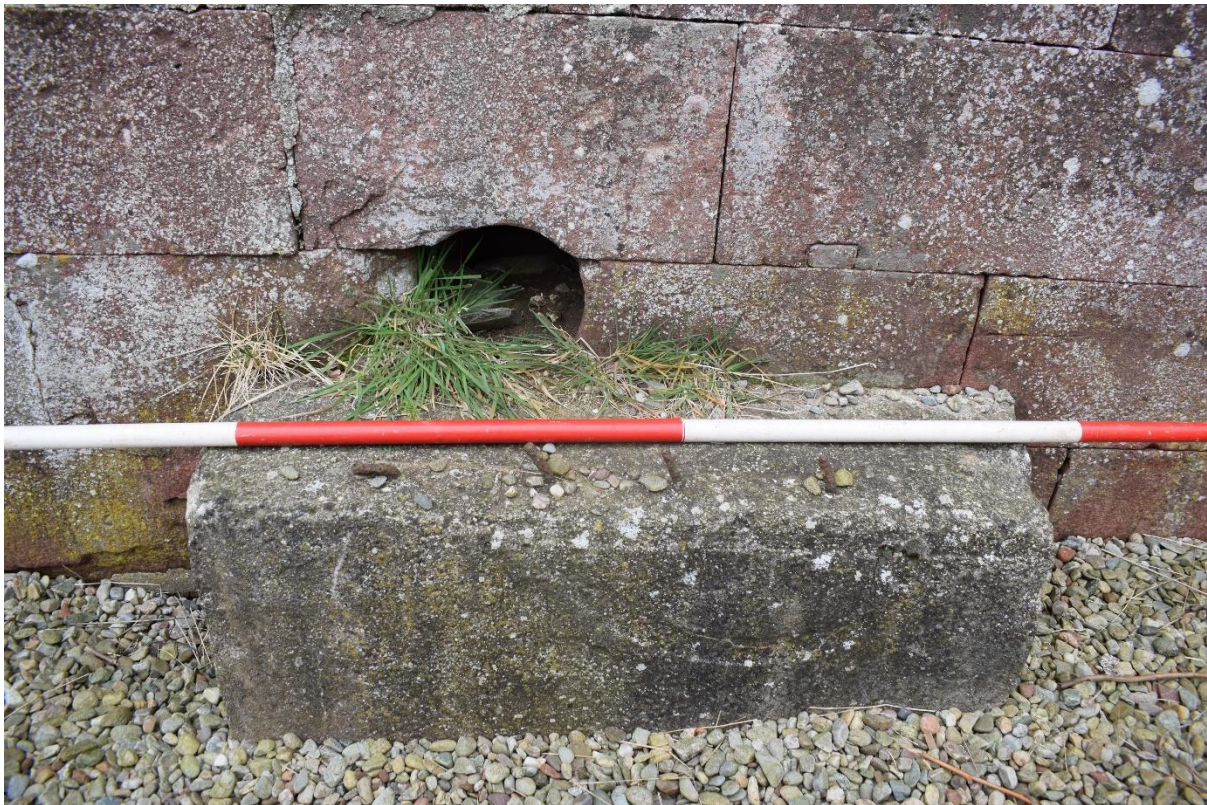
Illus 22 Concrete block possibly the outer headstock (F9) and circular axletree aperture (F8; above).
