**Inverharroch, Lower Cabrach, Huntly,  
Moray, AB54 4EU  
Level 1 Standing Building Survey  
Moray Council 17/01020/APP**

**Alison Cameron  
Cameron Archaeology Ltd  
1 October 2018**

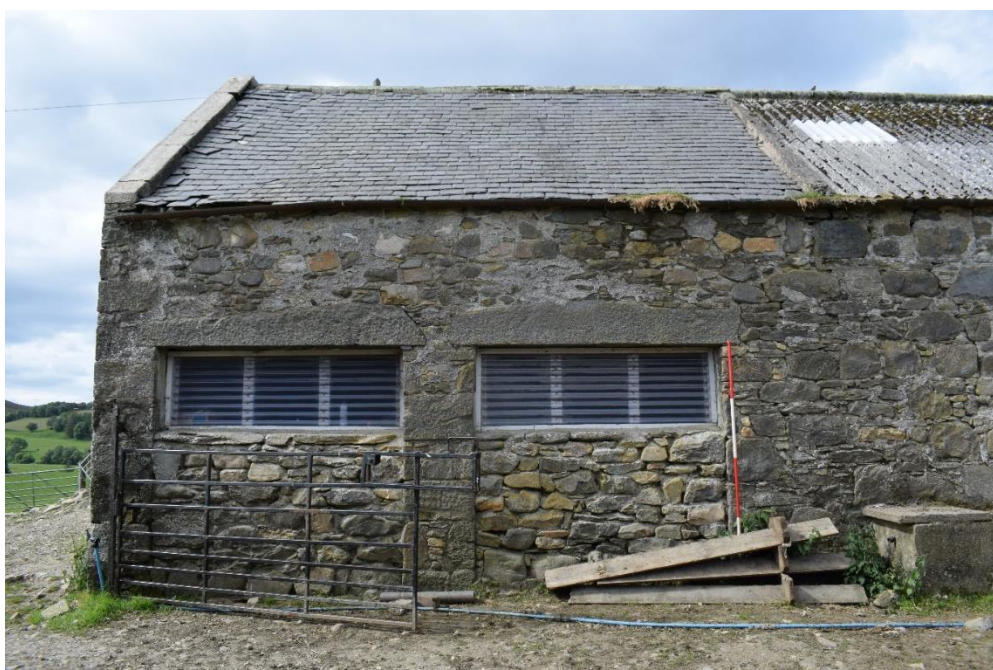
Illus 10 Room 1 N wall D22 and D23 both converted windows; facing SSW

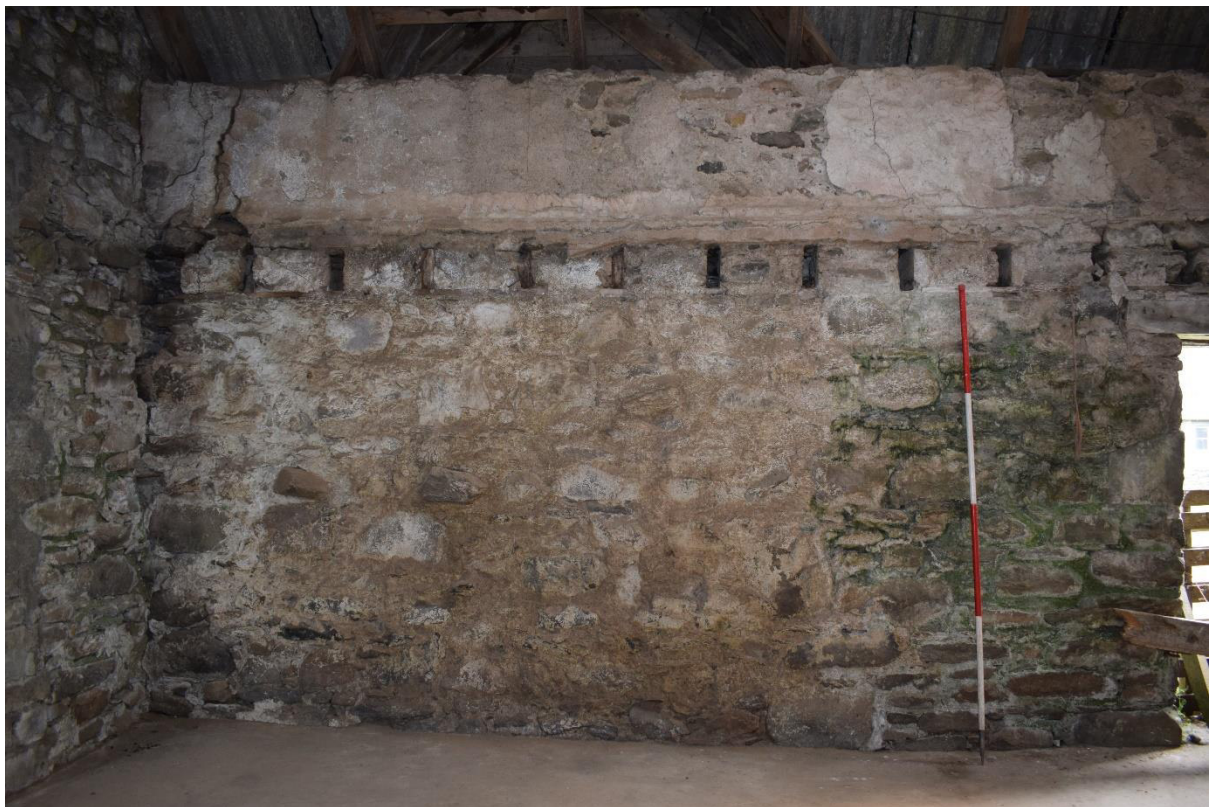
Illus 12 Room 1 N wall W end showing joist holes F7 and D24 (right); facing NNE

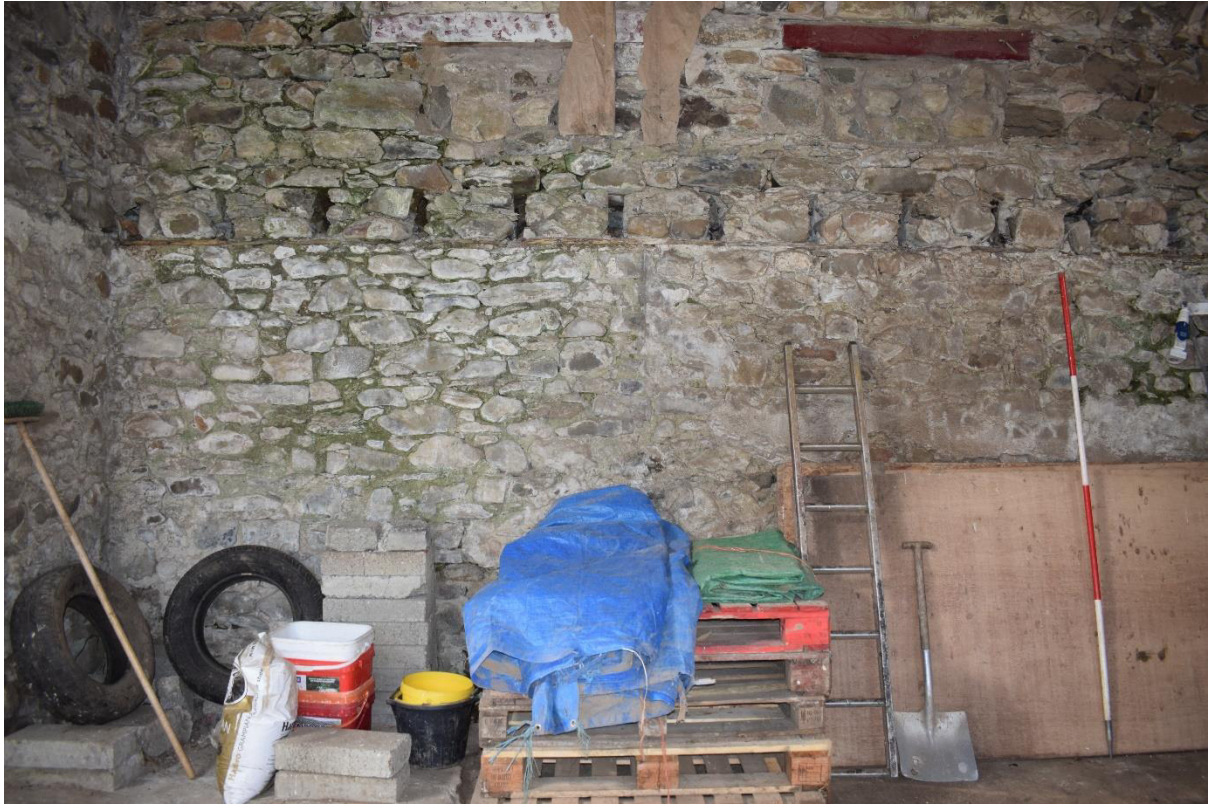
Illus 13 Room 1 S wall E end blocked windows W8 and W9 (top) with joist holes F9; facing SSW

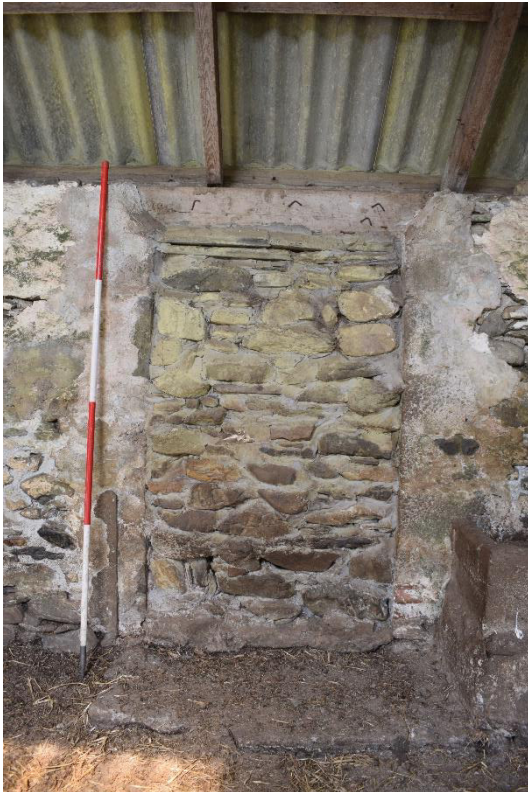
Illus 15 Room 2 Door D2 on the W wall of Room 2, blocked with stone; facing WNW

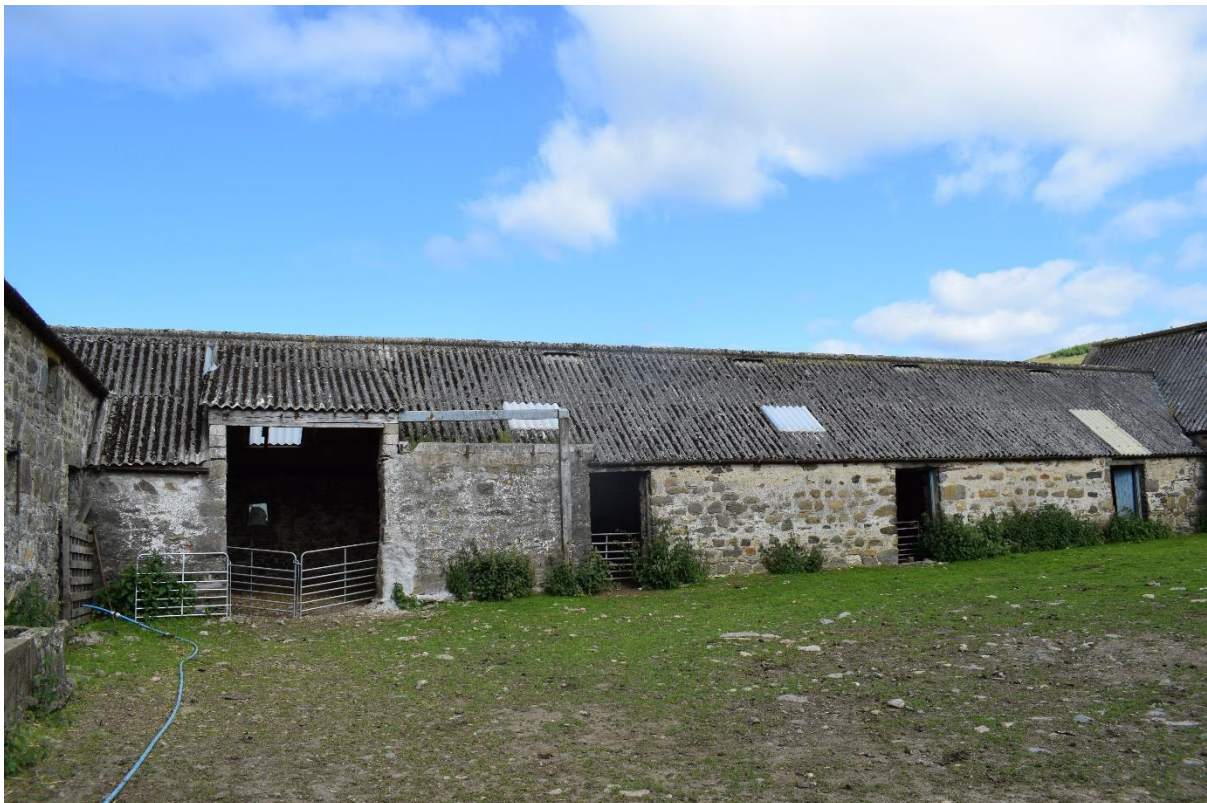
Illus 16 Room 2 E wall D10, D11, D12, D13; the right hand section of this building may be the earliest structure on the site; facing WNW

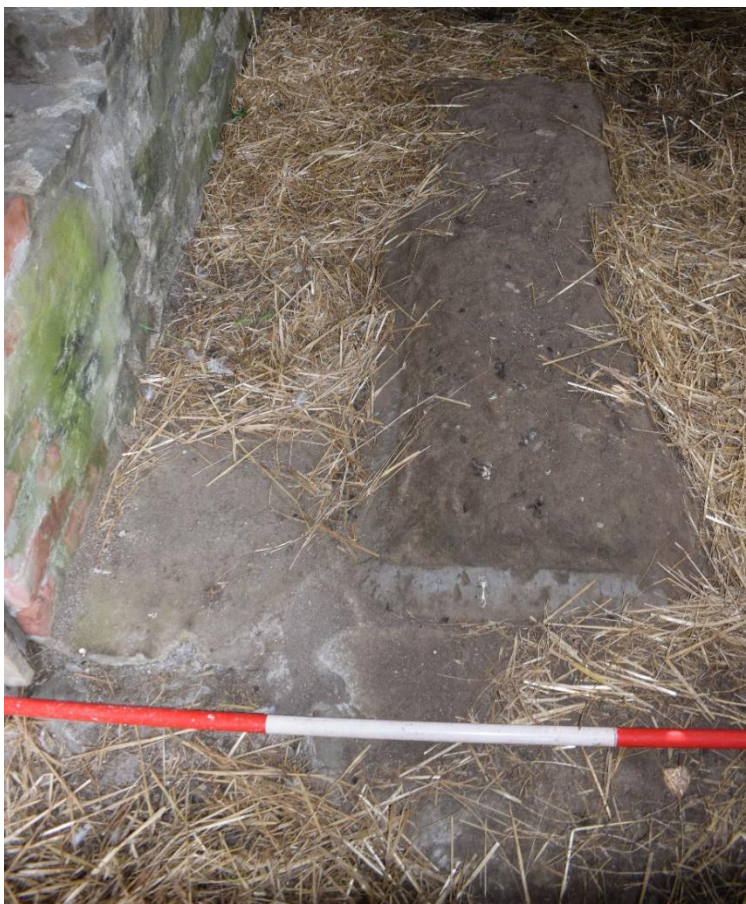
Illus 25 Room 6 concrete base F11, presumably the base for an engine for the mill after removal of horse-mill; facing E

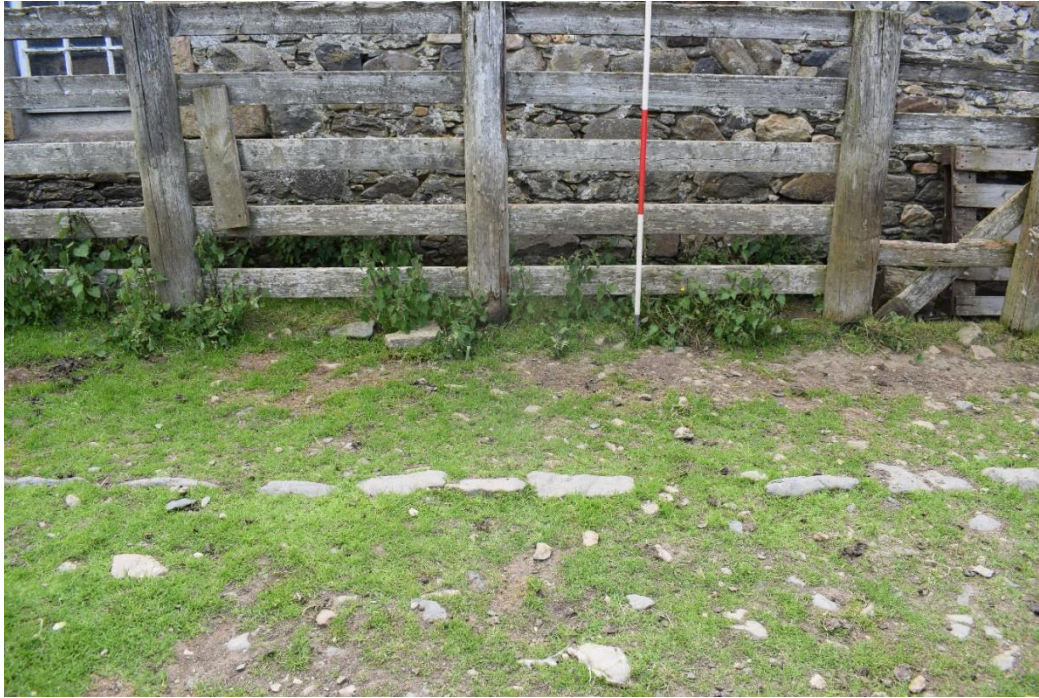
F2 is the remains of a stone cobbled surface in the courtyard (Illus 26); this is the remains of a cobbled path around the edge of the courtyard; in the centre was a sunken midden (Derek McBain; tenant farmer, pers comm). There are concrete troughs built in the 1960s, F3 on the S side of the courtyard (Illus 27) and F12 on the W wall of Room 2.

Illus 26 Stone cobbled surface F2 with W23 (top left); facing ESE

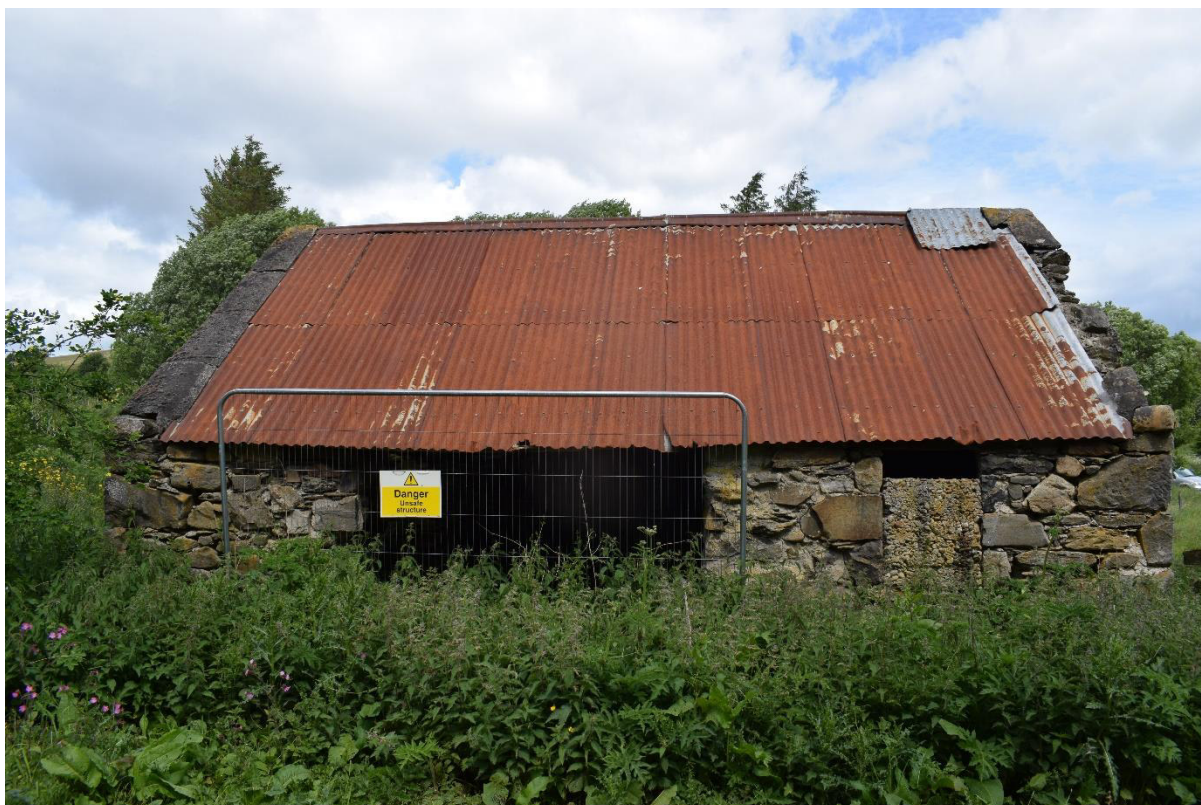
There is virtually no access to this building as it is overgrown with nettles and the W gable is collapsing. It has been recorded photographically (Illus 29-30).

Illus 29 Possible smithy, S wall (inaccessible)

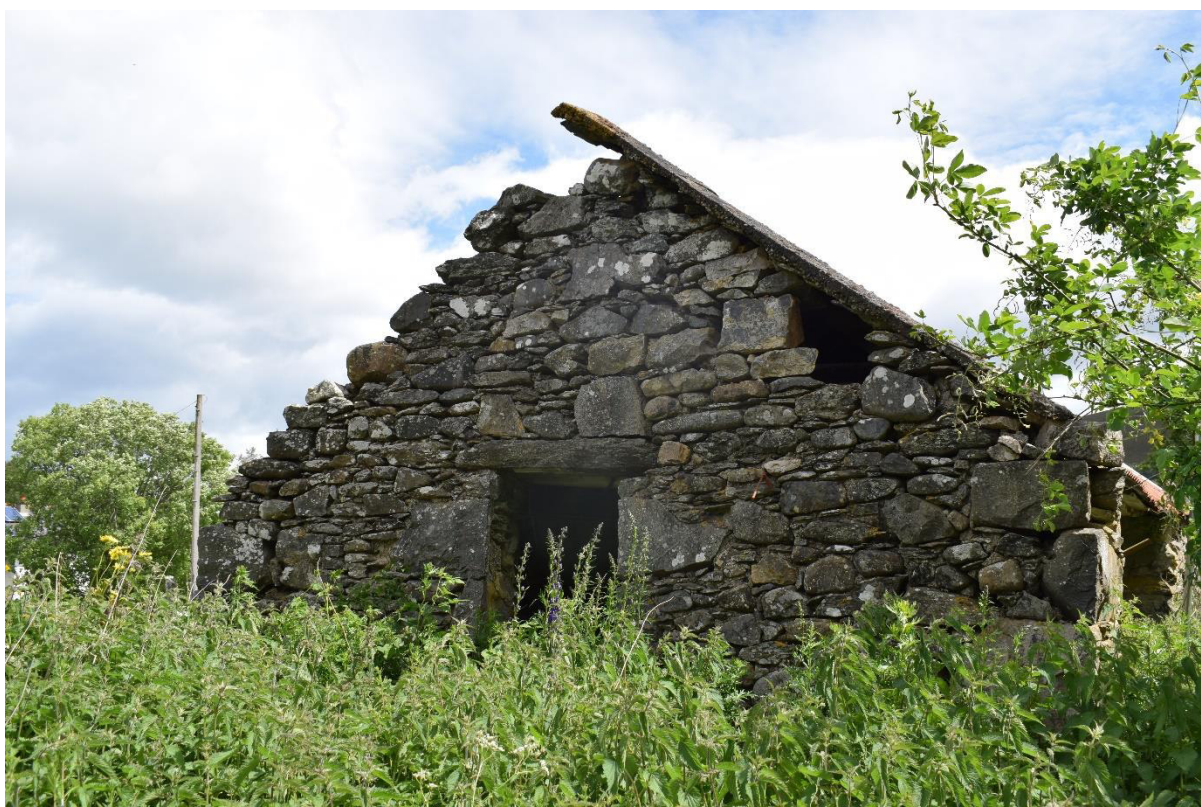
Illus 30 Possible smithy W wall (inaccessible)
