Crathes Castle, Banchory, Aberdeenshire, AB31 5QJ

A report on an Archaeological Watching Brief

Cable trenching for the Adventure Play-area extension

**Report prepared by:
Robert Lenfert, PhD, ACIfA
Cameron Archaeology
26-08-2018**

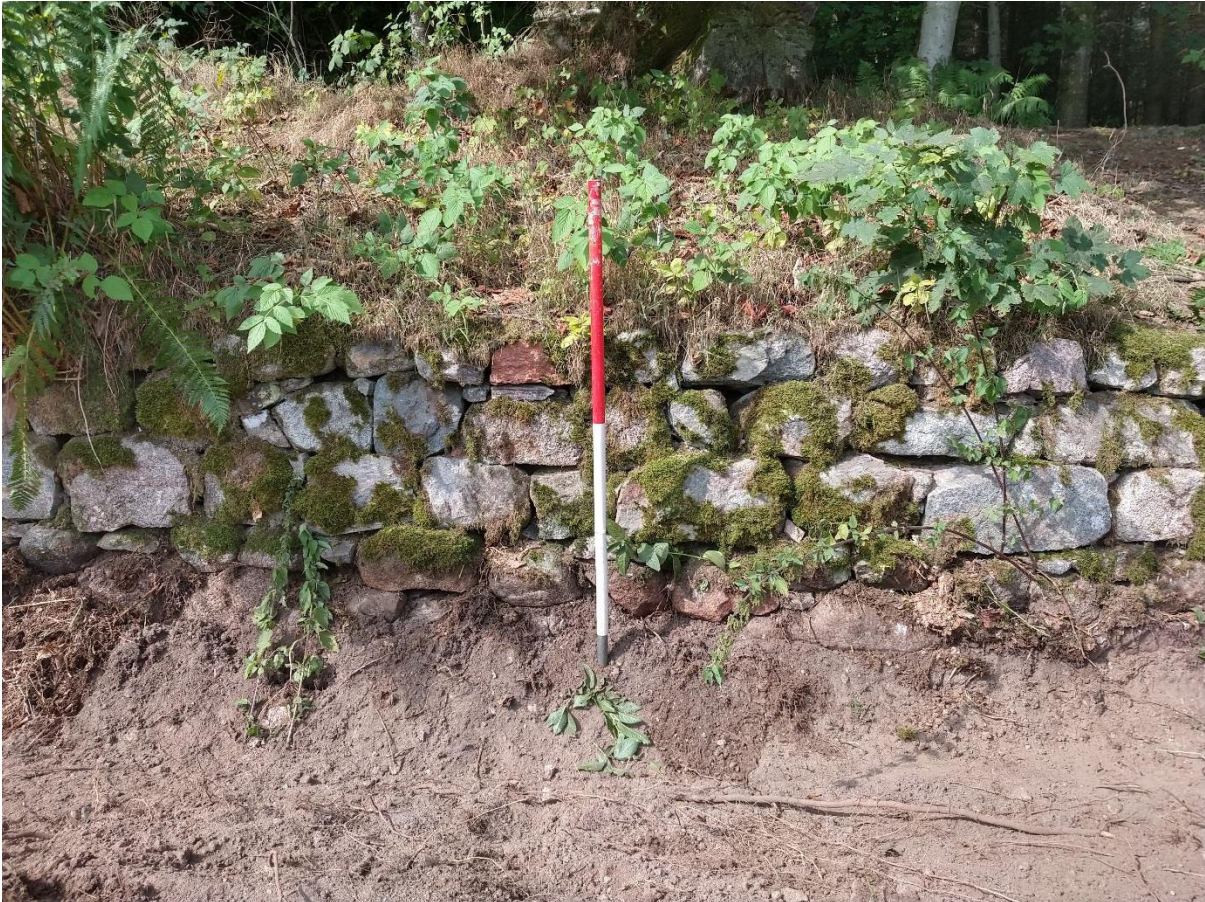
Cover: Section view of intact area of 'Ha-ha' walling after ditch cleaning

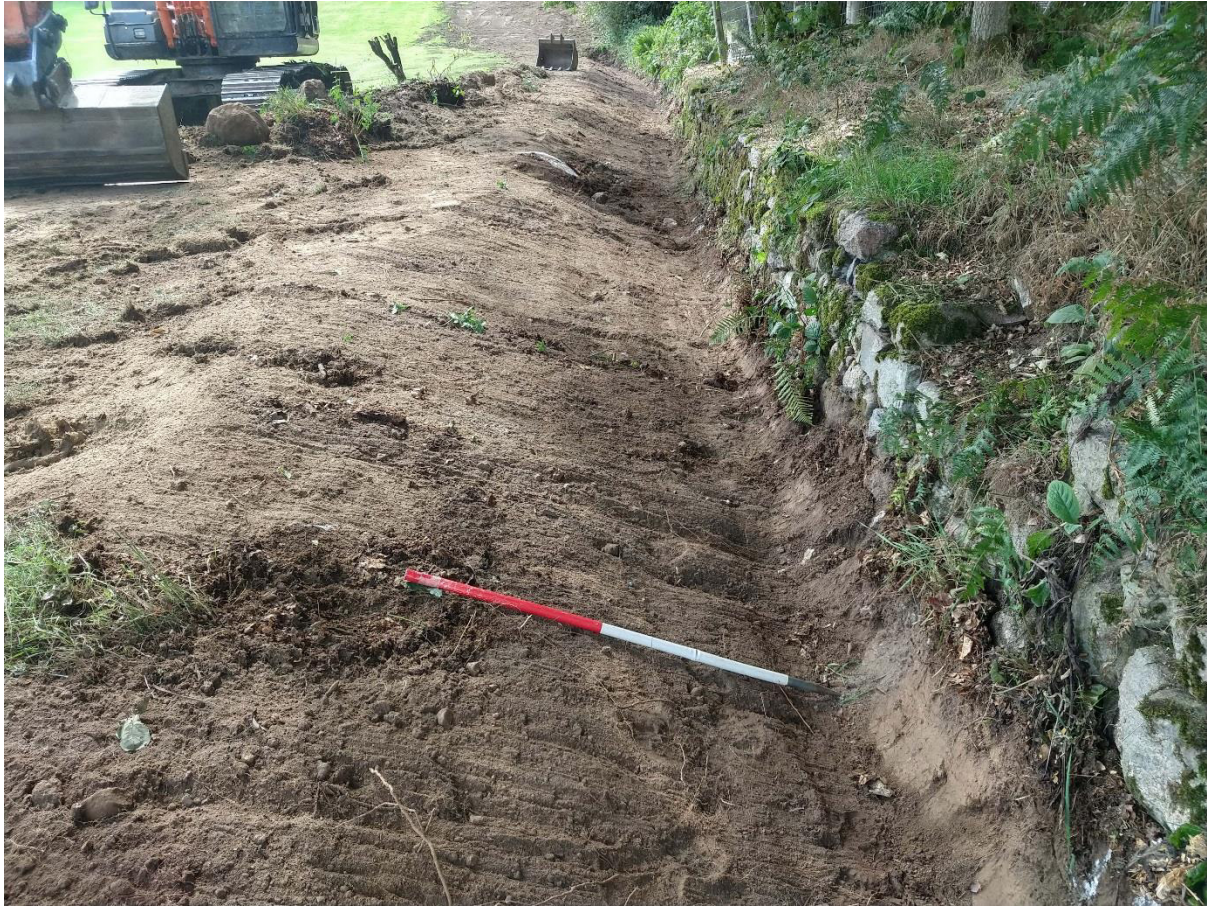
Illus 3 Section of ditch adjacent to ha-ha wall after clearing. Note varying levels of wall preservation in this particular section.

No new archaeological finds or features were noted. However, once the ha-ha ditch was cleared, close examination indicates the existing section of walling predating 1865 remains in surprisingly good overall condition, despite the intrusive effects of root action from nearby vegetation at the top of the wall, minus several small c.2-3m long sections which now stand to only two or three courses of stone.

Regarding a date for this construction, Ha-ha walling appears to have originated in France in the late-17th century and was likely employed in Scotland by the early- to mid-18th century. The first edition OS map (Illus 2) indicated the ha-ha may have originally extended much further SSE connecting with the NE garden area from the modern terminus at the west end. While this section may be partially obscured or most likely removed, intact sections might optimistically exist under the current landscaping. Beyond this, the existing visible ha-ha could be considered a candidate for future restoration work to prevent ongoing damage by intrusive root action and erosion along the upper areas adjacent to the forested area.
