**Bogendollo House, Fettercairn,
Laurencekirk, AB30 1DL
Report on Level 1 Standing Building Survey**

Aberdeenshire Council planning application APP 2014/0183

**Alison Cameron
Cameron Archaeology
8 January 2019**

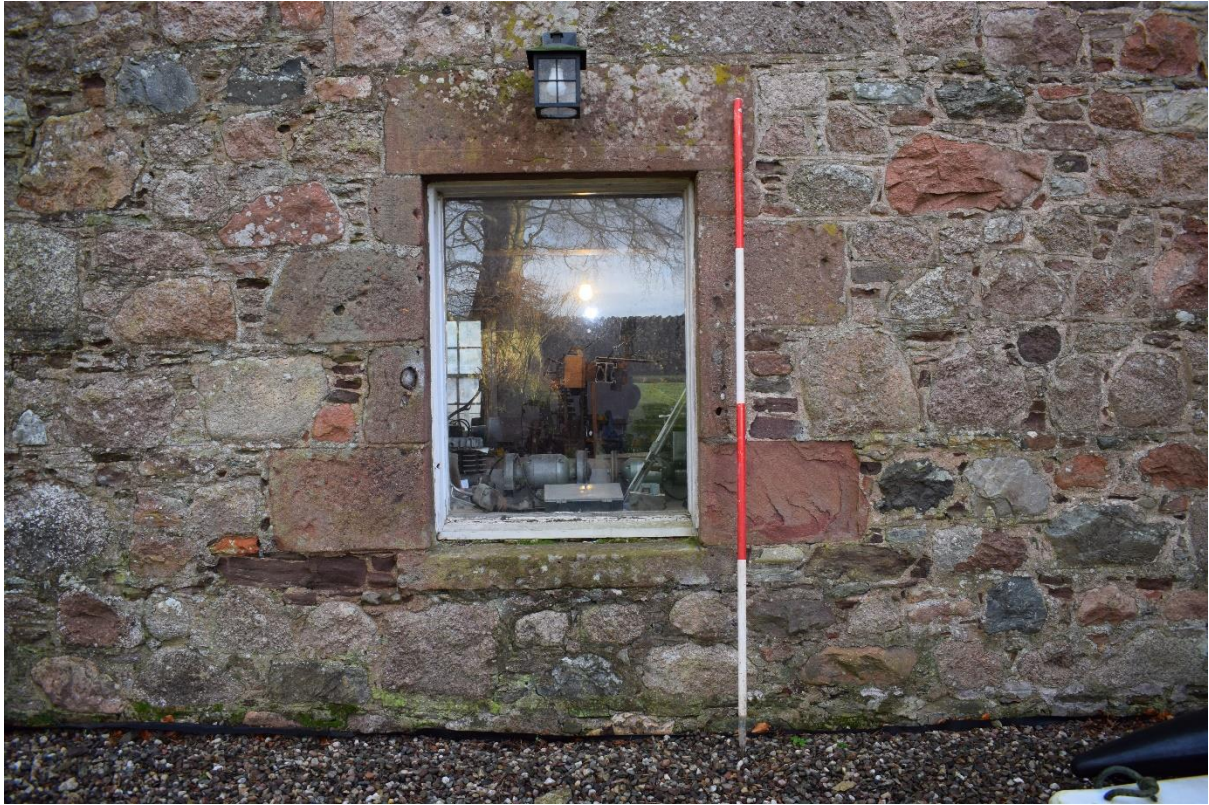
Illus 4 Building 1 W façade Window W1; this will be converted to a door; facing E

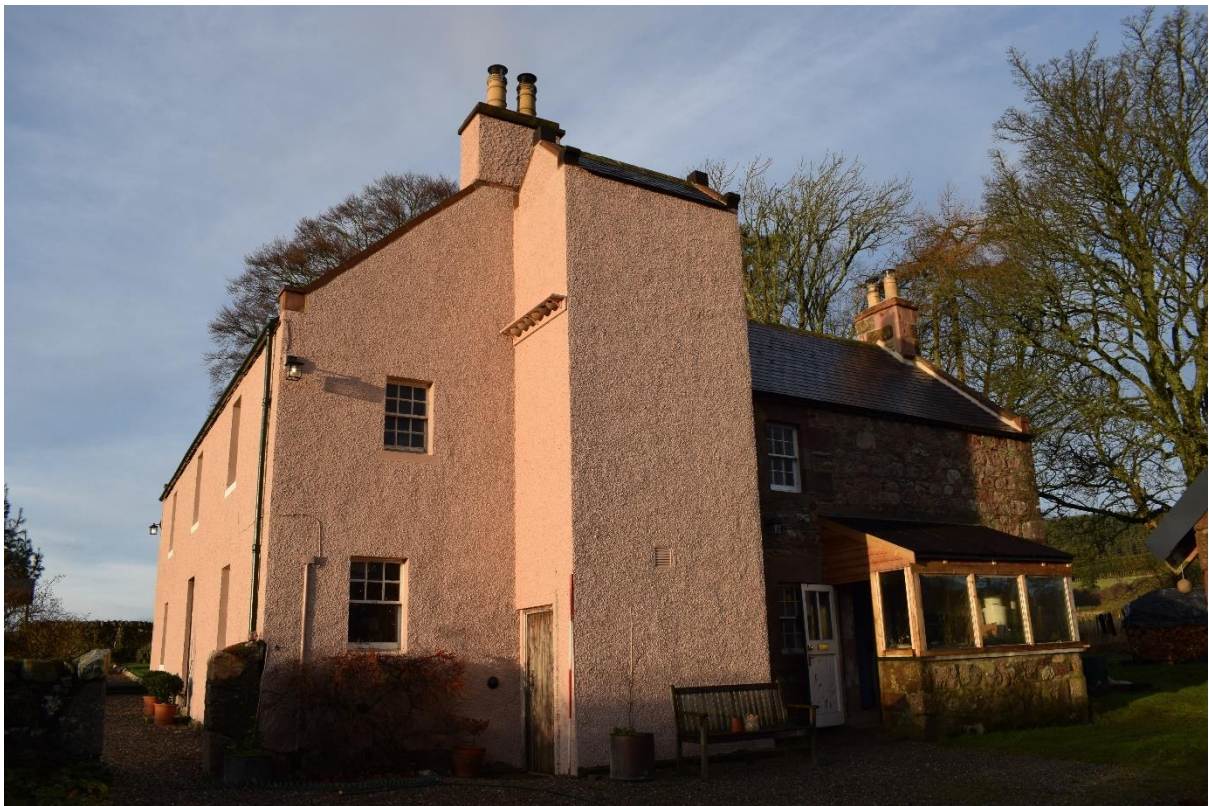
Illus 5 Building 1 E façade; there are internal alterations within the water tower (centre); facing W

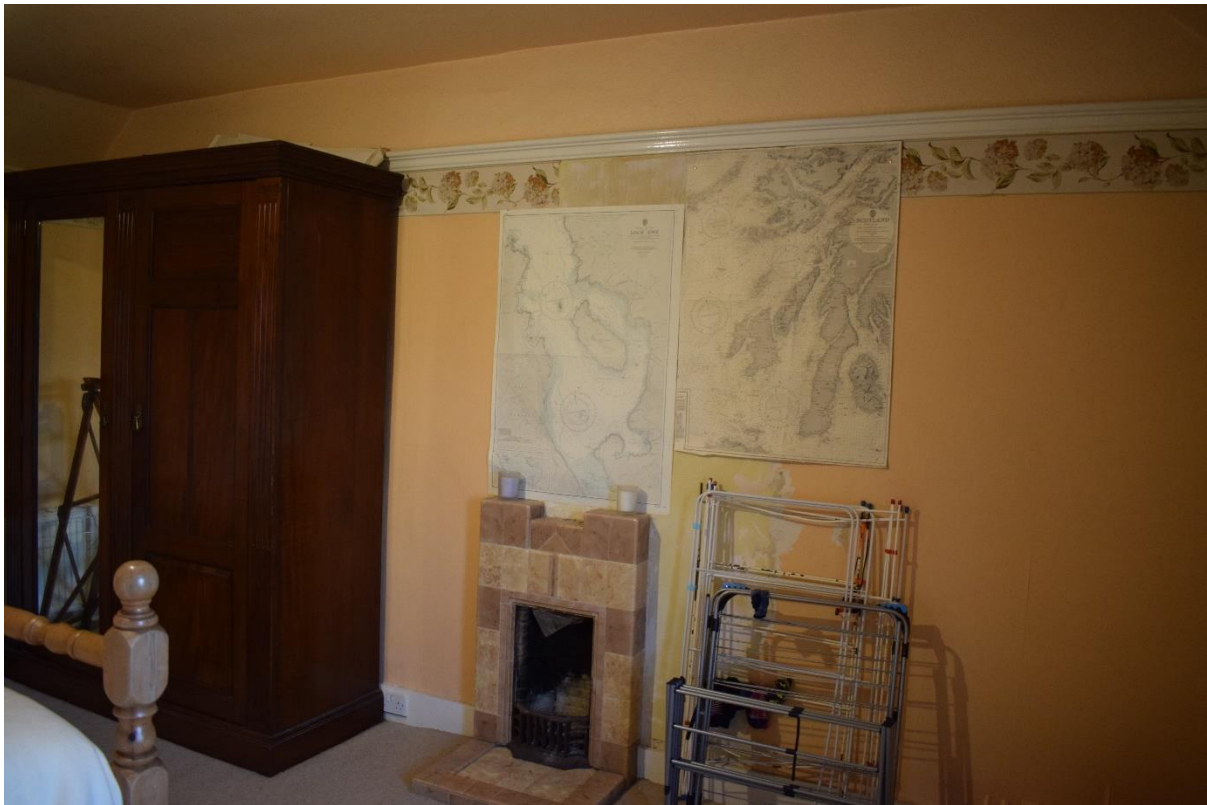
Illus 6 Building 1 Room 1; a door will be inserted behind the wardrobe to access Room 2; facing NE

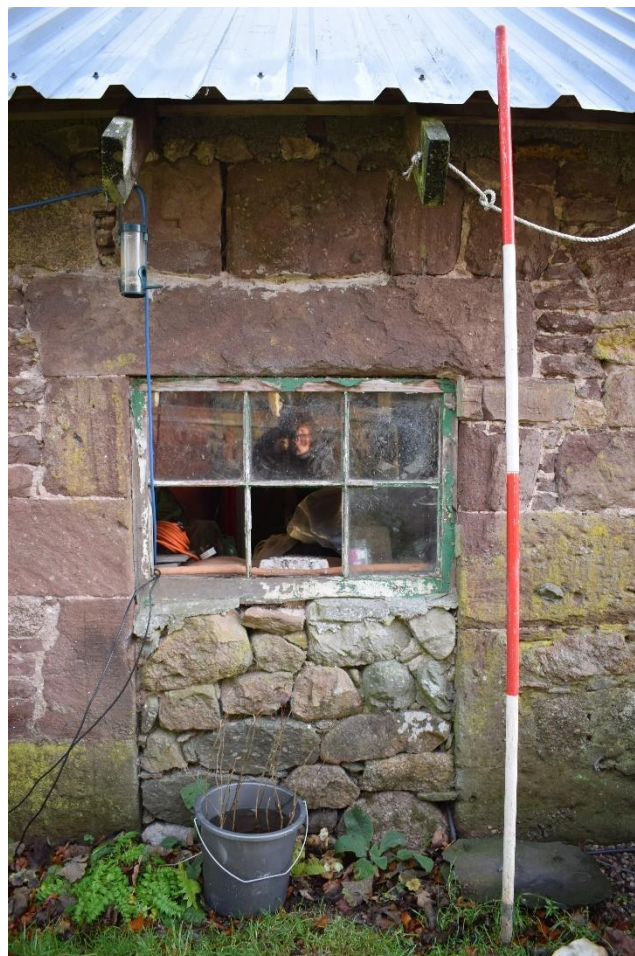
Illus 11 Building 2 Room 3 D7 converted to a window (W5); facing E

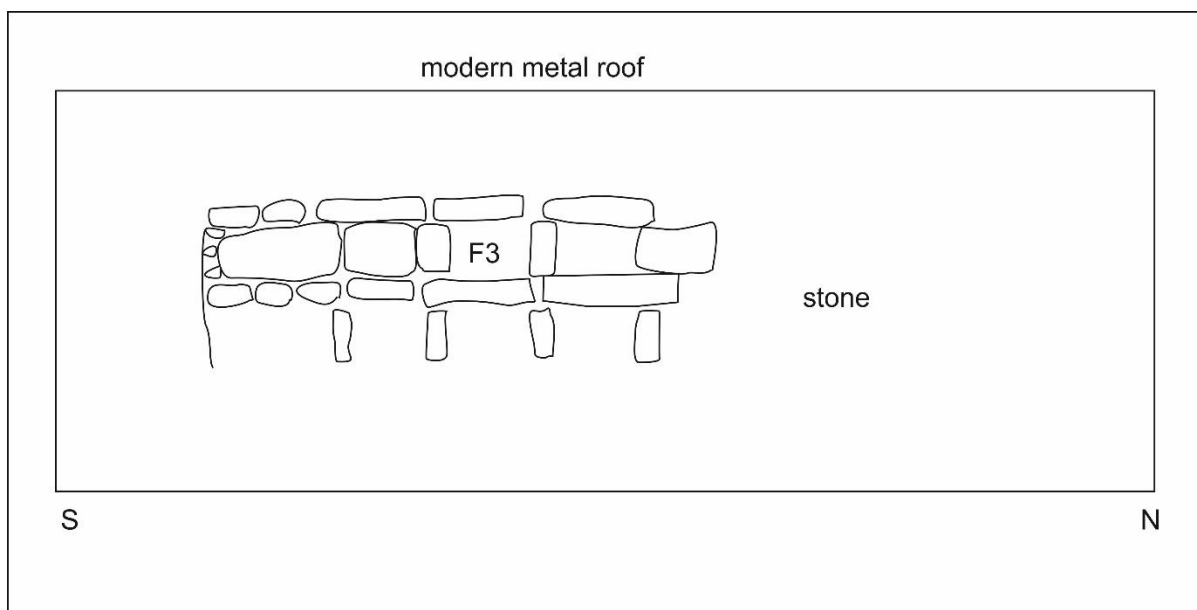
Illus 12 E wall Room 3 showing F3 bee boles

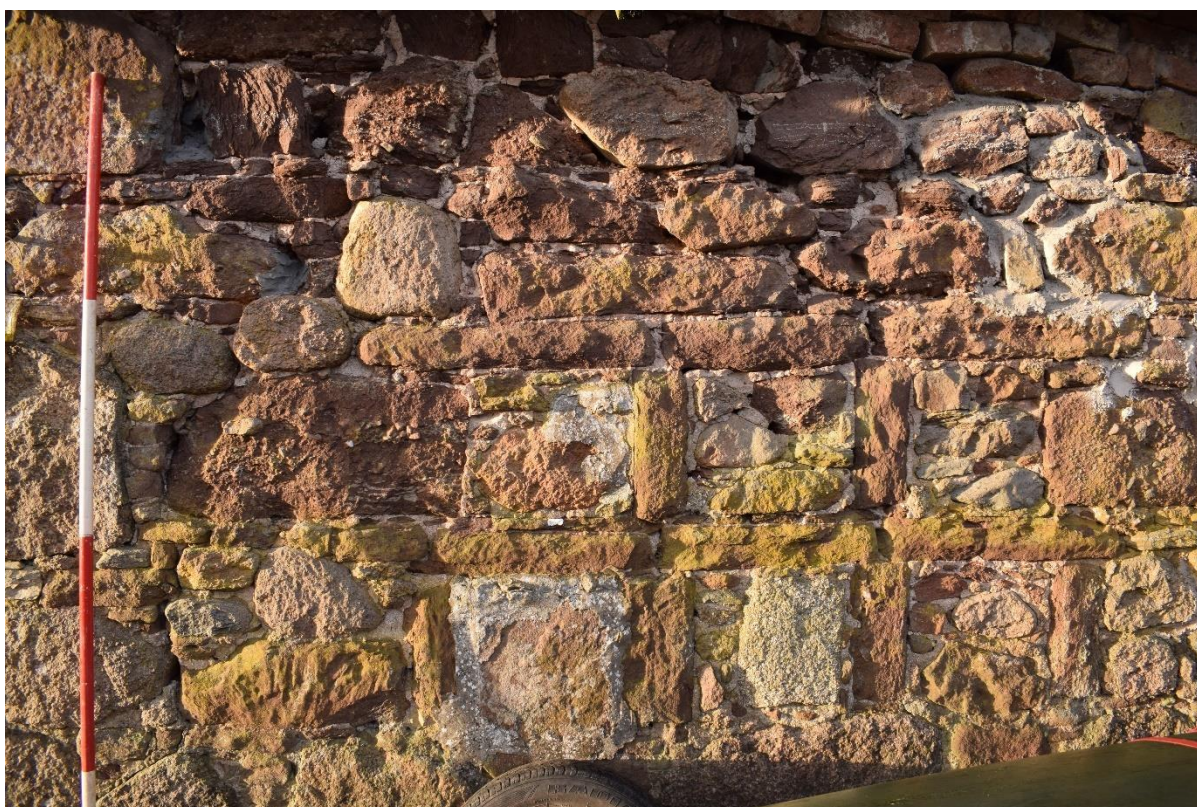
Illus 13 Room 3 E wall bee boles F3; facing W

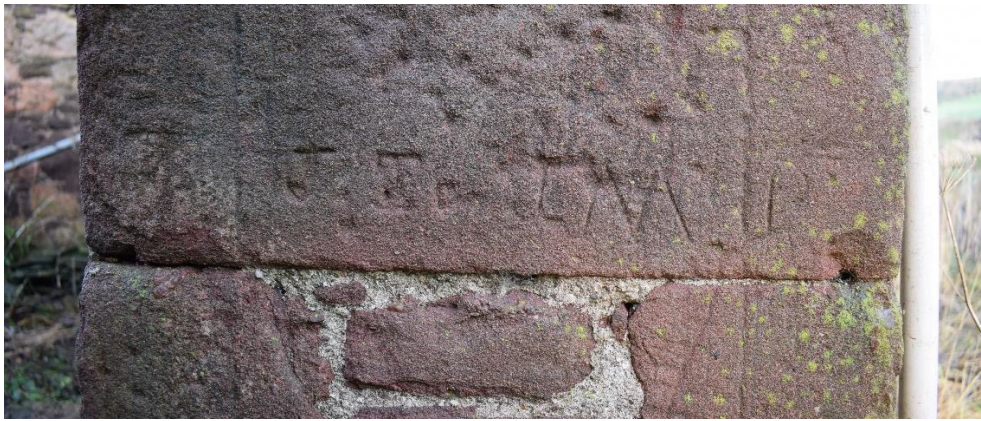
Illus 16 Graffiti on N jamb D4; facing N

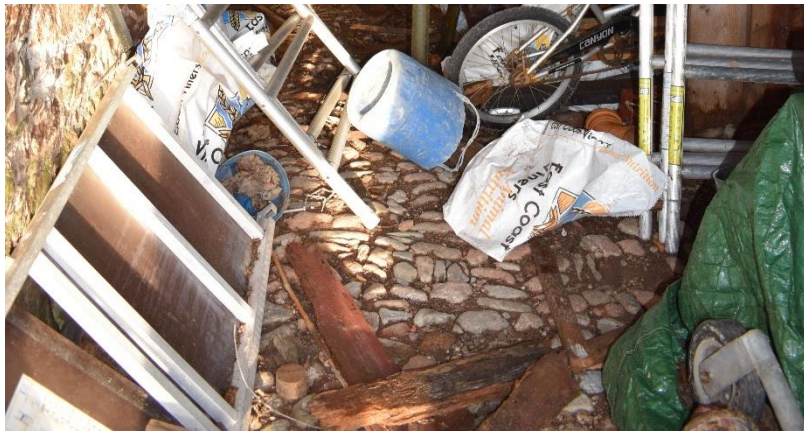
There is limited access to the interior of Room 8 as it is used for storage. There is a stone cobbled surface on the ground floor (Illus 18) and has been in agricultural use, possibly with accommodation on the upper floor.

Illus 18 Room 8 cobbled stone floor; facing N

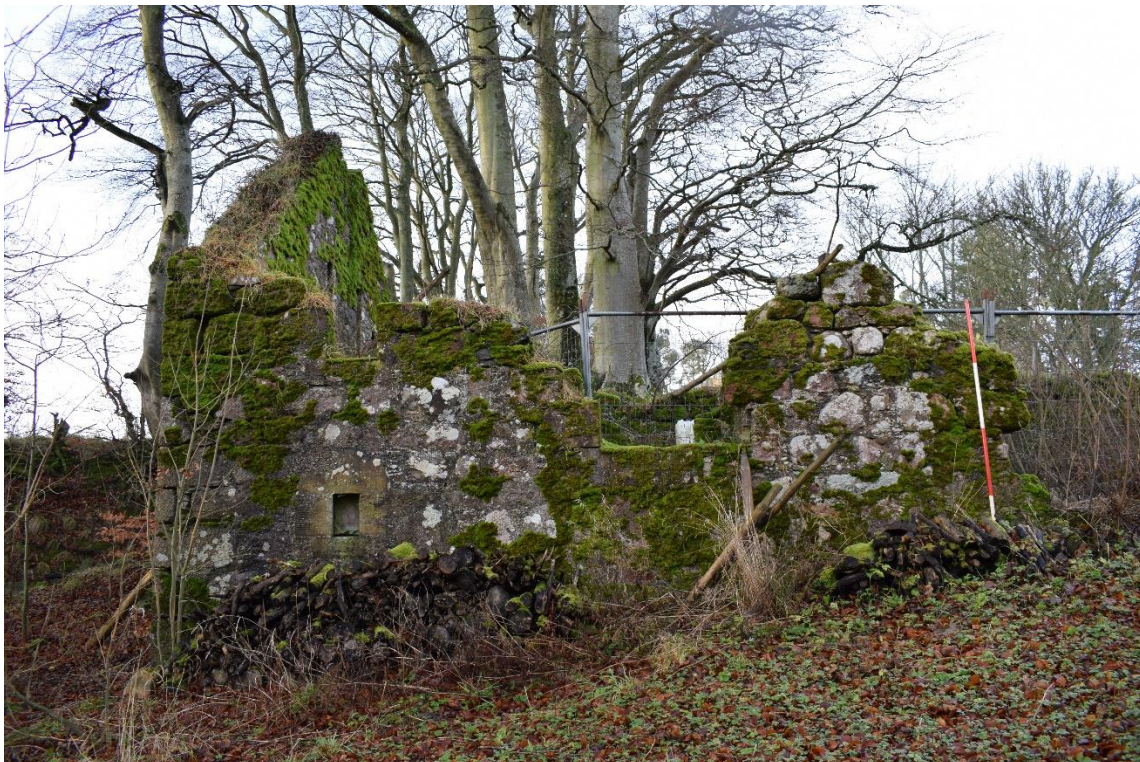
Three windows partially survive in the E wall including W12 which has been repaired or replaced with concrete surround (Illus 20, 21). There is an aperture in the W wall (F4), possibly for ventilation. The S gable is the most complete wall (Illus 20, 22) and it has two upper windows (W14 and W15) and a circular aperture (F1) which is 0.53m diameter. The wall thickness at F1 is 0.67m and F1 is constructed of granite blocks (Illus 20, 23). F1 is the aperture for the drive shaft for the waterwheel; there is no trace of the wheel and the wheel pit has been infilled. F2 is an arch of worked granite boulders; it is 1.9m W-E and 1.6m high. This is the channel through which the water flowed from the mill pond, under the SW corner of the building and along the S side of the building to power the waterwheel. This area has been infilled.

Illus 21 Building 3 E wall with windows W11 and W12 (left) and W13 (centre); facing W

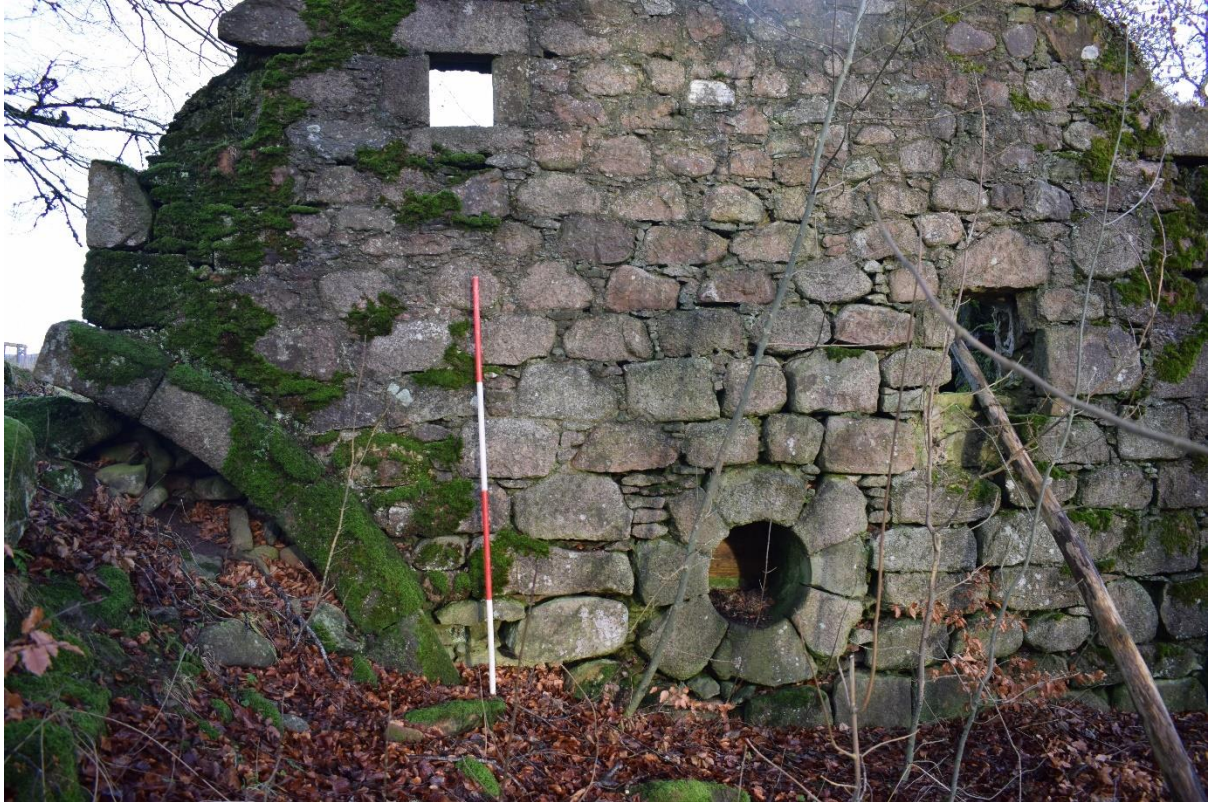
Illus 22 Building 3 S gable with W14 (top left) W15 (right), F1 (centre), F2 (left); facing N
