**Mains Of Williamston Farm, Culsalmond, Inch,
Aberdeenshire, AB52 6TX
Report on Level 1 Standing Building Survey**

**Alison Cameron
Cameron Archaeology
19 December 2018**

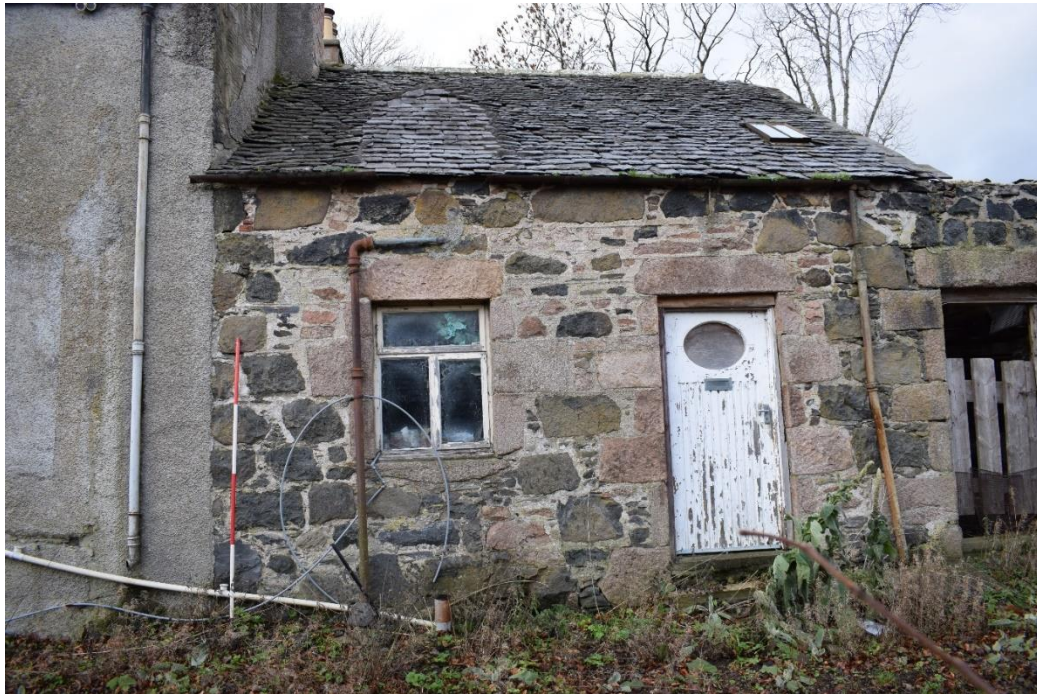
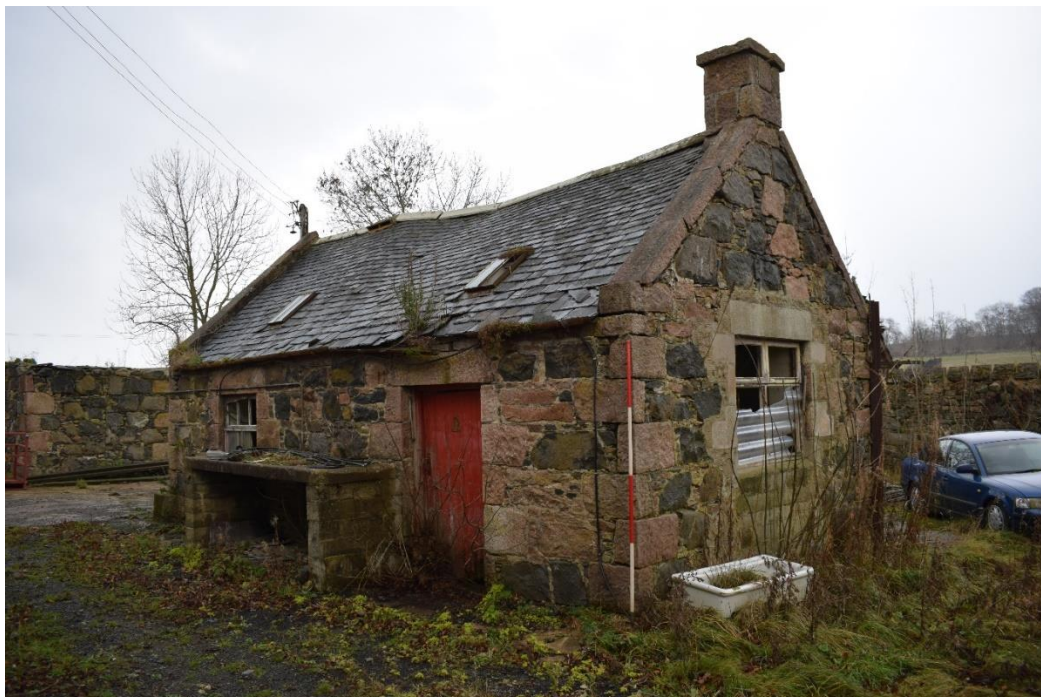
Cover: top Room 1 E elevation W4 and D1 showing fieldstone and red granite construction and grey slate roof; facing W. Bottom Building 2 facing NE

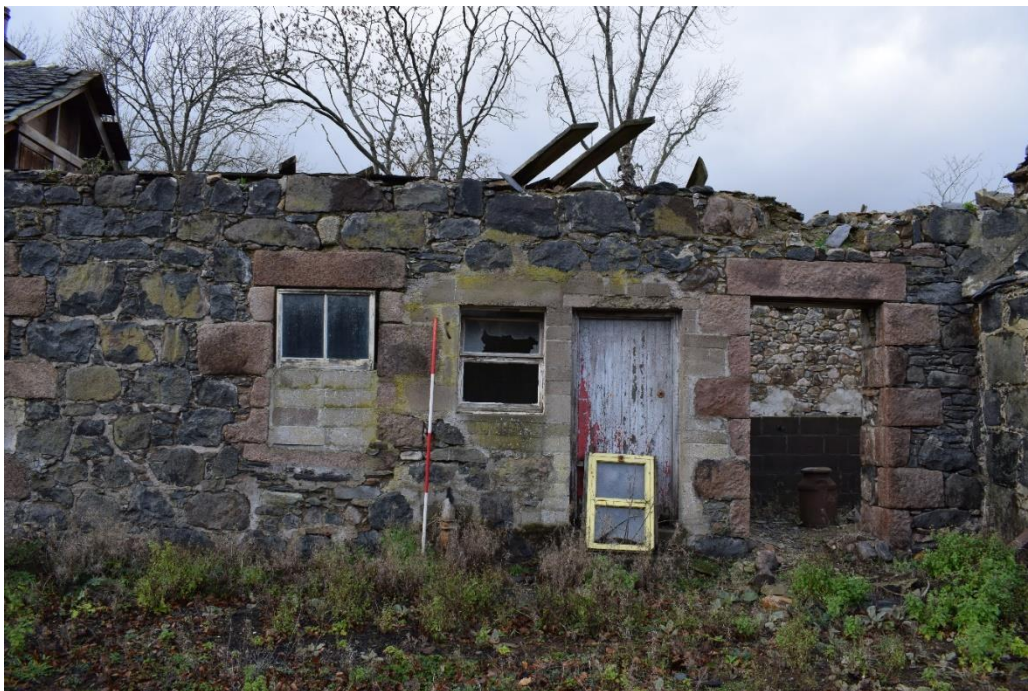
Illus 3 Room 2 and 3 E elevation W5, W6, D3 and D4; facing W

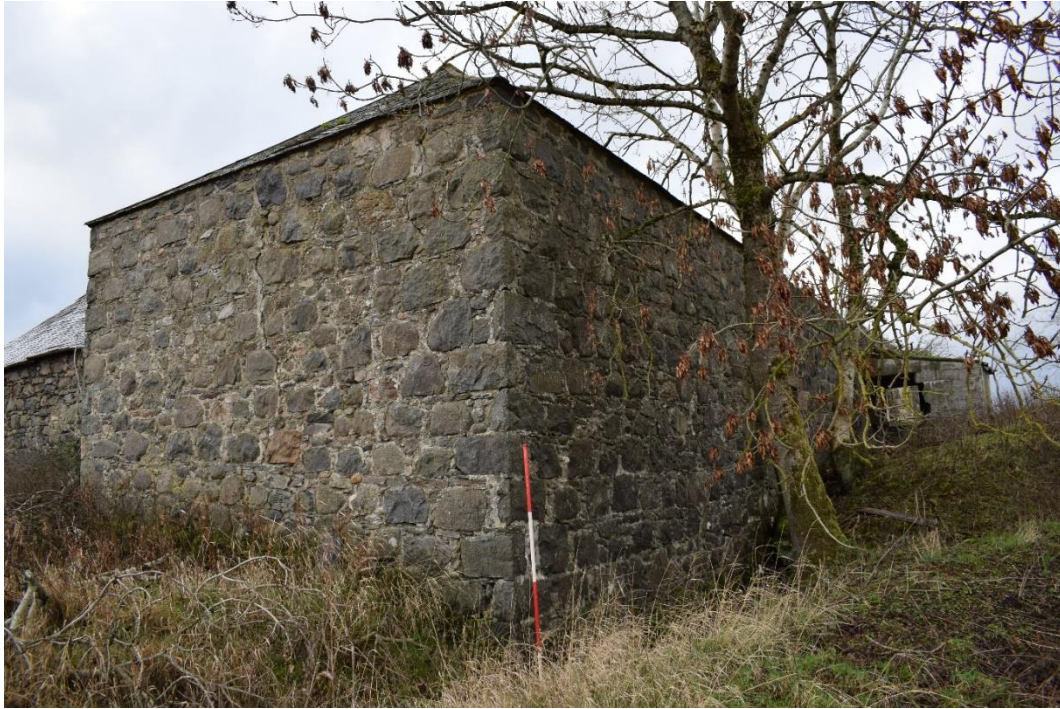
Rooms 6 and 7 were a mill. There was a waterwheel on the N side of these rooms which can be seen on the First Edition OS map (Illus 13) with a lade heading towards it from the NNE. By the Second Edition OS map a sluice has been added on the N of the building and a well on the E side. There is now a small concrete block building (Room 12; Illus 2, 5) although this post-dates the removal of the waterwheel and infilling of the lade; a section of lade wall (F3, Illus 5) can be seen on the N side of the N wall of Room 6. The lade is still visible as an infilled channel (Illus 2, 4) but no evidence of mill apertures are visible; the interior of this building has been rebuilt for cattle and the walls plastered.

Illus 4 NE corner of Room 7 showing the infilled lade (at the bottom of the ranging rod); facing SW

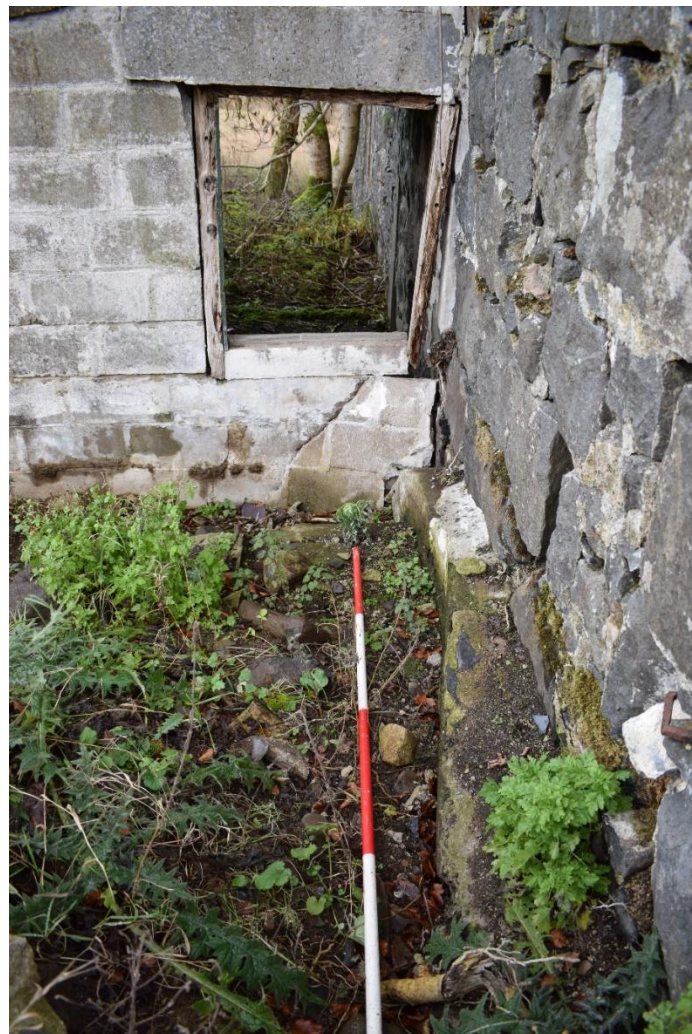
Illus 5 Edge of lade F3 on N side of N wall of Room 6 (to right of ranging rod); facing E

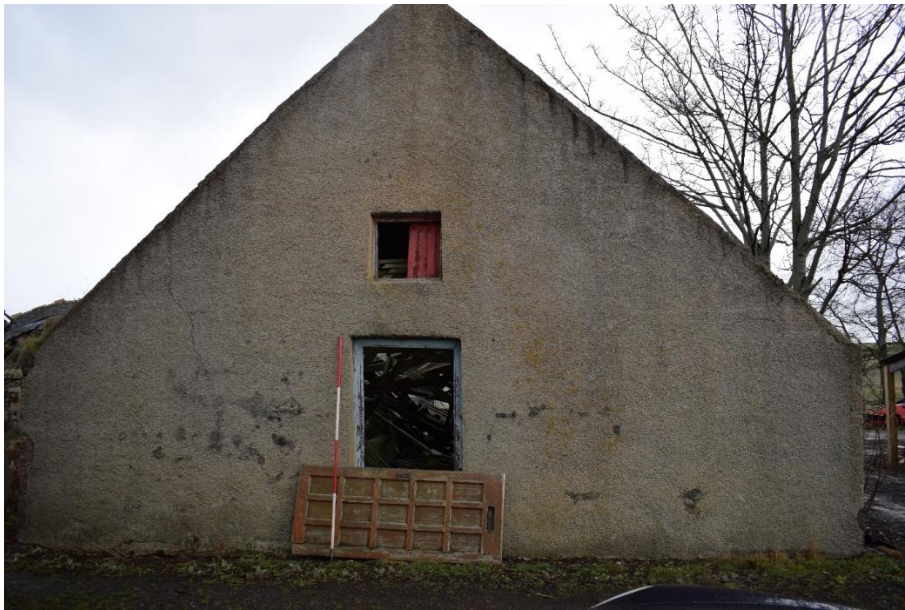
Illus 6 Room 10 W gable with D27 with W22 above; facing E

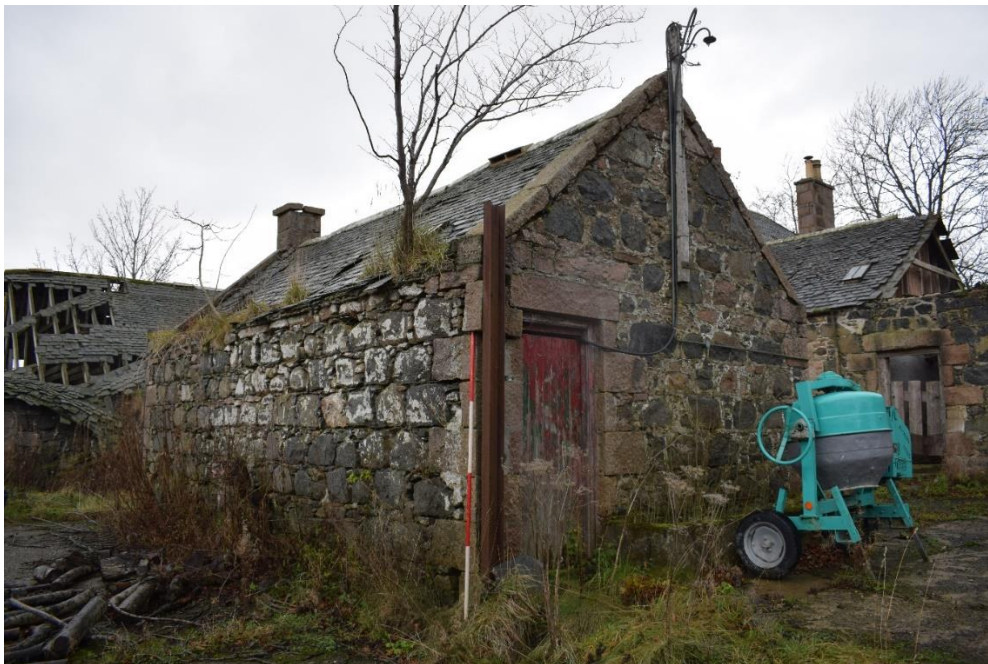
Building 2 is a bothy in the centre of the courtyard (Illus 9, 10). It is constructed of grey fieldstone with red granite quoins and door mouldings and is 8.6 x 4.8m in size and single storey. There is a window in the S wall within a blocked door (W19/D21) and the same on the N end of the W wall (W20/D22) and another door on the W wall (D24) and the N wall (D23). There was a chimney on the S gable. Another L-shaped building was attached to the E wall of this building on the 2nd Edition OS map (Illus 14) but this has since been demolished.

Illus 10 Building 2 facing SW

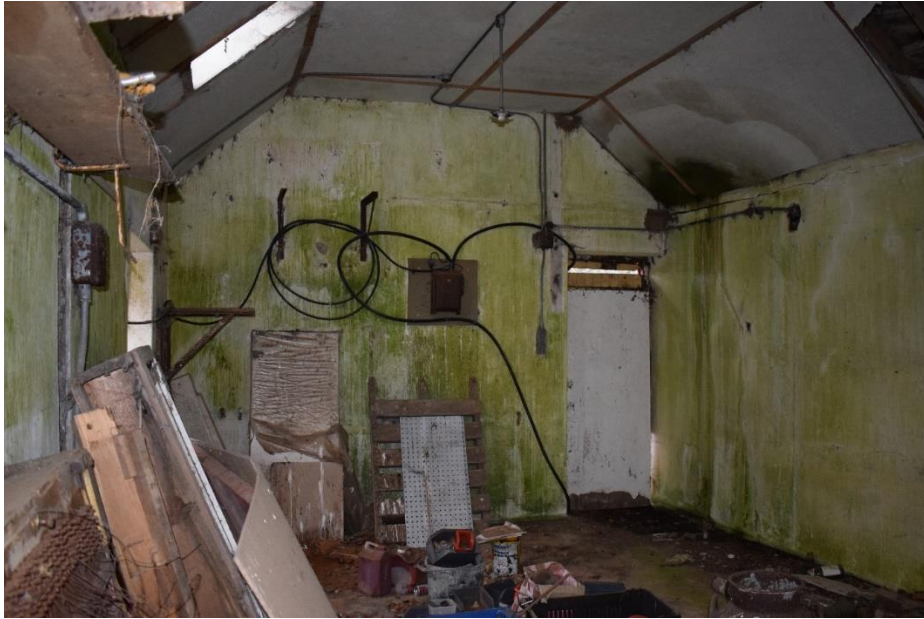
It was constructed between the dates of the First and Second OS maps as accommodation for farm staff. There is now no access into the interior as the roof is in very poor condition, but the interior has been plastered and converted for dairy use (Illus 11).

Illus 11 Building 2 interior; facing NNE
