**Land At Smiddyhill, Udney, Ellon,
Aberdeenshire, AB41 6SY**

Report on Level 1 Standing Building Survey

Aberdeenshire Planning application APP/2019/1064

**Alison Cameron
Cameron Archaeology
14 July 2019**

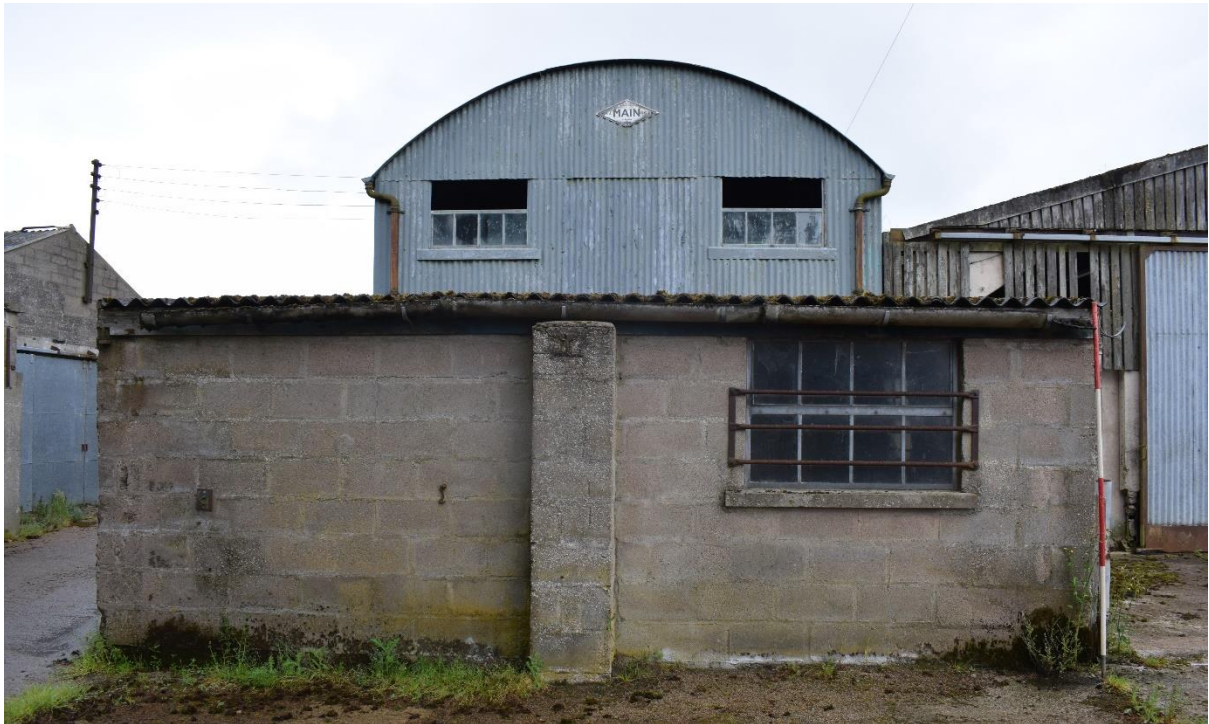
Building 1 is 33m long and 5.7m wide constructed of concrete blocks (Illus 3, 5) with a curved metal roof and corrugated metal walled first floor. It was a silo barn (Illus 4) and was constructed by A&J Main & Co Ltd, Glasgow and London (Illus 6).

Illus 3 Building 1 WNW end showing concrete base and metal upper floor; facing ESE

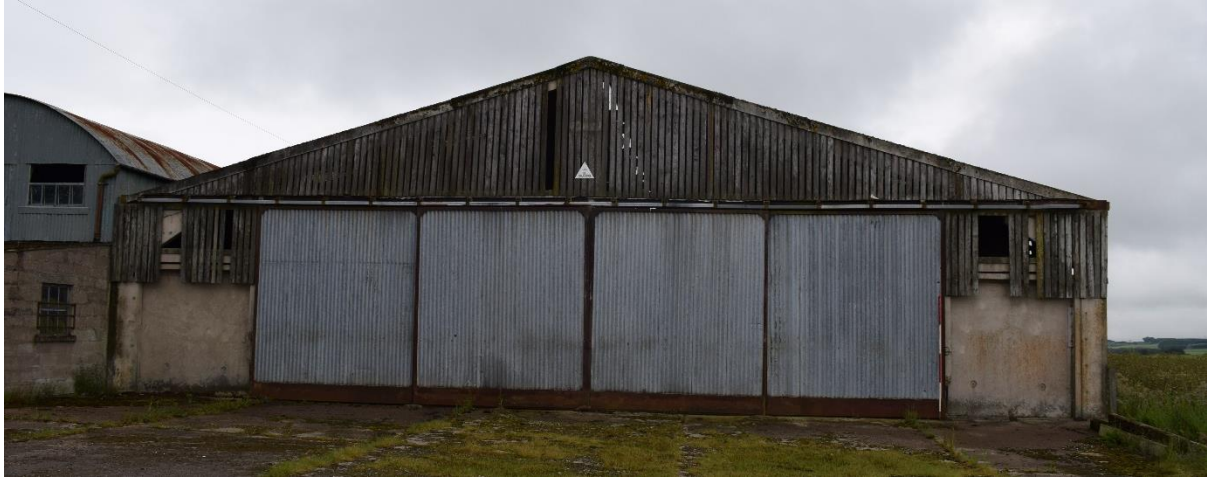
Building 2 was built by the Taylor family as a cattle court (Illus 4). It is 26.8m long and 18.2m wide and constructed of concrete blocks with asbestos roof and large metal doors in the WNW wall (D24; Illus 5) and ESE wall (D23).

Illus 7 Building 2 WNW wall D24; facing ESE

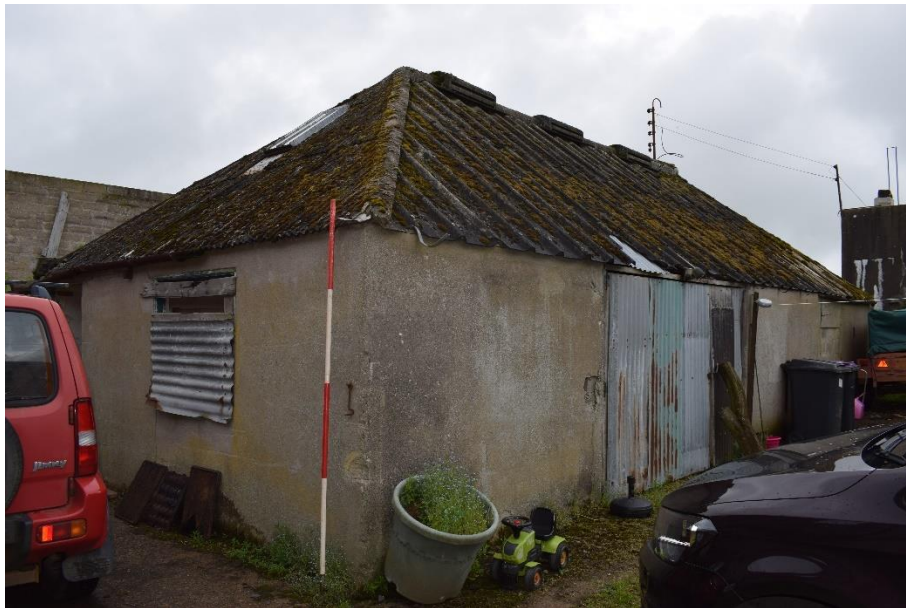
Building 3 is a shed 6 x 12.3m in size constructed of concrete blocks, harled on the exterior and with asbestos roof (Illus 2, 5). There is a door (D22) and window (W14) in the WNW wall and doors D20 and D21 in the SSW wall (Illus 8). It is shown on the 1926 3rd Edition OS map (Illus 30).

Illus 8 Building 3; facing NE

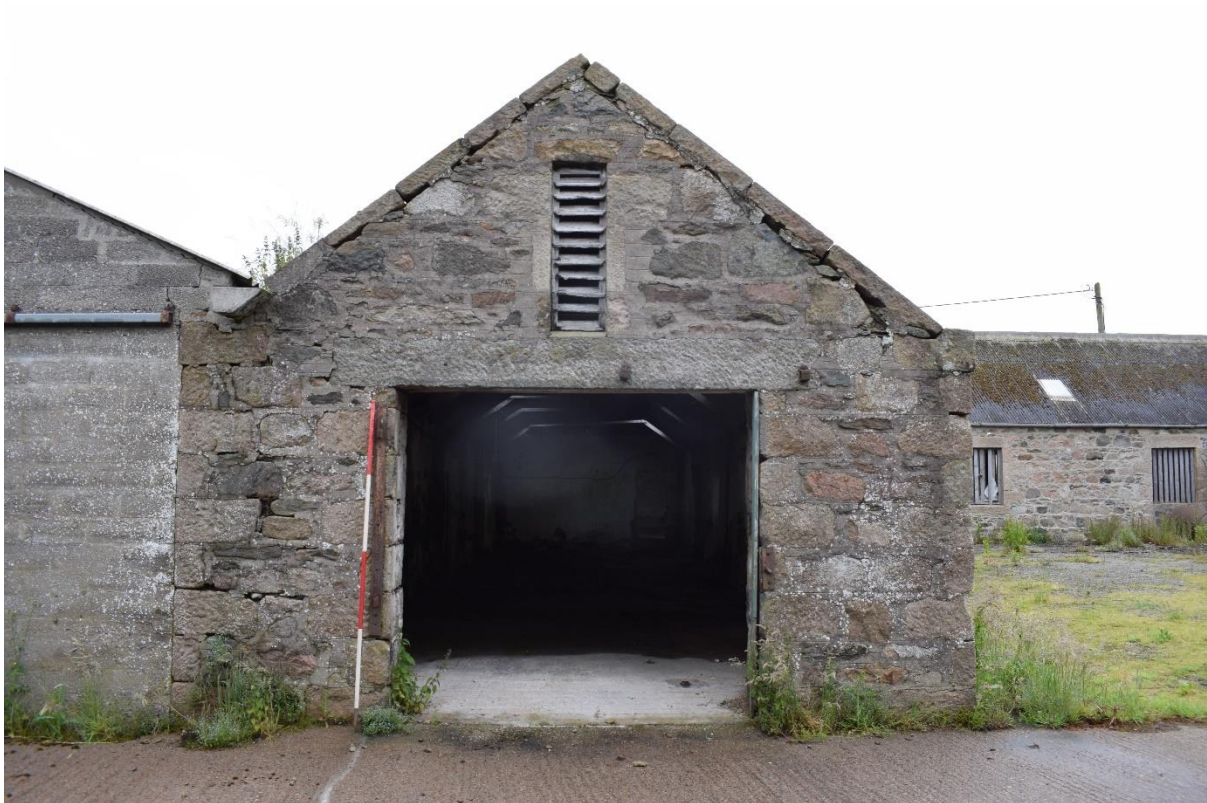
Illus 11 Building 4 W wing SSW wall D18; facing NNE

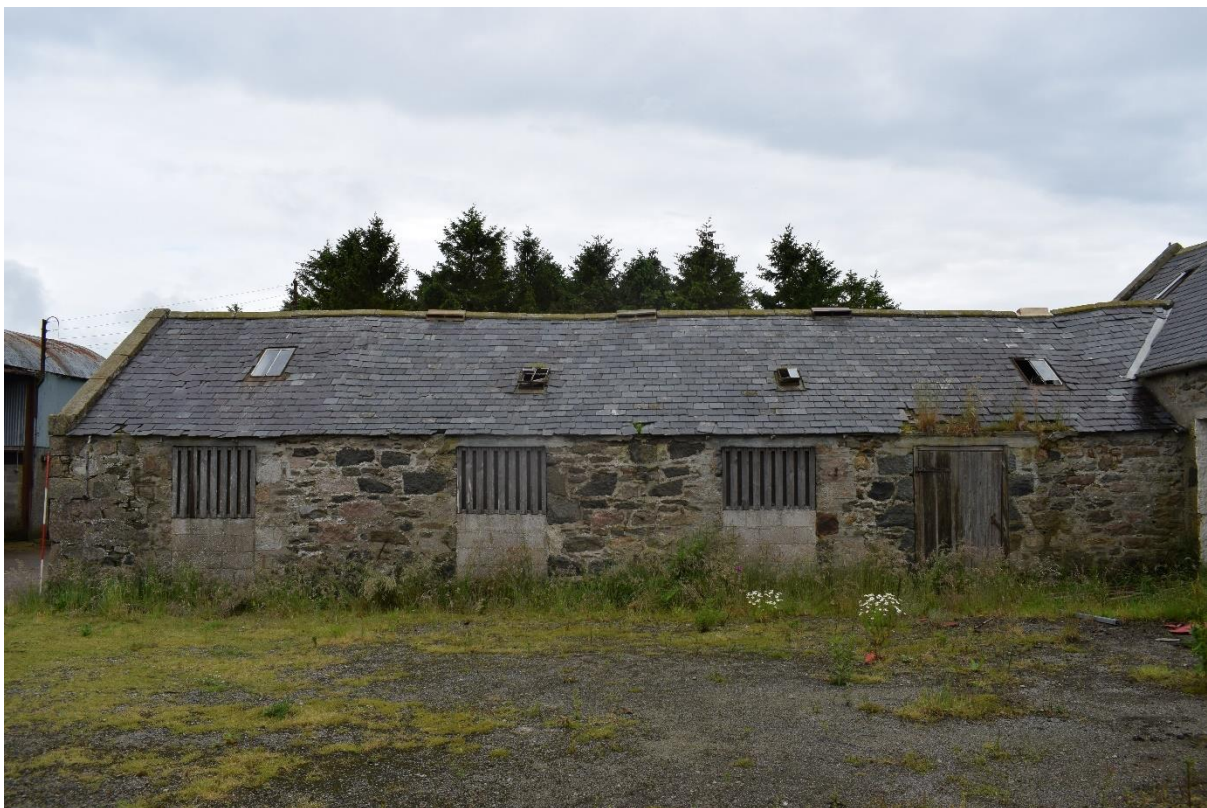
The W wing has a large door in the SSW wall (D18; Illus 11) and the wing had 4 doors on the ESE wall to access the courtyard (D14-17; Illus 12); three were later converted to windows (Illus 10, 12). A door (D13) has been broken through into the N wing but this is not an original door and has not been faced. It is roofed in grey slate.

Illus 12 Building 4 W wing ESE wall D17, D16, D15, D14; facing WNW

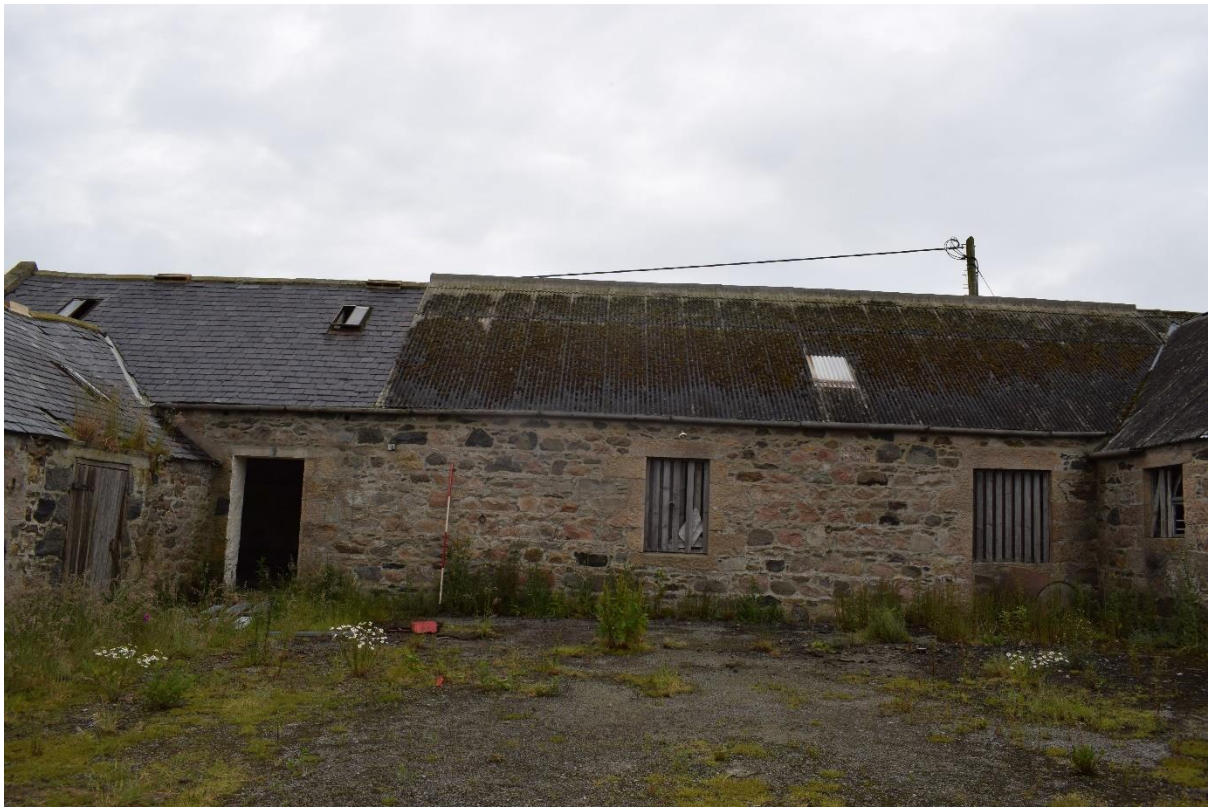
Illus 13 Building 4 N wing SSW wall D12, W5, D11; facing NNE

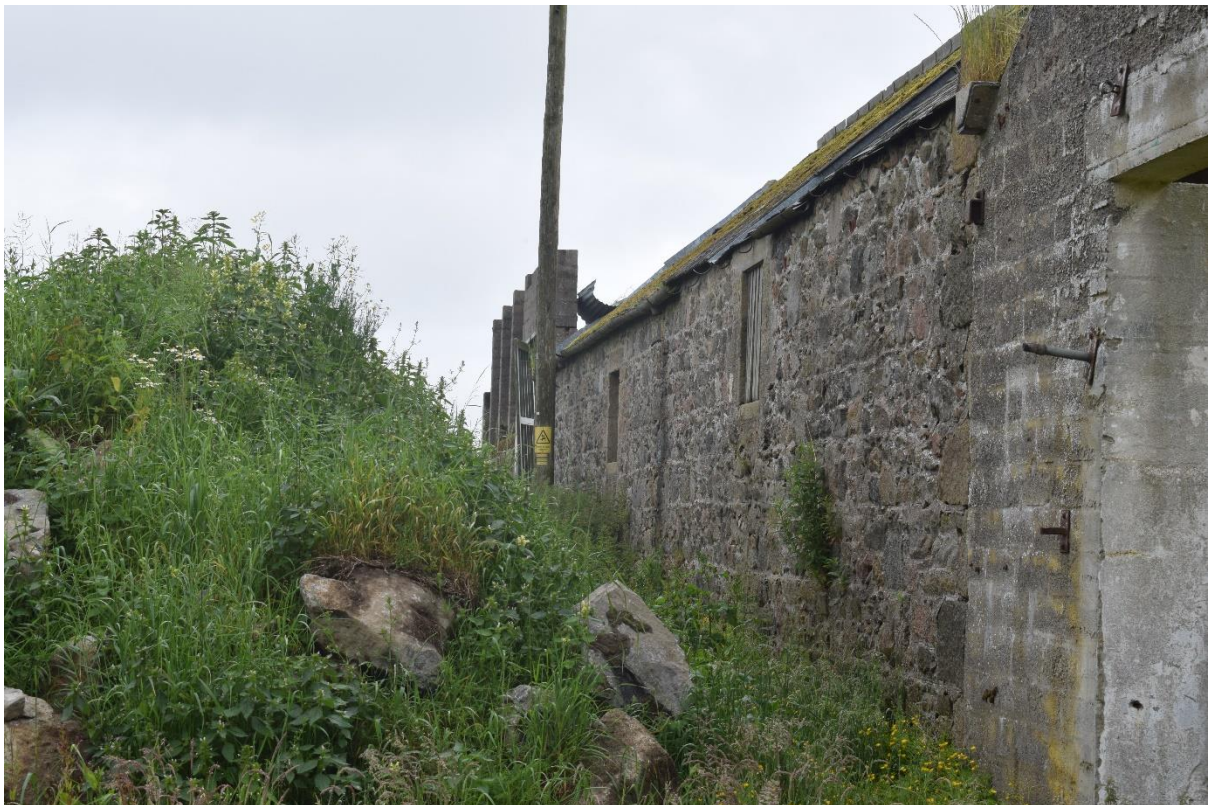
The N wing has two small windows in the NNE wall (W1 and W2); this was originally the location of the horsemill seen on the 1st and 2nd OS maps (Illus 28, 29) but the interior has been covered with concrete (Illus 16) and the exterior is inaccessible (Illus 14). This wing has two doors (D11 and D12 to the courtyard and one window (W5; Illus 13) and a door to the E wing (D10) and a large door in the ESE gable (D1). The WNW end of the wing is roofed with grey slate and the ESE section has been replaced with asbestos.

Illus 14 Building 4 N wing N wall showing overgrown and inaccessible; facing ESE

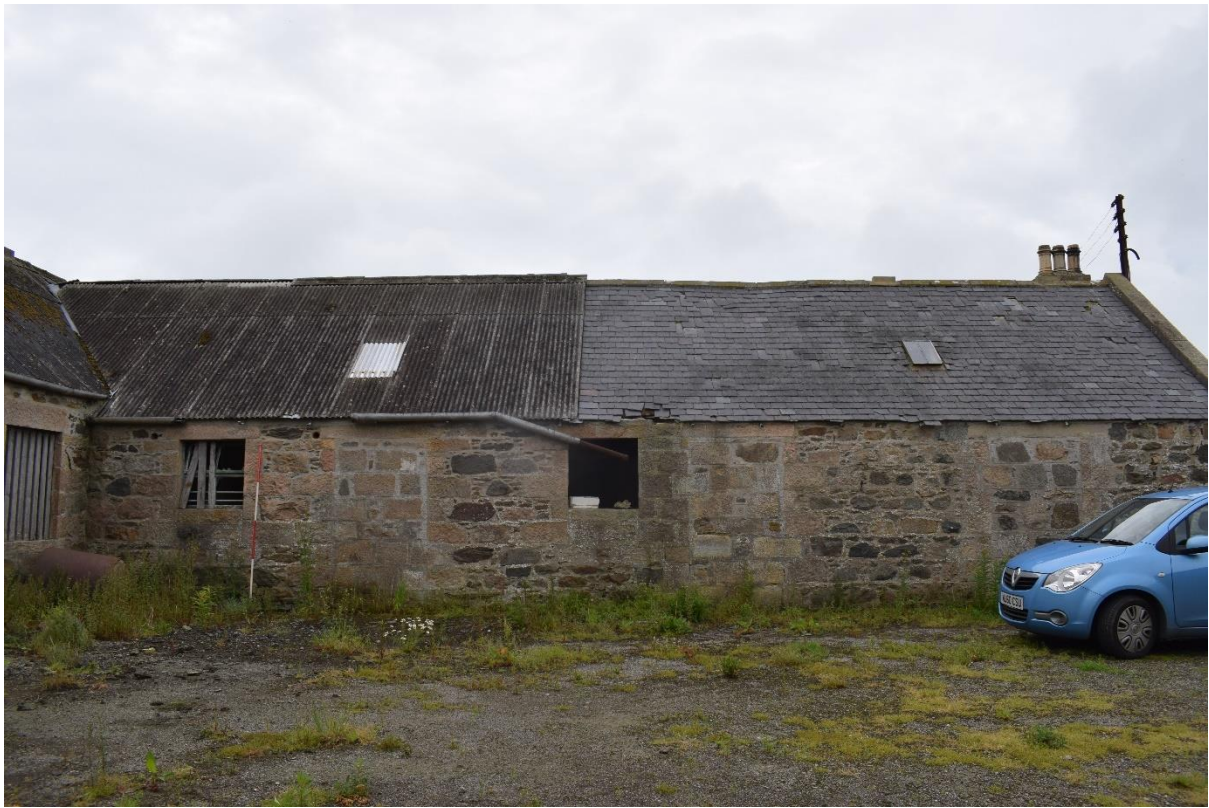
The E wing has had 5 doors to the courtyard (D9, D7 and D6; Illus 15) but two have been converted to windows by blocking the lower section with stone (W4, W17). There were 3 doors to the exterior ESE D2 has been partially blocked with concrete blocks, W3 is open at the top and blocked with stone below and the lower section of D3 has been blocked with stone and later the upper half blocked with concrete blocks. The interior walls and floor are covered with concrete (Illus 17).

Illus 15 Building 4 E wing WNW wall W4, D9, W17, D7, D6; facing ESE

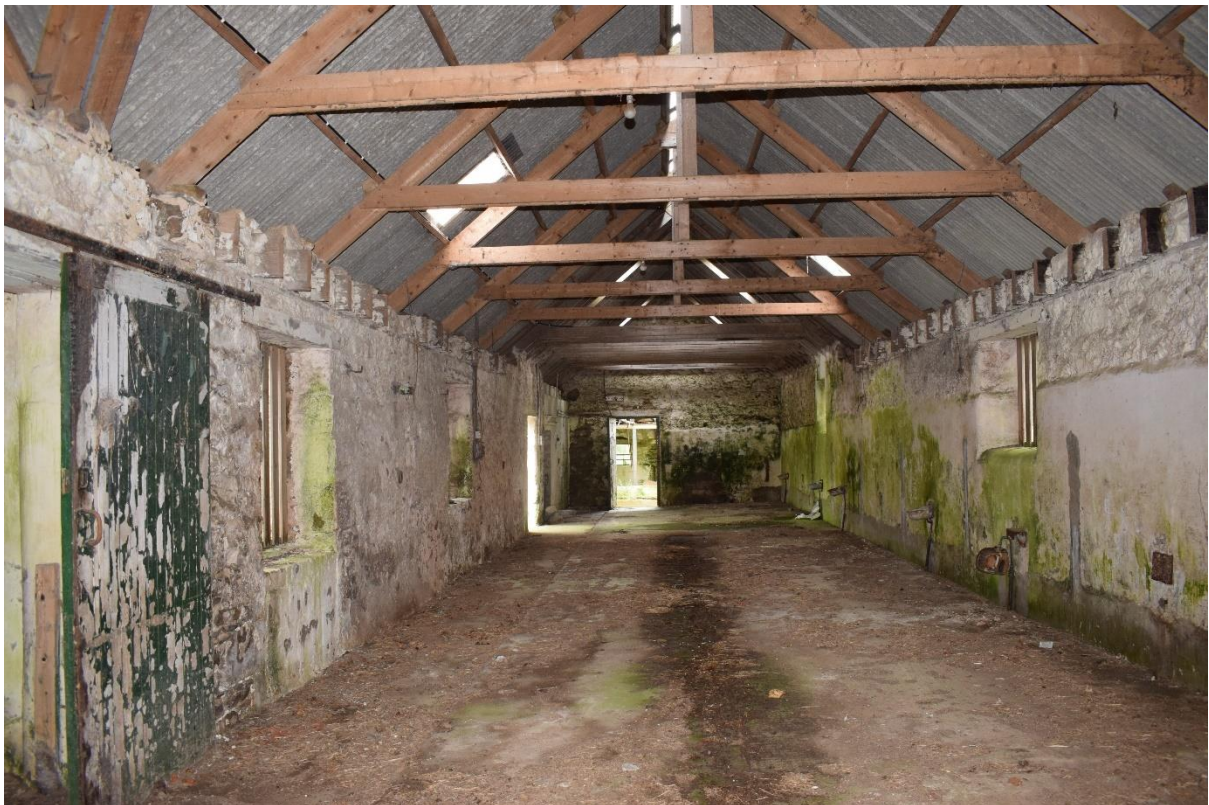
Illus 16 Building 4 N wing interior; facing NNE towards gable with D19

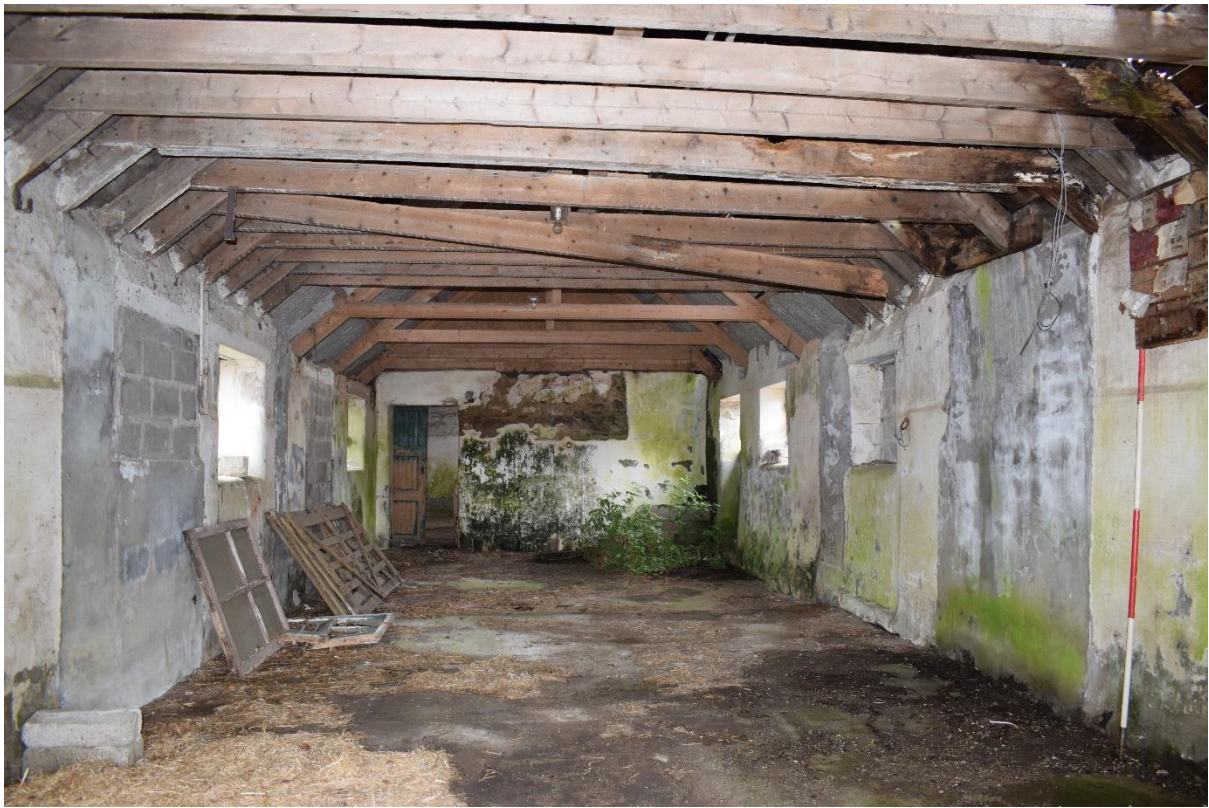
Illus 17 Building 4 E wing interior towards gable with D10; facing NNE

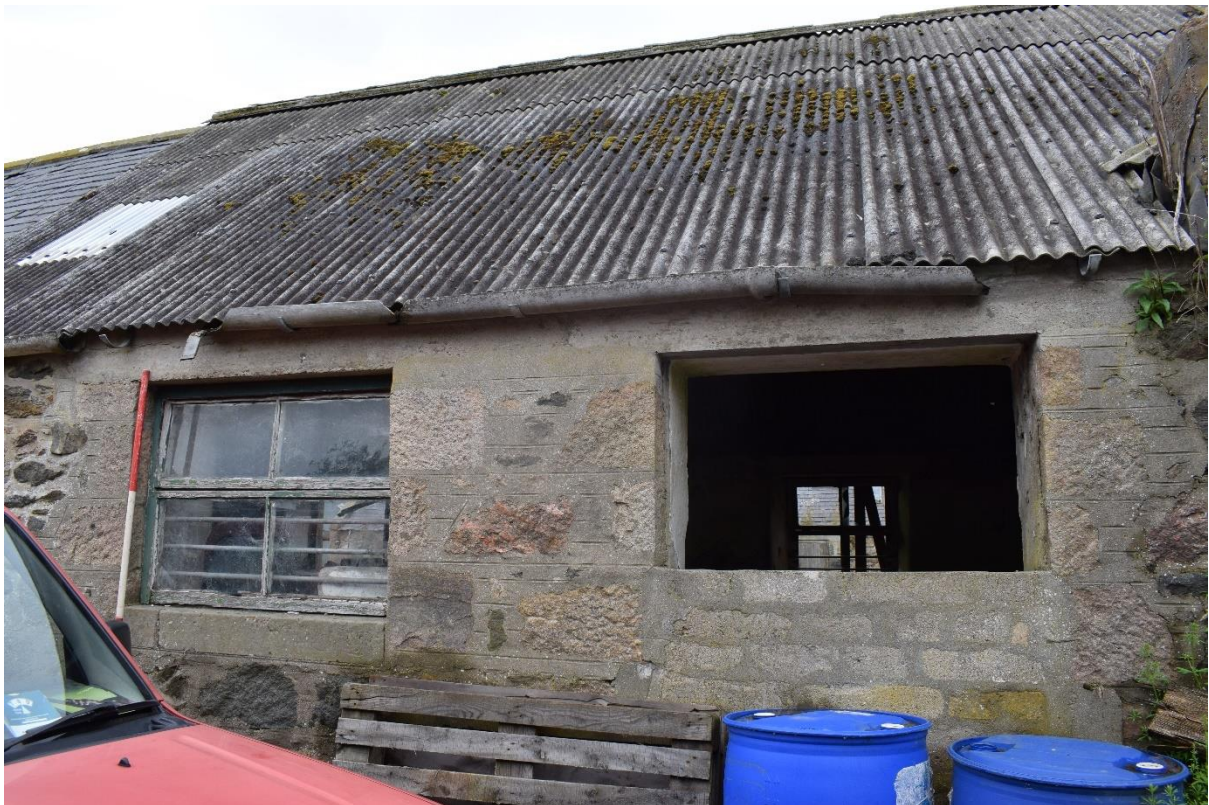
Building 4 is the earlier fieldstone steading constructed in a C shape with W wing 15 x 5.5m, N wing 24 x 6.2m and E wing 15.5 x 6.2m in size around a central courtyard (Illus 9) with access from the S. The original apertures are in granite but many of the doors have been blocked with stone and concrete blocks and some lintels and sills replaced in concrete (see Illus 18). The interiors have all been lined with concrete for housing cattle and there are concrete floors throughout. The original roofs have been grey slate but many have been replaced with asbestos roofs, including the NNE end of the E wing (Illus 18).

Illus 18 Building 4 E wing W3 (left) with new concrete sill, D2 (right) blocked with concrete

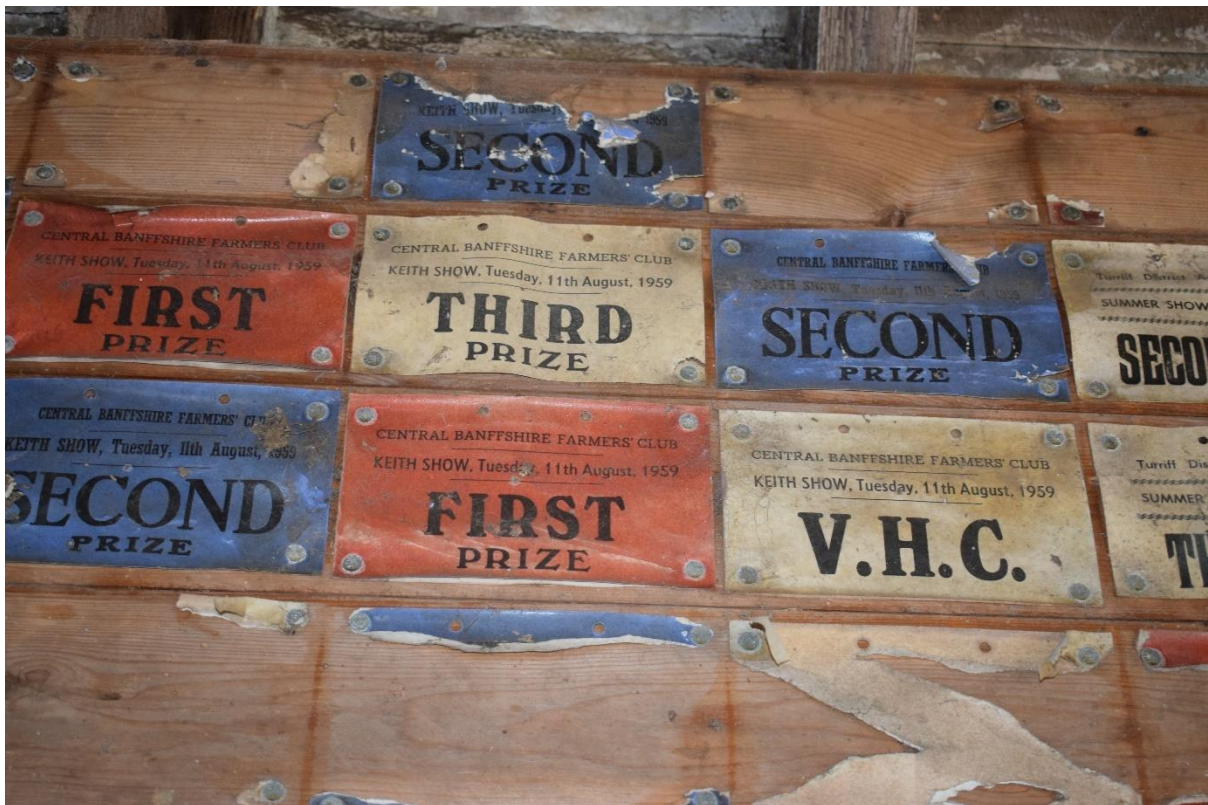
On the SSW end of the ESE wall is a wooden board covered with Show certificates (F2 Illus 19) which pre-date the purchase by the Taylors in 1966.

Illus 19 Building 4 E wing interior ESE wall detail of wooden board with show certificates F2

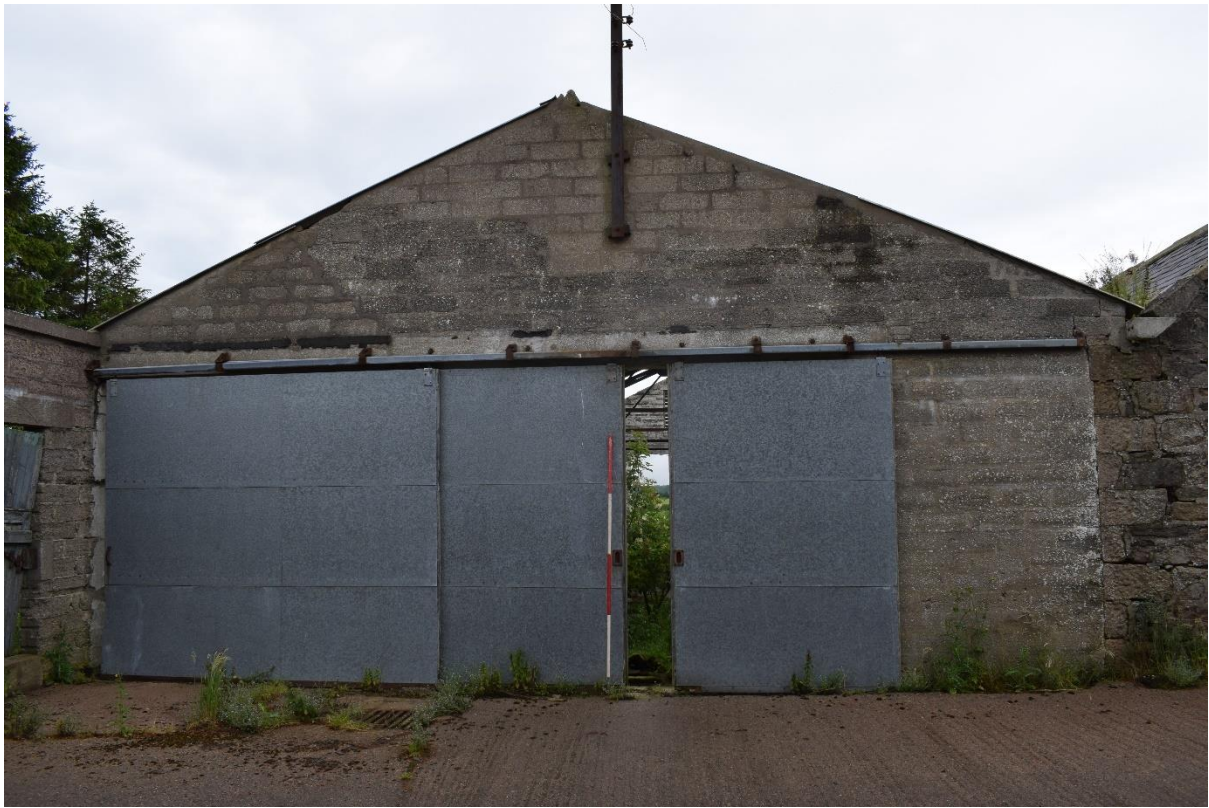
Building 5 was built by the Taylor family as a feeding court (Illus 20). It is 10m wide and 22.5m long and constructed of concrete blocks with asbestos roof, now collapsing (Illus 21-2). There was no access to the interior.

Illus 21 Building 5 SSW wall; facing NNE

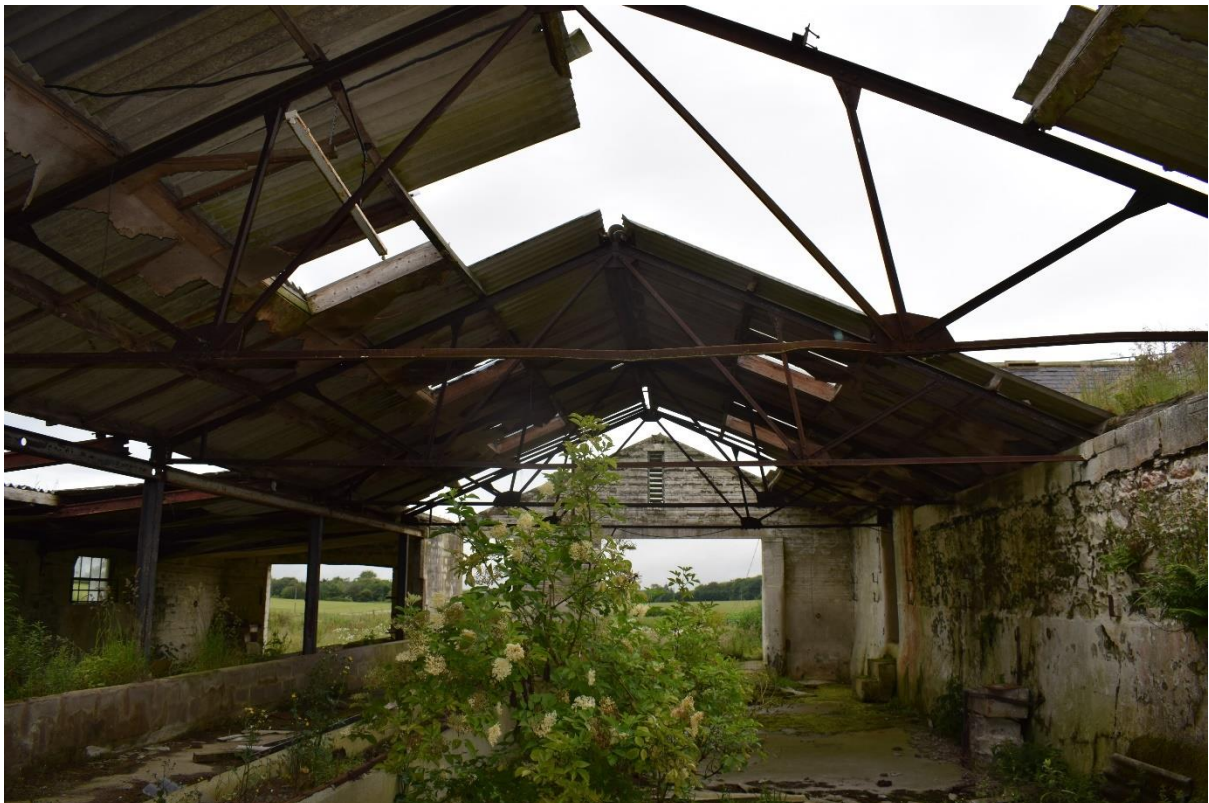
Illus 22 Building 5 interior; facing NNE showing collapsing roof and asbestos roofing broken on floor

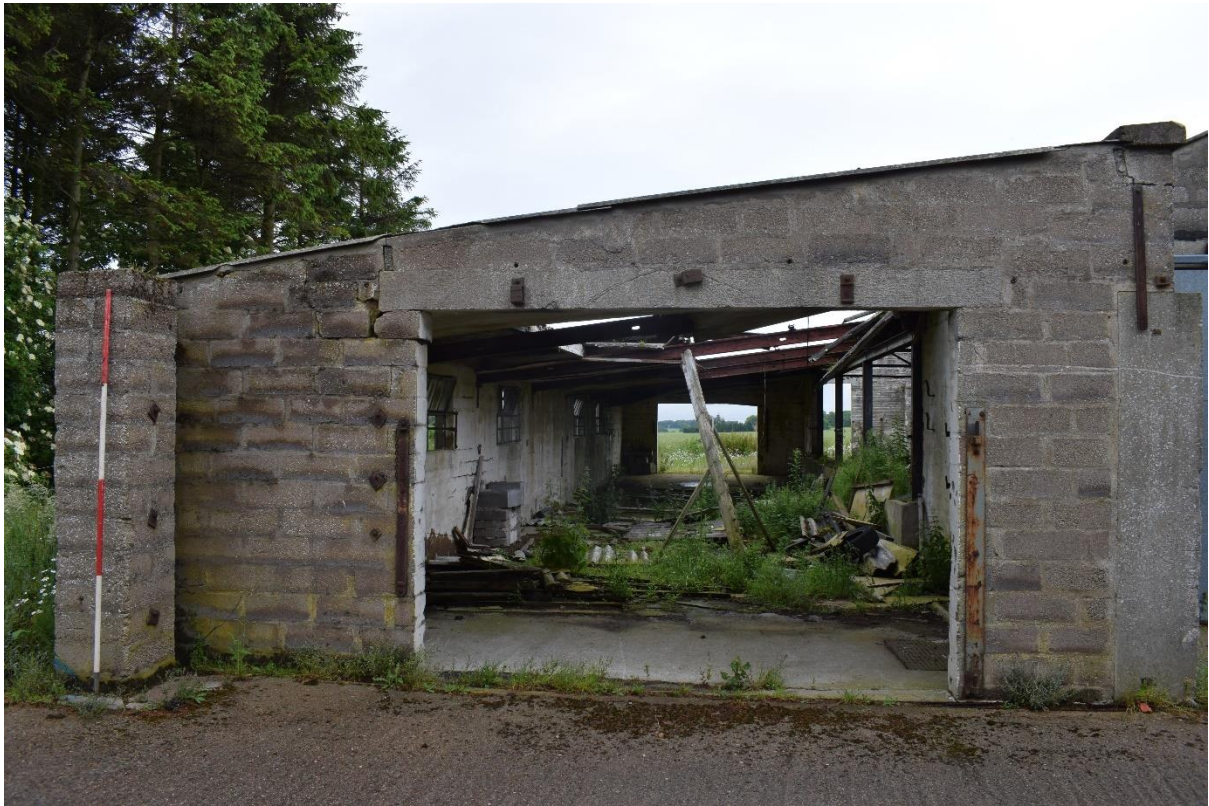
Building 6 was built by the Taylor family as a feeding court (Illus 20). It is 5.5m wide and 25m long and constructed of concrete blocks with asbestos roof, now collapsing (Illus 23-5). There was no access to the interior.

Illus 23 Building 6 SSW wall; facing NNE

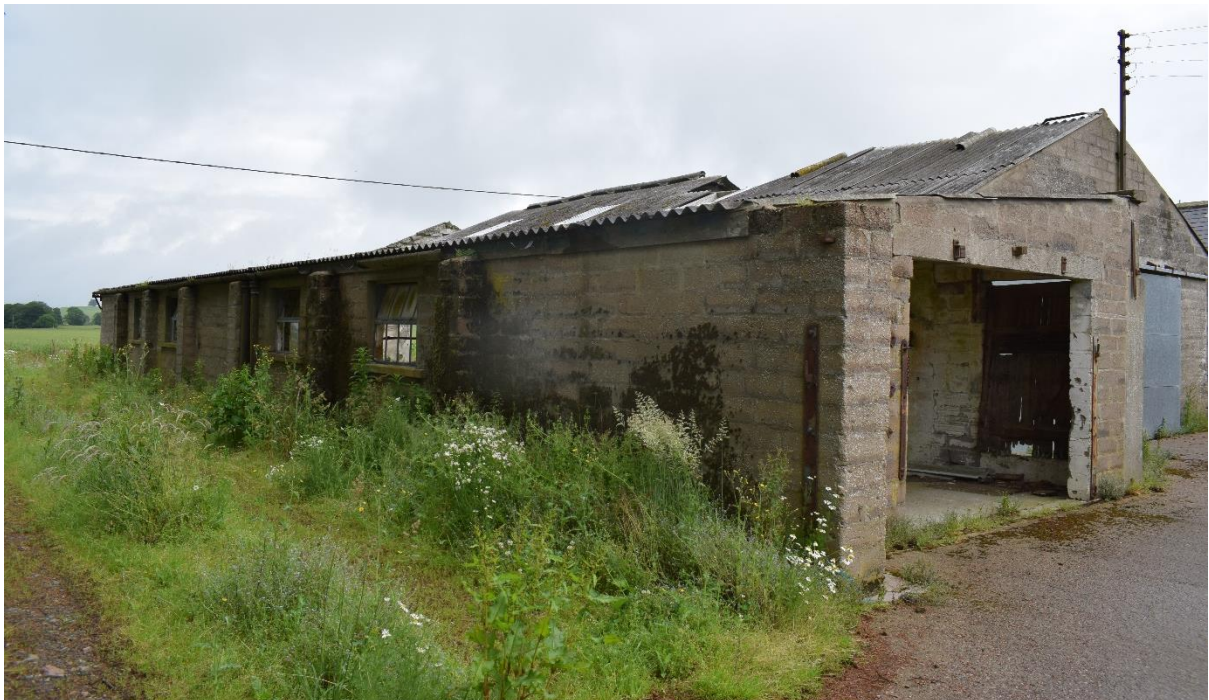
Illus 24 Building 6 WNW wall; facing NE

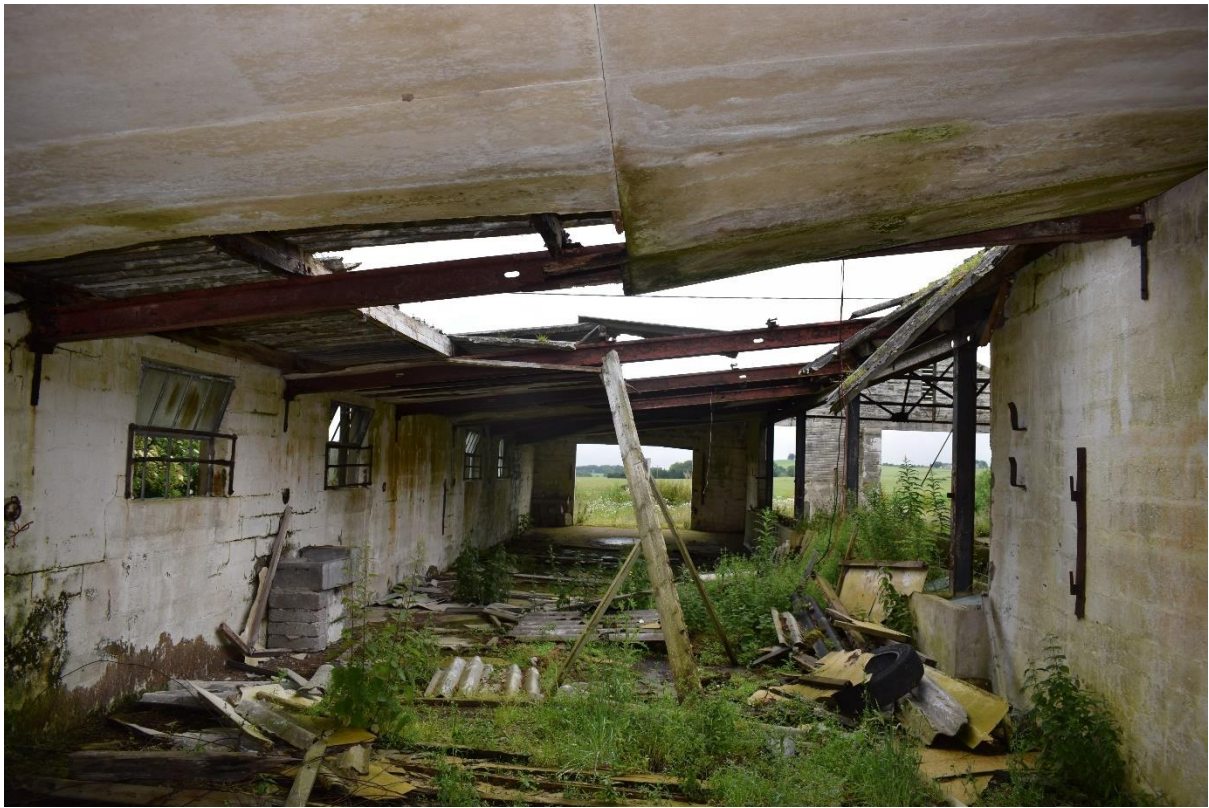
Illus 25 Building 6 interior showing collapsing roof and asbestos roofing broken on floor; facing NNE

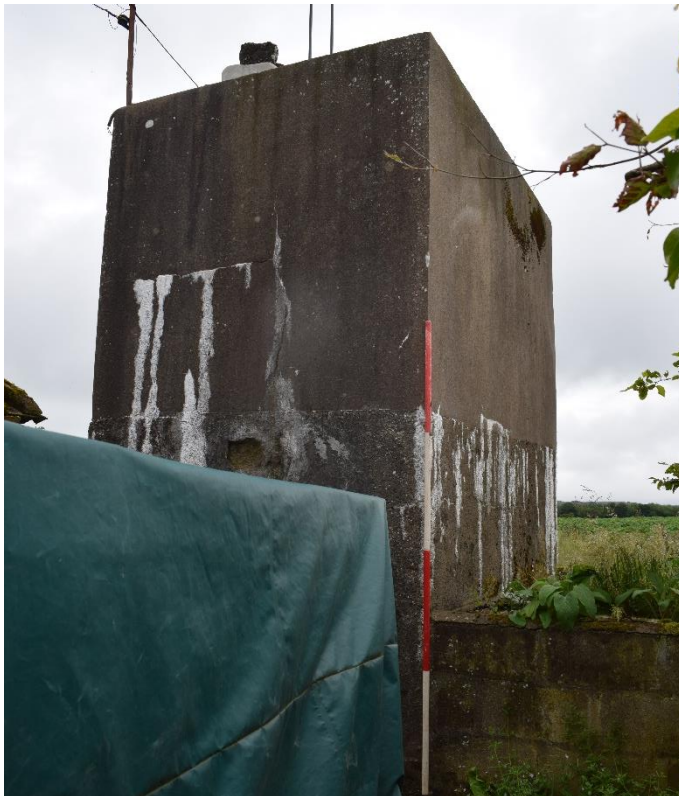
Building 7 (Illus 26) is a small, rectangular silo with a stone base and concrete harled upper level; it is not accessible.

Illus 26 Building 7; facing NE
