Plot 3, Site At Middlemuir, St Combs, Aberdeenshire Report on Level 1 Standing Building Survey

Aberdeenshire Council planning reference APP/2019/2023

Alison Cameron
Cameron Archaeology
14 January 2020

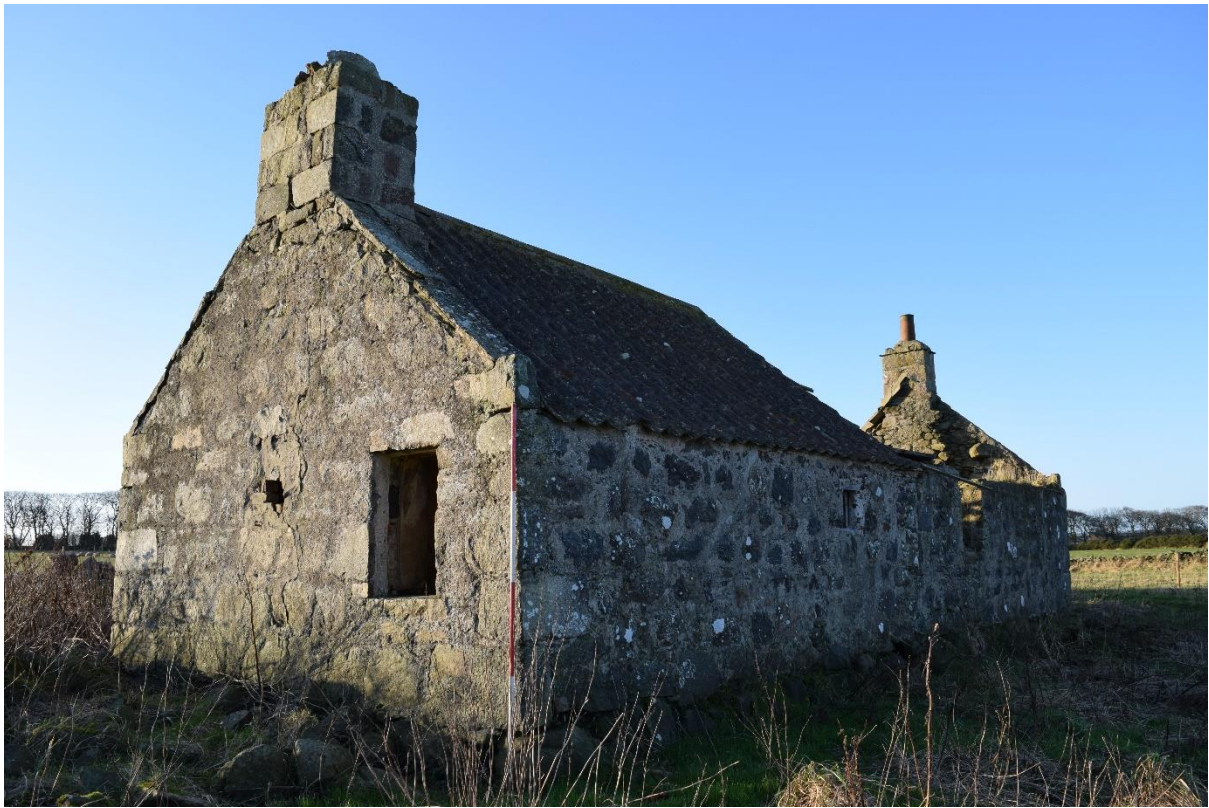
Illus 4 Building 1 E gable with W7 and N facade; facing SW

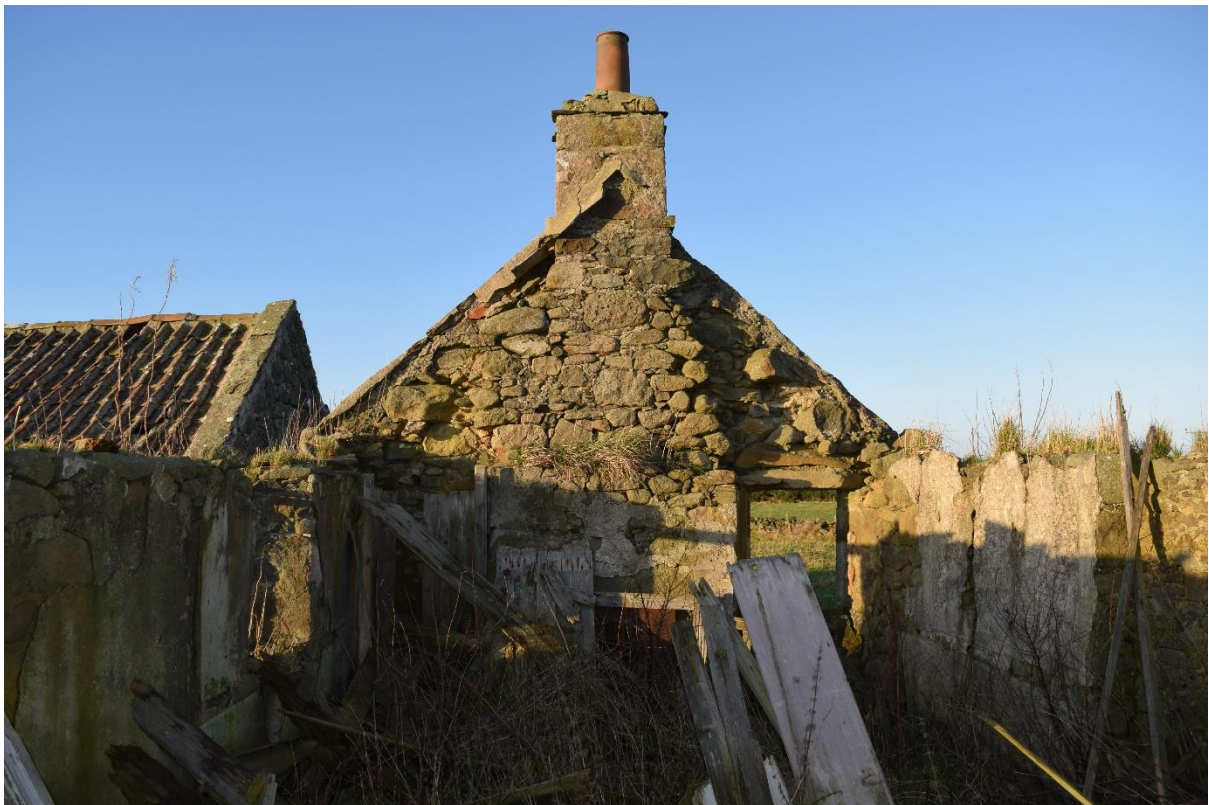
Illus 5 Building 1 Room 1 interior of W gable showing collapsed roof and rubble interior; facing W

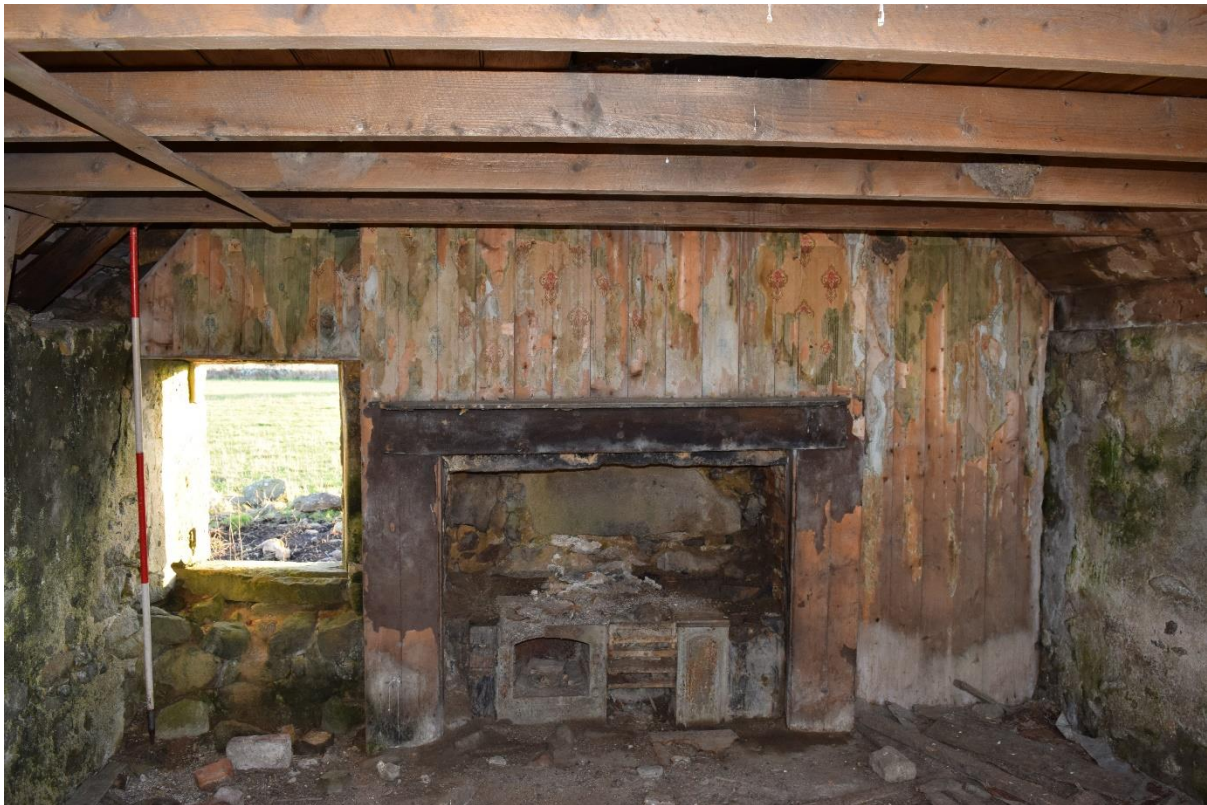
Illus 6 Building 1 Room 2 E wall range F2 on E wall with window W7 (left) showing wood paneling and wallpaper; facing E

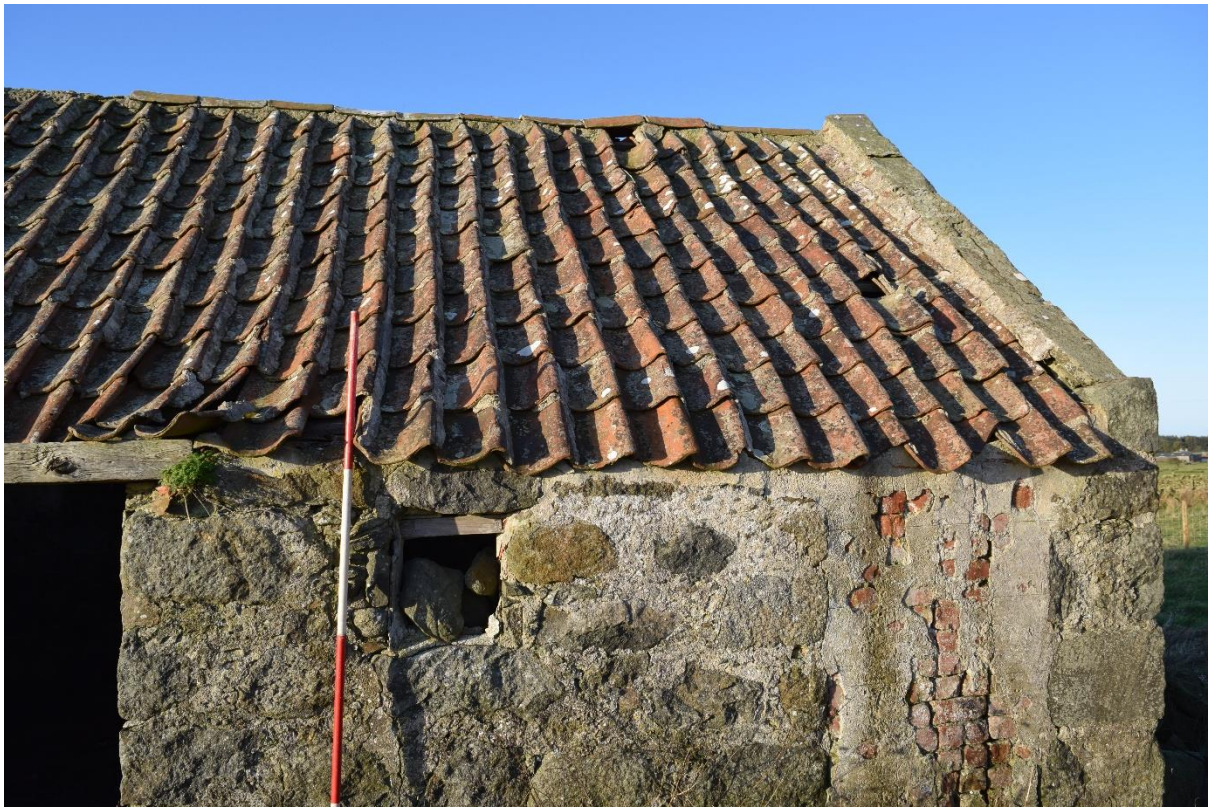
Illus 7 Pantile roof on Building 2 N end Room 1; facing W

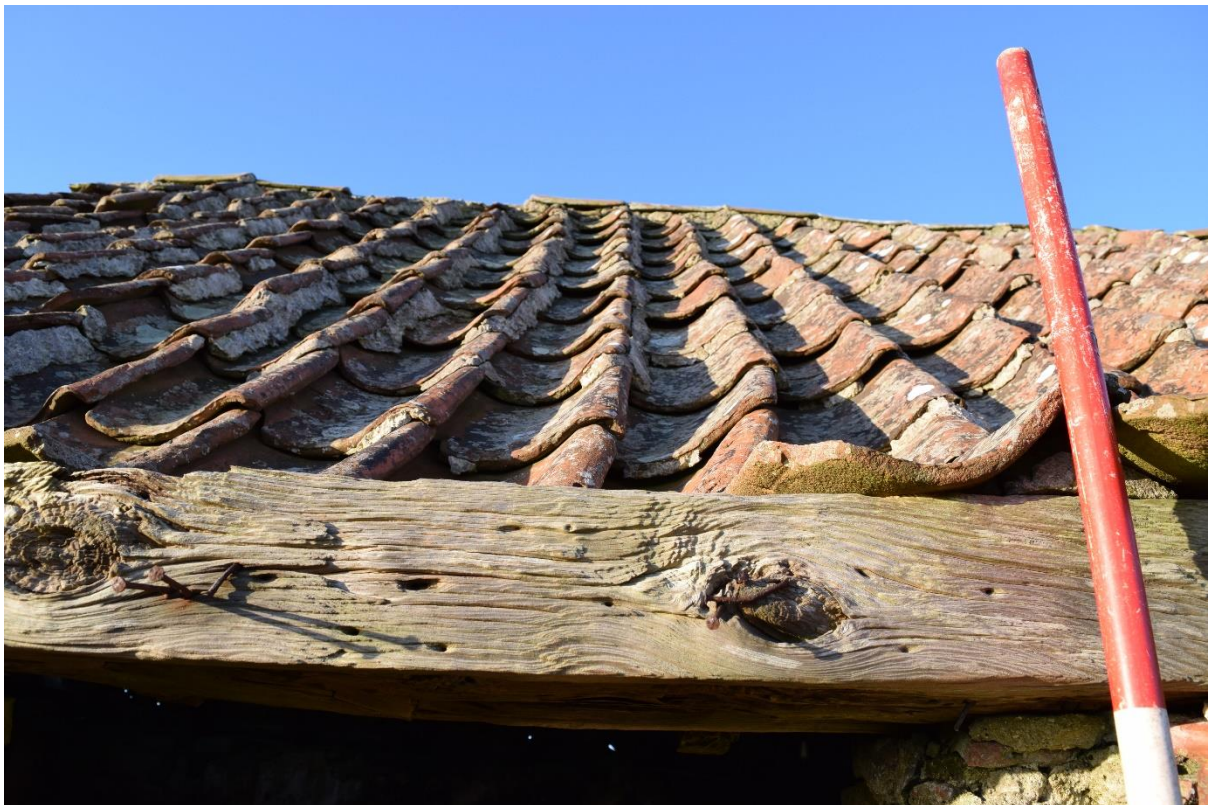
Illus 8 Pantile roof detail above D3; facing W

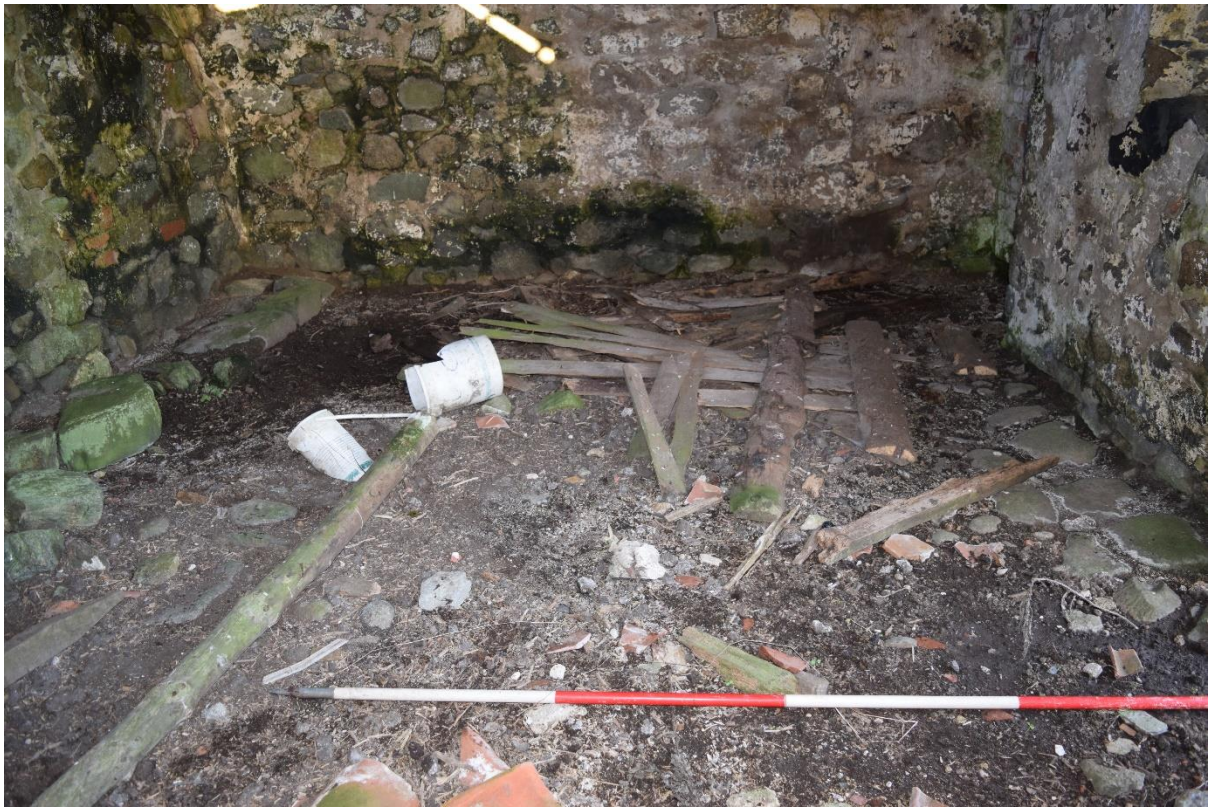
Illus 9 Building 2 Room 1 cobbled surface F7 with F6 (left); facing N

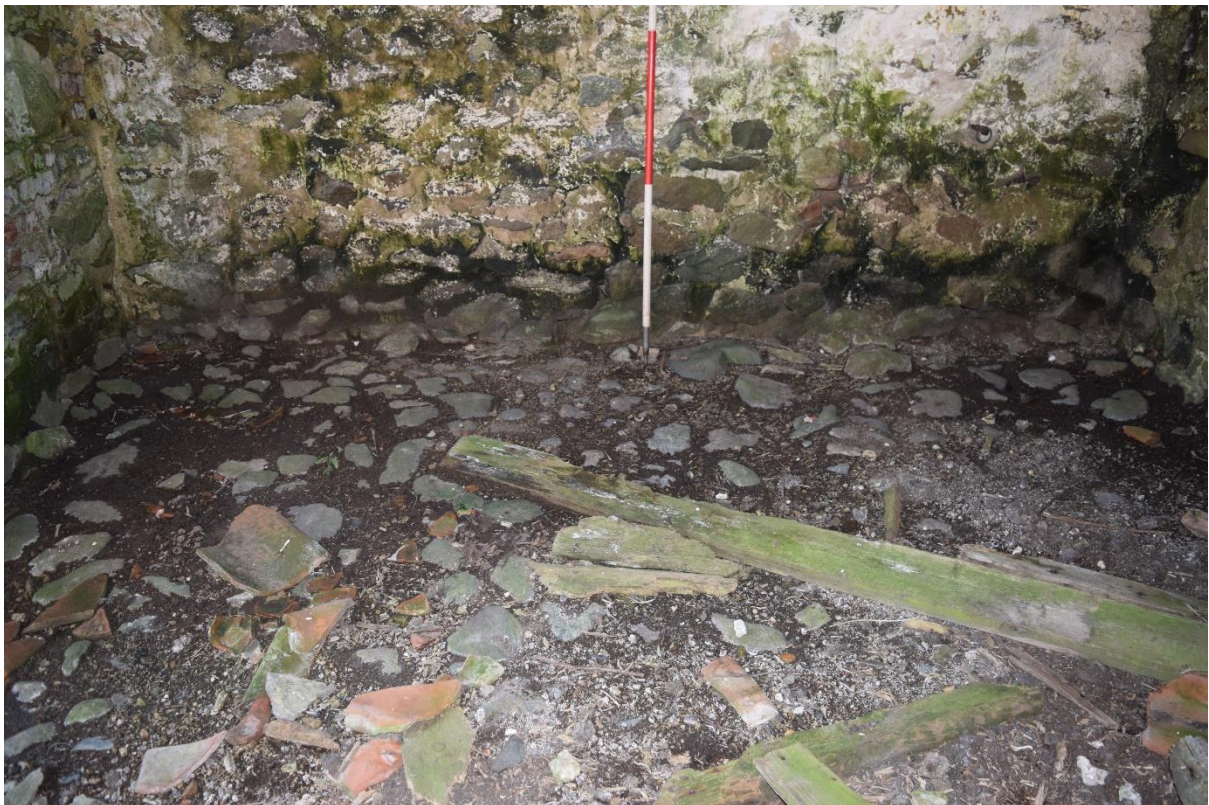
Illus 10 Building 2 Room 1 cobbled surface F8; facing S

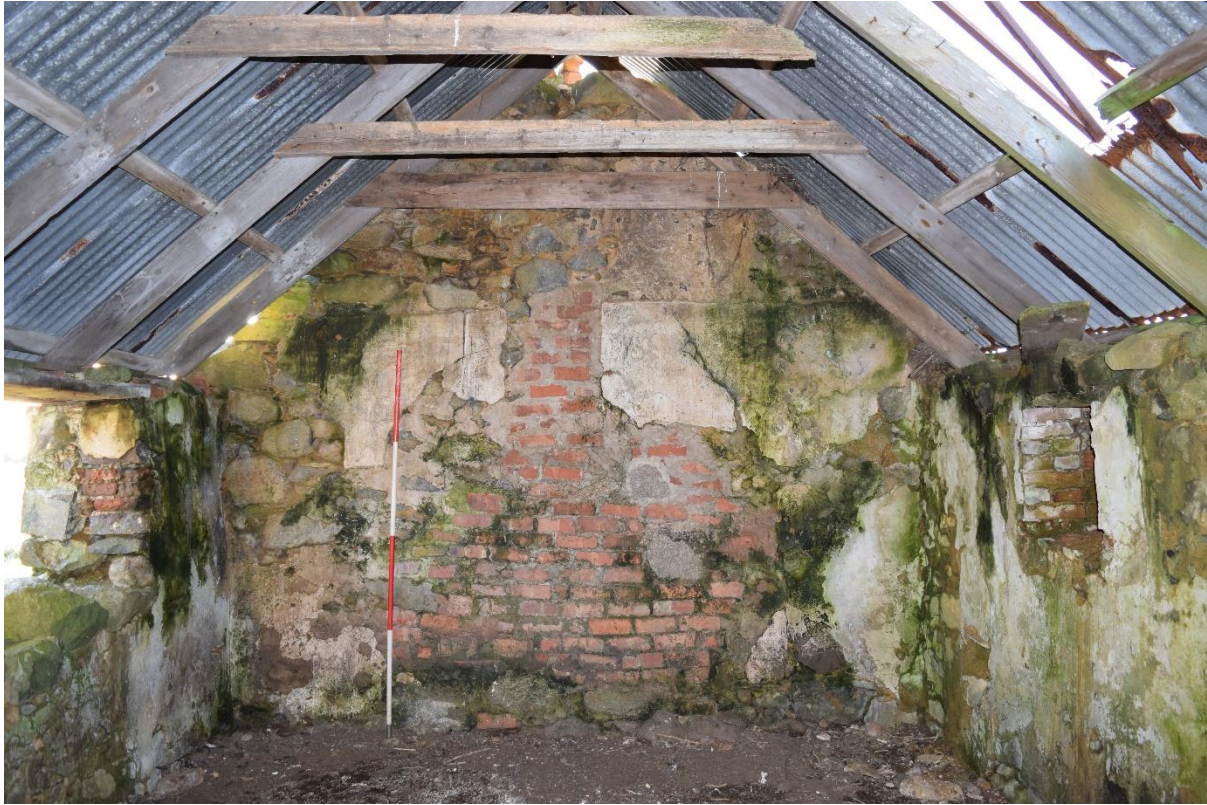
Illus 11 Building 2 Room 2 S wall with clay wall plaster; facing S
