Site At Burnside of Kirkbuddo, by Forfar, DD8 2NR
Report on Level 1 Standing Building Survey

Angus Council Planning Ref : 20/00201/FULL

Alison Cameron
Cameron Archaeology
21 July 2020

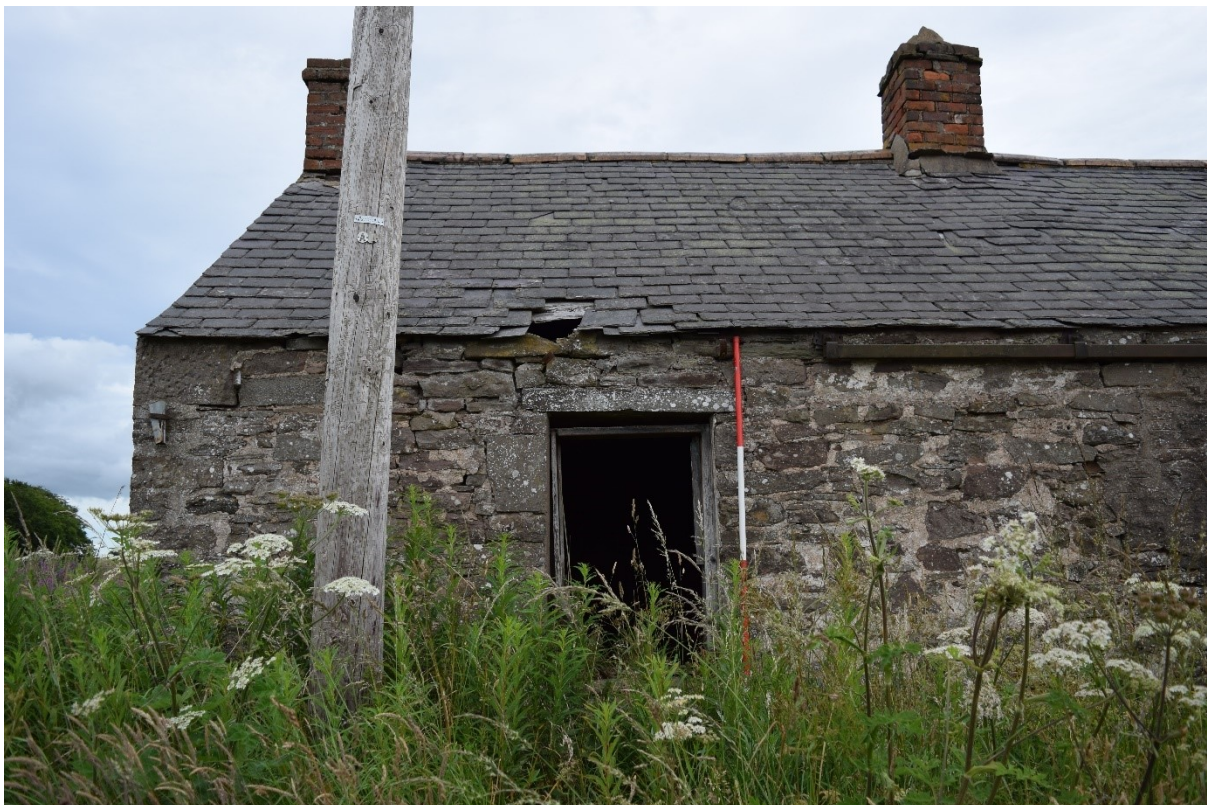
There are windows on the SW façade: W1 in Room 1 (Illus 4), W2 in Room 2 (Illus 5) and W4 (Illus 6) in Room 3 both blocked with stone and a possible blocked window W3 which has been infilled with brick and now forms the NW jamb of D2. D1 is inaccessible behind a rusted metal door and D3 may have been smaller but there is now no evidence of jambs on the SW wall of Room 4 (Illus 8).

Illus 4 Room 1 SW wall W1 with brick chimneys F1 (left) and F2 (right); facing NE

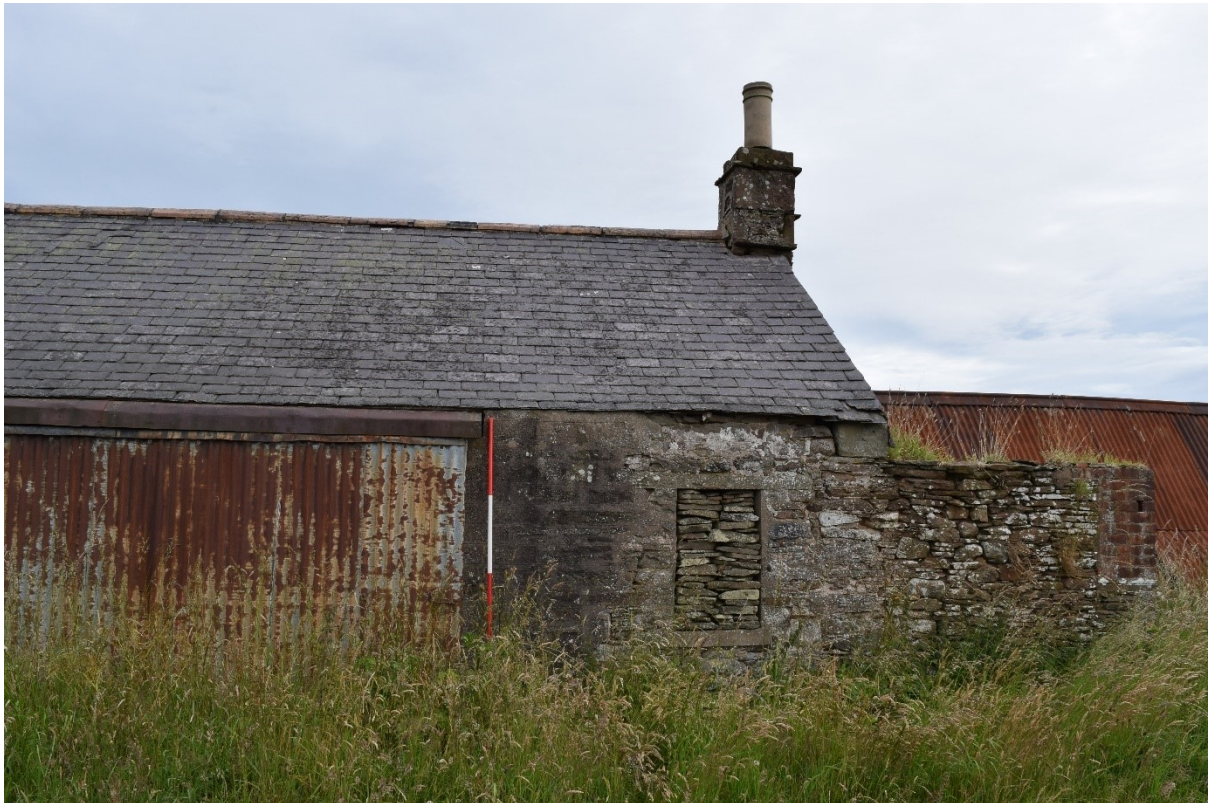
Illus 5 Room 2 SW wall D1 (left) blocked window W2 (centre); facing NE

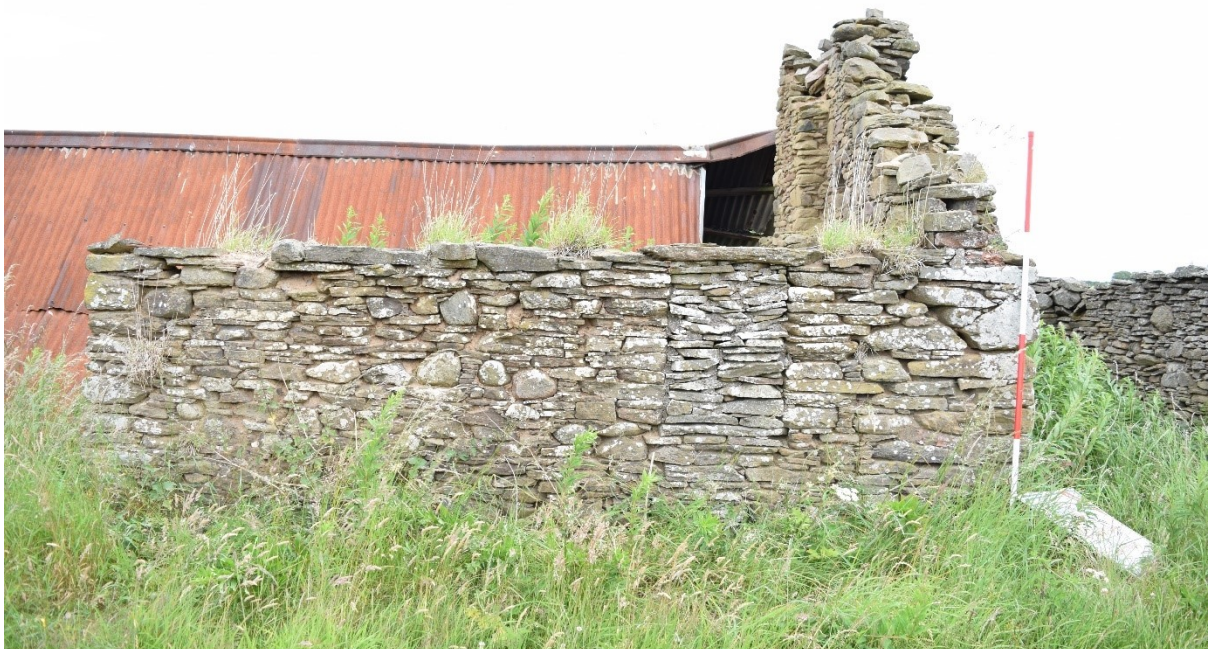
Illus 6 Room 3 SW wall blocked window W4; facing NE

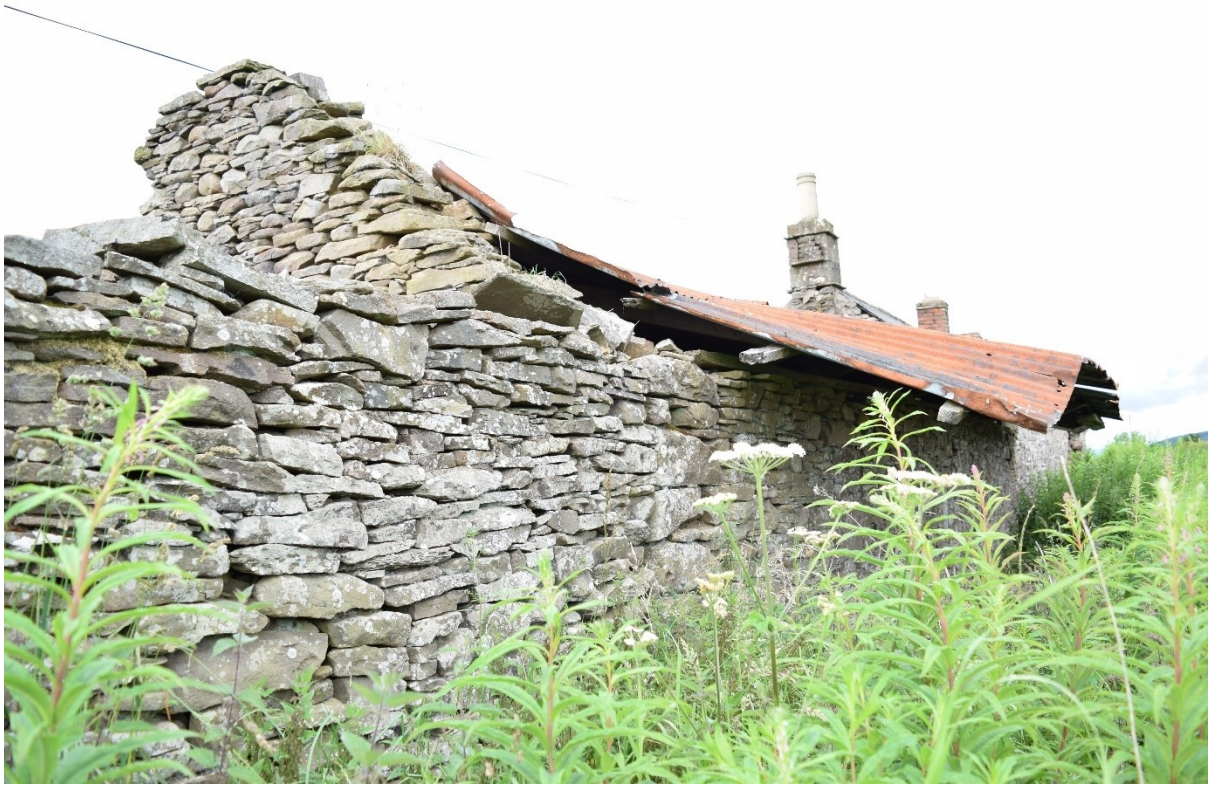
The building is 26.7m long and 5.3m wide. It is constructed of quarried sandstone and was built in one phase. There are 4 rooms: Rooms 1 and 2 are not accessible and have a grey slate roof. Room 3 is mostly not accessible as the corrugated metal roof has slipped to the NE (Illus 7). Room 4 is 5.3 x 2.8m in size and is overgrown and unroofed. Room 1 has a rotten wooden floor and a fireplace on the NW wall under brick chimney F1. There is also a brick chimney above the gable between Rooms 1 and 2 and a stone chimney above the SE gable of Room 2. The chimney which had stood above the SE gable of Room 3 has now fallen. There is a stone standing proud from the NW wall of Room 4 (F4) but the room is completely overgrown with rubble on the floor and it is not possible to tell what this stone was associated with.

Illus 7 NE wall showing slipped corrugated metal roof; facing WNW

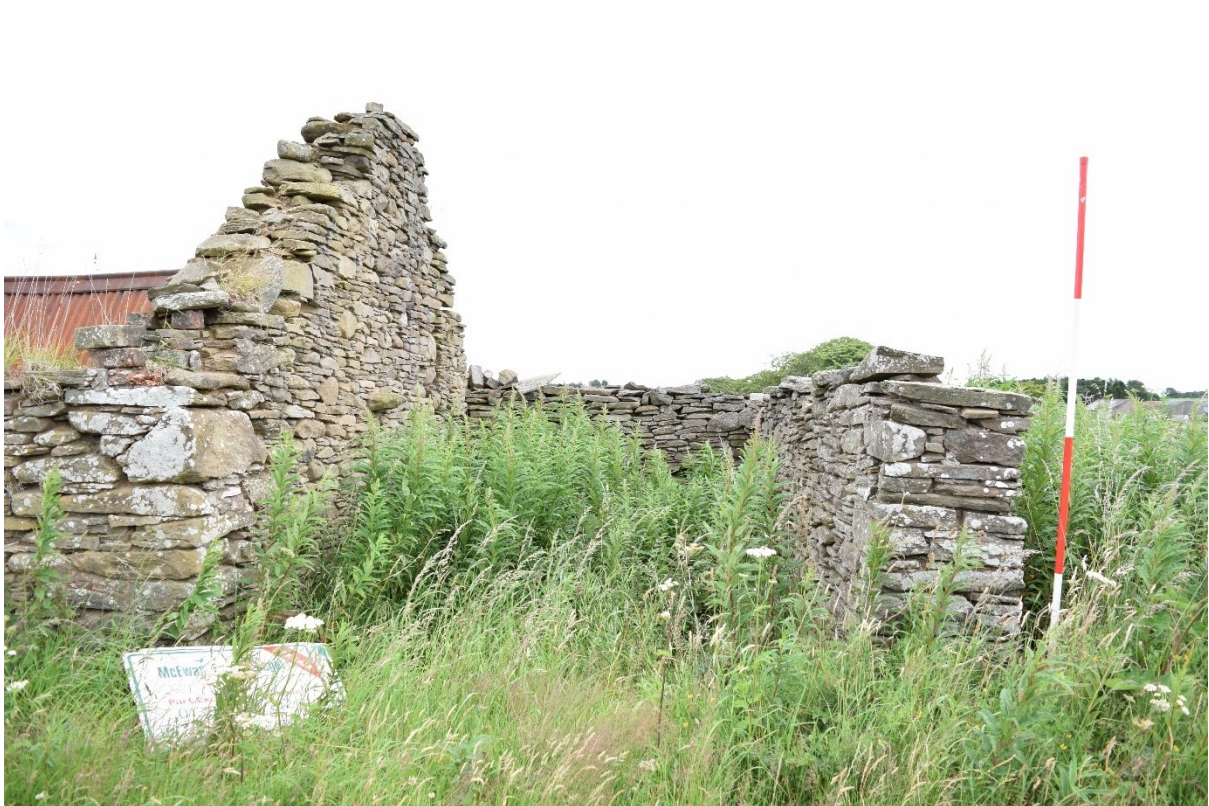
Illus 8 Room 4 SW wall; facing NE
