**Steading 60 Metres North East Of Islabank House,  
Coupar Angus  
Data Structure Report, Historic Building Survey**

**Perth and Kinross Council 20/00282/FLL**

**Alison Cameron  
Cameron Archaeology  
24 September 2020**

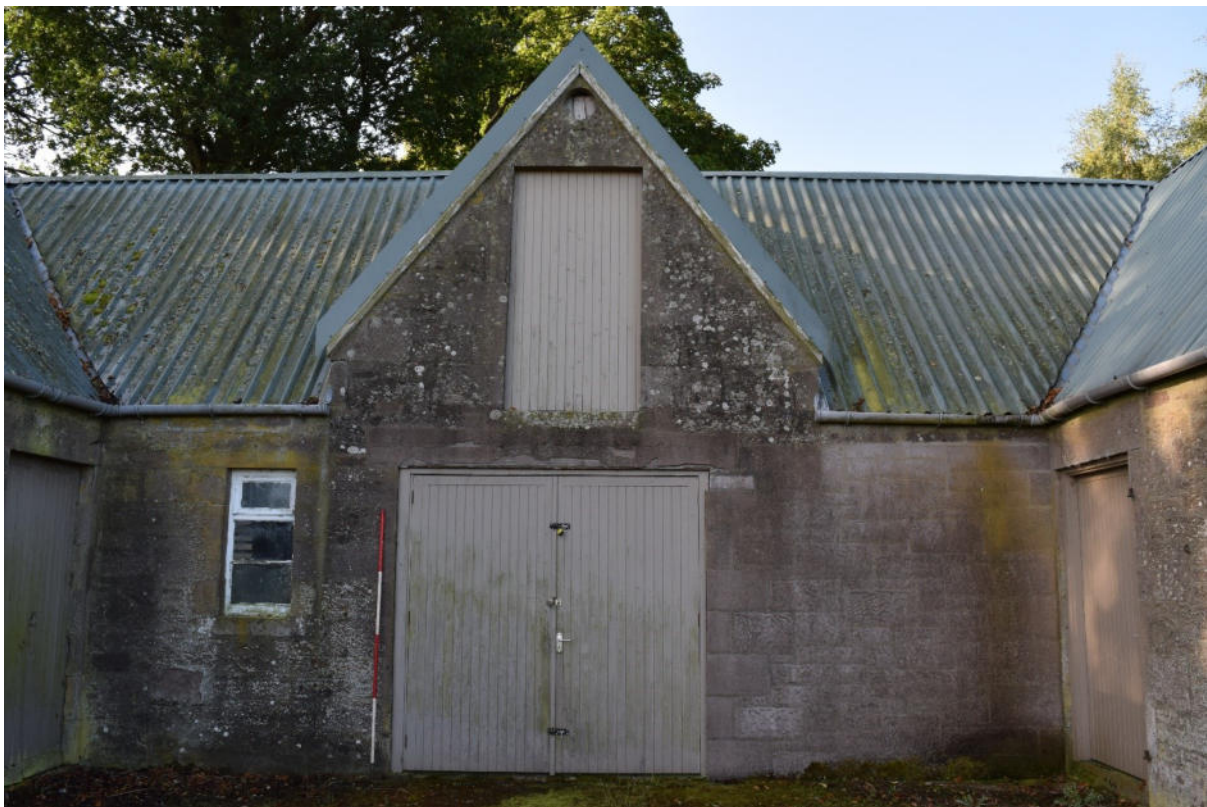
Illus 7 D4 (centre) with W4 (left) and infilled D8 (right); facing SW

As mentioned above the main building was constructed in one phase but in a later phase Rooms 1-4 were joined by removal of internal walls and D8 one of the cart doors was blocked and D4 was rebuilt with steel lintel and brick jambs. The upper floors were removed. The walls of Room 5 were partially demolished, and the SW wall of Room 7 was demolished, and the area concreted to form a yard.

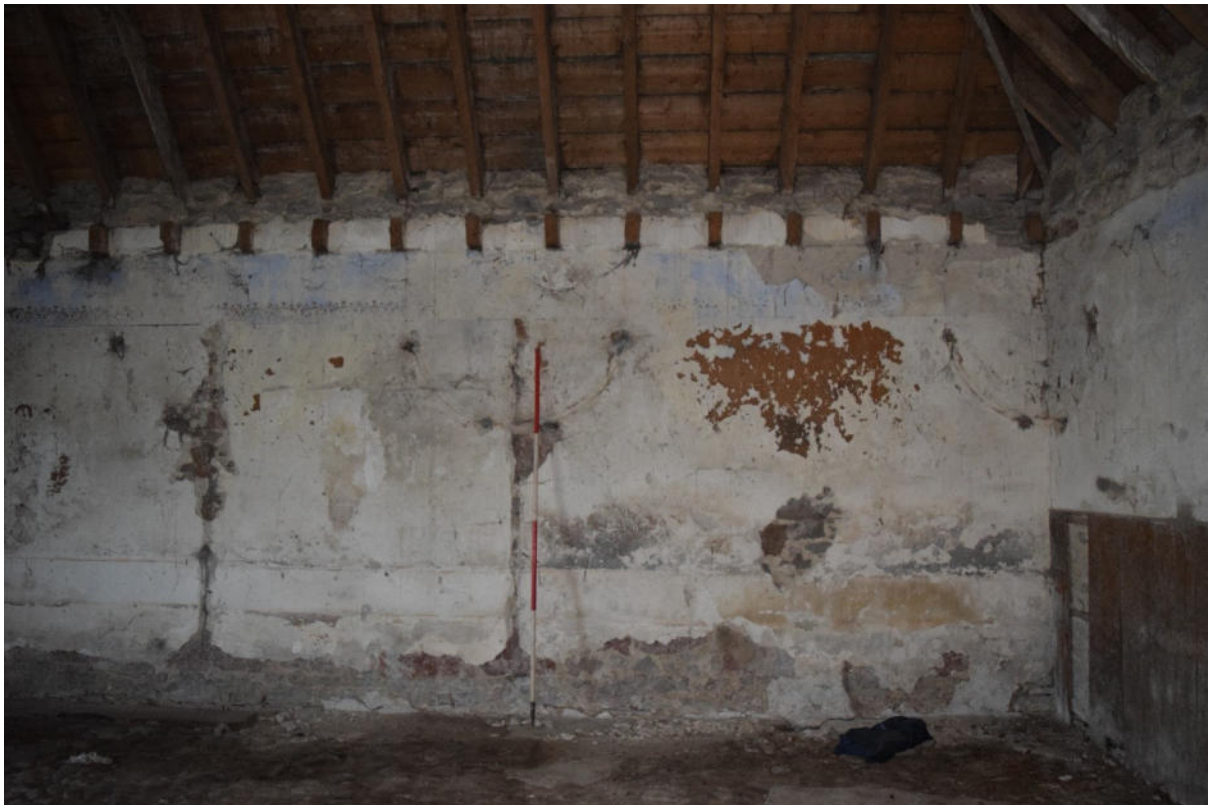
Illus 8 Room 1 SE wall scars from removal of stalls; facing SE

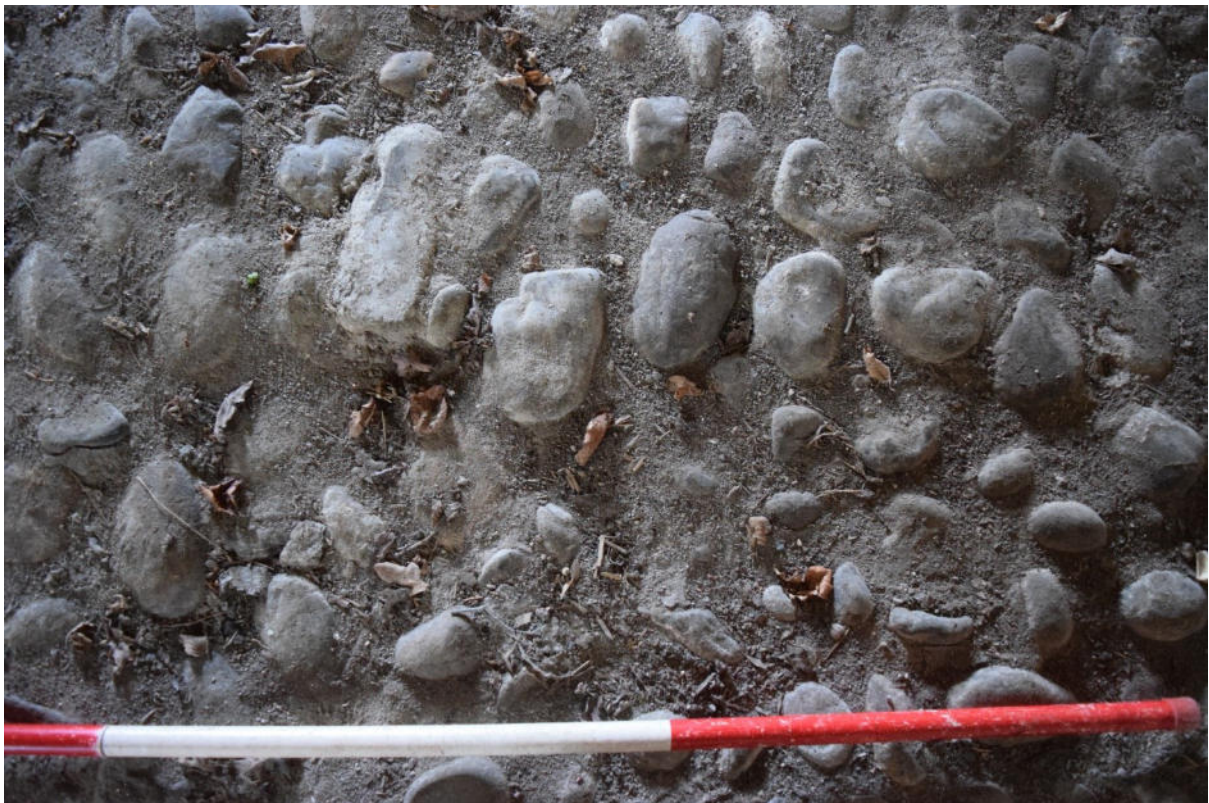
Illus 9 Detail of waterwashed cobbles F6

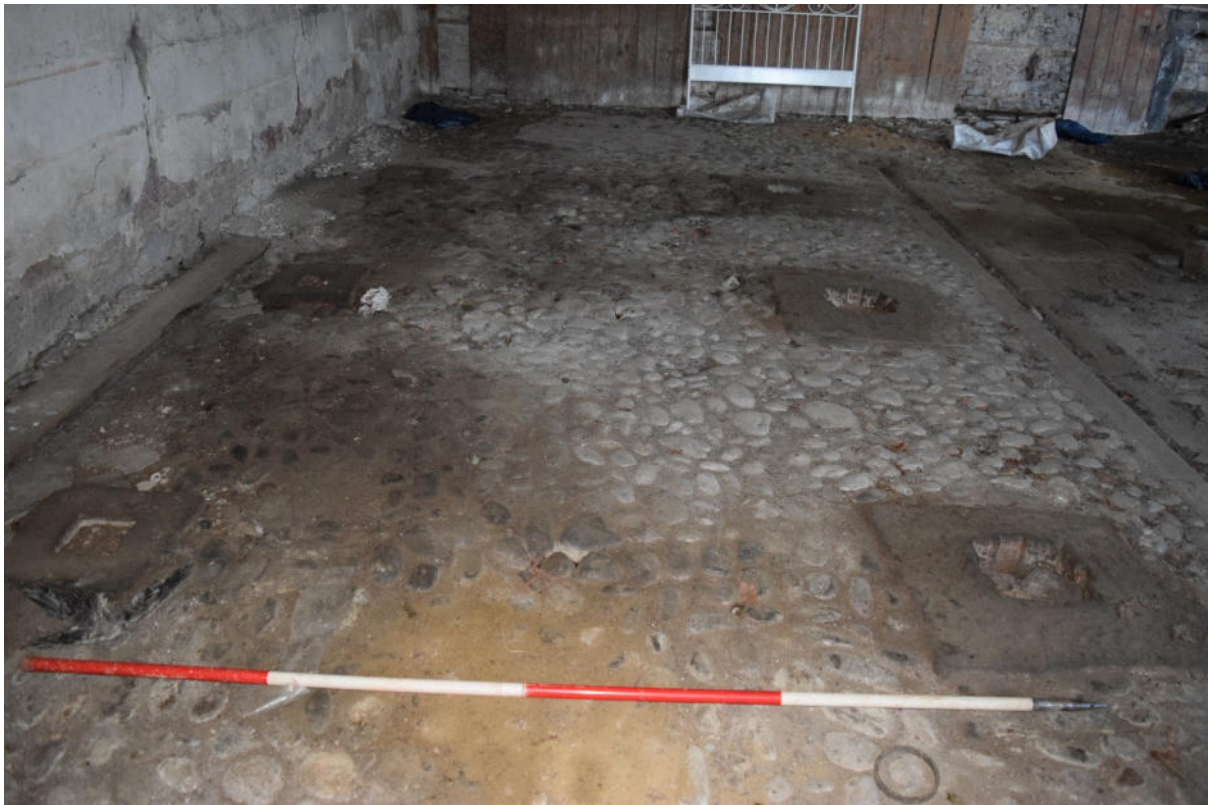
The steading consists of 6 rooms: Room 1 was stabling for animals. There is a window on the SW wall (W2) and one on the NE wall (W3) and two doors (D6, D7) on the NW wall to access the building from the courtyard. It has plastered walls and a waterwashed cobble floor (F6; Illus 9, 10) with a concrete drain F7 and stone blocks with post-holes for the uprights for stalls (F8-F13) in two lines of three. F8, 9 and 10 are 0.65x0.67m in size with a hole c0.25m diameter. F11, 12 and 13 are 0.4x0.4m in size with a hole 0.15m diameter. There are scars on the SE wall where the stalls have been removed (Illus 8). There is a concrete floor on the NW side of the room inside door D7.

Illus 10 Room 1 cobbled floor F6 with postholes for stalls F11-f13 (left), F10-F8 (centre right) and concrete channel F7 (right)

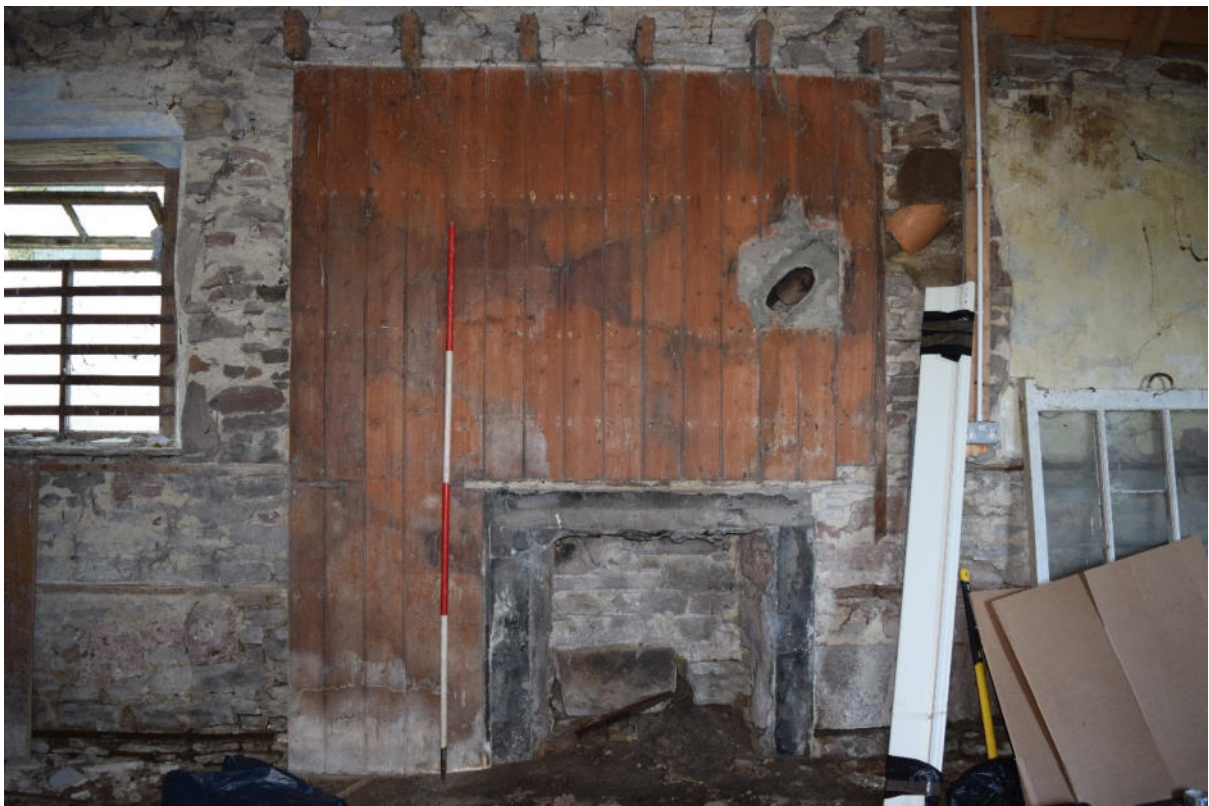
The walls of Room 2 have been removed but it was a small wood-paneled room with fireplace (F4) on the SW wall (Illus 11); F4 has a sandstone surround and is 0.92mx0.92m in size and 0.42m deep. There is a window on the NE wall of Room 2 and there is now an earthen floor; the room was presumably used as a bothy for staff. Room 3 has also had the walls removed and has stone slabs (max 0.5 x 0.8m in size) on the floor (Illus 12) and originally had two cart doors on the NE wall. D4 is still open but the lintel has been replaced with a steel beam covered with concrete to mimic the tooled sandstone and the jambs replaced so its original width cannot be determined. D8 has been infilled with concrete blocks which have also been covered with textured concrete to mimic tooled sandstone. These two large doors suggest that Room 3 was a garage for vehicles. Room 4 has a concrete floor and plastered wall and has a window W1 on the SW wall, large door D5 on the NE wall and smaller door on the SE wall. The room may have been divided but has been in general agricultural use.

Illus 11 Room 2 SW wall W2 (left) fireplace F4 (centre) with wooden paneling

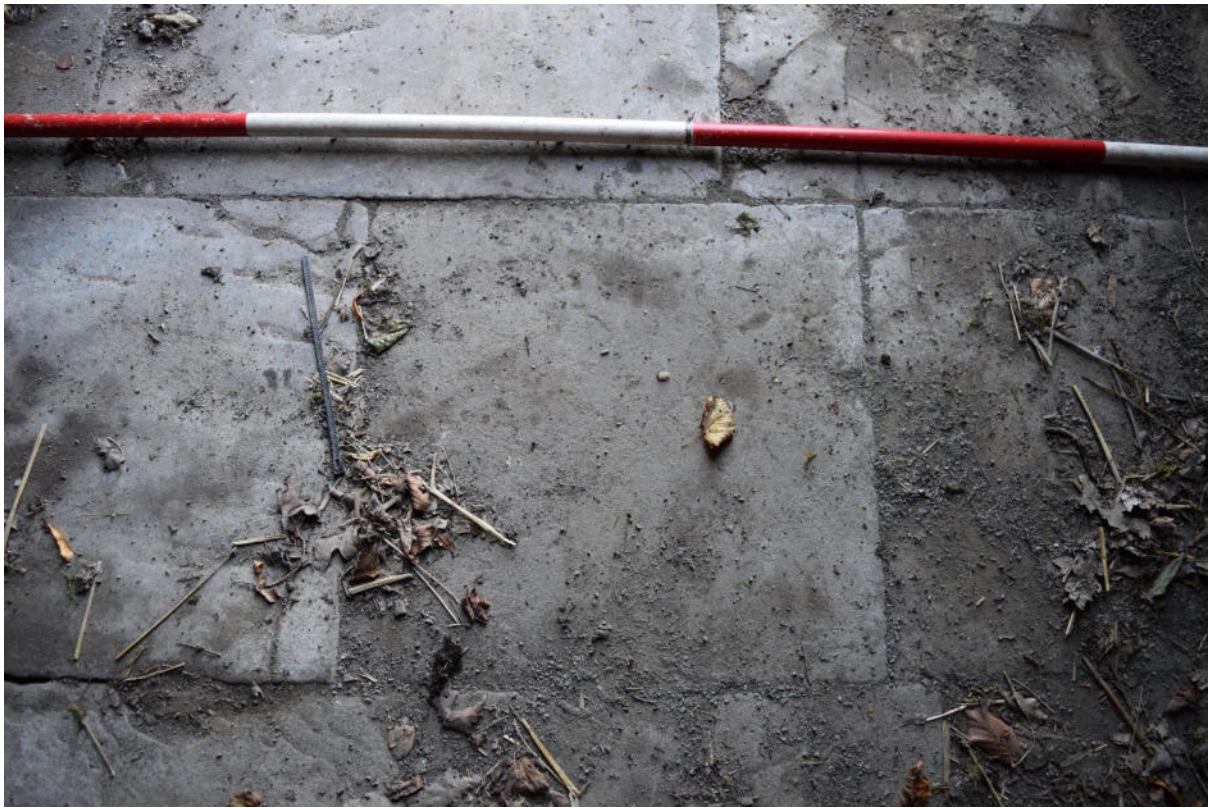
Illus 12 Stone slab floor of Room 2; facing SE

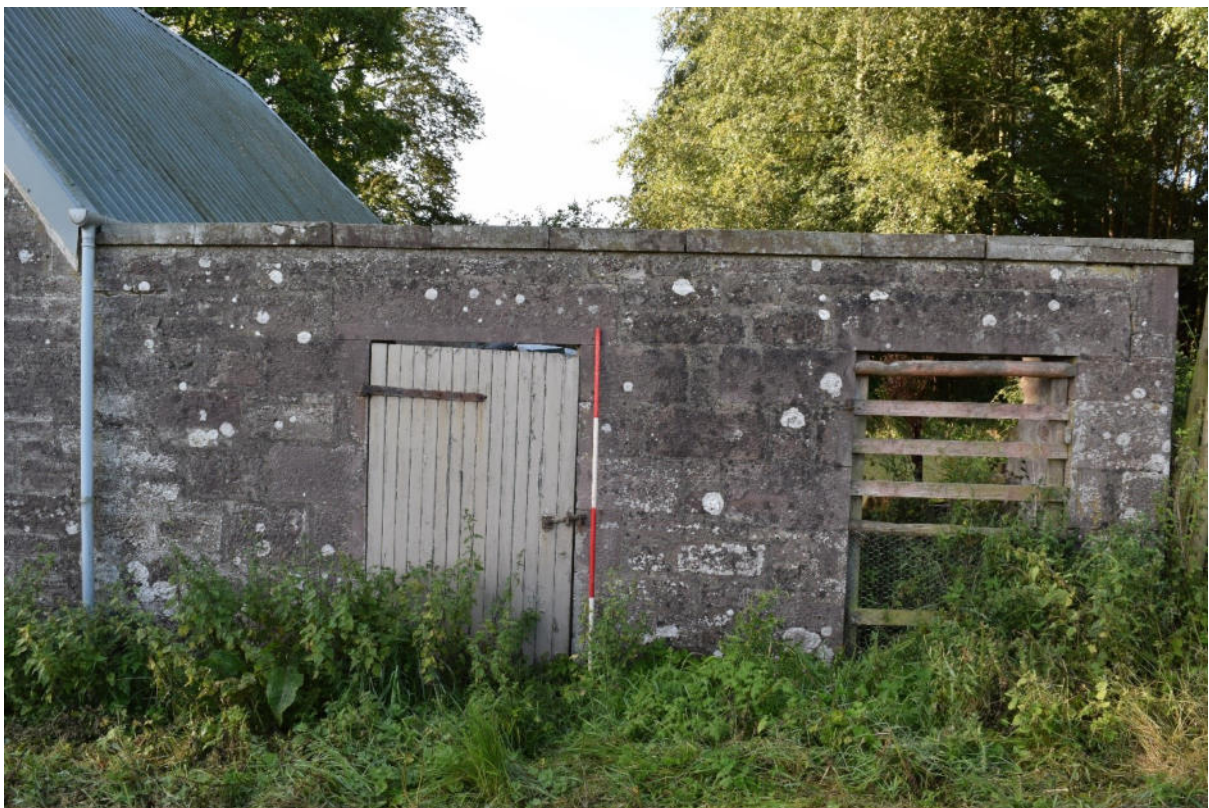
Illus 13 Rooms 6 and 7 with D10 (left) and D11 (right); facing SW

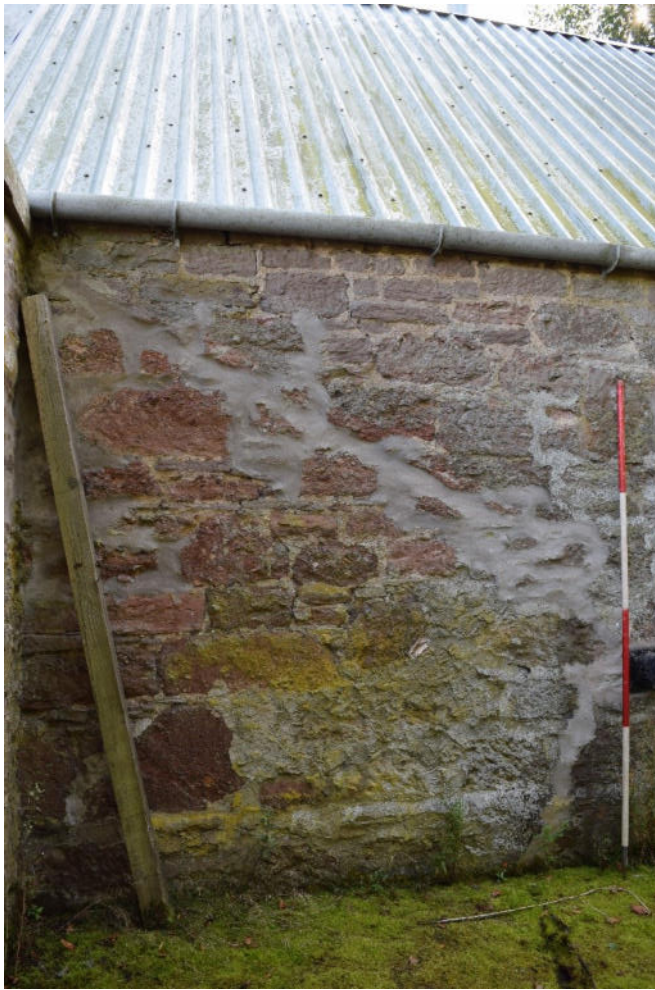
Rooms 5 and 6 form a small building 6.3x2.7m in size with walls 0.6m thick which is attached to the NW wall of the steading and appears to have been built at the same time. There are two small rooms each with a door (D10, D11; Illus 13) and the building has had a sloping roof which has been removed; the scar, F16, from the roof can be seen on Elevation 3 (Illus 6, 14). The walls of these rooms have been reduced and the area is overgrown so no internal fittings were recorded. The SW wall of Room 7 has been removed and the area concreted to form an exterior yard where the modern oil tank is sited.

Illus 14 Elevation 3 scar after removal of Room 6 F16; facing SE
