**Nether Bankhead Croft Cottage, Midmar,
Aberdeenshire, AB51 7QJ
Report on Level 1 Standing Building Survey**

**Aberdeenshire Council planning application
APP/2020/1279**

**Alison Cameron
Cameron Archaeology
26 October 2020**

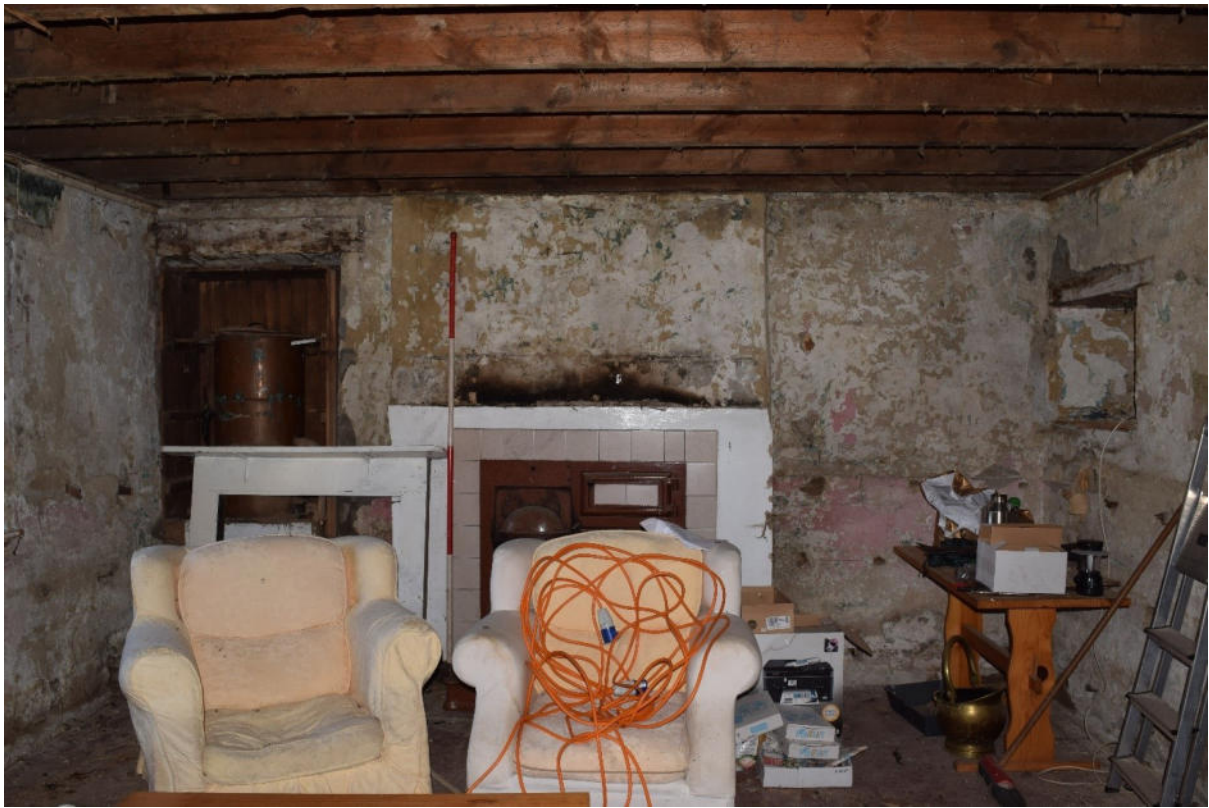
Illus 6 Room 3 S wall alcove F5 (left), stove F4 (centre), window W10 (right); facing S

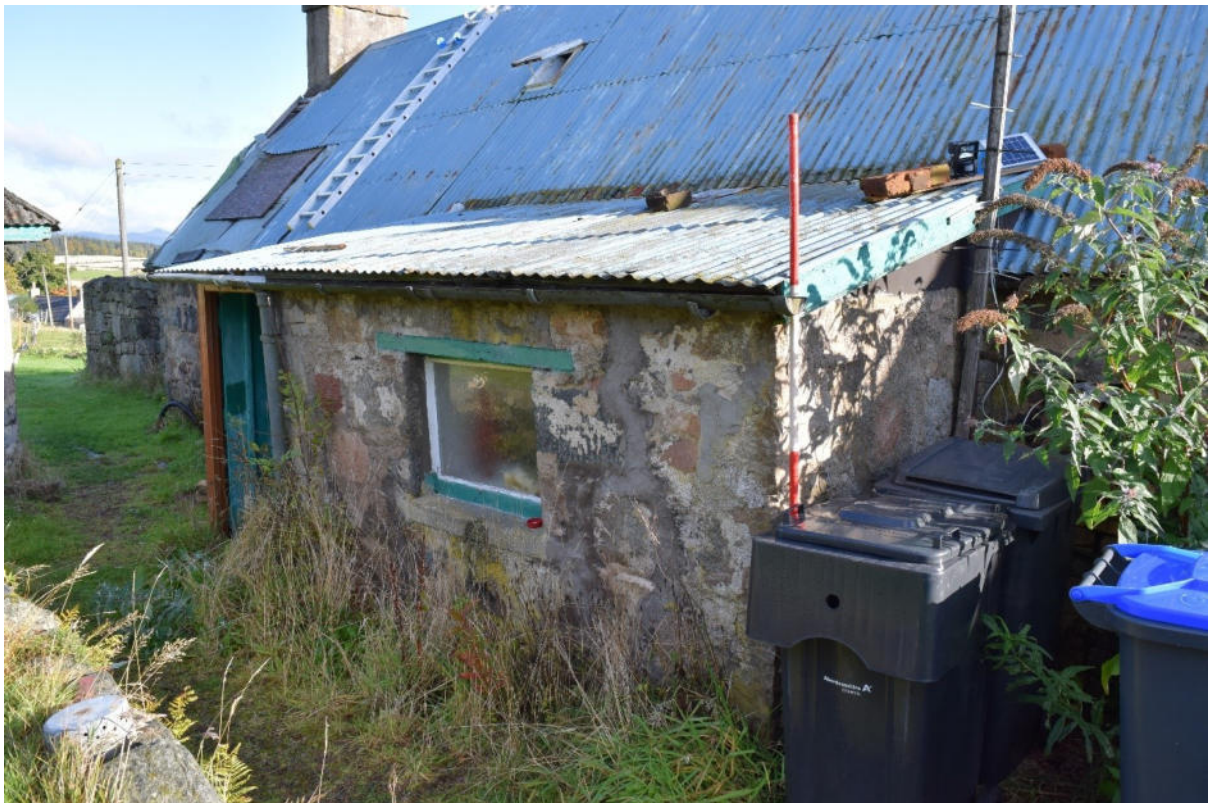
Illus 7 Porch Room 6 with Room 7 (left); facing NE

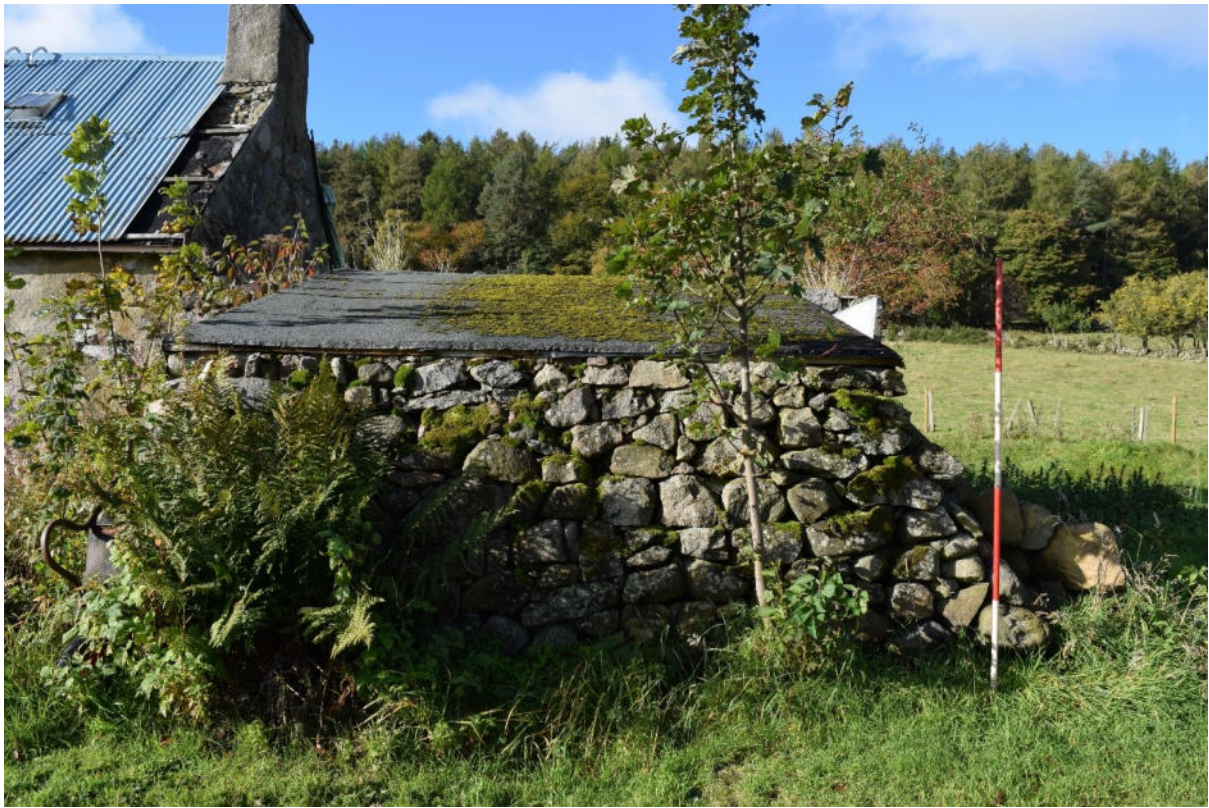
Illus 8 Room 5 E wall; facing W

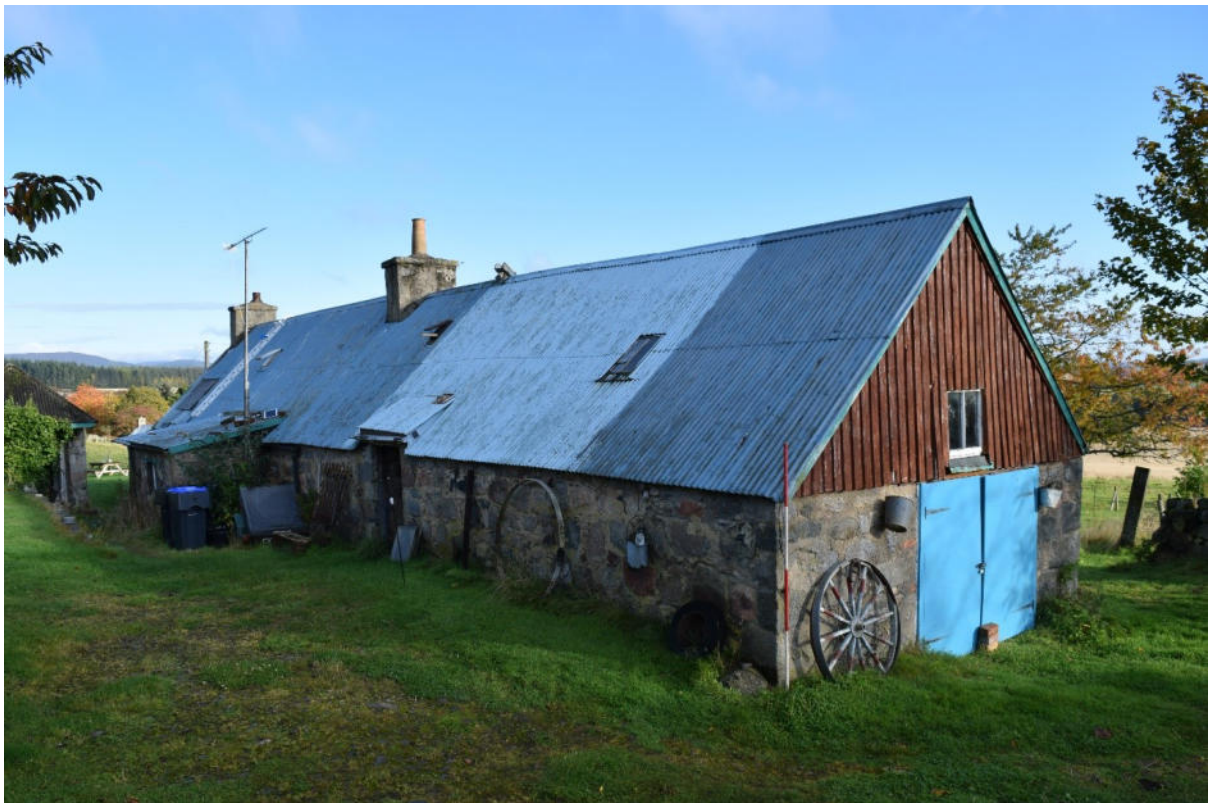
Illus 9 Steading from SW; facing NE

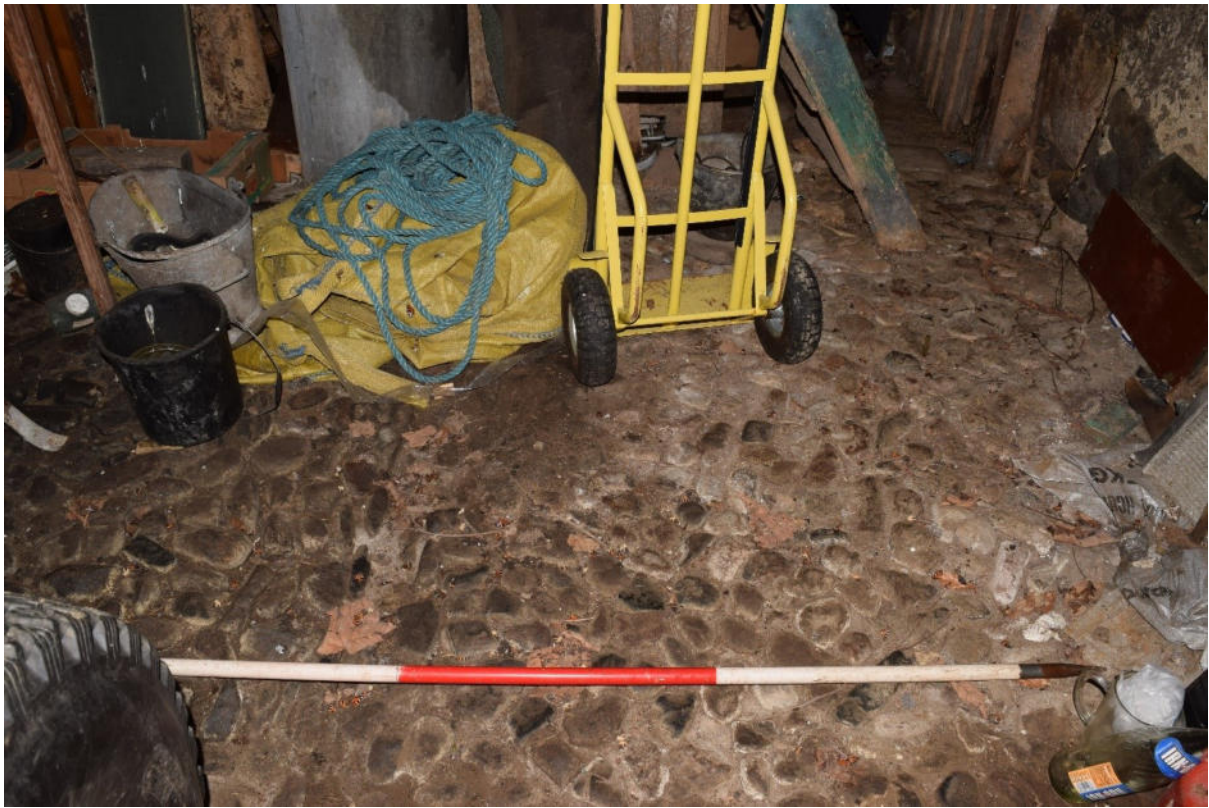
The steading is formed by Rooms 1 and 2; it is now a single storey but was originally a ground and first floor attic. Room 1 has cobbled stone floor with channel (or greip; F8) running N-S with a door (D2) on the E wall later converted to a window. There is a large door on the S gable (D1) and window above (W1). There is a wooden staircase (F3) but there is no access as it is in poor condition. Room 2 has an earthen floor, door (D8) on the W wall and window W2 on the E wall. There are 3 wooden ceiling supports (F19). There is a garden wall F15 parallel to Building 1 and attached to Building 2.

Illus 10 Room 1 cobbled floor F8

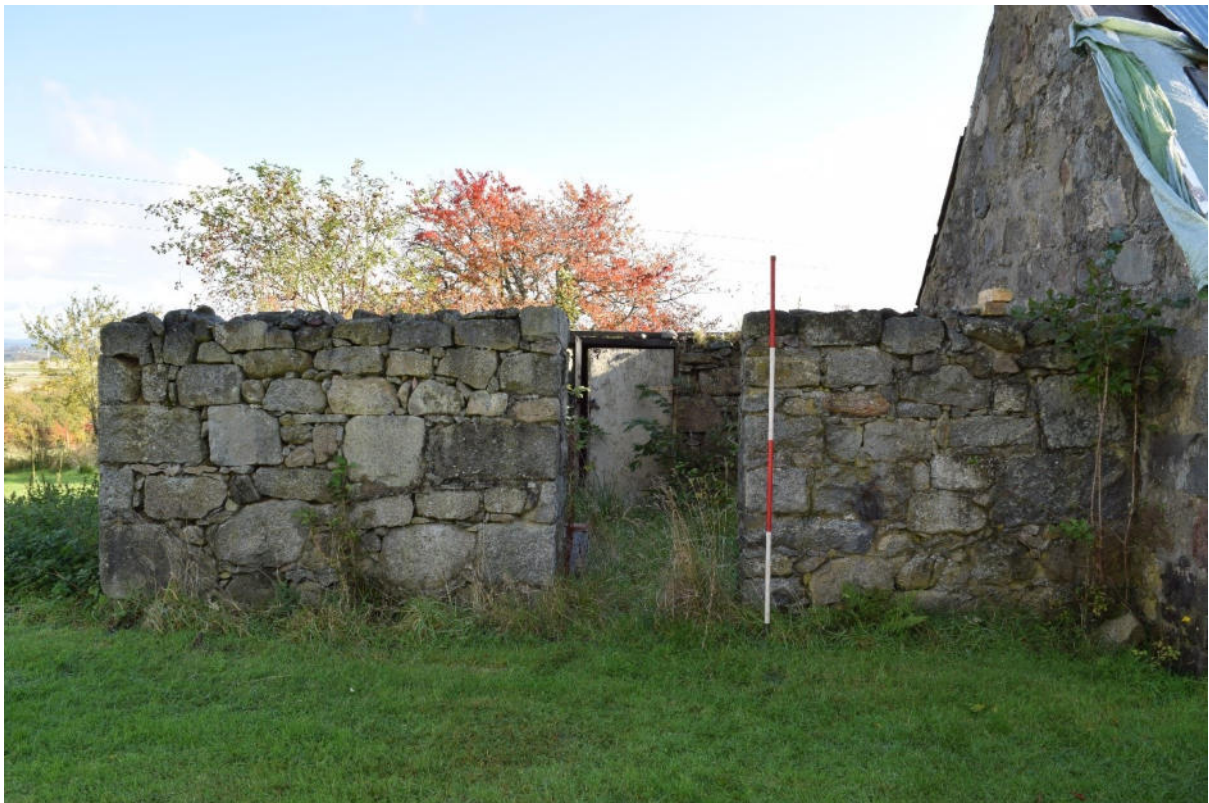
Illus 11 Room 4 with D6; facing E

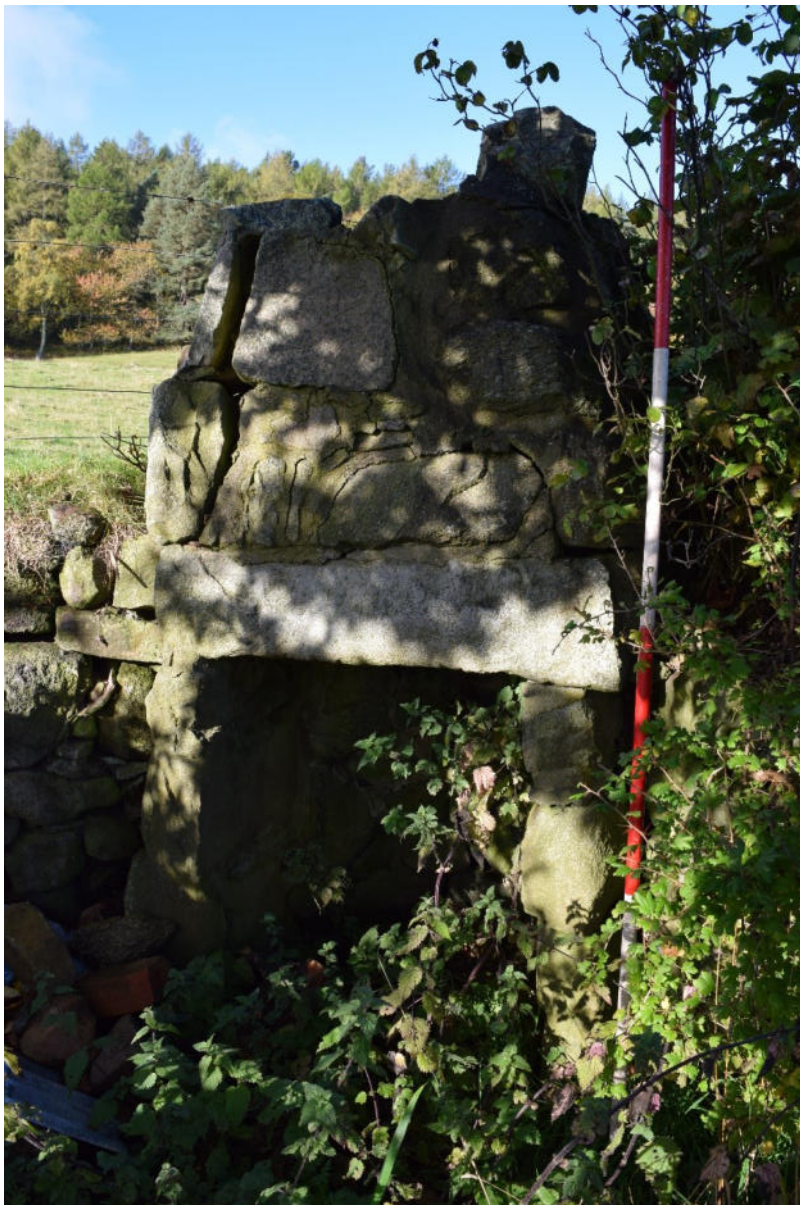
Building 4 appears on the 2nd Edition OS map. It survives as part of a garden wall and a small stone 'cupboard' which may have been for food storage such as a meat safe.

Building 4 stone 'cupboard'; facing NNW

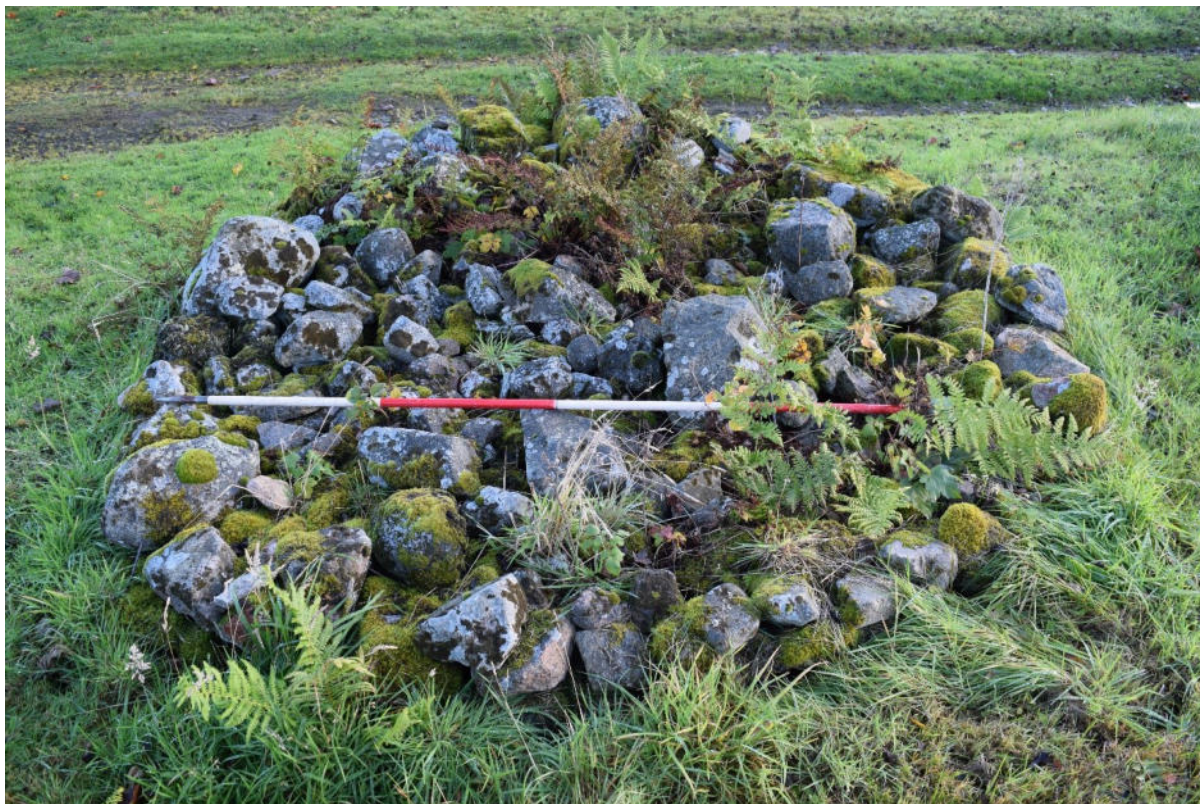
Six stone stack bases were constructed in the area of a small building on the 1st (when it was unroofed) and 2nd Edition OS map and are therefore later than 1899. They may have been constructed using the stone from this demolished building. They are circular, 3.1-3.7m in diameter and up to 0.8m high.

Illus 12 Stack base F12; facing E

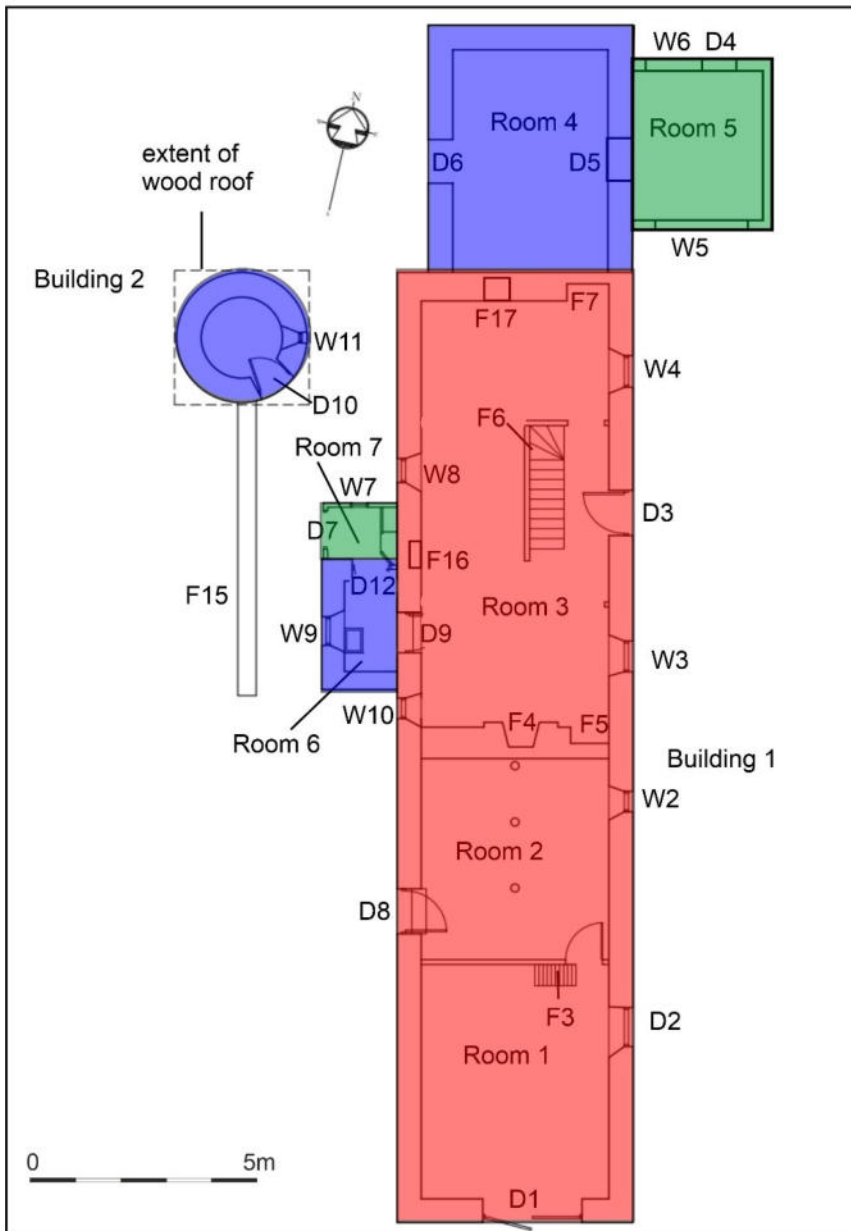
Illus 13 Phase plan: Phase 1 (red) Phase 2 (blue) Phase 3 (green) (copyright Gordon Gauld)
