**Reinacharn Bothy, Tarland,  
Aberdeenshire, AB34 4XT**

**Report on Level 1 Standing Building Survey**

**ABERDEENSHIRE COUNCIL PLANNING APPLICATION APP/2021/1737**

**Alison Cameron  
Cameron Archaeology  
14 October 2021**

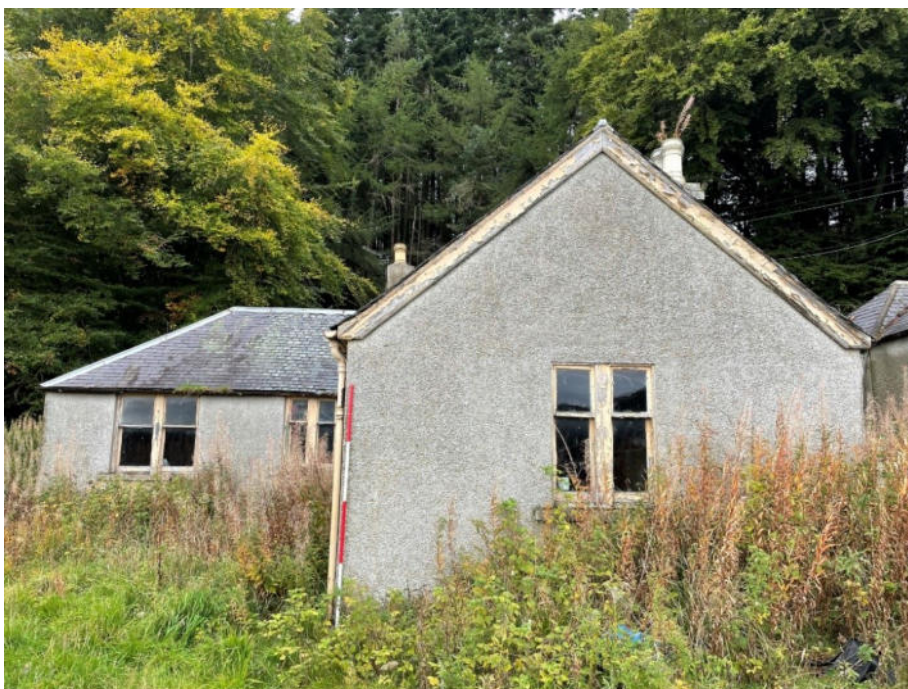
Illus 4 Building 1 from E

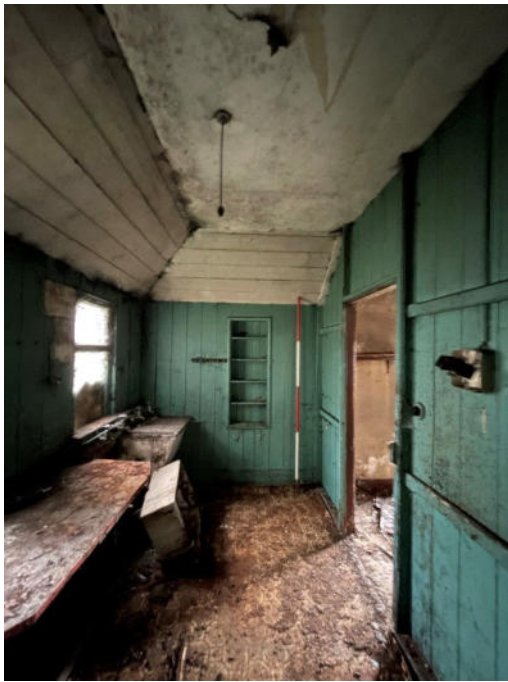
Illus 5 Room 4 showing wood paneling and W31 (left); facing E

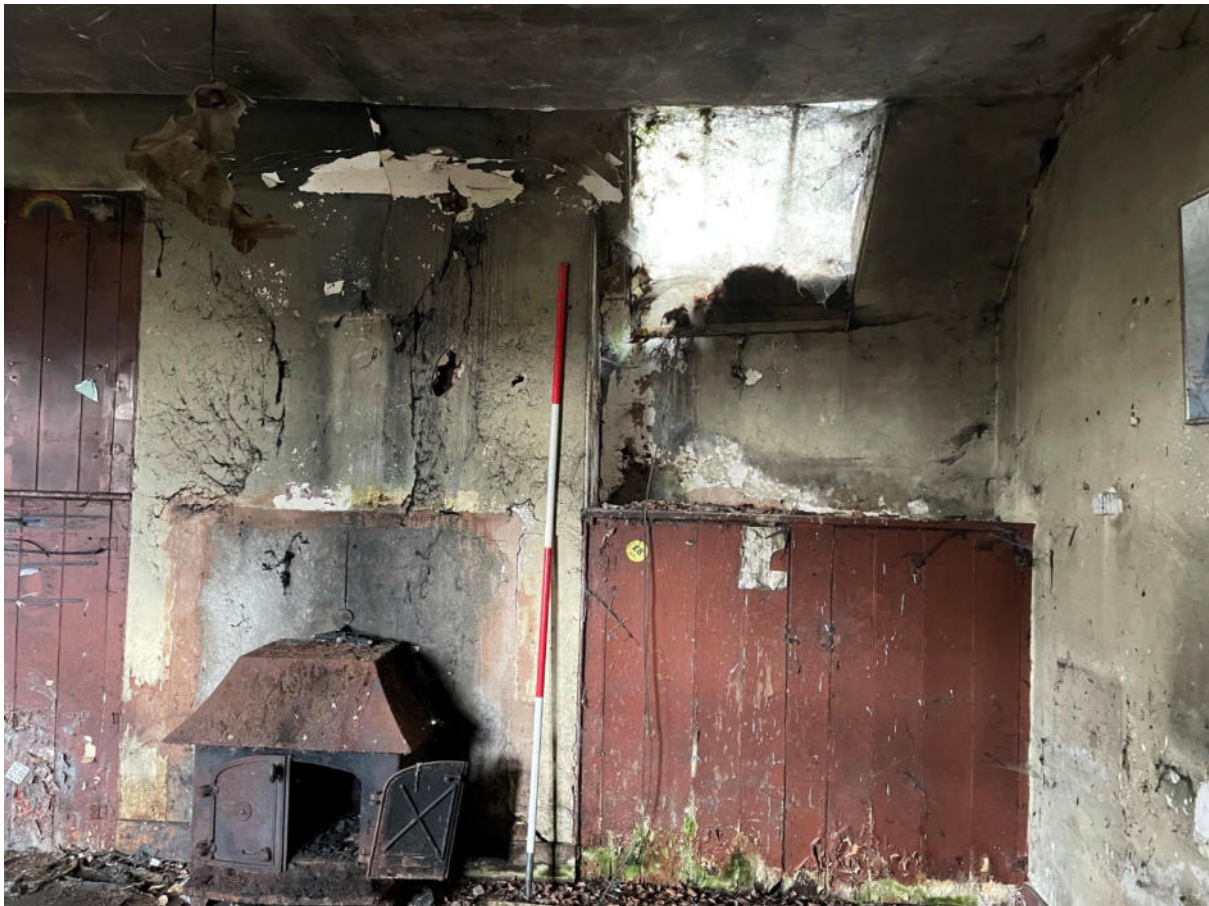
Illus 6 Room 5 W wall fireplace F1; facing W

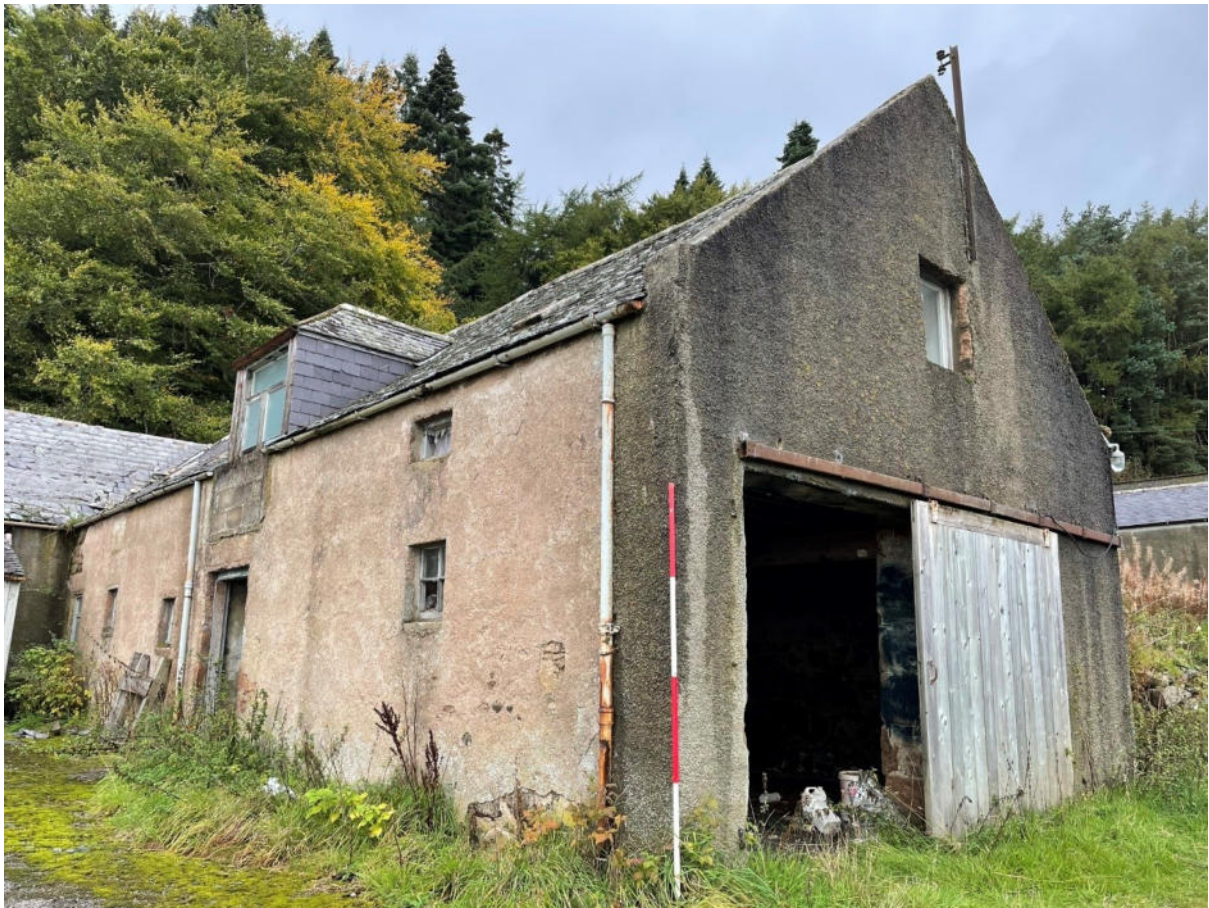
Building 2 is 24.8m N-S and 20m E-W. The first phase of the building is the stable block (Rooms 12 and 13); it is possible that the N and W wings of this building are contemporary but alterations and areas which are inaccessible make this impossible to confirm. It is 14x6.1m in size with stone walls 0.6m thick. Room 12 is the stables with a red brick floor

Illus 9 Room 13 (right), Room 12 (left); facing NW

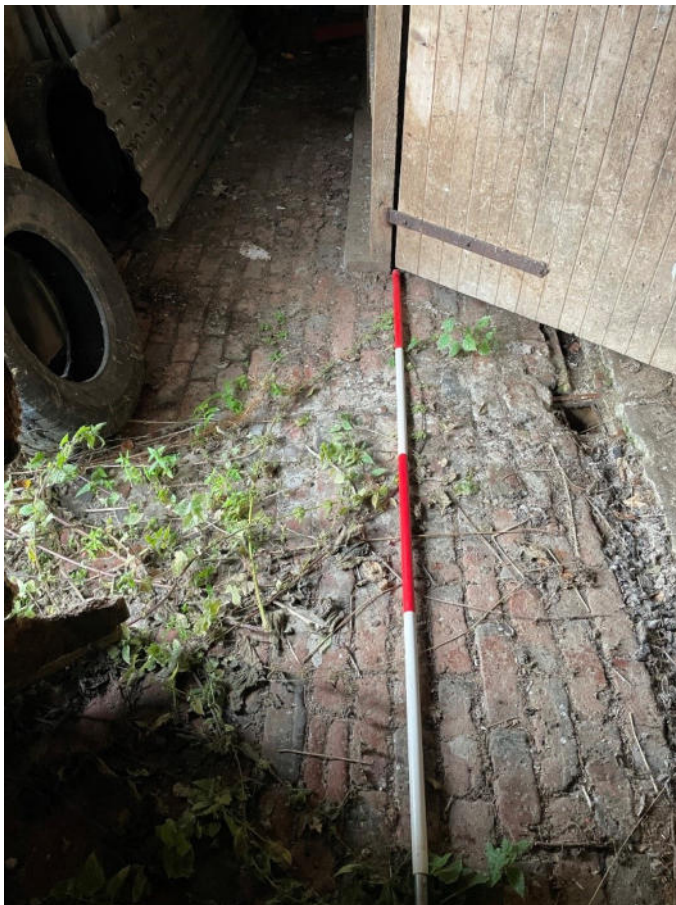
(F5); the bricks are 22.5x8cm in size. In the area of the stalls concrete floor has been laid (F6) with octagonal wood uprights (F7 and F8) forming the ends of the stall dividers. The room has two windows on the N wall (W30 and W31), small windows on the S wall W16, W17 and W19 on the ground floor and upper window W18. There is a door D7 and above that is a former door (D6) which has been partially blocked with concrete; a door on the N wall of this building (D12) is not accessible. The W wall is also in concrete block, presumably added when the W wing was constructed (or when it was converted if they are contemporary). Room 13 has a concrete floor, windows on the S wall (W20, W21) and large cart door on the E wall (D8) and smaller door (D9) with window (W22) on the upper floor (not accessible). There is a concrete block on the floor (F9) with metal fittings where a piece of machinery has been sited. This may have been the former smithy associated with the stables. There are rooflights on the S facing roof (W32-35).

Illus 10 Room 12 brick floor F5; facing W

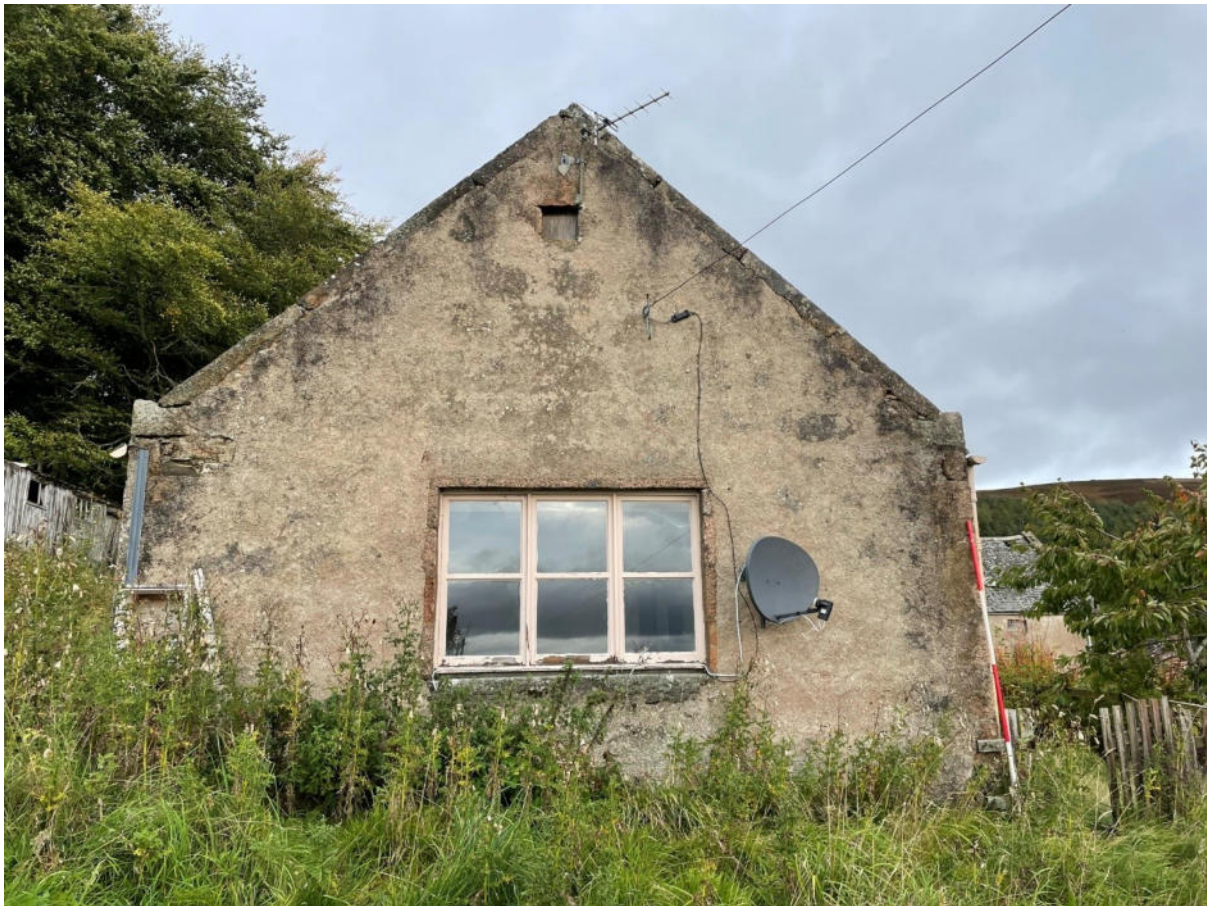
Illus 11 Room 6 S wall W14 (below) W15 (above); facing N

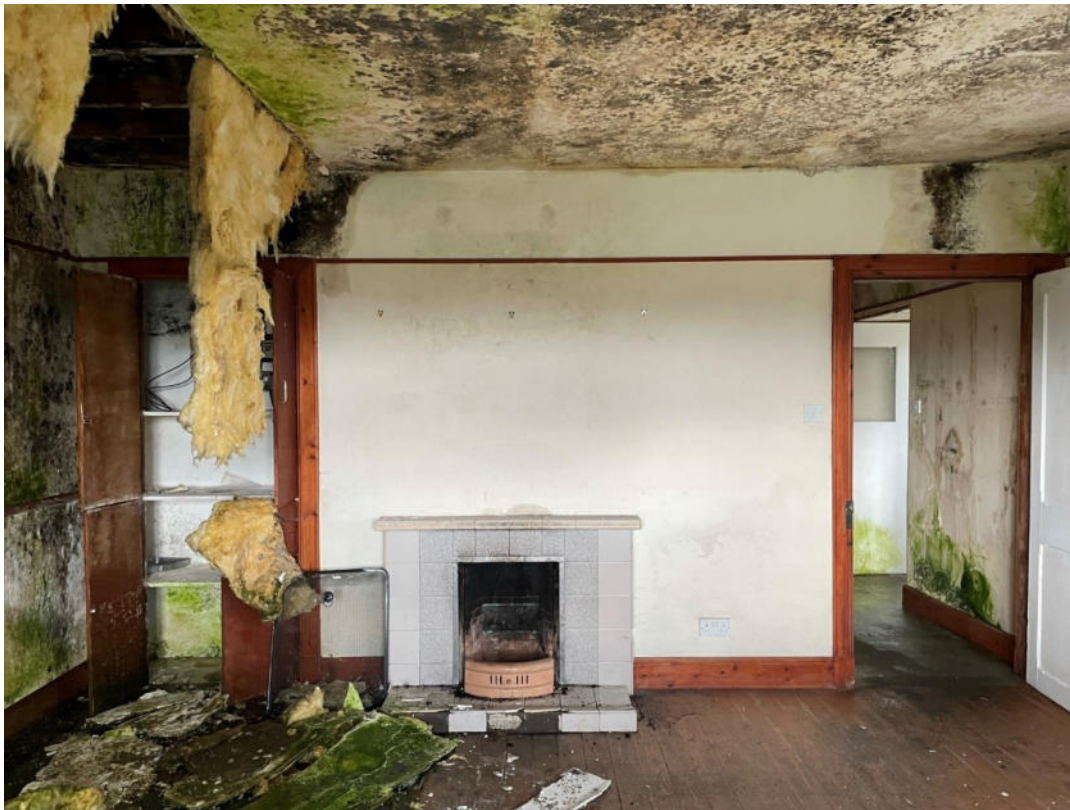
Illus 12 Room 6 N wall fireplace F14 showing collapsing ceilings and rotten floorboards; facing N

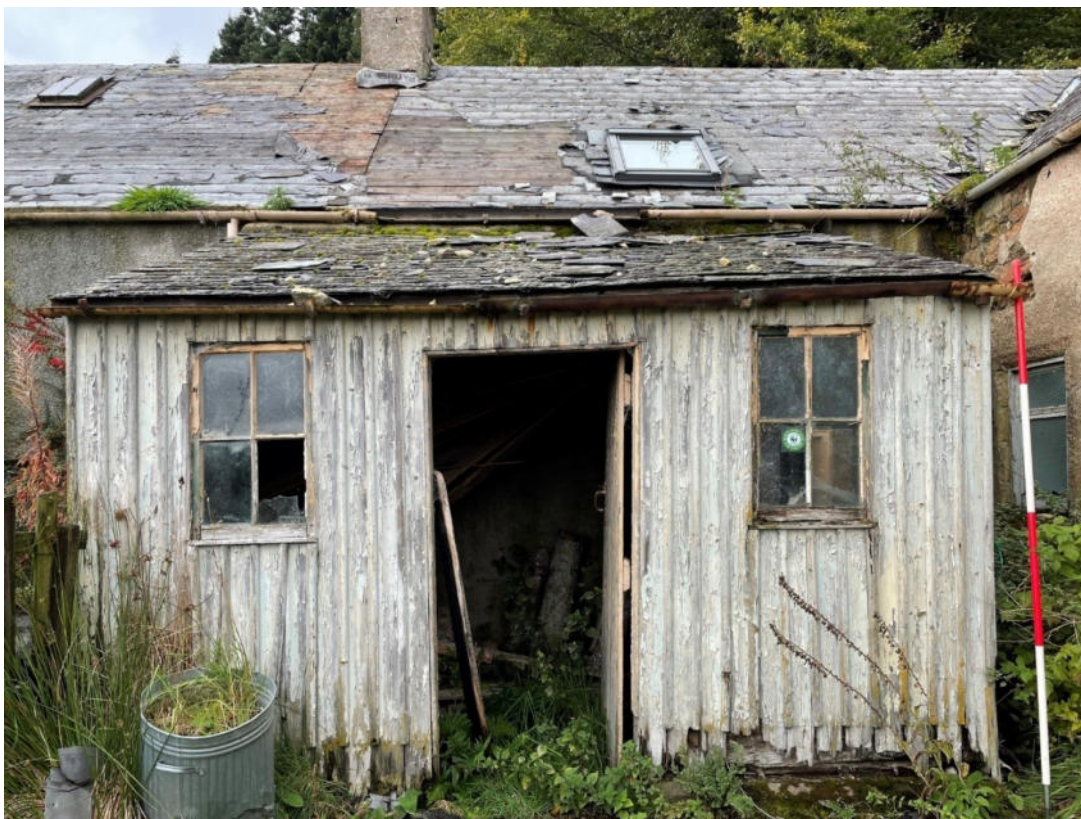
In Phase 3 Room 10, a lean-to shed 2.3x3.5m in size was added to the E wall of Room 14 (Illus 13). It was constructed of vertical wooden slats with door D11 on the N wall and door (D10) and two windows (W25, W26) on the E wall.

Illus 13 Shed Room 10; facing W
