**Land To The North East Of East Kinharrachie Farm,
Kinharrachie, Ellon, Aberdeenshire, AB41 8PQ**

Report on Level 2 Standing Building Survey

**Alison Cameron
Cameron Archaeology
15 February 2022**

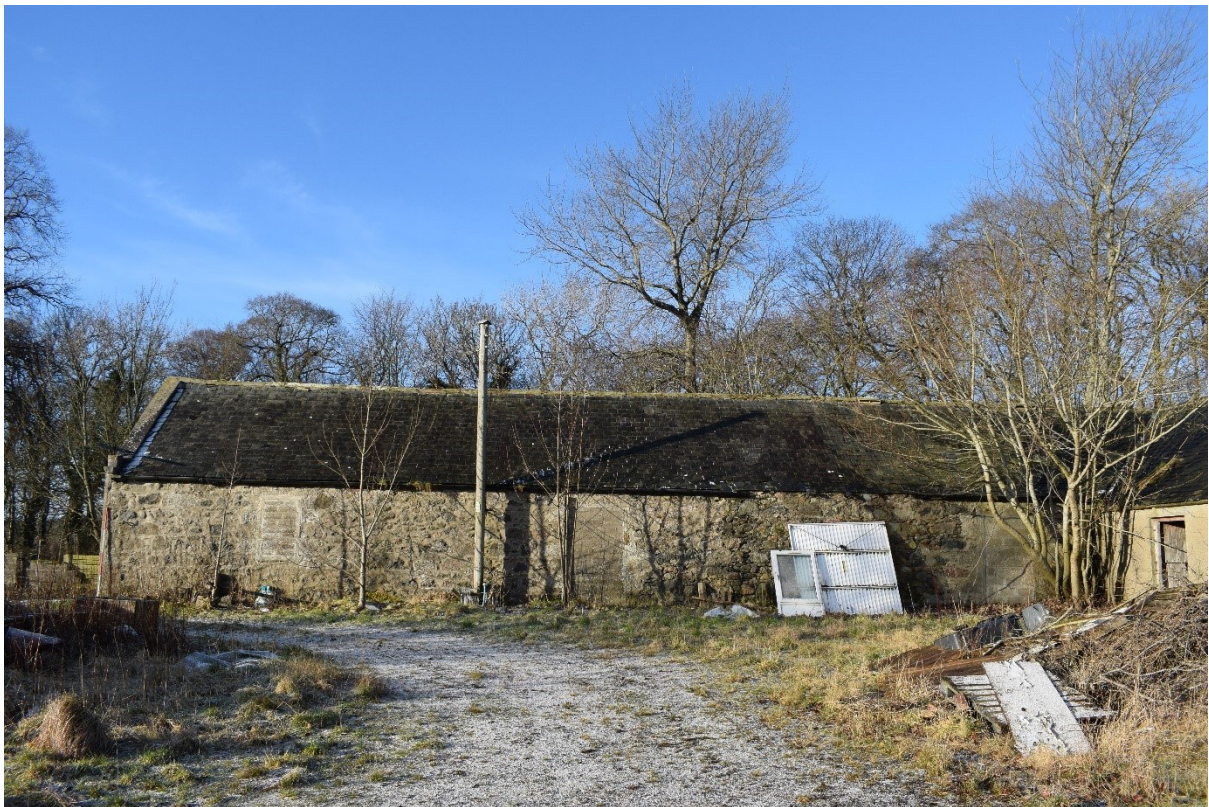
Illus 7 Courtyard WSW wing ENE elevation showing stone rubble construction and breeze block filled apertures; facing ENE

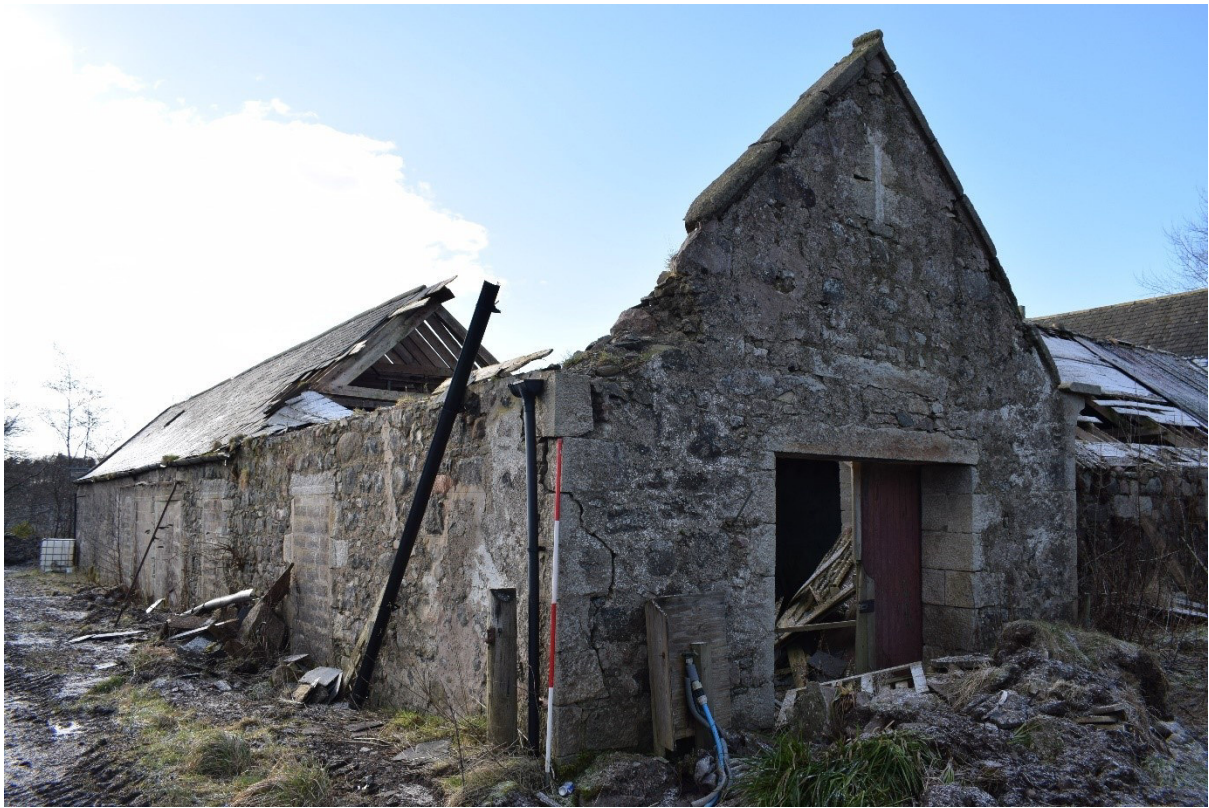
There is no access to Room 6 as the roof has collapsed and it is possible that this was actually two rooms. Visible on the exterior of the NNW wall there is a series of six blocked apertures in the NNW wall (W19-W24); these are only visible from the exterior as large granite blocks with an infilled slit suggesting a series of small ventilation holes. There are two doors to the courtyard on the SSE wall (D5 and D6) both blocked with breeze blocks and an open door in the corner of the courtyard D10. On the NNW gable is a cart door D12 (Illus 5) with stone mouldings and a lintel or sill above (W35). There are stone skewputts on the NNW gable (F21, F22; Illus 6). There are two large rooflights in the apex of the roof (W10 and W11).

Illus 8 Room 6 NNW end showing collapse of roof; facing SW

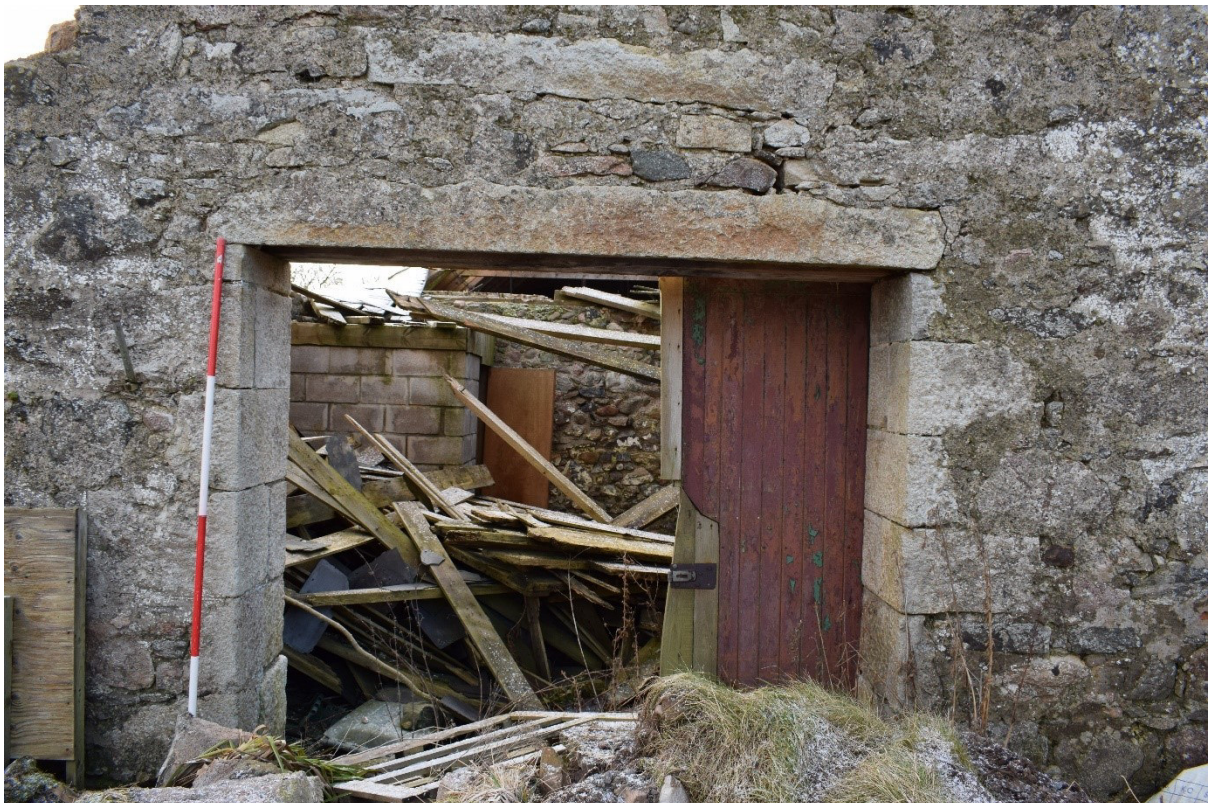
Illus 9 Room 6 NNW wall D12 with W35 sill above; facing SSE

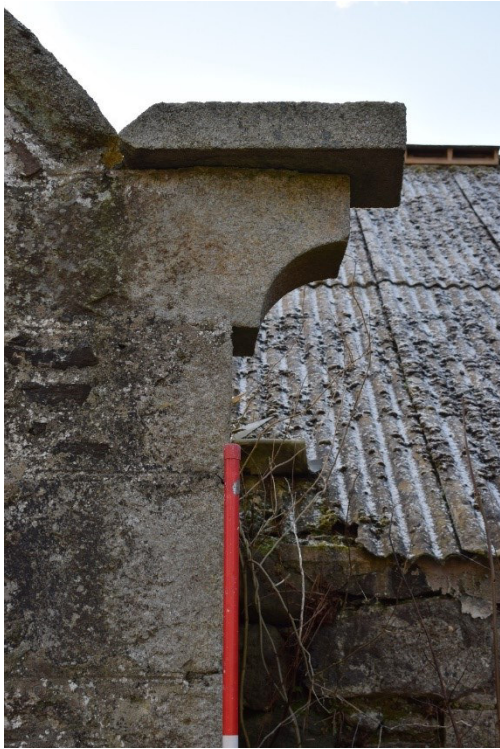
Illus 10 Skewputt F22; facing SSE

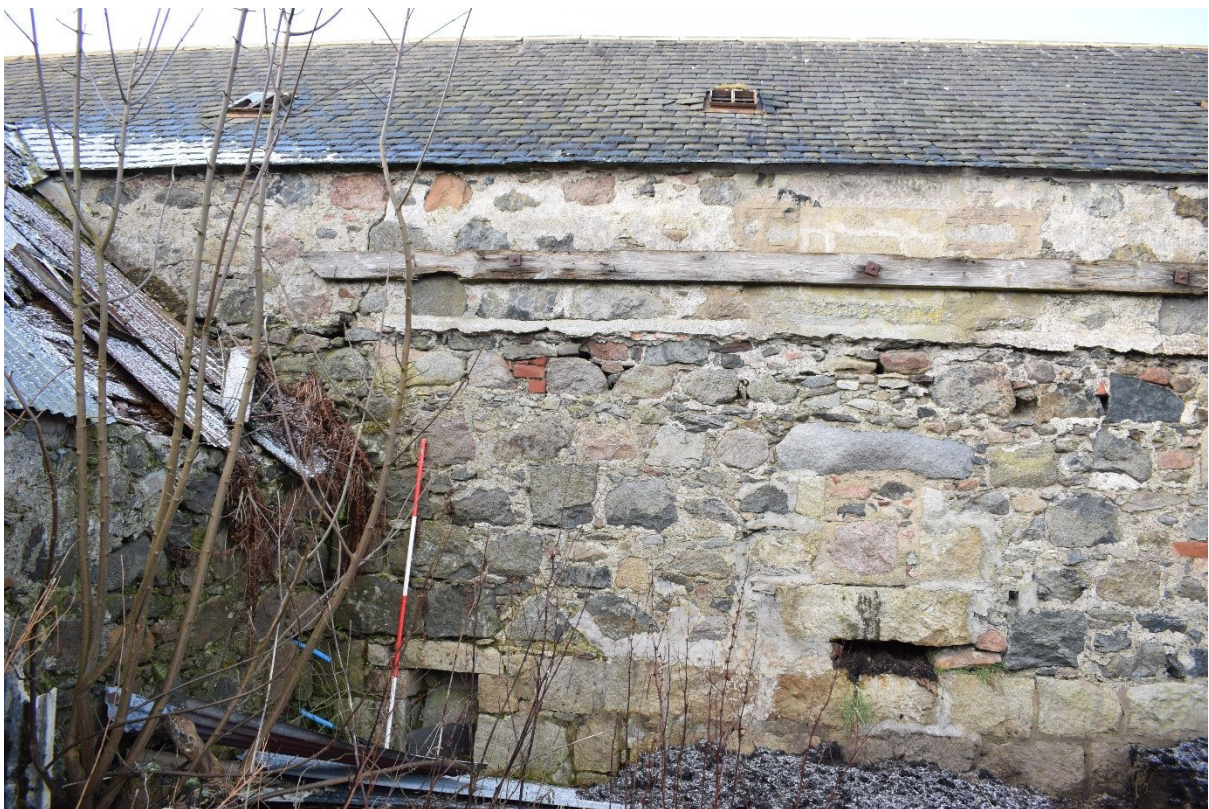
Illus 11 Room 5 ENE wall aperture F9 (bottom left), F11 (centre) with concrete roof scar F15 (centre); facing WSW

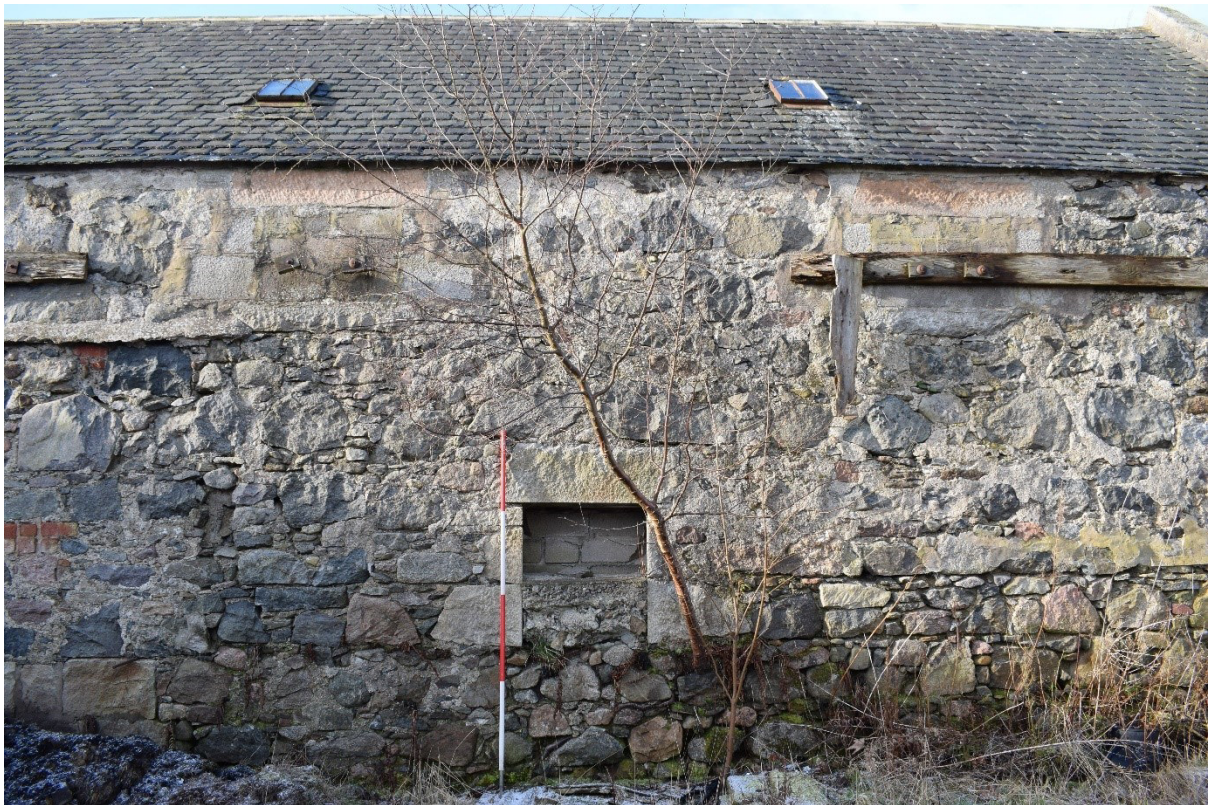
Illus 12 Room 5 ENE wall aperture F13 (centre) with W26 (top left) and W27 (top right); facing WSW

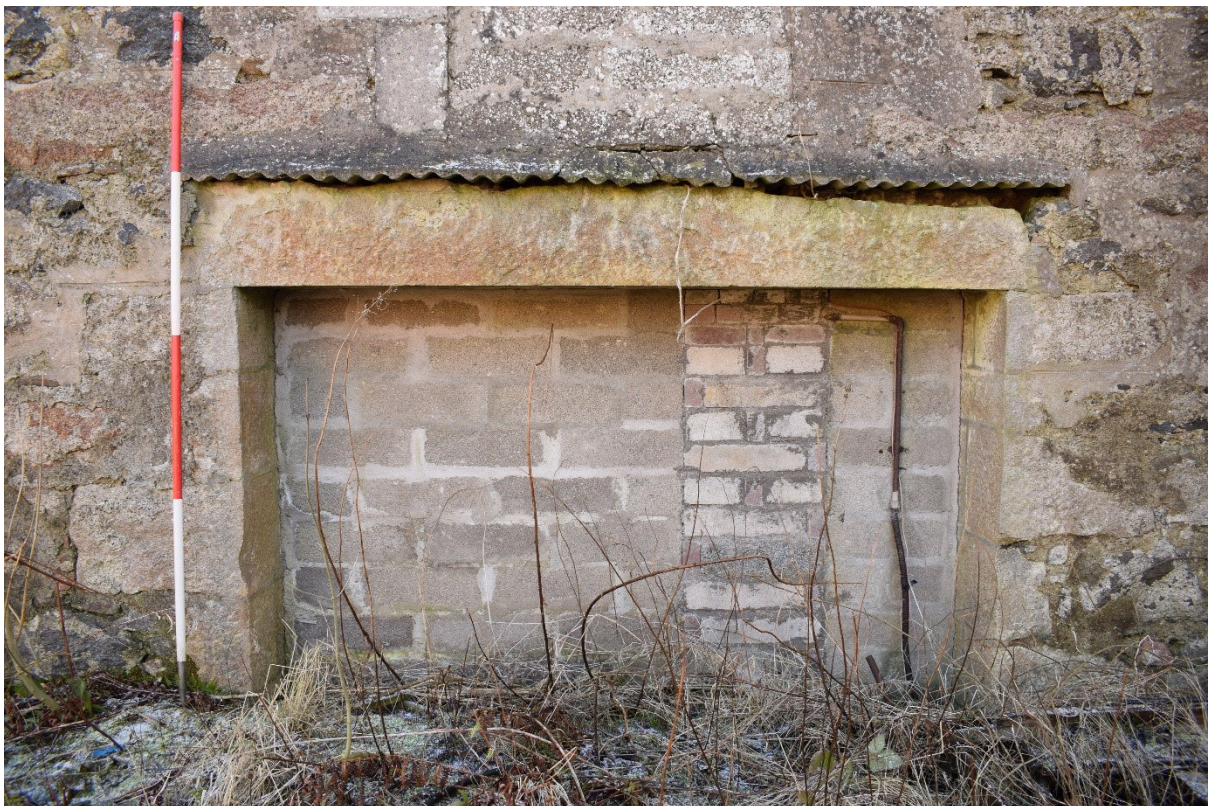
Illus 13 Room 5 NNW wall D27 with infilled W28 above; note foreground infilled with soil; facing SSE

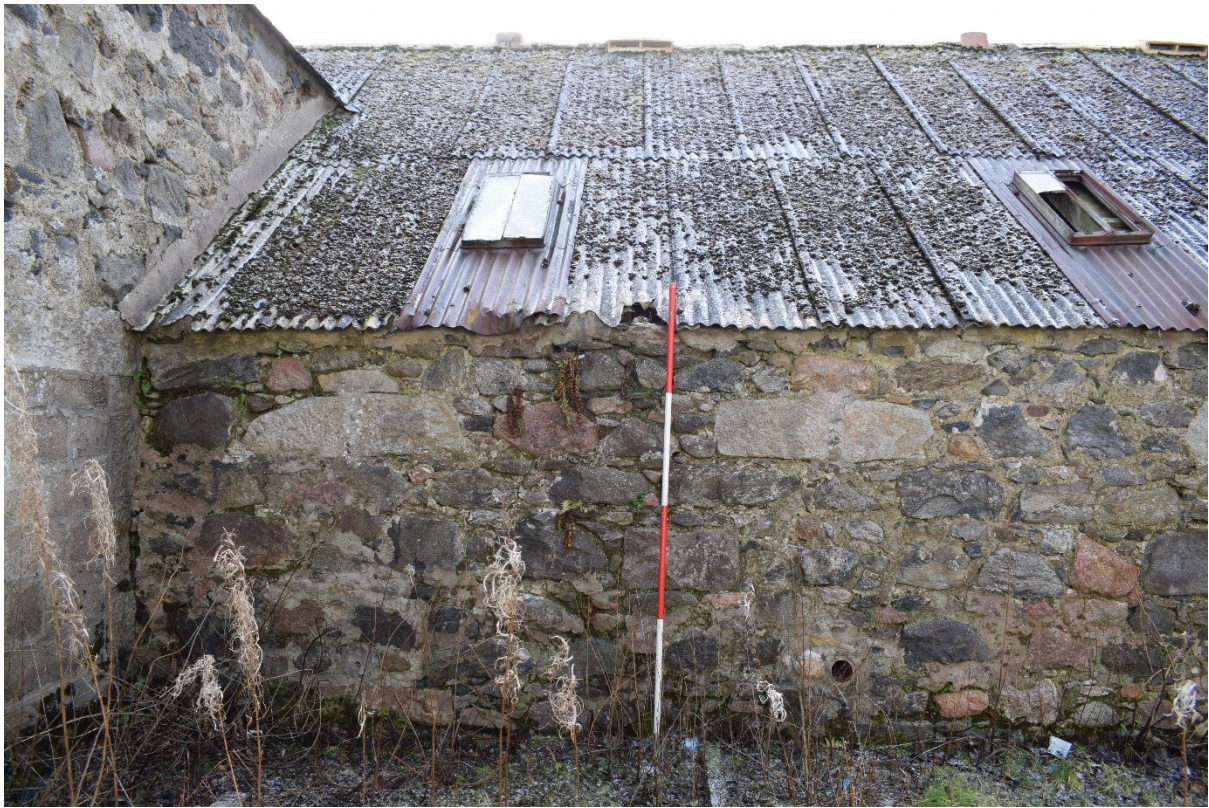
Illus 14 Room 4 blocked windows W13 (left) and W14 (right); facing SSE

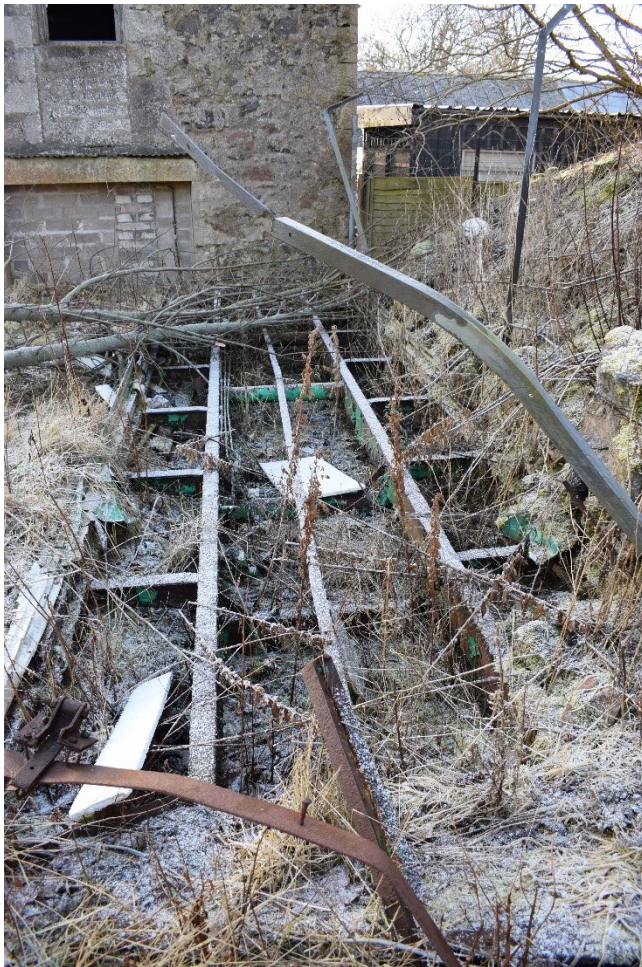
Illus 15 Lade F3 infilled; facing SSE

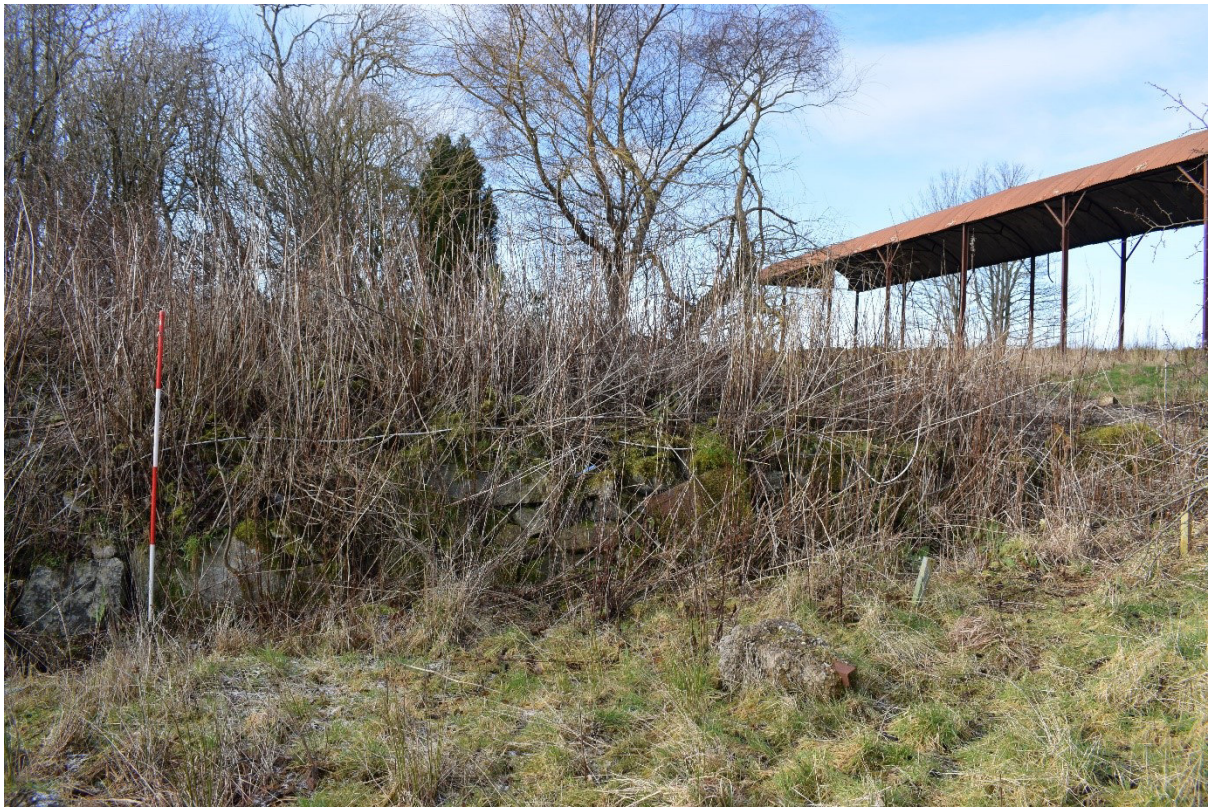
Illus 16 Lade WSW wall F3; facing WSW

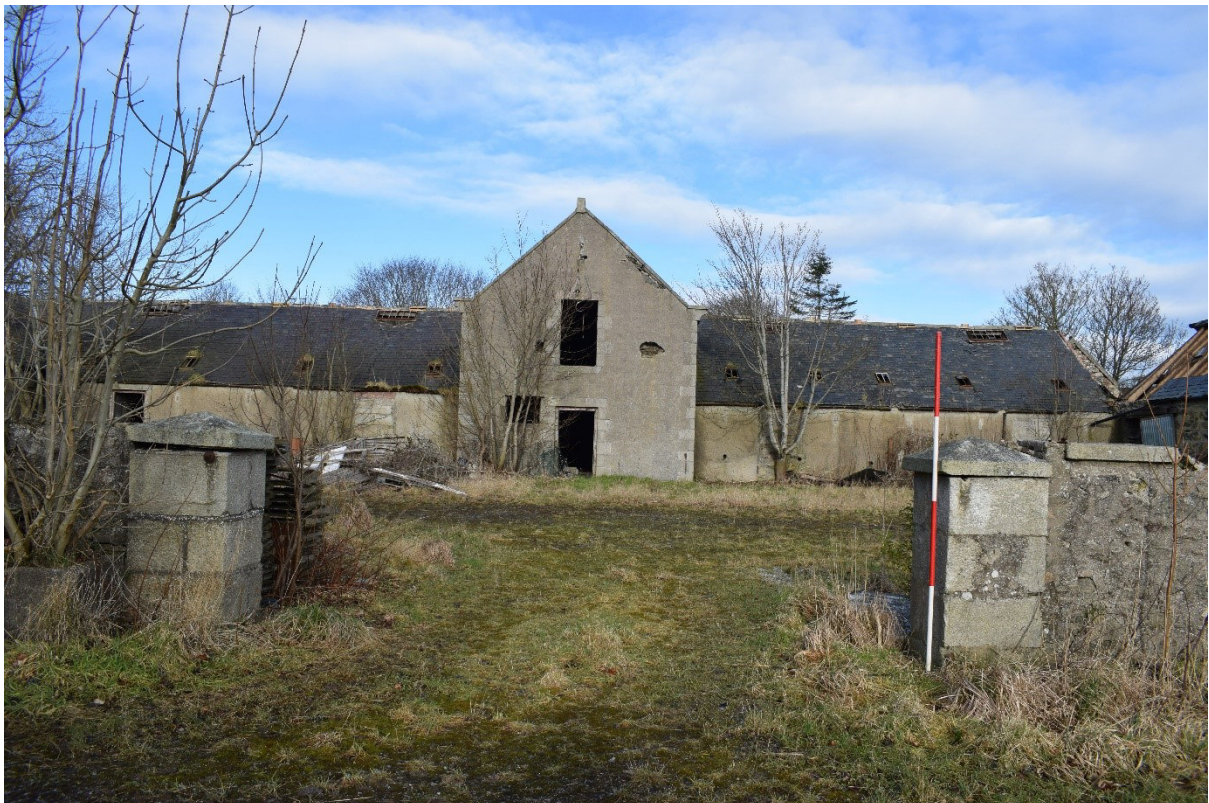
Illus 17 SSE courtyard wall with gateposts F1 (left) and F2 (right); facing NNW

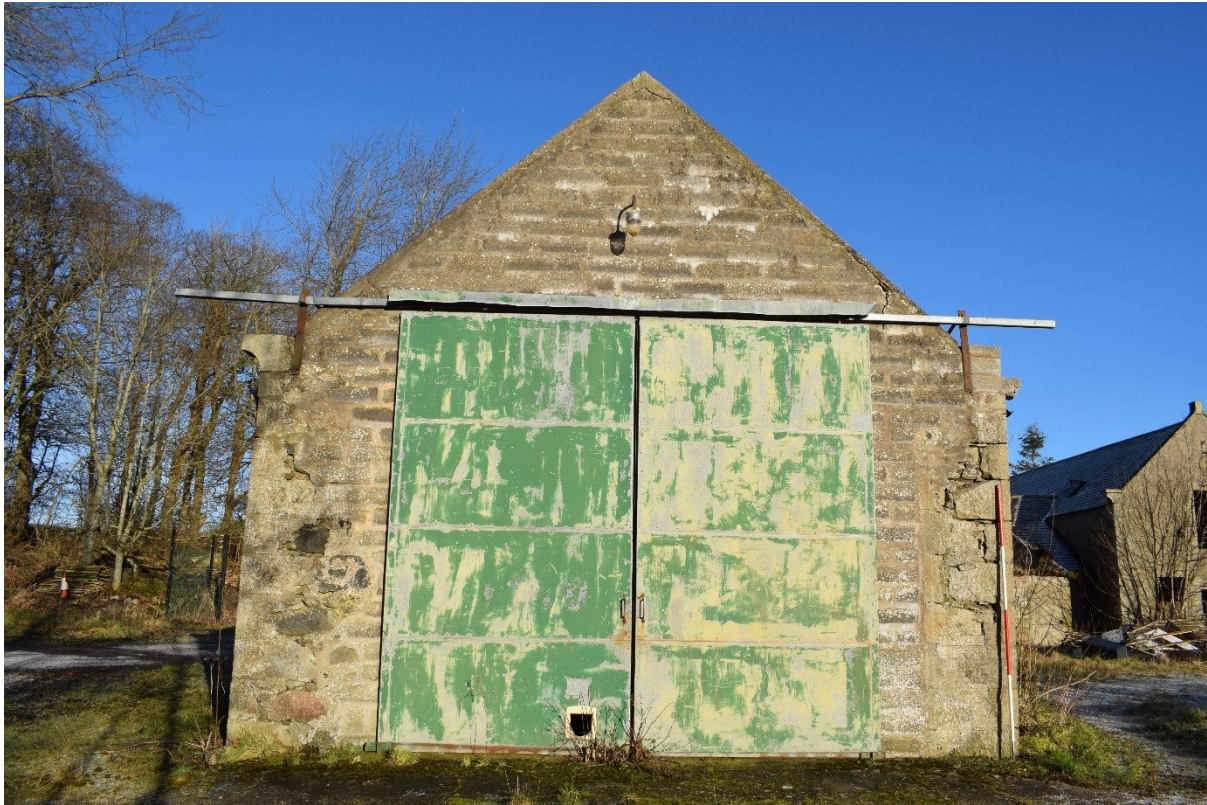
Illus 18 SSE gable Room 1 D1 with rebuilding in breeze block; facing NNW

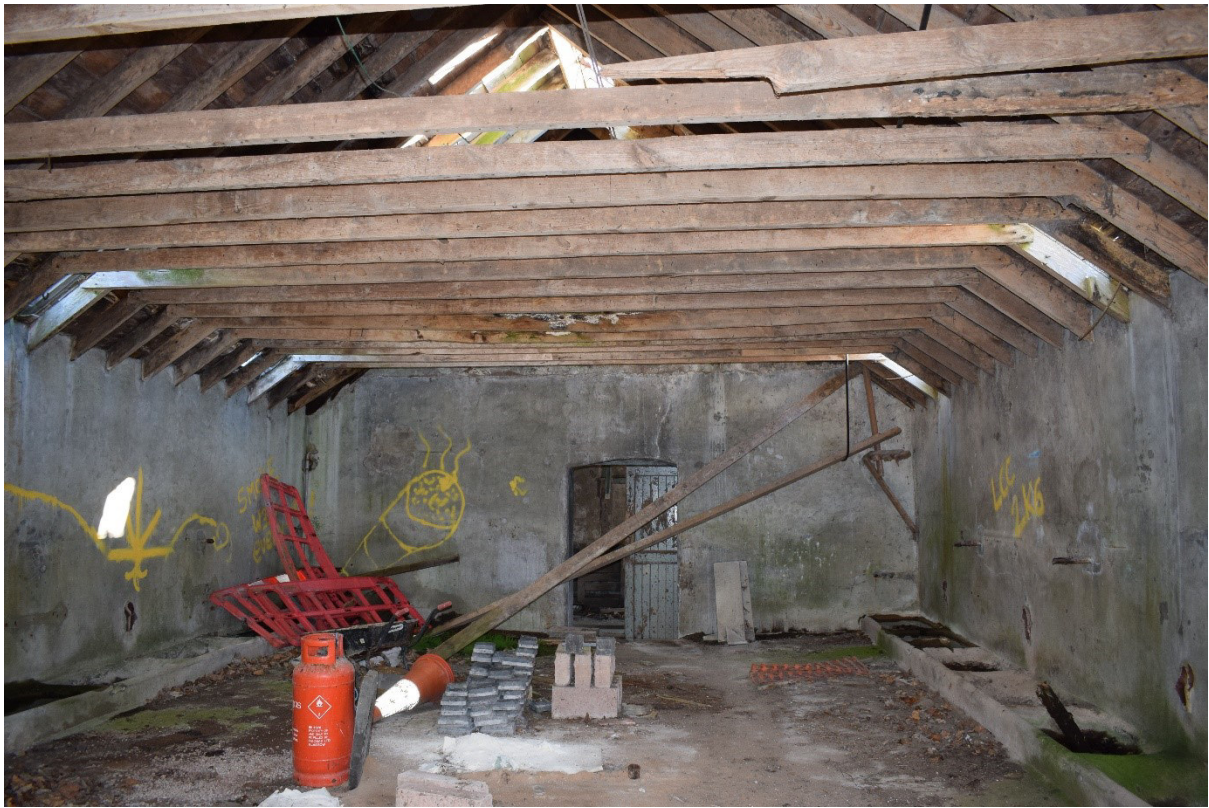
Illus 19 Room 4 ENE wall D24 showing concreted walls and concrete feeders F20; facing ENE

The SSE end of Room 5 has been rebuilt in concrete (Illus 19); this is probably due to the demolition of buildings seen within the courtyard on the 3rd Edition OS map (Illus 37) attached to this façade. When these buildings were demolished it's likely that this required

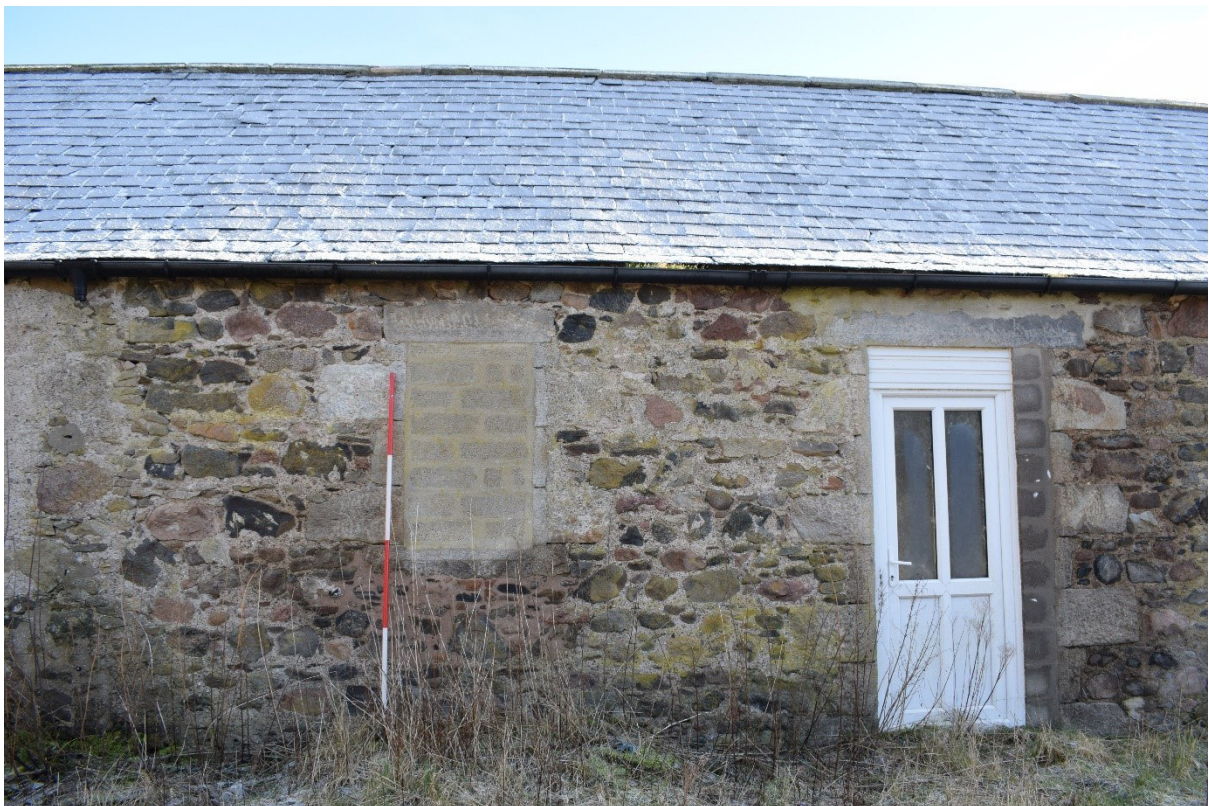
Illus 20 Room 7 WSW wall W6 (left) blocked with breeze blocks and D11 (right); facing ENE

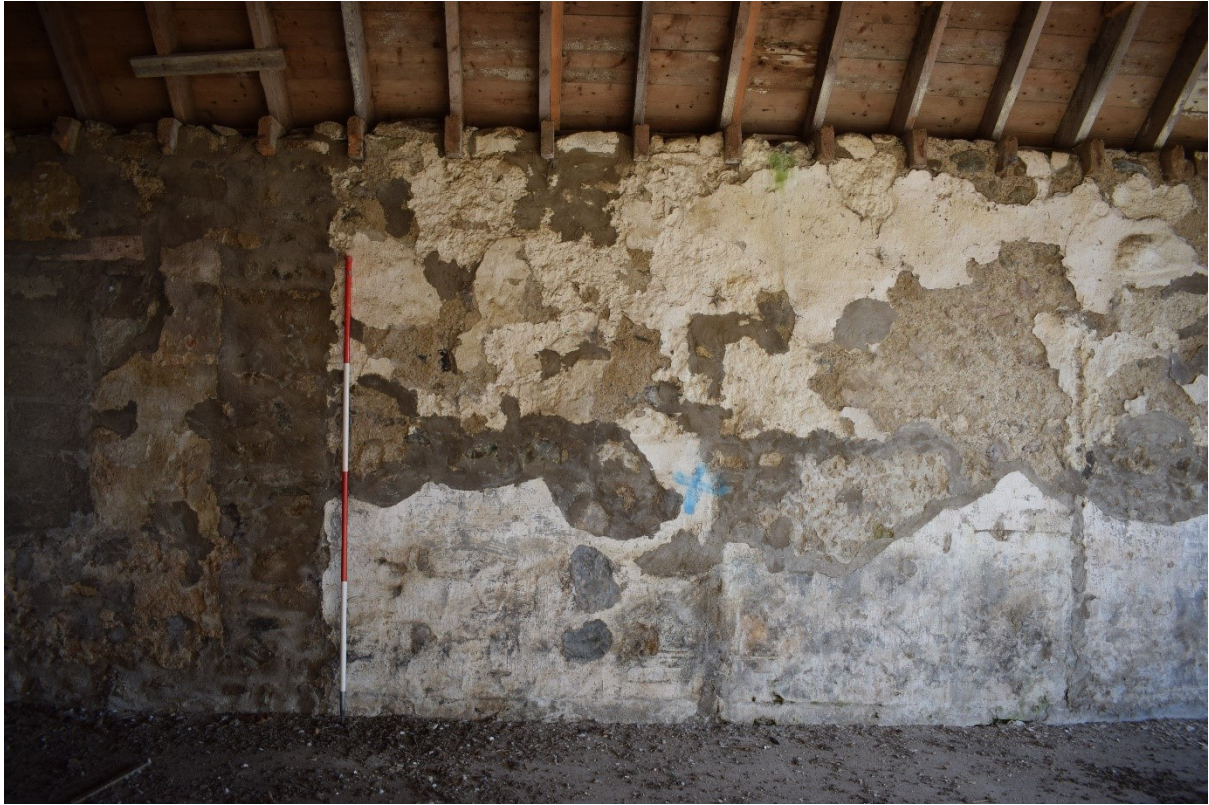
Illus 21 Room 7 ENE wall with scars of stalls (F8); facing ENE

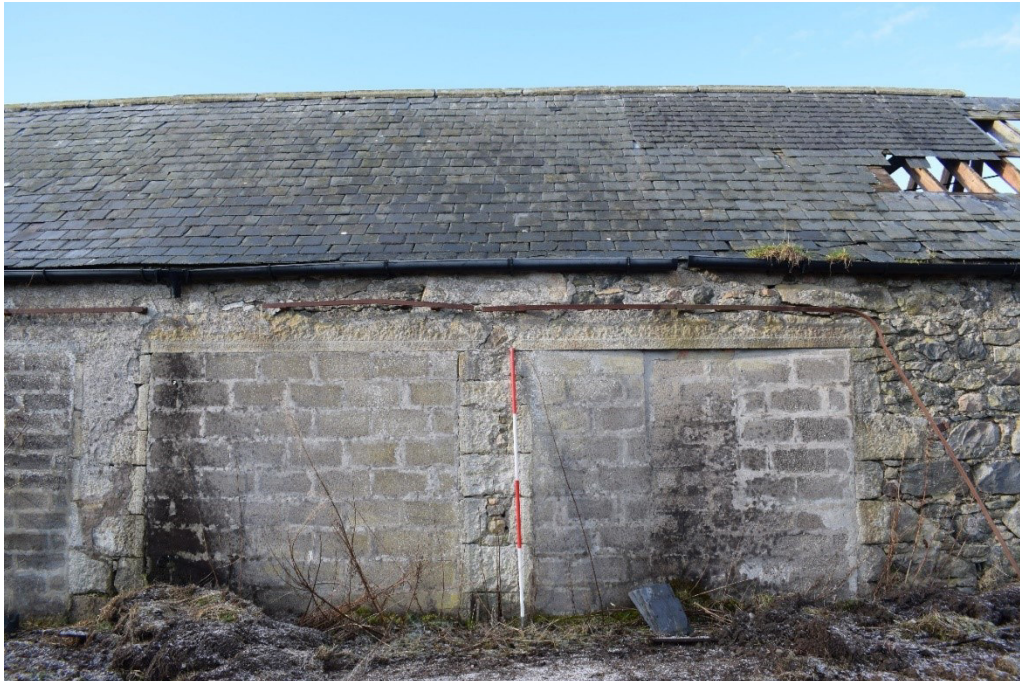
Illus 22 Room 7 ENE wall D16 (left) D17 (right) former cart doors infilled with breeze blocks; facing WSW

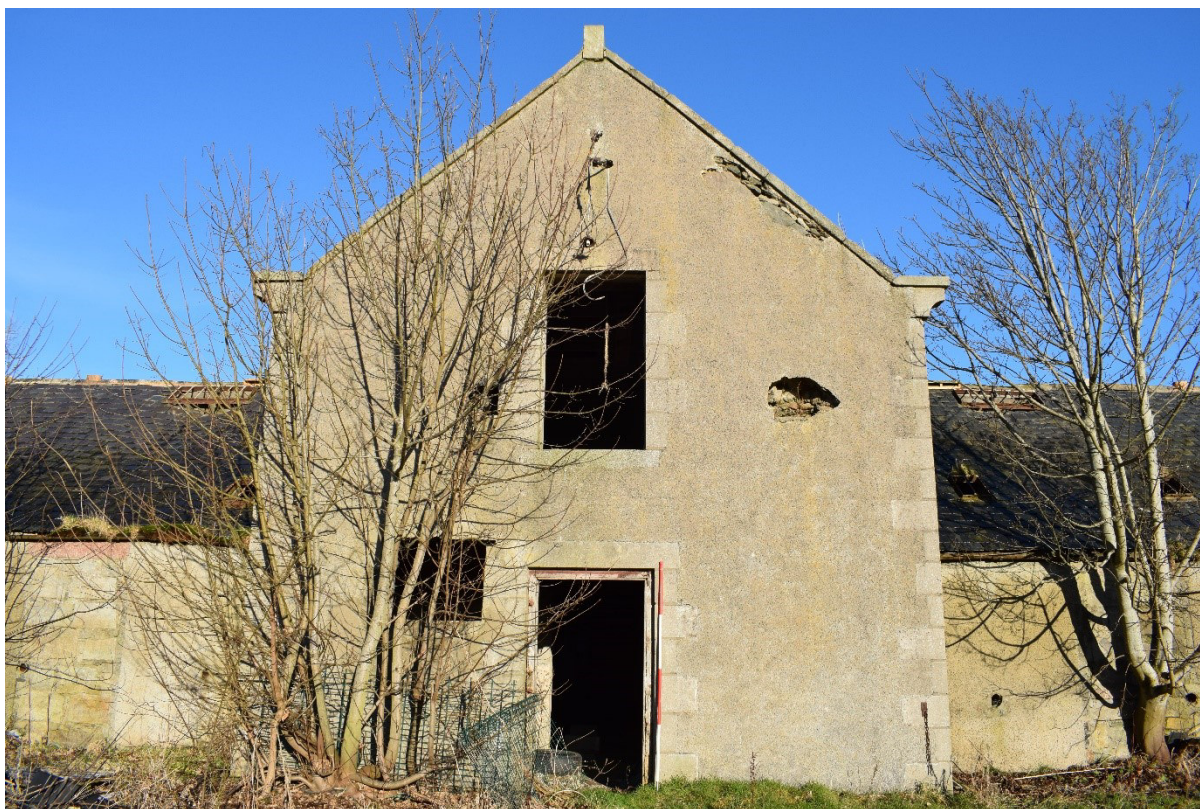
rebuilding to create a pleasing SSE façade. This includes D4, W12 and first floor window W5.

Illus 23 Room 5 SSE façade with DD, W12 (left) and W5 (above); facing NNW

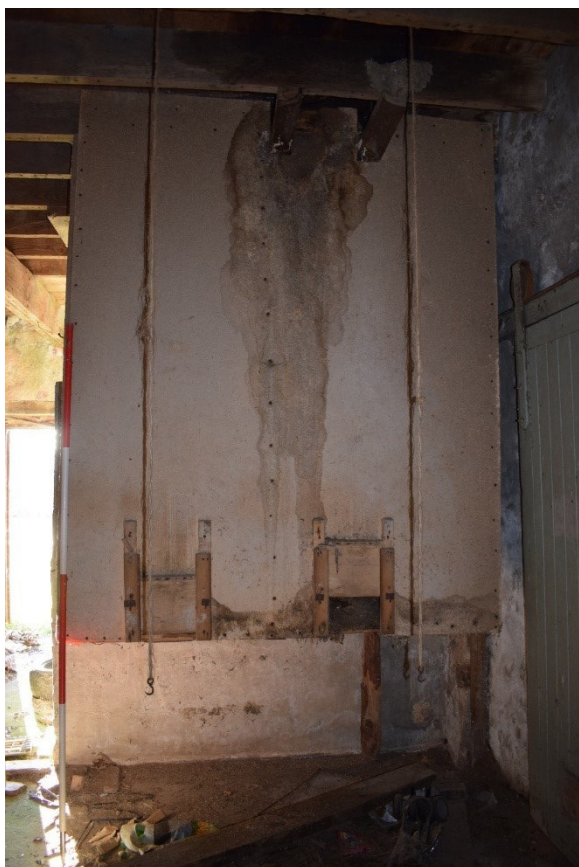
Illus 24 Room 5 wood hopper F4; facing SSE

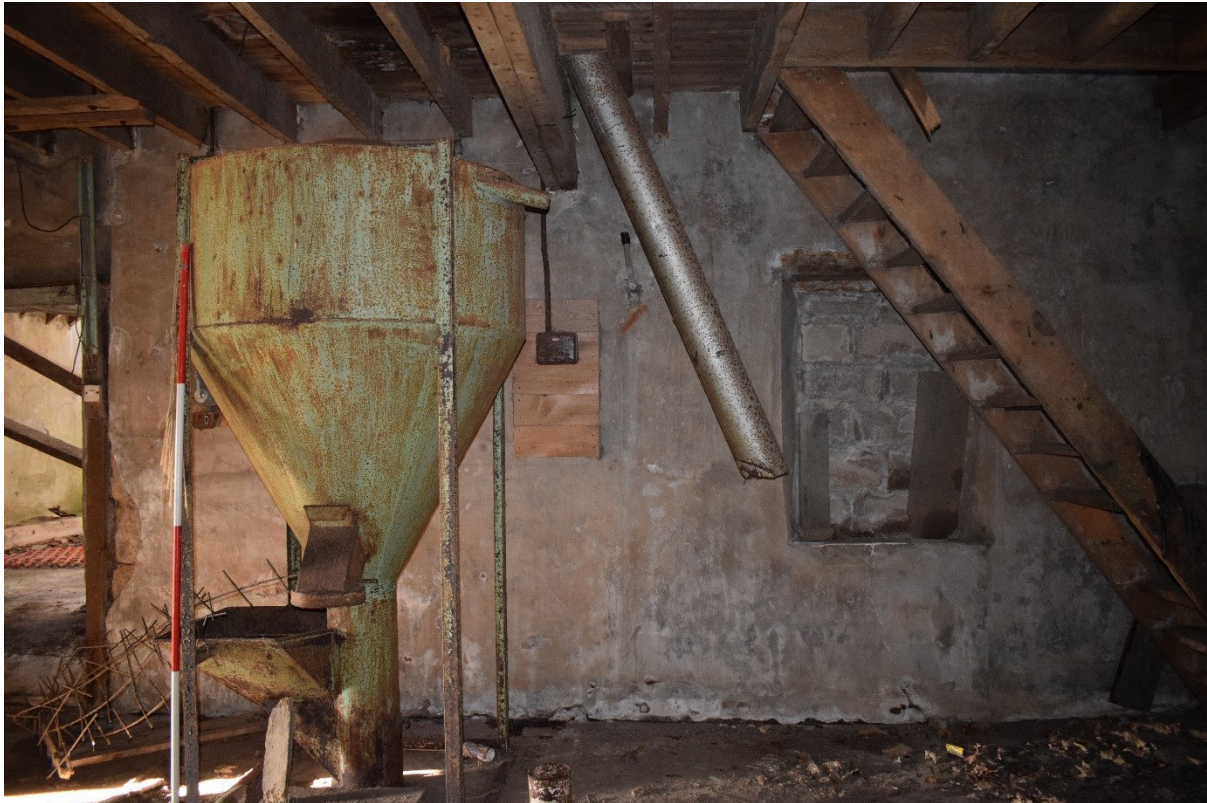
Illus 25 Room 5 metal hopper F5 with wooden stair F6; facing WSW

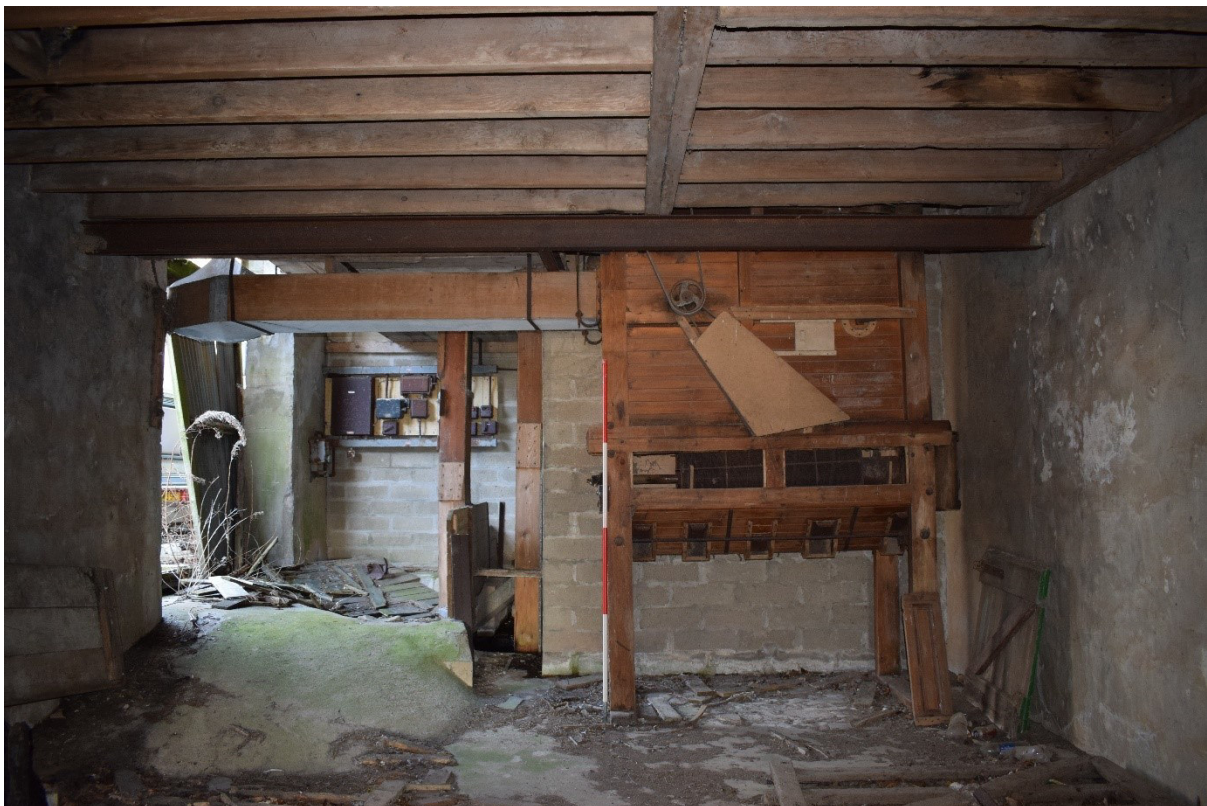
Illus 26 Room 5 wooden hopper F7 with wooden chute; facing NNW

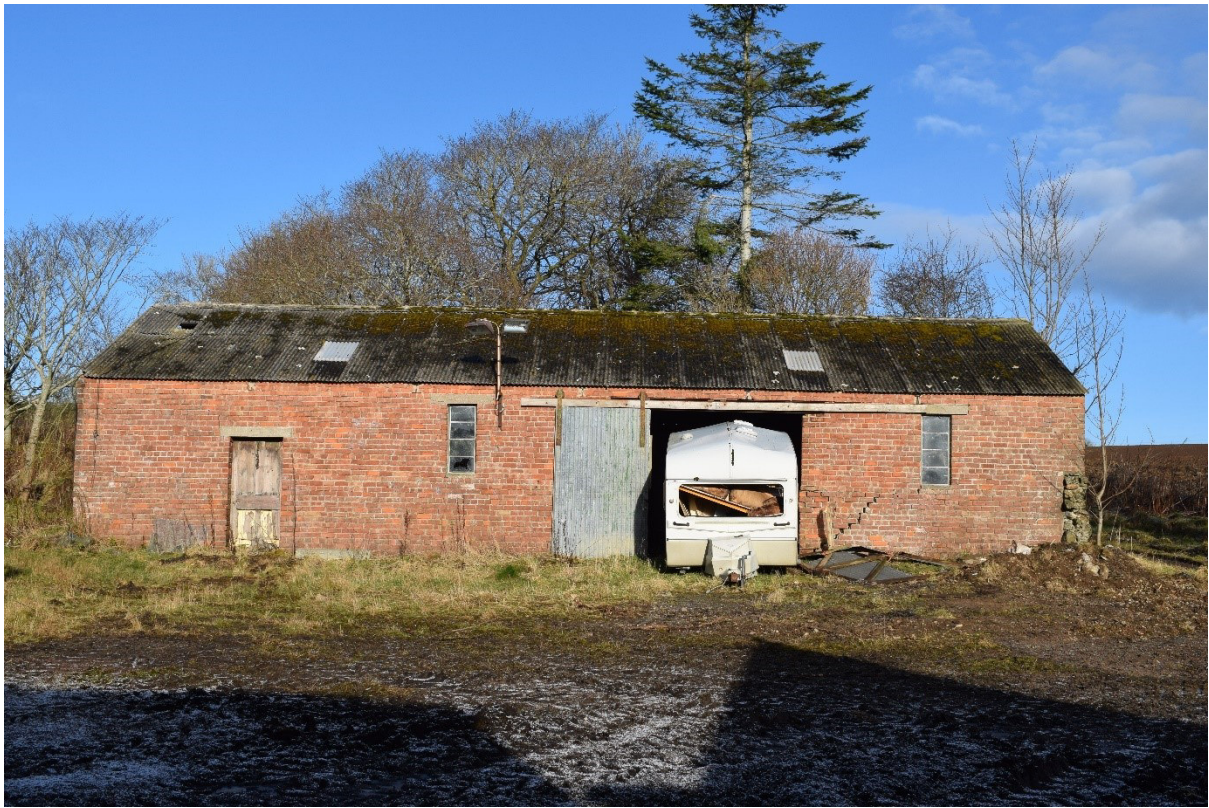
Illus 28 Building 2 SSE façade; facing NNW

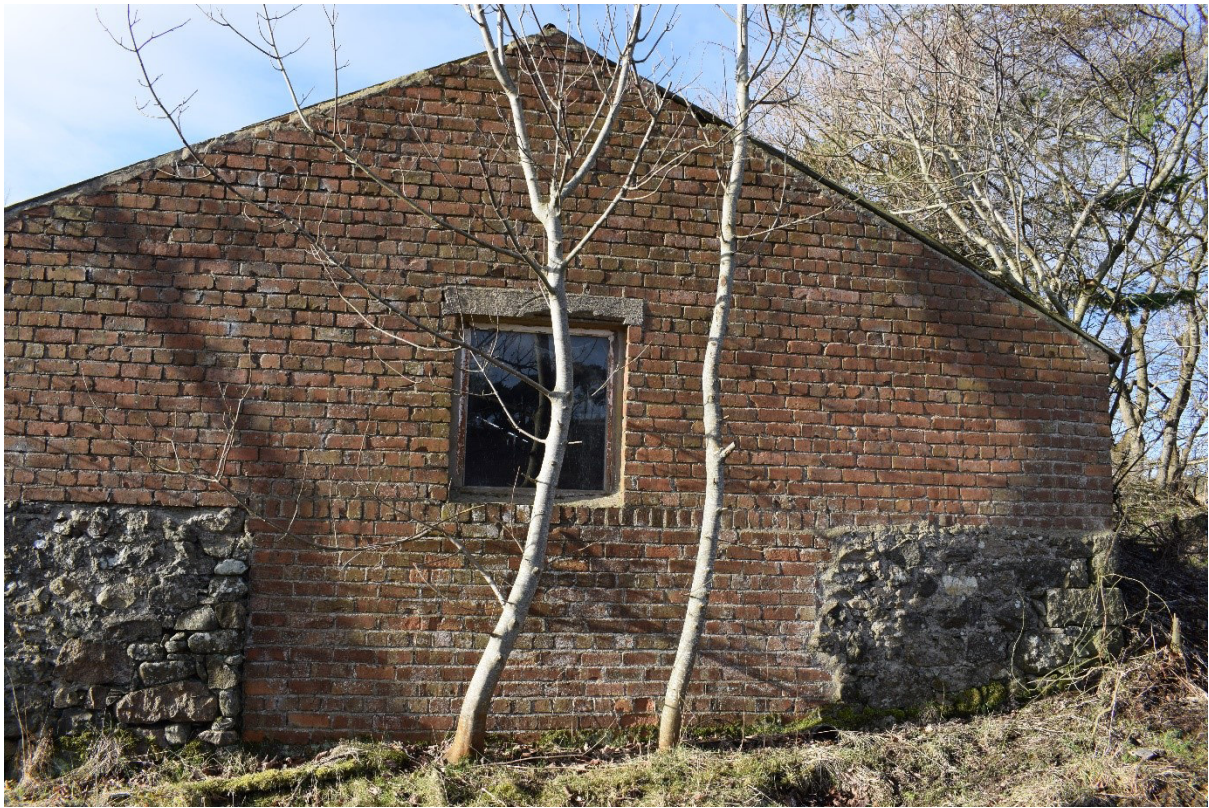
Illus 30 Building 2 ENE wall with W33 (centre) and Phase 1 stone walls; facing WSW

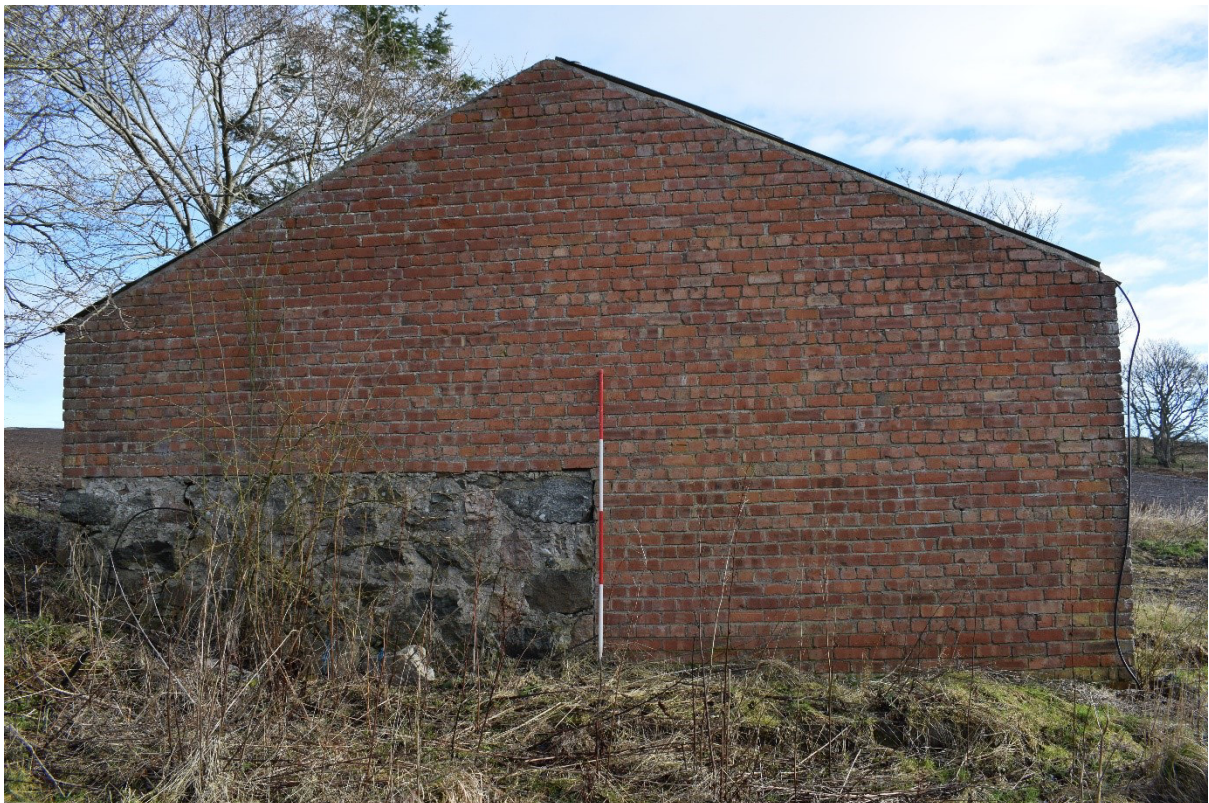
Illus 31 Building 2 WSW wall with Phase 1 stone wall; facing ENE

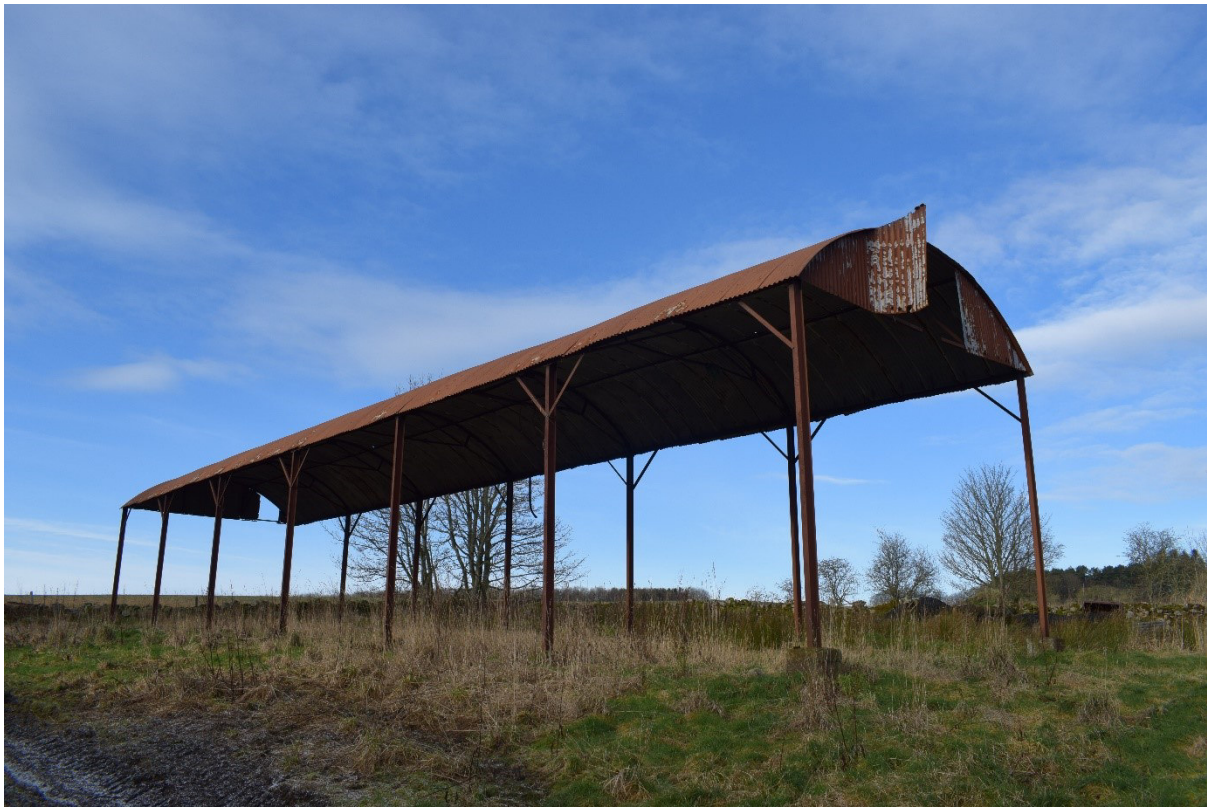
Building 3 is a Dutch barn 5.84m wide, 4.2m high and 29.19m long. Cast iron I beams are set on concrete block foundations 0.46x0.44x0.33m high. The I-beams and 0.15x0.08m in size and the roof is arched corrugated metal. The building has an earthen floor.

Illus 33 Building 3; facing NW
