STANDING BUILDING SURVEY  
PARK HOUSE,  
120 WESTBURN ROAD, ABERDEEN

CAMERON  
ARCHAEOLOGY

20 July 2010

# Standing Building Survey

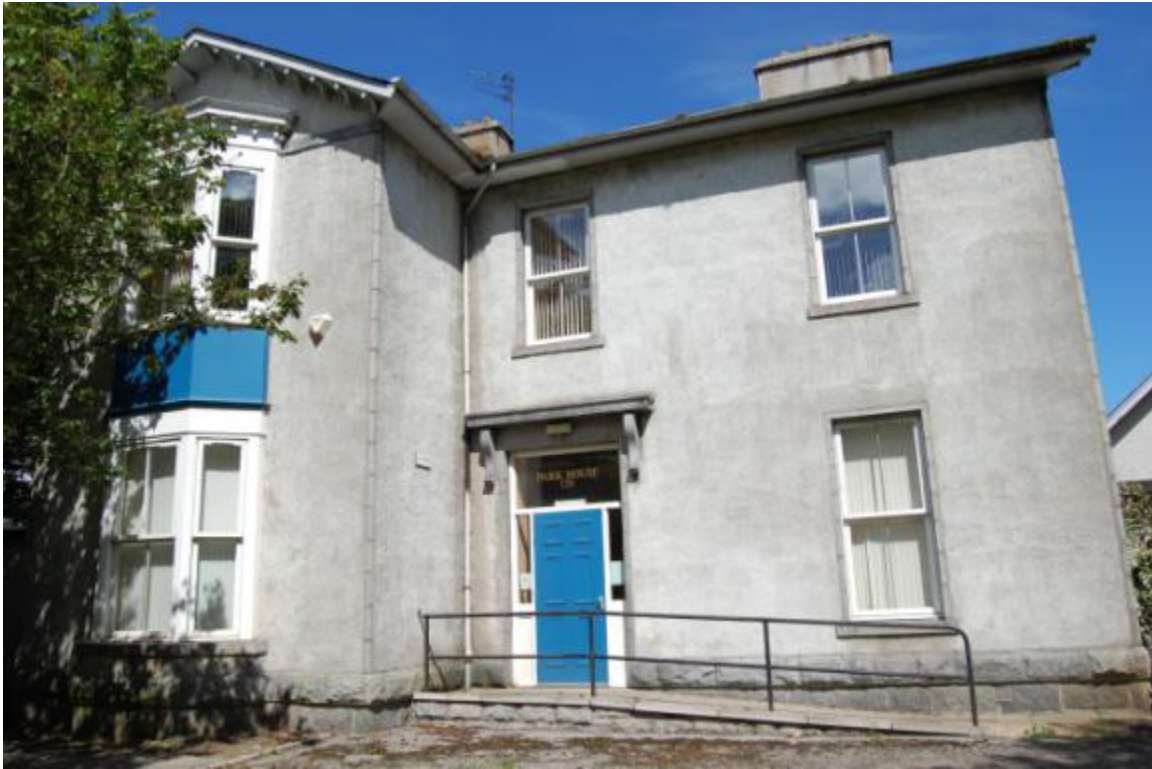
III 4 Front south façade

Park House is a substantial 2-storey building with harled walls, a slated pitched roof and double height bay window on the ground and first floors facing onto Westburn Road. The windows and front door have plain granite quoins and there is a rustic low-level string course around the front and rear façades of the building at the level of the front door and under the bay window. This string course only extends along the gables as one stone at each corner (Ill 15). The windows with plain quoins in the front façade are all original. The front door has a small unsupported portico over the front door in the form of a granite sill with two granite supports below. The frontage (Ill 4) has had a disabled ramp added to allow access to the front door. Extensions have been built on at the NE corner including a corridor to the 1960s extension, and a boiler house to the west.

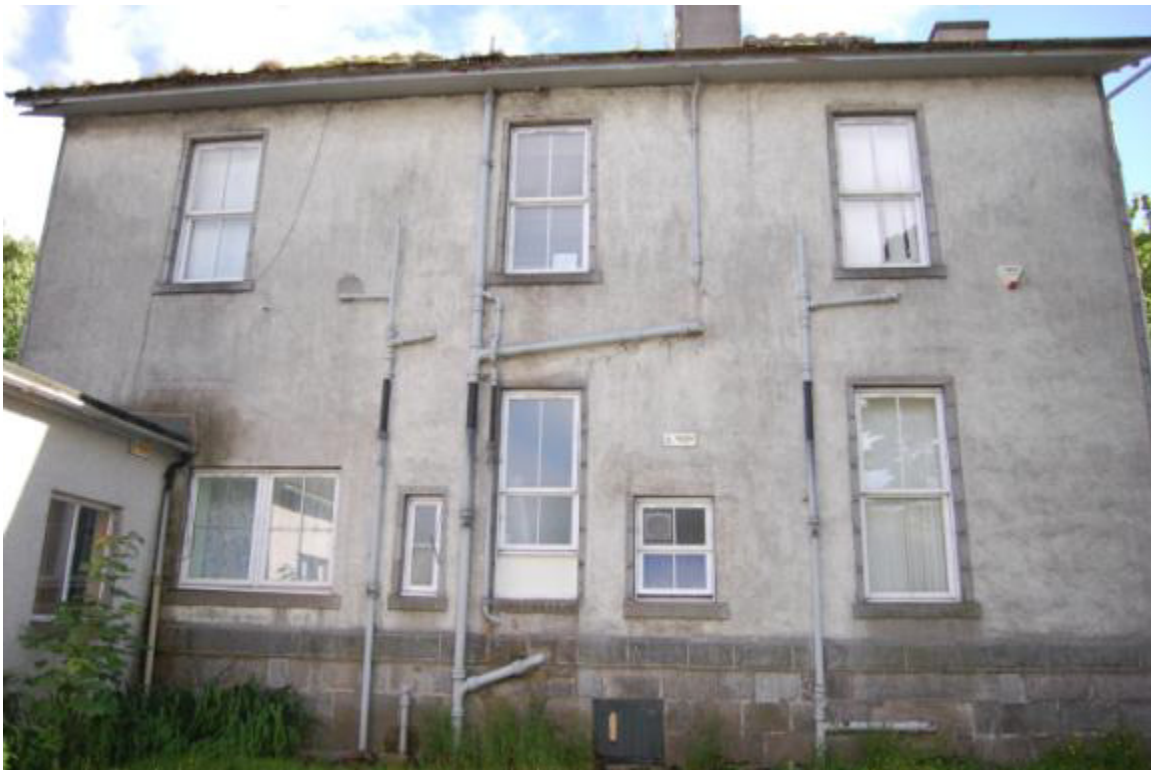
Ill 6 North rear façade

The rear north façade of the building (Ill 6) has had several alterations. A ground floor a corridor has been added to the NE corner and a new window associated with this corridor presumably replaced an old window. At ground floor level one of the bathroom windows was reduced in height, possibly to accomodate bathroom fittings. The upper floor windows with plain quoins are all original. Original cast iron vents are present in the north and west façades.

The house has been built on ground sloping down to the north and as a result the rear garden is lower than the front. This can be seen on the façade drawings (Ill 15): at the rear an extra 1.5m of granite blockwork is present at the base of the building and this incorporates a door for what was originally an access to the cellar for the delivery of coal. No access to the cellar area was attempted during this survey.

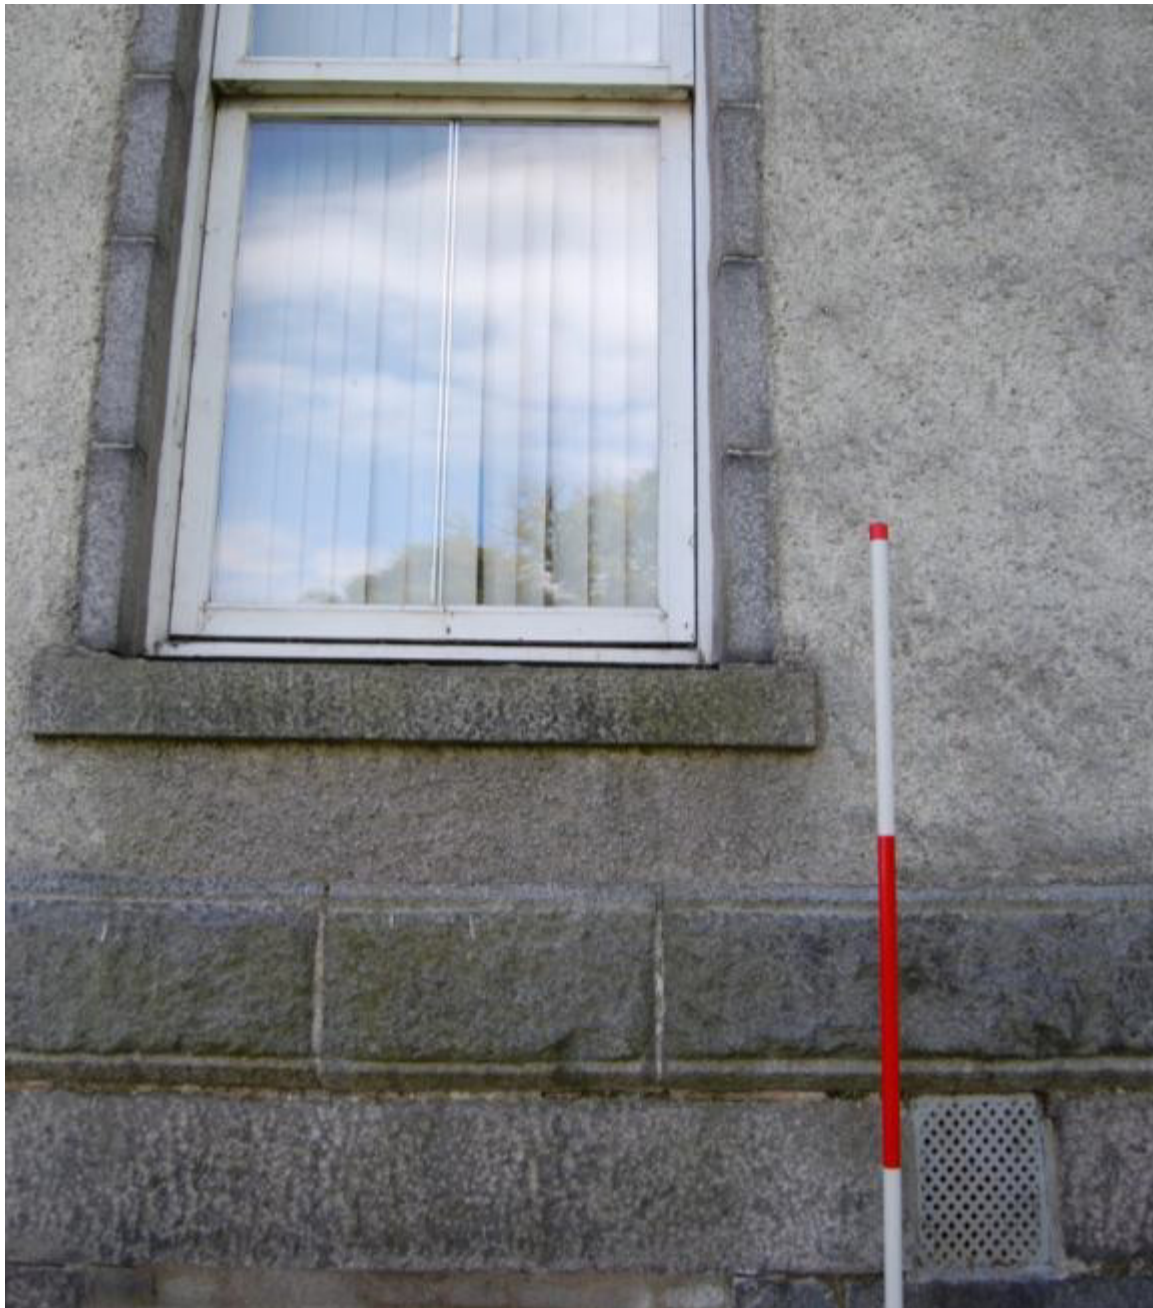
III 7 Detail of original window with plain granite quoin and lintel, rustic granite string course and cast iron vent (bottom right)

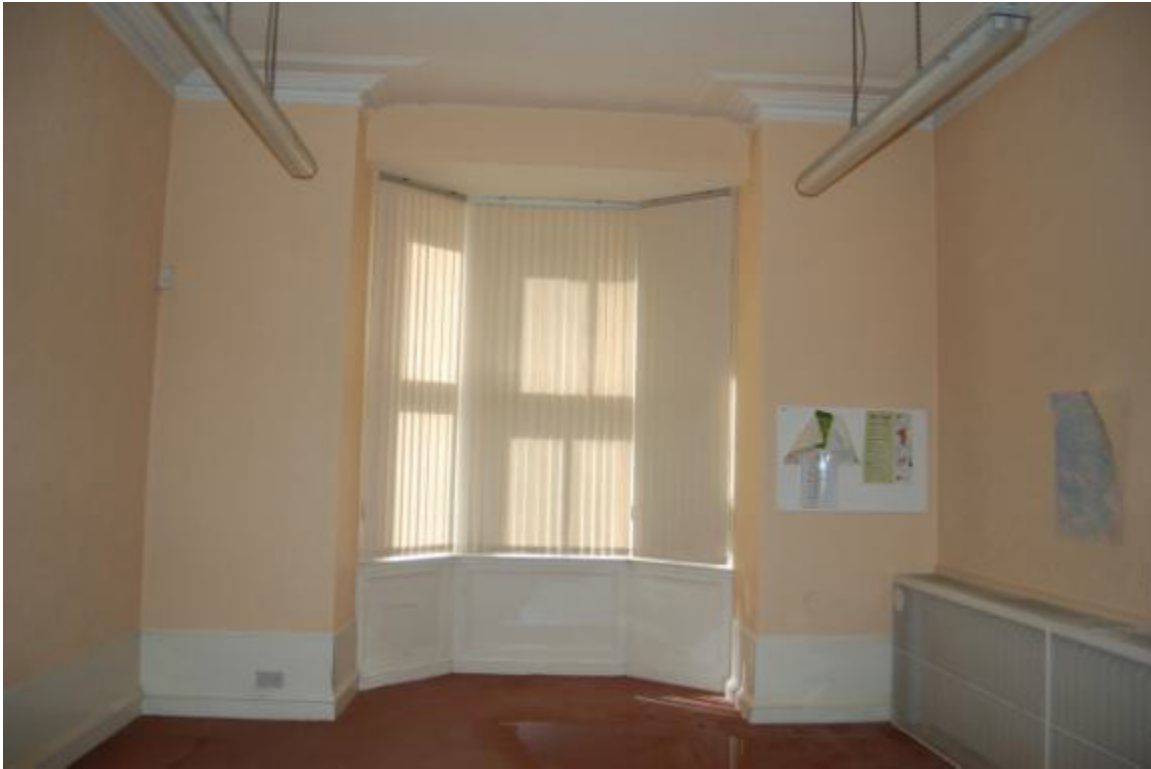
The house is of a traditional type with two large reception rooms at the front of the ground floor and two smaller family rooms at the rear. Rooms 1, 2 and 3 have original cornices; Room 4 has been altered presumably in the 1960s and the cornice removed at that time. The house has a central stairwell with an original wooden handrail and cast iron balluster. No original fireplaces are present as all have been removed to install modern heating.

III 10 Room 1 bay window, cornice and double skirting boards

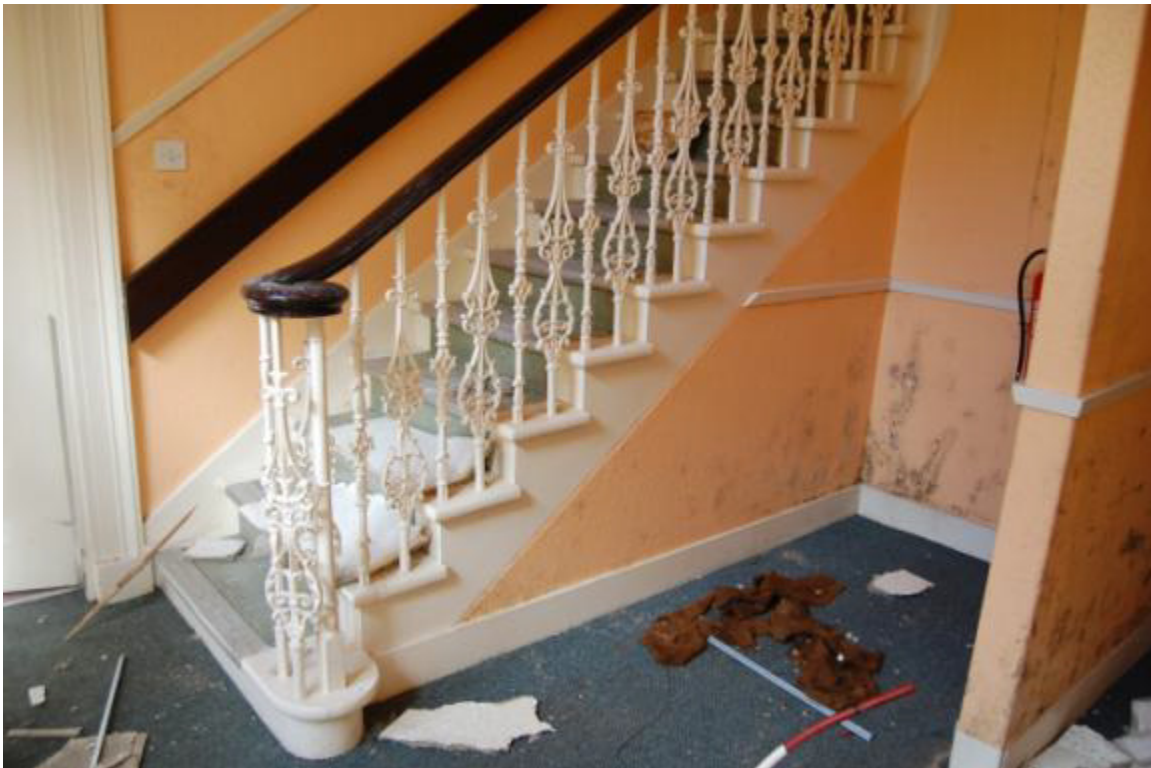
III 11 Room 5 ground floor hallway with central staircase

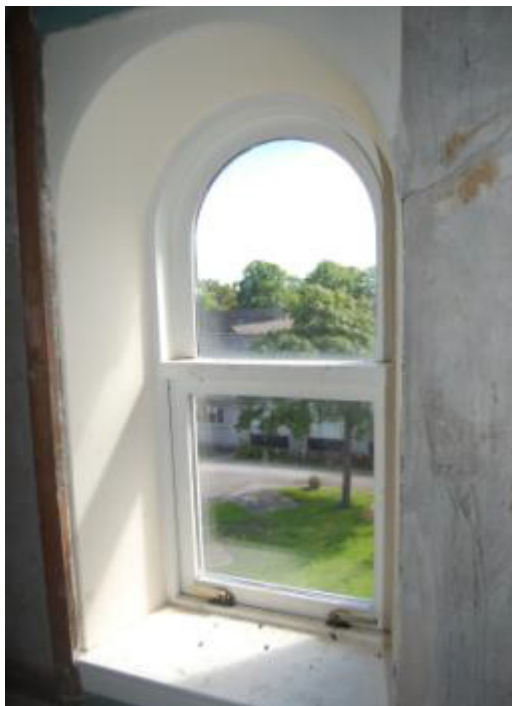
The gable ends of the original house had similar windows to the façades and most of the walls were harled. Each has a small arched window below the roof to allow light into the attic space (Ill 14).

III 14 Arched window in the east end gable façade
