STANDING BUILDING SURVEY,
FARM STEADINGS, PITTODRIE HOUSE
HOTEL, ABERDEENSHIRE, AB51 5HS

CAMERON ARCHAEOLOGY
17 December 2010

SUMMARY

A standing building survey was carried out on farm steadings at Pittodrie House Hotel prior to demolition of derelict buildings and conversion of part of the complex into timeshare facilities.

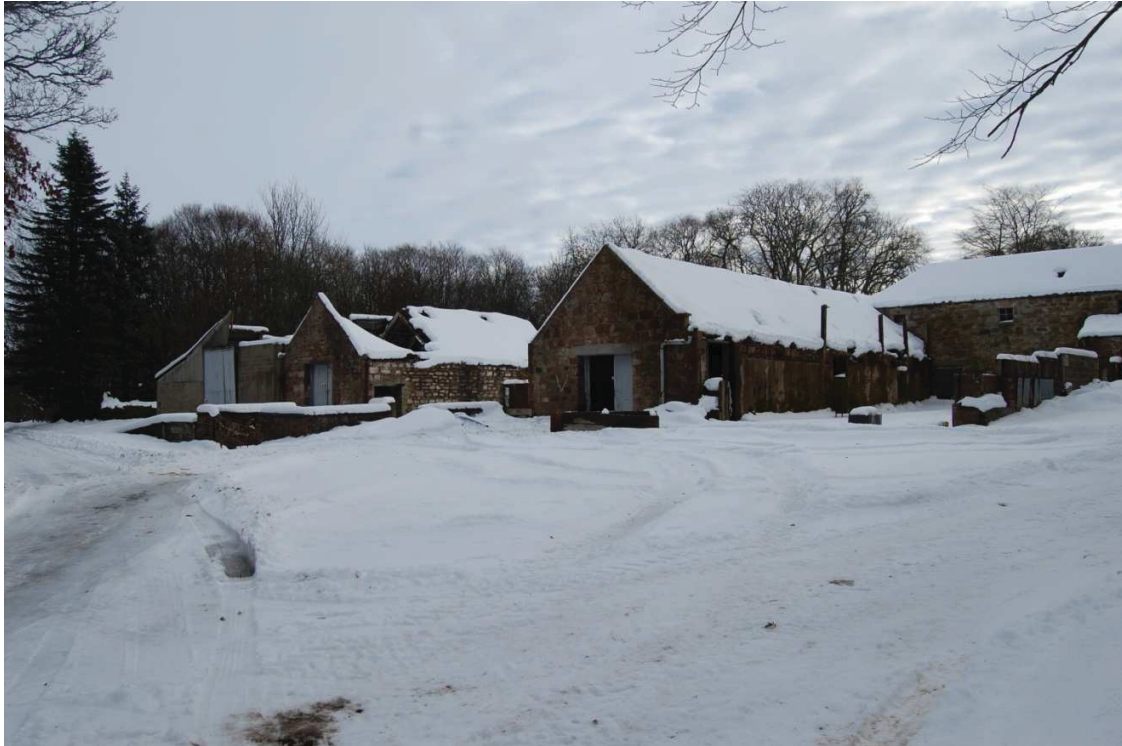
III 4 Building 3 (left) Building 2 (centre) Building 1 (centre right) Building 5 (right)

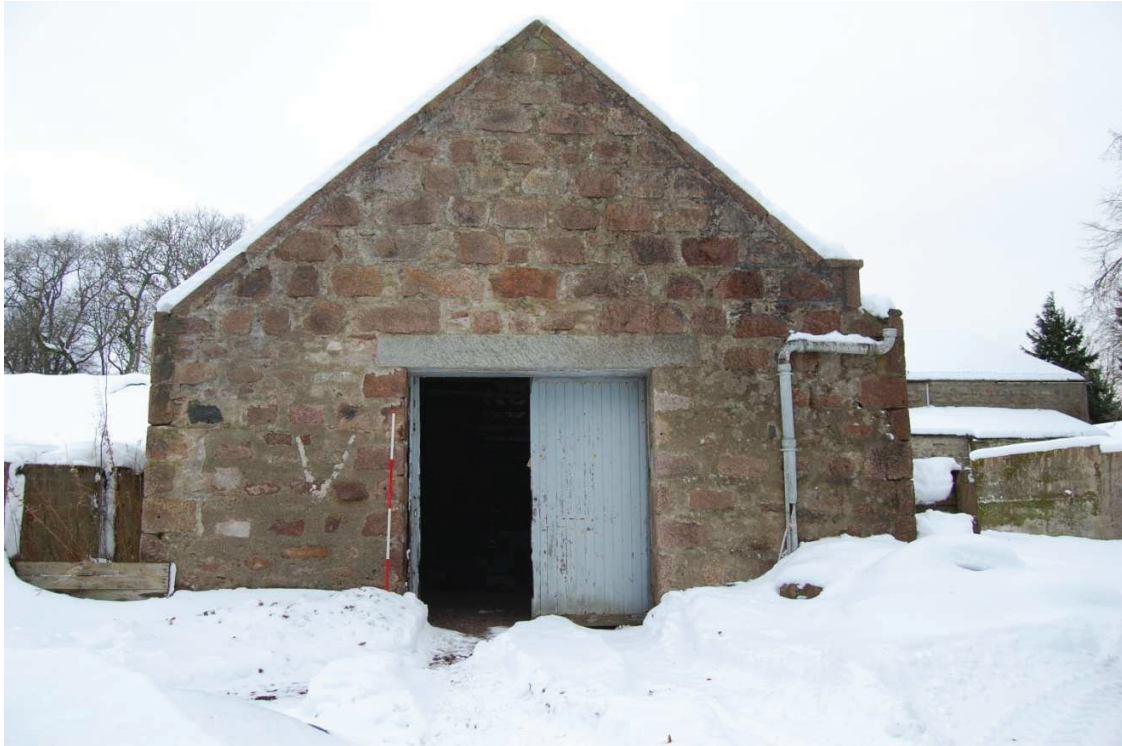
Building 1 is 22 x 8m in size and is constructed mainly of coursed granite rubble with coursed granite blocks on the north gable. Its construction suggests that it is contemporary with Building 2. It has been altered to accommodate cows and has a large barn door on the north gable (III 5). Barns B1 and B2 were part of the Phase 2 steadings and may date from the 19th century. This building is to be retained in the new development and converted for timeshare accommodation.

III 5 Building 1 north gable

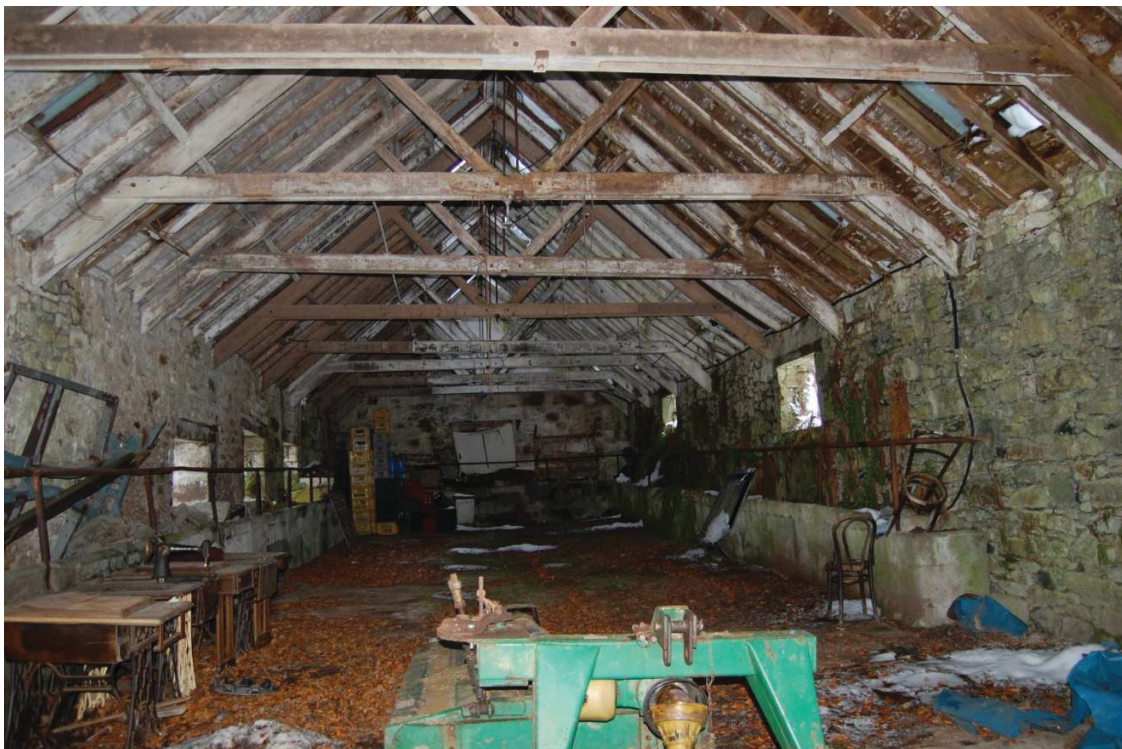
III 6 Building 1 interior facing south

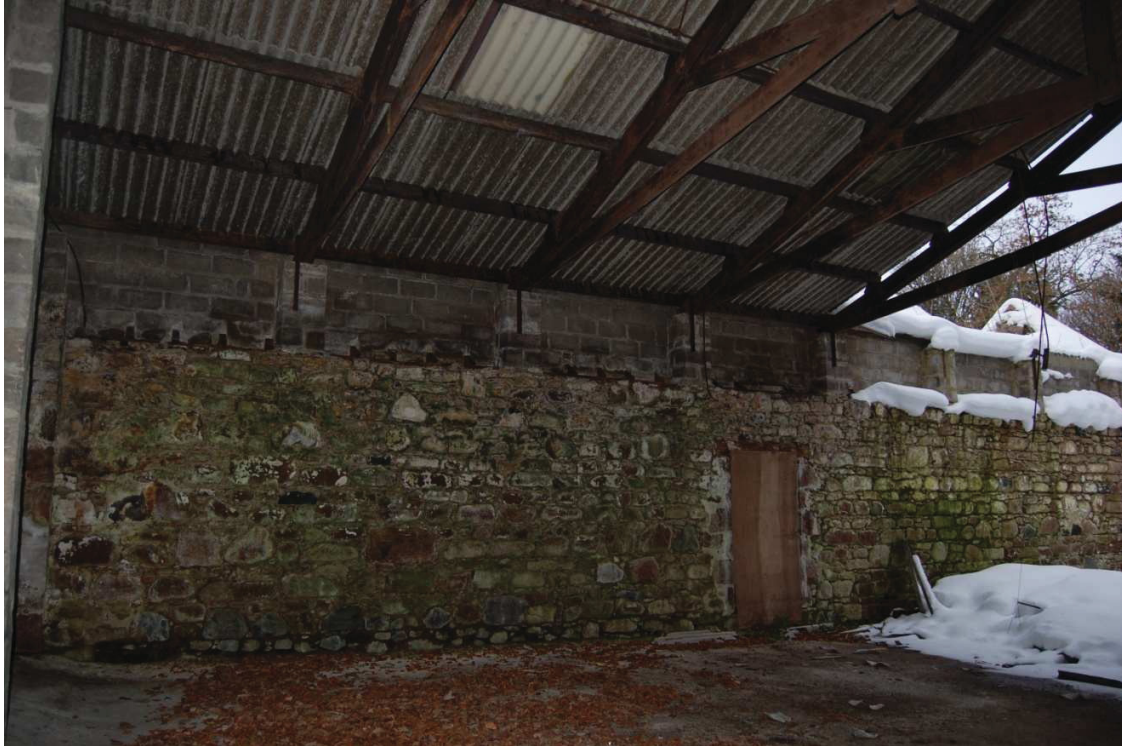
III 7 Building 2 exterior east wall from Building 3; facing WNW

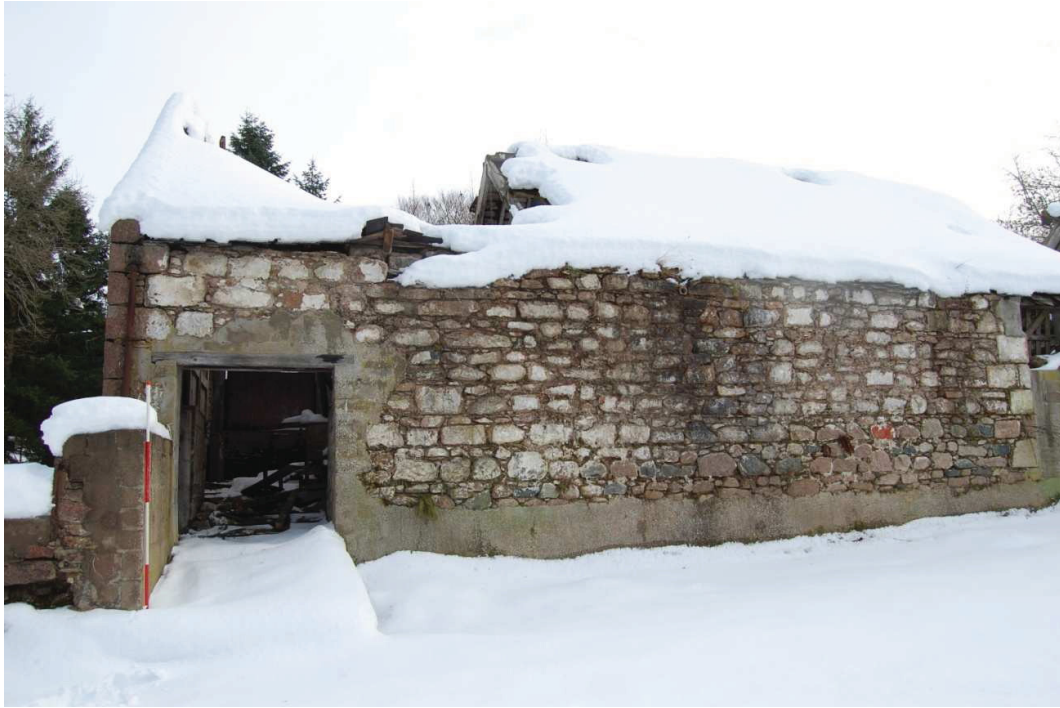
Building 2 is 22 x 8m in size and is constructed of mainly of coursed granite rubble with coursed granite blocks on the north gable. Its construction suggests that it is contemporary with Building 1. It has been altered to accomodate cows and has a large barn door on the north gable (III 5). Barns B1 and B2 were part of the Phase 2 steadings and may date from the 19th century. It is to be demolished during the current development.

III 8 Building 2 west wall showing entrance and collapsed roof

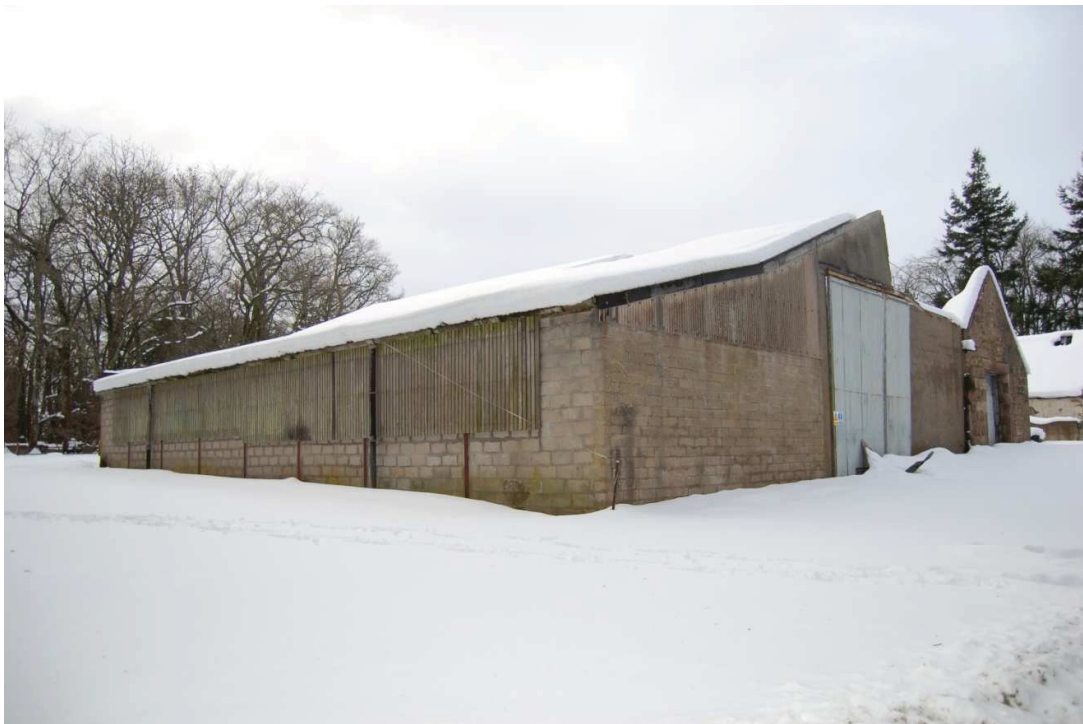
This modern shed was inaccessible during the survey as the roof and walls are in an advanced state of disrepair. It was built in the late 20th century and is to be demolished during the current development.

III 9 Building 3 from SE

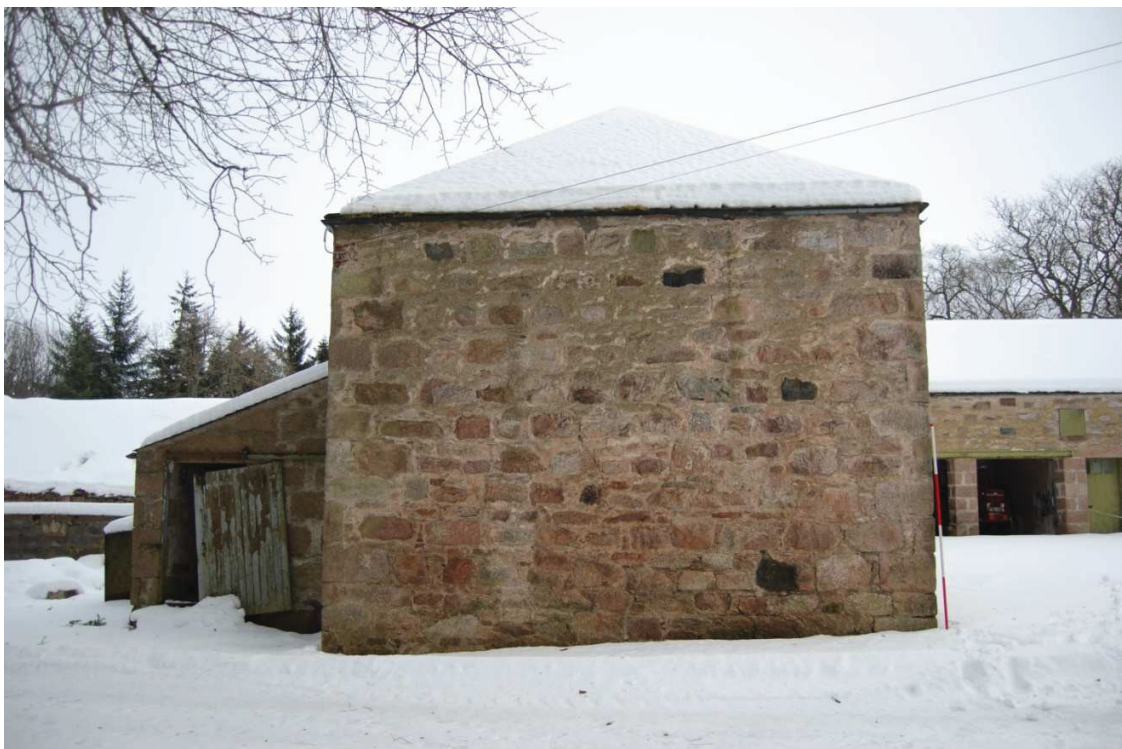
Ill 10 Building 5 from the west

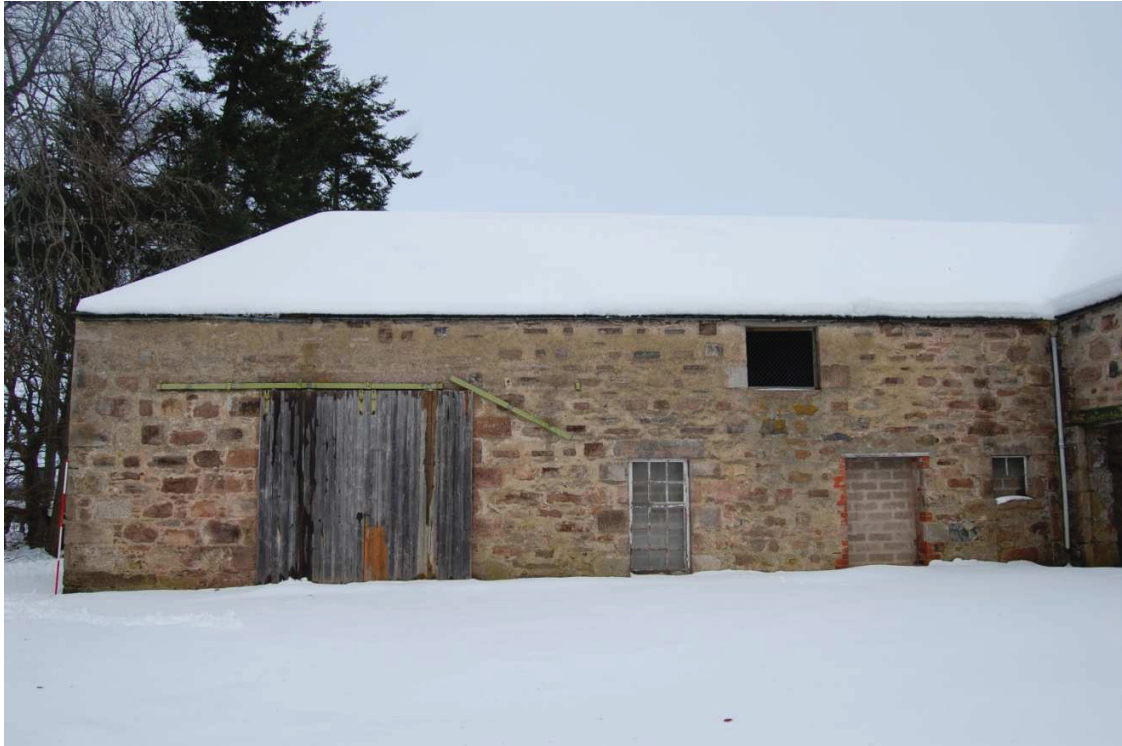
III 11 Building 5 from the south

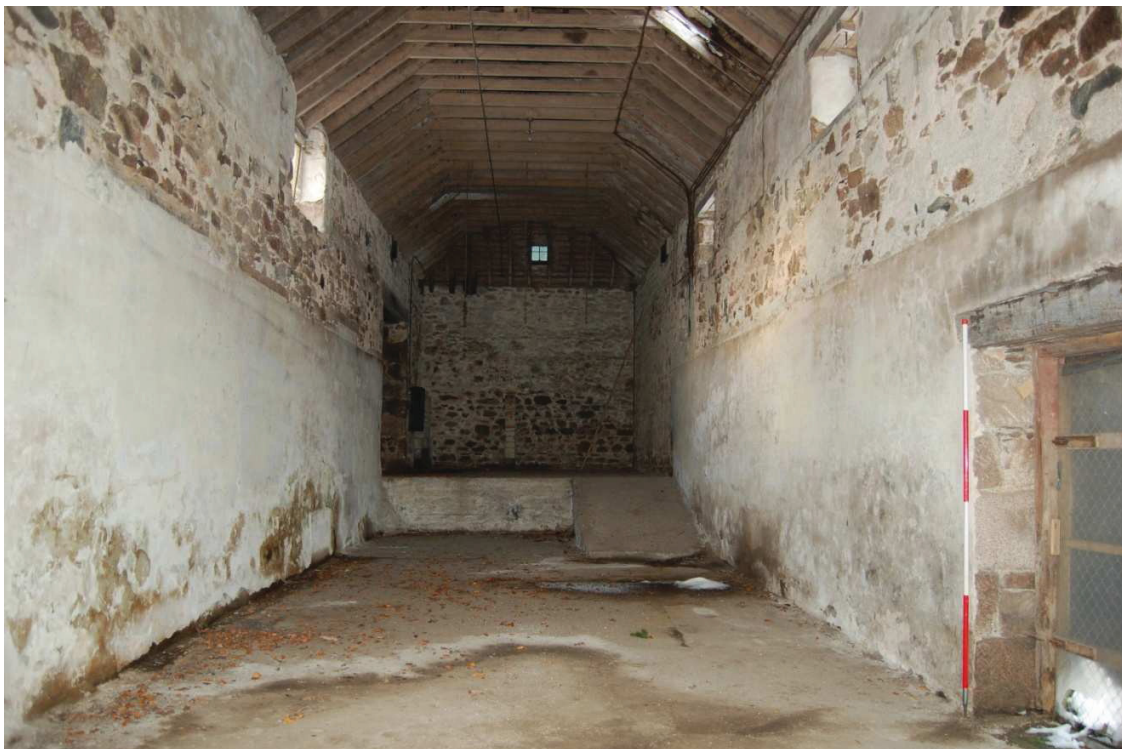
This building is 22 x 6m in size and built of semi-coursed granite blocks. It was probably part of the Phase 1 steading complex but has been extended and added to in recent times. A small extension from the east of this building can be seen on the 1867 OS map (Ill 2) which may have been part of the original layout but was probably demolished when Building 12 was constructed. A small granite rubble lean-to was also added to the north side (Ill 10). The lower walls have been cemented to allow for animal accomodation and the roof heightened in recent times (Ill 12). This building is to be retained in the new development and converted for timeshare accommodation.

III 12 Building 5 facing west

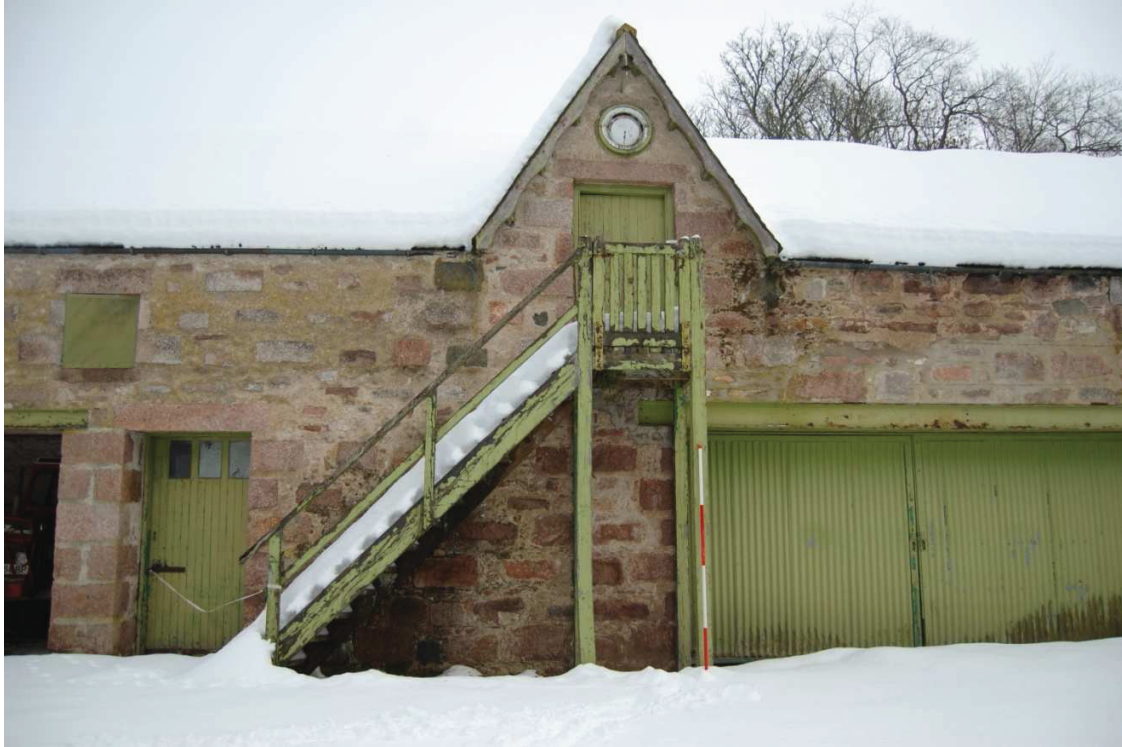
Ill 13 Building 6 facing east showing alterations to the building (right) to accomodate cars

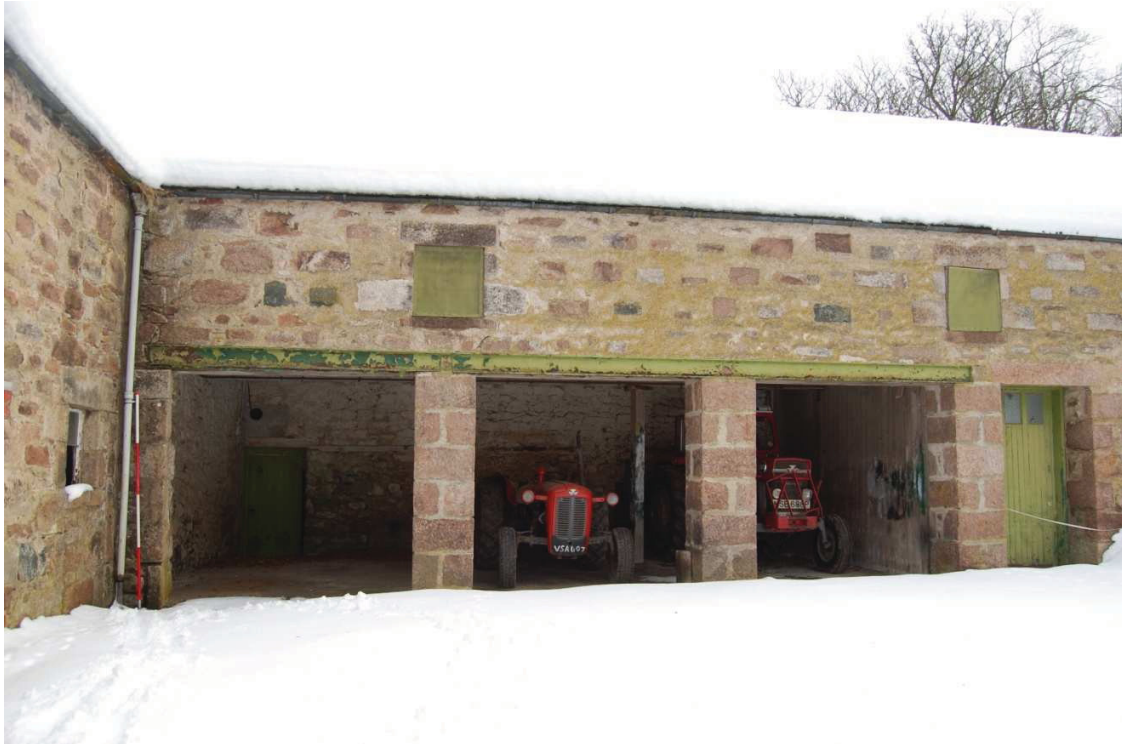
west wall to allow access to a door on the first floor of a gablet. Above this door is an old clock, now in poor condition. The building has been substantially modified in the late 19th or early 20th century to allow accommodation for cars and farm vehicles. This includes three pillars (Ill 14) constructed of large granite blocks on the north end of the west wall of the building to allow for the housing of farm vehicles. This building is to be retained in the new development and converted for timeshare accommodation.

III 14 Building 6 facing east showing granite pillars added to allow accomodation for tractors.

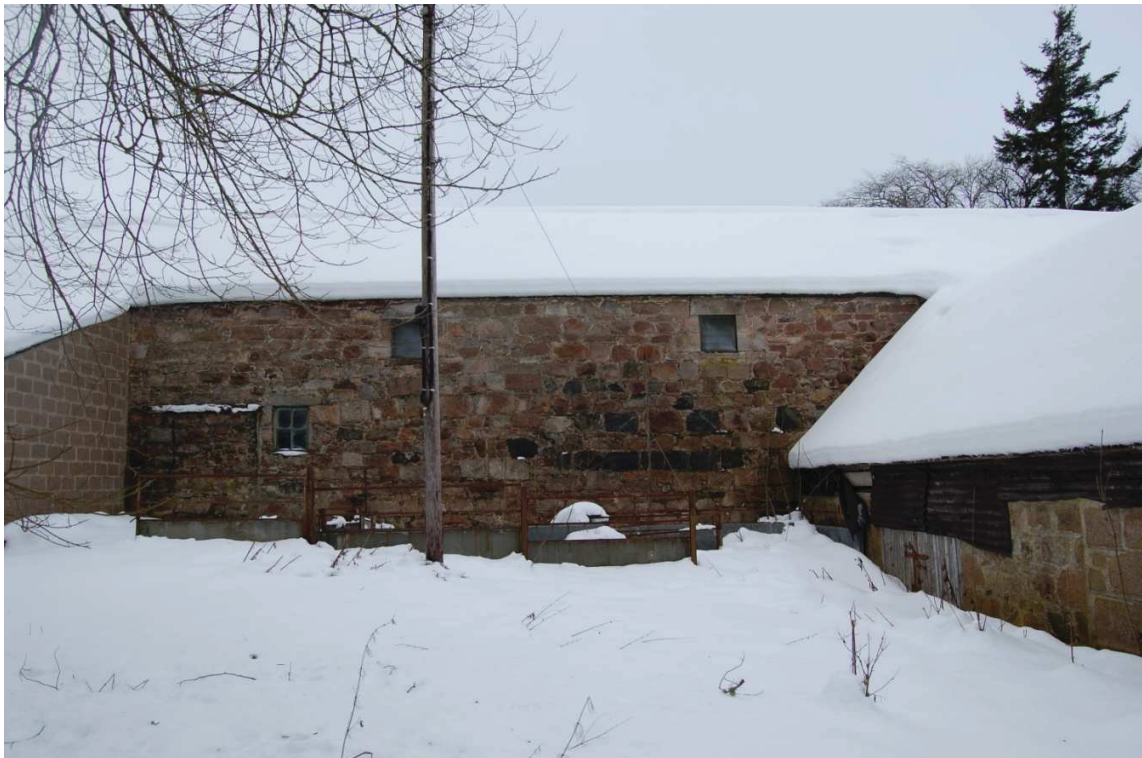
III 15 Building 5 from east showing section of original unaltered granite building with upper skylights

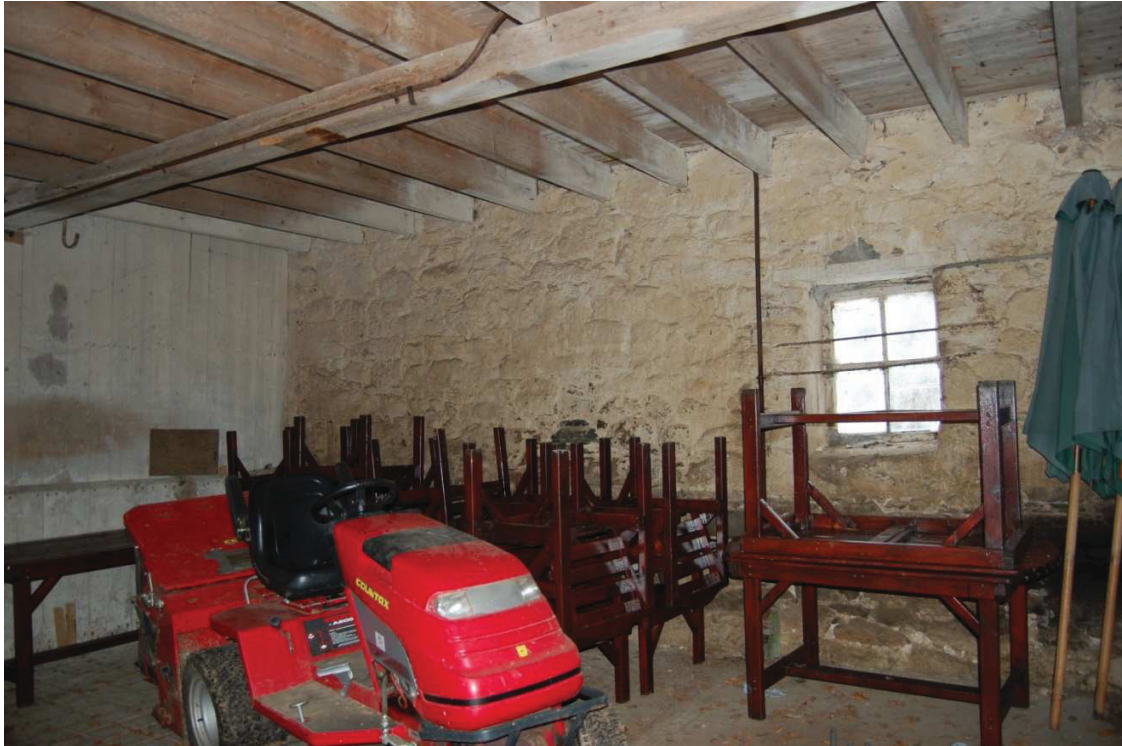
III 16 Building 5 interior facing NE

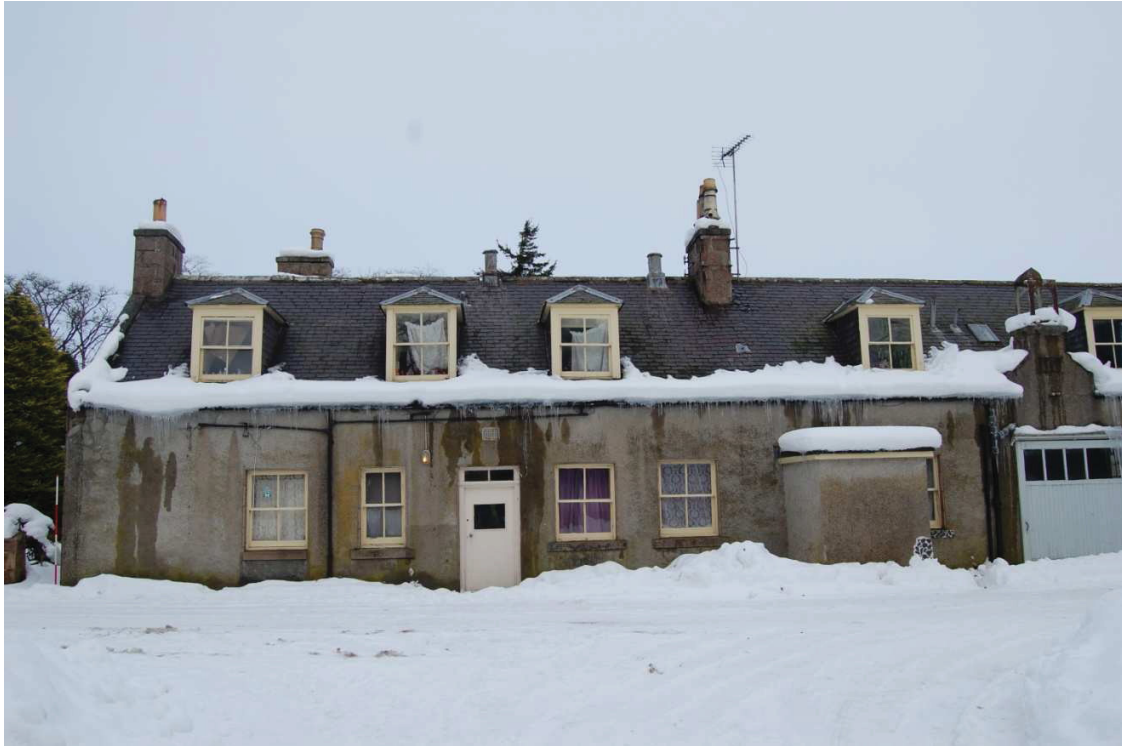
This building is 30 x 6m in length and now forms staff accommodation. It was inaccessible during the survey but has been substantially altered in the 20th century. It is to be retained in the new development and converted for timeshare accommodation.

III 17 Building 7 facing north

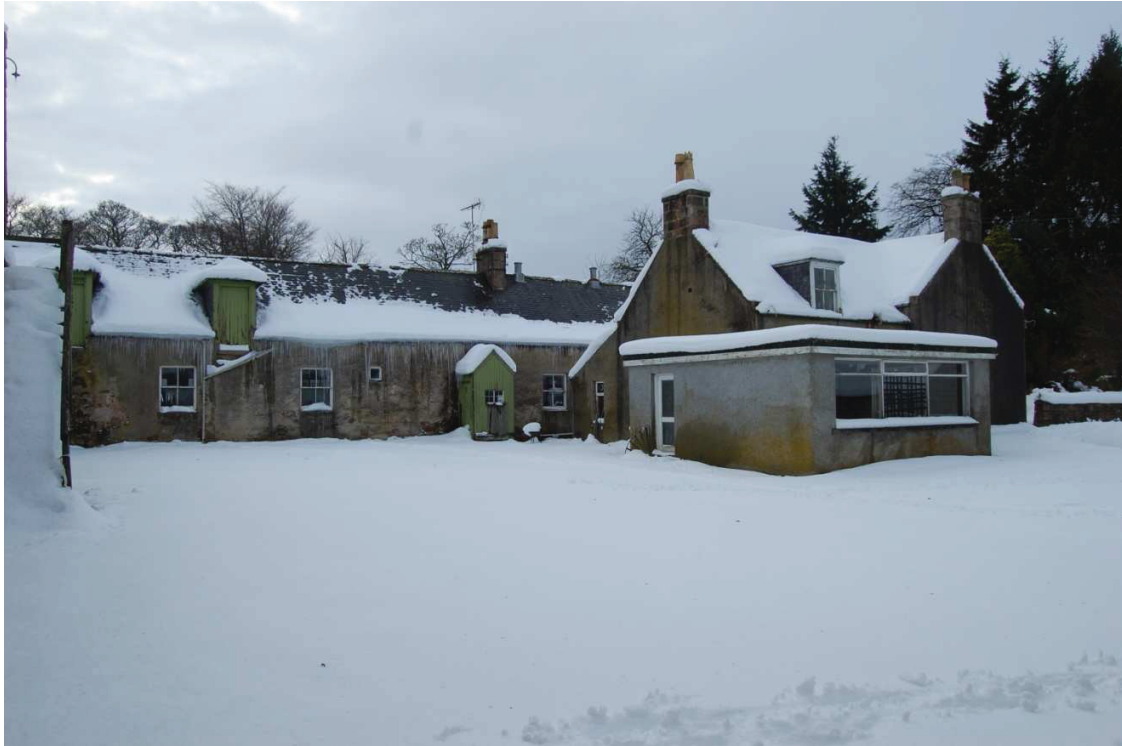
This farmhouse is c 13 x 10m in size and has been substantially altered during the 19th and 20th centuries. This building is to be retained in the new development and converted for timeshare accommodation.

III 18 Farmhouse (Building 8) facing SW

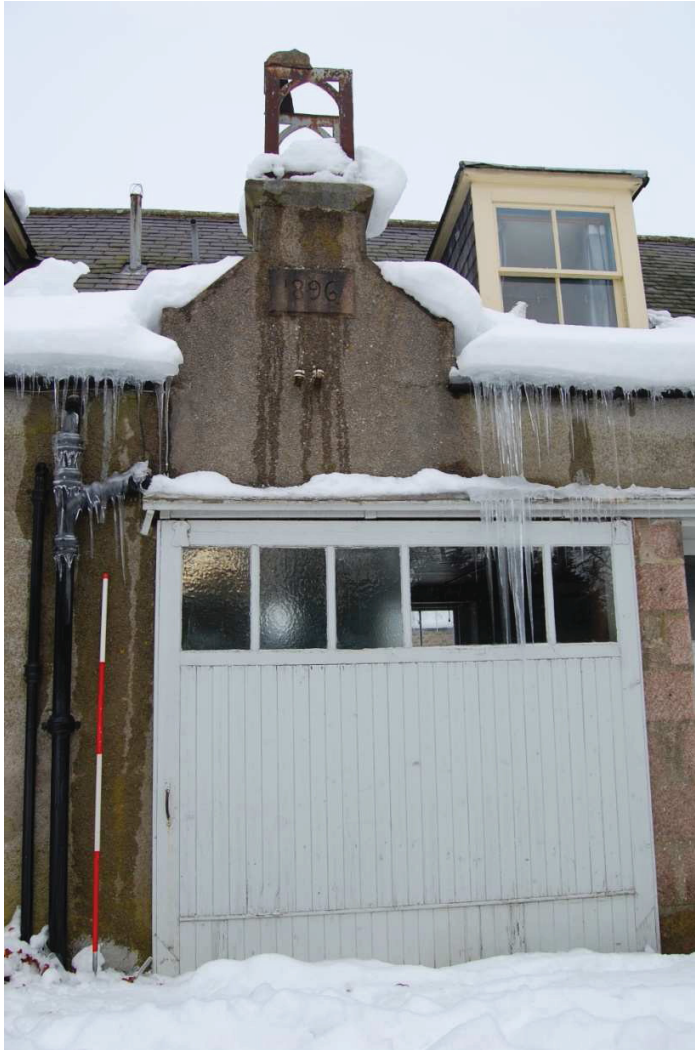
This building is part of original steadings which was altered substantially to accommodate cars in the 20th century. It has a series of garage doors on its south side that accommodated the Laird's Rolls Royce cars (pers comm hotel staff) and there is a date of 1896 (III 19) above the garage door. This is probably the date of the alterations to this building. This building is to be retained in the new development and converted for timeshare accommodation.

III 19 Cottage converted to garages (Building 9) showing date detail, facing north

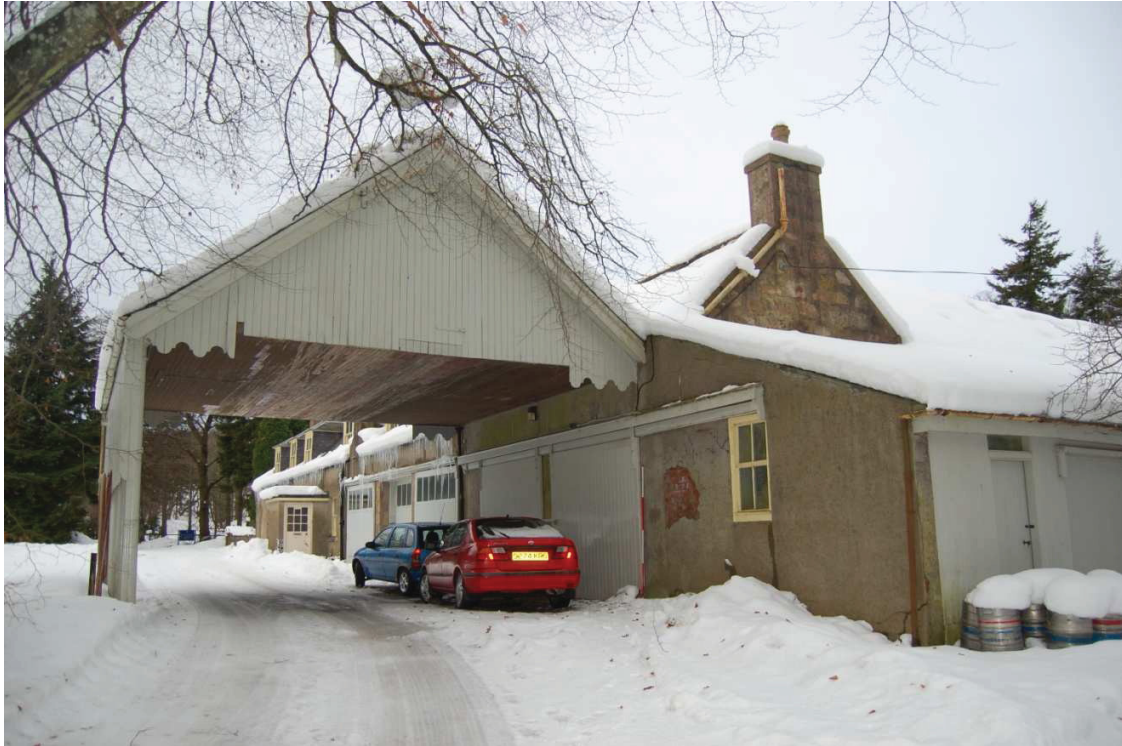
Building 10 is 8 x 8m in size and is a portico built of wood attached on to the south side of garage building B9. It is to be demolished during the current development.

III 20 Building 10, wooden portico attached to south side Building 9; facing NW

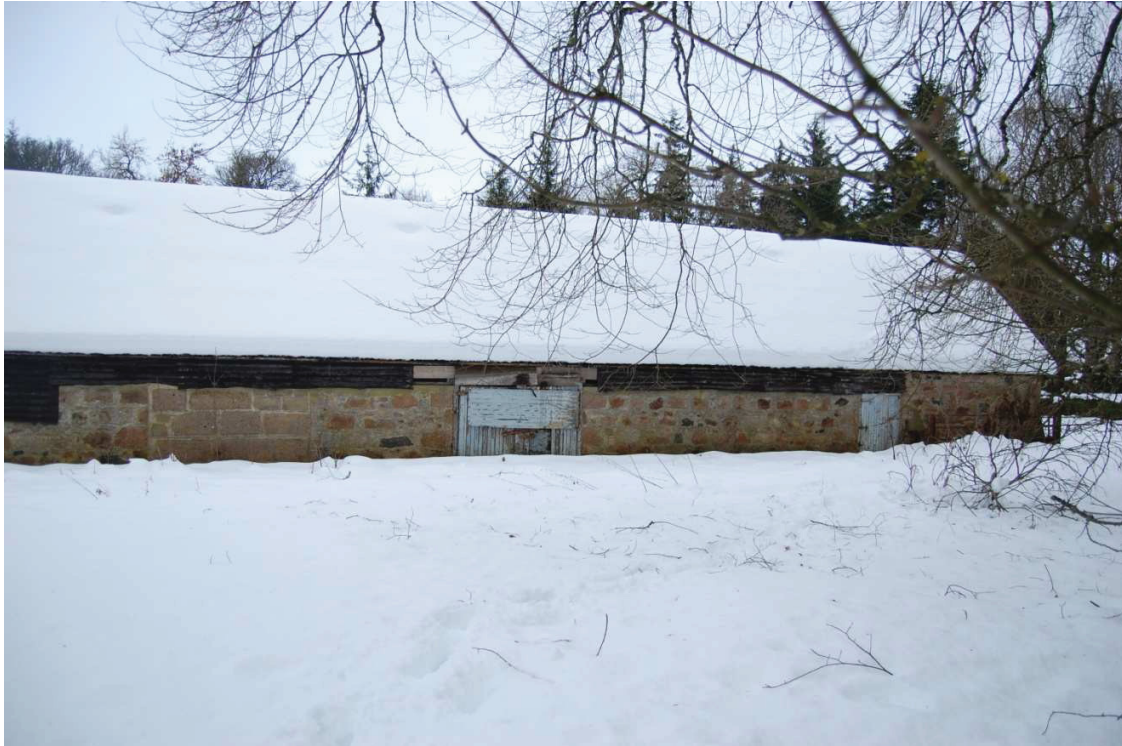
This granite rubble shed is 29 x 6m in size. The interior has been substantially altered for the accommodation of cows and much of the exterior of the building was obscured by snow during the survey. It is to be demolished during the current development.

III 21 Building 11 facing north

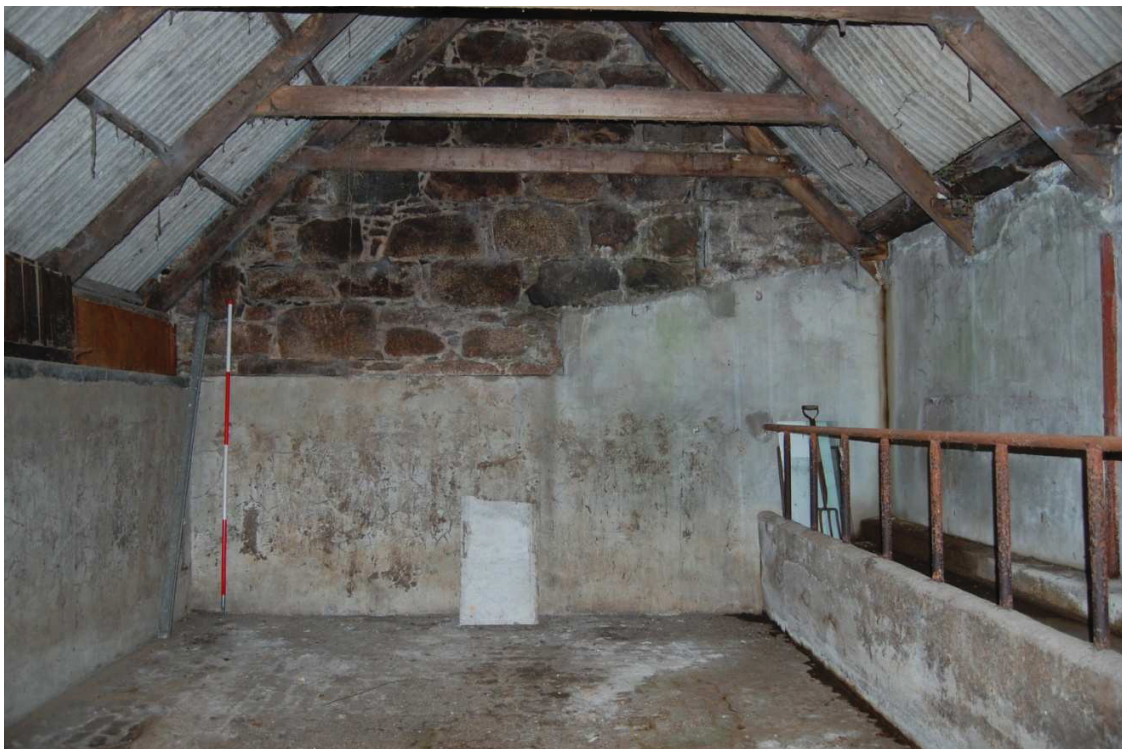
III 22 Building 11 interior concreted for cows; facing west

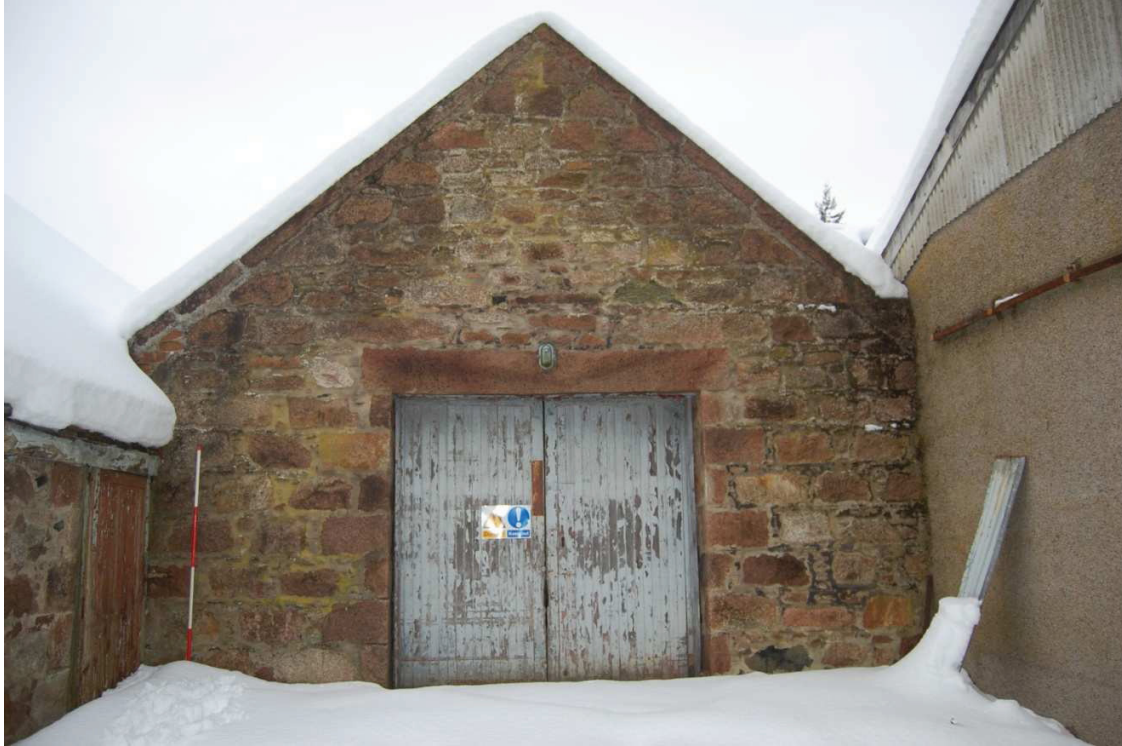
Building 12 is a granite rubble built steading 25 x 8m in size. It is to be demolished during the current development.

Ill 23 Building 12 east gable

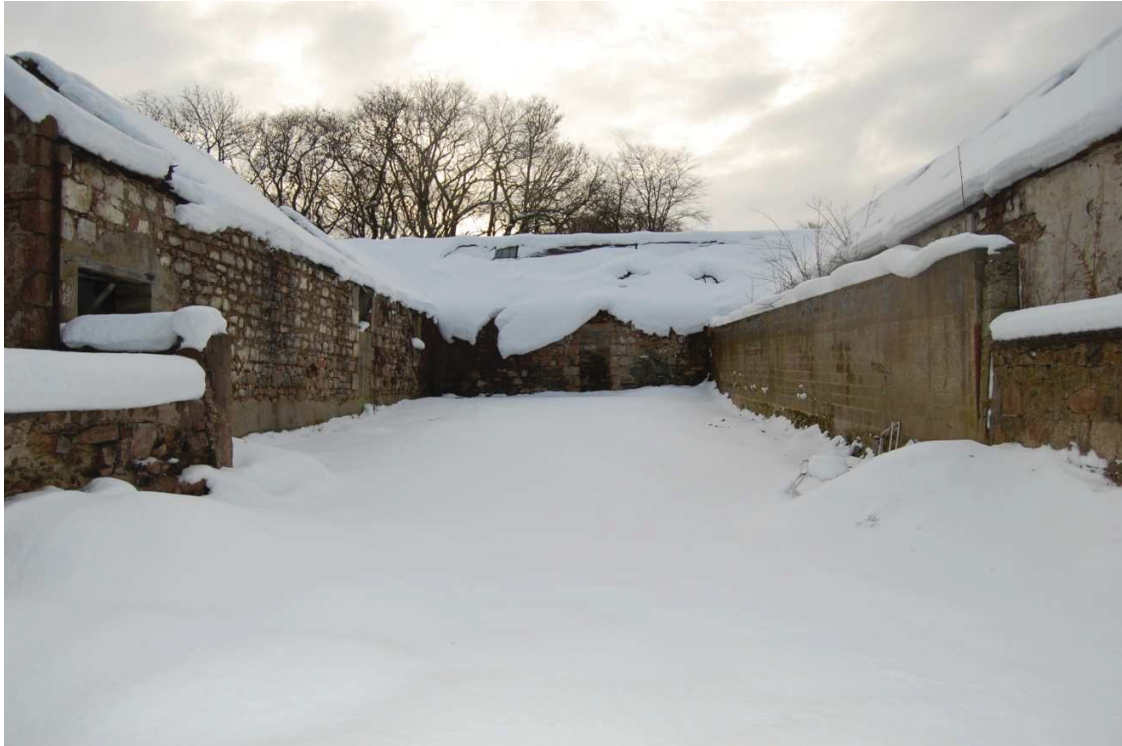
Walled courtyard between Buildings 1 and 2 (Ills 24, 25) is to be demolished during the current building works. A corral or paddock surrounded by a granite wall has been recorded at the north end of the courtyard.

III 24 Courtyard 1 facing south

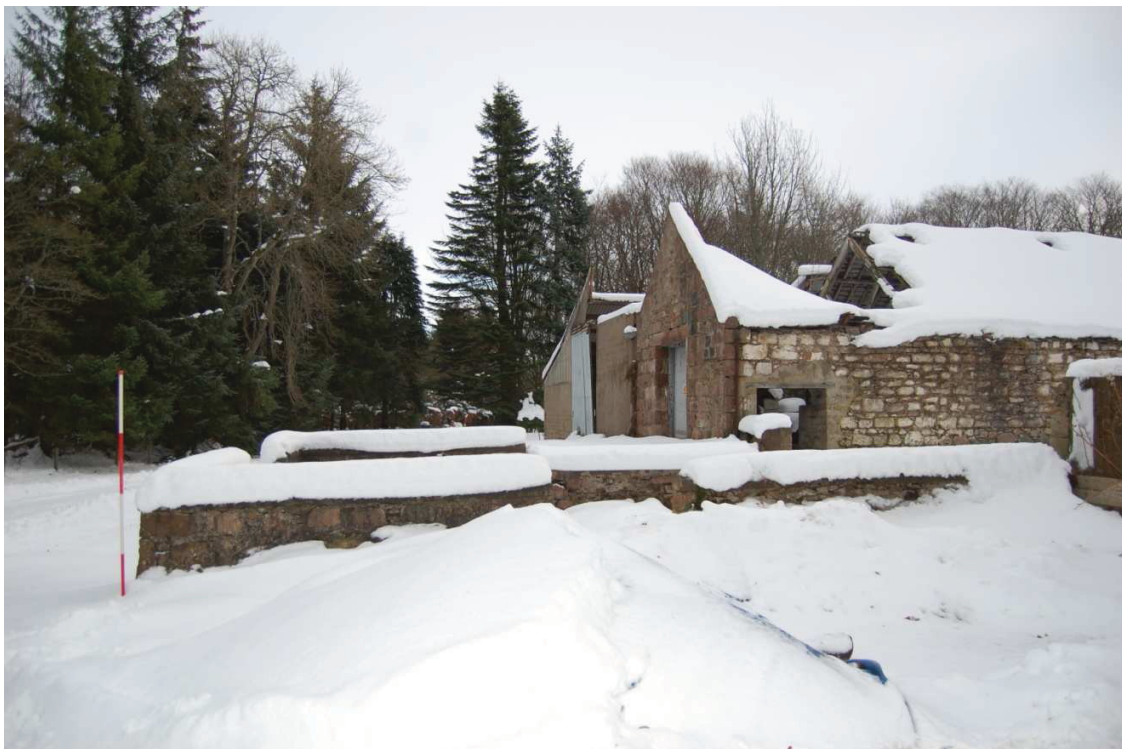
III 25 Courtyard 1 facing east
